Building and Timber Pest Inspection Report

Inspection Date: Mon, 16 Feb 2026

Property Address: 181 Cox St, South Windsor NSW 2756,
Australia

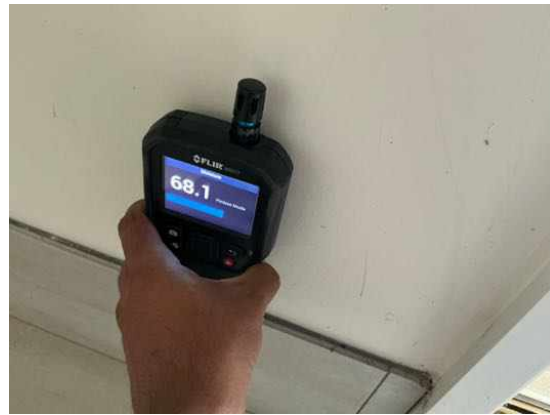
Information: At the time of inspection, rising damp was identified within the property. This condition results from the upward movement of moisture through porous building materials, such as bricks, sandstone, or mortar, via capillary action. A damp-proof course (DPC), an impermeable barrier installed at the base of walls above ground level during construction, is typically used to prevent rising damp. However, the absence, deterioration, or bridging of the DPC can compromise its effectiveness, specially in older buildings, leading to moisture ingress. Inadequate site drainage, which allows water to accumulate around the foundation, is a common contributing factor to this issue.

If left unaddressed, rising damp can pose significant health risks due to mould growth and cause extensive damage to building elements, including wall finishes such as paint and plasterwork. The current condition should be monitored over a 12-month period to assess its progression.

It is strongly recommended that the client engage a qualified damp-proofing specialist for remedial actions. Additionally, consulting a qualified plumber or drainage specialist to assess and improve site drainage is advised to mitigate further risks. Monitoring the condition for 12 months is essential to evaluate its status and prevent potential recurrence or further damage.

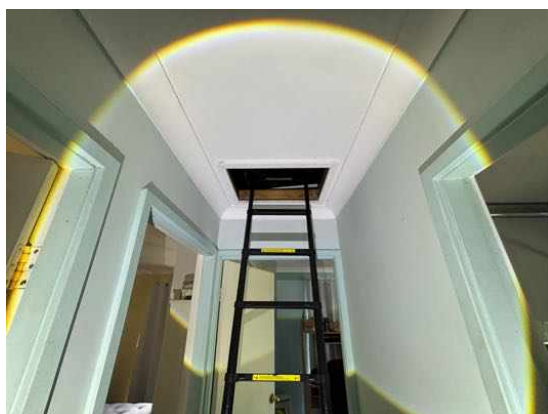
Building:	Main Building
Location:	Roof Void
Finding:	Vent - Extracted into Roof Space
Information:	During the inspection, it was noted that the exhaust vent has been improperly terminated into the roof space instead of being ducted to the exterior of the property.

This configuration is a defect as it allows moist air to accumulate within the roof cavity, increasing the risk of condensation, mould growth, and deterioration of insulation or timber framing. Proper ventilation is essential to maintain a healthy indoor environment and protect the structural integrity of the building. It is recommended that the vent be appropriately re-routed to discharge externally in compliance with relevant building standards.

A licensed mechanical ventilation contractor/electrician should be appointed as soon as possible to provide further consultation on the scope of these works and to provide

quotations for any necessary works.

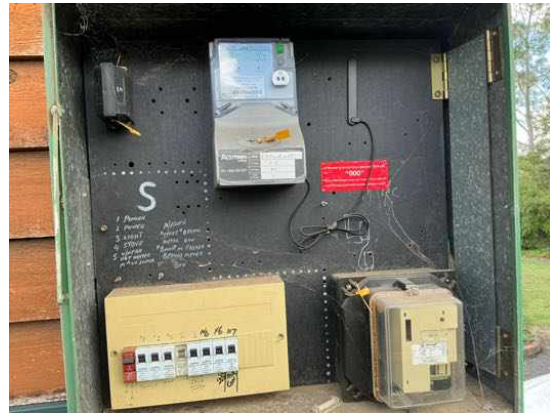
Building:	Main Building
Location:	Meter Box
Finding:	Termite Management System - No Evidence of Installation
Information:	The application of a post-construction chemical termite barrier is strongly recommended for all properties, especially if there has been any history of live termite activity on-site. These barriers are highly effective in protecting timber building elements throughout the property by preventing termite attacks. It is also advisable to install a durable notice within the switchboard unit, indicating the presence of any termite barriers for future reference.

licensed pest controller regarding the costs and procedures involved in the application of a termite barrier. Prioritizing this step in the short term is strongly advised to ensure long-term protection.

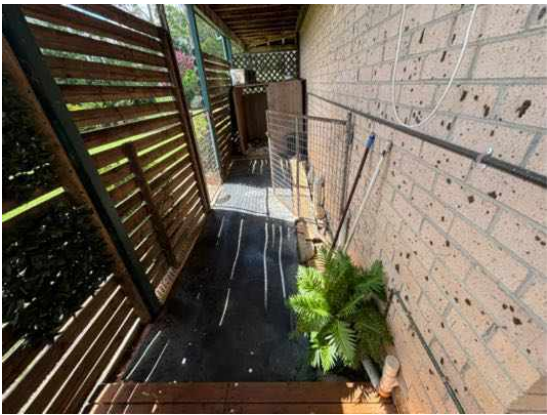
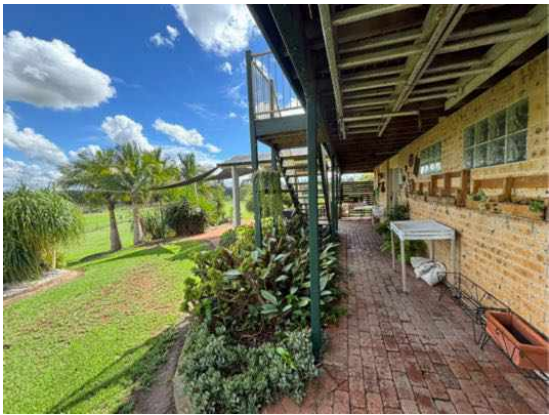
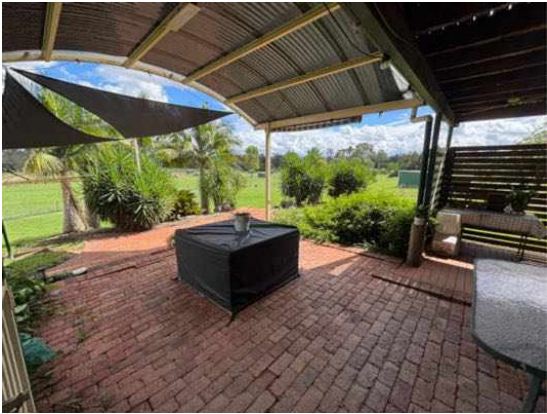
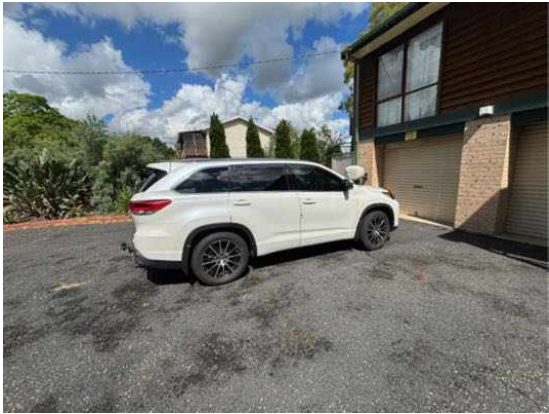
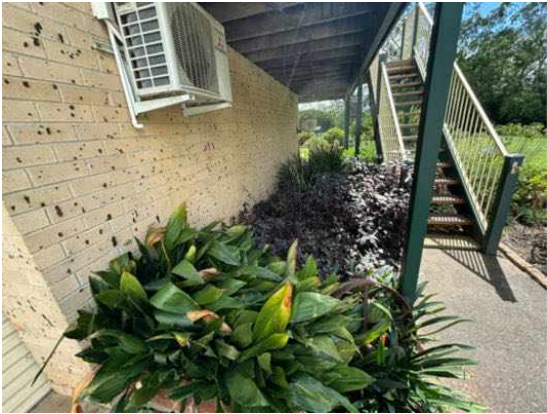
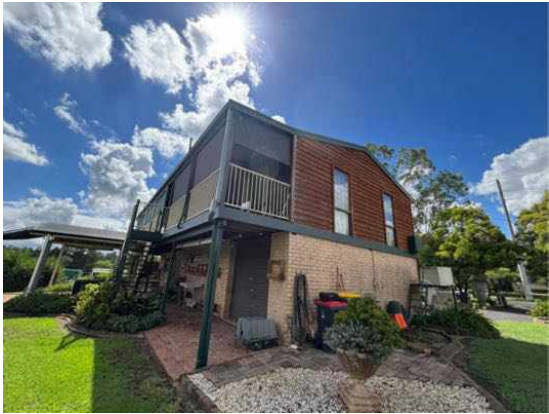
It is essential that these obstructions be cleared to allow for a comprehensive inspection of the external areas. Removing these barriers will enable a more accurate assessment of the property's condition and allow any hidden defects to be identified and addressed promptly. Failure to do so could result in undetected issues worsening over time, potentially leading to more costly repairs in the future.

Therefore, it is strongly recommended that the obstructions be removed and a re-inspection be scheduled once the affected areas are made fully accessible. This will ensure a complete evaluation of the property's exterior and provide the client with a clear understanding of any potential issues that may have been concealed during the initial inspection.

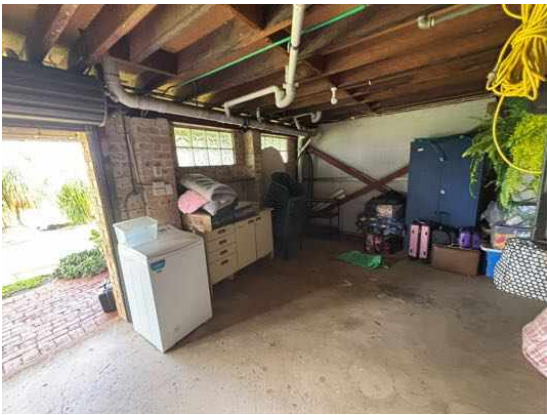
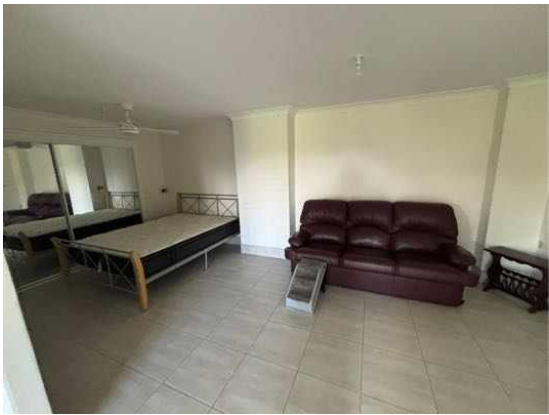
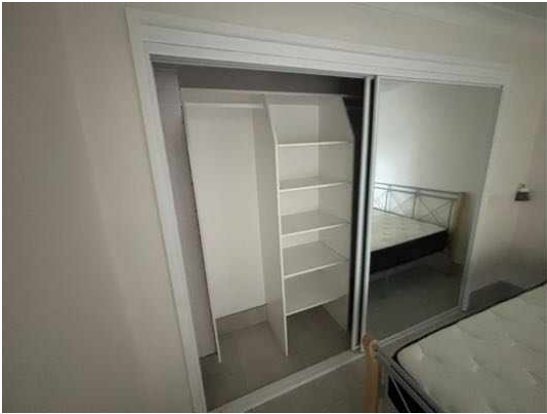
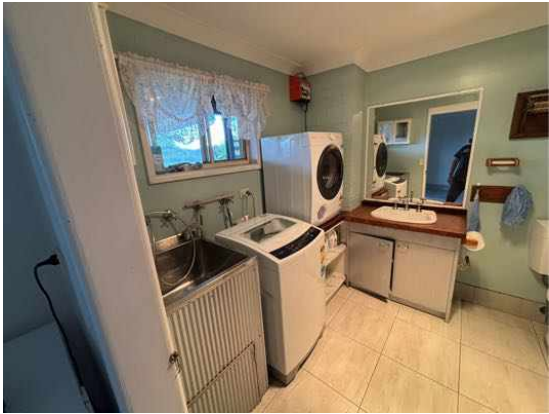
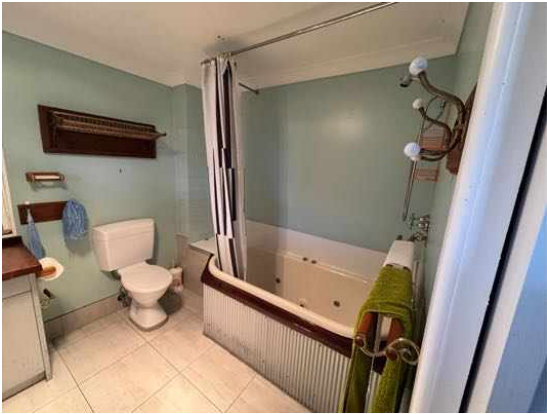
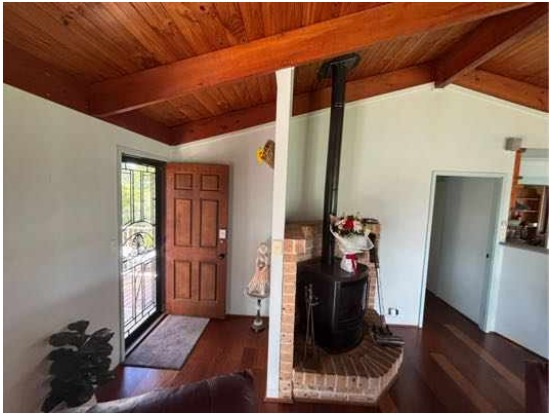
Building:	Main Building
Location:	All Internal Areas
Finding:	Obstructions and Limitations - Internal Areas
Information:	<p>The accompanying photographs provide clear evidence of the obstructions and limitations that restricted a comprehensive inspection of the internal areas of the property at the time of assessment. These obstructions, which may include furniture, personal belongings, stored items, or structural elements such as wall coverings and built-ins, significantly hindered the ability to thoroughly evaluate these areas. It is important to note that such obstructions can potentially conceal a wide array of defects, ranging from hidden structural damage, water leaks, pest infestations, or electrical issues, to deteriorating materials that may not be visible during the initial inspection.</p>

In summary, the limitations encountered during the inspection highlight the importance of ensuring full access to all areas of the property to accurately assess its overall condition. A re-inspection is strongly advised once these areas are made accessible.

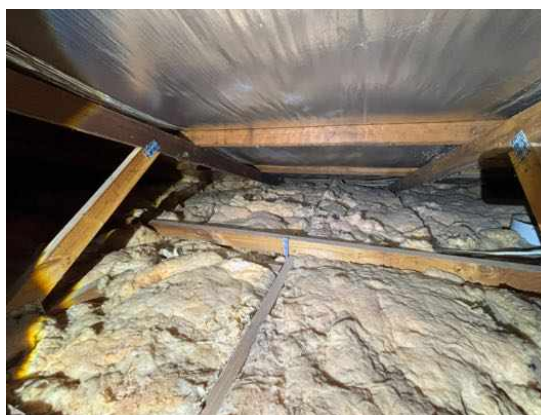
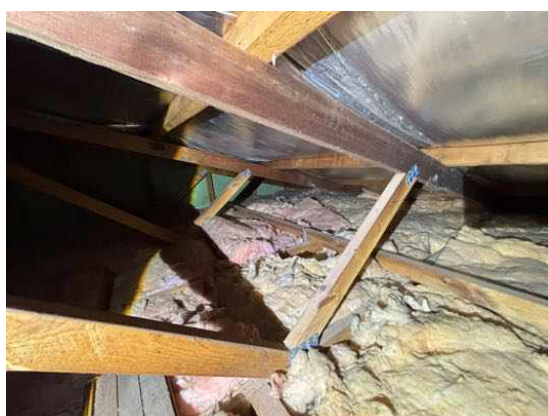
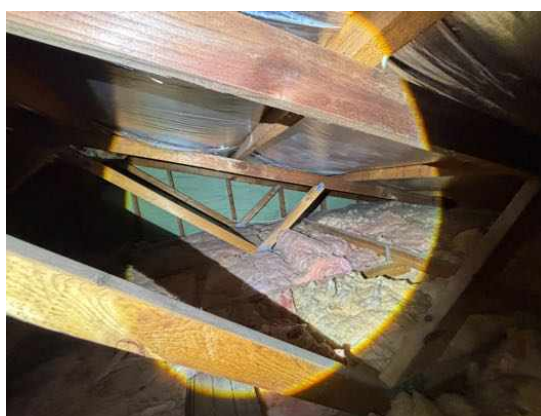
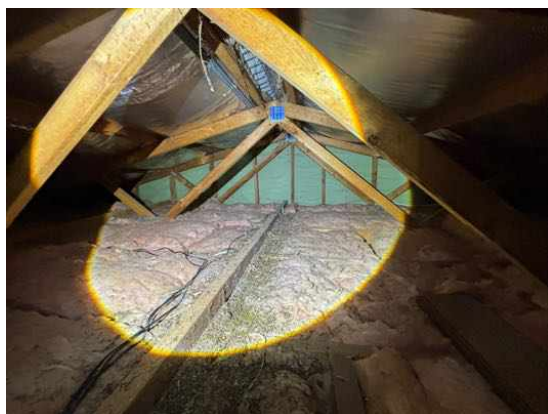
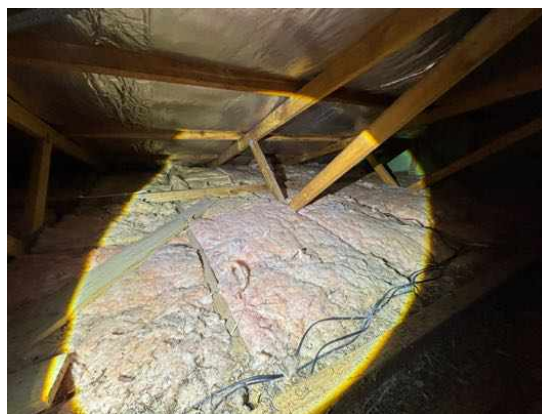
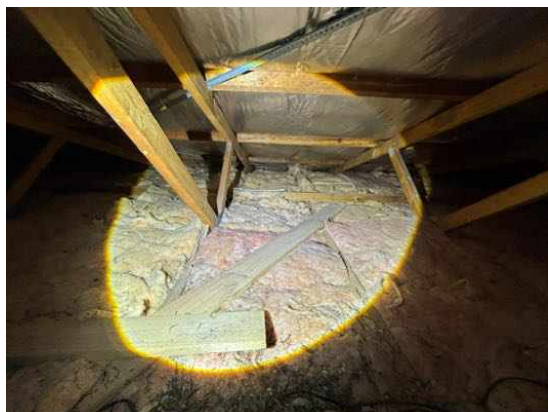
Building: Main Building
Location: Roof Void
Finding: Obstructions, Limitations, and General Roof Space Condition
Information: The photographs provided document both the general condition and the obstructions and limitations that were present in the roof cavity of the main building at the time of inspection. These obstructions—such as insulation materials, stored items, structural elements, or electrical wiring—restricted safe and adequate access to key areas within the roof space. As a result, a comprehensive inspection of all components could not be completed.

Obstructions of this nature may conceal a variety of potential defects, including damaged framing, compromised insulation, evidence of moisture ingress, pest activity, or electrical hazards. While no major issues were observed in the visible areas, the presence of these limitations means that some defects may remain undetected.

It is recommended that these barriers be removed or repositioned to facilitate full and safe access to the roof space. Once clear, a follow-up inspection should be conducted to allow for a thorough assessment of all concealed areas. This will help ensure that the condition of the roof cavity is accurately evaluated and any hidden issues are appropriately identified and addressed.

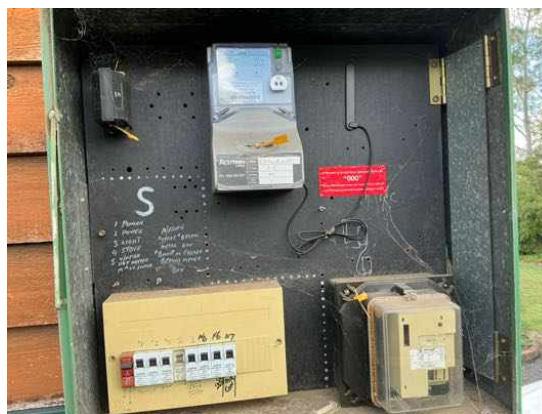
Building: Main Building
 Location: Meter Box
 Finding: Termite Management Recommendation – No Evidence of Chemical Installation
 Information: At the time of inspection, there was no visible evidence of a chemical termite management system installed around the property. Chemical barriers are a key component of termite protection and are particularly important in preventing concealed termite entry into timber elements of the structure.

In accordance with standard requirements, a durable notice should be located within the electrical switchboard to detail any termite protection systems applied, including chemical treatments. No such notice was observed during the inspection.

It is recommended that the client engage a licensed pest controller to assess the suitability of installing a chemical barrier, and to provide advice on associated costs and procedures. This should be considered a short-term priority, particularly if the property has any history of termite activity or is located in a high-risk area.
