Building and Timber Pest Inspection Report

Inspection Date: Fri, 6 Feb 2026

Property Address: 51 Homewood Dr, Mooroopna VIC 3629,
Australia

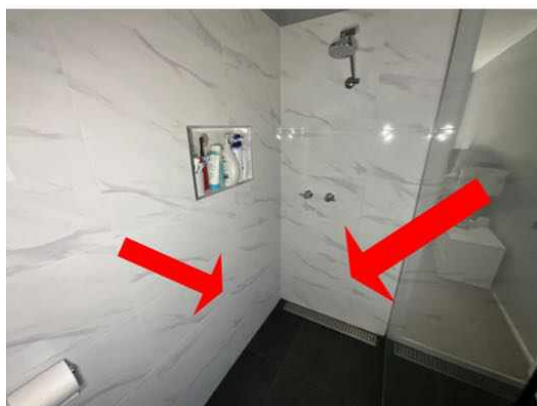
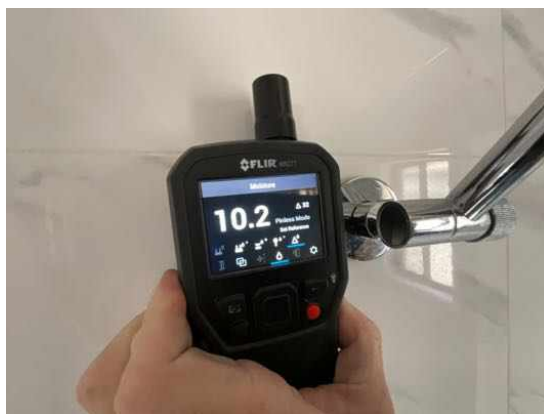
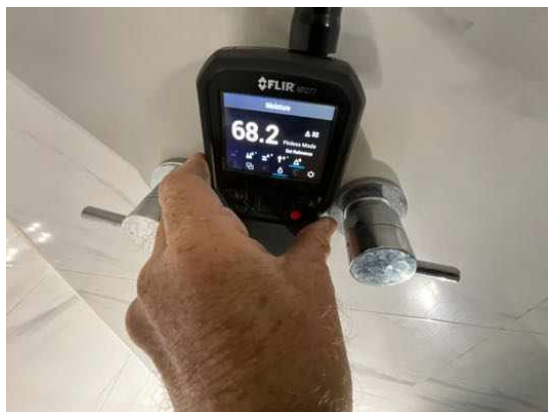
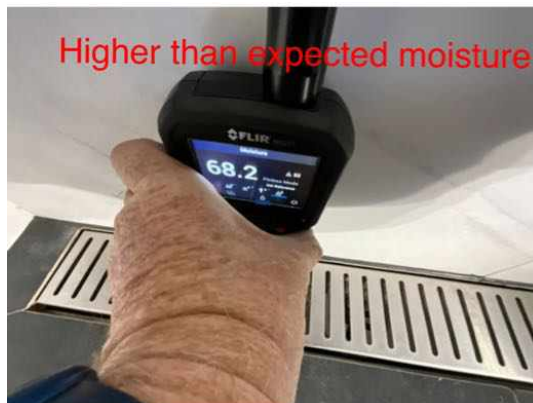
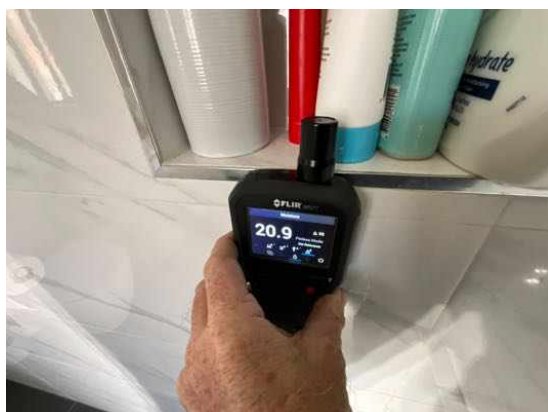
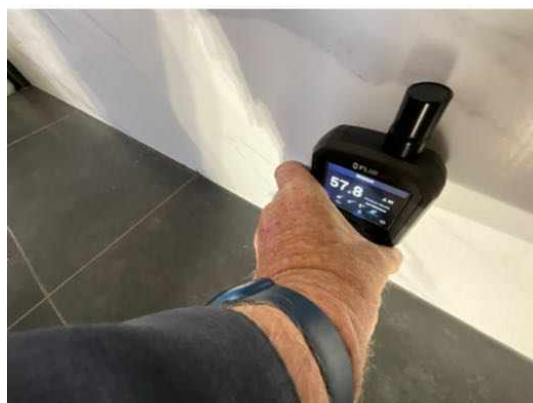
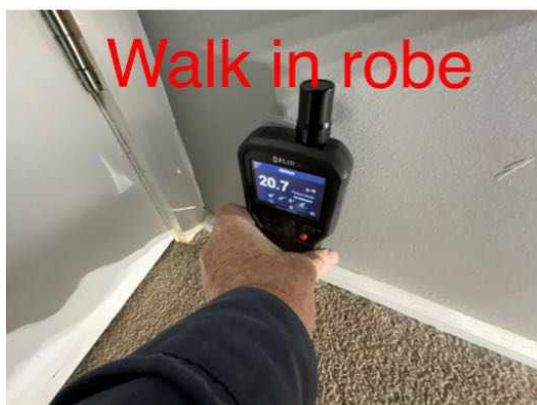
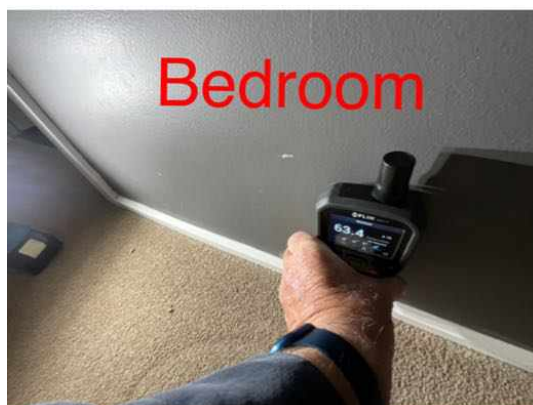
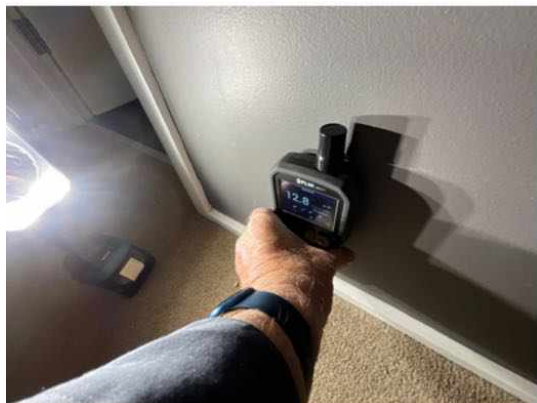
Finding 3.01

Building:	Building 1
Location:	Ensuite
Finding:	Shower damp- Monitor
Information:	Damp is evident to the lower 400mm of wall to the shower alcove.

This defect is quite common, and is suspected to have been caused by moisture permeating or leaching through the grouting and perhaps gaps in the sealant prior to repair.

Monitoring the area is advised and if any visual signs of excessive moisture appear (peeling paint, mould) then consultation with a qualified plumber or bathroom specialist would be advised to identify the cause of damp and to perform remedial works as required.

Always ensure that sealant and grout is in good condition to prevent any moisture issues occurring in the future.

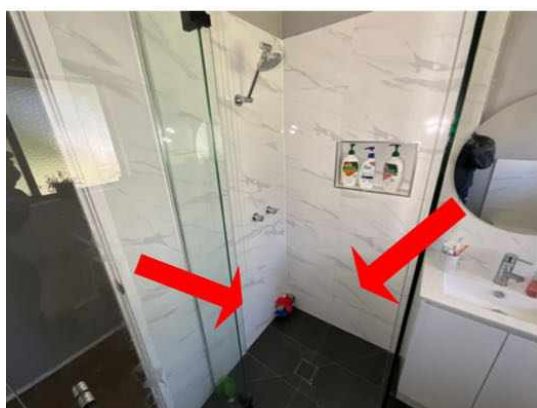
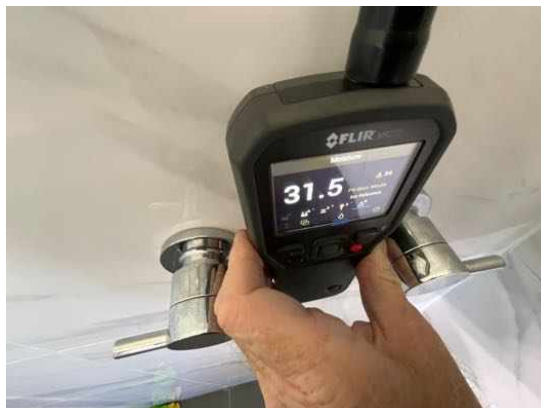
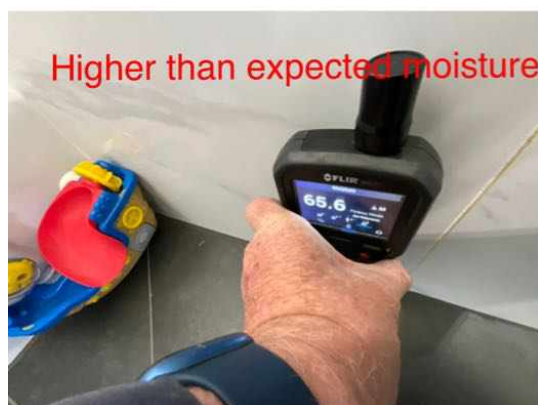
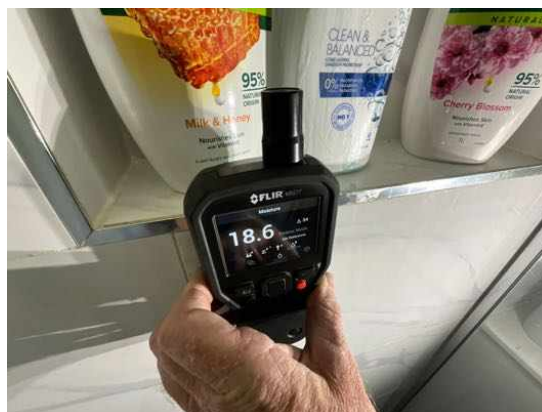
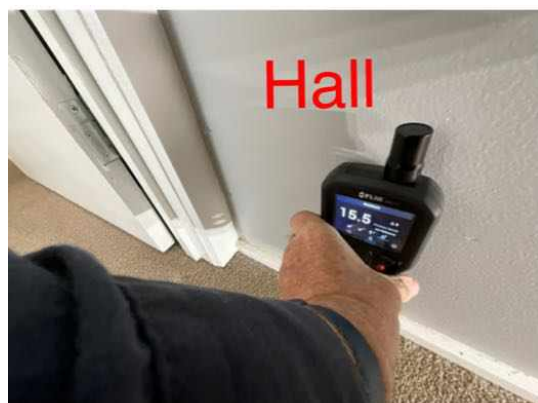
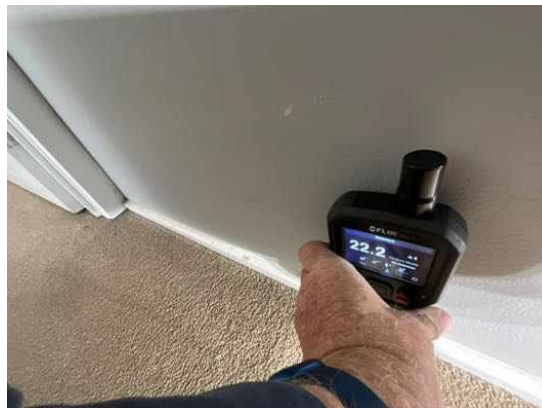
Finding 3.02

Building:	Building 1
Location:	Bathroom
Finding:	Shower damp- Monitor
Information:	Damp is evident to the lower 400mm of wall to the shower alcove.

This defect is quite common, and is suspected to have been caused by moisture permeating or leaching through the grouting and perhaps gaps in the sealant prior to repair.

Monitoring the area is advised and if any visual signs of excessive moisture appear (peeling paint, mould) then consultation with a qualified plumber or bathroom specialist would be advised to identify the cause of damp and to perform remedial works as required.

Always ensure that sealant and grout is in good condition to prevent any moisture issues occurring in the future.

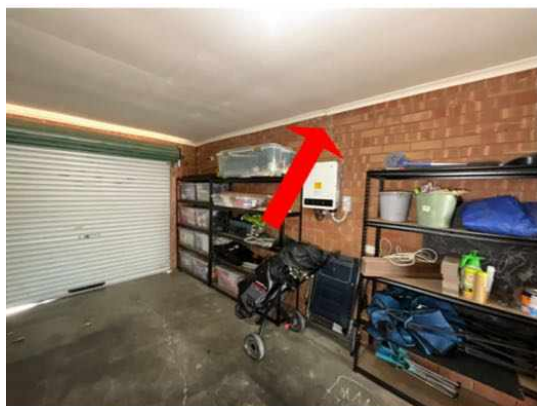
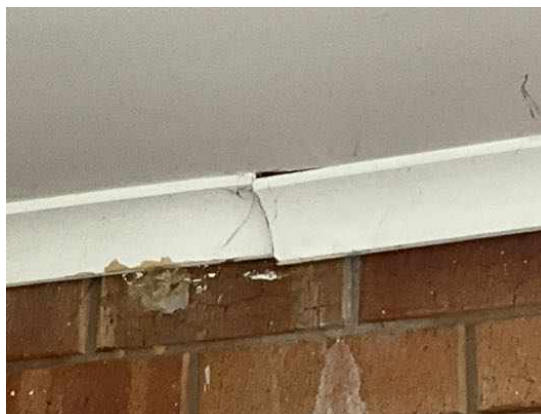
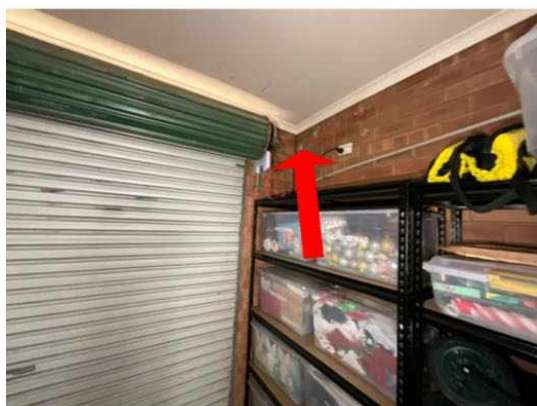
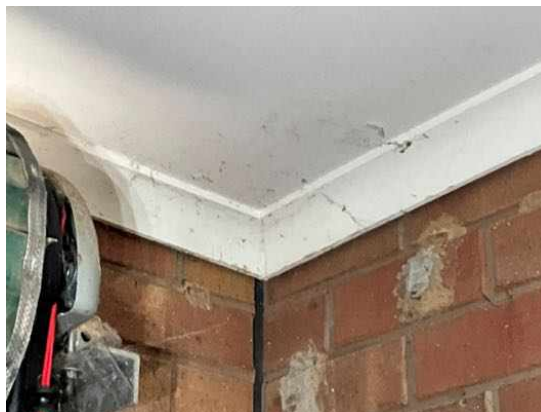
Finding 3.03

Building:	Building 1
Location:	Garage
Finding:	Ceiling - Sagging
Information:	Sections of the ceiling were found to be sagging at the time of inspection. Sagging to the fixed ceiling structure generally indicates that the building materials have swollen, due to contact with water, or that fixings (e.g. nails or glue) have become loose and require reattachment.

Where minor sagging is evident, comparatively minor works, such as re-gluing of ceiling sheets, may be required. Such works may be performed by relevant tradespeople, such as plasterers and painters. Where excessive moisture has caused the roofing structure to swell and sag, the source of the water leak should primarily be identified prior to any remedial works being performed.

In some cases, sagging ceiling linings may also indicate that there are structural issues, causing surfaces to warp, twist or sag. Where sagging appears to be major, appointment of a structural engineer is advised to further inspect the property and identify the source and rectification works required.

The appropriate action should be taken by the client as soon as possible to ensure that any potential further damage is limited.

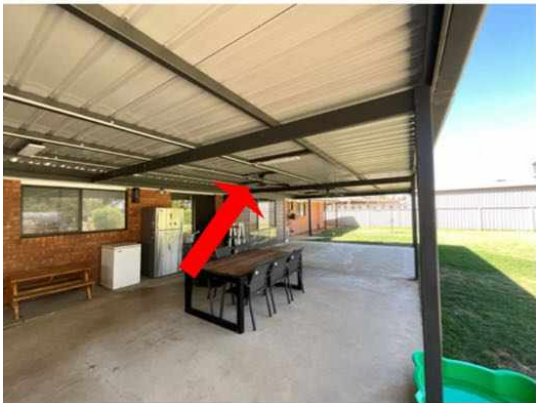
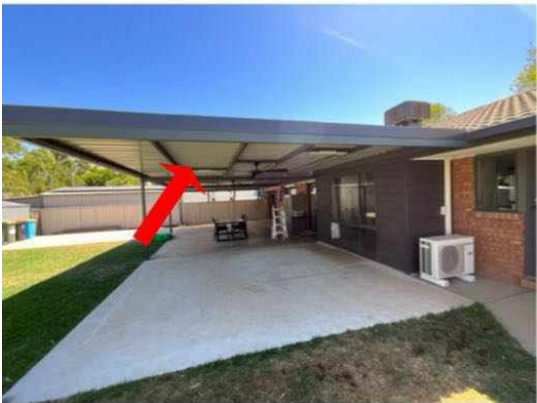
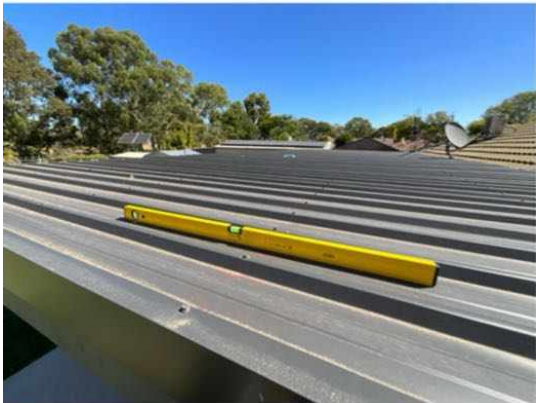
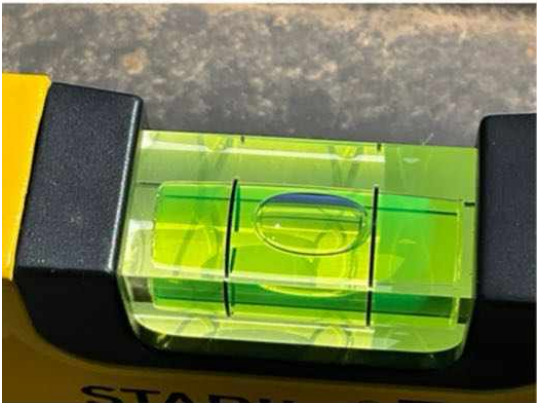
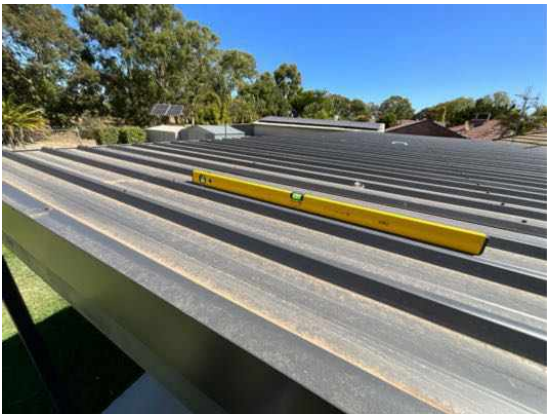
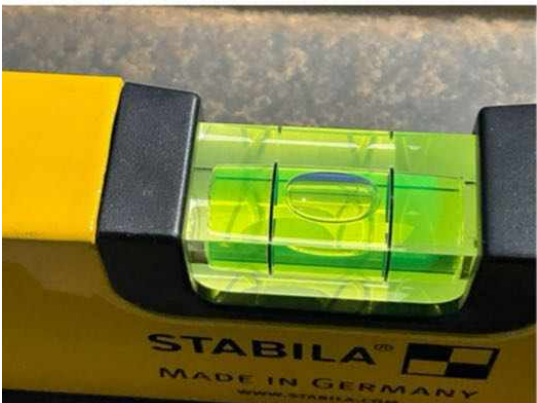
Finding 3.04

Building: Building 1
 Location: Alfresco
 Finding: Exterior roof - Insufficient fall
 Information: It was identified that there is insufficient fall or angle in the roofing structure, which is leading to pooling of water in some places.

Such defects are likely to include material deterioration, leaks and/or corrosion of associated building materials.

Consultation with a roofing plumber is required for quotations regarding these works. Where water pooling is quite significant, structural alterations to the roof may potentially be expensive and time-consuming.

No work is needed except at the discretion of the client.

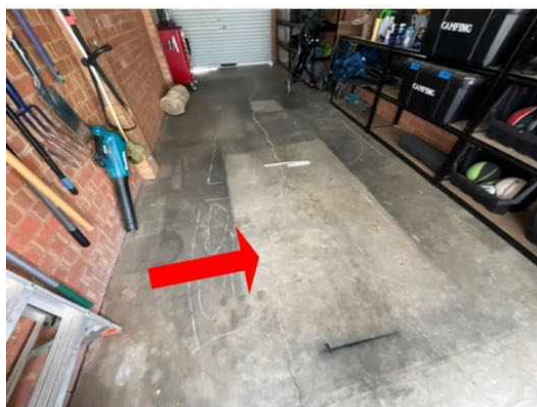
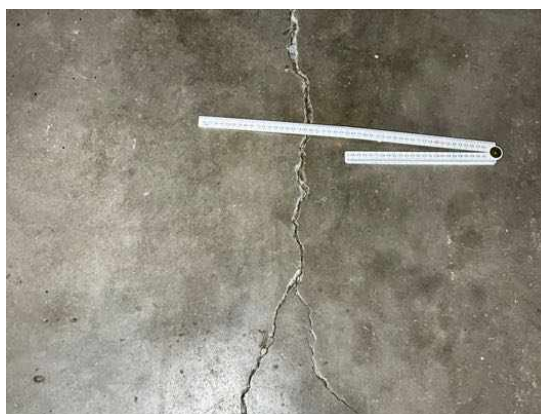
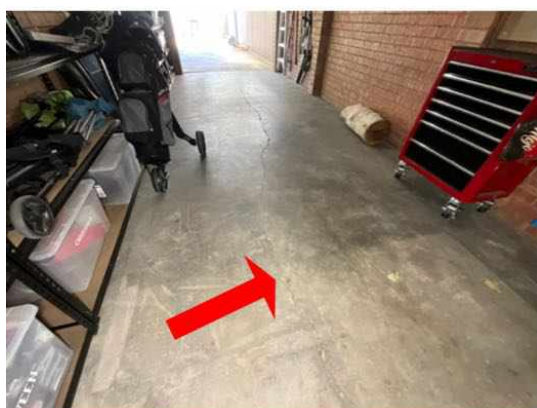
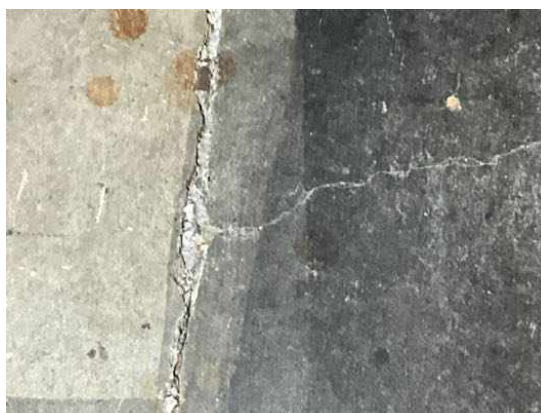
Finding 3.05

Building: Building 1
 Location: Garage
 Finding: Cracking - External Concrete Paving Damage Category 3 - Wide Cracks (2mm - 4mm)
 Information: Wide cracks were identified in external concrete paving Wide cracks are significant and are likely to lead to the development of safety hazards and secondary defects if left unmanaged.

General age and expected deterioration of the paved areas is a common cause of this type of cracking. However, expansion and contraction of the slab may also have occurred due to environmental factors. Such factors include variable moisture and weather conditions, the presence of trees and their roots having a settling or lifting

affect on the soil, or the effect of load bearing, e.g. heavy vehicles over a sustained period of time.

Cracking to this degree may also be due to poor original installation of the concrete. Factors such as poor compaction of the sub surface and/or inadequate reinforcing of the slab may create cracking and other secondary defects. Wide cracks may also have a more significant structural cause, such as subsidence of soils.

Where the crack is located adjacent to structural elements of the building, the advice of a Structural Engineer is advisable before undertaking repairs. Significant repair and likely replacement of the concrete paving is probable.

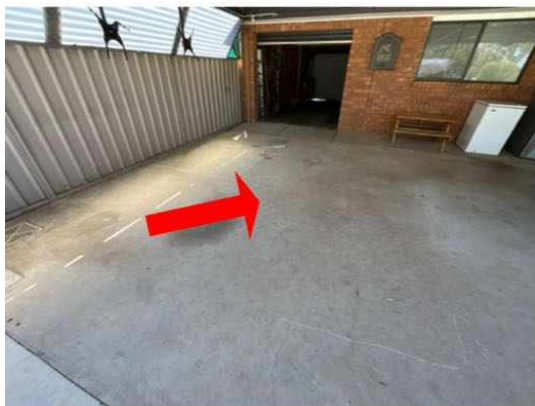
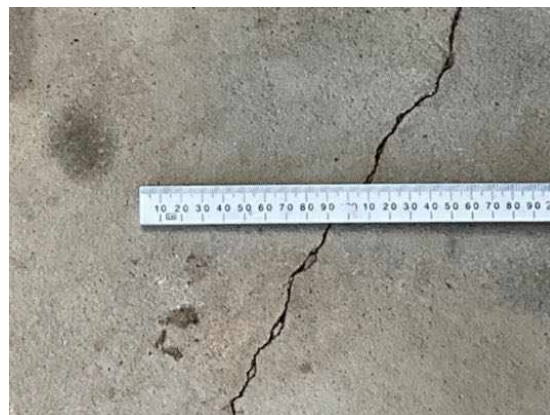
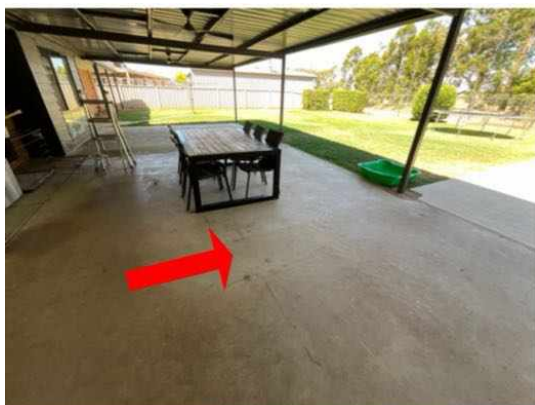
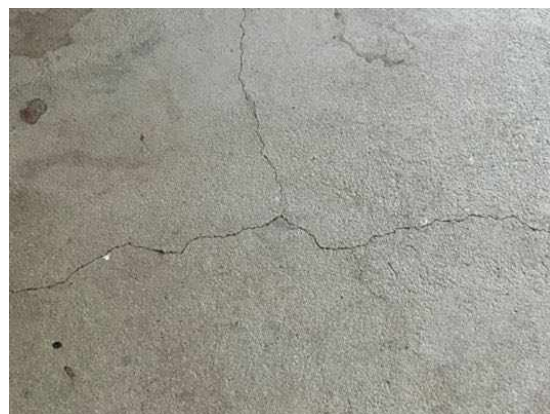
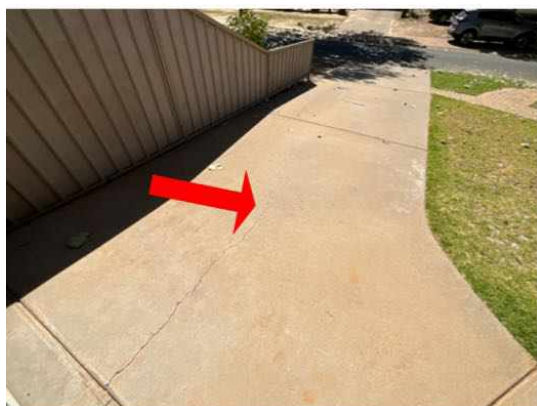
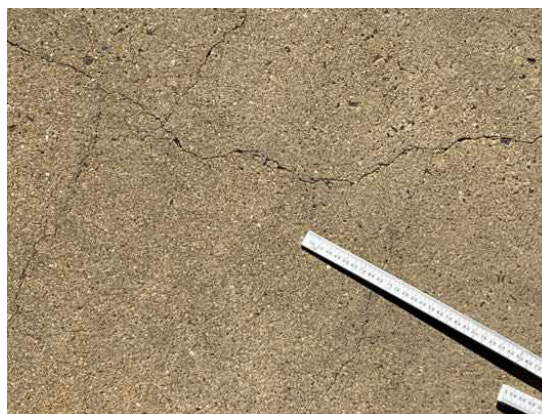
Finding 3.06

Building:	Building 1
Location:	Alfresco, driveway
Finding:	Cracking - External Concrete Paving Damage Category 2 - Distinct (less than 3mm)
Information:	Distinct cracks were identified in external concrete paving. Distinct cracks are generally found in older concrete paving, and may also present as a trip hazard as consequence of an uneven or curved surface.

General age and expected deterioration of the paved areas is a common cause of this type of cracking. However, expansion and contraction of the slab may also have

occurred due to environmental factors. Such factors include variable moisture and weather conditions, the presence of trees and their roots having a settling or lifting affect on the soil, or the effect of load bearing, e.g. heavy vehicles over a sustained period of time.

Cracking to this degree may also be due to poor original installation of the concrete. Factors such as poor compaction of the sub surface and/or inadequate reinforcing of the slab may create cracking and other secondary defects.

Repairs are likely to be required to prevent further cracking and to reduce hazards associated with cracking, such as tripping. Monitoring of all cracking should be conducted frequently. Always contact a building inspector should cracks widen, lengthen, or become more numerous.

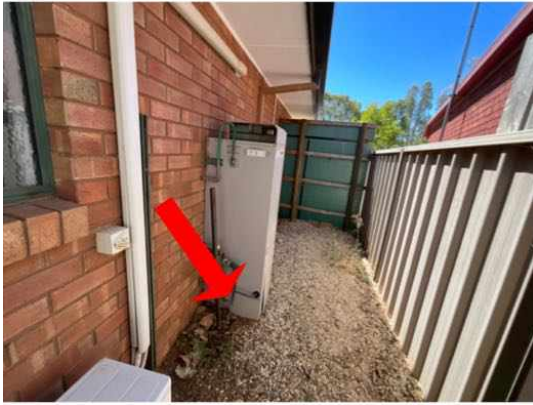
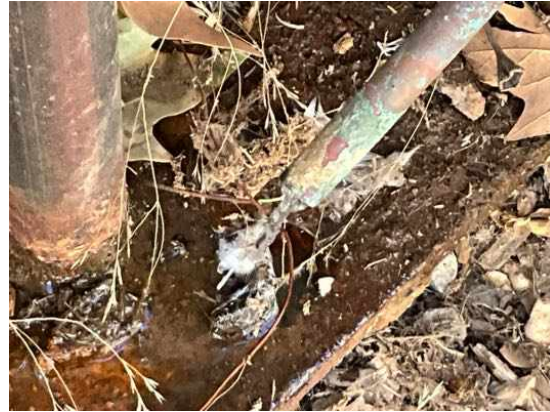
Finding 6.01

Building:	Building 1
Location:	Yard - Side
Finding:	HWS Overflow - Not Connected
Information:	The Hot Water System (HWS) overflow was found to be disconnected from storm water drainage and is creating excessive moisture in the surrounding area.

These damp conditions can lead to secondary defects such as rot, rust or corrosion of associated building elements, the formation of fungal decay, or even the creation of potential slip hazards. When coupled with poor site drainage, pooling of water may also attract termite activity to this area.

It is highly recommended that a licensed plumber be appointed to connect the HWS overflow in order to prevent such an environment from being created. These minor works should be carried out as soon as possible.

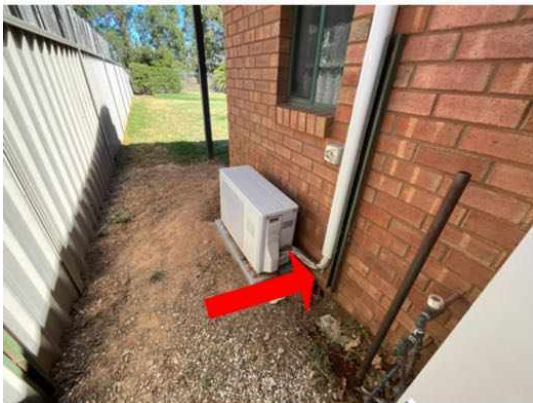
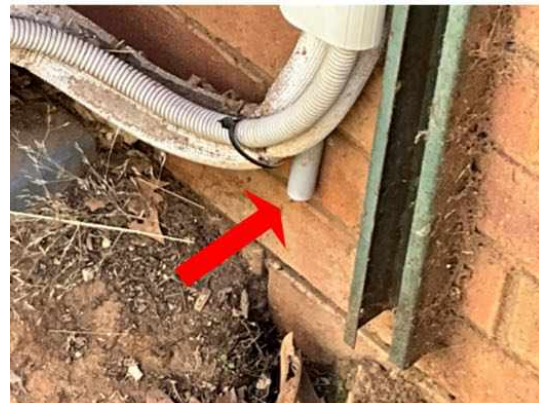
Finding 6.02

Building:	Building 1
Location:	Yard - Side
Finding:	Air conditioner - Disconnected overflow
Information:	The Air Conditioner (A/C) overflow was found to be disconnected from storm water drainage and is creating excessive moisture in the surrounding area.

Such leaking creates an environment which is conducive to an array of defects, including water damage to associated building elements and the attraction of termite or timber pest infestation.

It is highly recommended that a licensed plumber be appointed to connect the A/C overflow in order to prevent such an environment from being created. These minor works should be carried out as soon as possible.

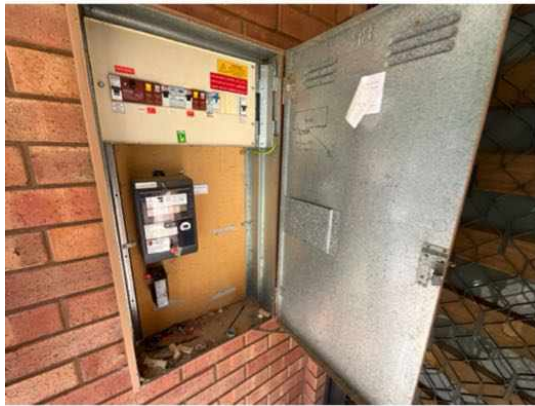
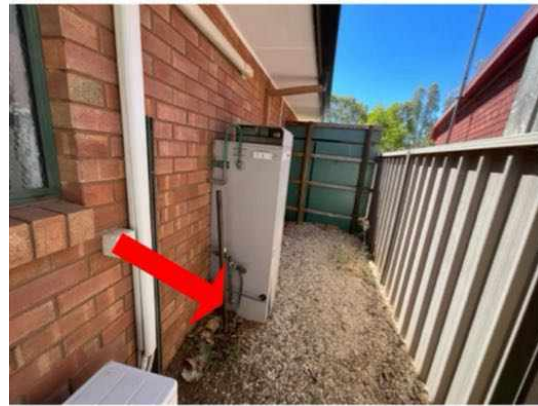
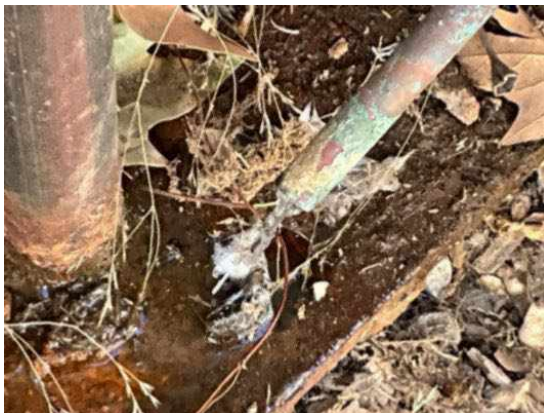
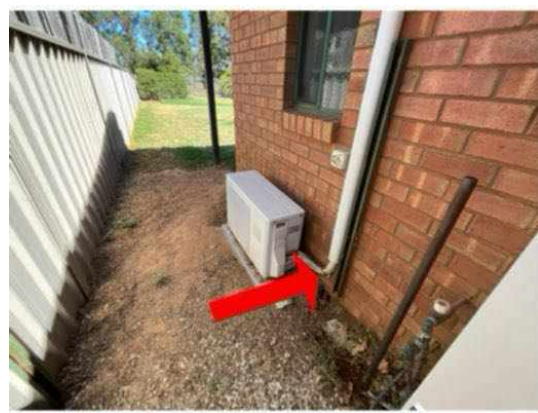
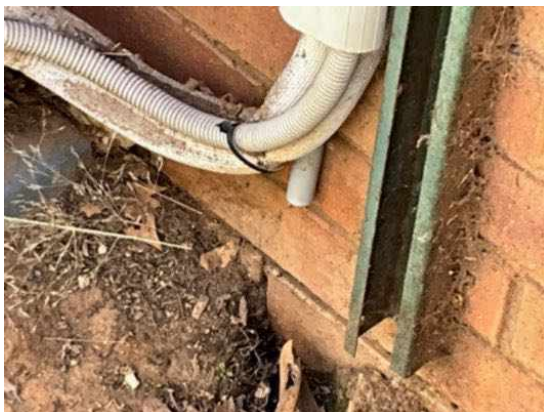
Finding 6.03

Building:	Building 1
Location:	All External Areas
Finding:	Termite Management System - no evidence of a chemical installation
Information:	The application of a post-construction chemical termite barrier is highly recommended for all properties, particularly if live termite activity has been found on the site

previously. Such barriers are highly effective in preventing termite attack on any timber building elements throughout the property.

A durable notice should be placed in the switchboard unit to indicate current termite barriers. At the time of inspection, it appeared as though no termite management system has been installed, with no evidence to suggest preventative works taking place.

The client may consider gaining further advice from a pest controller as to the costs and procedures involved with this application. It is recommended that obtaining such advice be a short-term priority.

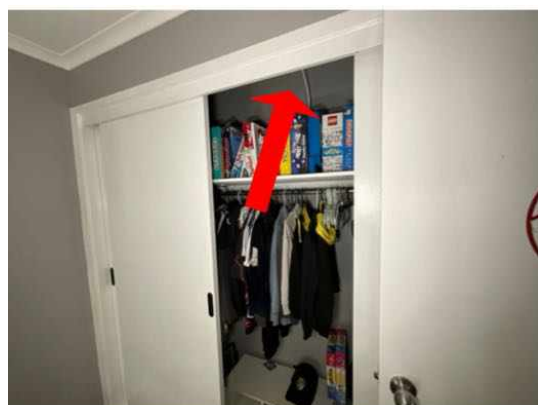
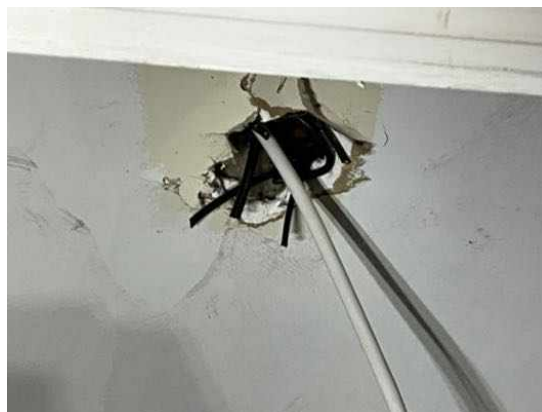
Building: Building 1
 Location: Bedroom 2
 Finding: Unconventional- handyman work
 Information: This handyman work appears to have been completed to a substandard level and does not comply with regular building practices. Where handyman work is not completed satisfactorily, accelerated deterioration of the associated building elements is likely to occur and secondary defects to surrounding structures may develop.

It is highly recommended that the substandard work be rectified by professional services to prevent potential future deterioration.

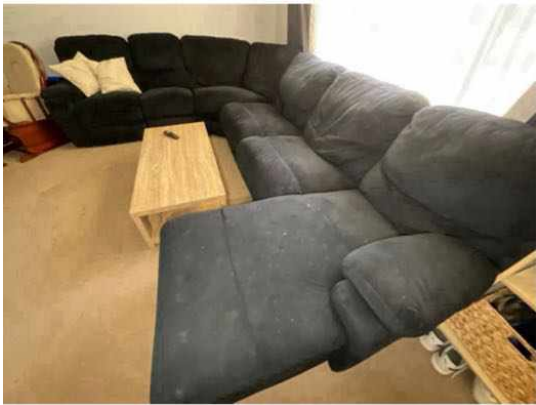
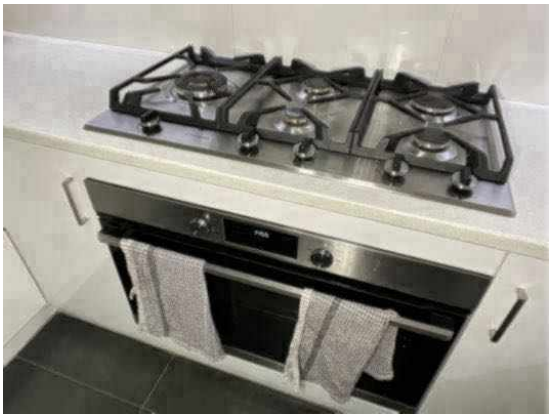
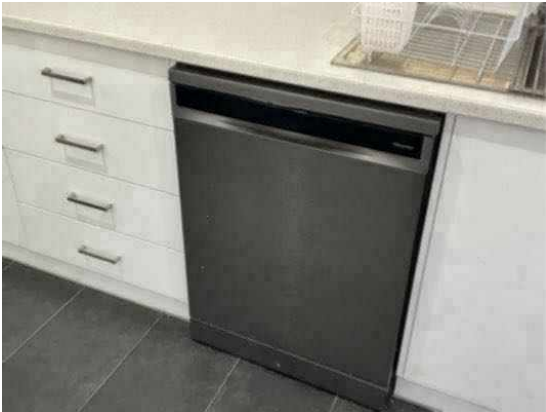
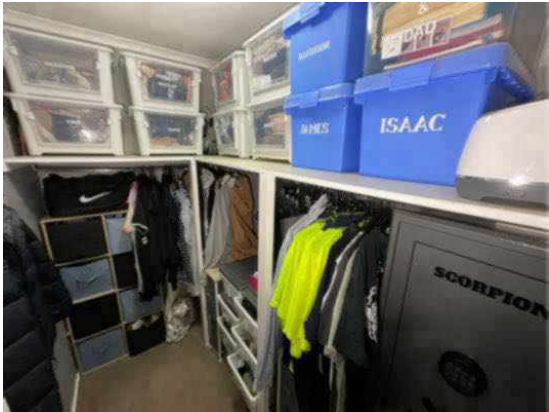
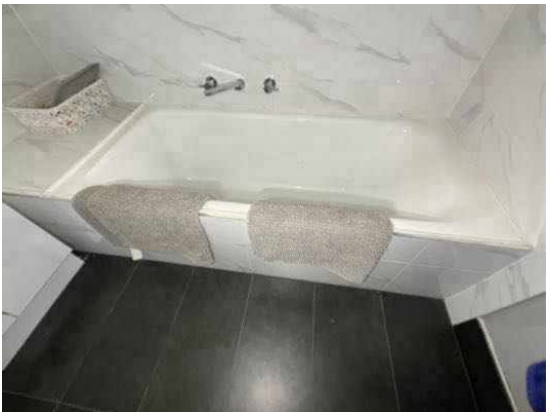
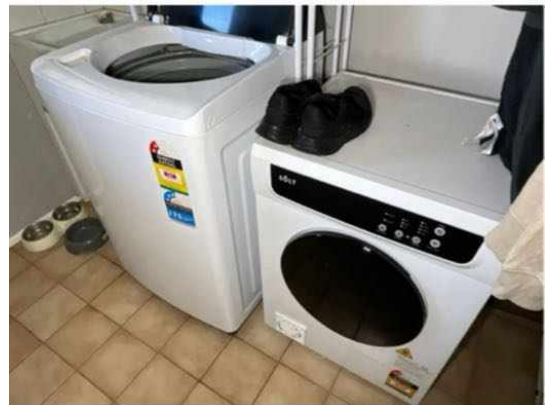
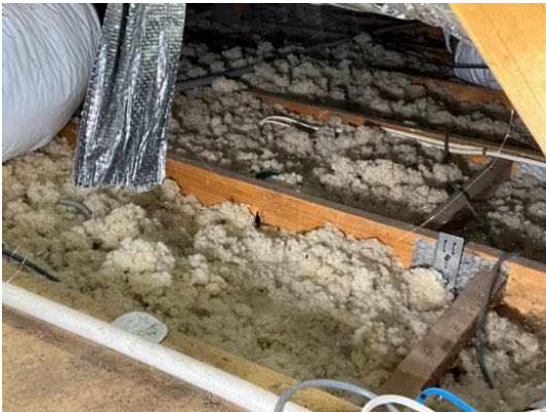
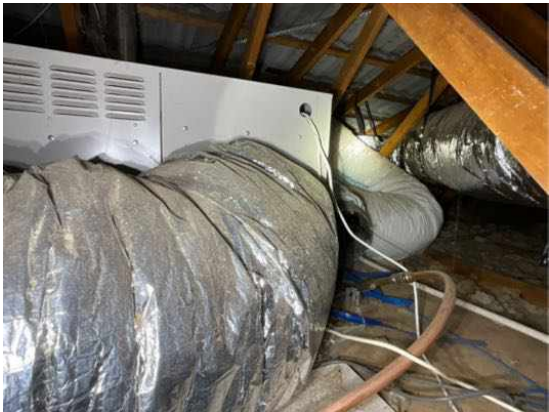
Building: Building 1
 Location: All Areas
 Finding: Additional Photos - Obstructions and Limitations
 Information: These photographs are an indication of the obstructions and limitations which impeded full inspection of the property at the time of inspection. These obstructions can hide an array of defects and should be removed to allow full inspection to be carried out. A re-inspection is recommended once the areas are made accessible.
