Building and Timber Pest Inspection Report

Inspection Date: Thu, 26 Mar 2026

Property Address: 1/91 Lamington Dr, Redbank Plains QLD
4301, Australia

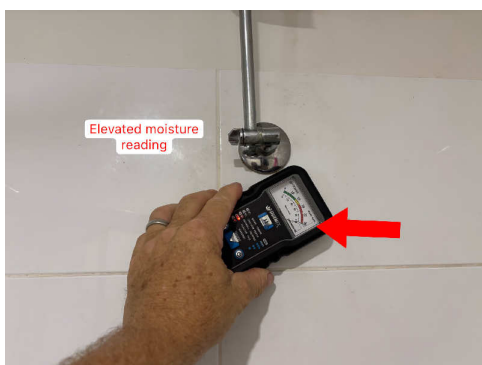
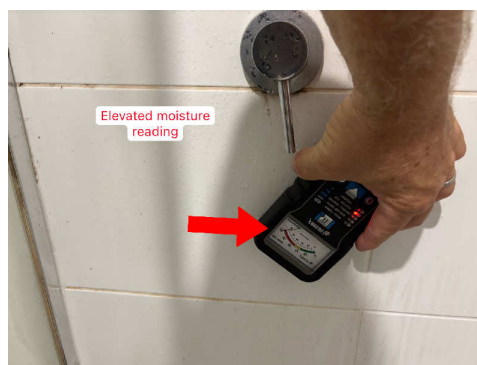
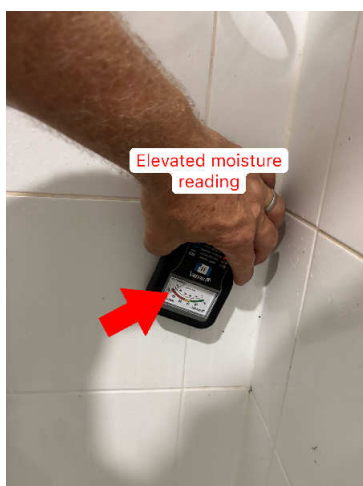
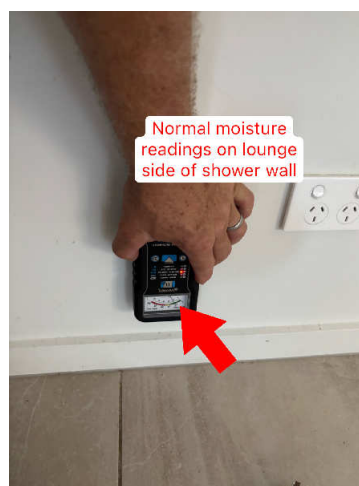
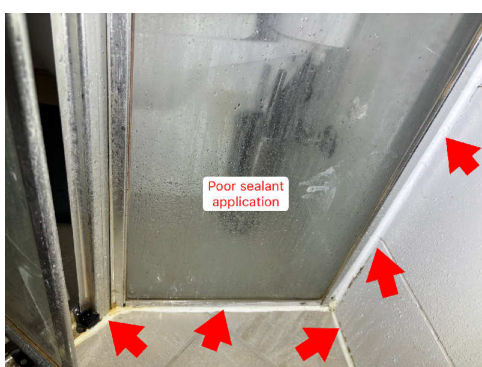
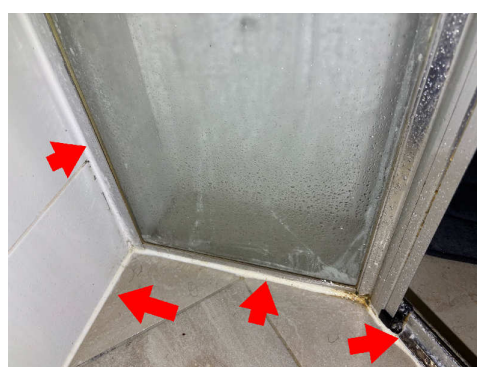
Finding 3.01

Finding: Ensuite - elevated moisture readings to shower wall

Information: At the time of the inspection, it was noted that there were elevated moisture readings recorded beneath the shower head and mixer tap on the shower wall in the ensuite. This may be due to the age of the materials.

Grout and certain tiles can be porous. It was also found the the sealant to the junctions in the shower has been re-done to a poor standard. Moisture behind the wall tiles may have a negative affect on the wall tile glue. This could result in loose tiles. If left unaddressed, this may become a major defect.

A bathroom specialist could be engaged to replace the grout and seal the floor and wall tiles in the shower cubicle. This will give longevity to the bathroom. This can be done at the clients discretion.

The client may wish to engage a licensed plumber to perform a pressure test to ensure that there are no plumbing leaks.

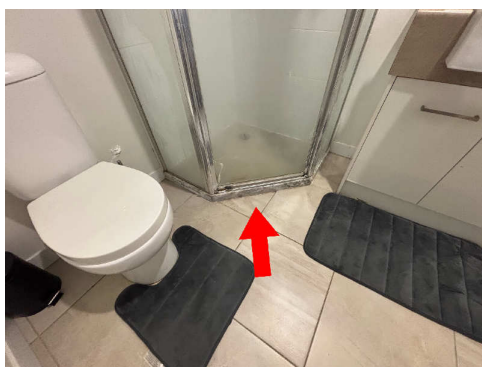
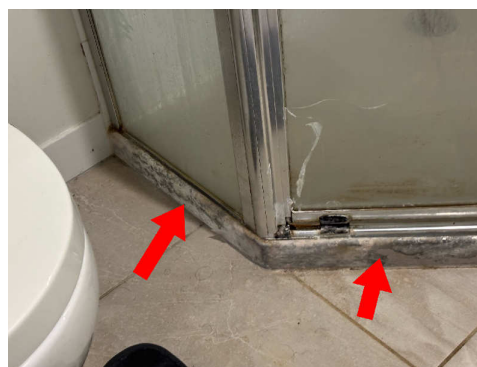
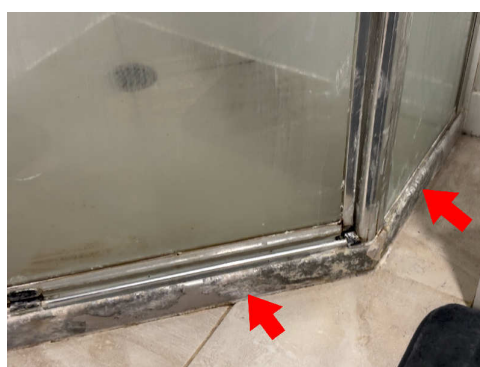
Finding 3.02

Finding: Ensuite - shower screen base deteriorating

Information: At the time of the inspection, it was noted that the base of the shower screen in the ensuite was deteriorating. The clear coat is coming off allowing moisture to corrode the exposed metal surface.

Due to the floor in the shower being built up behind the shower screen base, the shower screen may not be easily replaced. If left unaddressed, this may become a major defect.

A building maintenance professional or painting contractor may be able to treat and paint the shower screen base to prevent further corrosion. This should be done as a short term priority.

If treating and painting is not an option, then a new shower screen may be required which would require invasive works.

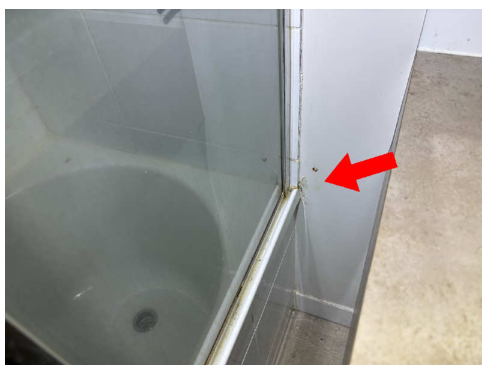
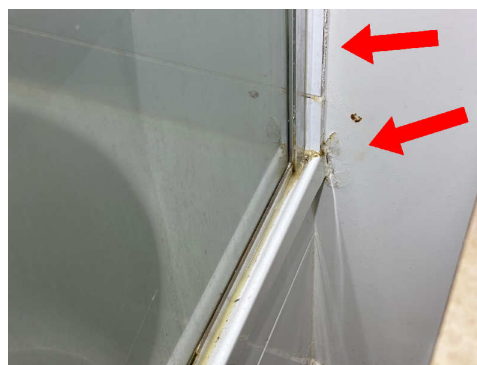
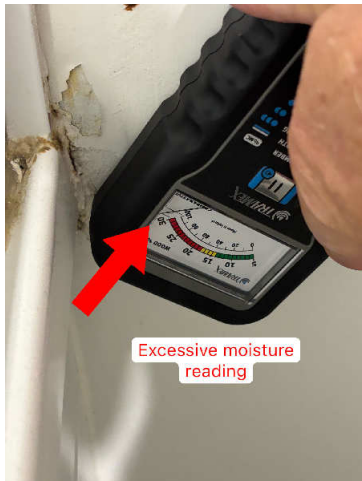
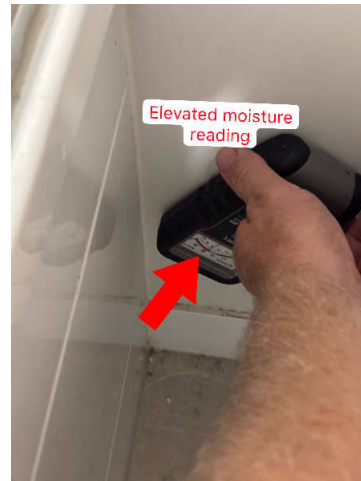
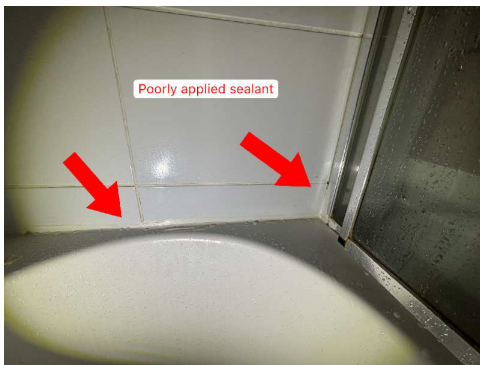
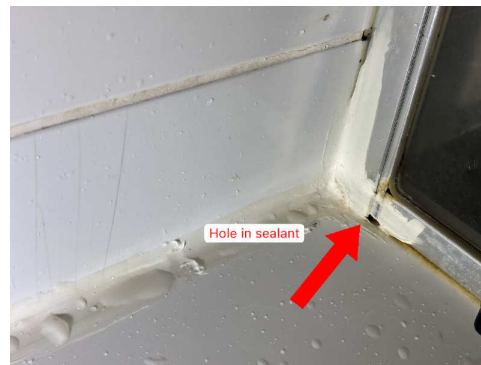
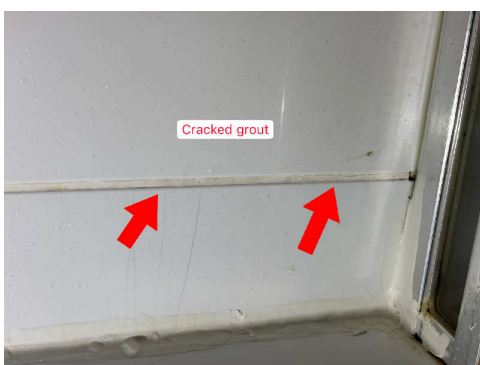
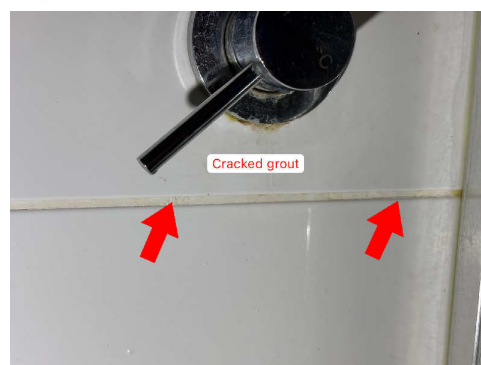
Finding 3.03

Finding: Family bathroom - evidence of moisture damage

Information: At the time of the inspection, it was noted that there was evidence of moisture damage to the wall lining outside of the bath tub in the family bathroom. Efflorescence can be seen on the edge of the wall tile above the area of the moisture damage.

The source of the moisture could not be determined, however, cracked grout lines and poorly installed sealant were found near this area. The sealant to the shower screen has a hole in it. Staining below the shower mixer indicates that the shower mixer has been leaking.

If left unaddressed, moisture may enter the wall cavity creating a major defect.

A bathroom specialist should be engaged to replace the grout and seal the wall tiles in the shower/bath tub area to prevent moisture from getting behind the wall tiles. The sealant to the shower screen will be replaced at the same time, eliminating this a source of the moisture damage. This should be done as a short term priority.

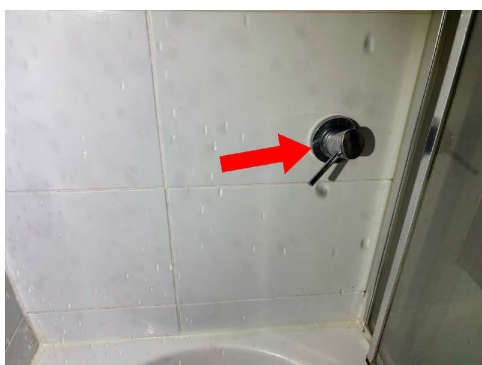
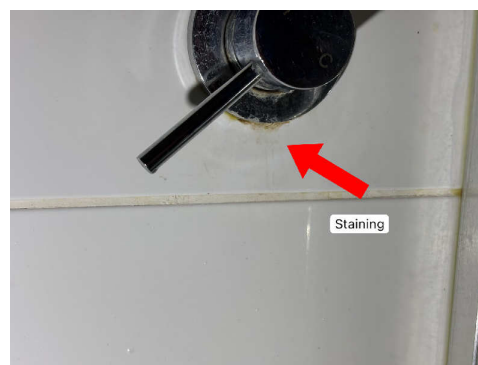
Finding 3.04

Finding: Family bathroom - evidence of leak from the shower mixer tap

Information: At the time of the inspection, it was noted that there was evidence of a water leak coming from the shower mixer tap. Water droplets could be seen on the underside of the mixer tap when it is turned on and staining can be seen on the wall tile directly below the shower mixer tap. If left unaddressed, moisture may track back into the wall cavity.

Moisture in wall cavities can be a conducive environment for termite activity and cause undetected damage to the associated building materials.

The client should engage a licensed plumber to make the repairs necessary to rectify this issue. This should be done as a matter of urgency.

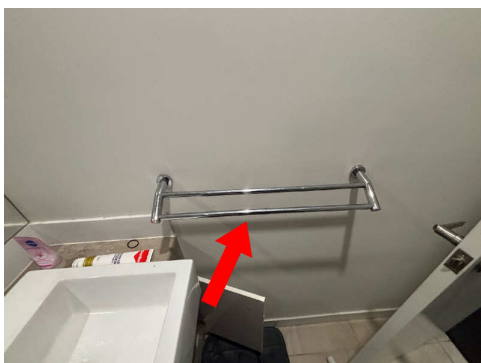
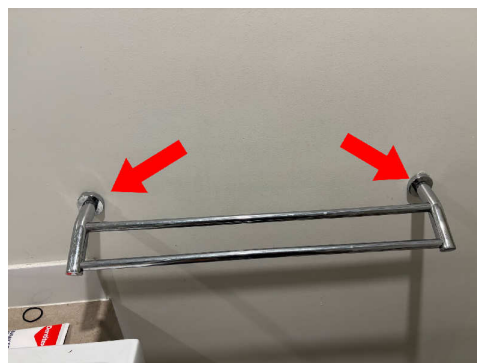
Finding 3.05

Finding: Ensuite - towel rail loose

Information: At the time of the inspection, it was noted that the towel rail in the ensuite was loose. This appears to be from general wear and tear. If not addressed, the towel rail may come away from the wall.

This may require simple adjustment of the fasteners attaching the towel rail. A building maintenance professional could be engaged to carry out this minor repair. This can be done at the clients discretion.

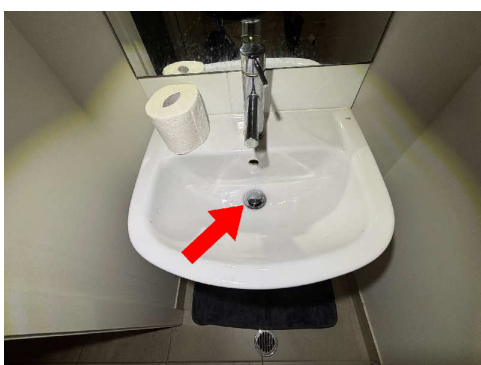
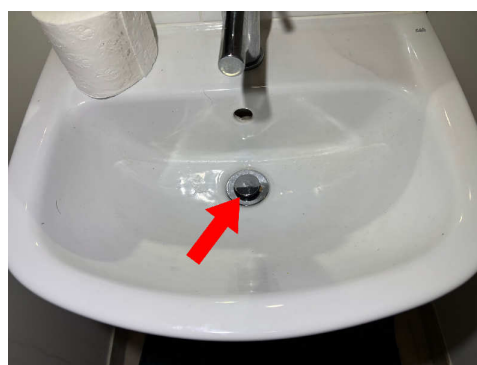
Finding 3.06

Finding: Pop up waste - stuck in the open position

Information: At the time of the inspection, it was noted that the pop up plug waste to the basin in the toilet was stuck in the open position. The basin cannot be filled.

A licensed plumber should be engaged to replace the pop up plug waste. This can be done at the clients discretion.

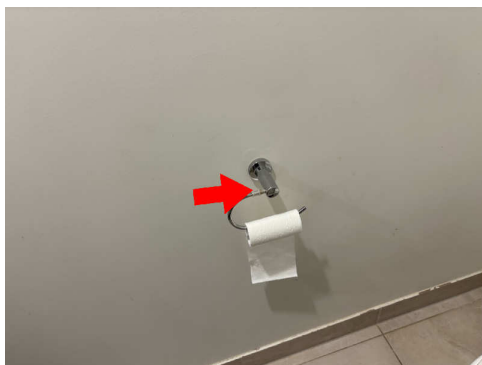
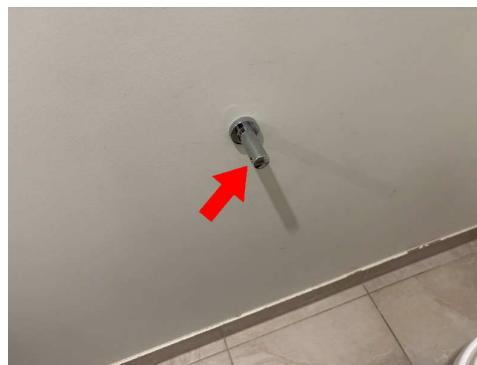
Finding 3.07

Finding: Toilet roll holder - broken

Information: At the time of the inspection, it was noted that the toilet roll holder in the separate toilet was broken. This may be due to general wear and tear.

A building maintenance professional could be engaged to replace the parts or install a new toilet roll holder. This can be done at the clients discretion.

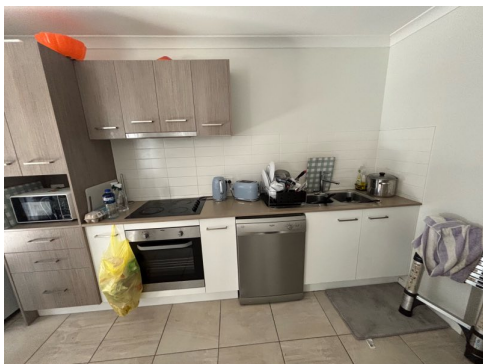
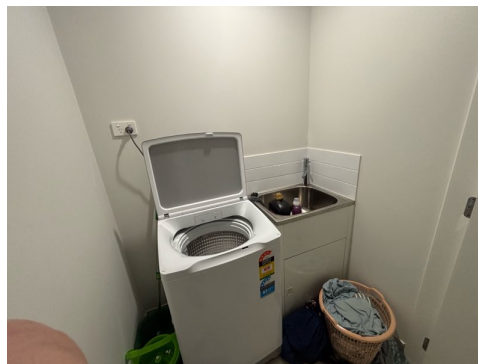
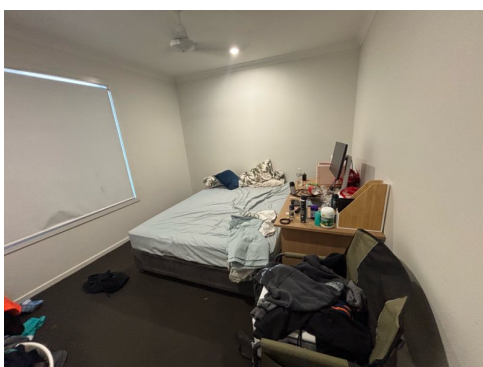
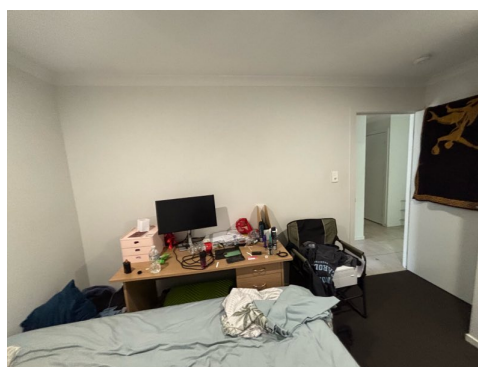
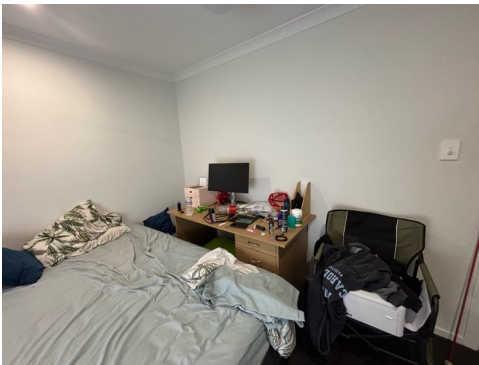
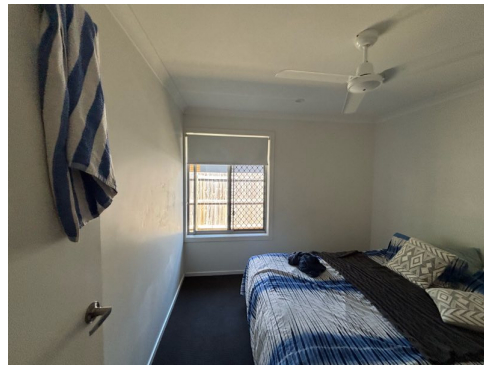
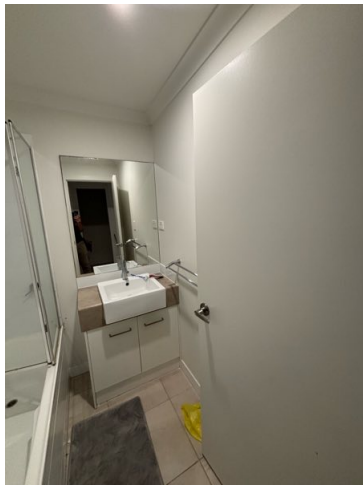
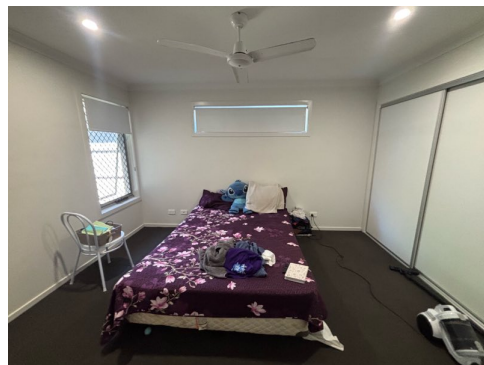
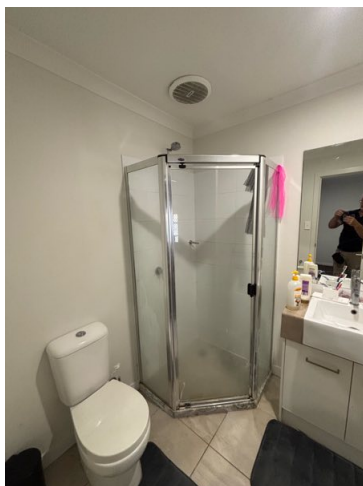
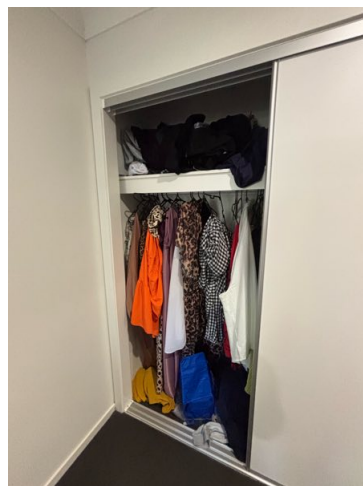
Finding: Obstructions and Limitations - Internal areas

Information: These photographs are an indication of the obstructions and limitations which impeded full inspection of the property of the internal areas at the time of inspection. These obstructions can hide an array of defects and should be removed to allow full inspection to be carried out. A re-inspection is recommended once the areas are made accessible.

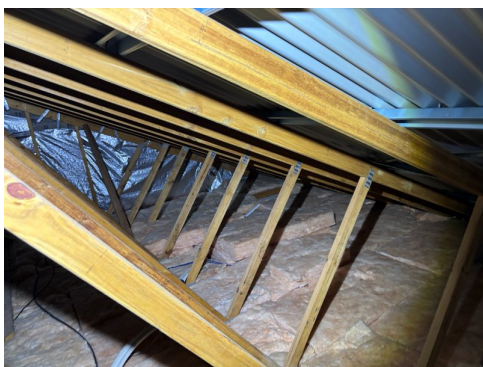
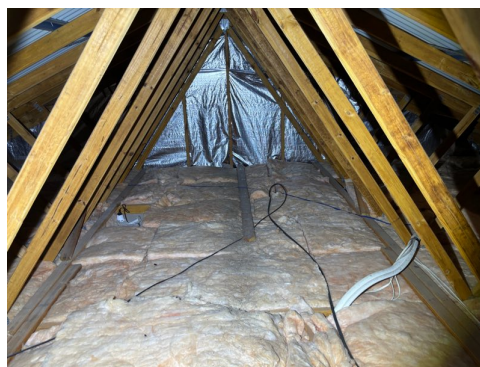
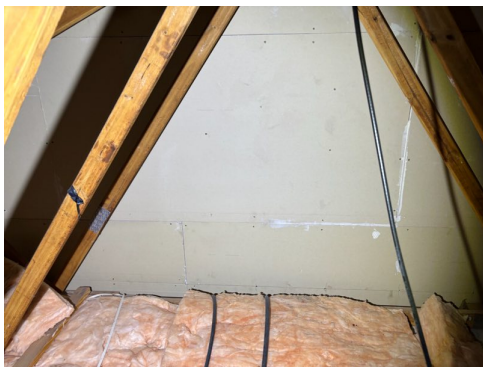
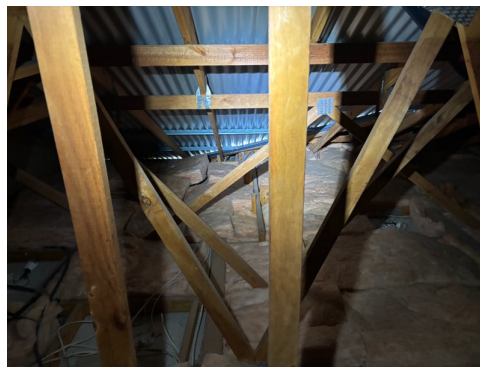
Finding: Obstructions and Limitations - Roof cavity

Information: These photographs are an indication of the obstructions and limitations which impeded full inspection of the property of the roof cavity at the time of inspection. These obstructions can hide an array of defects and should be removed to allow full inspection to be carried out. A re-inspection is recommended once the areas are made accessible.
