Building and Timber Pest Inspection Report

Inspection Date: Tue, 20 Jan 2026

Property Address: 55 McDougall Pl, Fernmount NSW 2454,
Australia

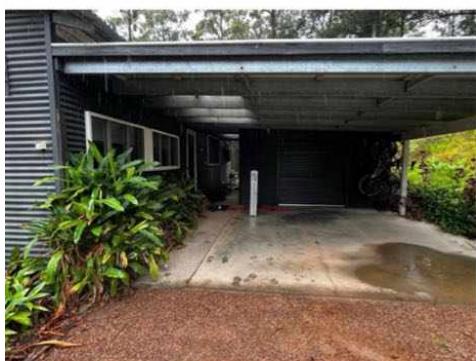
Building:	Main Building
Location:	Carport
Finding:	Carport - defects

Information: At the time of this inspection it was observed that the carport area had a number of defects,

1 - At the time of this inspection a number of significant cracks were evident in the concrete driveway.

A crack coded as Category 4 was identified in the slab.

A Category 4 crack is described as a crack that appears as a gap in the slab, with disturbing curvature or change in level affecting the slab.

The approximate width of the crack or gap is 4mm-10mm or a change in offset of greater than 25mm when a 3m straight edge is placed over the defect.

Category 4 cracking to slabs exceeds allowable Standards and Tolerances, and are therefore considered as major defects that require rectification..

2 - It was observed that there was minor fungal decay (wood rot) and damage to the carport timber fascia, it is recommended that the affected timber be repaired or replaced by a carpenter and all external timber elements be repainted.

3 - It was noted that there was damage to the clear roof sheeting, also noted was the excessive build up of leaves on the carport roof under the bungalow roof. All leaf litter should be removed and the damaged roof sheets replaced.

5 - It was further observed that the guttering to the walkway roof behind the carport had partially fallen off, also noted was that the water tank was over flowing. These issues has allowed water to pond at the rear of the carport. It is recommended that a plumber provide additional overflow drainage to the tank, repair or replace the damaged gutter and provide additional drainage to the rear of the carport if required.

6 - It was evident that there was excessive vegetation growth and stored items concealing areas of the external bungalow walls, this vegetation should be removed and the area be reinspected.

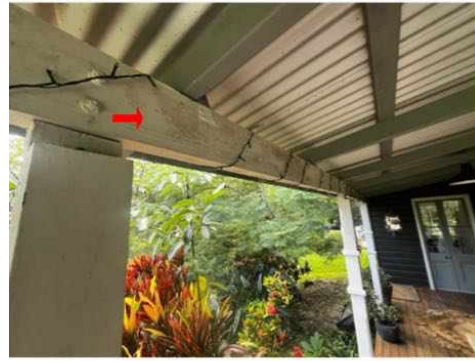
Building: Main Building
Location: Front deck
Finding: Front deck - defects

Information: At the time of this inspection, it was observed that there were several areas of the timber decking that were deteriorated, it is recommended that a painter prepare and coat the decking Timbers, this will increase the service life of the timber elements.

It was also observed that sections of the roof frame had mould growth evident, it is recommended that the mould be cleaned off the Timbers.

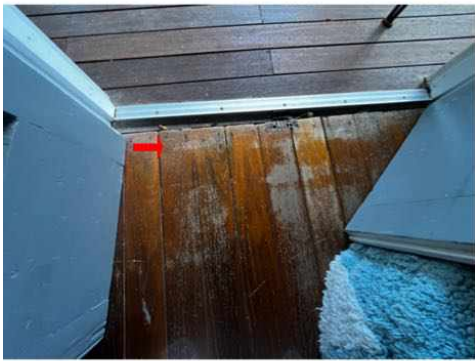
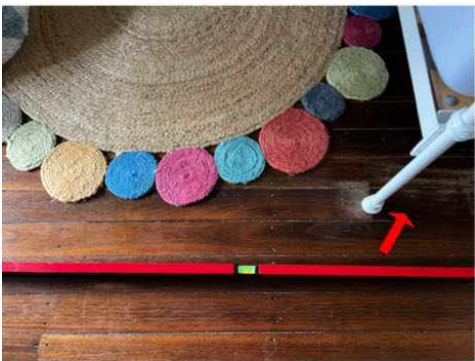
Finding: Bedroom 2 - defects

Information: At the time of this inspection, it was also observed that a section of the flooring inside the French doors and under the end of the bed were faded and deteriorated, it is recommended that the flooring be repaired as required, is re sanded and re polished at your discretion.

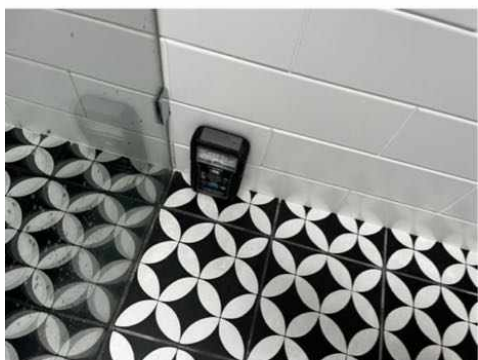
Building:	Main Building
Location:	Bathroom
Finding:	Moisture - ensuite excessive moisture evident
Information:	At the time of this inspection a moisture meter was used to take reading of moisture outside the shower cubicle on both tiled walls.

A higher than expected moisture reading was evident in the shower wall on the right side and the shower wall.

The moisture meter reading on the right side tile was 20 out of a maximum of 30 on the moisture meter.

No evidence of water damage to the underside of the shower floor was seen.

It was also noted that the shower floor falls towards the east wall, it was observed that there was a small amount of ponding water against the wall. Without re tiling the floor, there is not a lot can be done about this issue.

It is recommended that a builder and plumber investigate this issue further to determine the cause of the raised moisture content in the wall tiles and suggest required remedial works to be undertaken.

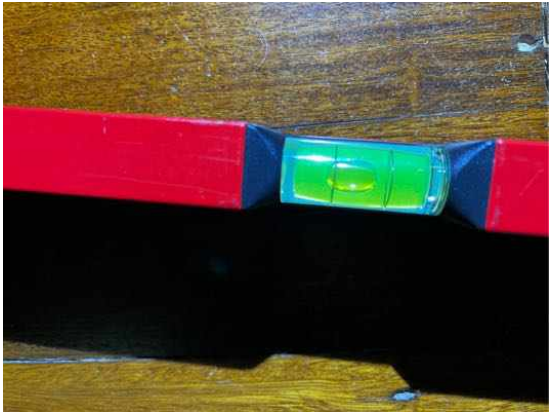
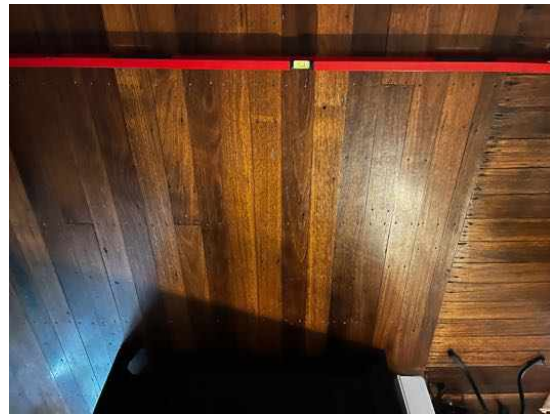
Building:	Main Building
Location:	All Internal Areas
Finding:	Timber floors - out of level
Information:	At the time of this inspection it was observed that the timber floors were generally reasonably level throughout the house.

It is assumed that this is as a result of movement in the subfloor piers and floor over time.

It is recommended that a builder thoroughly inspect the subfloor area to determine the cause of the movement and to recommended remedial works to level the floors if desired.

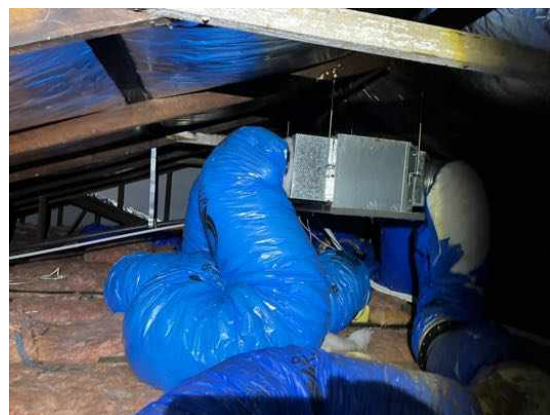
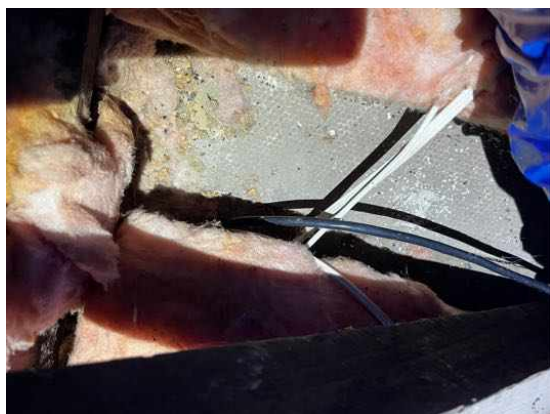
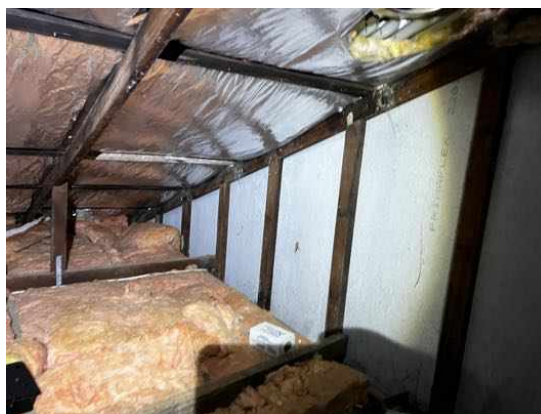
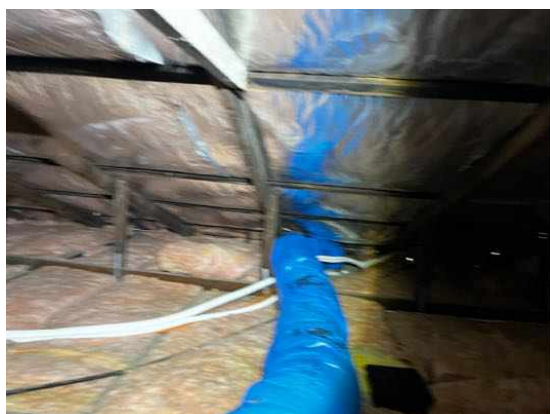
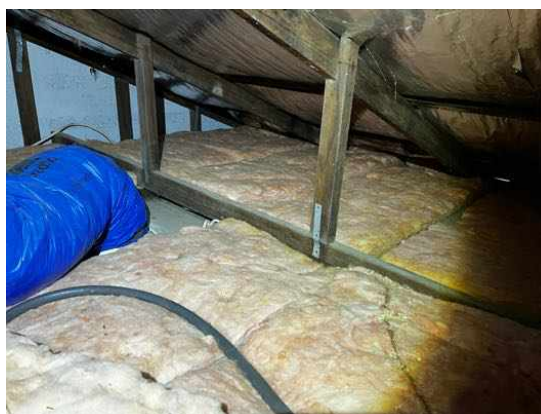
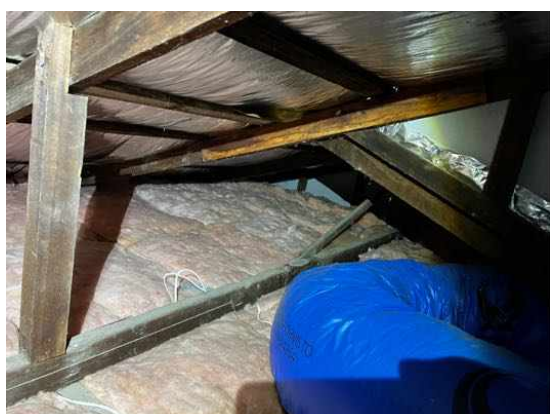
Building:	Main Building
Location:	Roof Void
Finding:	Roof void - excessive insulation
Information:	At the time of this inspection it was evident that numerous insulation batts extended over the top plate of the timber frame.

NOTE: Several insulation batt corners were pulled up for a random inspection.

NOTE: It was also observed that possible asbestos containing sheets were visible in the roofing void, it is recommended that no work be carried out in this area until the sheeting has been sampled, tested and reported for asbestos.

It is recommended that any offending insulation be adjusted to allow full inspection.

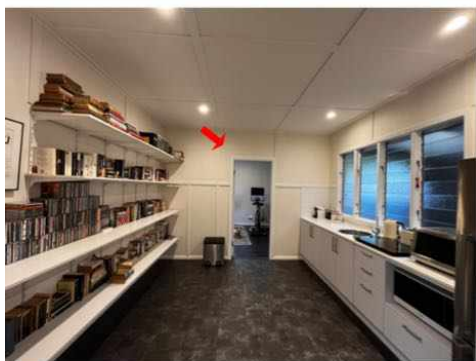
Building:	Main Building
Location:	Bungalow kitchen
Finding:	Kitchen - minor defects
Information:	At the time of this inspection, it was observed that there was a minor cracking to the wall sheeting above the southern kitchen passage door, it is recommended that a painter fill the crack and repaint the wall.

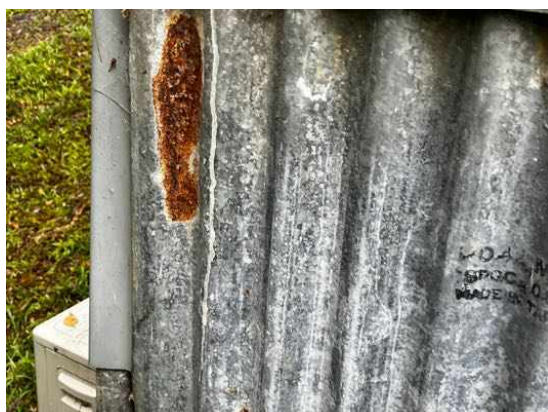
Building: Main Building
 Location: Bungalow exterior walls - rear
 Finding: Exterior rear - defects
 Information: It was observed at the time of this inspection that there were a number of minor defects to the rear of the house,

1 - There was rusting evident to the corrugated iron subfloor screening and minor corrosion to sections of the metal storm shutters. It is recommended that any rusted sheets be sanded and painted or replaced.

2 - It was evident that there was minor deterioration to sections of the timber window

exteriors, it is recommended that a painter sand, patch, putty and repaint all external timber elements to extend the service life of the timber.

3 - It was observed that the gutters had leaf litter evident, the gutters should be cleaned out and consideration given to fitting gutter guards.

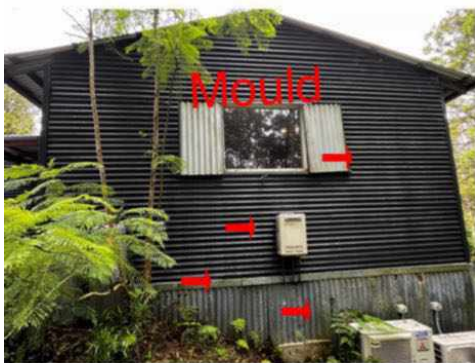
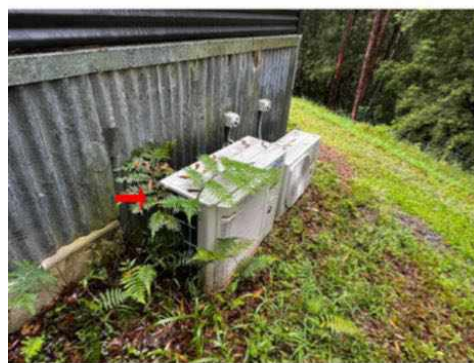
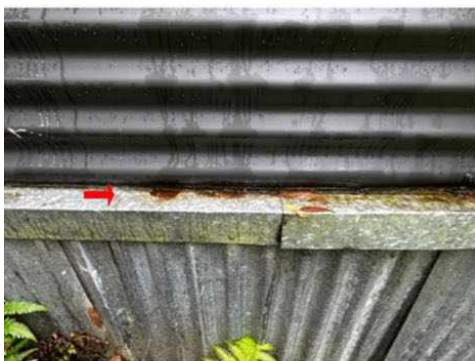
Building: Main Building
 Location: Bungalow exterior walls - right side
 Finding: Exterior area - right side
 Information: At the time of this inspection it was observed that there were several defects to the right side wall area of the house,

1.- It was observed that the end of several timber roof battens had minor fungal decay (wood rot) evident. It is recommended that a painter repaint all exposed timber elements for extended service life.

2 - It was observed that all surfaces of the end wall had areas of moss growth, this

3 - There was rusting evident to the corrugated iron subfloor screening and flashings, it is recommended that any rusted sheets be sanded and painted or replaced.

4 - It was observed that the air conditioning units were mouldy with vegetation growth around the units and sitting close to the ground, it is recommended that the vegetation be removed, the units cleaned and lifted up to gain airflow as soon as possible.

5 - It was observed that the rear paved area was overgrown with weeds and there were a number of sunken and damaged areas evident. It is recommended that a landscaper provide maintenance and cleaning to this area to level the pavers as soon as possible.

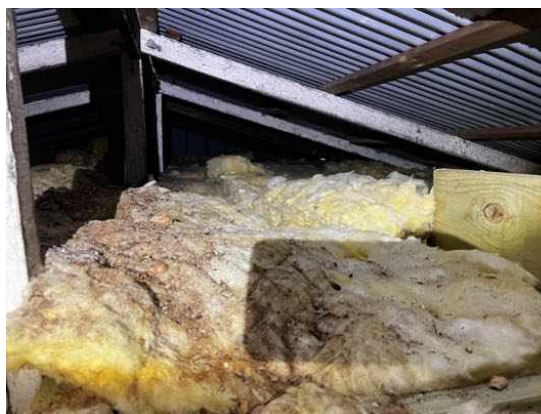
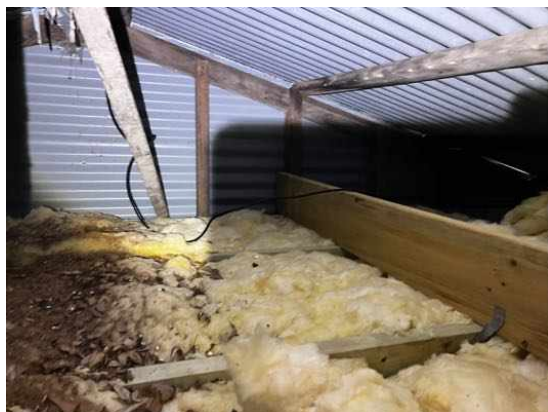
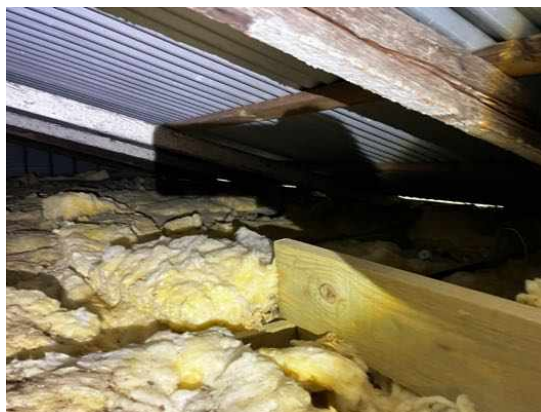
NOTE: The roof Timbers appeared to be recycled Timbers, no insulation blanket or sarking was evident under the roof sheeting and the crawl space was too low to inspect.

It is recommended that any offending insulation be adjusted to allow full inspection.

An insulation company should be engaged to complete this work at your convenience and the area be reinspected.

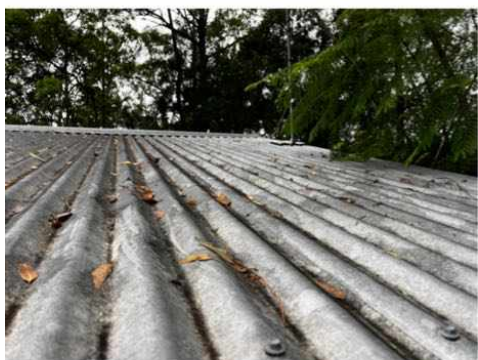
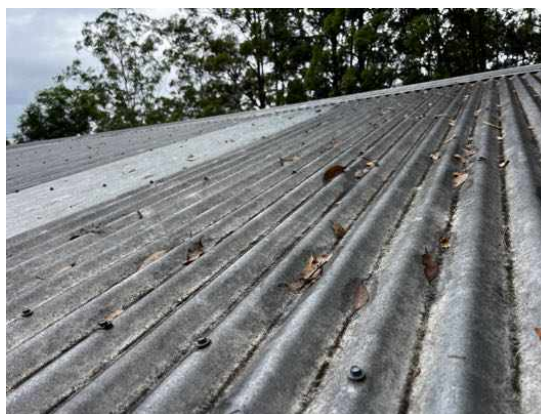
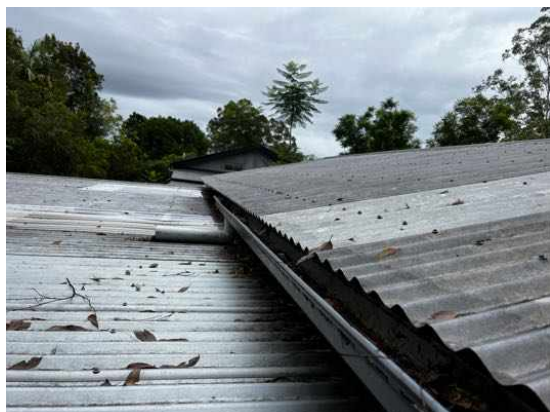
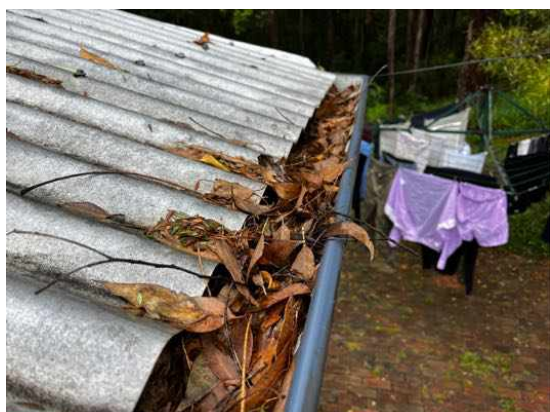
Building: Main Building
 Location: Roof exterior bungalow
 Finding: Roof exterior and guttering
 Information: At the time of this inspection, the roof sheeting and roof flashings appeared to be in a weathered condition with some deterioration and mould growth evident. The roof sheets should be pressure cleaned.

The front section of roof only, was inspected from a ladder, due to Workplace Health and Safety constraints.

It is recommended that a roofer thoroughly inspect the roof sheets, roof flashings and guttering as soon as possible.

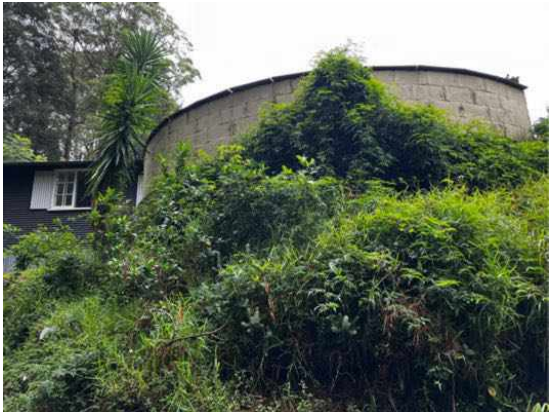
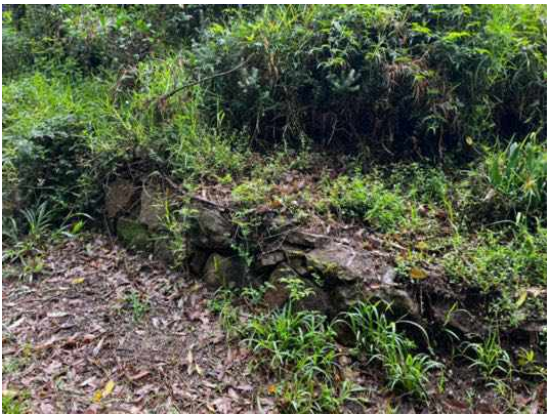
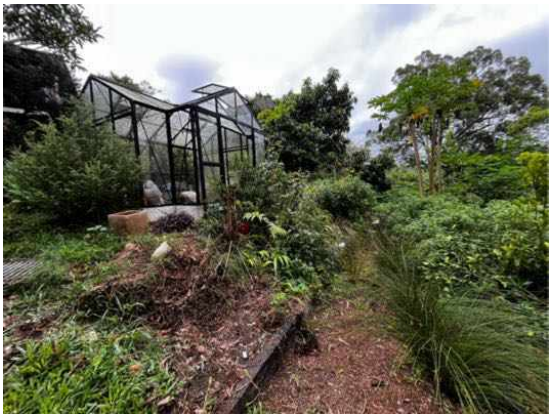
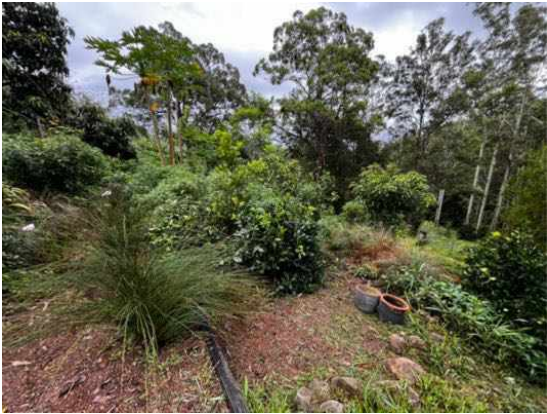
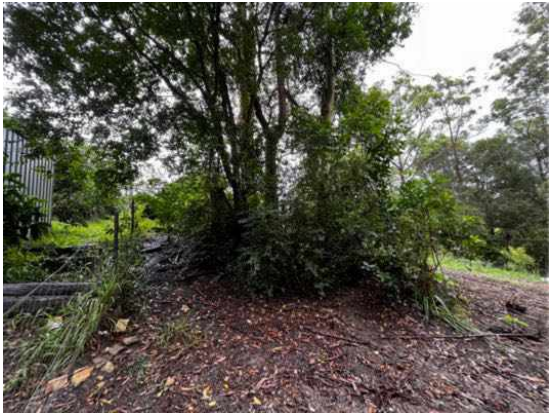
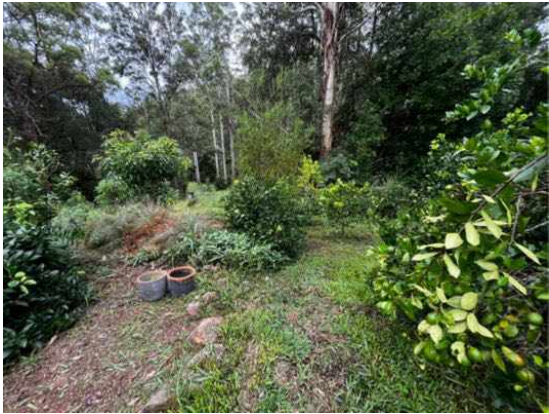
Building: Main Building
Location: All External Areas
Finding: Yard area - defects

Information: It was observed at the time of this inspection that the yard areas around the house were extremely overgrown with vegetation. Many items of the construction, fences, trees, paths and retaining walls were not able to be inspected thoroughly due to the overgrown nature of the vegetation.

It was observed that the driveway was unformed gravel.

It is recommended that all yard area vegetation be thinned out or removed and all yard areas be reinspected as soon as possible.

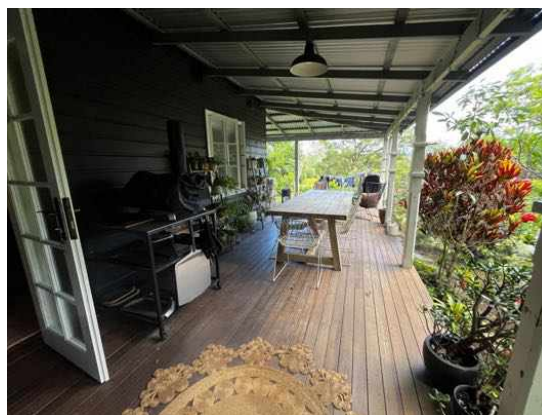
External timber structures are also constantly exposed to weather elements and can deteriorate in an accelerated manner, ongoing assessments are required.

It is highly recommended that a Structural Engineer further assess the external timber balcony or deck to inform the client of its load capacity. Regular maintenance

inspections by competent practitioners is needed.

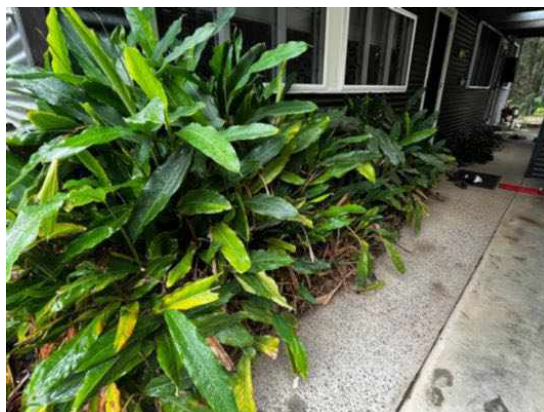
Building:	Main Building
Location:	Bungalow exterior walls - front
Finding:	Exterior area front - defects
Information:	At the time of this inspection it was observed that there were a number of minor defects to the external walls on the front of the house.

It was evident that there was excessive vegetation growth concealing areas of the external bungalow walls, this vegetation should be removed and the area be reinspected.

Also evident was that there was minor rust to the louvre window frames, it is recommended that the rust be sanded and the frames be painted or replaced at your discretion.

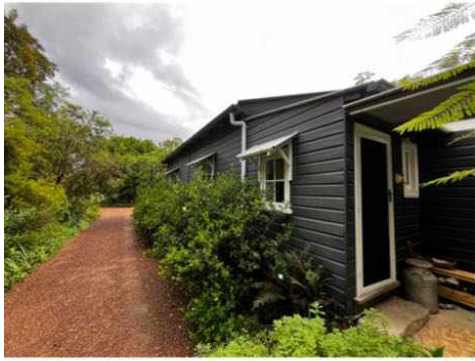
Building: Main Building
 Location: Exterior walls - right side
 Finding: Exterior area - right side
 Information: At the time of this inspection it was observed that there was excessive shrub and other vegetation growth obscuring the right side wall, it was observed that there was minor fungal decay (wood rot) evident in a number of the timber weatherboards it is recommended that the shrubs and other vegetation be thinned out or removed and the area be reinspected as soon as possible.

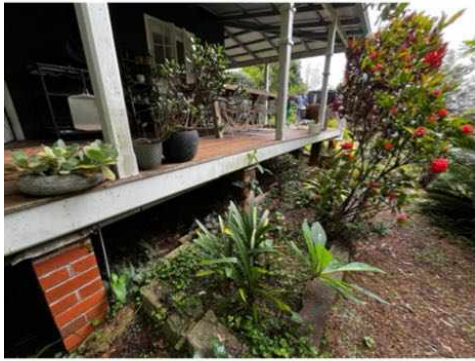
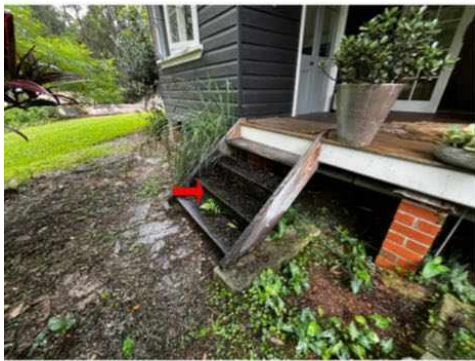
Building:	Main Building
Location:	Exterior walls - left side
Finding:	Exterior area - left side
Information:	At the time of this inspection it was observed that there was excessive shrub and other vegetation growth obscuring the right side wall and subfloor area, it was observed that there was minor fungal decay (wood rot) evident in a number of the timber weatherboards, It is recommended that the shrubs and other vegetation be thinned out or removed and the area be reinspected as soon as possible.

It was observed that a timber window had an unpainted edge visible, this edge should be painted as soon as possible.

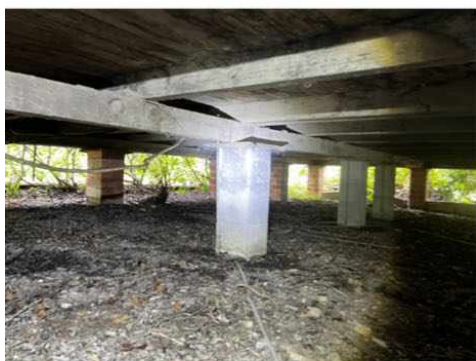
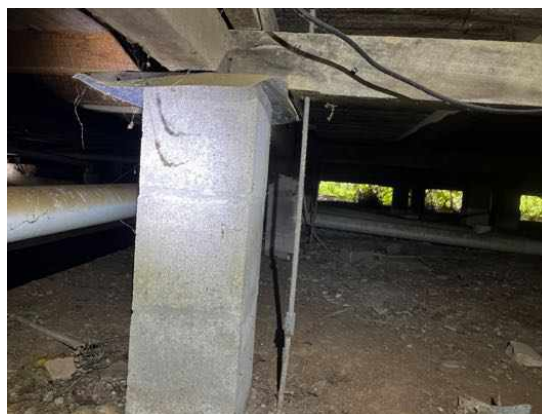
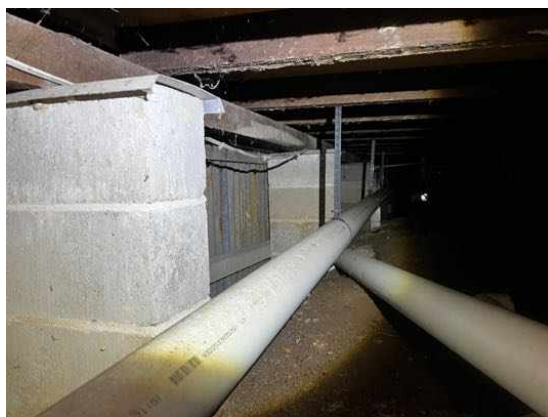
Building:	Main Building
Location:	Subfloor bungalow
Finding:	Subfloor space - defects
Information:	At the time of this inspection, it was observed that the subfloor area appeared to be in fair condition. Stored pipes were encountered, these should be removed. It was observed that the front side of the subfloor had low crawl space and excessive vegetation was obscuring the edges of the subfloor area. It is recommended that the vegetation be removed and the subfloor area be reinspected.

One section of the subfloor area to the house bathroom appeared to have no termite protection.

As a consequence of the conducive conditions for the infestation or attack by timber pests that exist around the external of the building (excessive vegetation) and the sub floor area (low crawl space), it is highly recommended that a professional timber pest practitioner be engaged to complete a thorough timber pest inspection to all areas of the yard and buildings once the vegetation has been thinned out or cleared and provide and implement a suitable Timber Pest Management Plan and soon as possible.

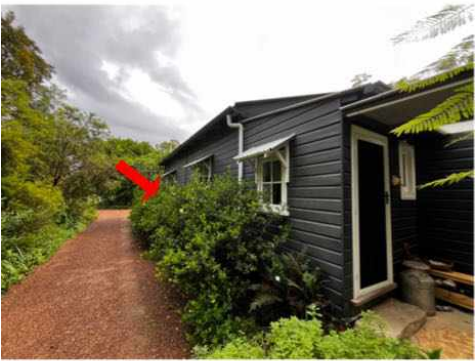
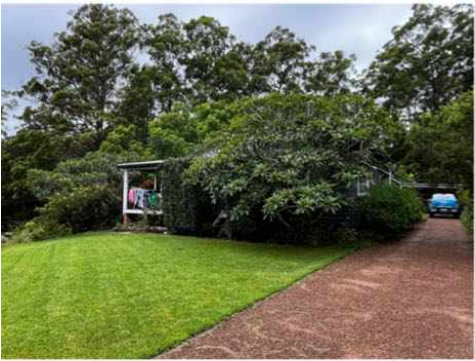
Building:	Main Building
Location:	All External Areas
Finding:	Possible concealed termite entry areas - conducive to termite attack
Information:	At the time of this inspection, numerous areas of possible concealed termite entry points were observed.

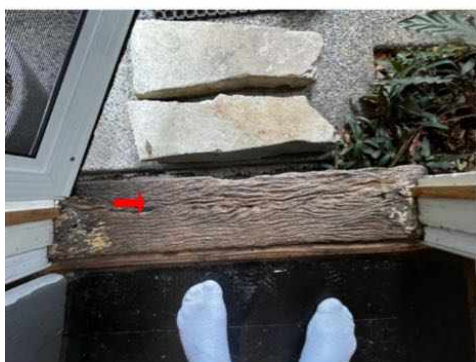
Finding: Office - defects

2 - The external office door had minor damage and the external timber door sill was severely deteriorated. It is recommended that a carpenter repair the damage to the door and replace the timber sill.
