Building and Timber Pest Inspection Report

Inspection Date: Mon, 9 Feb 2026

Property Address: 119B Waterdale Rd, Ivanhoe VIC 3079,
Australia

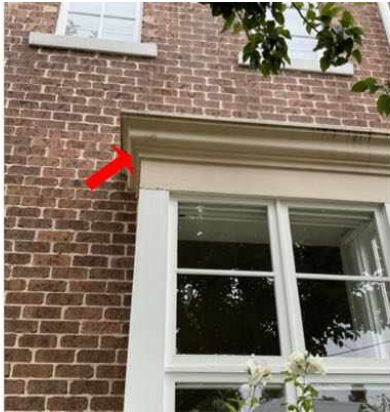
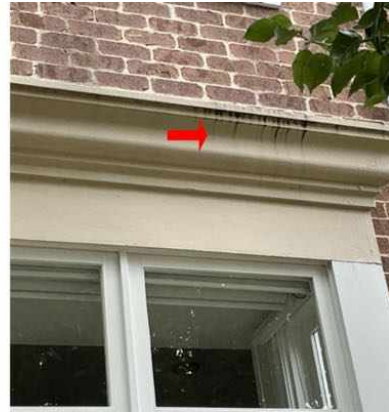
Building: Main Building
 Location: Window
 Finding: Rainwater runoff
 Information: Rainwater runoff staining was observed to the external window head moulding, with visible streaking/discolouration below the upper edge.

Ongoing runoff can contribute to accelerated paint deterioration and may increase the risk of moisture ingress and timber deterioration to the window surround over time if not addressed.

Engage a qualified tradesperson to investigate the source of runoff (e.g. roof/gutter/drip line above), rectify as required, and clean/prepare and repaint the affected moulding to improve weather protection.

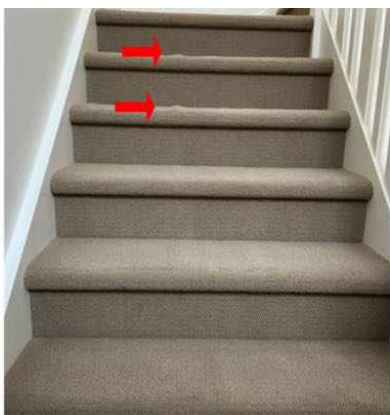
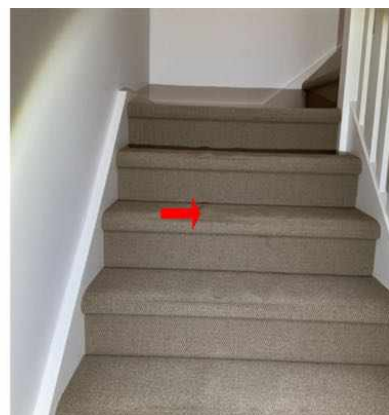
Finding 3.02

Information: The carpet shows visible rippling and unevenness. This condition is typically caused by improper stretching during installation, humidity changes, or gradual loosening over time due to regular use.

While it does not present a structural concern, the uneven surface may create a trip hazard and affect appearance. It is recommended to have a qualified carpet installer restretch or relay the carpet to restore a smooth, even finish.

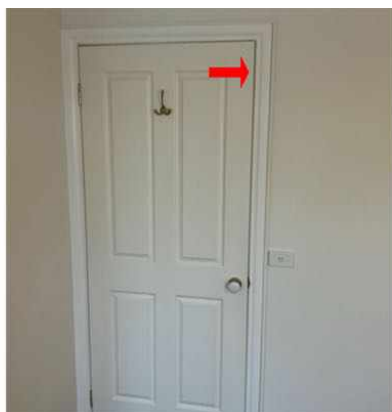
Finding 3.03

Building: Main Building
 Location: Bedroom - Master
 Finding: Door - Binding/jamming
 Information: Binding and/or jamming of this door is evident during standard operation. This defect inhibits the functionality of the affected door as well as creating potential for secondary defects to associated building elements, such as damage to the floor covering.

A door that binds the associated door frame may have several causes, ranging from minor defects, such as poor installation of the door or deteriorated hinges.

For minor causes, a qualified carpenter or general handyperson should be appointed to perform minor rectification works at client discretion.

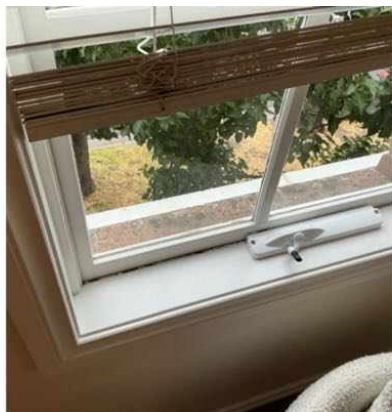
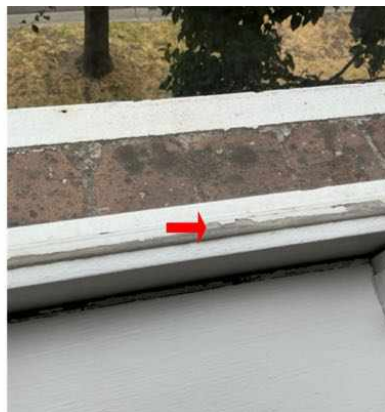
Finding 3.04

Building: Main Building
 Location: Bedroom - Master
 Finding: Window observation
 Information: Deteriorated paintwork and open/cracked joints were observed to the external timber window sill/frame and glazing putty/bead (as shown), including splitting/flaking to the sill and gaps along the glass-to-frame junction.

These defects can allow rainwater to penetrate into the timber, increasing the risk of timber decay/rot and internal moisture damage over time.

Engage a qualified carpenter/glazier to repair/replace any decayed timber, reinstate appropriate glazing seal/putty and perimeter sealant, and then prepare and repaint the window frame/sill to restore weather protection.

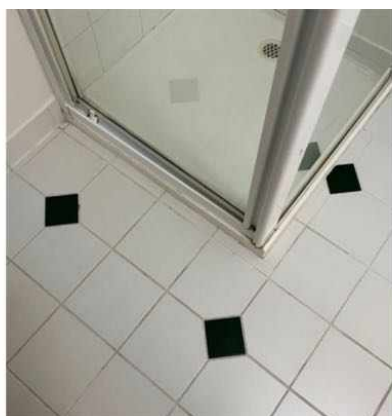
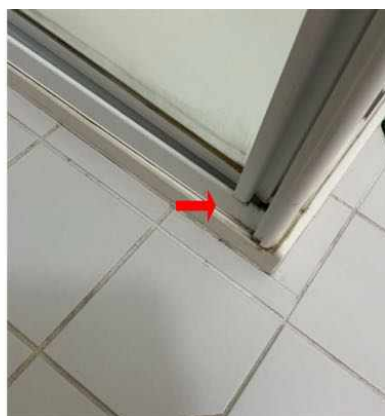
Finding 3.05

Building: Main Building
 Location: Ensuite - Master
 Finding: Shower Door Misalignment
 Information: The shower door was observed to be misaligned and does not close smoothly. It requires force to shut, preventing it from naturally closing and sealing as intended. This may result in gaps that allow water to escape onto the bathroom floor during use. Water leakage may cause damage to adjacent flooring, walls, or cabinetry, and pooled water outside the shower presents a slip hazard.

Engage a shower screen/glass specialist to realign the door and service or replace hinges and seals as required, so the door can close naturally and form a proper seal.

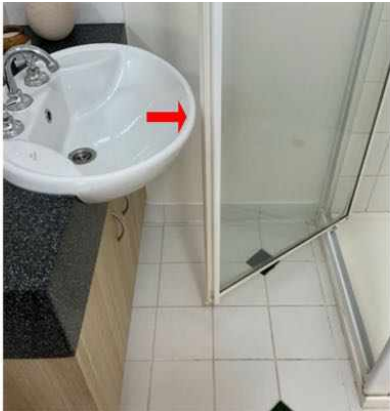
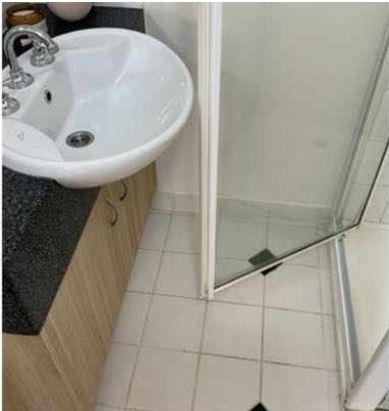
Finding 3.06

Building: Main Building
 Location: Ensuite - Master
 Finding: Shower door not fully open
 Information: The shower screen door could not be fully opened at the time of inspection, with the opening arc restricted.

Restricted operation may cause inconvenience and may increase the risk of impact

damage to the door, hinges, or adjacent fixtures during use.

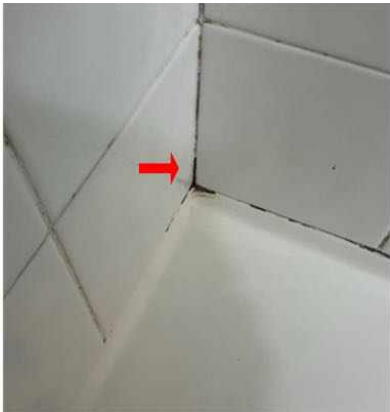
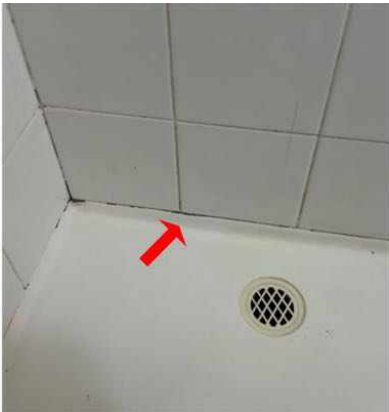
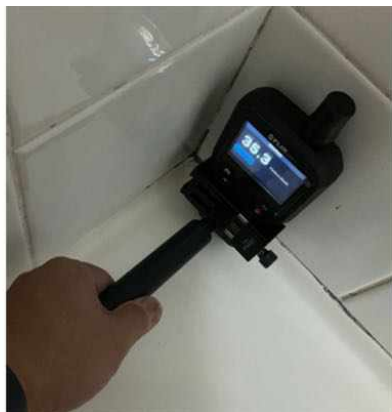
Finding 3.07

Building: Main Building
Location: Ensuite - Master
Finding: Missing Sealant
Information: Sealant was found to be missing. The gap is exposed and may allow water to penetrate into the substrate or wall cavity.

If left unattended, this can lead to moisture ingress, deterioration of the underlying waterproofing membrane, and potential damage to adjacent wall or floor finishes.

Slightly elevated moisture reading detected.

It is recommended that a qualified tradesperson remove any loose material, clean the area, and reapply an appropriate waterproof-grade sealant to restore a watertight seal around the shower screen.

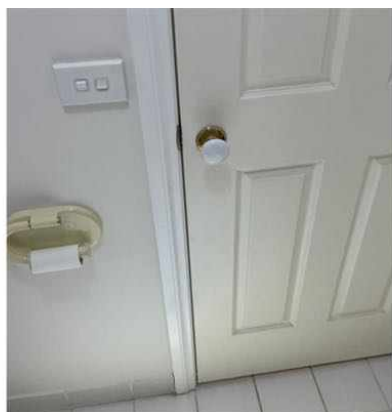
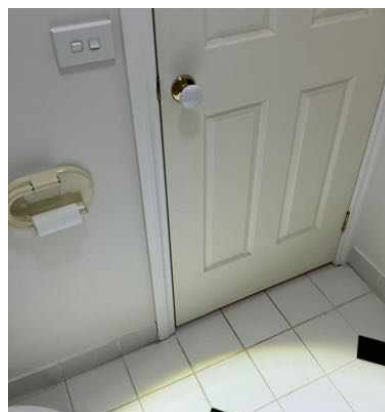
Finding 3.08

Building: Main Building
 Location: Ensuite - Master
 Finding: Door handle - Not latching
 Information: It was noted that the door in this area was not latching during operation at the time of inspection. Whilst detracting from the functionality of this building element, this minor defect may also be a security risk, and may therefore have serious implications if left unattended.

It is suspected that this defect has occurred due to minor issues with the associated hinges. Such damage is identified as general wear and tear, which is expected for building elements of this age.

A qualified carpenter or general handyperson may be appointed to perform rectification works as necessary, at client discretion. If left unattended, further functional impairment is likely to occur.

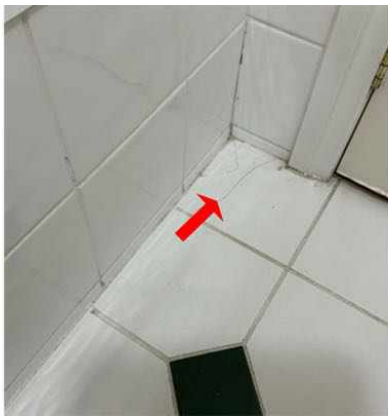
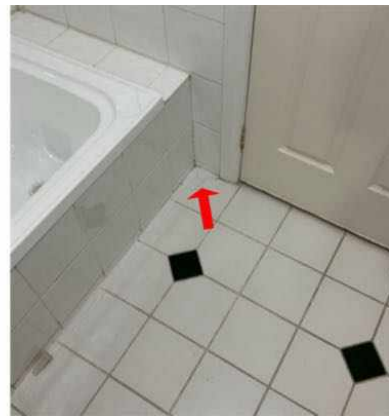
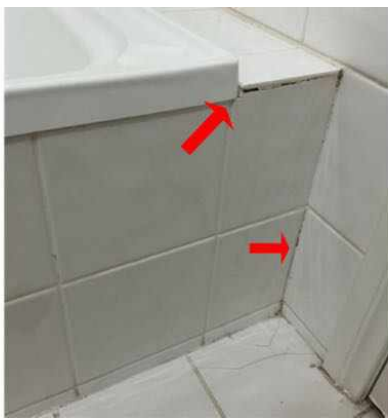
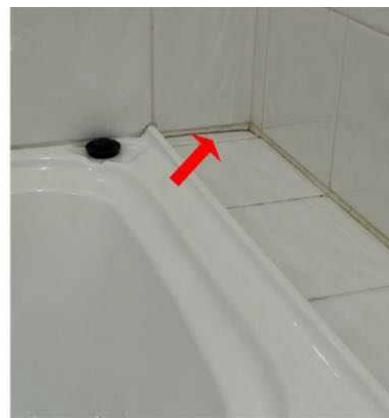
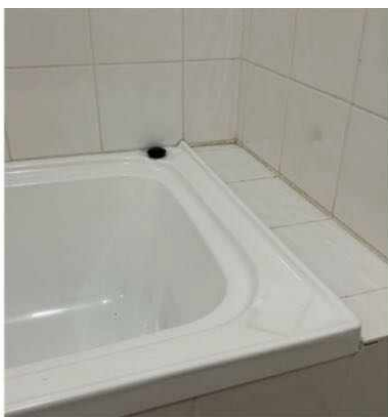
Finding 3.09

Building: Main Building
 Location: Bathroom
 Finding: Deteriorated sealant and tile cracks

Information: Deteriorated sealant was observed at the wall junctions around the bath/shower area, with localised gaps/discolouration, and a visible crack to a floor tile adjacent to the wet area.

Defective junction sealing and cracked tiles can allow moisture to penetrate into the substrate, increasing the risk of water damage and potential deterioration of the waterproofing system over time.

Engage a qualified contractor to replace the wet-area sealant and assess the cracked tile(s) (including checking for any movement or moisture-related damage), and complete rectification before any cosmetic re-finishing.

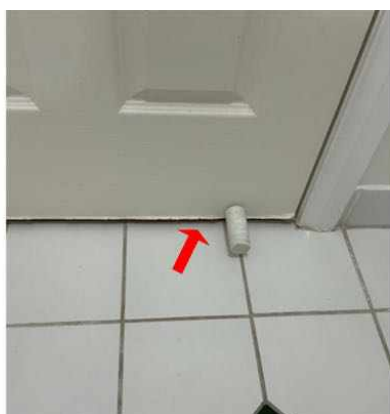
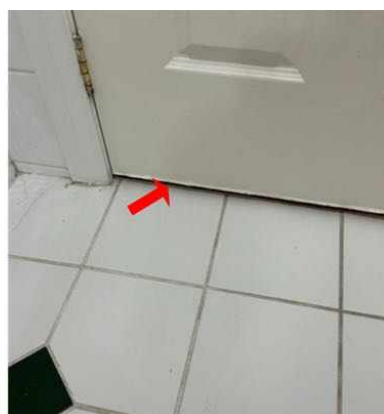
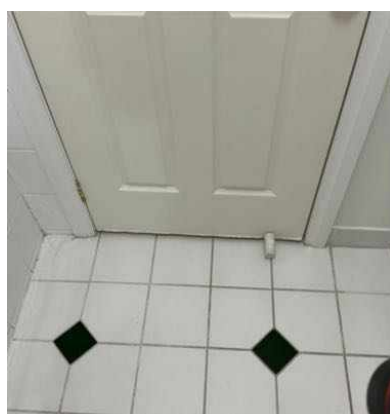
Finding 3.10

Building: Main Building
 Location: Bathroom
 Finding: Bathroom door distortion
 Information: The bathroom door shows distortion/warping at the bottom edge, with paint peeling and deterioration to the lower portion of the door.

This is typically consistent with moisture exposure and may continue to worsen, potentially affecting door operation and reducing the durability of the door finish.

Improve moisture control to the bathroom (e.g., ensure adequate ventilation) and engage a qualified tradesperson to repair/replace the affected section or replace the door as required, then prepare and repaint using a suitable moisture-resistant coating.

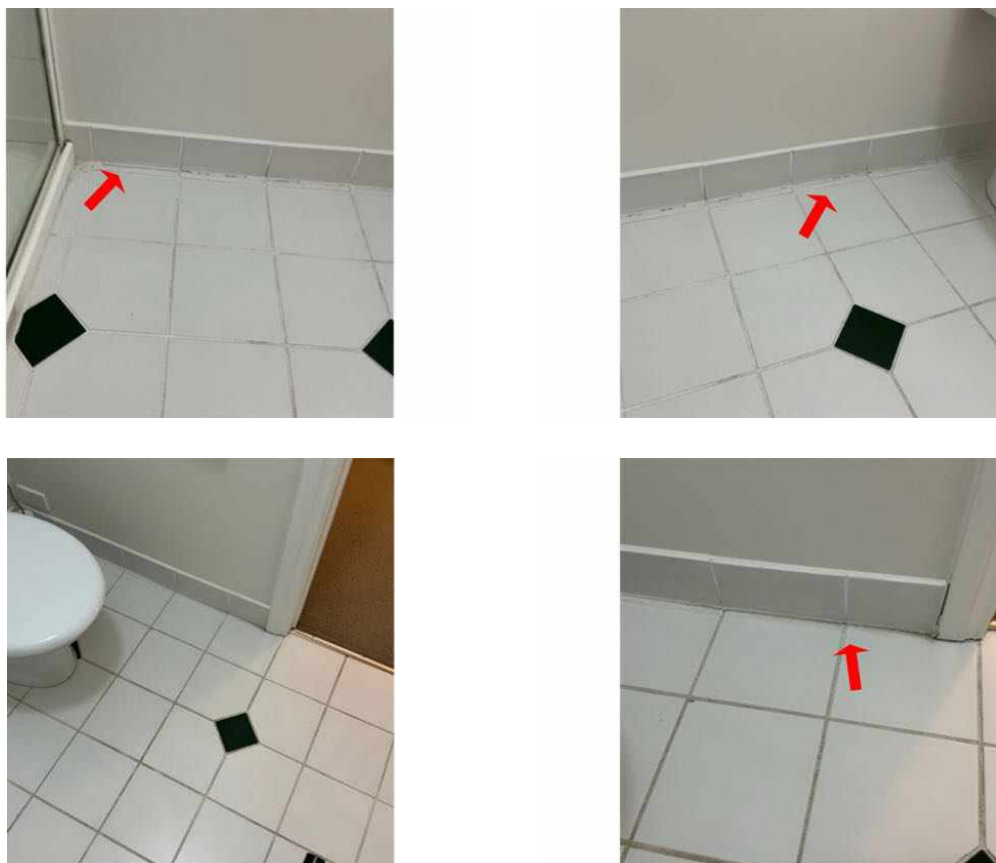
Building:	Main Building
Location:	Ensuite - Master
Finding:	Sealant deteriorate
Information:	The compromised sealant may allow water to penetrate into the substrate beneath the tiles. Over time, this can lead to deterioration of the underlying waterproofing membrane, increasing the risk of moisture ingress and potential structural damage.

A licensed waterproofing contractor should be engaged to remove the degraded sealant and reapply suitable waterproof-grade sealant.

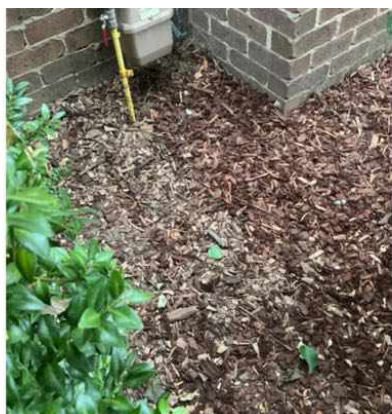
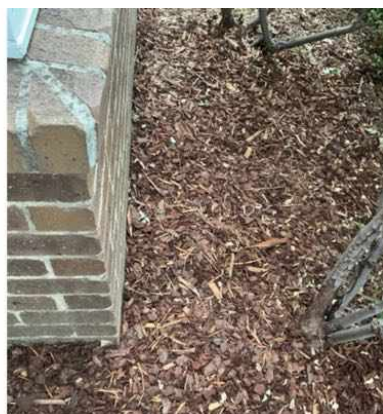
Building: Main Building
 Location: All Areas
 Finding: Stored timbers - subfloor space or external area
 Information: The storing of timbers in the subfloor space or around the external property (including bark mulch) increases the risk of termite activity being present. As they are likely to come into contact with weather conditions or excessive moisture wood rot is likely to develop on timbers that are not treated.

It is highly recommended that any stored timbers be immediately removed from areas in which they may attract any termite / timber pest attack. Minimisation of risk / prevention of termite attack is far more adequate than dealing with the presence of termite activity.

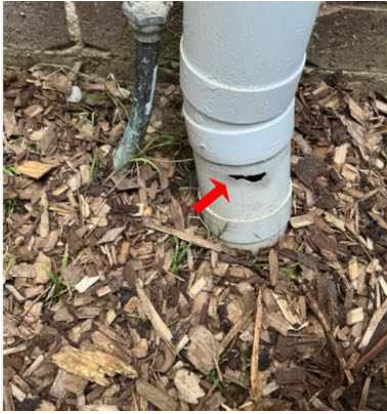
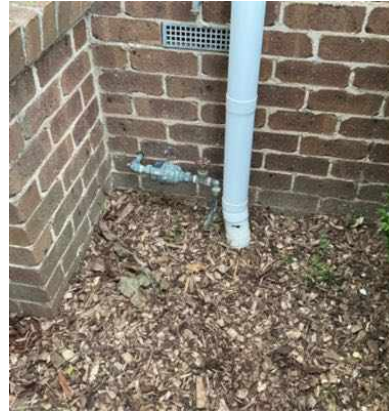
Building:	Main Building
Location:	Downpipe
Finding:	Damaged downpipe
Information:	A section of the external downpipe is damaged, with a visible hole/opening near the base causing stormwater to discharge directly at ground level adjacent to the building.

This can lead to localised soil saturation and moisture accumulation near the footing line, which may contribute to moisture-related damage and create conditions conducive to termite activity.

Engage a qualified plumber to repair or replace the damaged downpipe section and confirm stormwater is discharged to an appropriate point of discharge away from the building.

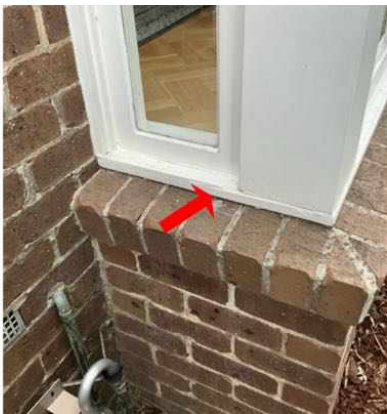
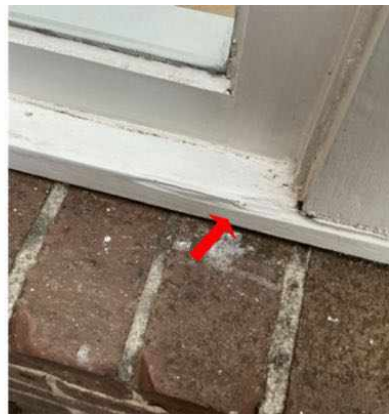
Finding 7.01

Finding: Windows - Wood rot

Information: Wood rot was found to be affecting external windows. Wood rot, also known as Fungal Decay, occurs when timbers and other cellulose building materials are exposed to damp conditions on an ongoing basis.

It is likely that this wood rot has developed as a result of frequent exposure to rain and other weather conditions. It is suspected that failure to maintain the window frames over a prolonged period has resulted in them deteriorating at an accelerated rate, increasing their susceptibility to the development of wood rot.

Repair and/or replacement of affected window frames may be a necessary step in protecting surrounding building elements from such deterioration. Remedial works should be performed by a qualified carpenter or registered builder as soon as possible to prevent any further damage.

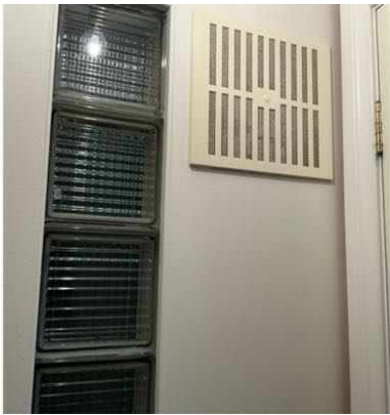
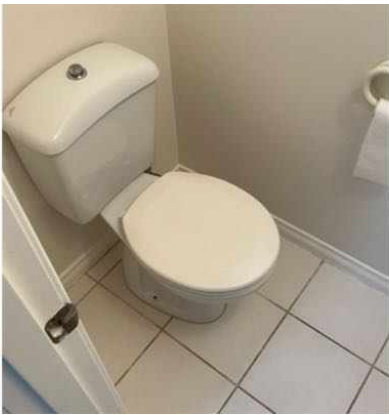
Building:	Main Building
Location:	Toilet (WC)
Finding:	Toilet no exhaust fan.
Information:	The toilet does not have a powered exhaust fan installed (ventilation appears to be natural only).

Limited ventilation may contribute to moisture and odour build-up, which can increase the likelihood of condensation and mould growth over time.

Consider engaging a licensed electrician/qualified contractor to install a compliant exhaust fan ducted to the exterior, if improved ventilation is desired.

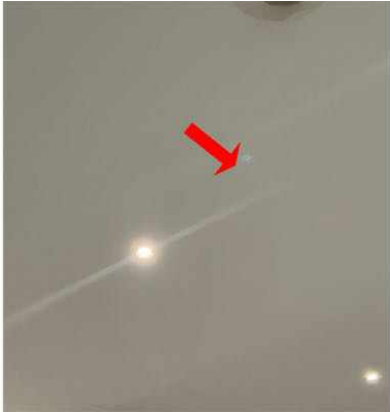
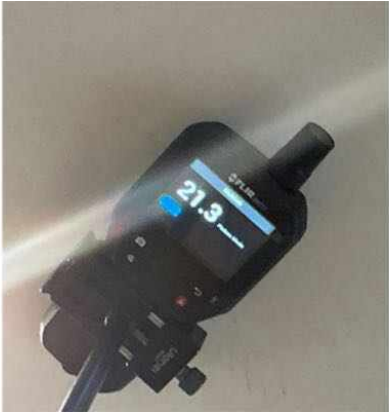
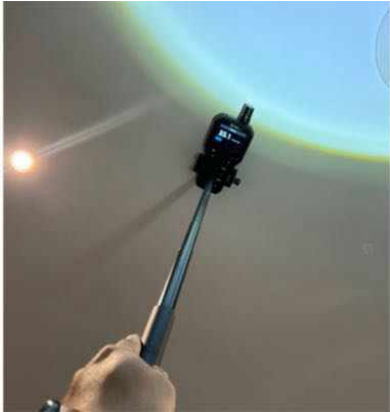
Building: Main Building
 Location: Living Room
 Finding: Additional photo
 Information: The living room ceiling shows some colour variation/staining. Moisture meter testing was undertaken and no elevated moisture readings were detected at the time of inspection.
