Building Inspection Report

Inspection Date: Tue, 3 Mar 2026

Property Address: 204/14 Half St, Wentworth Point NSW
2127, Australia

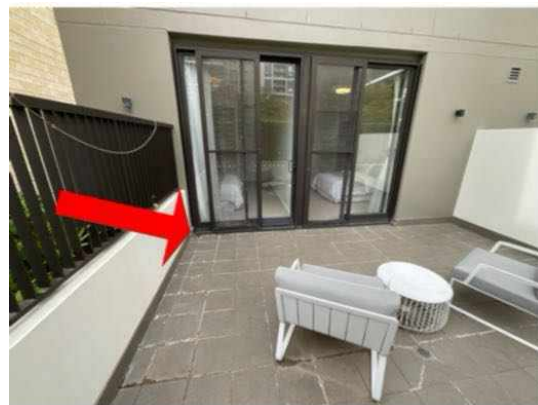
Defects 3.01

Building: Main Building
 Location: Yard - Back
 Finding: Moisture to Base of Sliding Door
 Information: Moisture staining and dampness observed beneath the external sliding door threshold. Debris and leaf build-up were also noted, which may be restricting drainage.

This condition indicates possible inadequate drainage, blocked weep holes, or failed threshold sealing, allowing water accumulation at the door base.

Clear debris, check weep holes and threshold drainage, and inspect sealing/flashing to prevent water ingress into the building. Further investigation recommended if moisture persists.

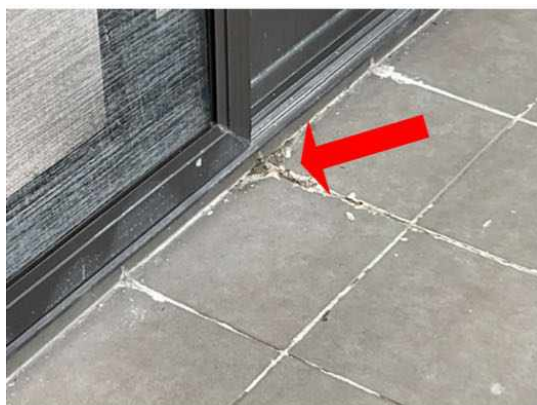
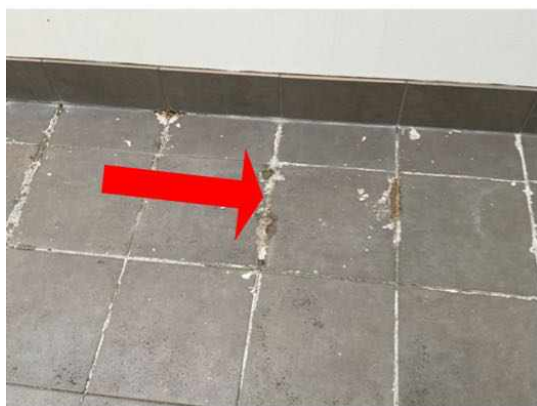
Defects 3.02

Building: Main Building
Location: Yard - Back
Finding: Alfresco – Tiling & Wall (Evidence of Moisture Ingress)
Information: Evidence of moisture-related deterioration was observed to the Alfresco area. Tile adhesive is lifting through grout joints, tiles show signs of debonding, and cracking is visible to the adjoining concrete wall. Water staining and efflorescence were noted to the base of the external brick wall.

The conditions observed are consistent with possible waterproofing failure and/or inadequate drainage to the balcony. Ongoing moisture ingress may result in further deterioration of tiling, substrate damage, and structural cracking over time.

An invasive inspection by a qualified waterproofing specialist is recommended to:

- Lift tiles as required
- Assess condition of waterproof membrane and substrate
- Check falls toward drainage point
- Rectify waterproofing and drainage defects as necessary

Monitoring is recommended to determine whether moisture intrusion is active.

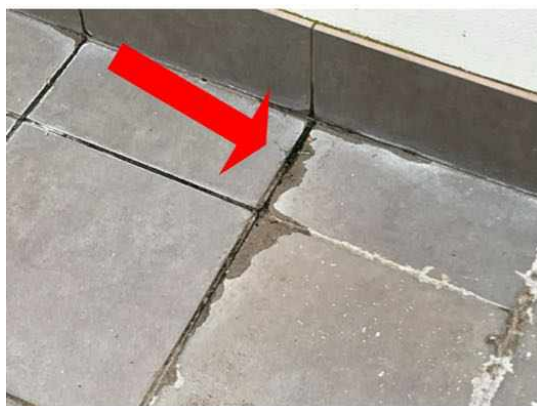
Defects 3.03

Building:	Main Building
Location:	Yard - Back / Balcony
Finding:	Tiles - Drummy
Information:	Drummy tiled areas were identified at the time of inspection. The term 'drummy' refers to tiles that have become detached from their fixing, despite otherwise being in relatively good condition. Such defects are generally caused by physical or moisture damage to the area. Drummy tiled areas may also be a direct result of poor workmanship during the construction process.

Tiled areas may swell and shrink with changes in air humidity if the area has sustained moisture damage. Any exposure to moisture is capable of causing tiled areas to become drummy and/or cracked over a prolonged period of time. Drummy tiled areas generally require removal and replacement of affected tiles, with adequate sealant and grouting.

Specialist trades are available for these types of services. A registered builder may be required to undertake works if damage is extensive or if secondary building defects have resulted. Otherwise, it is advised that a tiling contractor be appointed to perform works as necessary. Immediate action is recommended to ensure that no further damage is sustained in the affected area.

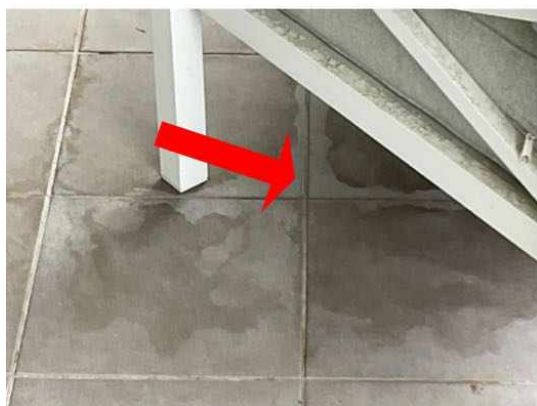
Defects 3.04

Building:	Main Building
Location:	Balcony
Finding:	Balcony - Water Pooling
Information:	Evidence of water pooling around the floor waste and on the floor in these wet area were noticed at the time of inspection. It is suspected that this excessive moisture is attributed to insufficient fall in the wet area floor tiles.

This pooling is minor overall but is still considered unsatisfactory, as standard tiling practices would not permit this situation to occur. Pooling water around floor wastes or on floor can create a slip hazard in extreme cases and create conditions that are conducive to mould growth over time. Where left unmanaged, the degradation of sealant and grouting is also likely to occur, possibly necessitating further repair works.

Remedial works may involve some sections of tiling and flooring repair and replacement. A tiling contractor should be appointed to provide further advice on reparation options and to perform works as necessary.

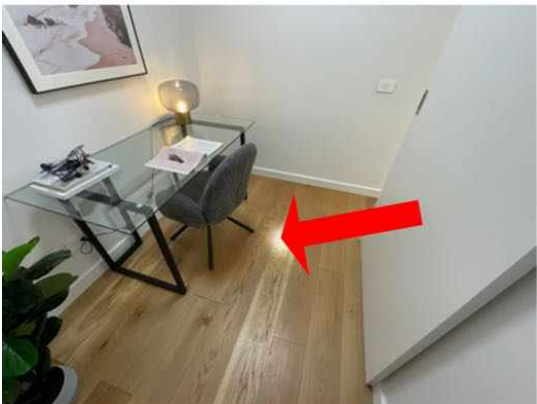
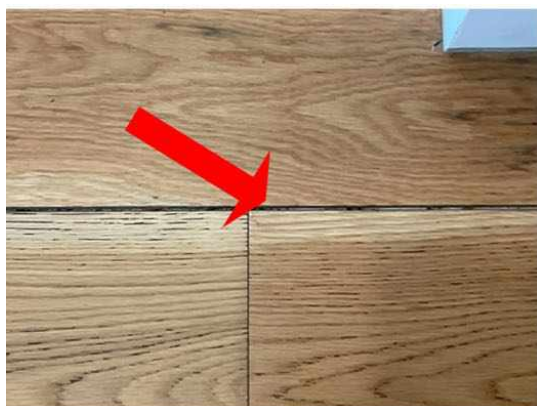
Defects 3.07

Building: Main Building
Location: All Internal Areas
Finding: Float Timber flooring - damaged / gap
Information: Damages / gaps to float laminate flooring were found during inspection. The laminate timber flooring is typically resistant to water damage, but standing water and large amount of moisture that gets under the floor (as the water has no place to evaporate) can eventually destroy the floor and delaminate the product.

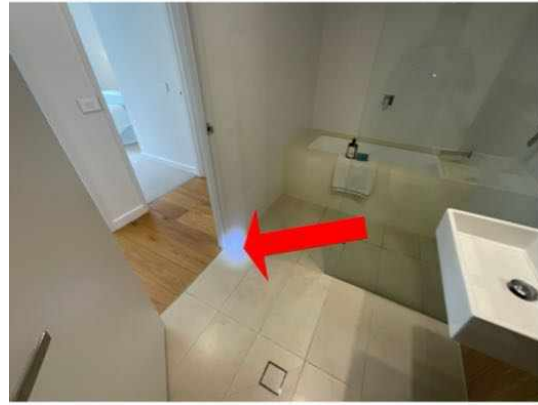
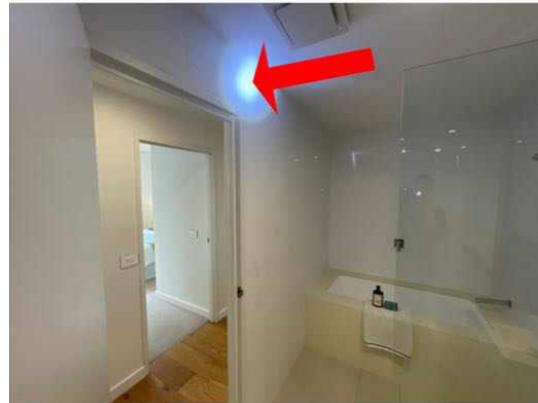
Defects 3.08

Building:	Main Building
Location:	Bathroom
Finding:	Tiles - Cracked or damaged
Information:	Cracking was evident to the tiling in this area at the time of inspection. While the cracking appears to be minor, this area is frequently exposed to water, allowing potential for water penetration into adjoining sections of walls or flooring.

If left unmanaged, water penetration to these areas may lead to subsequent water damage, which is likely necessitate repair work to affected building elements.

A tiling contractor should be appointed to ensure that no further water damage occurs. The re-application of silicone and grouting throughout remaining tile work is also advised, to further protect the area against water penetration.

Where water penetration has led to water damage, appointment of a relevant tradesperson may be required to repair damaged building elements.

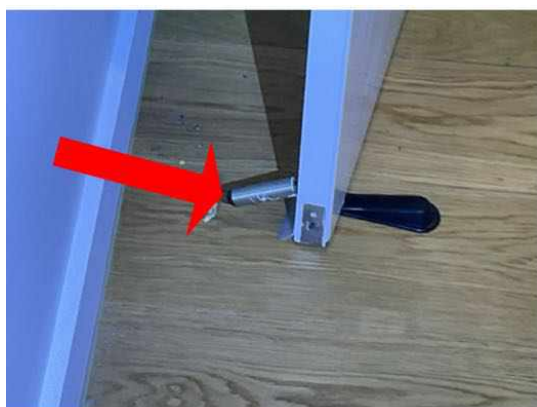
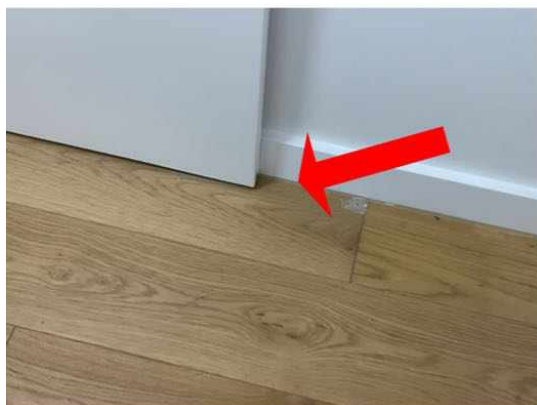
Defects 3.11

Building:	Main Building
Location:	All Internal Areas
Finding:	Door stop - inadequate
Information:	The door stop is missing or is inadequate to stop the door handle from damaging the wall. Although some building elements may seem irrelevant or unnecessary, all building elements play a key role in the operation and function of the overall structure and its performance.

Re-installation or replacement of the door stop is advised as soon as possible to prevent any subsequent damage to the door or associated structures. A general handyman may be appointed to perform these works at client discretion.

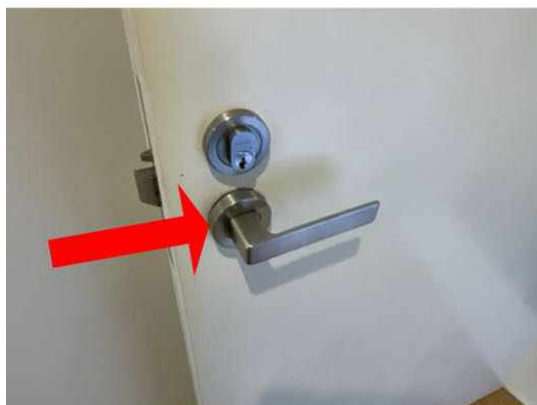
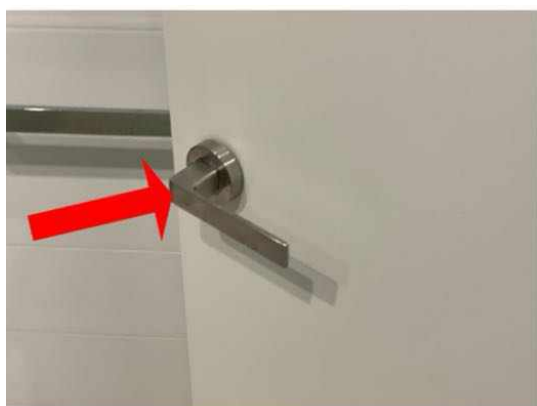
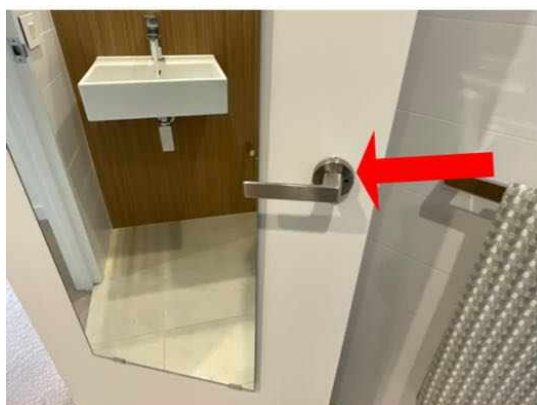
Defects 3.12

Building:	Main Building
Location:	All Internal Areas
Finding:	Fitting (door handle) - Loose
Information:	The fitting in this area is loose and requires adjustment to tighten.

If left unmanaged, the fitting may further deteriorate, causing potential for the development of other minor secondary defects.

A relevant tradesperson should be appointed to perform these rectification works at discretion of the client.

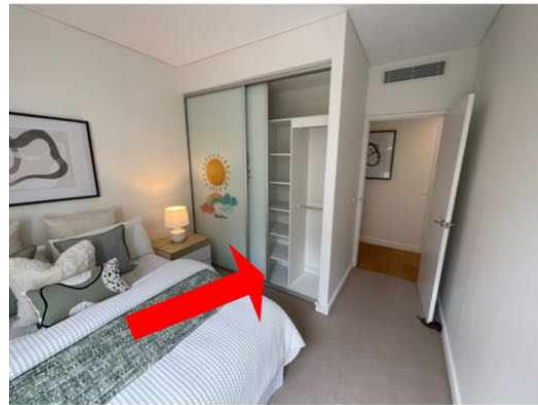
Defects 3.13

Building:	Main Building
Location:	Bedroom 2
Finding:	Misaligned Sliding Door – Wardrobe
Information:	The sliding door to the wardrobe was found to be misaligned. The door panels are not sitting level within the tracks and do not close flush, resulting in poor operation and uneven appearance.

The builder/tradesperson is to realign the sliding door panels by adjusting the rollers and track guides to ensure smooth operation and flush closure in accordance with manufacturer's installation requirements.

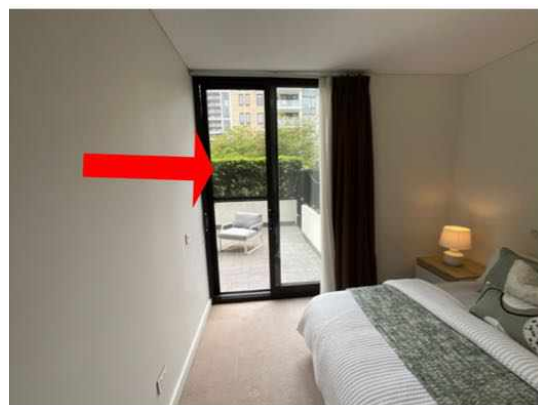
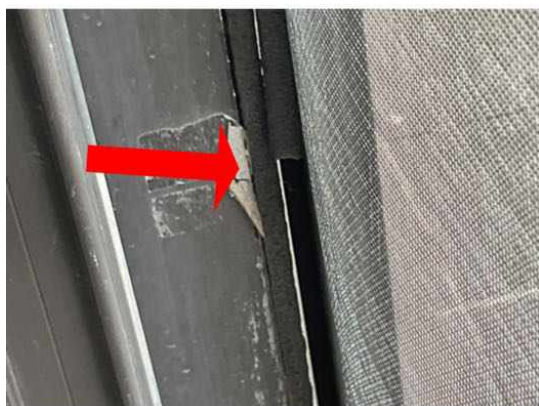
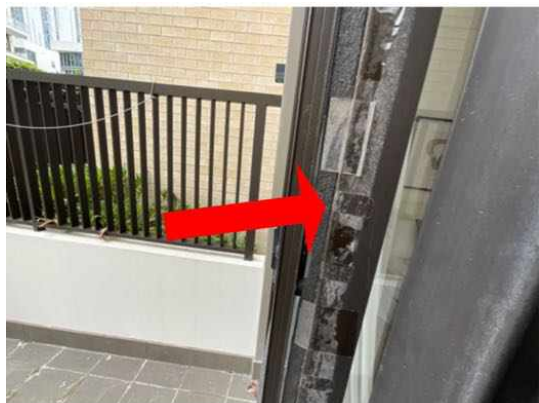
Defects 3.14

Finding: Flyscreens - Damaged

Information: Flyscreens were found to be damaged to the windows in this area at the time of inspection. This damaged building element detracts from the operational state of the window. Where not replaced, damaged flyscreens allow pest and insect ingress into the adjoining room/s. It is advised that all damaged building elements be replaced in order to ensure the full function of all building structures. A general handyperson may be appointed to replace flyscreens at the discretion of the client.

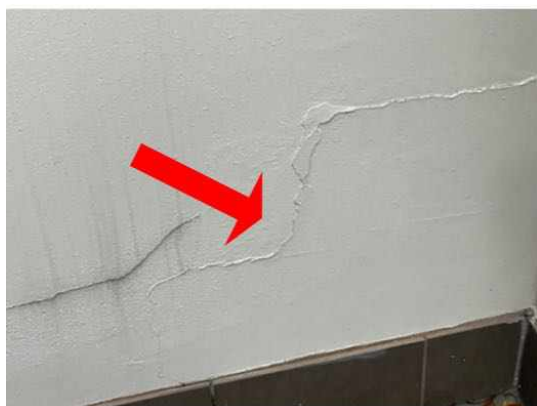
Defects 3.15

Building: Main Building
 Location: All Areas
 Finding: Cracking & moisture to Masonry Wall (Adjacent Planter)
 Information: Cracking & Moisture observed to the rendered masonry wall next to the planter box. Likely due to movement and/or moisture from planter drainage.

Classification: Minor defect (monitor).

Check planter drainage and waterproofing. Seal crack and monitor for further movement. Structural review recommended if cracking worsens.

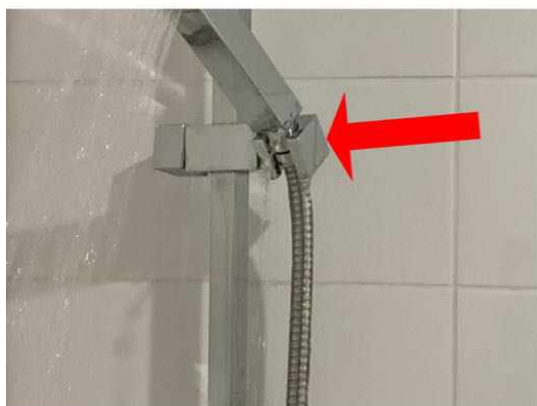
Defects 3.16

Building: Main Building
 Location: Ensuite
 Finding: Shower Head Leaking
 Information: The handheld shower head was observed leaking at the hose connection point. The fitting is not watertight, resulting in water escaping during use.

- NCC 2022 – Volume Two, P2.2.1 (Health and Amenity – Sanitary Facilities): Plumbing and sanitary fixtures must be installed to avoid water leakage and provide safe, sanitary conditions.
- AS/NZS 3500.1:2021 – Plumbing and Drainage (Water Services): Requires all plumbing fittings and fixtures to be installed in a way that prevents leakage and ensures durability.
- Guide to Standards and Tolerances 2017 (Section 11.02 – Plumbing Fixtures): Plumbing fixtures and fittings are defective if they leak when tested under normal operating conditions.

- Water wastage and increased utility costs.
- Risk of water damage to adjacent finishes and building elements.
- Reduced serviceability of the plumbing fixture.

The builder is to rectify the leaking shower head by checking the hose and fitting connections, ensuring they are correctly installed and sealed. If required, the faulty shower head or hose is to be replaced to achieve compliance with AS/NZS 3500.1.

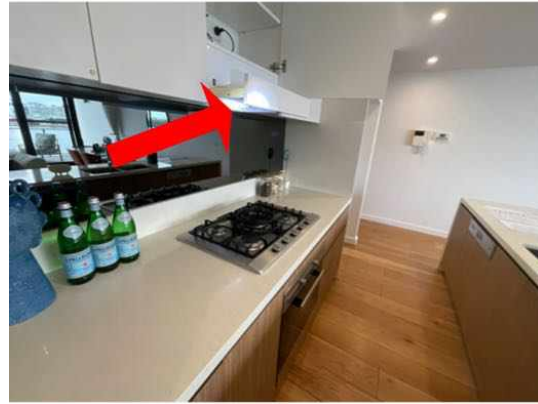
Defects 3.17

Building:	Main Building
Location:	Kitchen
Finding:	Rangehood - Fan not working properly
Information:	While the range hood appears to be working at a satisfactory level, the fan to the structure was not working at the time of inspection.

Without a functional fan, a build-up of grease and evaporative moisture is likely to accelerate deterioration of the range hood and associated flue. This potential build up

may also create a minor fire hazard, particularly if left uncleaned.

A licensed electrician should be appointed to replace the fan on the range hood to restore it to a fully operational state.

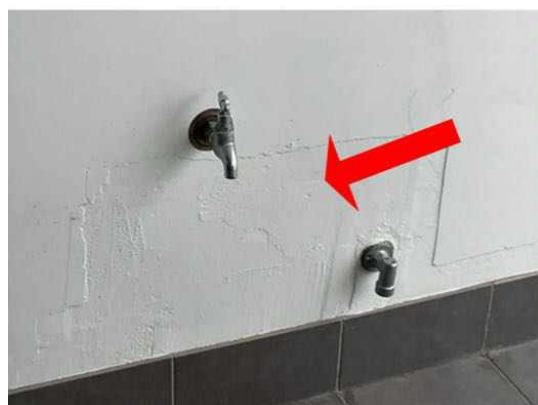
Noted Item

Building: Main Building
 Location: Balcony
 Finding: Patch Repair / Inconsistent Render Finish
 Information: A section of wall below the external tap fittings shows inconsistent render finish and patching, indicating previous repair works. The repaired area is visually distinct from surrounding wall surfaces.

This suggests prior damage or moisture-related defect has been rectified; however, workmanship is uneven and aesthetic finish is poor.

- NCC 2022 Vol 2 – H2D2 (Weatherproofing – protection from moisture)
- General workmanship requirements under the NSW Guide to Standards and Tolerances

Monitor for signs of recurring moisture. If dampness reappears, further investigation of plumbing or waterproofing is recommended. Re-rendering for uniform finish may be required.
