Building and Timber Pest Inspection Report

Inspection Date: Mon, 9 Mar 2026

Property Address: 28 Mahon Ave, Kennington VIC 3550,
Australia

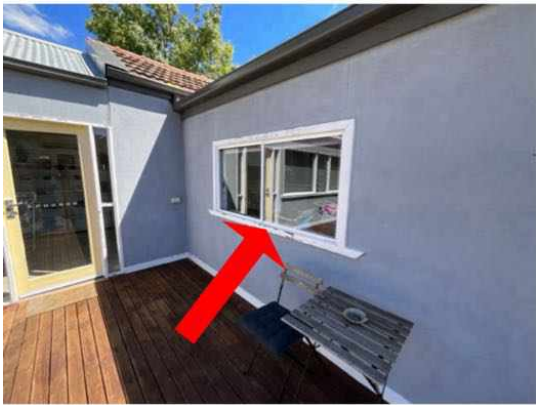
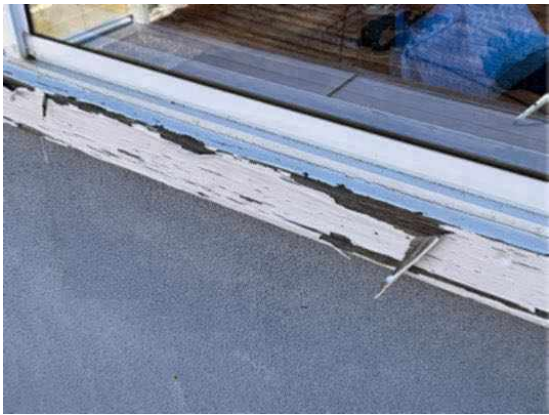
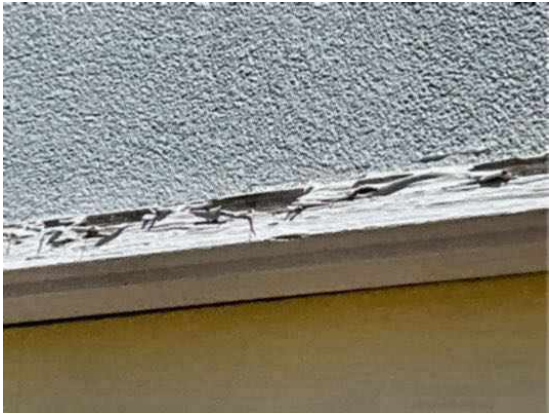
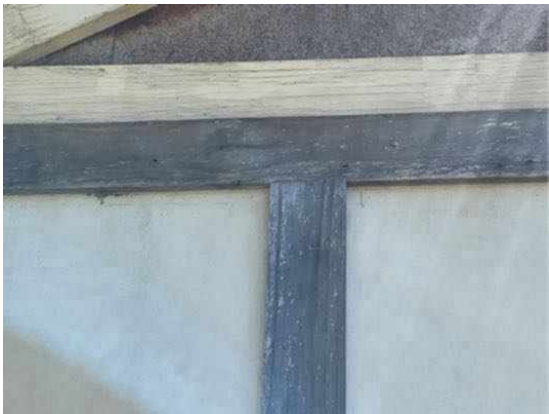
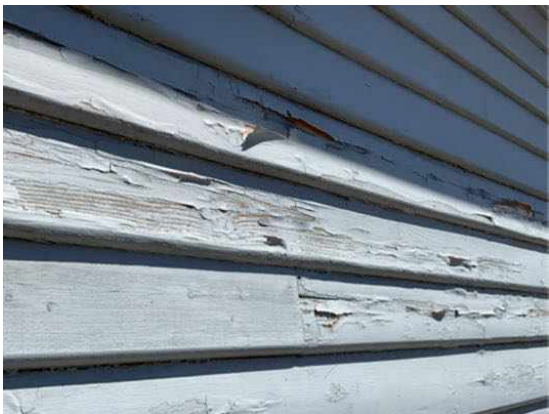
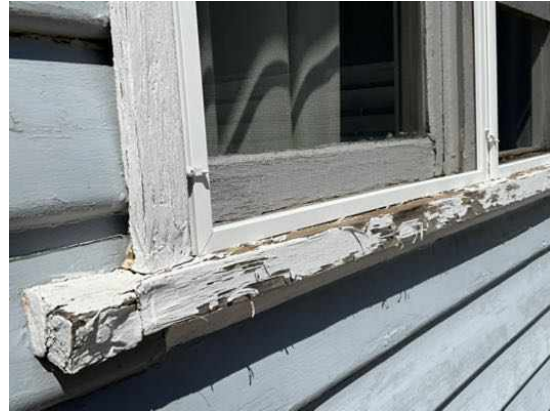
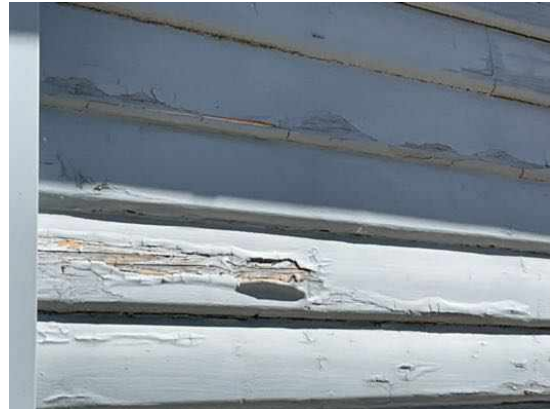
Finding 3.01

Building:	Building 1
Location:	All External Areas
Finding:	External painting deteriorated
Information:	Much of the external paintwork including but not limited to windows, fascias, guttering, veranda and other external fitments have been neglected and require attention to prepare and re-paint.

Whilst incomplete or missing paint finish is generally an appearance defect, it can also lead to the development of secondary building defects over time. Incomplete areas of paint finish expose the area to moisture, potentially accelerating the deterioration of underlying building materials.

Degraded paint finishes should be sanded back, filled, leveled and painted, as applicable. Where inadequate or missing paint protection has led to the deterioration of the associated building element, repair and/or replacement of this building element may be required.

A painting contractor should be appointed as soon as possible to perform necessary works to aid the appearance of the affected area and to ensure the area is protected against further deterioration. Alternatively, the homeowner following manufacturer instructions may perform these works.

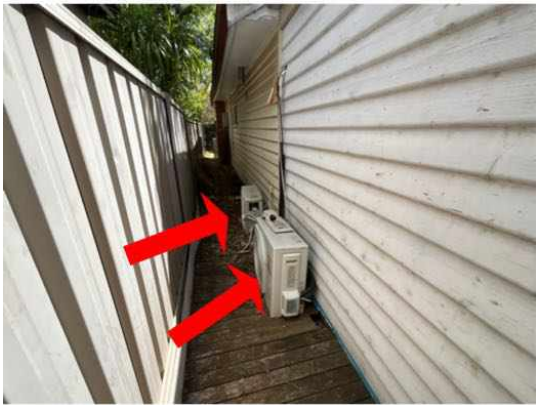
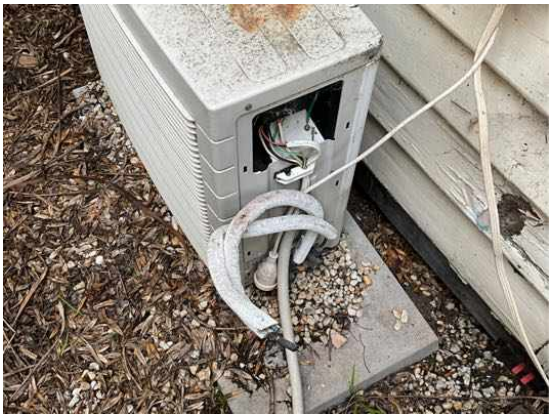
Finding 3.02

Building:	Building 1
Location:	Yard - Side
Finding:	Installation - substandard or incomplete
Information:	The installation of this building element appears to have been completed to a substandard level of workmanship or is incomplete. Generally substandard repairs or installation are related to poor workmanship, the use of inappropriate materials, or a failure to complete installation to a suitable standard.

Where installation is substandard and/or incomplete, the client should contact the responsible trade to undertake rectification. Unfinished and substandard building works are likely to degrade more quickly and may create potential for secondary defects to associated building elements.

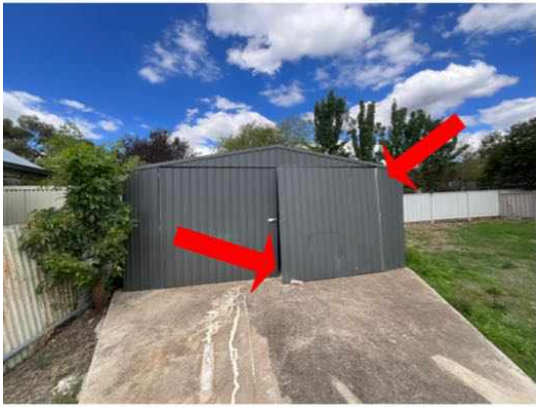
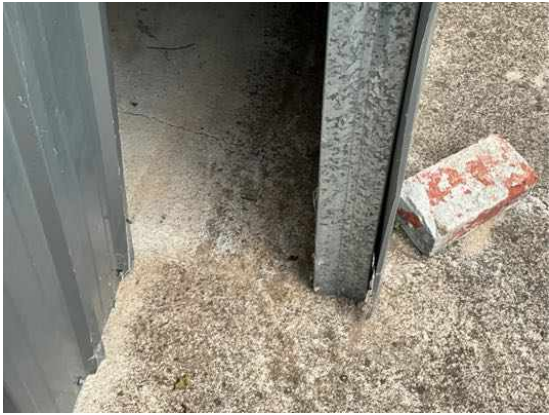
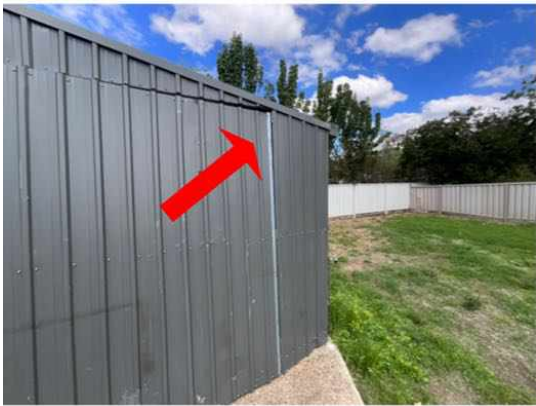
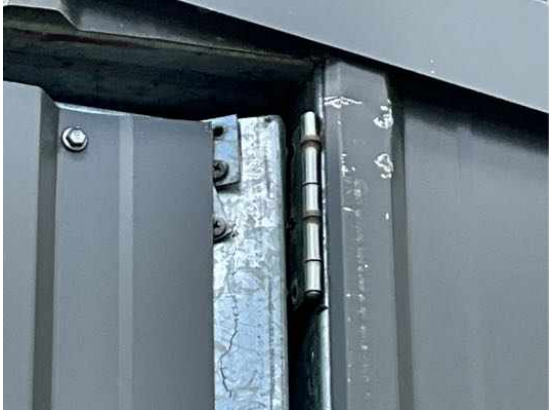
Finding 3.03

Information: Binding and/or jamming of this door is evident during standard operation. This defect inhibits the functionality of the affected door as well as creating potential for secondary defects to associated building elements, such as damage to the floor covering.

A garage specialist or general handyperson should be appointed to perform minor rectification works at client discretion.

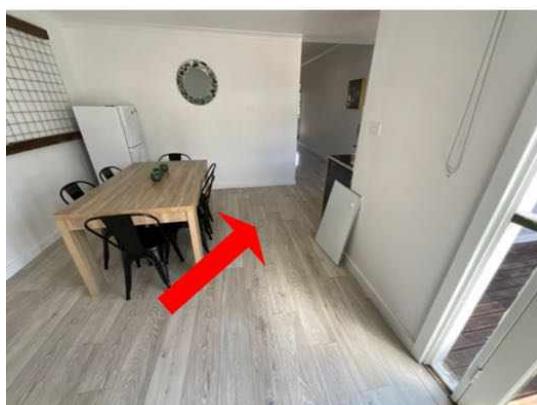
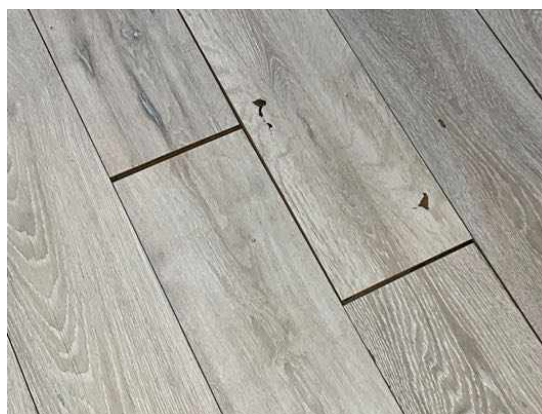
Finding 3.04

Building:	Building 1
Location:	Dining Room
Finding:	Timber flooring- deterioration
Information:	The flooring in this area shows signs of deterioration. Movement and separation of the Boards is evident.

A Flooring specialist should be contacted soon to restore the area and prevent further deterioration.

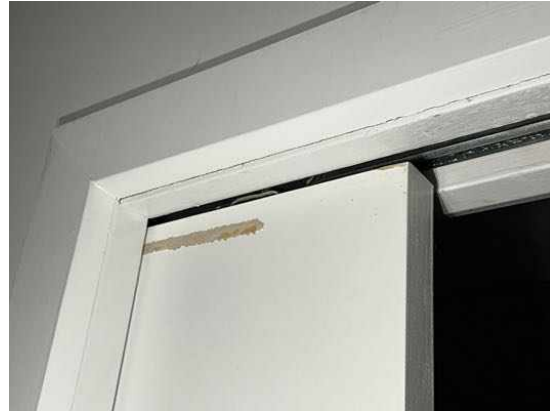
Finding 3.05

Building:	Building 1
Location:	Ensuite
Finding:	Door- Stiff to slide
Information:	The door in this area was jammed and difficult to slide along the associated tracks at the time of the inspection. Restricted function of the affected door may pose as a potential safety hazard if required for emergency egress from the building.

Generally, factors such as general age of the building element and a lack of maintenance are the usual causes for this type of defect.

Replacement of door hardware or tracks may be required, as well as minor repairs and cleaning. A registered builder or general handy person will be required to repair the affected doors.

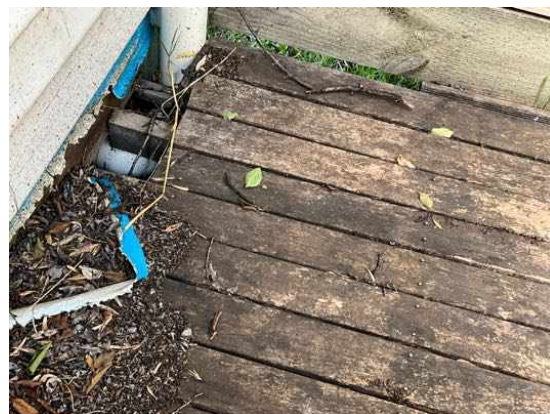
Finding 3.06

Building: Building 1
 Location: Yard - Side
 Finding: Floors/ deck - bouncy
 Information: The flooring in this area was identified as being bouncy at the time of inspection. A bouncy floor surface generally presents as a discernible change in level as they are walked across, in noisy or creaking flooring, or in consequent movement of surrounding furniture and fixtures.

Bouncy floors generally indicate that the floorboards or the subfloor structures are coming loose from the joists that they are installed on. Bouncy flooring may also be the result of gaps between flooring and stumps or joist structures, which require packing.

The client is advised to seek quotations for required repairs from a Registered Builder specialising in decking or flooring . The potential resolution may range from packing gaps in subfloor structures through to replacement of subfloors stumps and refixing of flooring.

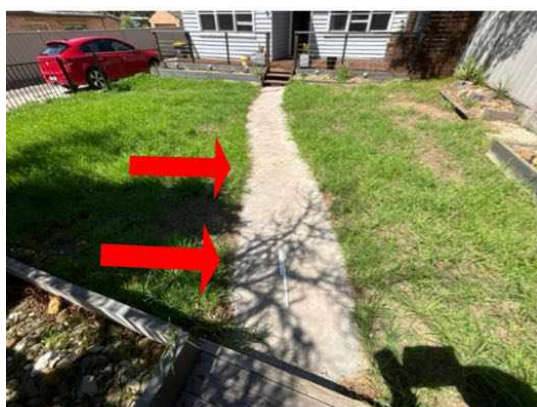
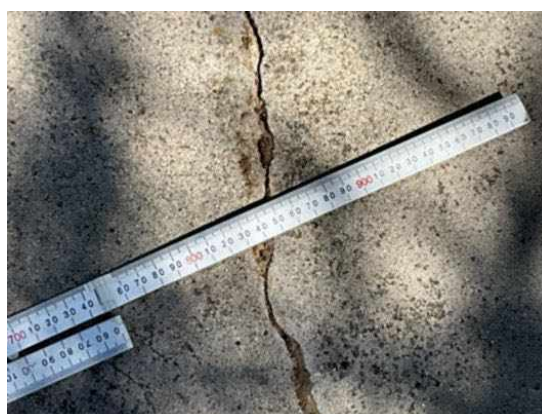
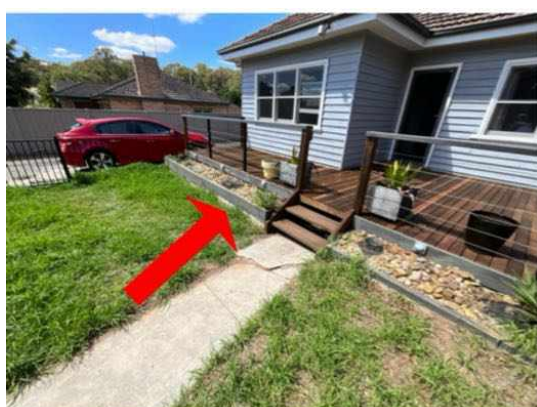
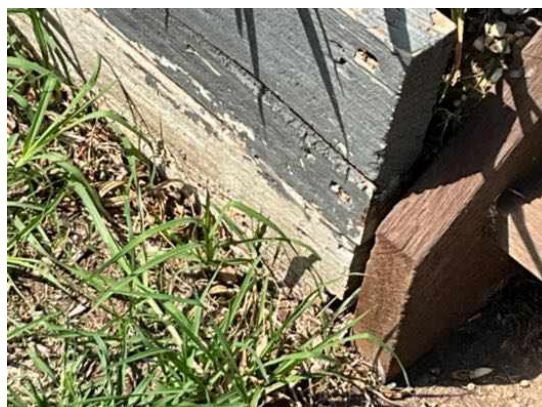
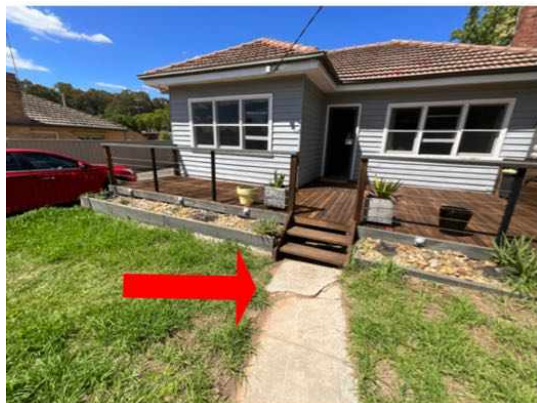
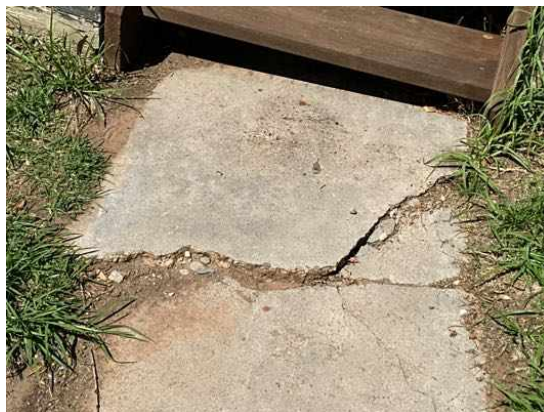
Finding 3.07

Building: Building 1
 Location: Yard - Front

Finding: Cracking - External Concrete Paving Damage Category 3 - Wide Cracks (2mm - 4mm)
 Information: Wide cracks were identified in external concrete paving Wide cracks are significant and are likely to lead to the development of safety hazards and secondary defects if left unmanaged.

General age and expected deterioration of the paved areas is a common cause of this type of cracking. However, expansion and contraction of the slab may also have occurred due to environmental factors. Such factors include variable moisture and weather conditions, the presence of trees and their roots having a settling or lifting affect on the soil, or the effect of load bearing, e.g. heavy vehicles over a sustained period of time.

Cracking to this degree may also be due to poor original installation of the concrete. Factors such as poor compaction of the sub surface and/or inadequate reinforcing of the slab may create cracking and other secondary defects. Wide cracks may also have a more significant structural cause, such as subsidence of soils.

Where the crack is located adjacent to structural elements of the building, the advice of a Structural Engineer is advisable before undertaking repairs. Significant repair and likely replacement of the concrete paving is probable.

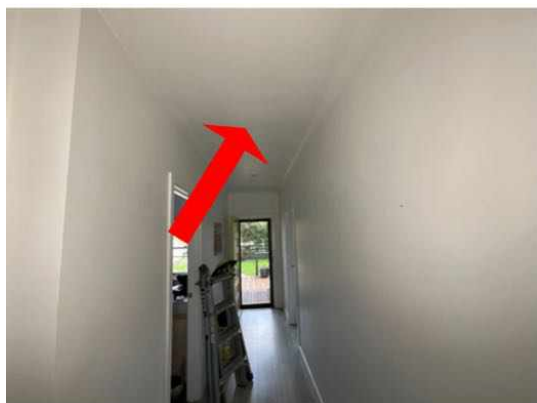
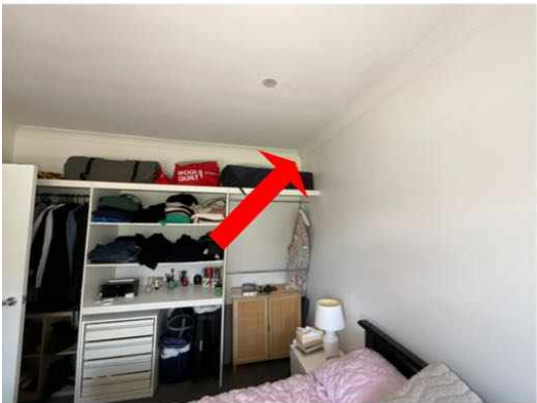
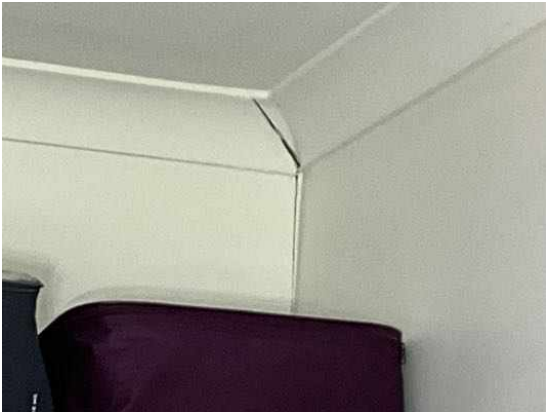
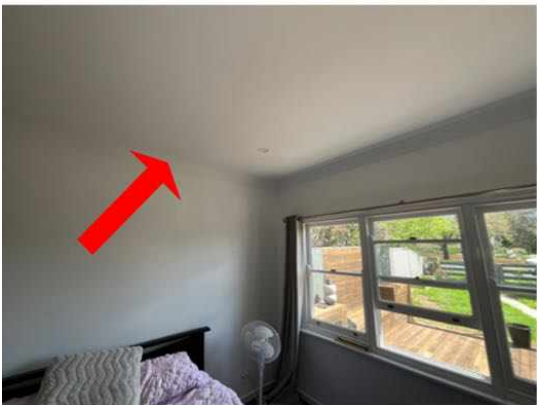
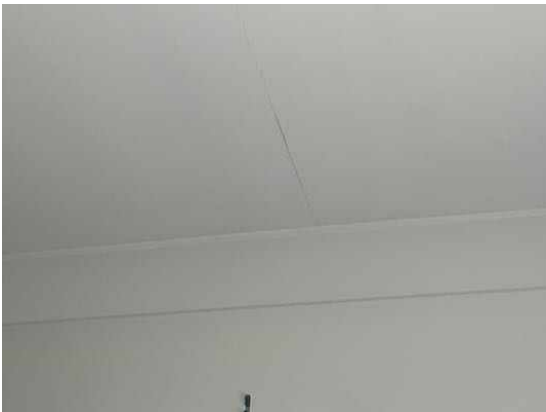
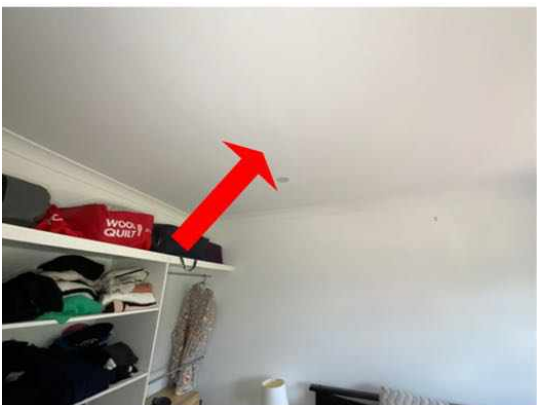
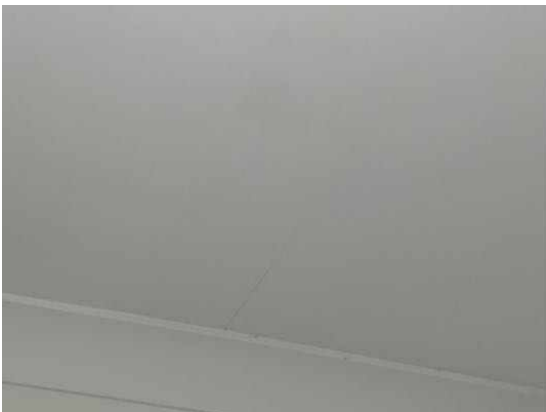
Finding 3.08

Building:	Building 1
Location:	Hall, bed 2,
Finding:	Cracking - Damage Category 1 - Fine (up to 1mm)
Information:	Although fine cracks are quite noticeable, they are often only considered to be an appearance defect, and usually do not indicate any structural damage. Generally, the cause of a fine crack is indicative of a separation between building materials and finishes (e.g. paint, plaster, etc.) along joints.

Cracking of this nature can generally be repaired with minor sanding, filling and/or repainting. Such works should be performed by a qualified painter or a general handyman.

Monitoring of all cracking should be conducted frequently. Always contact a building inspector should cracks widen, lengthen, or become more numerous.

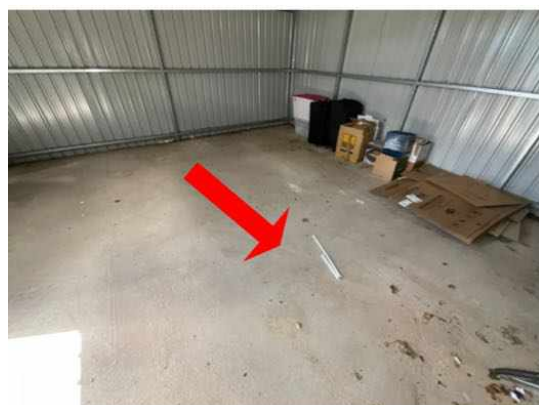
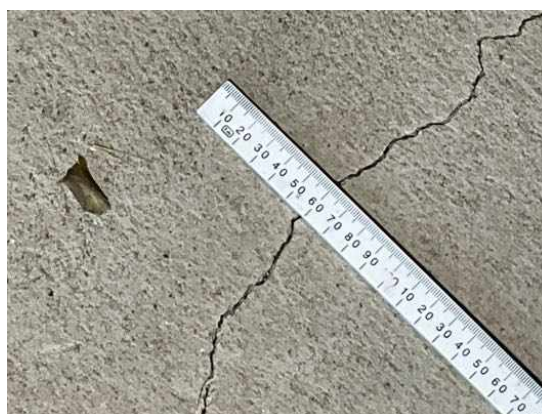
Finding 3.09

Building: Building 1
 Location: Garage
 Finding: Crack in concrete slab - Category 1
 Information: A crack coded as Category 1 was identified in the slab. A Category 1 crack is described as a fine but noticeable crack, with the slab at an otherwise reasonable level.

To be considered Category 1, the approximate width of the crack is less than 1.0mm, or a less than 10mm change in offset when a 3m straight edge is placed over the defect.

Category 1 cracks should be monitored for a period of 12 months. At the end of the monitoring period, identified cracks that are rated greater than Category 2 are considered defects, and require rectification.

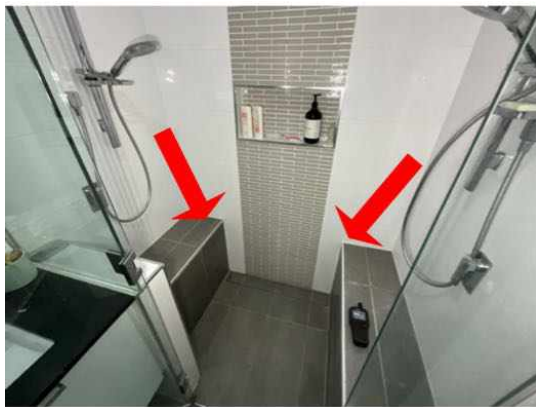
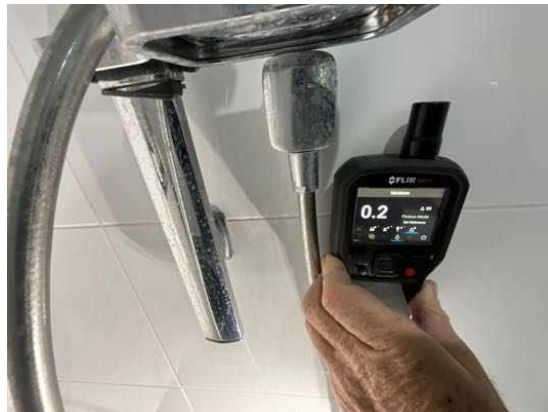
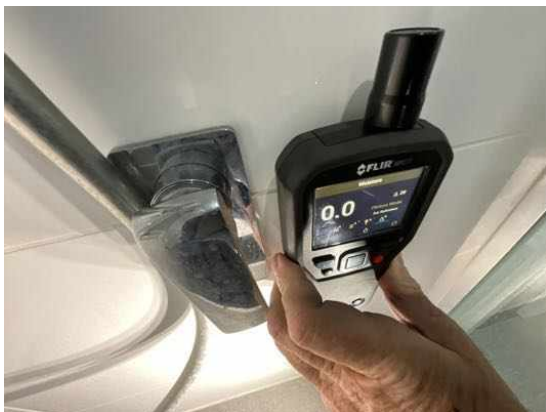
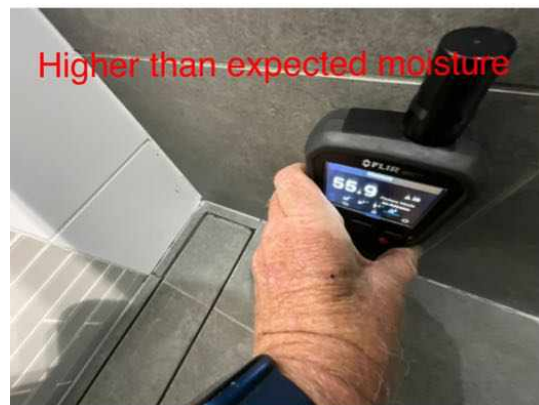
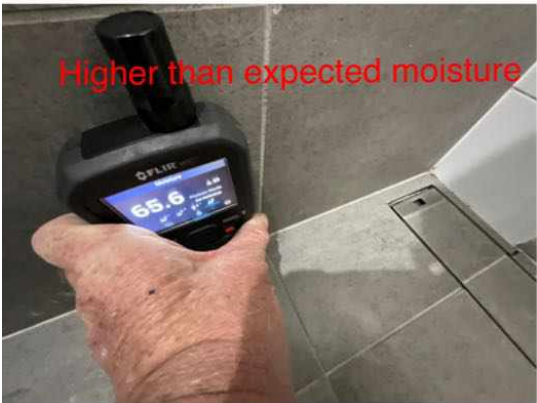
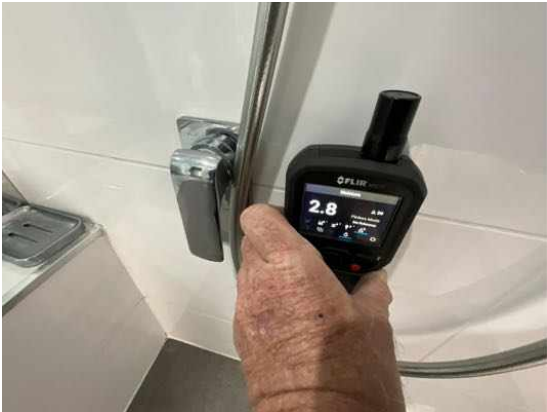
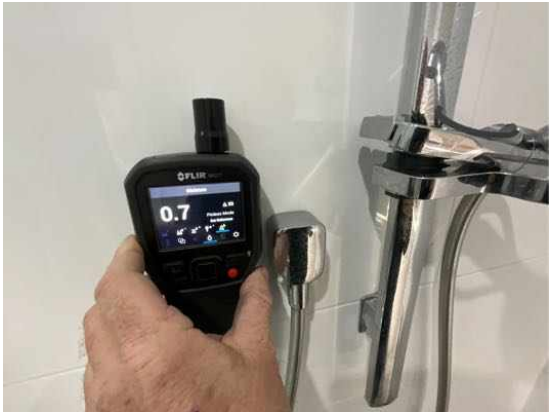
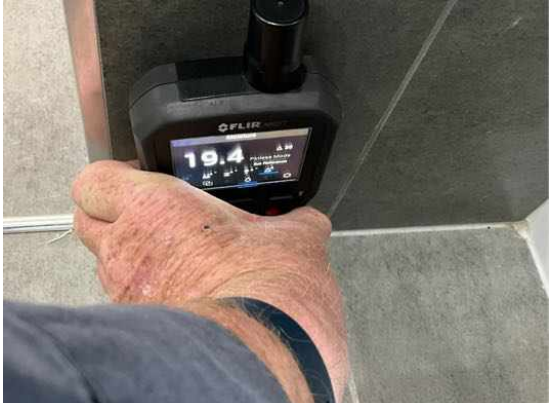
This defect is quite common, and is suspected to have been caused by moisture

permeating or leaching through the grouting and perhaps gaps in the sealant prior to repair.

Damp (or structural damp) refers to the presence of unwanted moisture in the structure of a building, either as the result of intrusion from outside, or condensation from within the structure. In the shower area, internal water leaks or other sources of excessive moisture are generally the cause of damp.

Monitoring the area is advised and if any visual signs of excessive moisture appear (peeling paint, mould) then consultation with a qualified plumber or bathroom specialist would be advised to identify the cause of damp and to perform remedial works as required.

Always ensure that sealant and grout is in good condition to prevent any moisture issues occurring in the future.

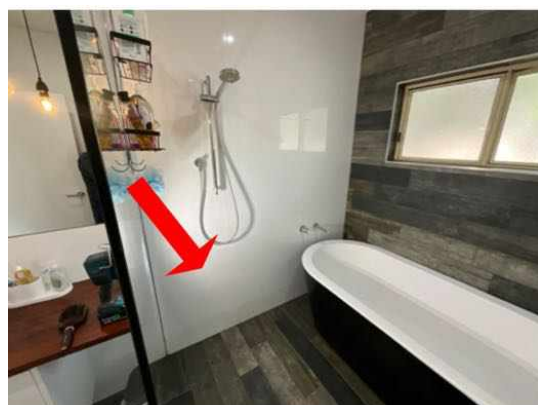
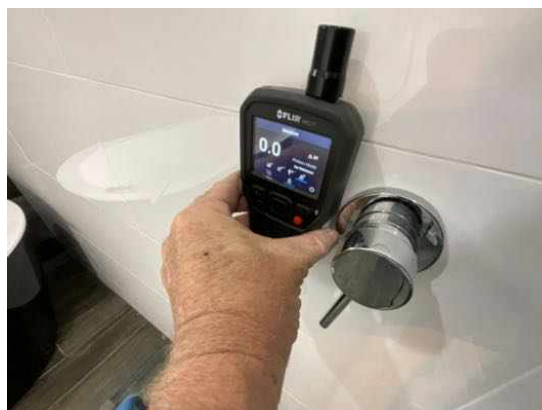
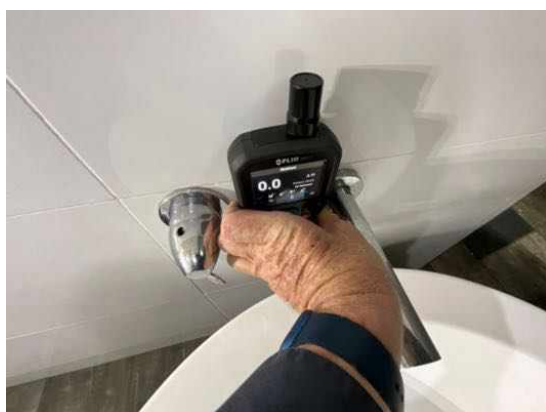
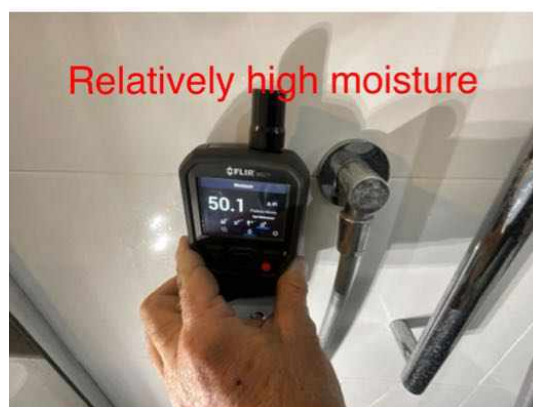
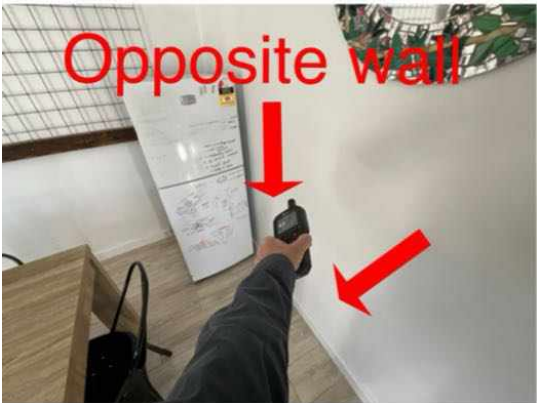
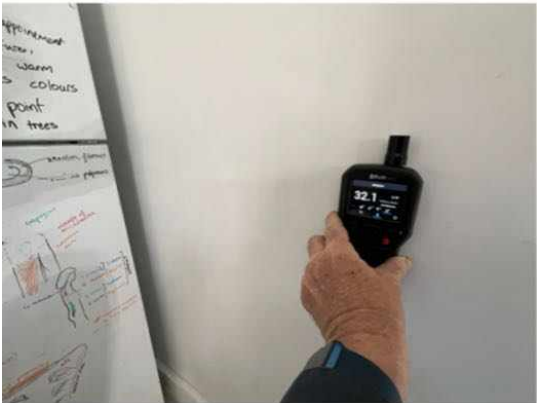
Finding 6.02

Building: Building 1
Location: Bathroom
Finding: Shower Damp- Significant
Information: Damp is evident to the lower wall to the Shower Alcove. This is suspected to have been caused by moisture permeating through the grouting in this area.

Relatively High levels of moisture were observed on the outside of the shower walls in the opposite wall.

Damp (or structural damp) refers to the presence of unwanted moisture in the structure of the building, either as a result of intrusion from outside, or condensation from within the structure. In the Shower area, internal water leaks or other sources of excessive moisture are generally the cause of damp.

Consultation with a qualified Plumber or Bathroom Specialist is advised immediately to identify the cause of damp and to perform remedial works as required.

Always ensure that sealant and grout is in good condition to prevent any moisture issues occurring in the future.

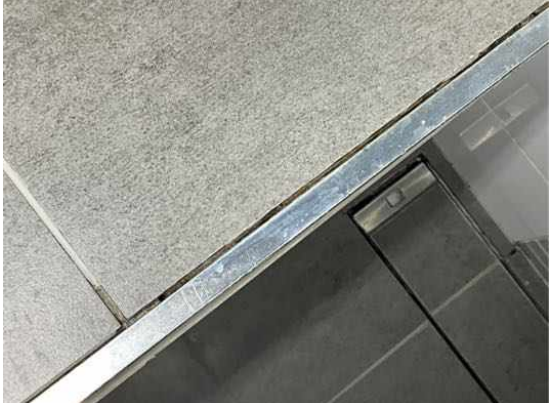
Finding 6.03

Building: Building 1
 Location: Ensuite
 Finding: Inadequate sealant or Grout
 Information: This area has a lack of effective Sealant or Grout. This is allowing the ingress of water to the structure inside the wall.

The presence of water encourages Termite attack, Mould and Fungal Decay.

A Tiler or General Handy person must be contacted as soon as possible to effect repairs and prevent further deterioration.

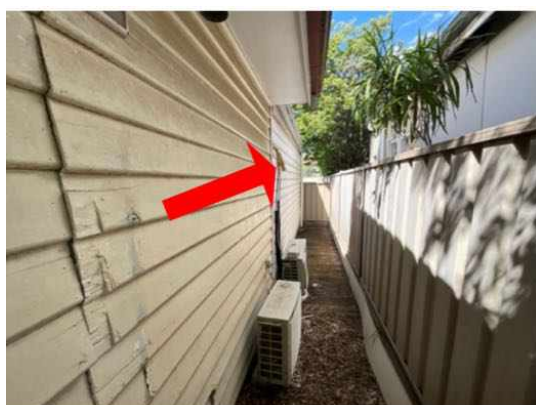
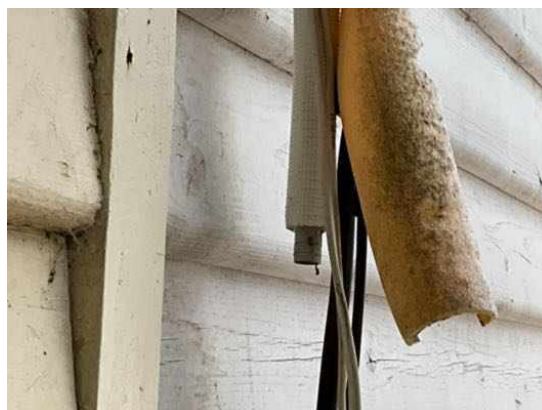
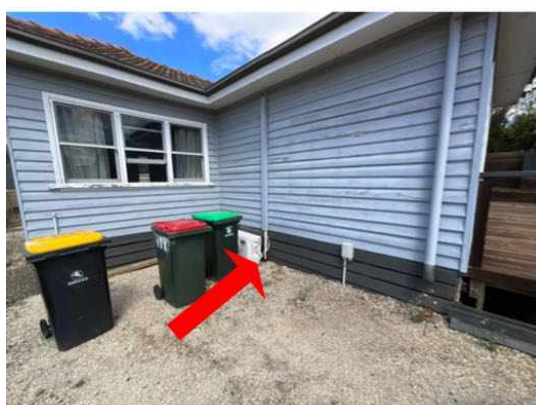
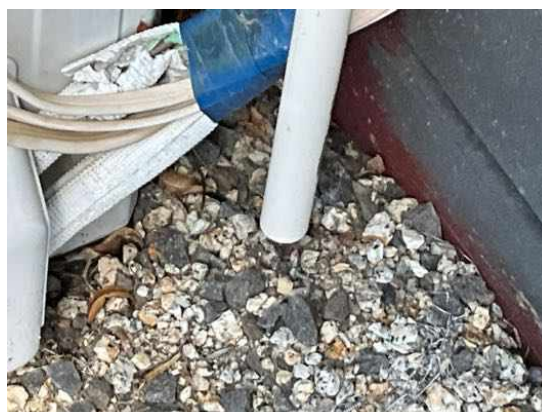
Finding 6.04

Building:	Building 1
Location:	Yard - Side, driveway
Finding:	Air conditioner - Disconnected overflow
Information:	The Air Conditioner (A/C) overflow was found to be disconnected from storm water drainage and is creating excessive moisture in the surrounding area.

Such leaking creates an environment which is conducive to an array of defects, including water damage to associated building elements and the attraction of termite or timber pest infestation.

It is highly recommended that a licensed plumber be appointed to connect the A/C overflow in order to prevent such an environment from being created. These minor works should be carried out as soon as possible.

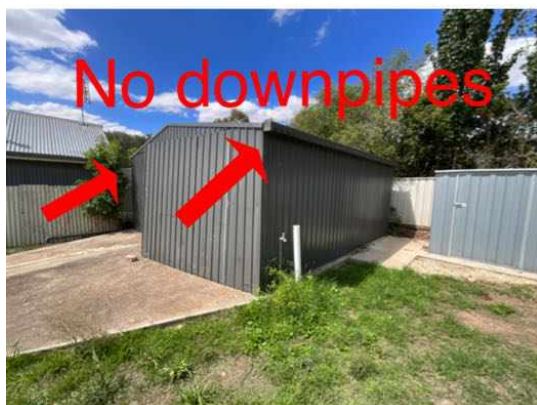
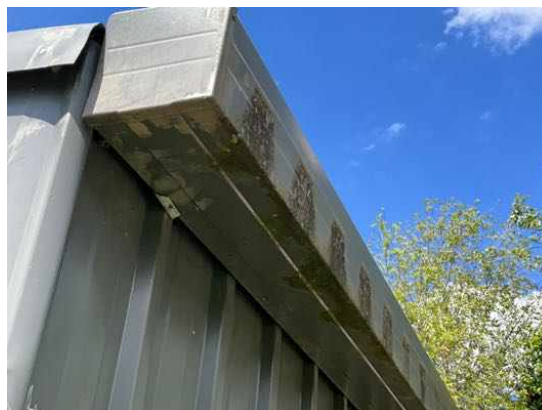
Finding 6.05

Building:	Building 1
Location:	Garage
Finding:	Stormwater drain - Not connected
Information:	The roof plumbing is not adequately connected to stormwater drainage on the site. This disconnection negatively impacts the functional capacity of the roof plumbing.

Where roof plumbing doesn't drain adequately, the area at the base perimeter can become excessively damp, potentially creating an environment that is susceptible to rust and corrosion of surrounding building elements, as well as attracting termites and other pests.

It is highly recommended that a plumber be appointed to further inspect the area and to install adequate drainage equipment where necessary.

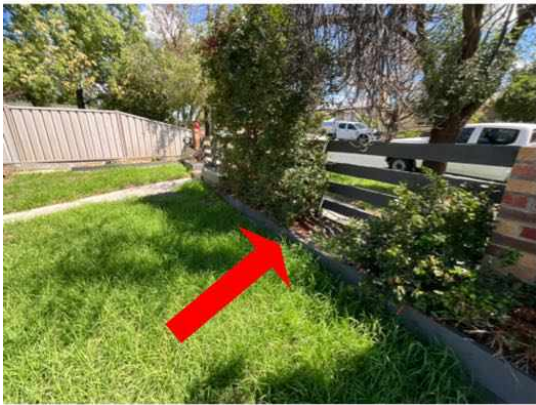
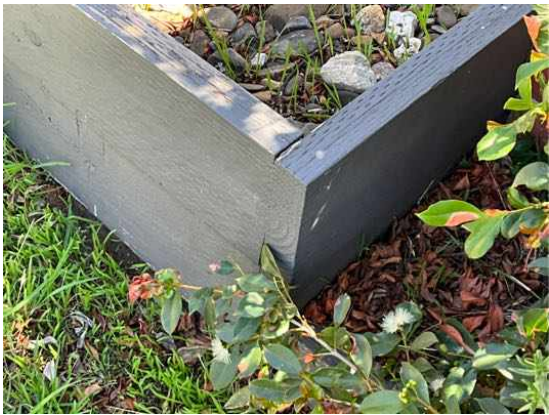
Finding 6.06

Building:	Building 1
Location:	Yard - Front
Finding:	Untreated or non-durable timbers in a hazardous environment
Information:	To reduce the risk of timber pest attack it is essential that timber used in a hazardous environment (e.g. in direct contact with the ground or frequently exposed to damp conditions) is of sufficient durability and/or is adequately preservative treated.

Untreated timbers in direct contact with the ground are likely to develop severe wood rot and/or fungal decay if left unattended creating attraction for subterranean termites to infest the timbers from surrounding areas.

If untreated or non-durable timbers are found to be in a hazardous environment it is highly advised that replacement of these building elements be performed as soon as possible to aid the protection of the property against termite / timber pest attack.

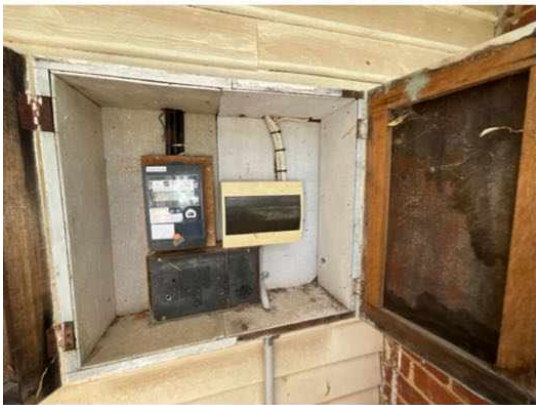
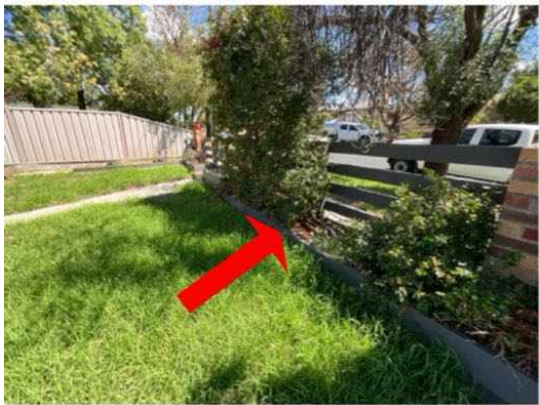
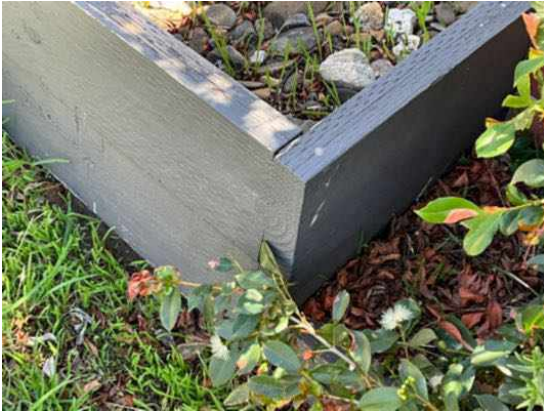
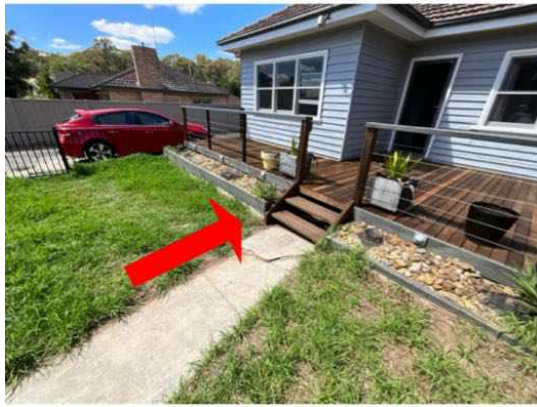
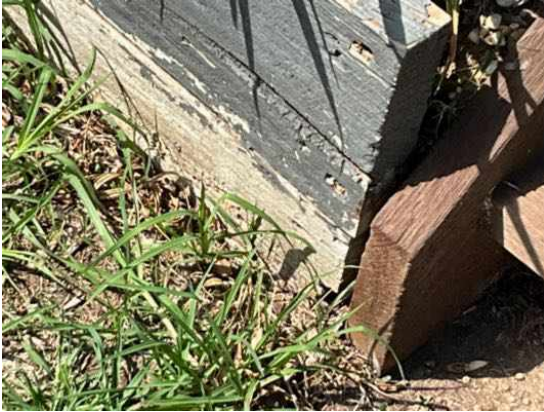
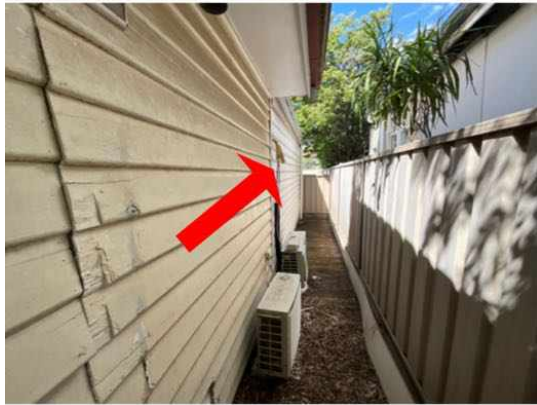
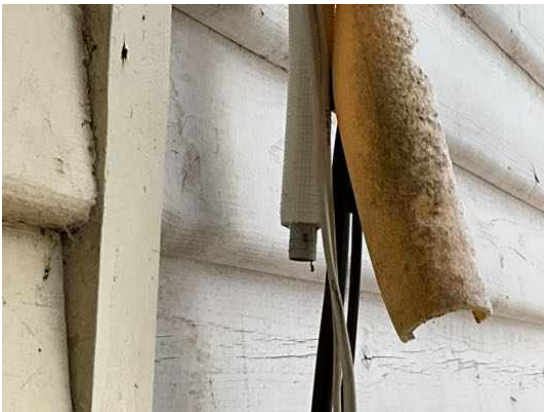
Finding 6.07

Building: Building 1
Location: All External Areas
Finding: Termite Management System - no evidence of a chemical installation
Information: The application of a post-construction chemical termite barrier is highly recommended for all properties, particularly if live termite activity has been found on the site previously. Such barriers are highly effective in preventing termite attack on any timber building elements throughout the property.

A durable notice should be placed in the switchboard unit to indicate current termite barriers. At the time of inspection, it appeared as though no termite management system has been installed, with no evidence to suggest preventative works taking place.

The client may consider gaining further advice from a pest controller as to the costs and procedures involved with this application. It is recommended that obtaining such advice be a short-term priority.

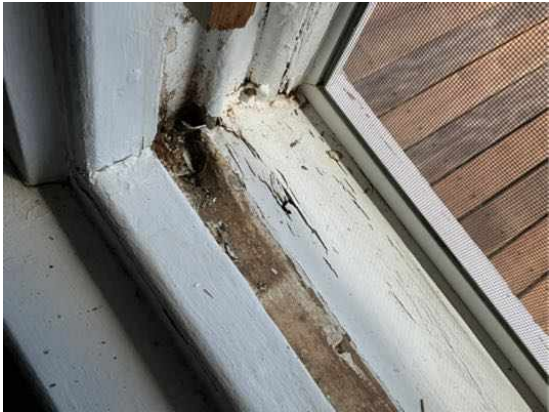
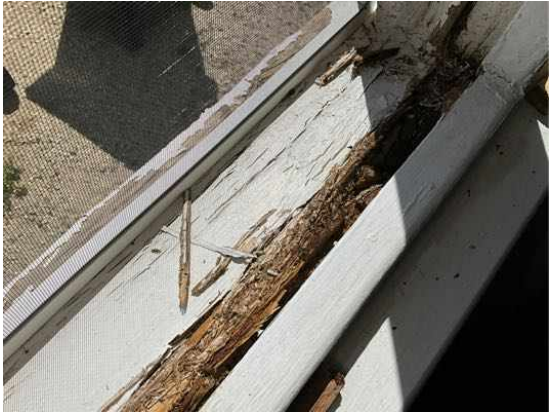
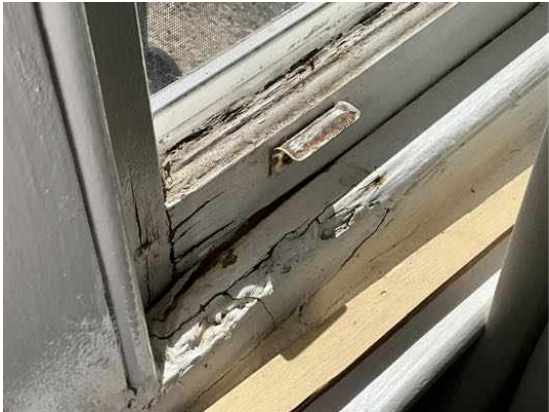
Finding 7.01

Building:	Building 1
Location:	Bedroom - Master, 3
Finding:	Fungal decay - present (localised)
Information:	Fungal decay also known as wood decay or wood rot generally refers to the deterioration of timber elements when in contact with excessive levels of moisture for a prolonged period of time.

The development of fungal decay is accelerated by temperatures in the range of 5degreeC to 40degreeC as well as the presence of oxygen. Generally fungal decay develops on timber elements that are in use in an external environment which are exposed to rain penetration.

In this case although the affected timber element is in a decaying state the extent of any visible damage appears to be localised to a specific area and is yet to spread to other parts of the building element or affect adjoining structures. The fungal decay is therefore likely to be of a relatively superficial nature with minimal impact on the structural integrity or tensile strength of the timber element.

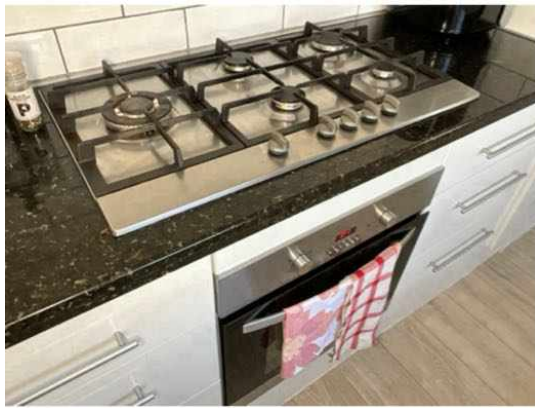
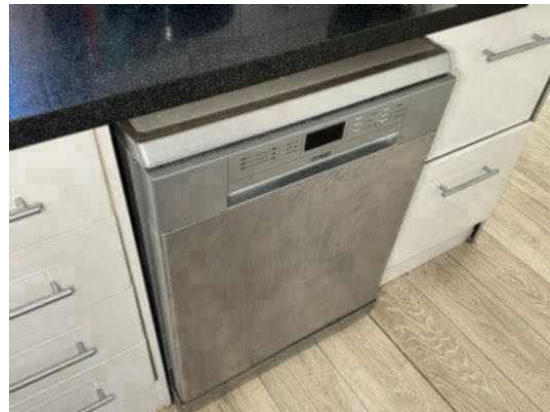
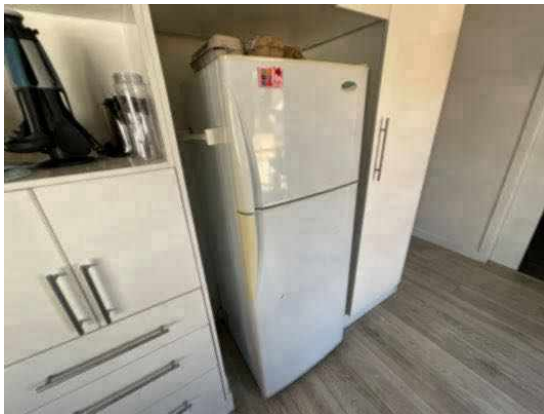
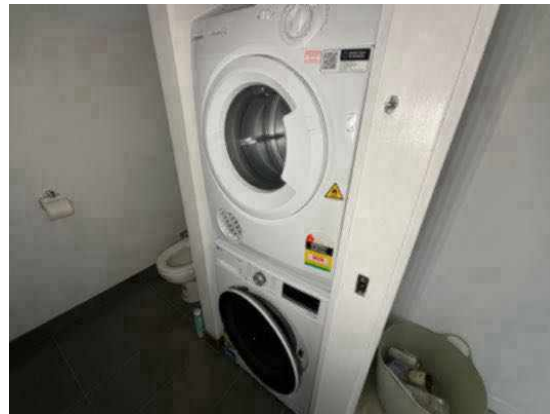
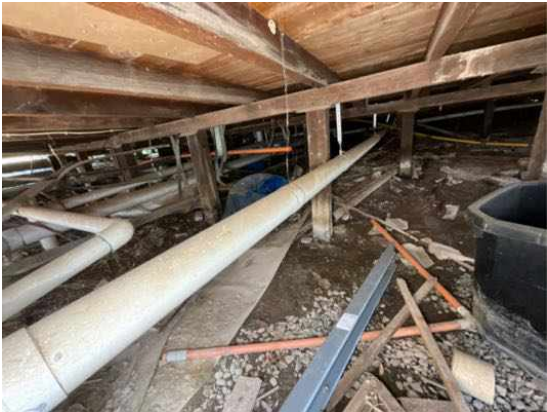
Noted Item

Building: Building 1
Location: All Areas
Finding: Additional Photos - Obstructions and Limitations
Information: These photographs are an indication of the obstructions and limitations which impeded full inspection of the property at the time of inspection. These obstructions can hide an array of defects and should be removed to allow full inspection to be carried out. A re-inspection is recommended once the areas are made accessible.
