Building Inspection Report

Inspection Date: Wed, 25 Mar 2026

Property Address: 37 Swinburne Ave, Mooroolbark VIC 3138,
Australia

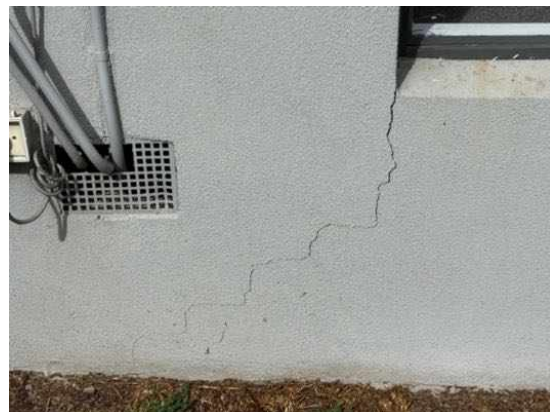
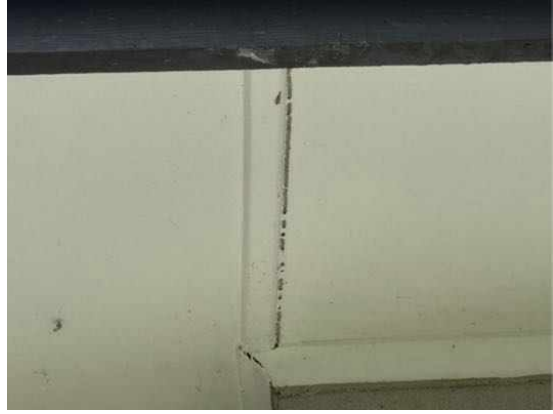
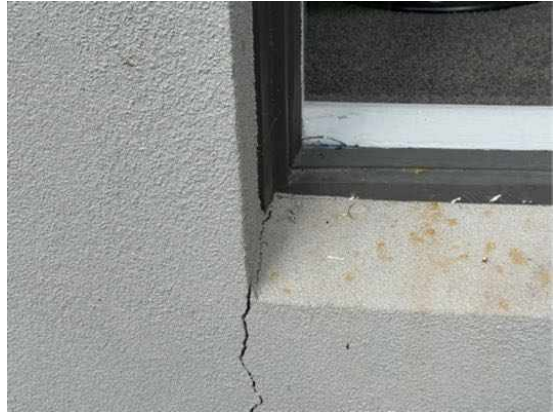
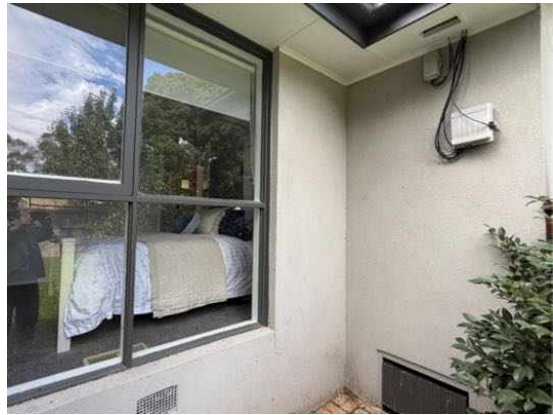
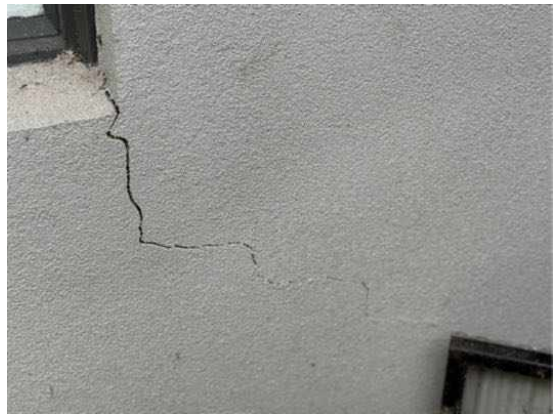
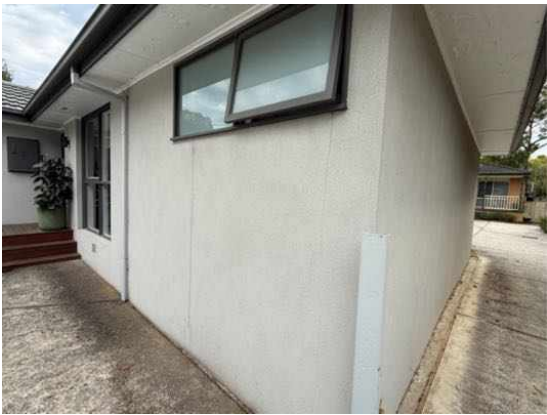
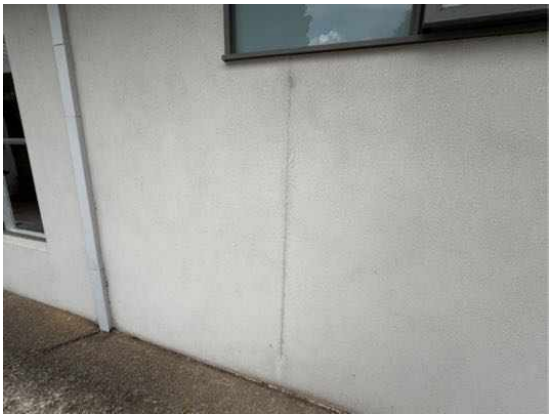
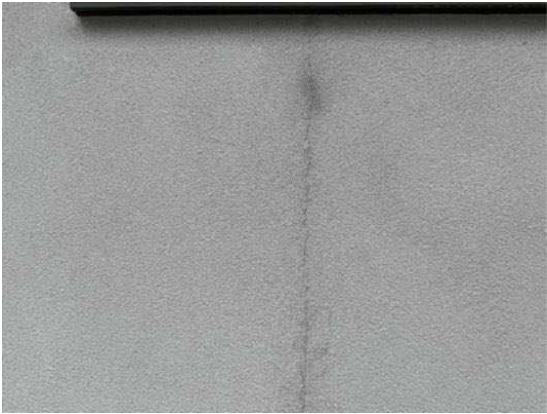
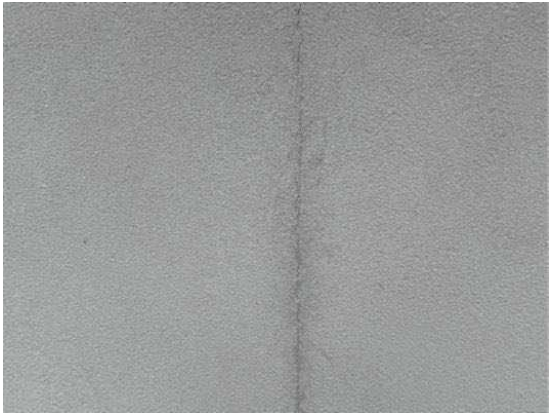
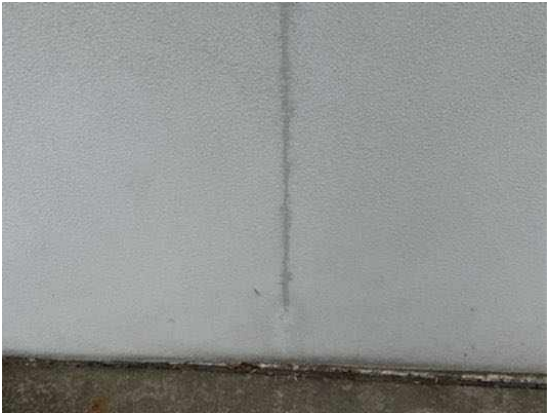
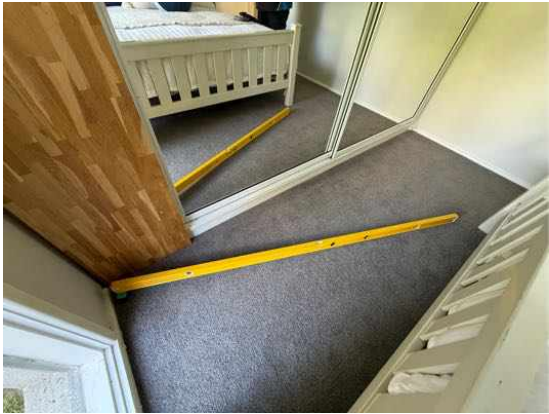
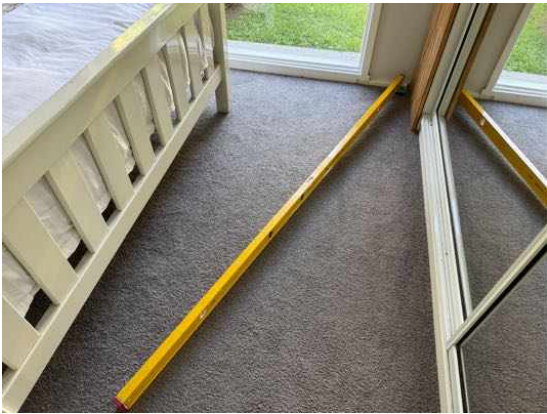
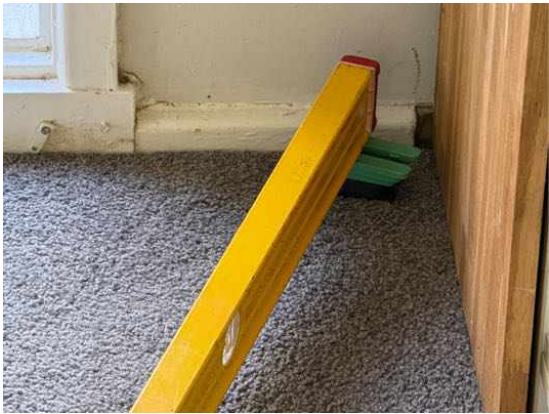
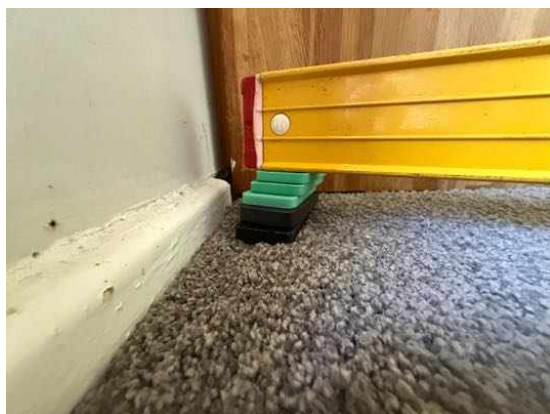
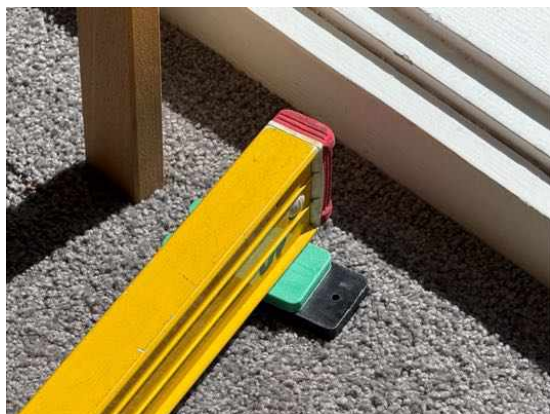
Defects 2.01

Building:	Building 1
Location:	All Areas > All Areas
Finding:	Rendered brickwork - Cracking noticeable
Information:	At the time of the inspection numerous cracks were observed on the left hand side of the home. Due to the cracks and deterioration to these areas of the exterior rendered brickwork, the client is recommended to appoint a Structural Engineer to further inspect or in the future carry out and repair work where deemed necessary or required. Such work may involve foundation underpinning or repair or replacement of sections of affected brickwork.

Structural issues such as foundation movement are generally the underlying cause of such cracking. It is suspected that this damage has been created due to movement of key structural elements or general subsidence of associated footings and normal age and deterioration. Noticeable cracks are a common occurrence in external brickwork and are a likely result of age expected building movement, general expansion, and/or contraction of building materials in different weather conditions. These types of cracks in brickwork may develop if left unattended, with potential for necessitating in major remedial works in the future or replacement of the brickwork.

For the client's attention, major areas of the rendered brickwork, cracks were observed at the left hand end of the home to the front and rear areas. When managing these types of cracks, some remedial work will generally required, this will need to be in consultation with your structural engineer. Where the client was intending to repair these areas it will involve the client appointing a structural engineer to advise on the repair or remedial work to the affected rendered brickwork and foundations. Structural issues are generally the underlying cause of such movement and cracking. It is suspected that this damage has been created due to movement of key structural elements and or general subsidence of associated footings. A structural engineer should be appointed immediately to inspect the structural integrity of the affected rendered brickwork to assess the safety of the associated structures. The engineer can also nominate a scope of works that may be required for rectification. Always contact a structural engineer should cracks widen lengthen or become more numerous, even after repair works have been completed.

A structural engineer and bricklayer may be appointed, to inspect the structural integrity of the affected brickwork and to assess the safety of the associated structures. The structural engineer can also nominate a scope of works where required. Always contact a Registered builder or engineer should cracks widen lengthen or become more numerous, even after repair works have been completed.

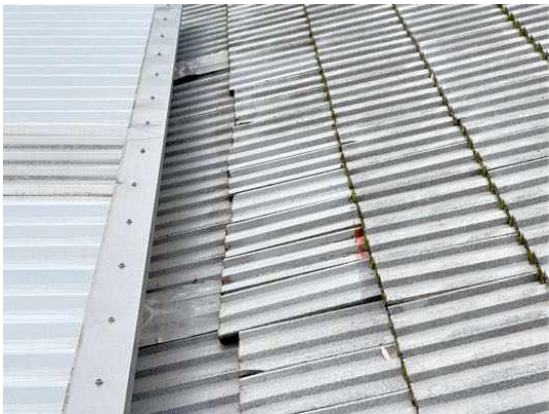
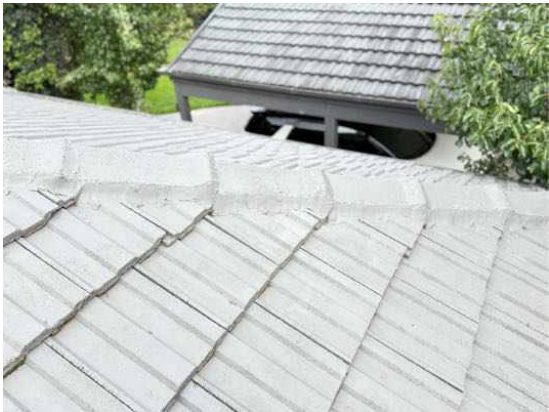
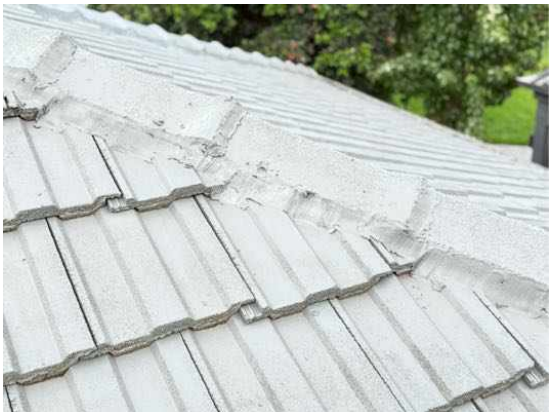
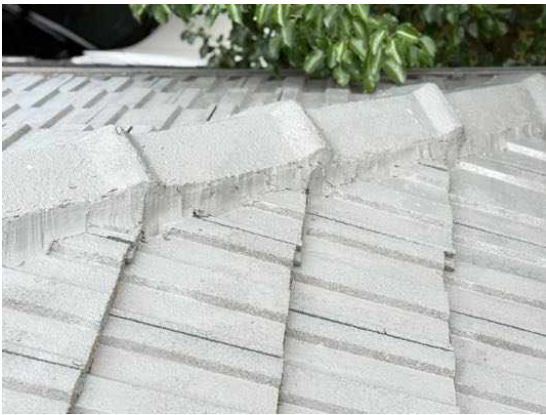
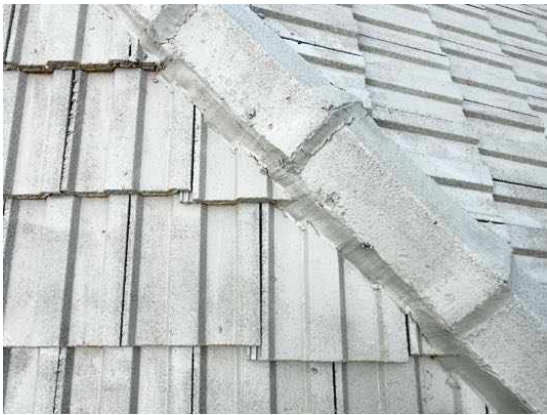
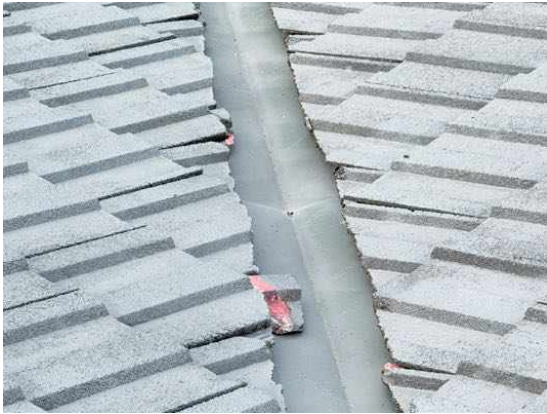
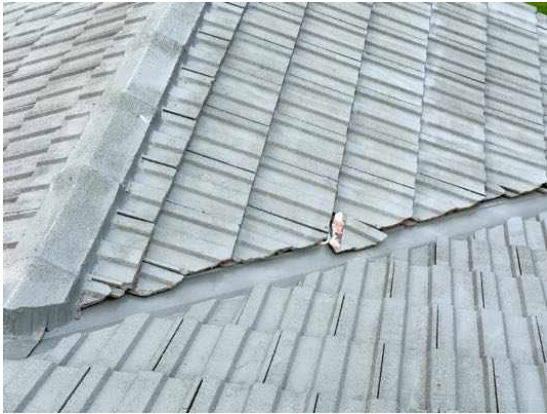
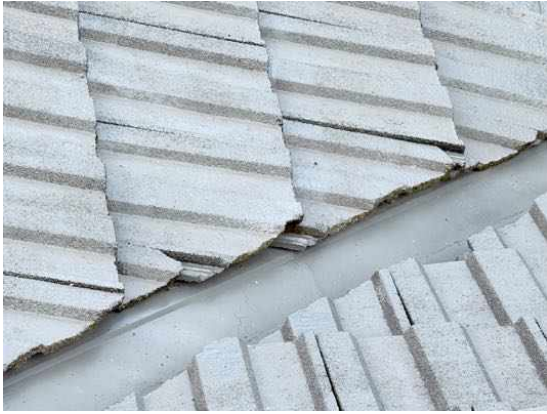
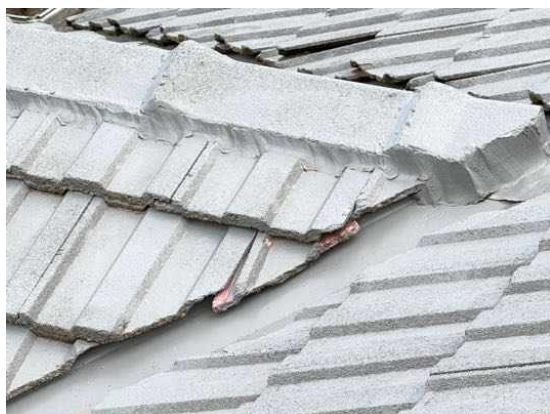
Defects 3.01

Building:	Building 1
Location:	All Areas > All Areas
Finding:	Roof tiles - Dislodge or slippage
Information:	Upon inspection of the roof tiles, it was observed that numerous roof tiles have either slipped or have been dislodged from their original positions. Roof tiles may slip over time due to a number of minor causes, including not placed correctly upon installation, not stuck down on the top of valley irons, flashings, roof tile chips and breakages, failings in the adjoining battens, or fixings that may have failed.

Upon inspection of the roof tiles, it was observed that numerous roof tiles have either slipped or have been dislodged from their original positions. Roof tiles may slip over time due to a number of minor causes, including not placed correctly upon installation, not stuck down on the top of valley irons, flashings, roof tile chips and breakages, failings in the adjoining battens, or fixings that may have failed. In this case I suspect that tiles have slipped or dislodged from they original positions overtime. These roof tiles will require immediate attention for replacement and some form of fixing down or adhesive sash as a good quality silicon sealant, client may consider to add silicon to the bottom side of the tiles to stick them down to the top of the metal flashings. Roof tiles that have moved from their original position may allow water penetration into the roof void, exposing roofing structures to excessive moisture. This creates an environment that is conducive to water damage and accelerated deterioration of all associated building elements below. Replacement of broken, loose or missing roofing tiles is recommended immediately or in the short term future to prevent the development of any

In this case I suspect that tiles have slipped or dislodged from they original positions, these roof tiles will require replacement and some form of fixing down or adhesive sash as a good quality silicon sealant, client may consider to add silicon to the bottom side of the tiles to stick them down to the top of the metal flashings. Roof tiles that have moved from their original position may allow water penetration into the roof void, exposing roofing structures to excessive moisture. This creates an environment that is conducive to water damage and accelerated deterioration of all associated building elements below.

Replacement of broken, loose or missing roofing tiles is recommended immediately or

in the short term future to prevent the development of any secondary defects. A roofing plumber or roof tiler should be appointed to complete such works as deemed to be necessary.

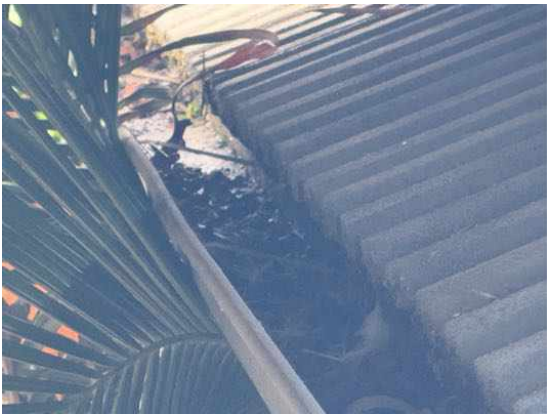
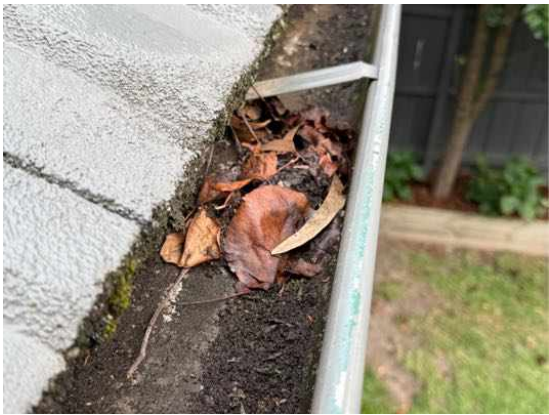
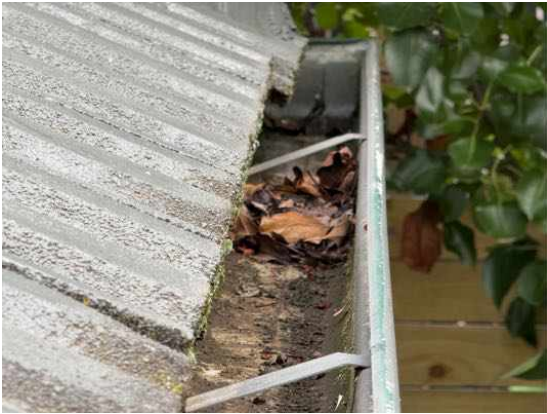
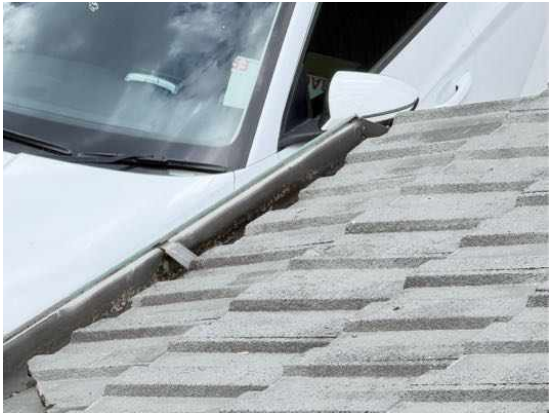
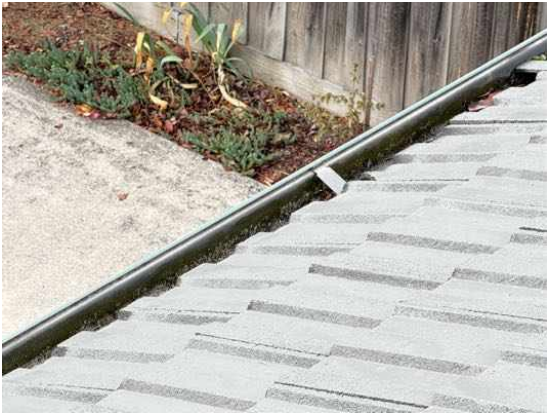
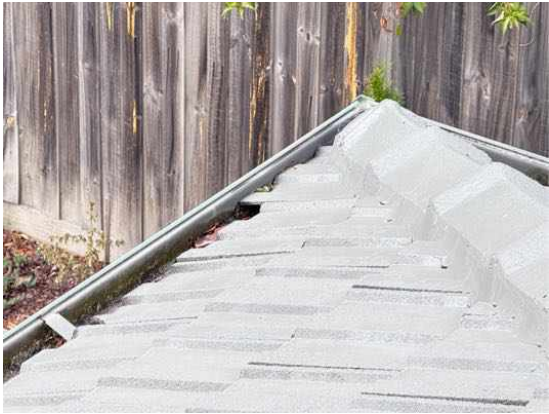
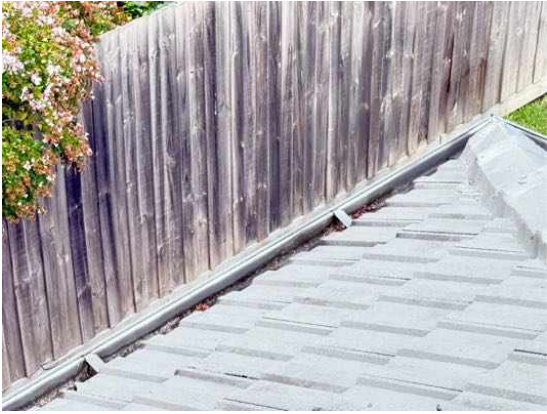
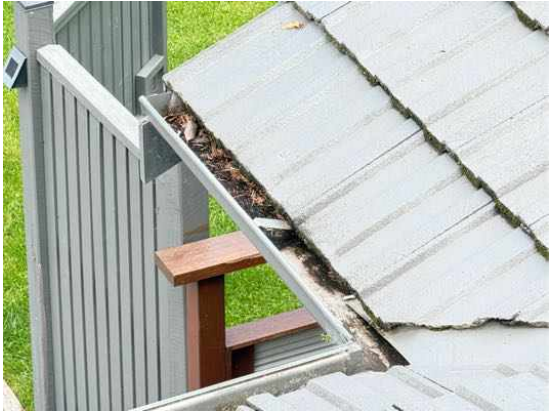
Defects 3.02

Building:	Building 1
Location:	All Areas > All Areas
Finding:	Gutters - Partially blocked
Information:	Roof plumbing structures, such as guttering and downpipes, should be free of all leaf matter and debris to prevent blockages. Blockages of the guttering and downpipes will lead to pooling and accumulated water overflows, which is likely to subsequently flood eaves and exterior walls. Blocked gutters are likely to lead to high levels of moisture in the affected areas. Such moisture will not only cause rust and decay of the associated building materials, but can also provide conditions that are conducive to termite and timber pest activity.

Blockages in gutters should therefore be removed immediately to ensure dry conditions are maintained. Client should consider the appointment of a gutter cleaning company to carry out these works or with a Licensed Plumber for further specific advice on remedial works that may be deemed to be required. In the interim, it is highly advised that blocked gutters be removed by the homeowner, gutter cleaning company or a general handy-person in the short term future.

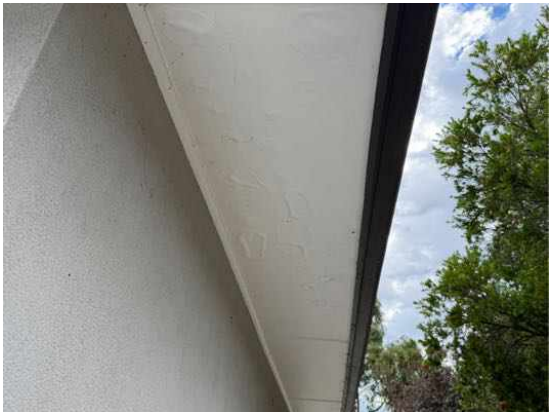
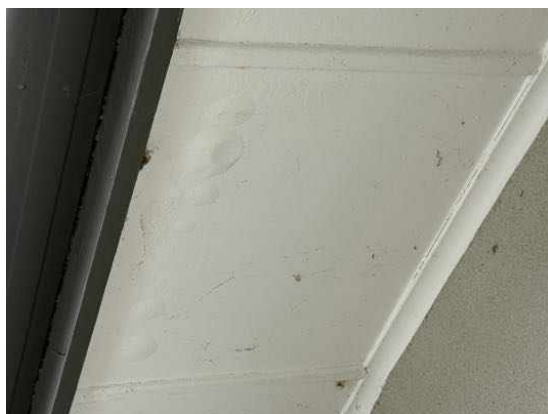
Defects 3.03

Building: Building 1
Location: All Areas > All Areas
Finding: Eaves paint bubbles from suspected moisture behind the paint
Information: Eaves paint bubbles primarily due to moisture trapping, typically caused by roof leaks, overflowing gutters, or high humidity, forcing the paint away from the surface. To fix, identify the moisture source, scrape off loose paint, sand, apply a high-quality primer, and repaint with exterior acrylic paint. The eaves linings to the front areas were observed to show bubbling paint, this is suspected to be from moisture under the paint. Where moisture damage is evident, the primary requirement is to ensure there are no leaks.

The damage to the eave linings in these areas detracts from the appearance of the structure and other adjoining building structures and framework in the roofing area. Where eaves show this type of damage, remedial works are suspected to be required in the short term future. Where water damage is suspected as being the underlying cause, appointment of a roofing contractor and or other relevant tradespersons is recommended to identify the exact source.

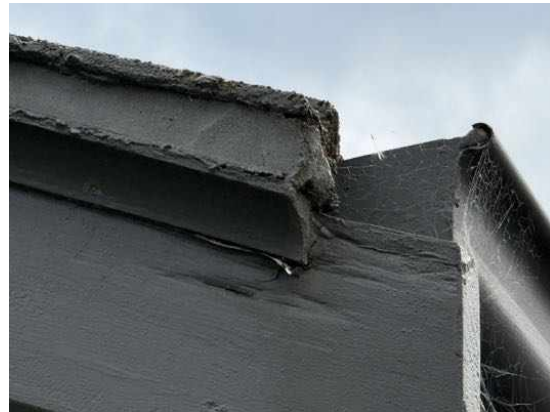
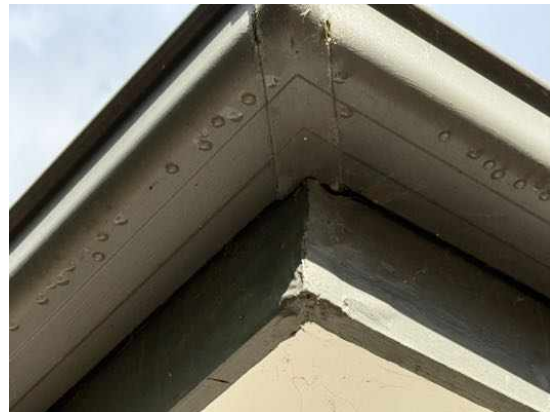
Defects 3.04

Building:	Building 1
Location:	Bedroom > All Areas
Finding:	Minor wood rot
Information:	Minor wood rot is suspected to be affecting some fascias around the exterior areas. Wood rot, also known as Fungal Decay, occurs when timbers and other cellulose building materials are exposed to damp conditions on an ongoing basis. The roof plumbing in these areas may be creating excessive moisture in this areas and or it may be due to frequent exposure to rain and other weather conditions also make fascias and windows and other building elements susceptible to accelerated deterioration.

Early intervention and regular maintenance such as painting will prolong the useful life of these building elements. Prior to any works being performed, the cause of the moisture that has created the visible wood rot should be identified and addressed in a suitable manner. It is advised that a licensed plumber be appointed to inspect all roof plumbing and subsequently identify the cause of the wood rot. Replacement of affected fascias or window elements and or other building elements may then be a necessary step in protecting surrounding areas from such deterioration. A qualified plumber may be appointed to assess the cause of excessive moisture and to provide advice on any remedial works as required. A qualified carpenter or registered builder may also be required to replace affected building materials.

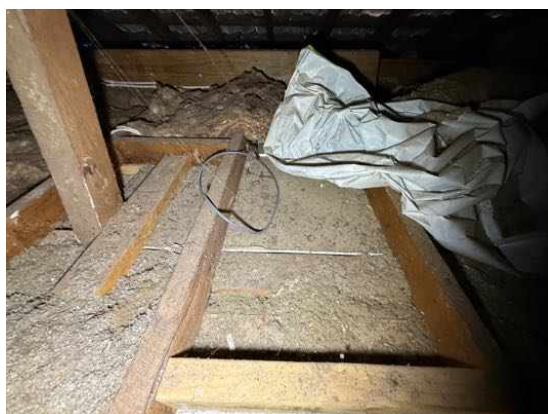
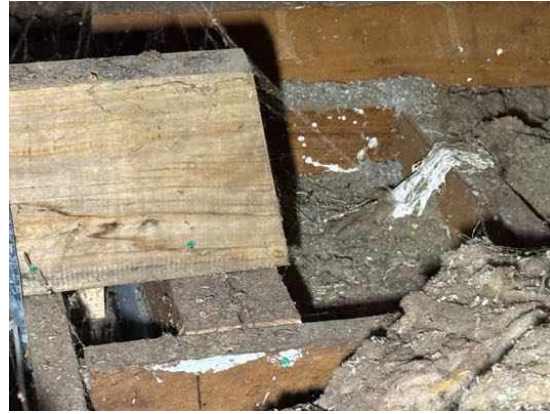
Defects 3.05

Building: Building 1
Location: All Areas > All Areas
Finding: Insulation - poorly installed - missing or moved
Information: Some areas of the roof insulation in the roof space is suspected to have been poorly installed, missing or have been moved from their original position. Insufficient insulation will result in a comparatively higher cost to heat and cool a property as there is a lack of Insulation (or uneven coverage of insulation) which works as a barrier to heat transfer. This helps to keep out unwanted heat in summer and preserves warmth inside your home in winter. It can also help soundproof your home from unwanted airborne noise transfer.

Example - Where there is a gap in coverage totaling 5% there is a potential for up to 50% of the energy efficiency to escape. Caution should always be exercised when accessing the roof void. Do not attempt to stand on the framework where cabling is crossing and especially be aware that there is a potential for electric shock if contact is made with exposed or faulty electrical wiring.

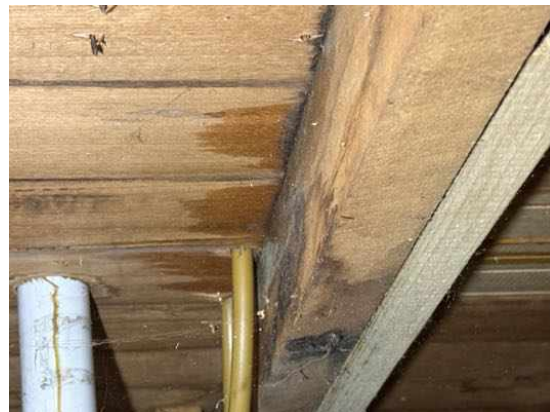
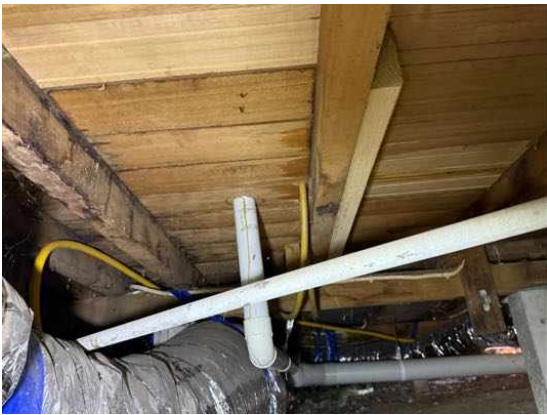
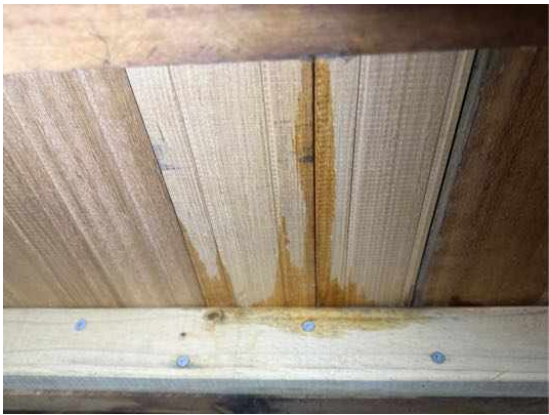
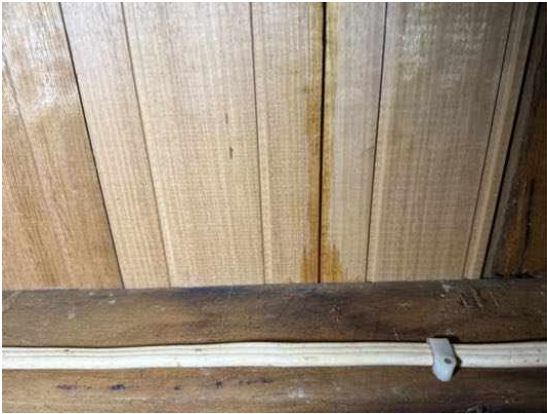
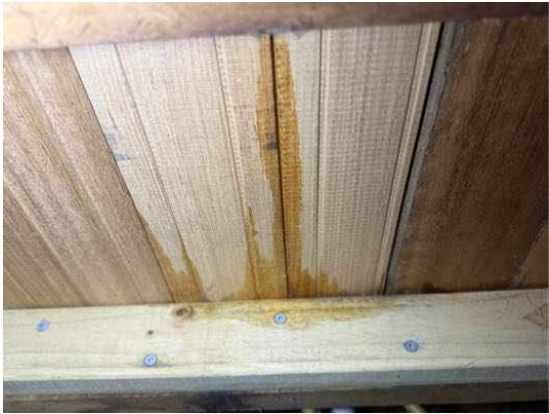
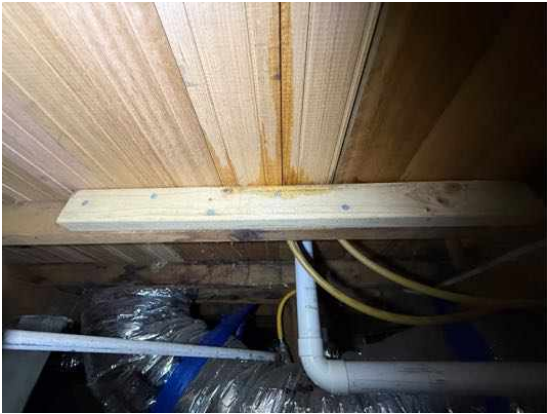
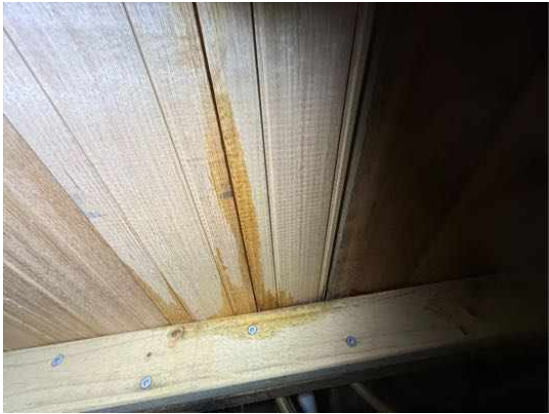
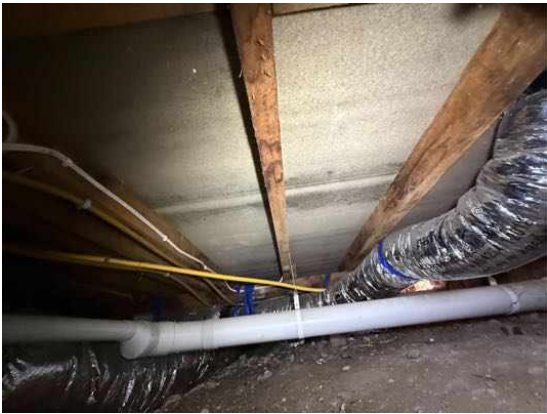
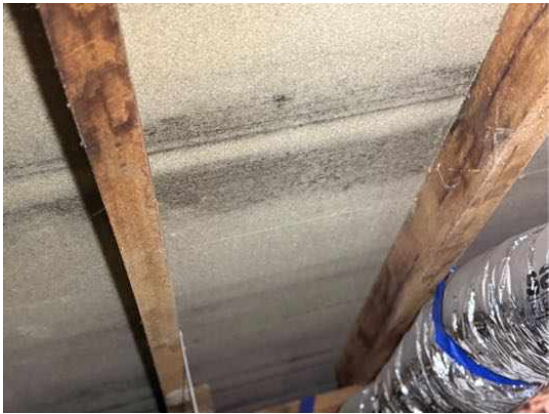
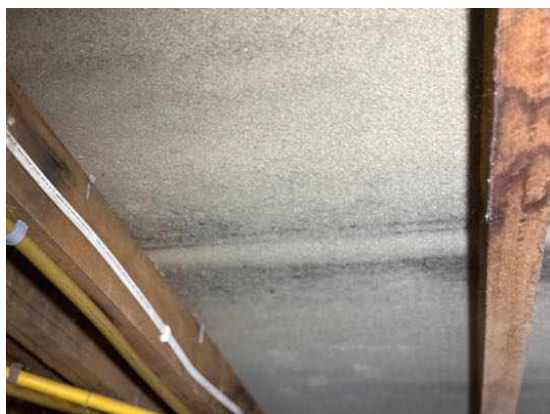
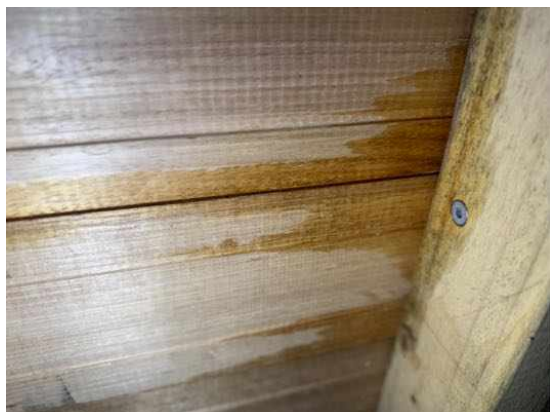
Defects 3.06

Building: Building 1
 Location: All Areas > All Areas
 Finding: Subfloor moisture and dampness
 Information: Some moisture and dampness was observed under the Laundry area in the subfloor. No conclusion for where the moisture was coming from at the time of the inspection and client is recommended to investigate further as to the cause of the moisture. Damp and moist conditions in the subfloor areas make these areas susceptible to wood rot, termite and pests and other secondary damage and defects.

Some moisture and dampness was observed under the Laundry area in the subfloor. No conclusion for where the moisture was coming from at the time of the inspection and client is recommended to investigate further as to the cause of the moisture. Damp and moist conditions in the subfloor areas make these areas susceptible to wood rot, termite and pests and other secondary damage and defects. Remedial work to rectify the moisture from these areas of the subfloor is recommended to ensure further damage and deterioration and better over all conditions in the subfloor areas, this types of defects should be rectified in the short term future. It is recommended that the client appoint a licensed plumber to inspect these areas and provide advice to eliminate moisture and dampness from the subfloor areas.

Remedial work to rectify the moisture from these areas of the subfloor is recommended to ensure further damage and deterioration and better over all conditions in the subfloor areas, this types of defects should be rectified in the short term future. It is recommended that the client appoint a licensed plumber to inspect these areas and provide advice to eliminate moisture and dampness from the subfloor areas.

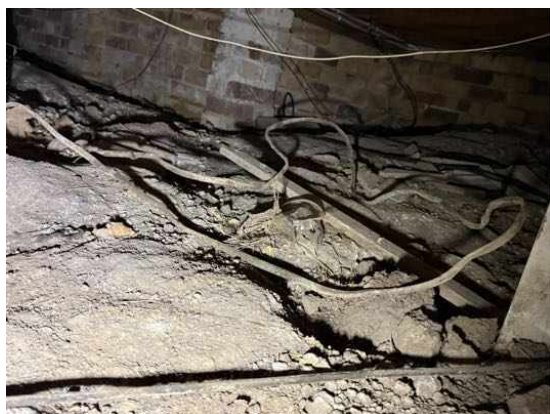
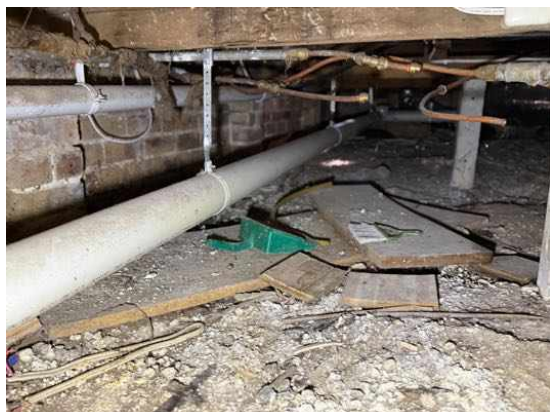
Defects 3.07

Building:	Building 1
Location:	All Areas > All Areas
Finding:	Subfloor - Debris
Information:	A minor array of debris was found in the subfloor area at the time of inspection. Debris in this area restricts subfloor ventilation and creates potential for concealed pest entry. Stored household goods and other materials may also make these areas susceptible to termite activity, insects and vermin. A clear and empty subfloor will be better ventilated and easier to maintain in a dry condition. The removal of any debris is vital in minimising the risk of termite, insects, rats, mice or wood borer activity.

Debris in the subfloor should be removed in the short to medium term future.

Depending on the location and amount of debris and stored items, the homeowner may elect to undertake this task. Alternatively there are a large number of rubbish removal subcontractors that could undertake these works.

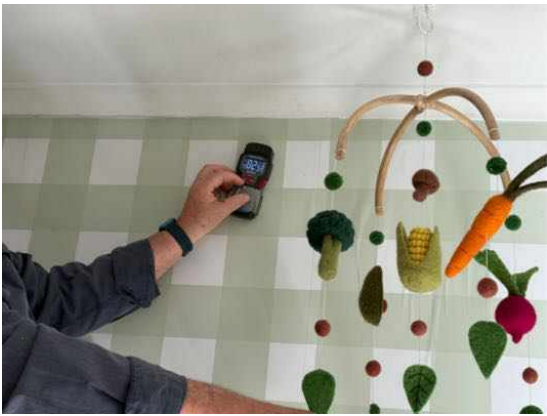
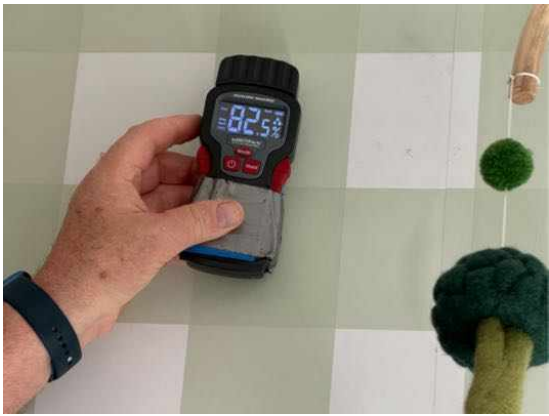
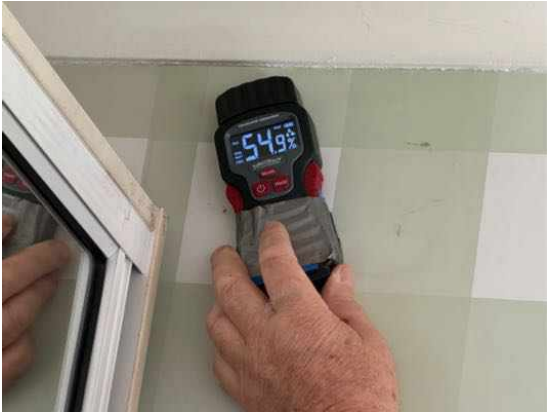
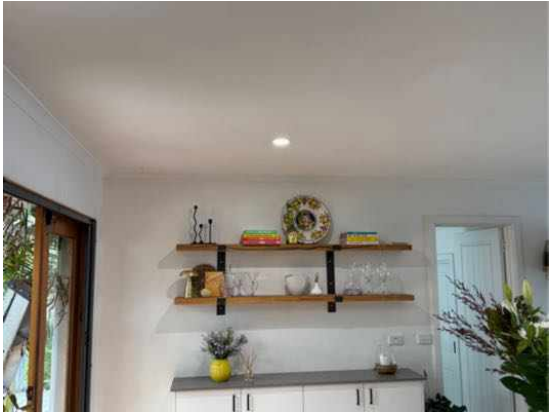
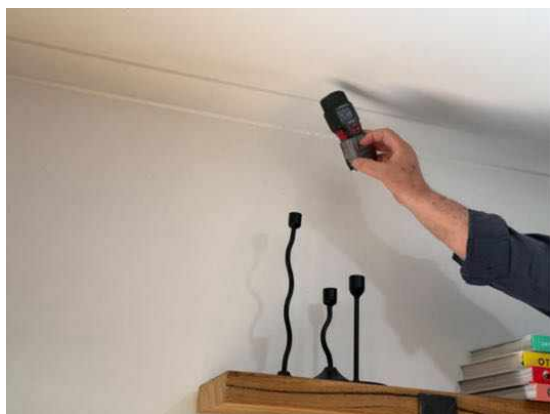
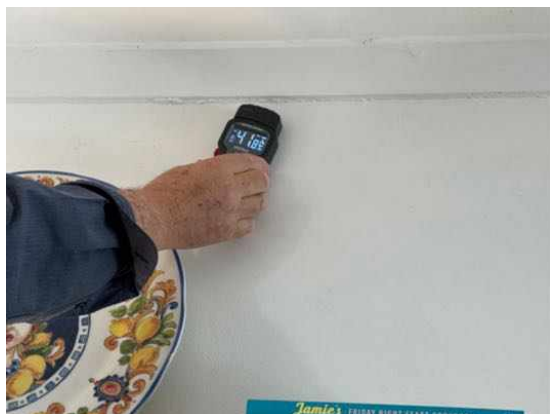
Defects 3.08

Building:	Building 1
Location:	All Areas > All Areas
Finding:	Bedroom and family ceiling and wall plaster showed suspected moisture
Information:	The bedroom and family room ceilings, walls showed suspected moisture and moisture damage. These areas were both checked via a moisture meter, showing a suspected active moisture. No conclusive answer at the time of the inspection as to where the leak was coming from, however it is likely to be from either overwhelmed gutters or roof above. It is highly recommended that a further investigation of these areas be carried out in the short term future. The primary requirement is to identify and rectify the source of the moisture and or leaks.

If left unmanaged any damage sustained while the moisture is active, could potentially compromise the adjoining framing structural and other building elements in the roof, ceiling and walls in these areas. The plaster wall and ceiling linings may be currently concealing damage and deterioration in the roof space and wall framing and other adjoining building elements, which will graduate to secondary defects, further damage and deterioration if left unmanaged.

The bedroom and family room ceilings, walls showed suspected moisture and moisture damage. These areas were both checked via a moisture meter, showing a suspected active moisture. No conclusive answer at the time of the inspection as to where the leak was coming from, however it is likely to be from either overwhelmed gutters or roof above. It is highly recommended that a further investigation of these areas be carried out in the short term future. The primary requirement is to identify and rectify the source of the moisture and or leaks.

Remedial works are suspected to be required in the immediate future to further investigate, repair and make good. Where water damage is suspected as being the underlying cause, this moisture will eventually produce mould and mildew on the inside plaster, making it necessary to remove and replace these areas of plaster. Client

should appoint of a Registered builder and or licensed plumber to identify the source of any water and moisture leaks immediately.

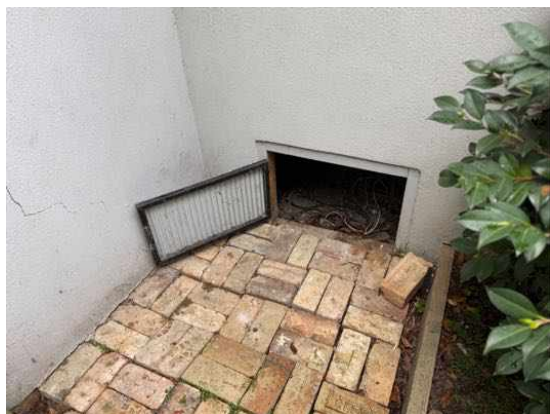
Building: Building 1
 Location: All Areas > All Areas
 Finding: Termite Management System - no evidence of a chemical installation or durable notice
 Information: At the time of the inspection no application of a chemical termite barrier or durable notice was observed. Such barriers are highly effective and highly recommended for

all properties in preventing termite attack on any timber building elements throughout the property.

A durable notice should be placed in the switchboard unit or in the another accessible area to indicate current termite barriers. At the time of inspection, no evidence to suggest preventative works taking place. The client may consider gaining further advice from builders or a pest controller and as to the costs and procedures involved with this application. It is recommended that obtaining such advice be a short-term priority.

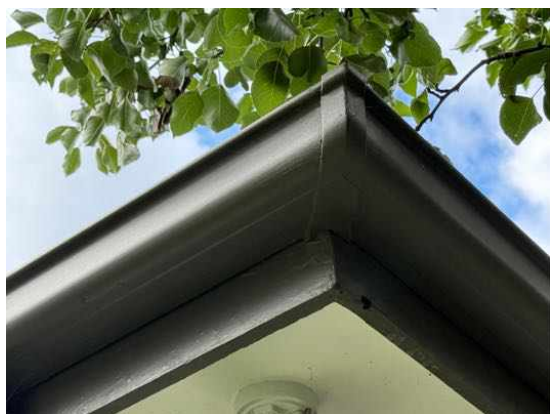
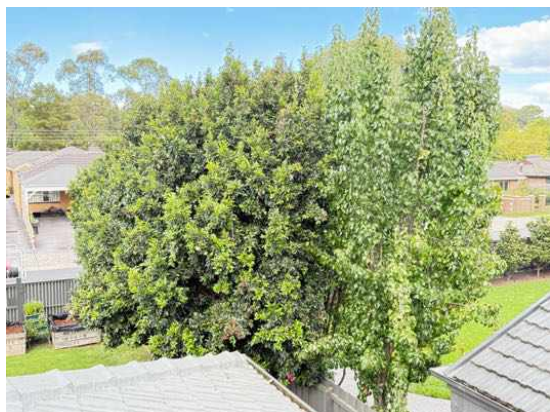
Building:	Building 1
Location:	All Areas > All Areas
Finding:	Trees - close trees
Information:	The surrounding trees did not appear to have visibly affected the adjoining structure or brickwork, however trees that are close to the perimeter of the home can in the future create defects to building elements such as brickwork, foundations and plumbing elements. At the time of the inspection the surrounding eaves were suspected to have been overwhelmed in numerous areas and has damaged these eaves. It is unknown as to if these trees will cause foundation and brickwork defects and cracks in the future. It is therefore recommended that the client appoint a geotechnical engineer or other relevant professional or specialist in the future to determine any foreseeable

problems from these trees. Client should also consider the potential for falling branches and limbs which can cause serious defects to the roof structure, secondary defects and headaches.

Overhanging trees often result in excessive amounts of leaf matter and debris accumulating in gutters. Blockages of the guttering and downpipes will lead to pooling and accumulated water overflows, which is likely to subsequently flood eaves and exterior walls. Blocked gutters are likely to lead to high levels of water and moisture sitting in the gutters, which can cause rust and decay of the associated building materials, but can also provide conditions that are conducive to termite and timber pest activity. Blockages in gutters should be clean and kept clean at all times to ensure dry conditions are maintained.

It is therefore highly recommended that all overhanging trees and branches be removed as soon as possible to prevent any future damage. Such works should be performed by the homeowner; however, appointment of a landscape contractor or an arborist may be required and highly recommended.

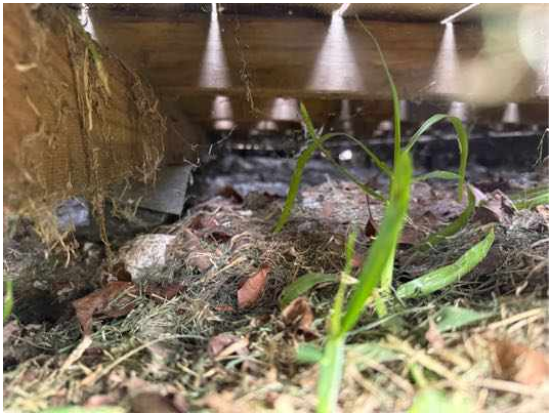
Building:	Building 1
Location:	All Areas > All Areas
Finding:	Timber deck too close to the ground and soil
Information:	It was observed that the rear timber deck structure was sitting in the ground soil or too close to the ground which exposes these timbers to accelerated damage and deterioration over time. It is good practice to have a minimum of at least 200mm away from the ground soil to the timber. Due to the susceptibility to wood rot and deterioration over a prolonged period of time. Good airflow through the subfloor areas should also be maintained. The client should be prepared that in purchasing a property, that some remedial work in the near future will be required to preserve these areas that are susceptible to excessive moisture.

External timbers that are frequently exposed to harsh and extreme weather conditions and sitting in the ground or close to the soil will require adequate protection and maintenance in order to maintain their condition. Any timbers that are exposed to harsh weather conditions and moisture from ground contact, exposes these areas to accelerated damage and deterioration. Where timbers have not been painted or protected properly or treated adequately, will show signs of general deterioration which is likely to occur at an accelerated rate. If left unattended, replacement of these timbers is likely to be necessary in the future. Adequate treatment of these timbers is required as soon as possible by a painting contractor, home owner or general handyman.
