## Building Inspection Report

Inspection Date: Wed, 14 Jan 2026

Property Address: 212/11B Conferta Ave, Tallawong NSW  
2762, Australia

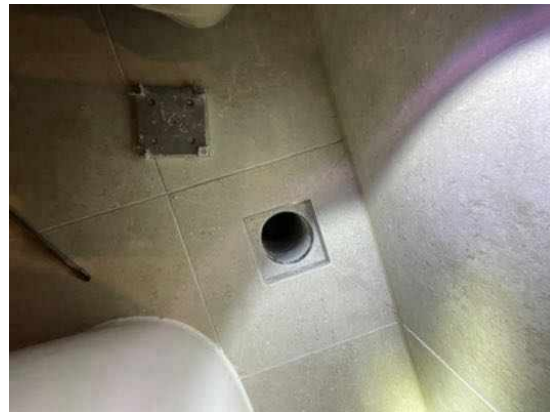
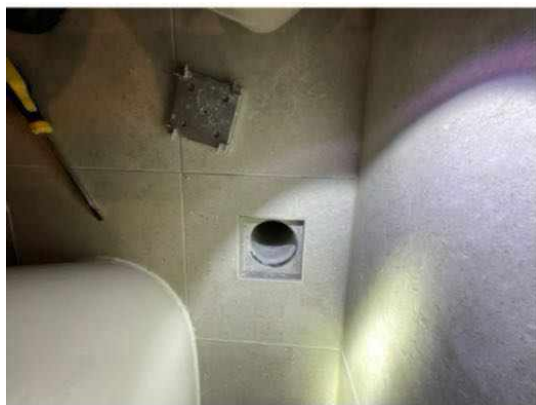
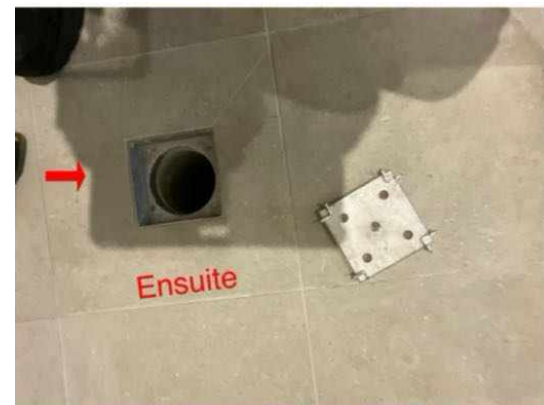
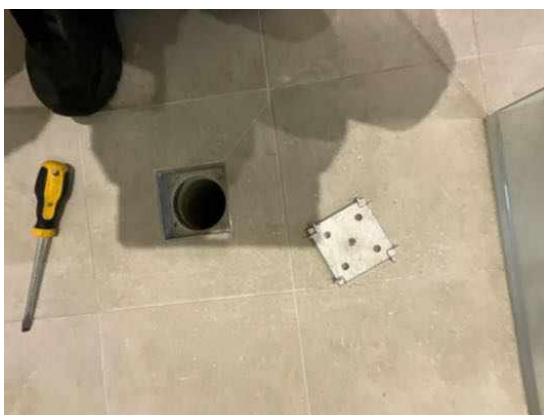
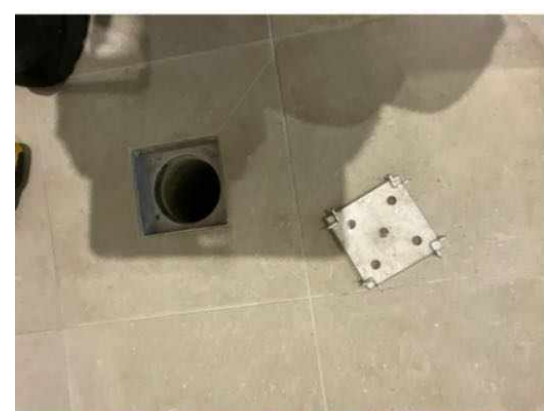
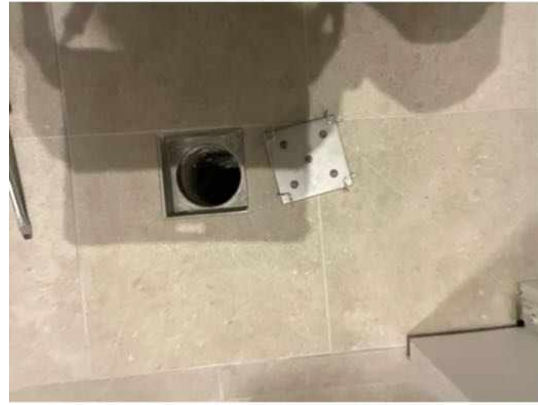
### Defects 3.02

Building: Main Building  
Location: All Areas  
Finding: Floor waste- missing internal grill component (strainer or insert)  
Information: The drain cover in the tiled floor area is missing its internal grill component (strainer or insert), exposing a direct opening into the drain pipe. This is considered a non-compliant installation as the drain cover is incomplete.

- AS/NZS 3500.2:2021 – Plumbing and Drainage – Sanitary plumbing and drainage requires that all plumbing fittings and fixtures must be installed in a manner that prevents debris from entering the drainage system and ensures the safe operation of the drain.
- The Guide to Standards and Tolerances 2017, Section 13 (Plumbing and Drainage), notes that drainage systems should be installed in accordance with relevant standards, including correct fitting of drain covers and grates to ensure hygiene, safety, and protection from blockages.

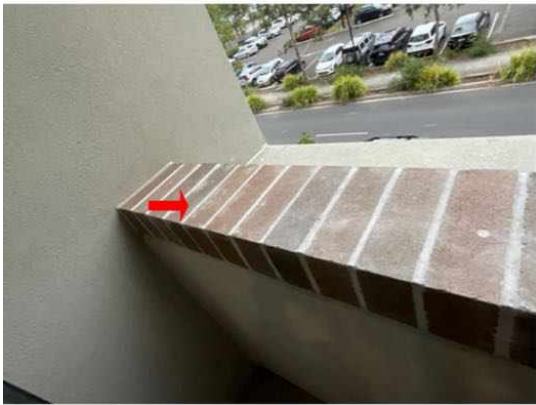
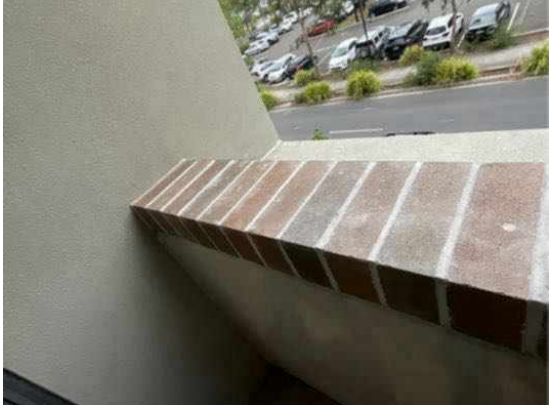
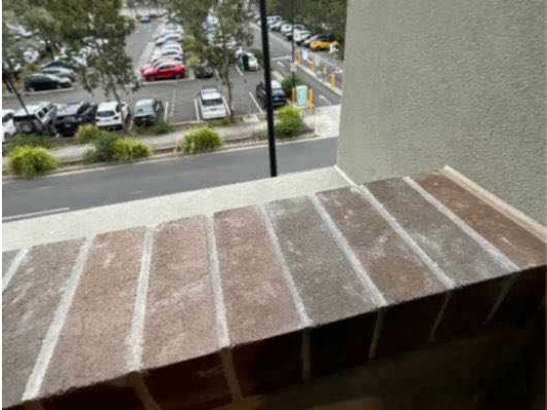
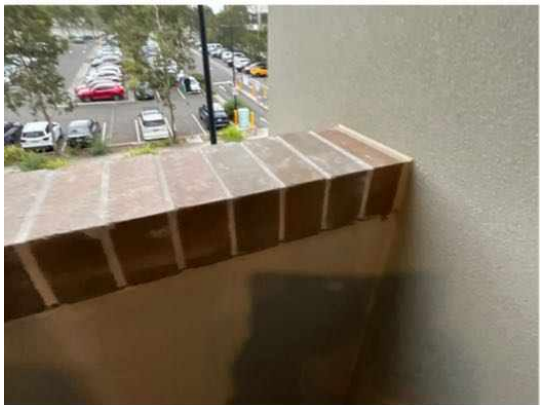
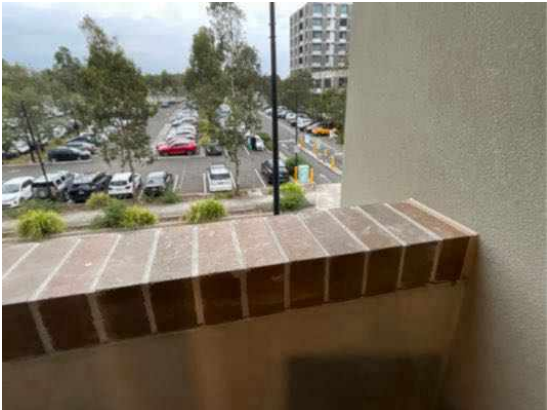
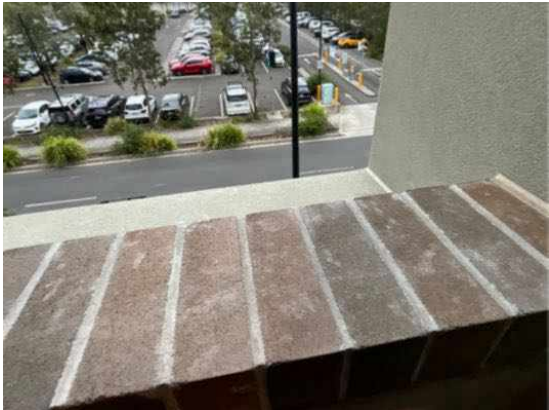
**Defects 3.04**

Building: Main Building  
Location: All Areas  
Finding: Cleaning  
Information: At the time of inspection all areas and surfaces were found to be dirty with dust, leaf litter and spider webs evident throughout internal and external surfaces.

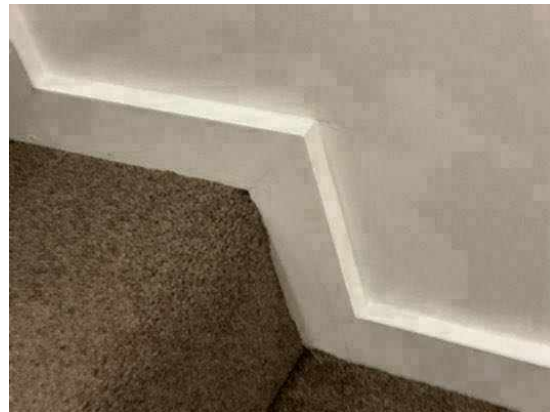
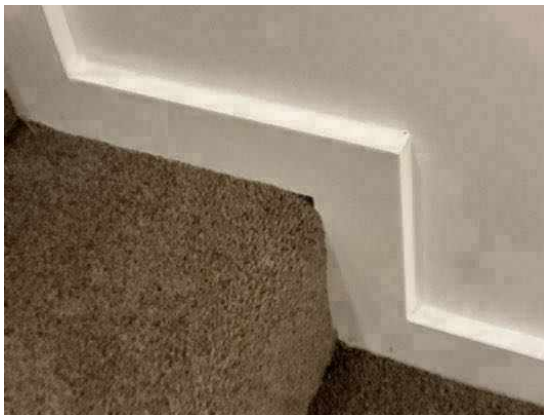
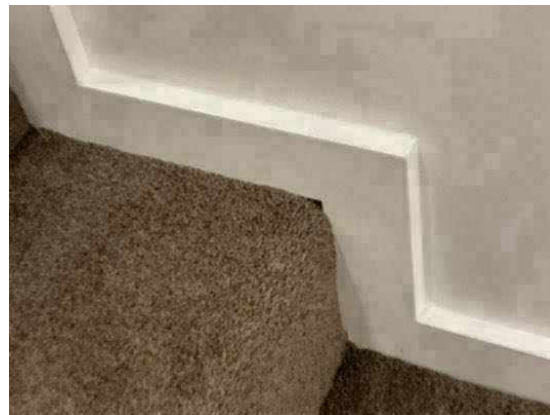
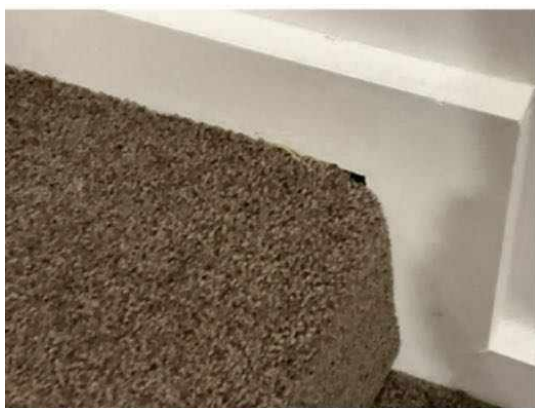
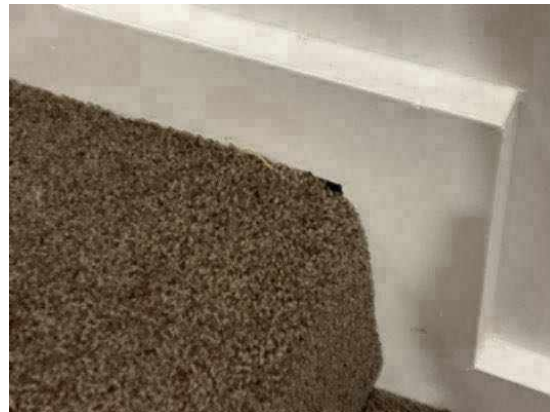
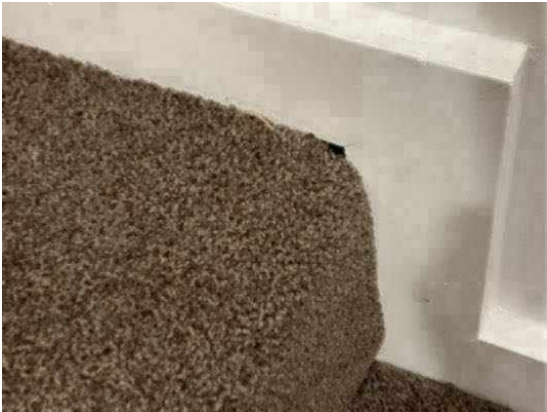
### Defects 3.05

Building:	Main Building
Location:	All Areas
Finding:	Substandard Work- Various Areas of the Building
Information:	Substandard work has been identified in multiple areas throughout the building, failing to meet the requirements specified by Australian Guides and Tolerances.

- **\*\*Paint Application:\*\*** Inconsistent and incomplete paint coverage on walls with visible brush marks, drips, and streaks.

- **\*\*Surface Preparation:\*\*** Poor surface preparation resulting in inadequate paint adhesion and flaking.

- **\*\*Fixtures and Fittings:\*\*** Misaligned or improperly installed fixtures and fittings, not meeting the standard requirements for level and alignment.

- Accelerated deterioration and reduced durability of the affected elements.
- Compromised aesthetic quality and overall value of the property.
- Potential safety hazards and increased maintenance costs.
- Negative impact on the building's functionality and usability.

A comprehensive inspection should be conducted post-repairs to ensure all rectifications comply with the required standards.

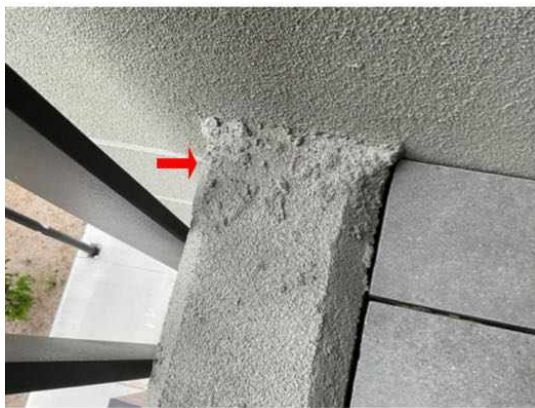
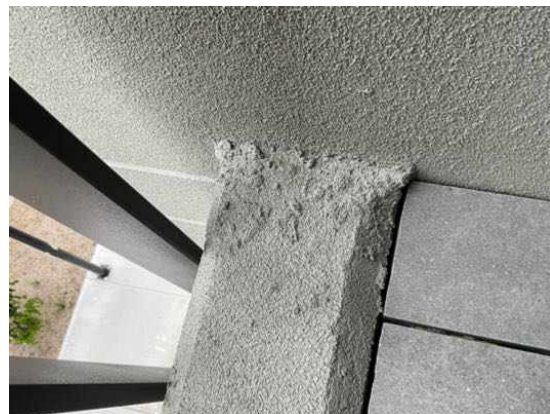
Defects 3.06

Building: Main Building  
Location: Balcony  
Finding: Brickwork - Excessive mortar (AS4455)  
Information: It was observed at the time of inspection that several bricks in this area of brickwork require cleaning to remove excessive mortar. While not likely to cause secondary defects, excessive mortar detracts from the overall appearance of the area and should therefore be removed.

At the time of inspection, this area does not meet contractual requirements regarding acceptable finishes. The responsible contractor should be appointed to complete these works in order to comply with standards and regulations. Such works should be completed prior to final handover.
