Building and Timber Pest Inspection Report

Inspection Date: Tue, 3 Mar 2026

Property Address: 35/5 Broughton Rd, Artarmon NSW 2064,
Australia

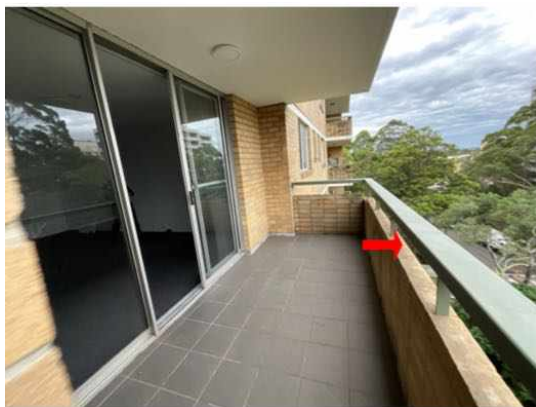
Finding 1.01

Building:	Main Building
Location:	Balcony
Finding:	Balustrade - Suspected Non-Compliance
Information:	The balustrade gaps between the balustrade cladding were found to be greater than the present building regulation requirement of 125mm.

This defect creates a potential safety hazard and should be rectified as soon as possible to ensure the safety of the area and to meet present building standards and regulations.

The balcony balustrade was found to be non-compliant, requiring immediate rectifications by a licensed builder.

A licensed builder should be contacted to discuss possible rectification solutions.

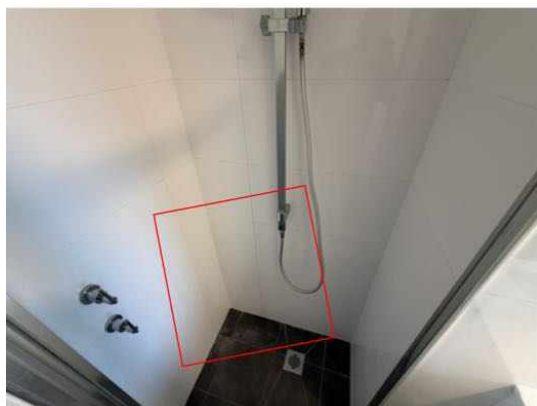
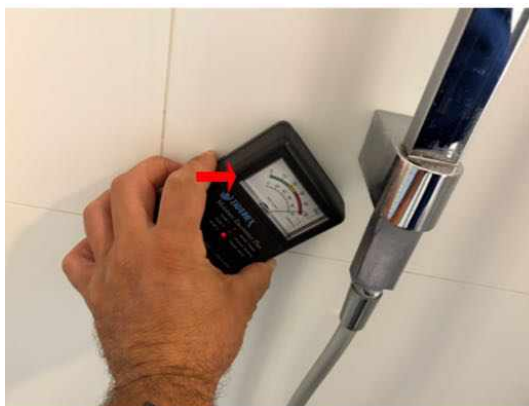
Finding 2.01

Building:	Main Building
Location:	Bathroom
Finding:	Water leak - Suspected
Information:	A water leak is suspected in this area as excessive moisture was detected at the time

of inspection. Another potential cause maybe moisture ingress behind the tiles from around the wall fittings and penetrations.

Excessive moisture was identified to the walls in the shower. There maybe a water leak OR otherwise moisture maybe penetrating around the fittings. A licensed plumber must be appointed urgently for further assessment and repairs.

In extreme cases, structural damage may develop due to a prolonged water leak. It is highly advised that internal water leaks be addressed by a licensed plumber as a matter of relative urgency.

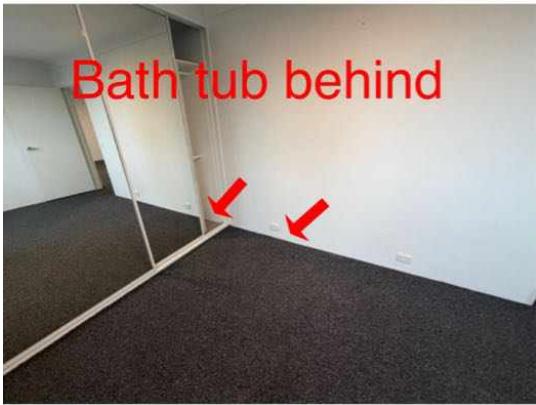
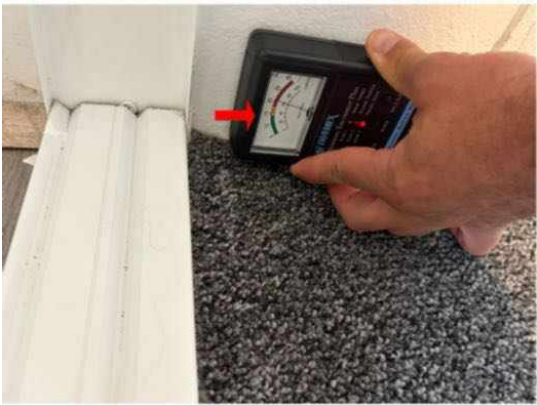
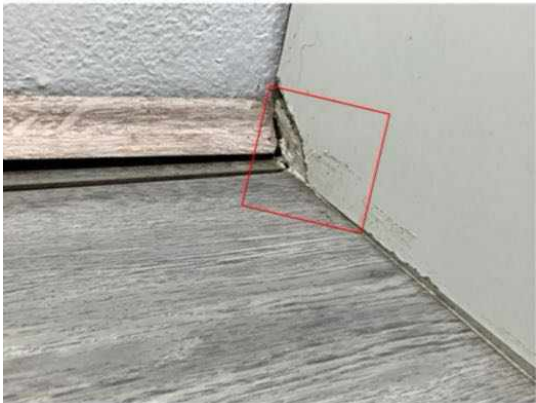
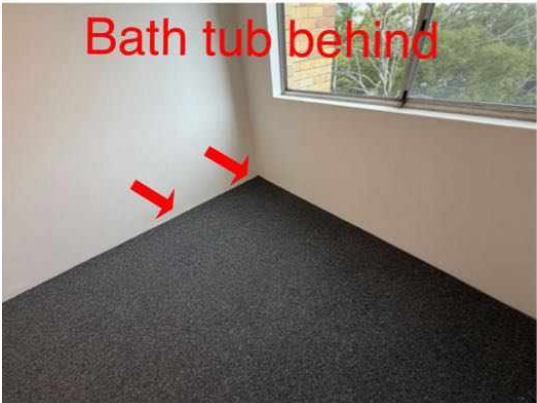
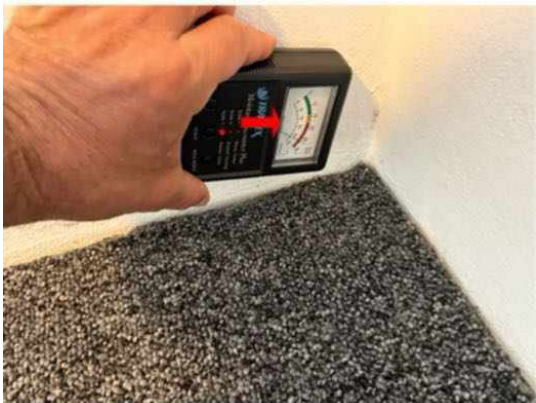
Finding 2.02

Building:	Main Building
Location:	Both bedrooms
Finding:	Water leak suspected - Internal
Information:	A water leak is suspected in this area at the time of inspection. Internal water leaks can be detrimental to surrounding building elements; their potential causes include damage to plumbing fittings and fixtures, through to water damage and deterioration of associated building elements.

Excess moisture was measured to the bottom of the wall, behind the bath tub to both bedrooms. A bathroom specialist must be appointed immediate for assessment and repair as there maybe an internal water leak concealed.

In extreme cases, structural damage may develop due to a prolonged water leak. It is highly advised that a bathroom specialist be appointed urgently for assessment and repair.

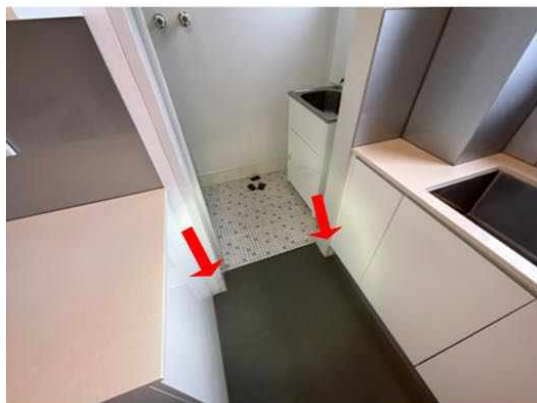
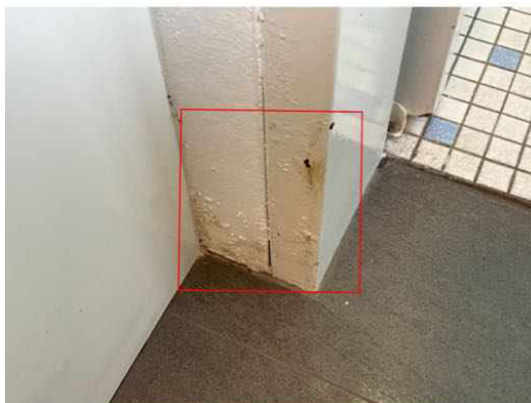
Finding 3.01

Building: Main Building
Location: Laundry
Finding: Water Damage
Information: Water damage is generally an indication of excessive moisture being present, usually via a leak.

source of the leak. A licensed plumber should be appointed as soon as possible to identify the leak and perform rectification works as necessary, ensuring the water damage is restricted.

- Appoint a licensed plumber to assess and repair the water damage to the bottom of the door frame to laundry.

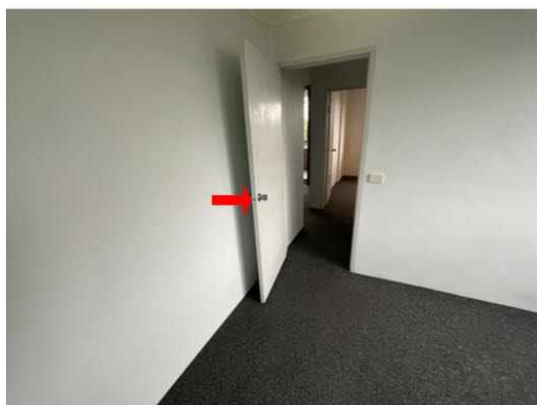
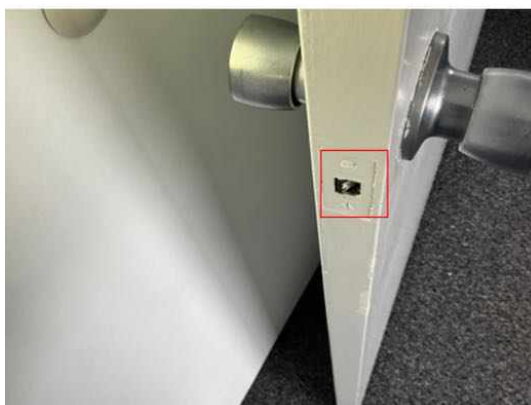
Finding 3.02

Building: Main Building
 Location: Bedroom 2
 Finding: Door handle - Not latching
 Information: It was noted that the door in this area was not latching during operation at the time of inspection. Whilst detracting from the functionality of this building element, this minor defect may also be a security risk, and may therefore have serious implications if left unattended.

Such damage is identified as general wear and tear, which is expected for building elements of this age. A licensed carpenter or general handyperson may be appointed to perform rectification works as necessary, at client discretion. If left unattended, further functional impairment is likely to occur.

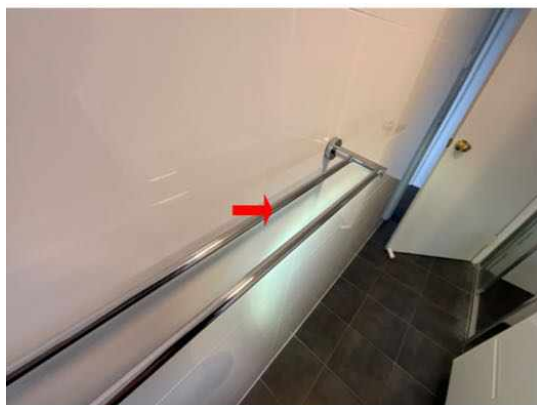
Finding 3.03

Building: Main Building
Location: Bathroom
Finding: Toilet roll holder / Towel rack - Loose
Information:

The toilet roll holder and or the towel rack was found to be loose at the time of inspection. While not a major operational defect, function can deteriorate if the problem is left unmanaged.

It is advised that a registered builder performs remedial works to re-attach this element to its original fixing.

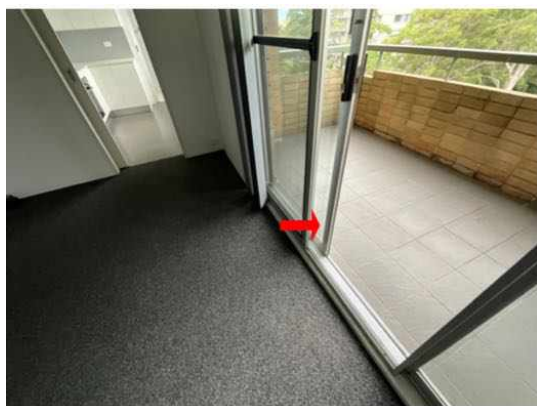
Finding 3.04

Building: Main Building
Location: Balcony
Finding: Door - Stiff to slide
Information:

The door in this area was jammed and difficult to slide along the associated tracks at the time of the inspection. Restricted function of the affected door may pose as a potential safety hazard if required for emergency egress from the building.

Generally, factors such as general age of the building element and a lack of maintenance are the usual causes for this type of defect.

Replacement of door hardware or tracks may be required, as well as minor repairs and cleaning. A registered builder will be required to repair the affected doors.

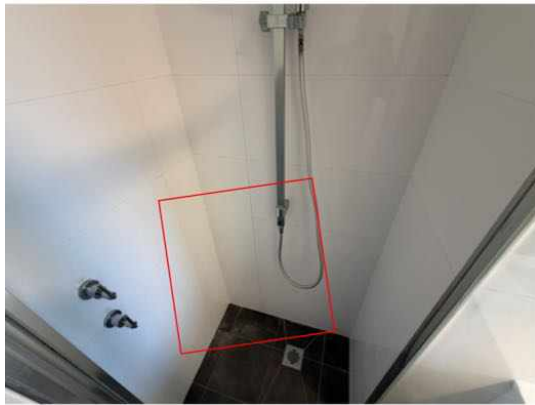
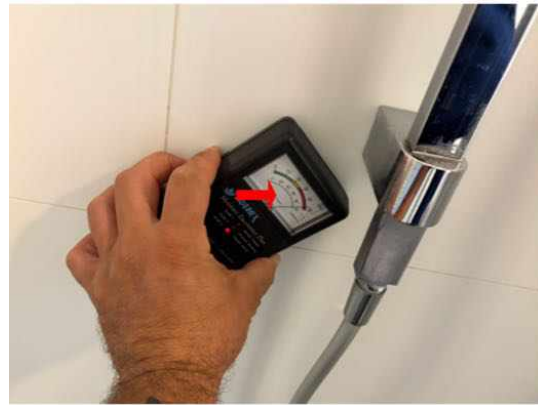
Finding 6.01

Building:	Main Building
Location:	Bathroom
Finding:	Water leak - Suspected
Information:	A water leak is suspected in this area as excessive moisture was detected at the time of inspection. Another potential cause maybe moisture ingress behind the tiles from around the wall fittings and penetrations.

In extreme cases, structural damage may develop due to a prolonged water leak. It is highly advised that internal water leaks be addressed by a licensed plumber as a matter of relative urgency.

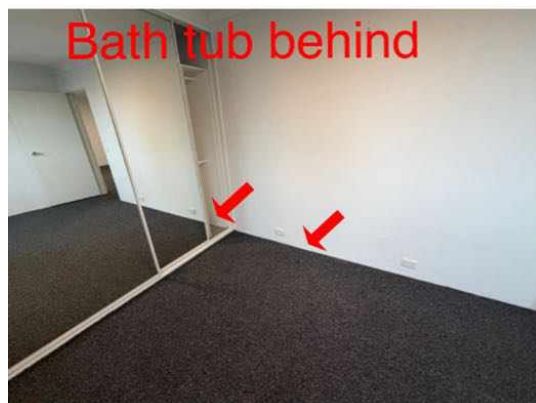
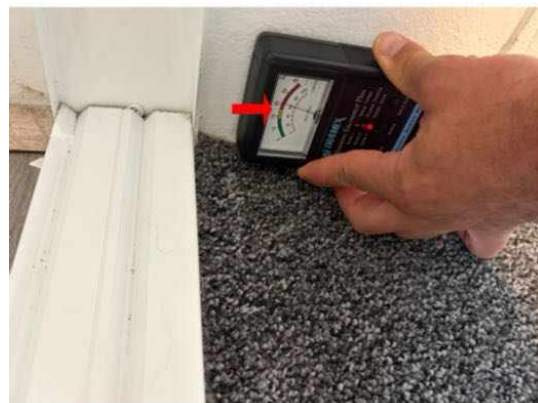
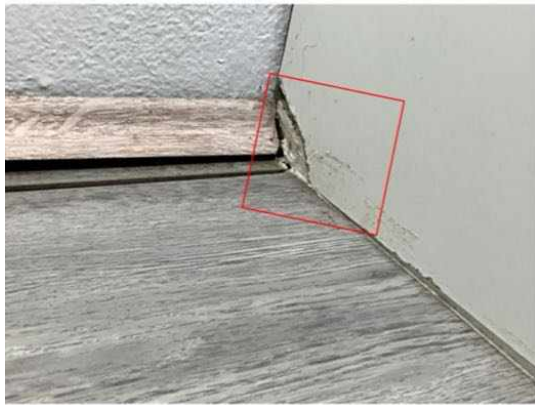
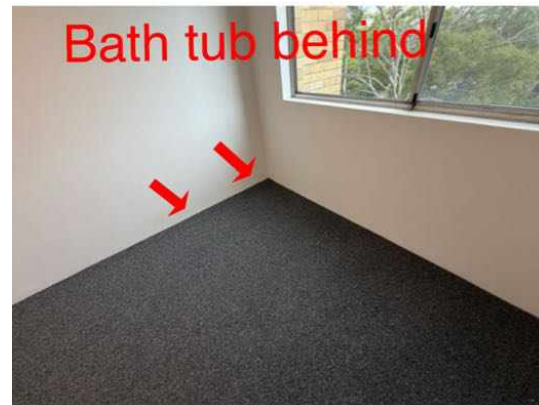
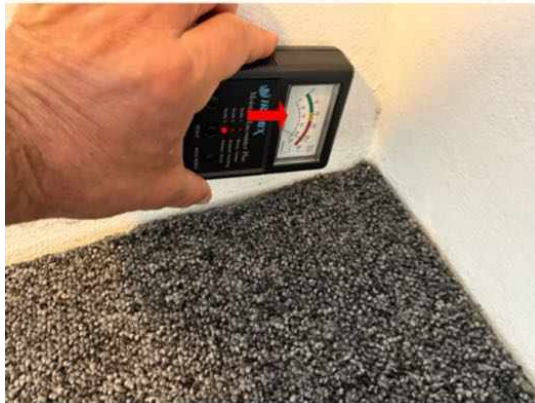
Finding 6.02

Finding: Water leak suspected - Internal

Information: A water leak is suspected in this area at the time of inspection. Internal water leaks can be detrimental to surrounding building elements; their potential causes include damage to plumbing fittings and fixtures, through to water damage and deterioration of associated building elements.

In extreme cases, structural damage may develop due to a prolonged water leak. It is highly advised that a bathroom specialist be appointed urgently for assessment and repair.

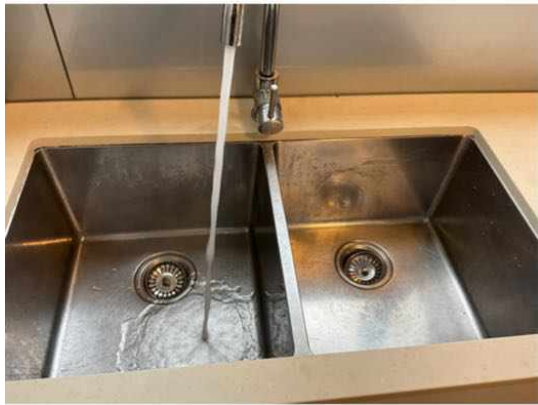
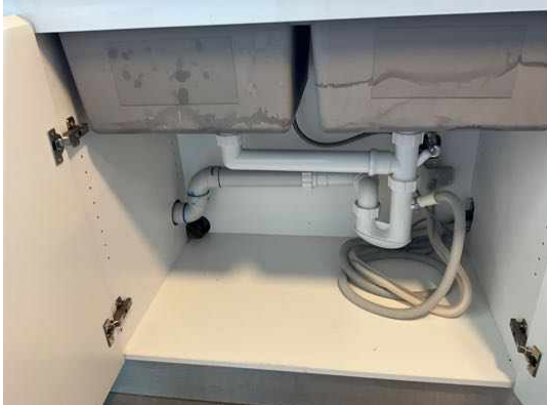
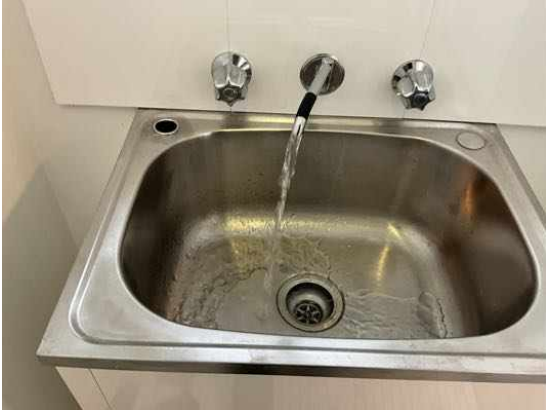
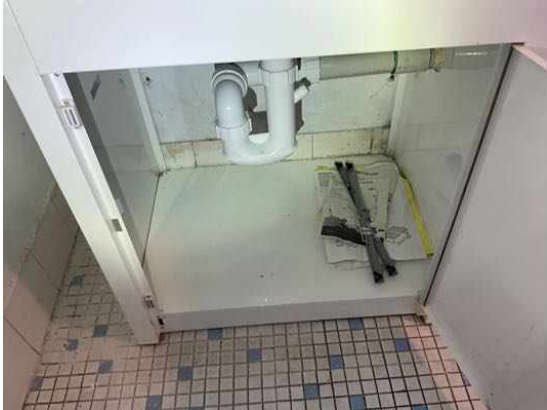
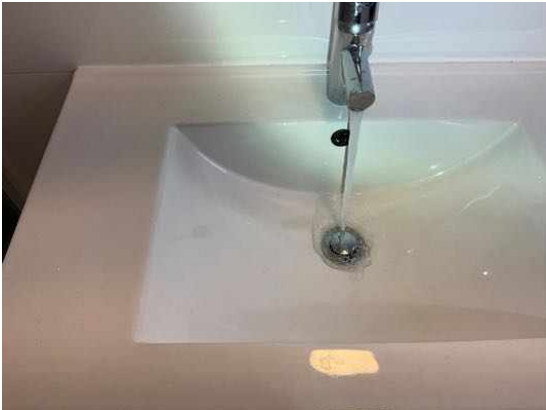
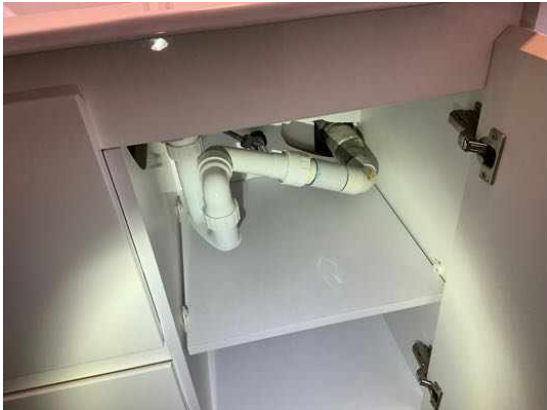
Building: Main Building
 Location: All Wet Areas
 Finding: Waterproofing
 Information: All taps, mixers and toilets were tested for operation, except for those obstructed. The waterproofing to the shower recess was assessed by checking the walls in and around the shower recess for varying moisture content. There were no significant variations across the tested areas. No sign of recent water damage was evident upon a visual inspection of the surrounding walls, where the visual nature of the inspection was possible.

Consequently, there is no conclusive evidence of any current shower recess leakage other than those which may have already been mentioned earlier in this report. It is reasonable to assume the shower waterproofing is sound. Note that if the shower is not used, or has not been used for some time, moisture readings would not vary significantly and this can lead to erroneous results. It is not possible under the visual inspection criteria (under which a prepurchase inspection is carried out) to categorically determine if there are leaks. If a more accurate assessment is required, a special purpose inspection should be requested. Alternatively, the assumption should be made that the shower may leak.
