Building Inspection Report

Inspection Date: Sat, 28 Feb 2026

Property Address: 61 Weroona Ave, Park Holme SA 5043,
Australia

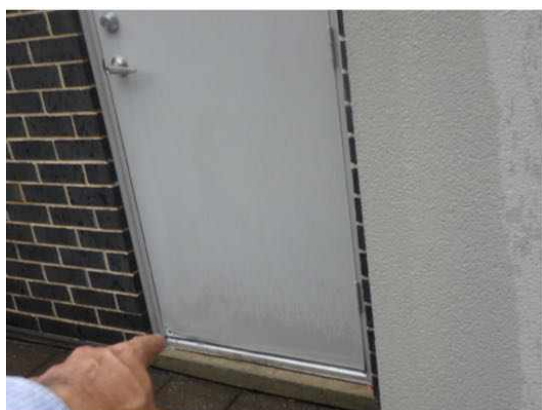
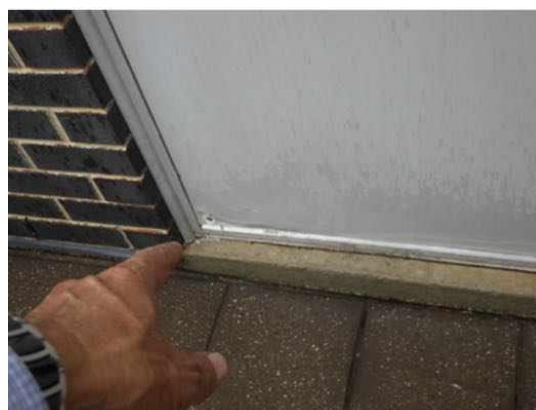
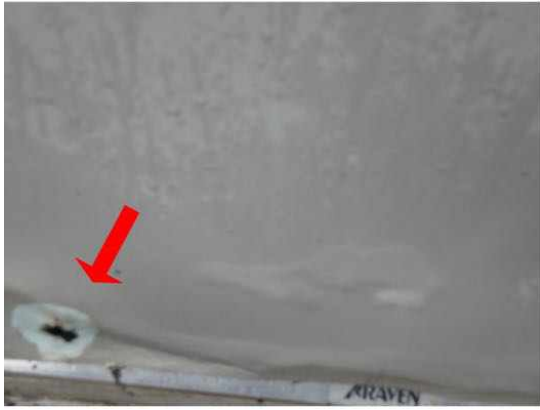
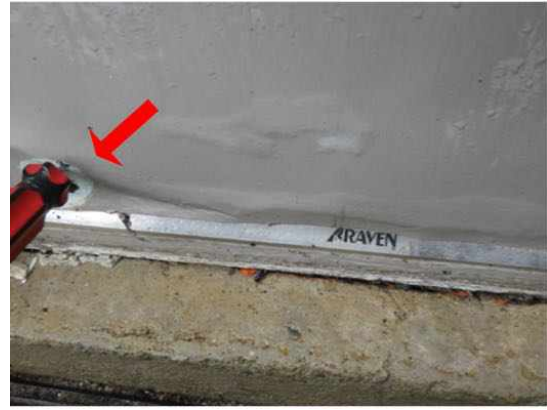
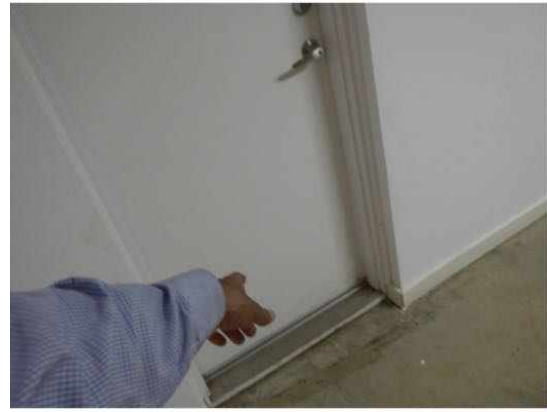
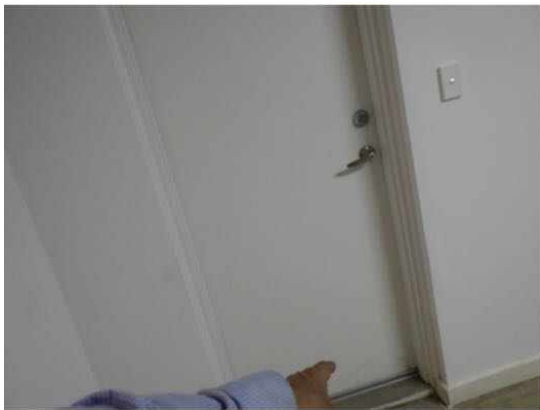
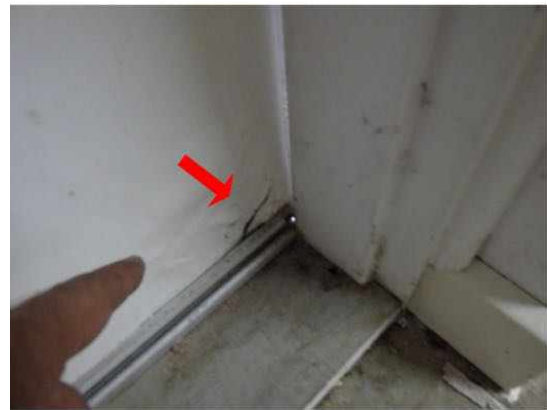
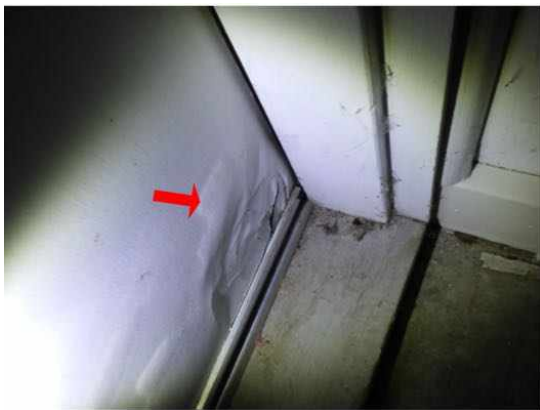
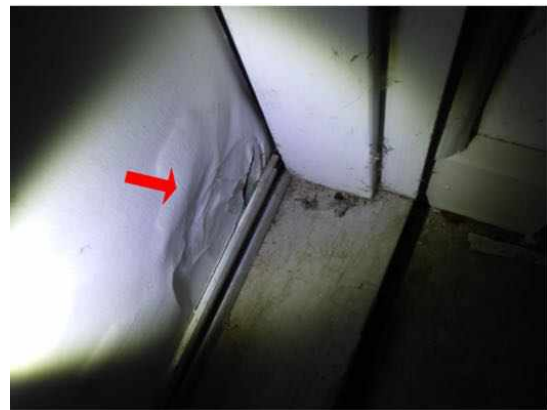
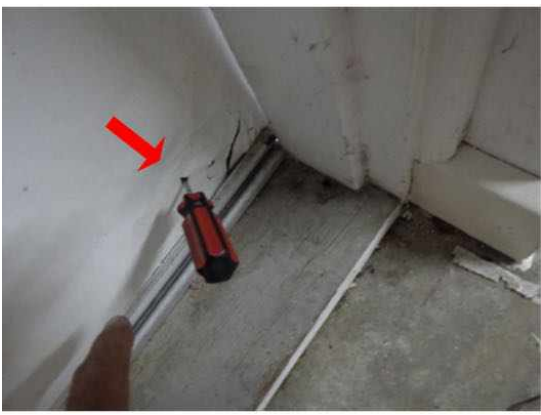
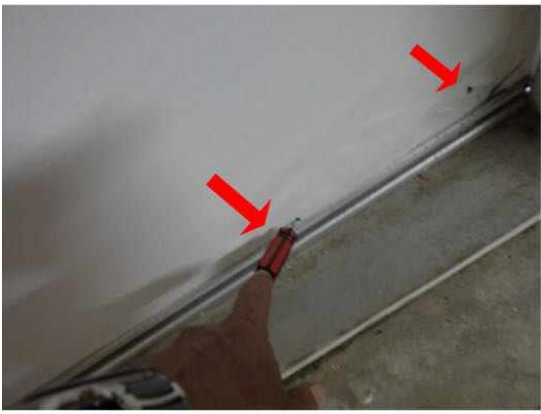
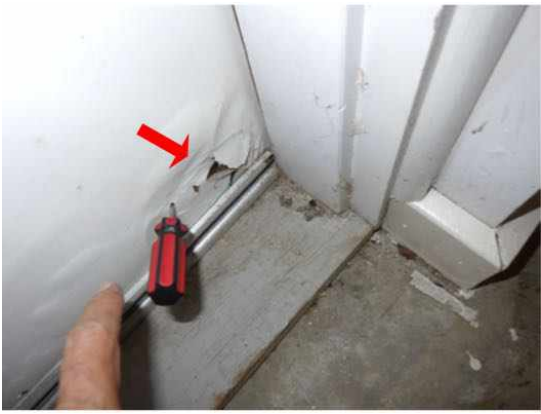
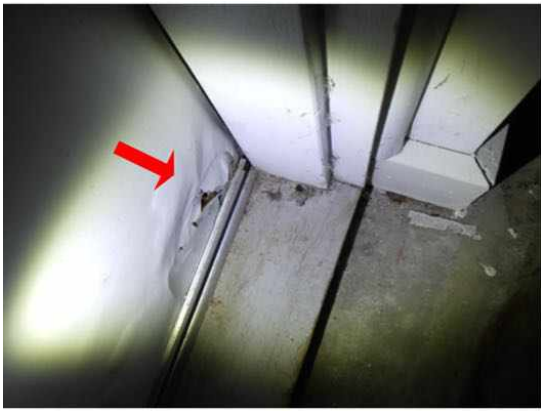
Defects 2.01

Building: Building 1
Location: All Areas
Finding: Rear Garage Door - Swollen
Information: At the time of inspection it was noticed that rear garage door is swollen.

Swollen building elements generally indicate that the building materials have been affected by excessive moisture over a prolonged period of time, and have swollen as a result. The formation and development of mould/fungi or mildew is also a likely consequence of excessive moisture, which may pose major respiratory issues for occupants, particularly the elderly, the very young and those with existing illnesses and could be potential health safety hazards. In these cases an appropriately qualified inspector/tester should also be contacted for advice and/or technical assistance.

The structural integrity of swollen building elements can not be guaranteed, and further damage is likely to develop if left unmanaged. Excessive moisture is likely to lead to the development of secondary damage to any associated building elements, which may necessitate major reparation works if prolonged.

Rectification of the cause of the water leak should be addressed prior to any remedial works to the swollen building elements. A licensed plumber should be appointed immediately to identify the cause of the leak and provide advice on remedial works as necessary, Repair and/or replacement of swollen building elements should be conducted as a matter of urgency by a registered builder or qualified carpenter.

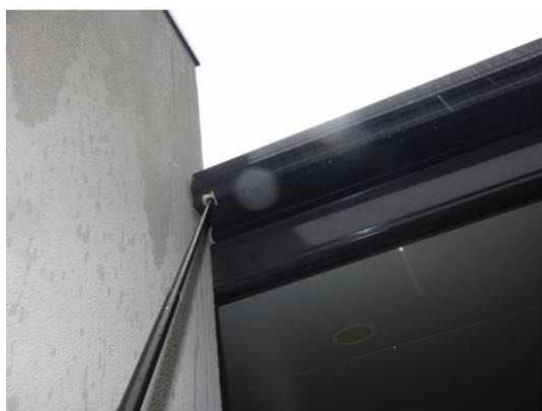
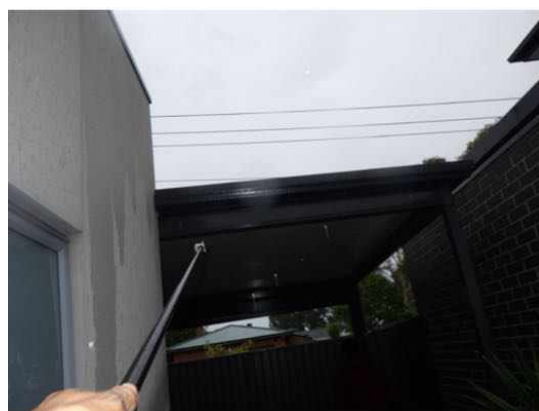
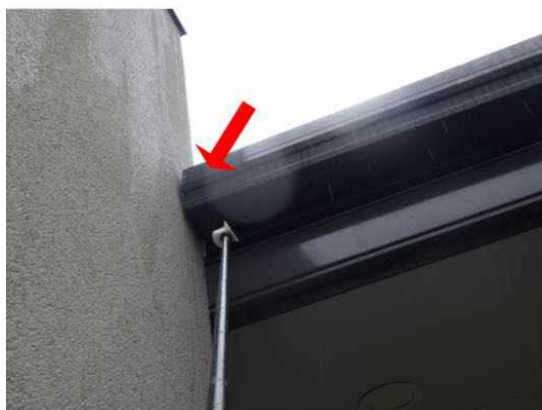
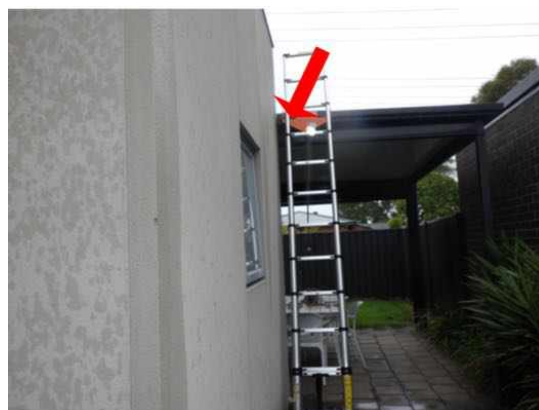
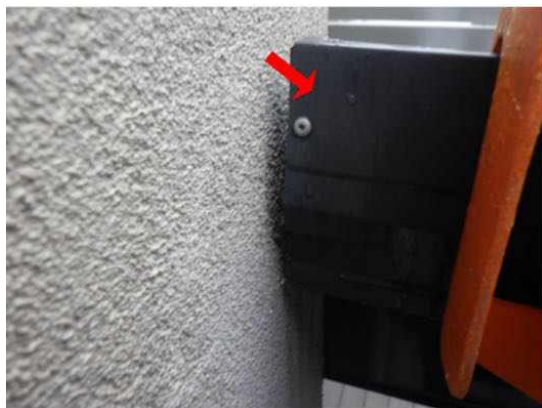
Defects 3.01

Building: Building 1
Location: All External Areas
Finding: External wall rear - Gutters - Loose from its original fixing
Information: At the time of inspection, it was observed that the gutters located along the rear external wall are loose and have detached from their original fixings. This condition may result from natural aging and deterioration of building materials or could be due to accidental or external impact damage.

Loose gutters can compromise the effective drainage of rainwater, potentially leading to water ingress, damage to external walls, and accelerated wear of other building elements. If left unattended, this defect may contribute to secondary issues such as water staining, mould growth, or structural deterioration.

It is advised that the affected gutters be repaired or replaced as necessary to restore proper functionality. A qualified and licensed tradesperson should be engaged to assess the extent of the issue and undertake appropriate rectification works. Timely repairs will help maintain the integrity and performance of the building envelope and prevent further damage.

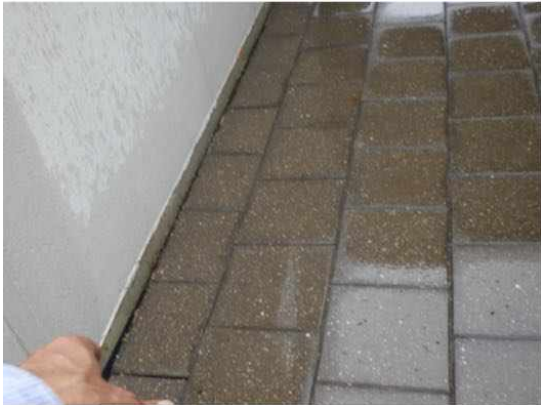
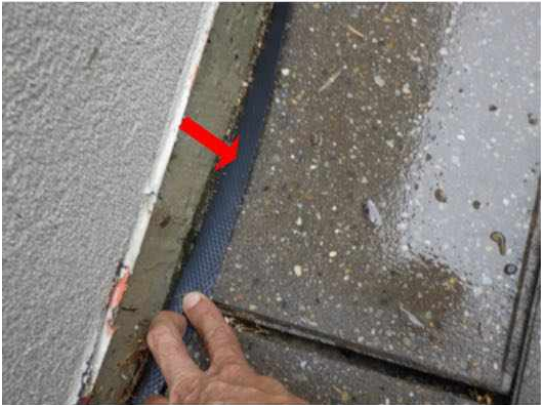
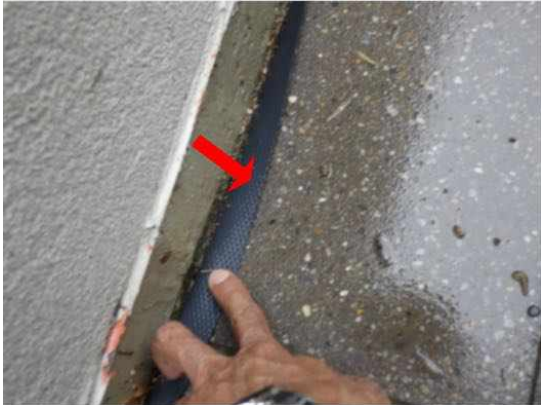
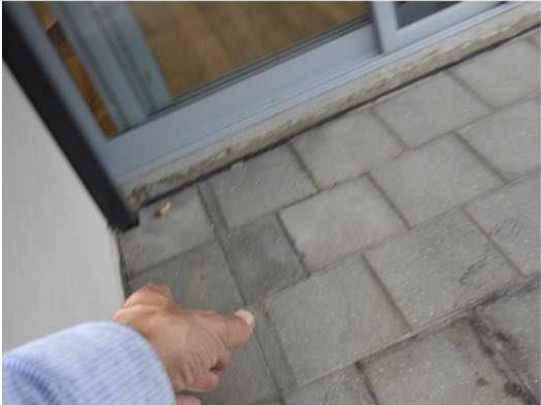
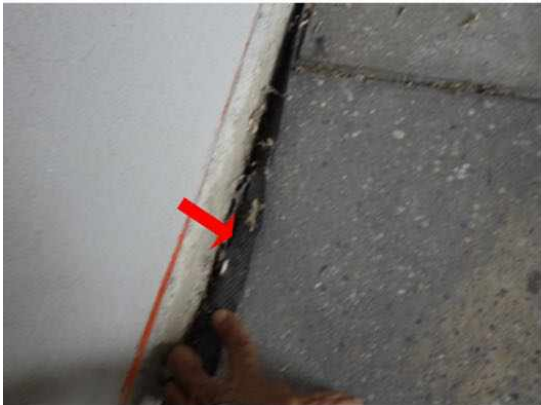
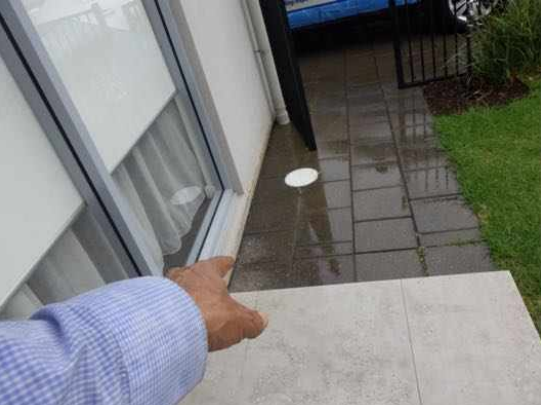
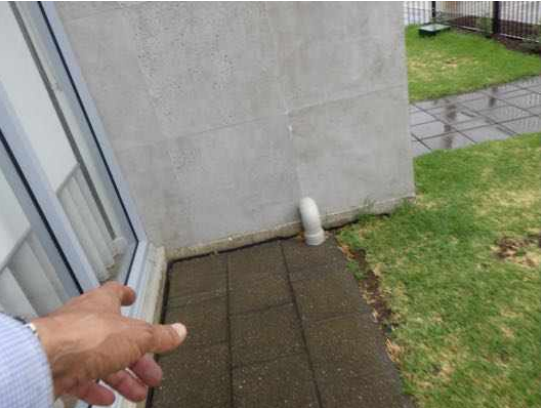
Defects 3.02

Building:	Building 1
Location:	All External Areas
Finding:	Slab Edge - Exposure compromised
Information:	At the time of inspection it was noticed that damp course member has been popping upwards from the external paving in few sections around property and result of that slab edge exposure has been compromised. It's advised to cut the extra popping upwards damp course.

An inspection zone of at least 75mm in relation to the exposed slab edge, between the bottom brick and the perimeter pavement, is required. This inspection zone should be maintained in order to force termites into the open where they can be detected more readily during regular inspections. The slab edge should not be concealed by anything that may prevent inspection of the area, including render, landscaping, soil, turf, paving, concrete cladding or other structures.

If the slab edge is not properly exposed there is a high risk of termite attack. Sometimes, in order to determine the type of slab, a suitably qualified person such as an architect or builder may be required to consult the construction plans.

Where the slab edge cannot be properly inspected, it is highly recommended that termite or timber pest inspections be carried out every 6-12 months to aid protection of the property against infestation.

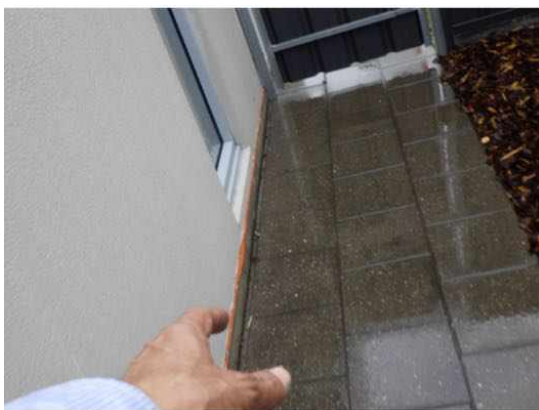
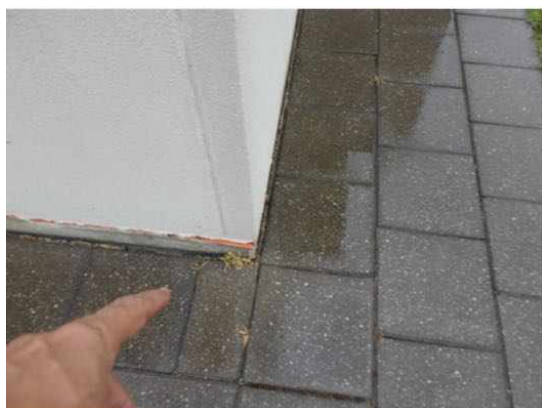
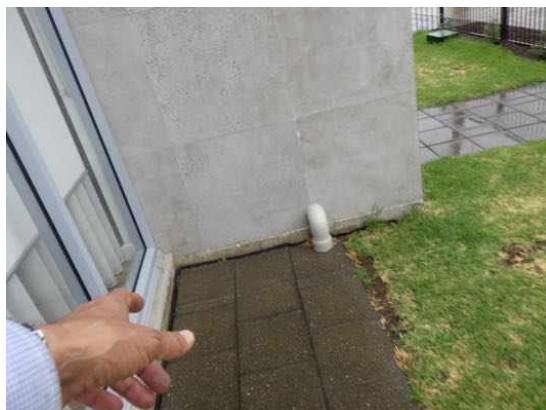
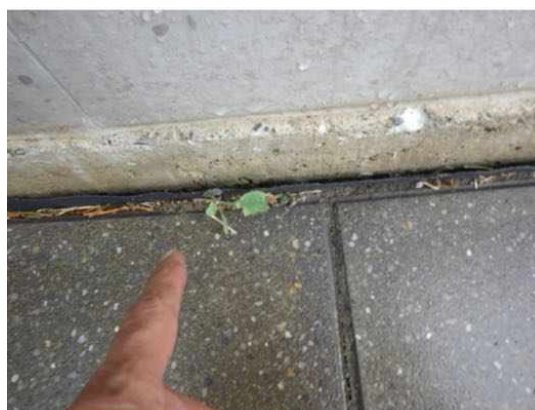
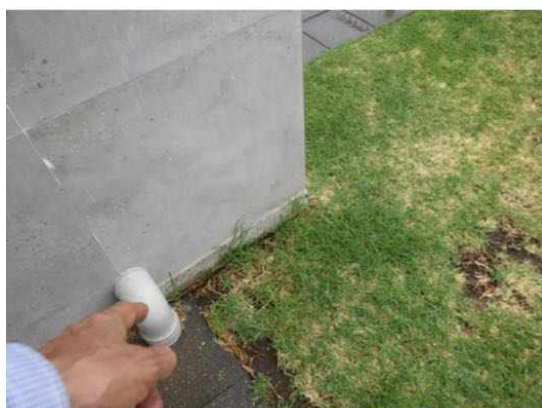
Defects 3.03

Building:	Building 1
Location:	All External Areas
Finding:	Bridging - Vegetation
Information:	Where vegetation obstructs inspection of building elements, also known as bridging as it provides a bridging point for the access of termites, full inspection can not be achieved. Consequently moisture or dampness may be present and the areas becomes conducive to termite activity. Plants against or very close to buildings provide cover, shade and can provide an environment that is attractive to termite infestation.

The removal and replanting of species that do not provide "cover" or cutting back of existing vegetation will assist greatly in preventing Bridging from occurring.

The removal of any such materials that may be conducive to termite activity should be carried out as soon as possible and arrange re inspection to minimize the risk of termite attack.

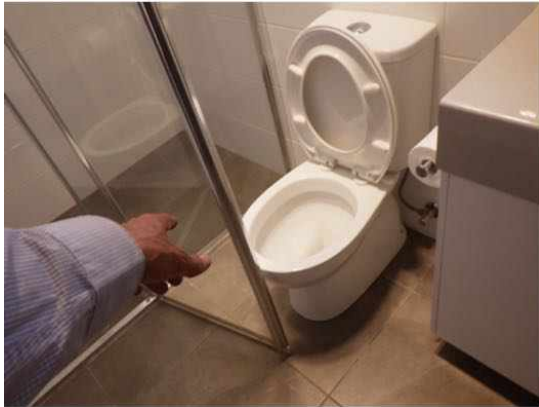
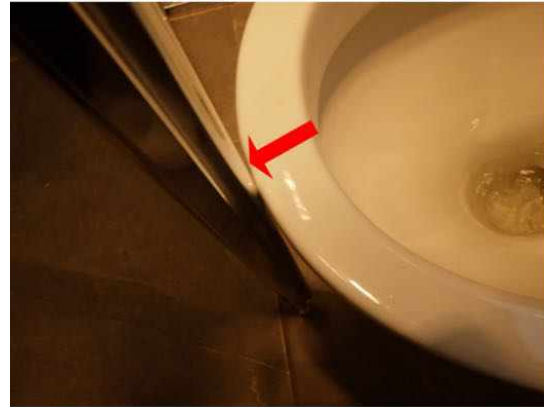
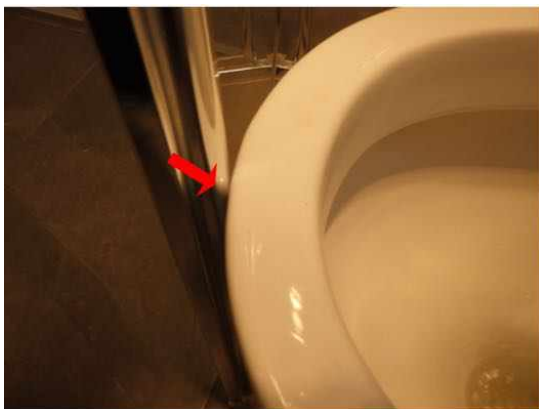
Defects 3.04

Building: Building 1
 Location: Ground floor - Bathroom
 Finding: Shower screen touching -Toilet assembly during standard operation
 Information: At the time of inspection it was noticed that shower screen door is touching to the toilet assembly and creating a potential safety hazard in the ground floor -bathroom area.

It advised that builder should take appropriate measures to avoid/ reduce the impact of shower screen hitting during door operations.

A qualified glazier is required to repair the shower screen as soon as possible. Please

be advised that any persons coming into contact with the shower screen should do so with due caution to avoid any personal injury that may ensue.

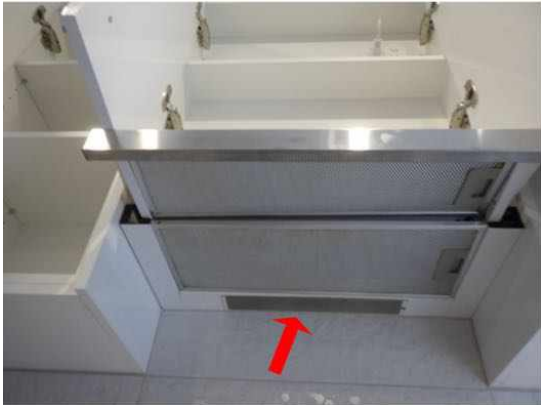
Defects 3.05

Building: Building 1
Location: All Internal Areas
Finding: Rangehood - Light not working
Information: While the range hood appears to be working at a satisfactory level, the light to the appliance was not working at the time of inspection.

A licensed electrician should be appointed to replace the light on the range hood to restore it to a fully operational state.

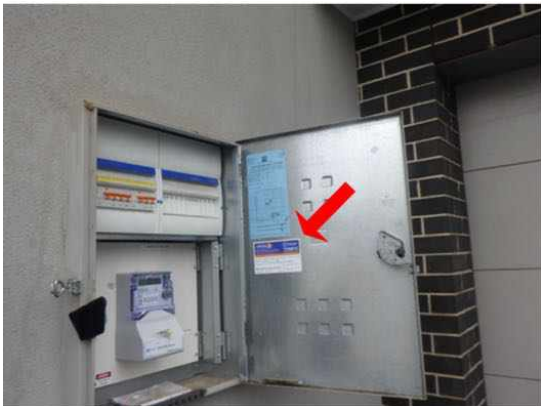
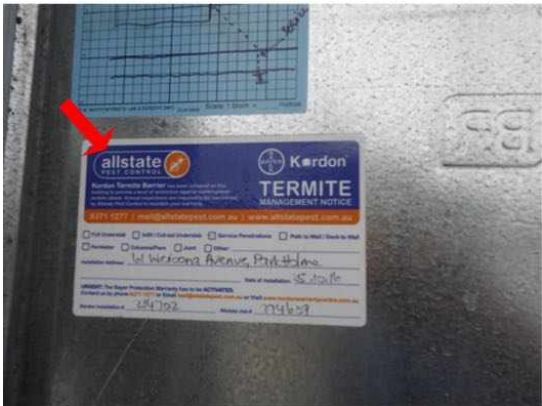
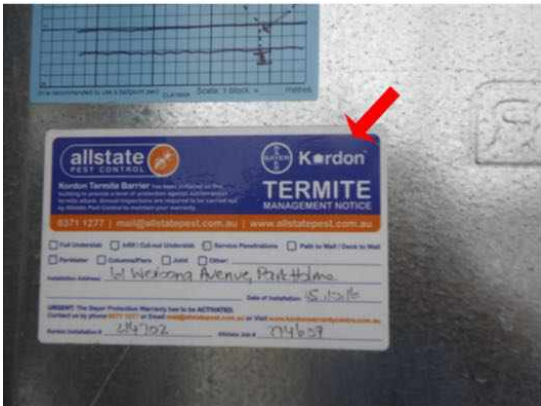
Building: Building 1
 Location: All External Areas
 Finding: Evidence of a previous termite management system was identified
 Information: There are a number of factors which indicate the presence of a previously installed or applied termite barrier. The most common are a durable notice (to the inside of your meter box) observable physical barriers installed to building perimeter and in ground reticulation systems.

Where a Termite Management System has been identified you should refer to the type of barrier date of installation warranty conditions and any documentation provided by a builder or past owner. Consult the company who installed the barrier to confirm whether the system is still under warranty.

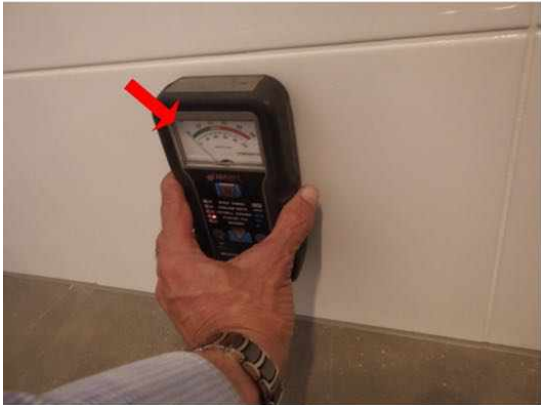
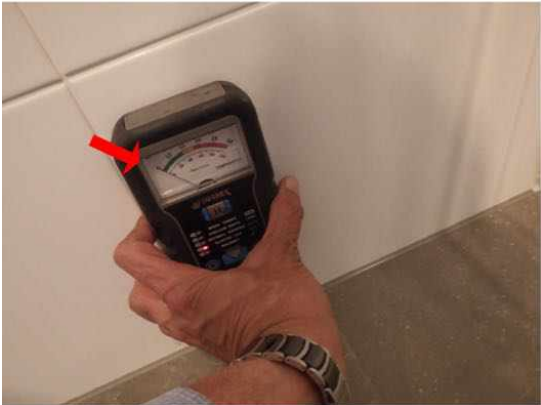
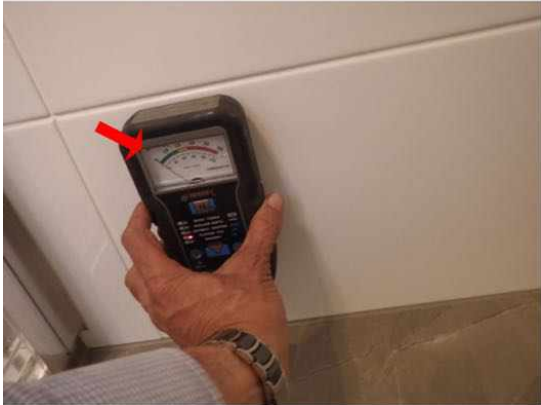
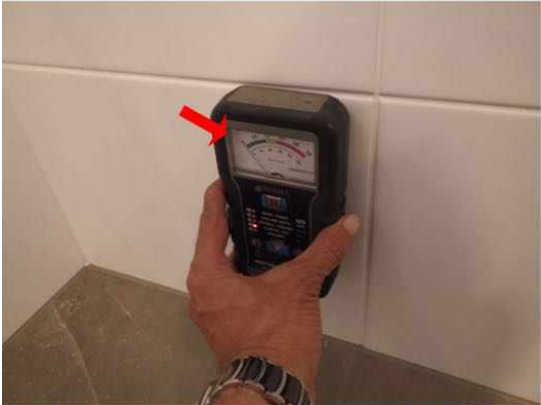
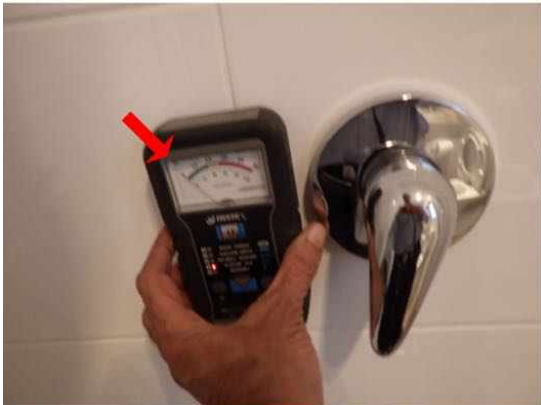
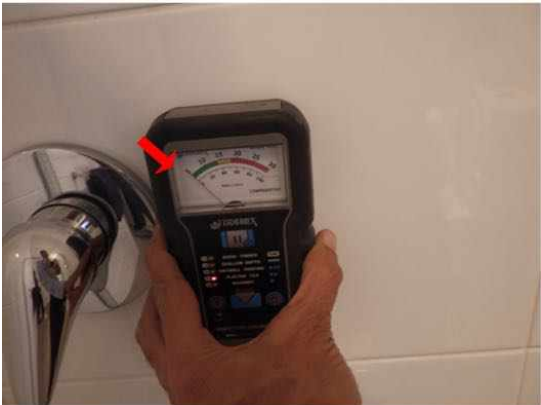
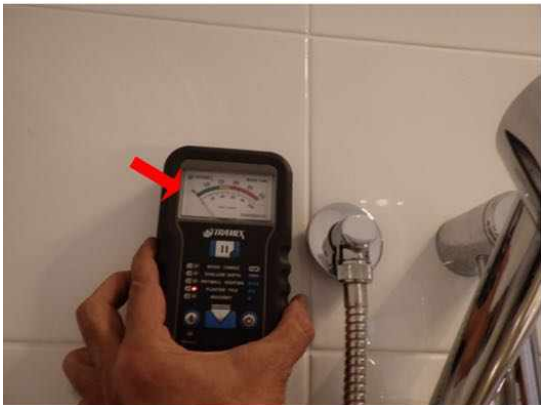
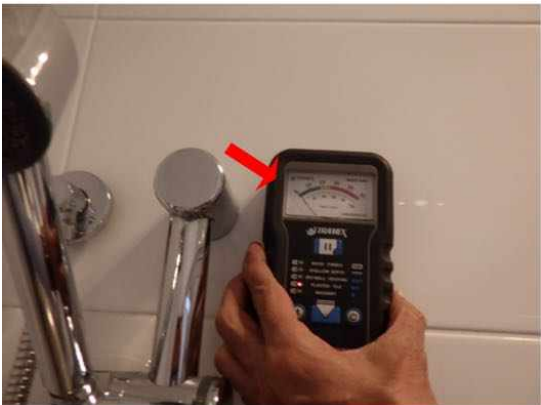
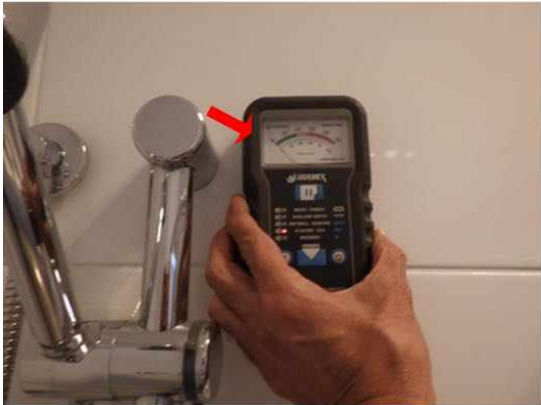
Building: Building 1
Location: Ground floor - Bathroom
Finding: Shower Alcove - No Damp
Information: At the time of inspection it was noticed that damp is not evident to the shower alcove.

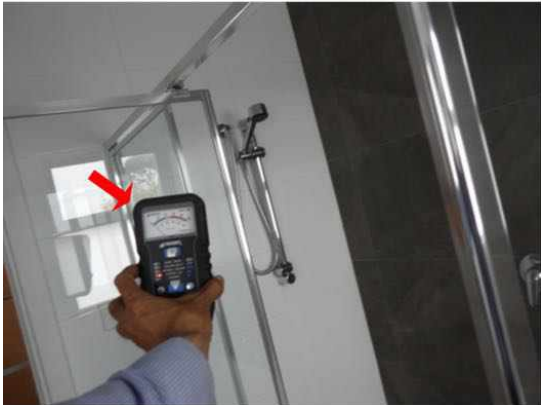
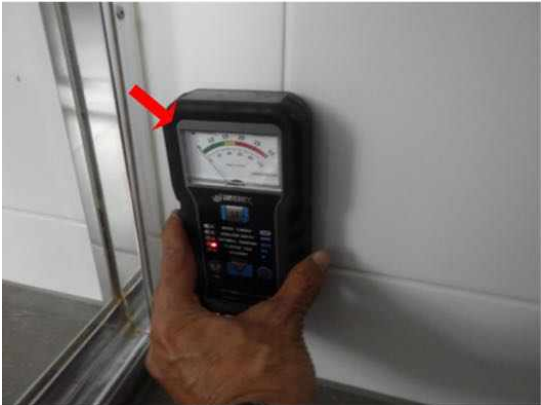
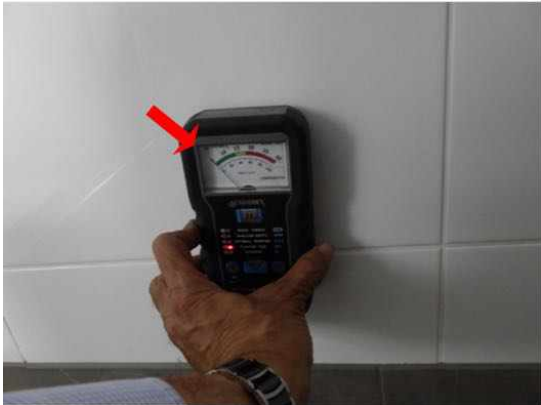
Building: Building 1
Location: Upper floor - Bathroom
Finding: Shower Alcove - No Damp
Information: At the time of inspection it was noticed that damp is not evident to the shower alcove.

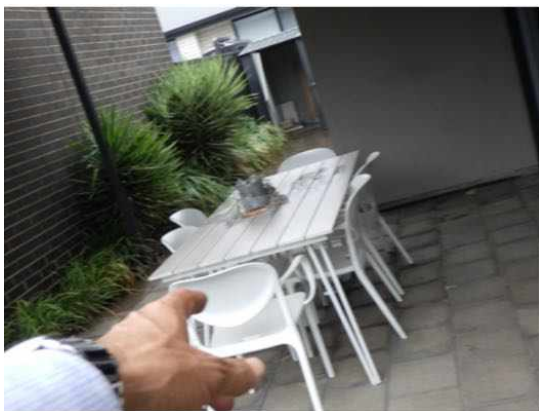
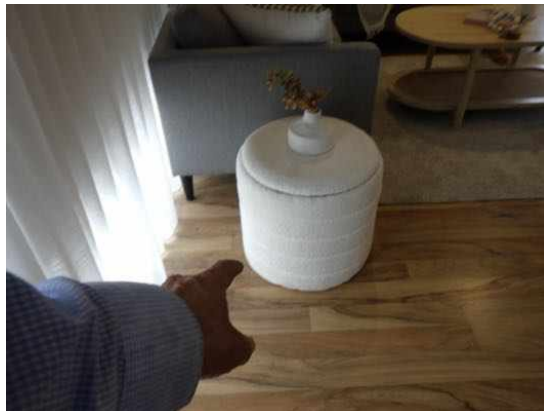
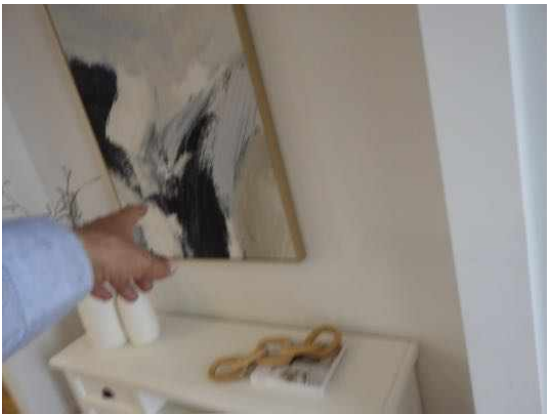
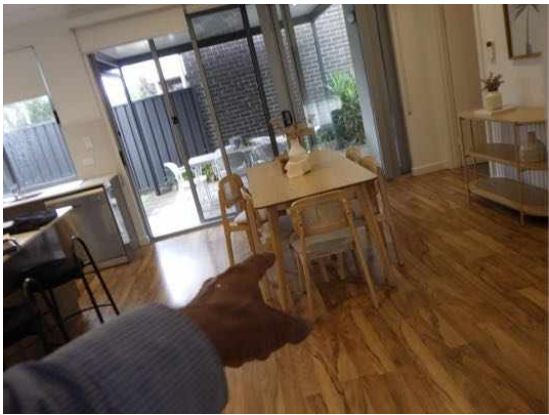
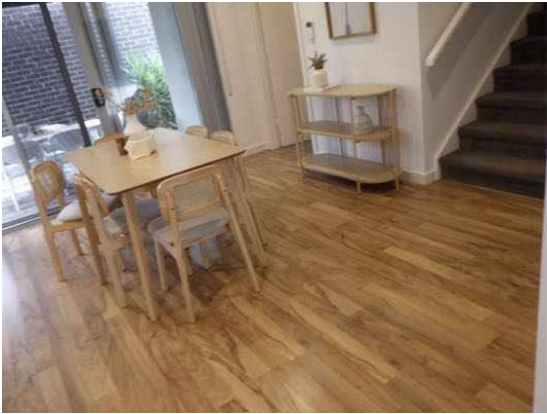
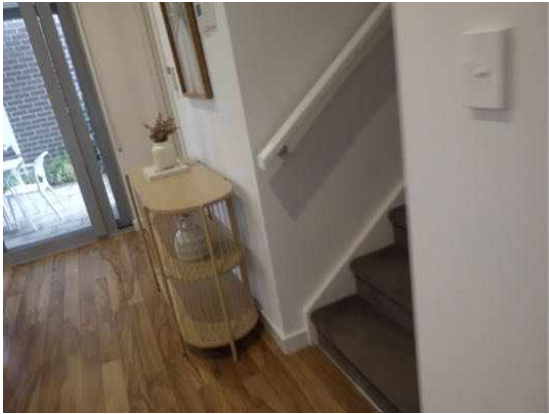
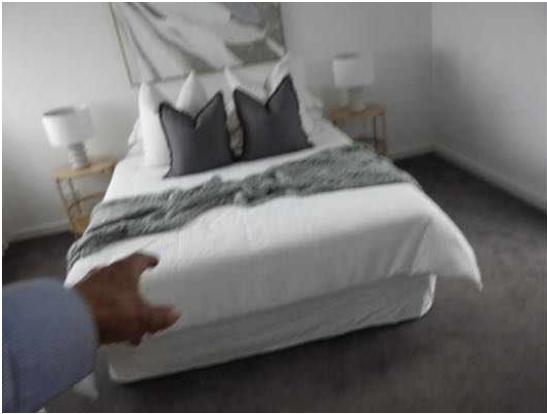
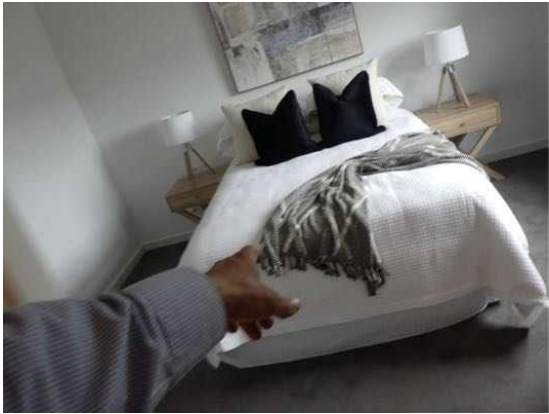
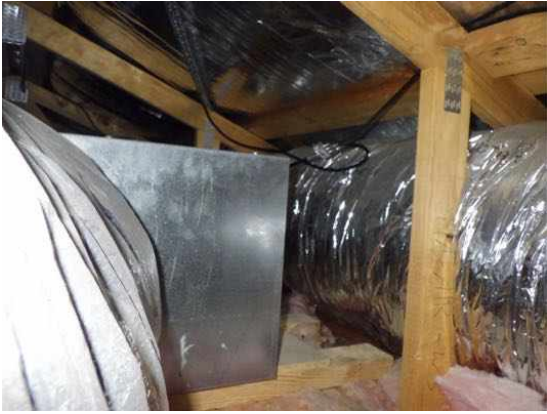
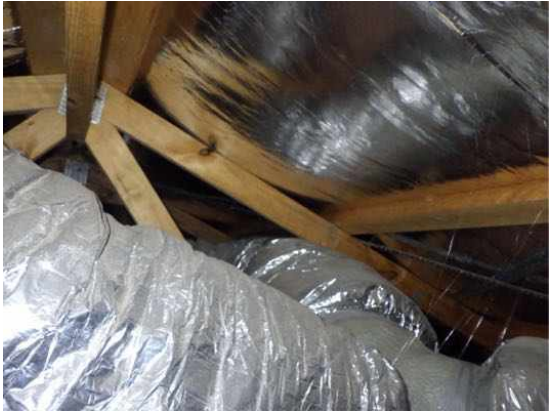
Building: Building 1
 Location: All Areas
 Finding: Additional Photos - Obstructions and Limitations
 Information: These photographs are an indication of the obstructions and limitations which impeded full inspection of the property at the time of inspection. These obstructions can hide an array of defects and should be removed to allow full inspection to be carried out. A re-inspection is recommended once the areas are made accessible.
