Building and Timber Pest Inspection Report VR

Inspection Date: Fri, 27 Mar 2026

Property Address: 2 Kerrani Pl, Coutts Crossing NSW 2460,
Australia

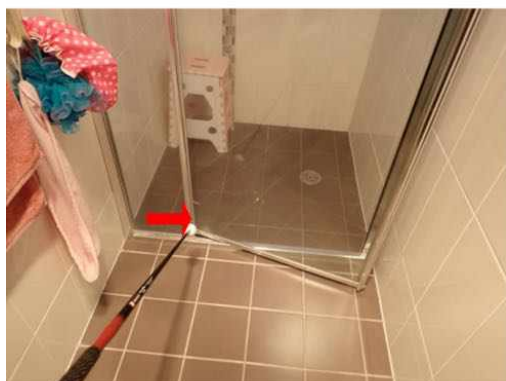
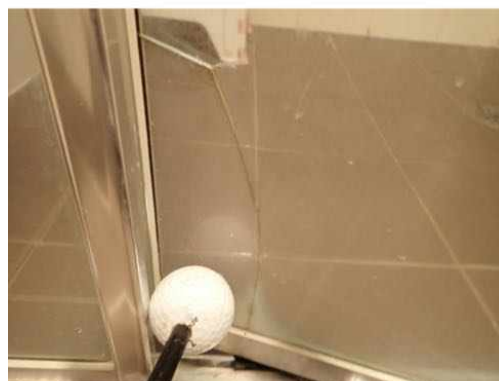
Finding 1.01

Building:	Main Building
Location:	Bathroom
Finding:	Crack Identified To Shower Screen Door
Information:	A crack was identified to the shower screen door, likely due to impact or stress within the glass. Cracked glass may weaken over time and presents a potential safety risk if failure occurs. Repairs should be carried out by a glazier, including replacement of the affected glass panel. Repair or replacement is recommended to address the safety concern.

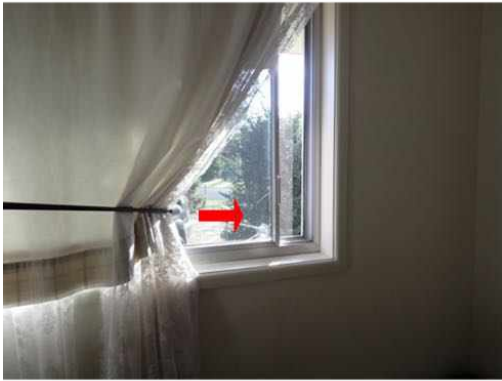
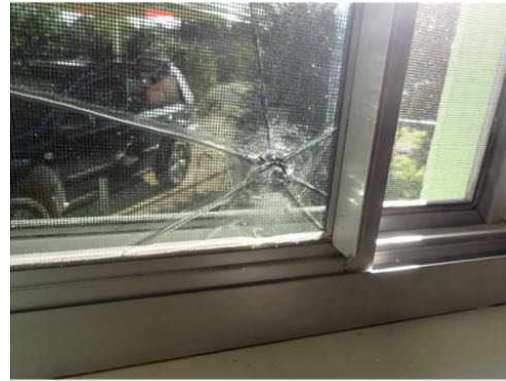
Finding 1.02

Building:	Main Building
Location:	Bedroom
Finding:	Crack To Bedroom Window Pane
Information:	A crack was identified to the bedroom window pane, likely impact-related. Cracked glass may weaken over time and presents a potential safety risk if failure occurs. Repairs should be carried out by a glazier, including replacement of the affected pane. Repair or replacement is recommended to address the safety concern.

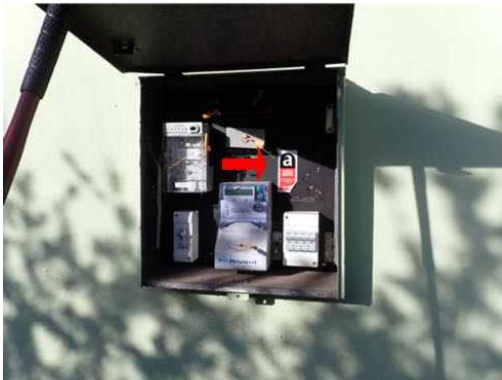
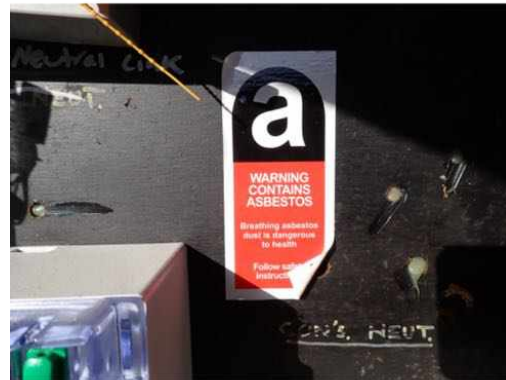
Finding 1.03

Building:	Main Building
Location:	Electrical meter box
Finding:	Asbestos Warning Sticker Identified
Information:	An asbestos warning sticker was identified on site, indicating the possible presence of asbestos-containing materials. While the material itself was not disturbed at the time of inspection, care should be taken to avoid damage or disturbance. If works are planned in the affected area, further assessment by a licensed asbestos assessor is recommended, with any removal or handling carried out by a licensed asbestos removal contractor in accordance with relevant regulations. Ongoing management may be undertaken at the owner's discretion.

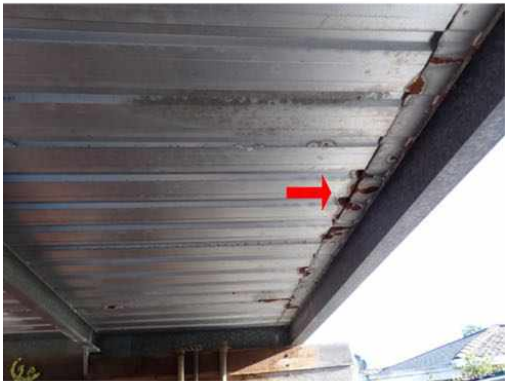
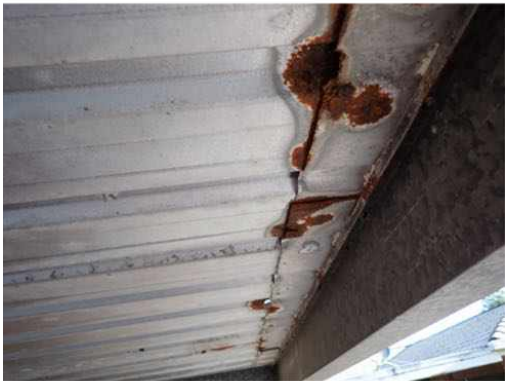
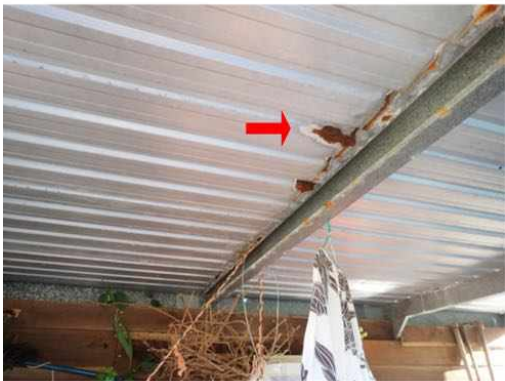
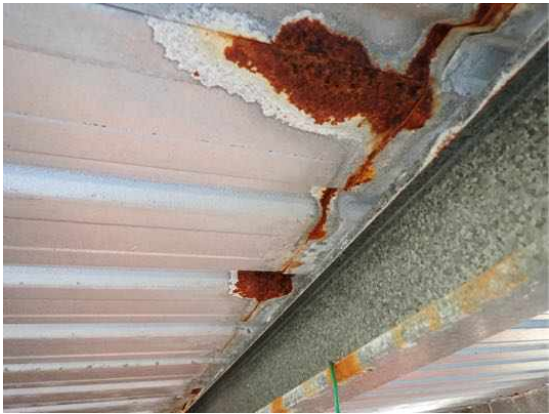
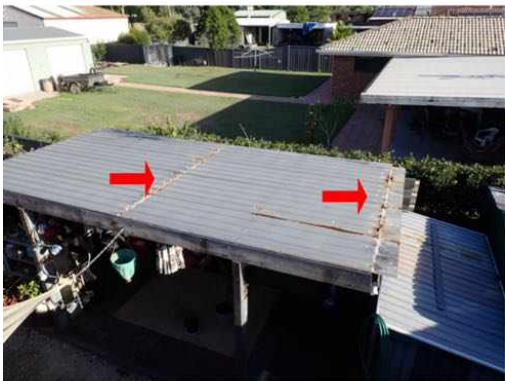
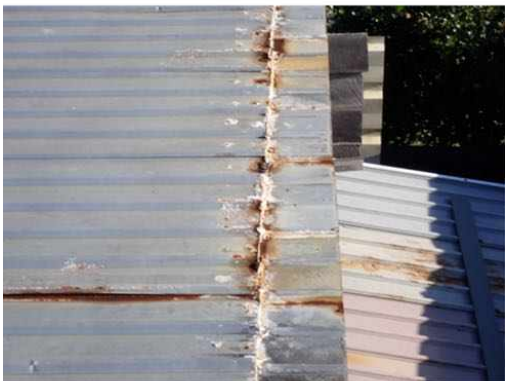
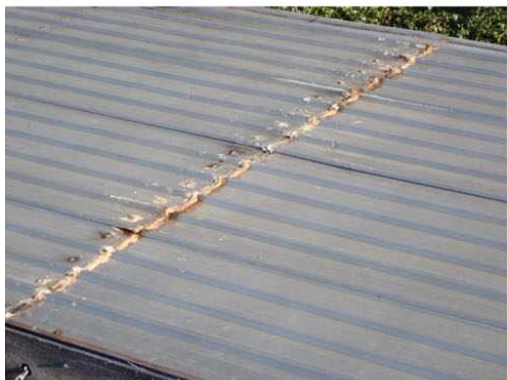
Finding 2.01

Building:	Yard
Location:	Covered concrete area
Finding:	Roof To Concrete Covered Area In Poor Condition
Information:	The roof to the concrete covered area was found to be in poor condition, with rust identified to the roofing components. This is likely due to age-related deterioration and

ongoing exposure to the elements, which may lead to further corrosion and potential water ingress if not addressed. Repairs or replacement should be carried out by a licensed roofing contractor. Works may be undertaken at the owner's discretion.

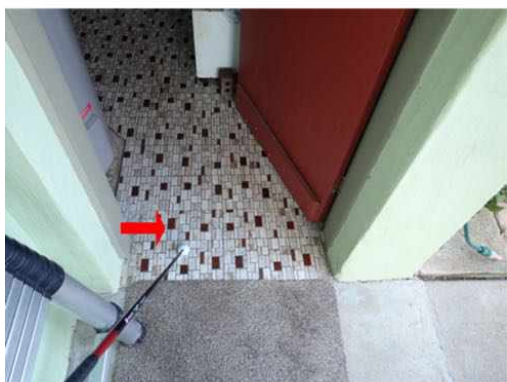
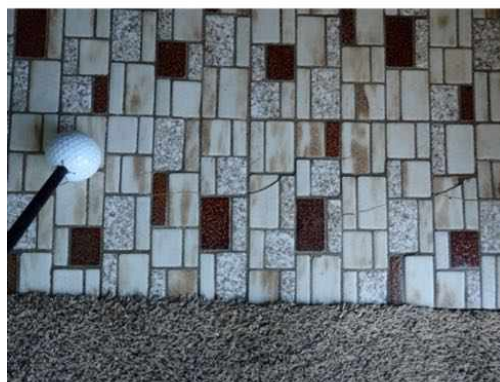
Finding 3.01

Building:	Main Building
Location:	Laundry
Finding:	Damaged Floor Tiles To Laundry
Information:	Damage was identified to the laundry floor tiles, likely due to impact, movement, or age-related deterioration. If left unaddressed, further deterioration and potential moisture ingress may occur. Repairs should be carried out by a tiler, including replacement of the affected tiles and ensuring a suitable substrate. Repairs are recommended to prevent further deterioration.

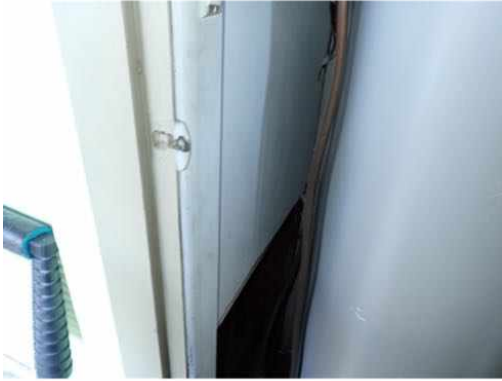
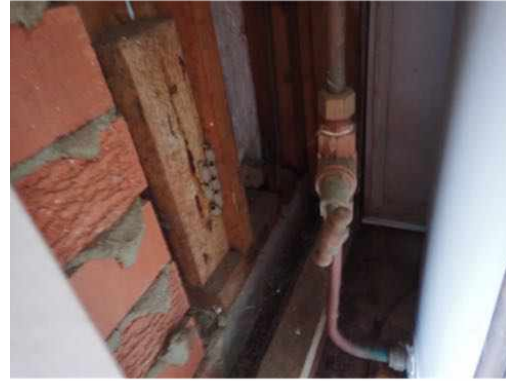
Finding 3.02

Building:	Main Building
Location:	Laundry
Finding:	Missing Wall Cladding To Laundry Behind Hot Water Unit
Information:	Wall cladding was missing to the laundry area behind the hot water unit, exposing underlying materials. This may allow moisture ingress and increase the risk of deterioration to surrounding building elements. Rectification should be carried out by a plasterer or suitably experienced handyman, including installation of suitable cladding

and ensuring adequate protection against moisture. Repairs are recommended to prevent further deterioration.

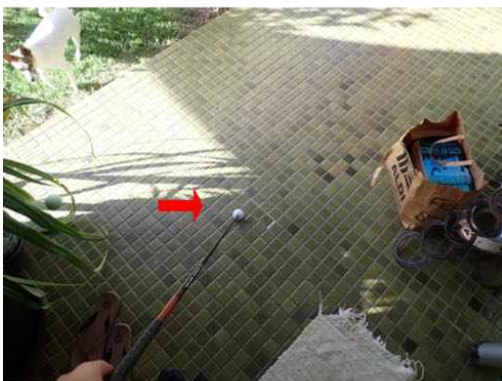
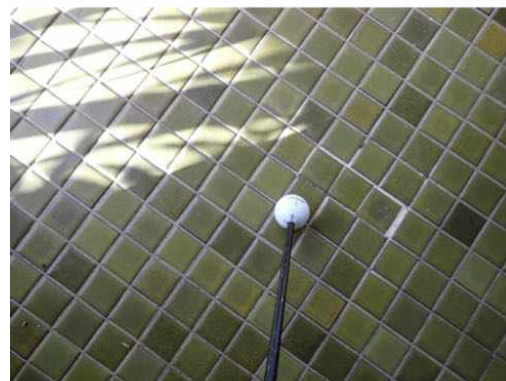
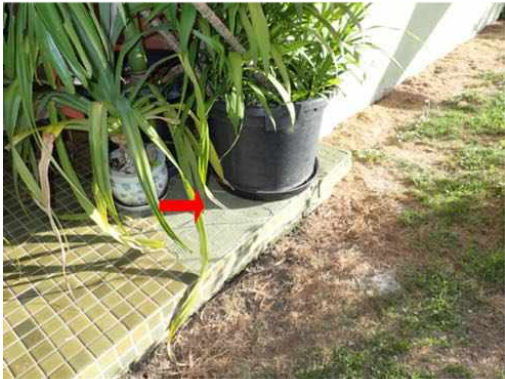
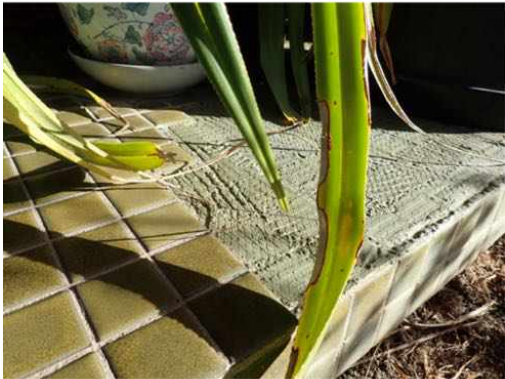
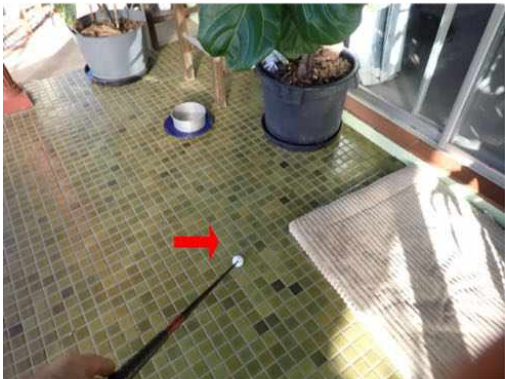
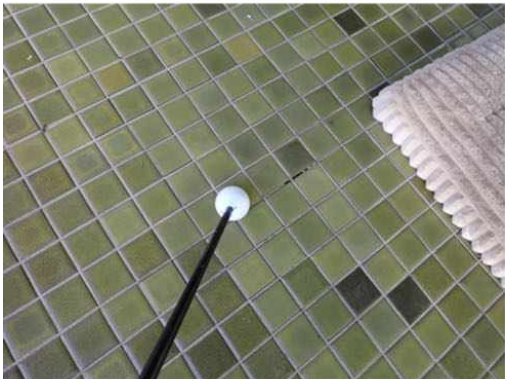
Finding 3.03

Information: Missing and drummy tiles were identified to the front porch area. This defect is consistent with tile failure and may be related to age, movement of the substrate, poor adhesion, or previous poor installation and, is a common defect with a home of this age. Left unattended, the affected tiles may continue to loosen and deteriorate further. Repairs should be carried out by a licensed tiler or suitably experienced handyman, with further assessment of the underlying substrate if required. Repairs should be undertaken at the owner's discretion.

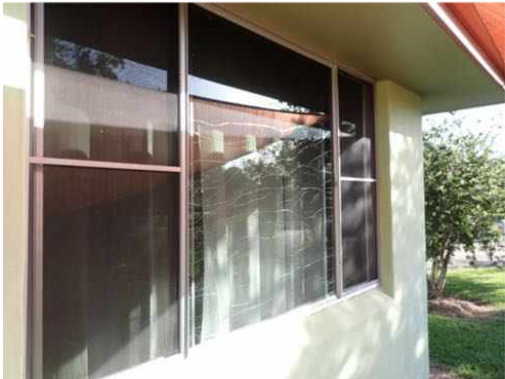
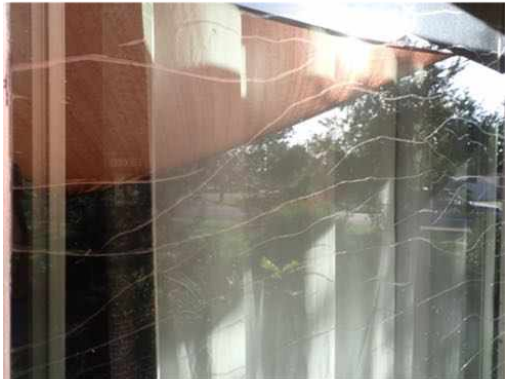
Finding 3.04

Building: Main Building
 Location: External windows
 Finding: Damaged Window Tint To External Windows
 Information: Tint to the external windows was found to be damaged. This is typically caused by age-related deterioration, UV exposure, or poor installation, and may reduce effectiveness for glare, heat control, and privacy. Repairs or replacement should be carried out by a suitably qualified window tinting specialist. Works may be undertaken at the owner’s discretion.

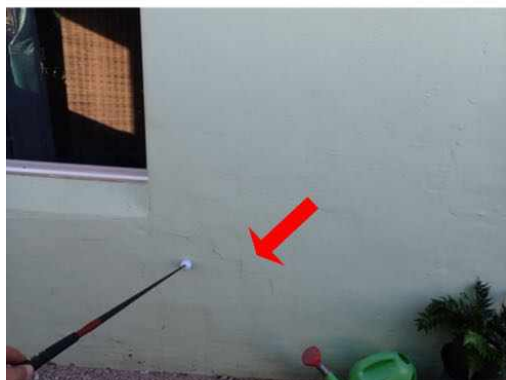
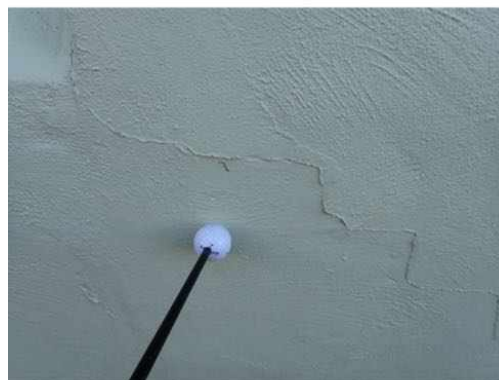
Finding 3.05

Building:	Main Building
Location:	Rear wall
Finding:	Minor Crack To Rear Brick Wall Render
Information:	A minor crack was identified to the render on the rear brick wall. This is typically associated with age-related movement, minor settlement, or shrinkage of the render. While generally cosmetic, ongoing movement or moisture ingress may lead to further deterioration over time. Repairs should be carried out by a licensed renderer or suitably experienced handyman. Works may be undertaken at the owner's discretion.

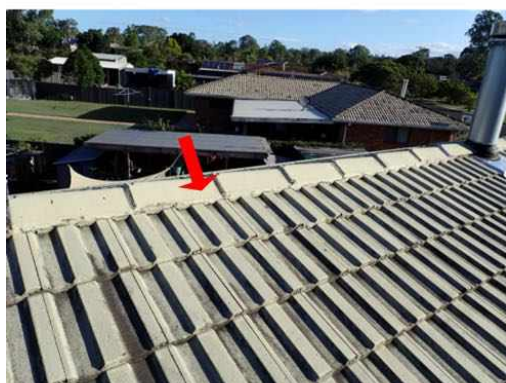
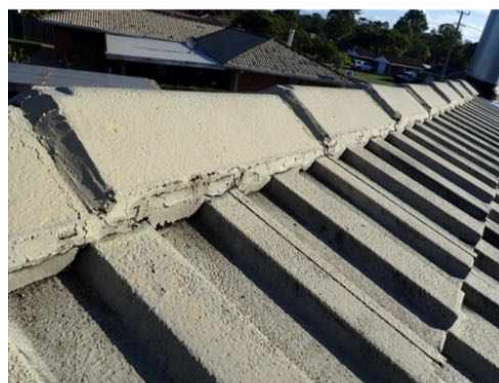
Finding 3.06

Building:	Main Building
Location:	Roof
Finding:	Roof Tiles In Fair Condition With Minor Ridge Capping Cracks
Information:	The roof tiles were in fair condition overall, however minor cracking was identified to the ridge capping. This is a common defect typically associated with age-related deterioration and thermal movement. While generally not of immediate concern, deterioration of ridge capping may lead to water ingress over time if left unaddressed. Repairs should be carried out by a licensed roofing contractor. Works may be undertaken at the owner's discretion.
