Building and Timber Pest Inspection Report

Inspection Date: Wed, 4 Mar 2026

Property Address: 3B George St, Windsor VIC 3181, Australia

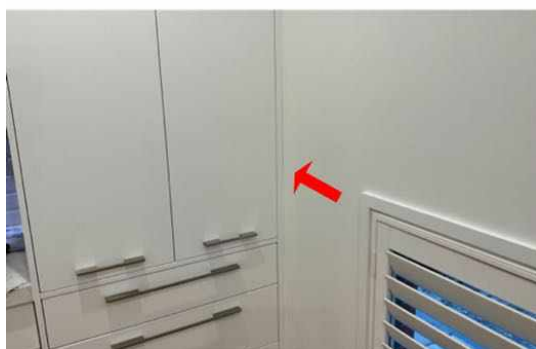
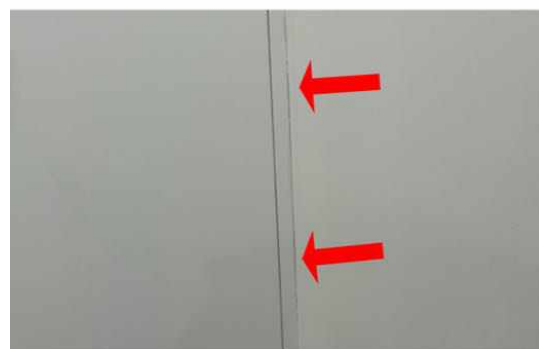
Finding: Cracking - fine

Information: Some fine cracking was noted throughout the property.

Although fine cracks are quite noticeable, they are often only considered to be an appearance defect, and usually do not indicate any structural damage. Generally, the cause of a fine crack is indicative of a separation between building materials and finishes (e.g. paint, plaster, etc.) along joins.

Cracking of this nature can generally be repaired with minor sanding, filling and/or repainting. Such works should be performed by a qualified painter or a general handyman.

Monitoring of all cracking should be conducted frequently. Always contact a building inspector should cracks widen, lengthen, or become more numerous.

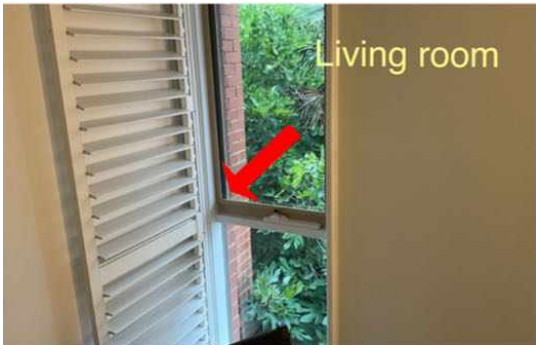
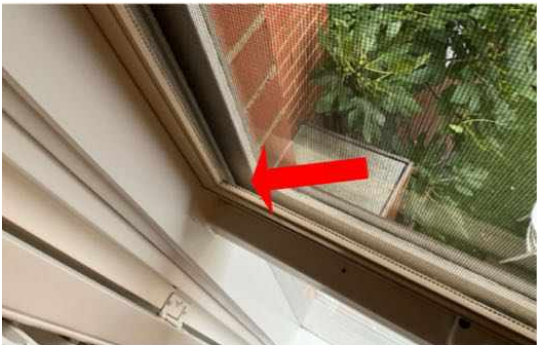
Finding 3.02

Restricted function of the window may also create potential for secondary defects to the associated building elements, such as damage to the window frames as well as a potential safety hazard if required for emergency egress from the building.

The most usual causes are swelling of timbers due to moisture, bulging or bowing of frames, or general material degeneration. Lack of maintenance can also contribute to the windows sticking.

Easement may be required, which may involve some sanding and repainting. It will almost always include ensuring the areas are cleaned and free of any debris that may be detrimental to their operational state

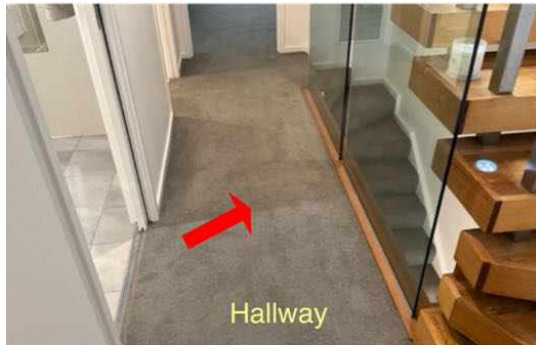
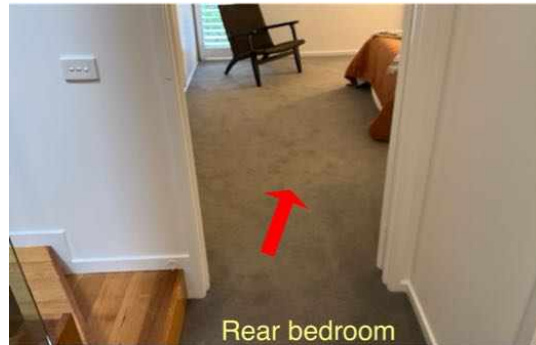
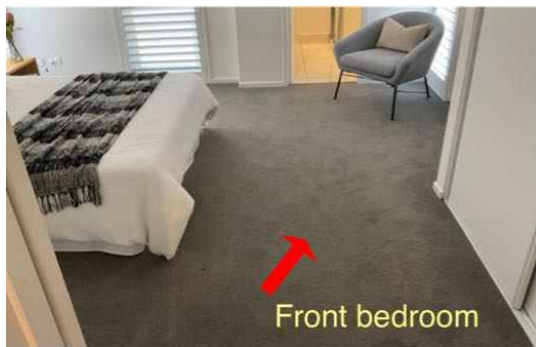
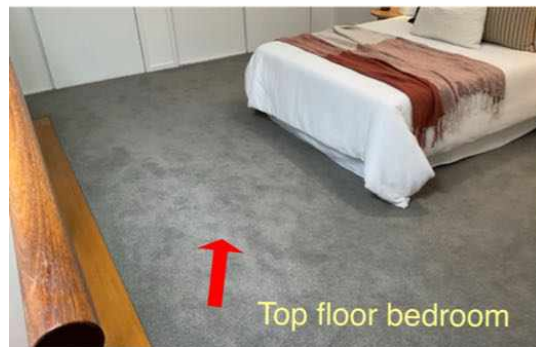
Creaking floors generally indicate slight movement of the flooring which may be due to the fixings coming loose slightly or in the case of floating floors, how they have been laid or the quality of the flooring and is a very common defect.

The area should be monitored for any changes or movement. Should this occur, consultation with a flooring specialist should be undertaken to determine the cause. The potential resolution may involve lifting and relaying the flooring through to full replacement of the flooring.

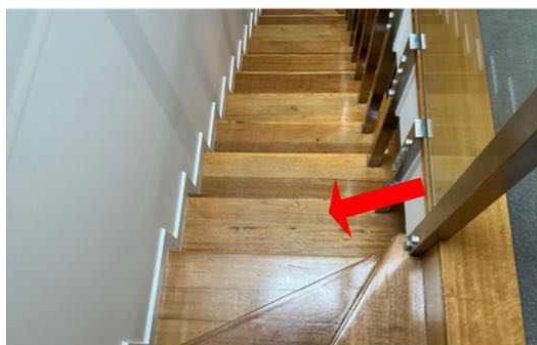
Finding 3.06

Creaking flooring generally indicate that the treads are coming loose slightly from the supporting structures that they are installed on as opposed to any structural issues.

Should the client wish to address this, they should seek quotations for required repairs from a qualified carpenter or Registered Builder .

The potential resolution may involve regluing and screwing the floor down through to replacement of flooring.

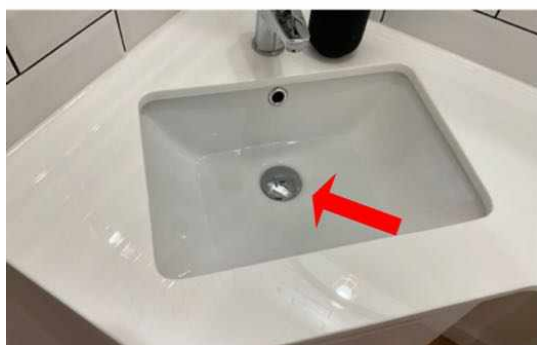
Finding 3.07

Information: At the time of inspection, it was noted that the vanity sink in the powder room drained slowly when filled. This could be due to a number of factors but is generally due to a partial blockage in the pipes from hair or other materials.

Should the slow draining become an issue, a plumber can be engaged to open the pipes and inspect and repair where necessary.

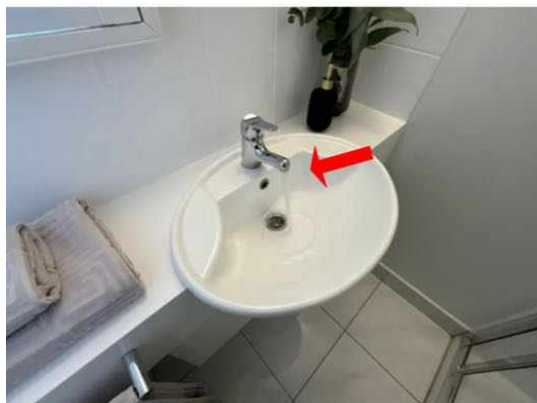
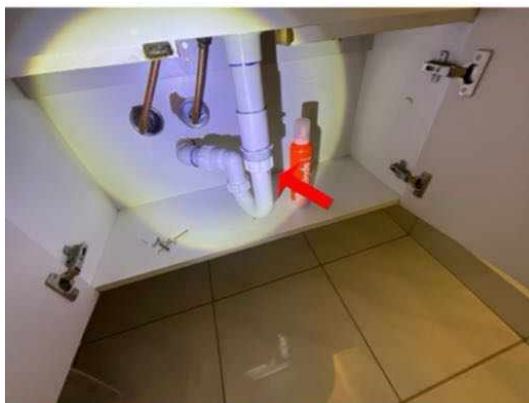
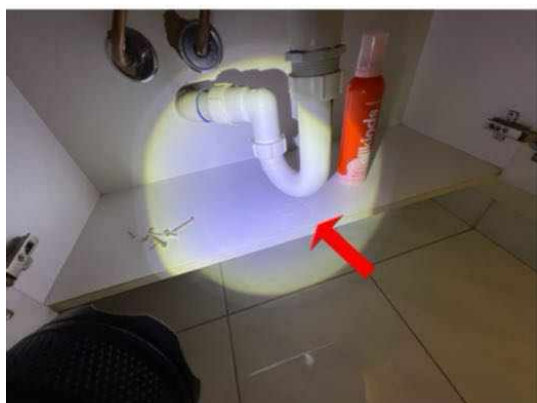
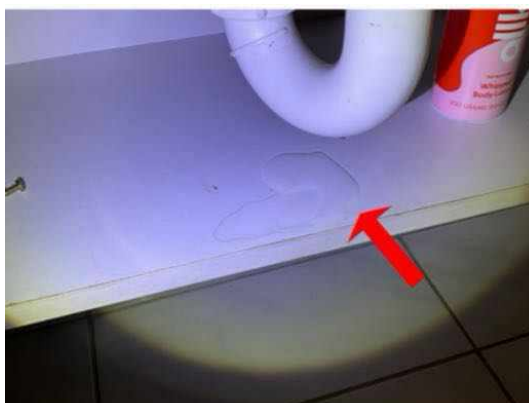
Finding 3.08

Finding: Bathroom vanity pipes - Leaking

Information: The pipe underneath the bathroom vanity sink was found to be leaking at the time of inspection. This is a common defect that is consistent with general ageing of the building element. However, it may also be indicative of substandard plumbing workmanship.

While this defect only seems minor, if left unmanaged, it is likely to result in the

development of water damage.

A leak was noted to the pipes within the ensuite bathroom vanity. It is suspected this is just a damaged seal within the pipes and it suspected to be a relatively simple fix.

It is advised that a licensed plumber be appointed to perform remedial works on the area. Such works should be performed prior to the development of secondary defects to other associated building elements.

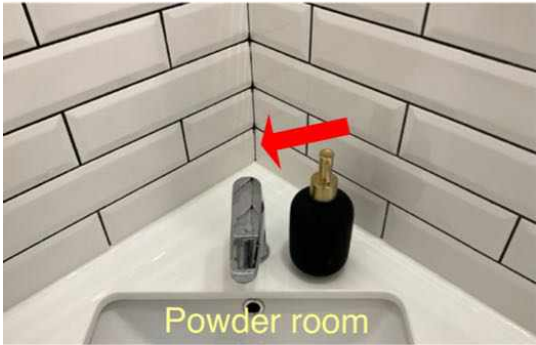
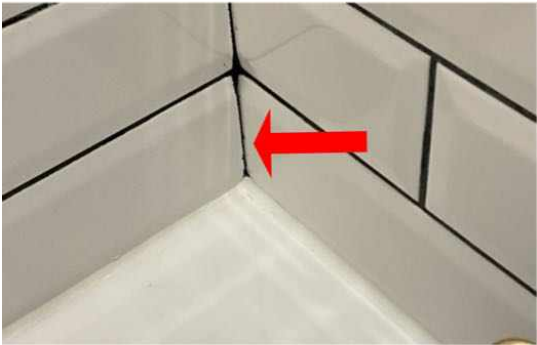
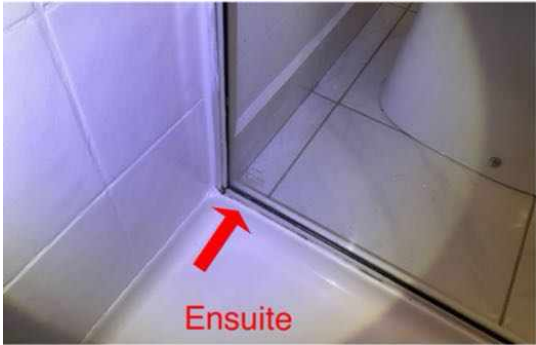
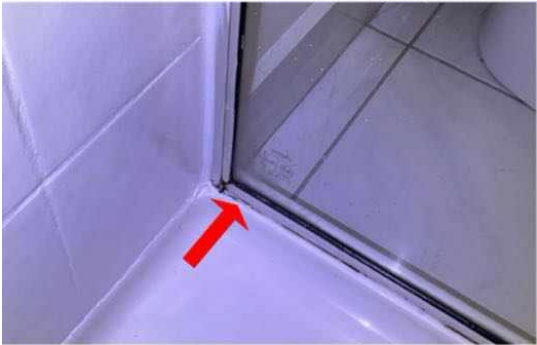
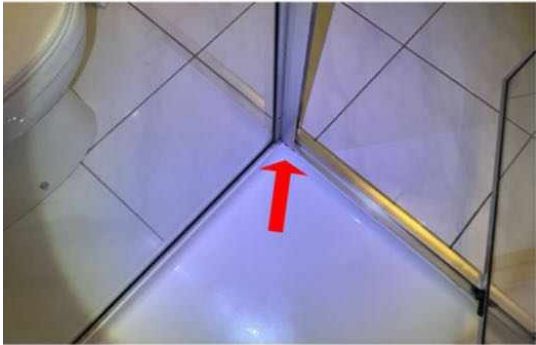
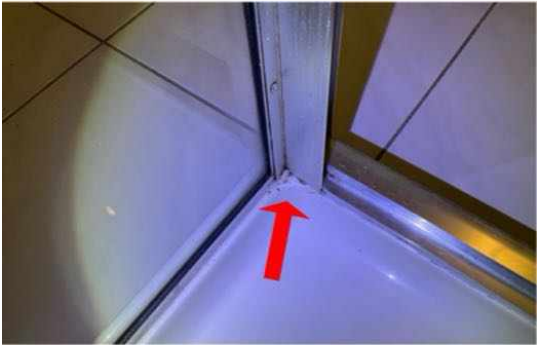
Finding 3.09

Finding: Grout / sealant - Missing or degraded within the bathroom area

Information: It was noted on inspection that grout or sealant is degraded to areas within the wet areas .

Different materials move at different rates, generally causing cracking to grout at this point. Build up of moisture in the bathroom can also cause grout and sealants to degrade and become mouldy.

Any damaged or degraded materials should be scraped out and flexible and mould resistant materials should be applied to affected areas to prevent any subsequent

water damage that may occur. Regular maintenance and replacement of damaged or missing grout/ sealant is highly recommended to the wet areas, as this is a regular wear and tear defect. Both grout and sealant in areas that come into regular contact with water should be maintained for the long term care of your property.

A bathroom specialist or tiling contractor should be appointed to complete these works as soon as possible.

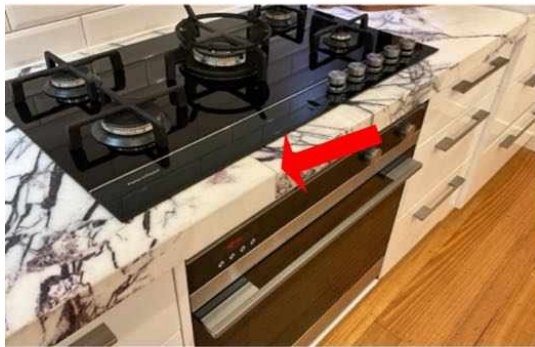
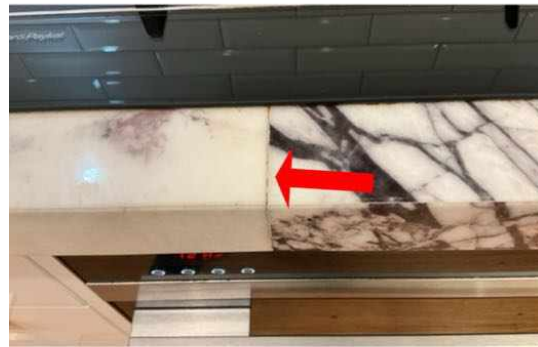
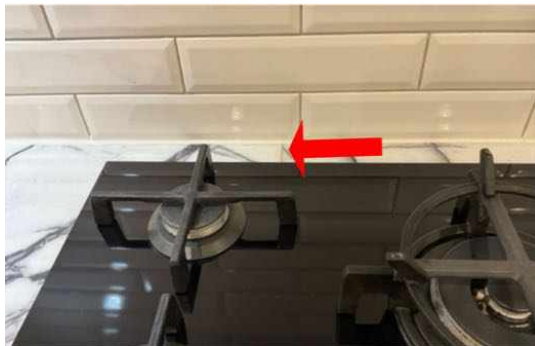
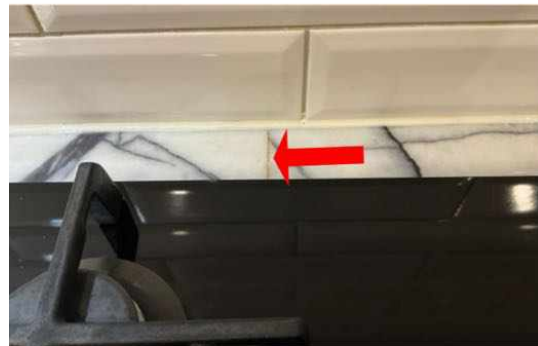
Building:
 Location: Kitchen
 Finding: Join not sealed effectively within the kitchen benchtop
 Information: At the time of inspection, the join within the bench top surface was slightly open and not sealed effectively. This has the potential to allow water ingress into the gap and cause secondary damage to the cabinets underneath.

It is highly recommended that the benchtop be sealed to prevent water ingress.

A competent handyman or kitchen benchtop specialist may be engaged to perform this task.

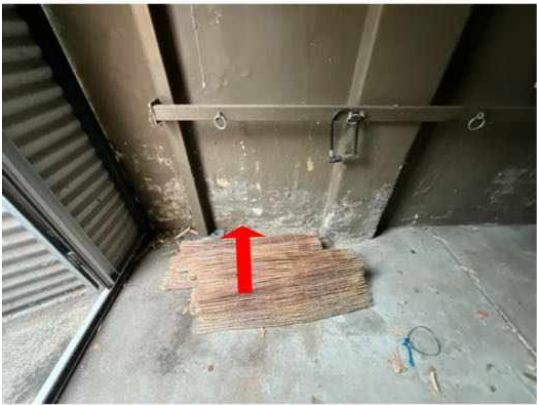
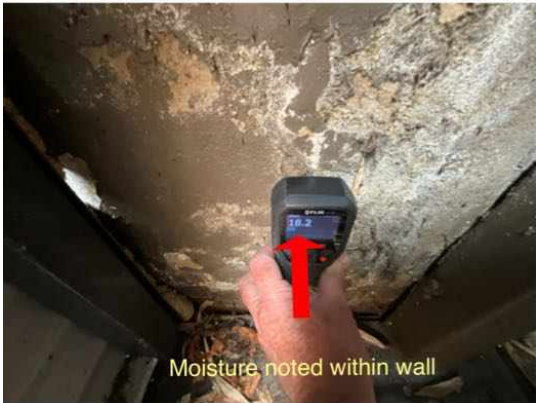
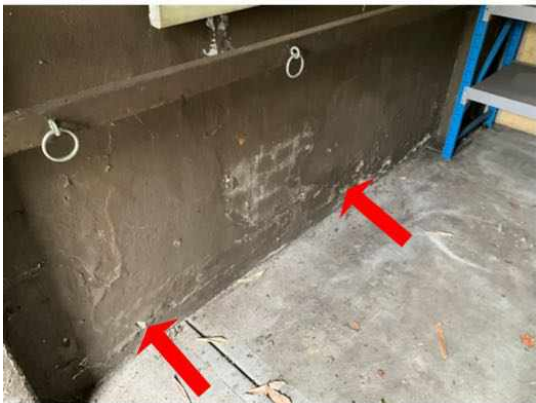
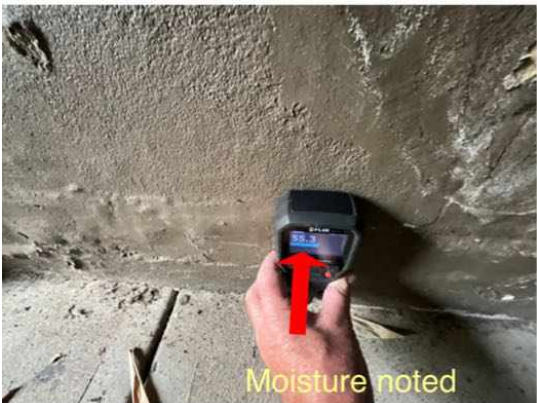
Information: Dampness was identified around the walls of the garage. It is suspected that this dampness may have occurred due to moisture moving laterally through the wall or upwards from the ground. This defect is very common in garage walls as they generally do not have any damp proof course..

Dampness and excessive moisture can create mould and secondary damage to building elements as well as creating an environment which is conducive to termite and pest infestation.

It is recommended where possible that measures be put in place to lessen the amount of moisture within the garage. This may involve painting the wall with a waterproofing membrane.

A builder or plumber specialising in moisture issues may be engaged to inspect the area and make any necessary changes.

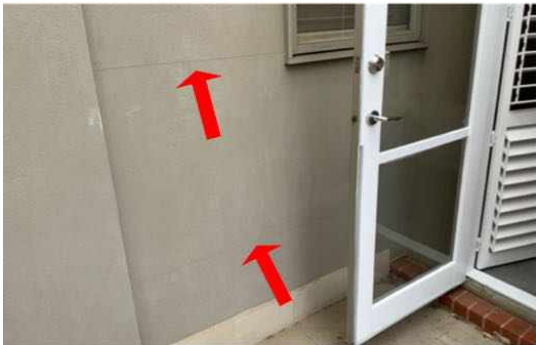
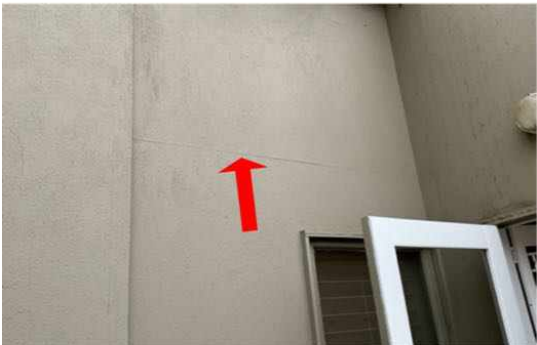
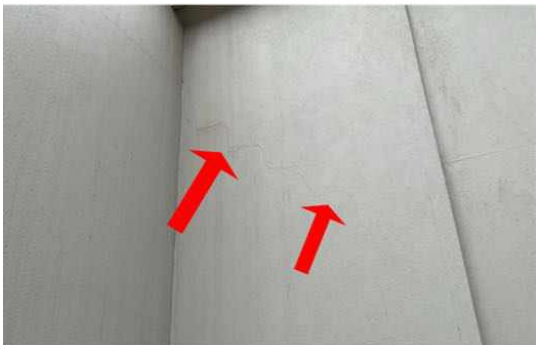
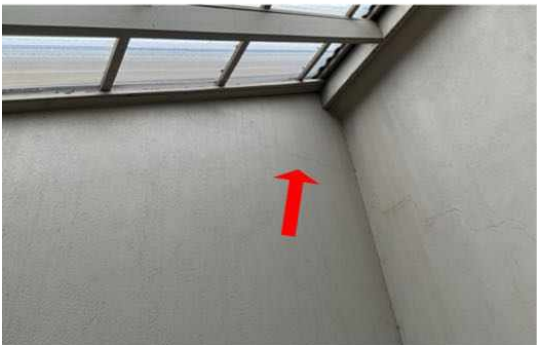
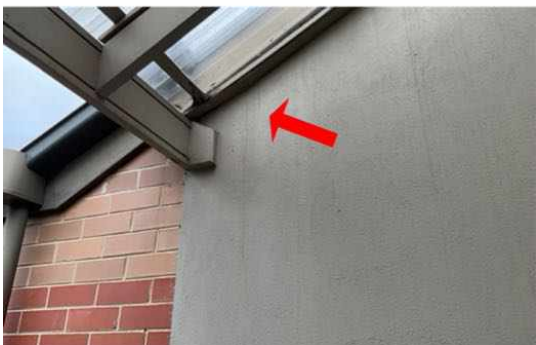
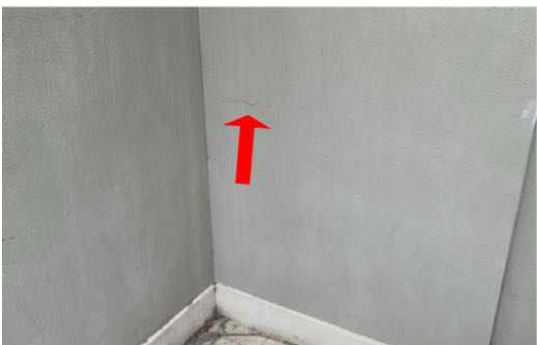
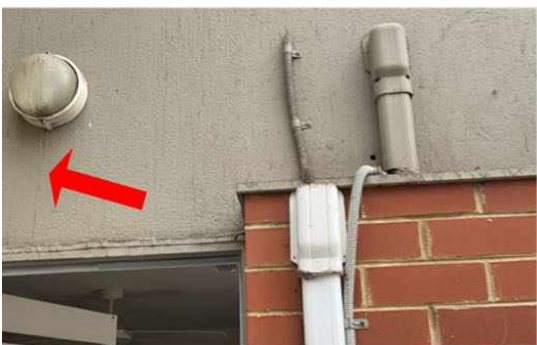
Finding: Rendered wall - minor cracking

Information: Minor cracking to the rendered wall was identified at the time of inspection. It is suspected the cracking has occurred in the joints between various cement sheets on the wall.

This type of cracking is often consistent with general movement of the foundations of the property and is not considered a major structural defect.

Whilst it is more of an appearance issue, repairs may be required as failure to act may allow moisture to enter the crack and cause secondary damage to other building elements.

Consultation with a suitably qualified renderer should be sought to determine costs involved with any repairs necessary.

Should cracks increase in size or number, speak with your building inspector for further advice.

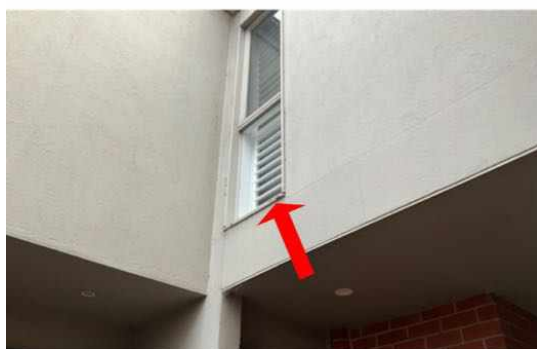
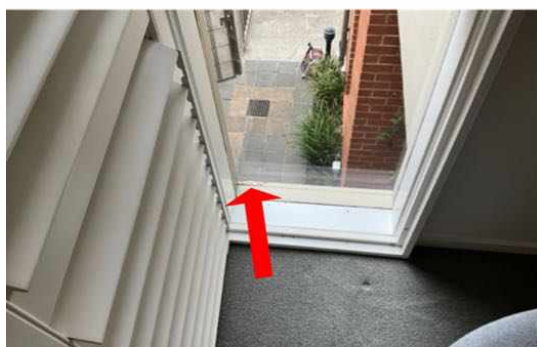
Finding 3.16

Building:
 Location: Exterior walls - left side
 Finding: Window - Wood rot
 Information: Wood rot was found to be affecting this external window. Wood rot, also known as Fungal Decay, occurs when timbers and other cellulose building materials are exposed to damp conditions on an ongoing basis.

It is likely that this wood rot has developed as a result of frequent exposure to rain and other weather conditions. It is suspected that failure to maintain the window frame over a prolonged period has resulted in it deteriorating at an accelerated rate, increasing its susceptibility to the development of wood rot.

Repair of the affected window frame will be necessary to prevent further deterioration.

Remedial works should be performed by a qualified carpenter or registered builder as soon as possible.

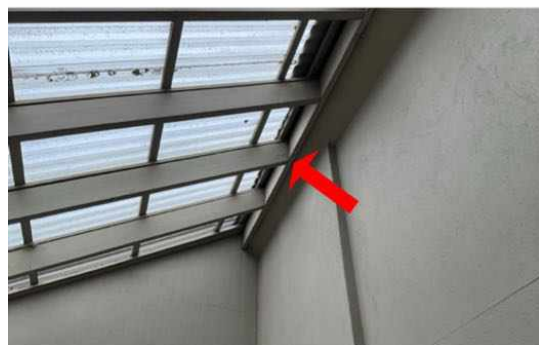
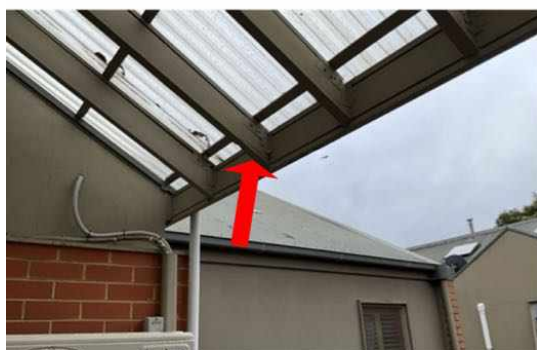
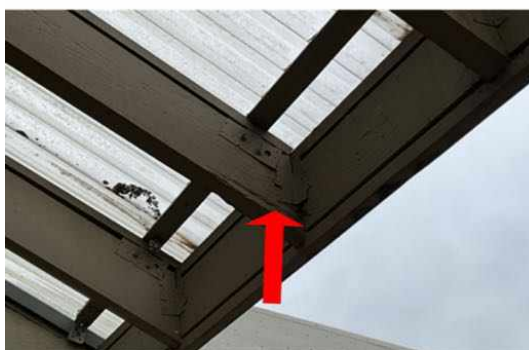
Finding 3.17

Building:
 Location: Exterior walls - left side

Finding: Wood rot to framing timbers of the balcony covered area
Information: The timber framing of the covered area above the balcony shows evidence of wood rot. It is suspected that constant exposure to moisture may have caused the wood rot in the area.

Wood rot, also known as Fungal Decay, occurs when timbers and other cellulose building materials are exposed to damp conditions on an ongoing basis. This could be the result of exposure to weathering over a prolonged period of time, or the attraction of excessive moisture from other abutting building materials.

Early intervention and regular maintenance, particularly of exterior timbers, will prolong the useful life of these building elements. Prior to any works being performed, the cause of the moisture that has created the visible wood rot should be identified and addressed in a suitable manner. Repair or replacement of affected timbers may then be a necessary step in protecting surrounding building elements from such deterioration.

A qualified plumber may be appointed to assess the cause of excessive moisture and to provide advice on any remedial works as required. A qualified carpenter or registered builder may be engaged to replace affected building materials where necessary.

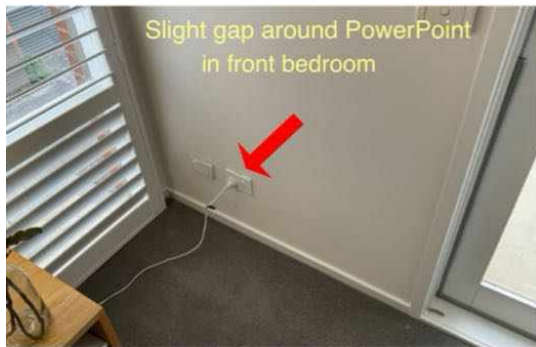
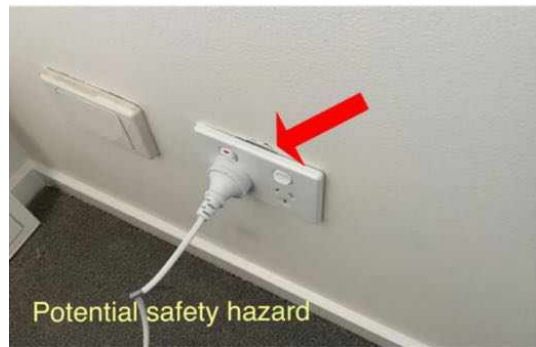
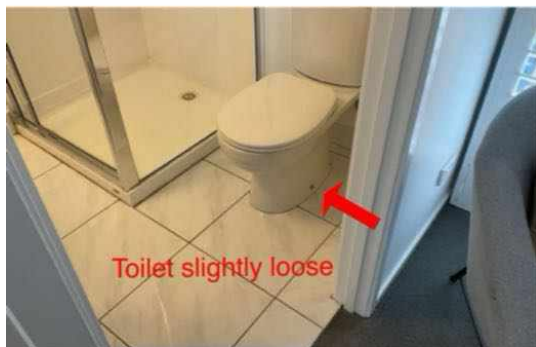
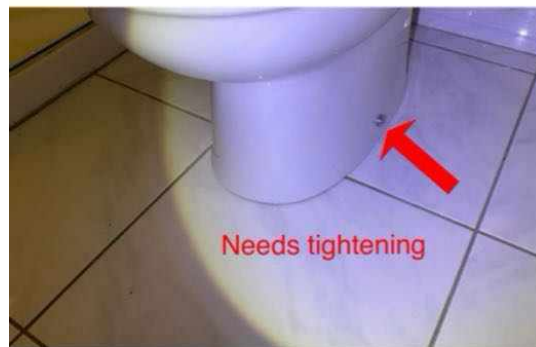
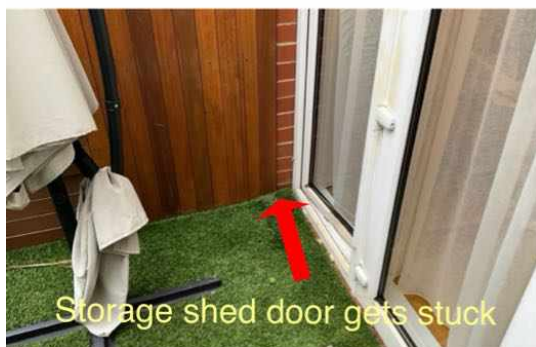
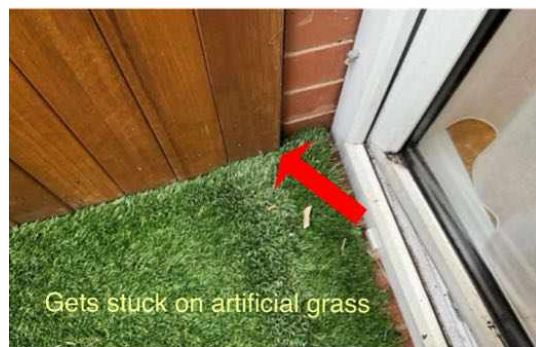
Building:
Location: All Areas
Finding: Additional Photos - minor defects
Information: Additional photos are provided for your general reference. Arrows have been included where necessary to highlight areas of importance.

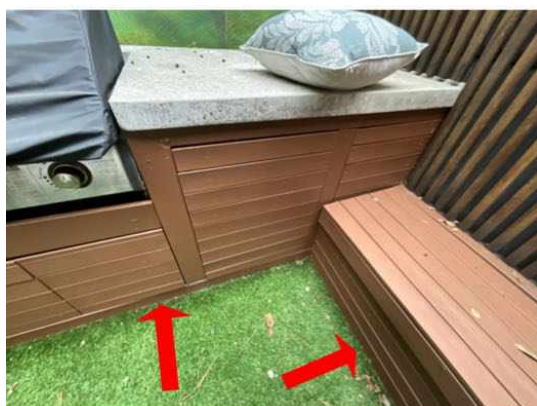
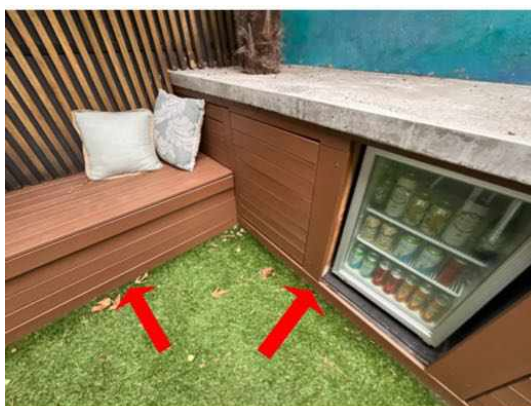
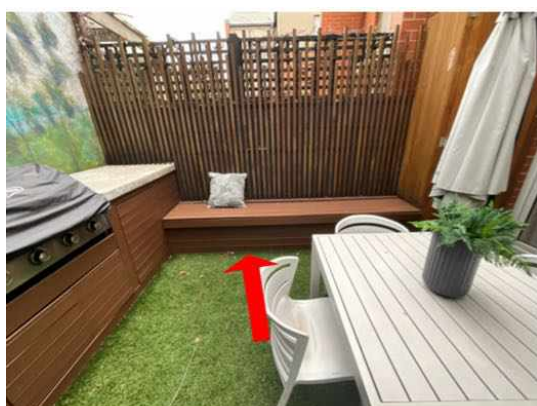
Building:
Location: All External Areas
Finding: Building materials in direct ground contact - conducive to termites
Information: Where timber elements are in direct contact with the ground and consequently moisture or dampness, they become conducive to termite activity. Whether timber is used as a building element, part of a fencing structure or stored as an unused item, they can provide an environment that is attractive to termite infestation.

When met with excessive moisture, timber begins to decay and develop wood rot. Any timbers that are in direct contact with external grounds especially if left untreated or non-durable also provide ingress for subterranean termites into that particular element.

Where possible, the removal of any such materials that may be conducive to termite activity should be carried out as soon as possible to minimise the risk of termite attack. Where not possible or practical, regular monitoring of timber elements is recommended. Replacement of any damaged materials should be carried out where necessary.

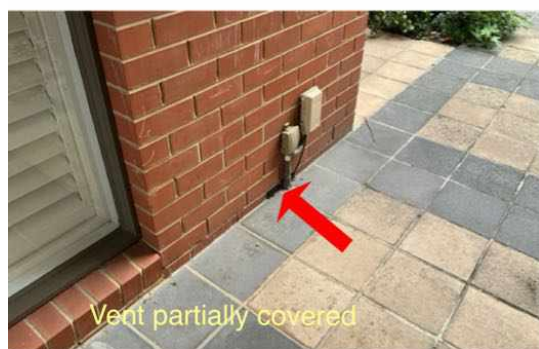
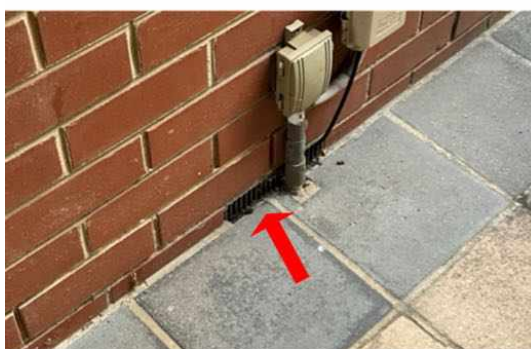
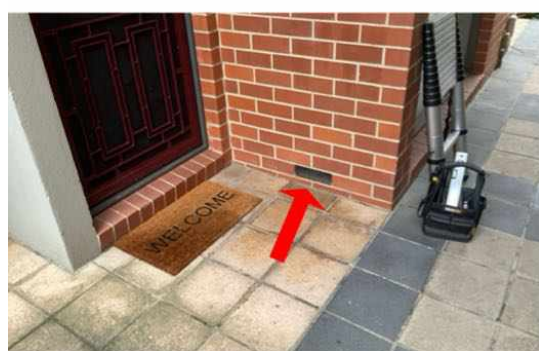
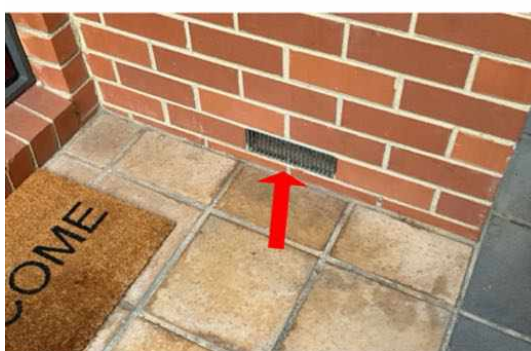
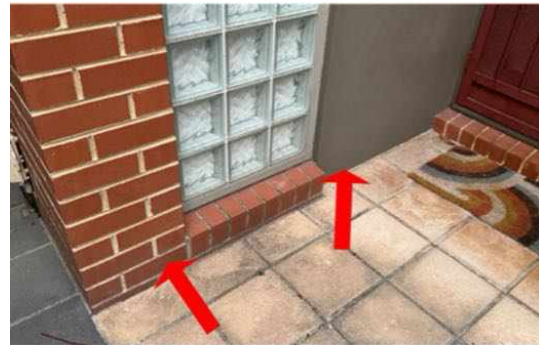
Finding 6.02

Building:
Location: Subfloor

Finding: Subfloor - suspected lack of cross flow ventilation in semi detached properties
Information: It was noted at the time of inspection that the subfloor area may lack adequate cross flow ventilation. Ventilation can be restricted by a variety of minor defects, including obstructions in the subfloor space, a lack of vents or a low clearance. Semi detached properties also may not have adequate cross flow ventilation due to lack of vents on all sides of the property (as noted in this instance).

A well ventilated subfloor aids in maintaining dry conditions, preventing secondary damage such as wood rot and pest activity, as well as preventing the development of mould and mildew (which can lead to respiratory safety hazards for occupants).

The initial step in improving ventilation is to ensure that all existing vents are clear of blockages. Should issues with lack of ventilation occur, additional vents may be installed. The client may also consider mechanical ventilation (powered fans) to improve subfloor airflow where relevant.

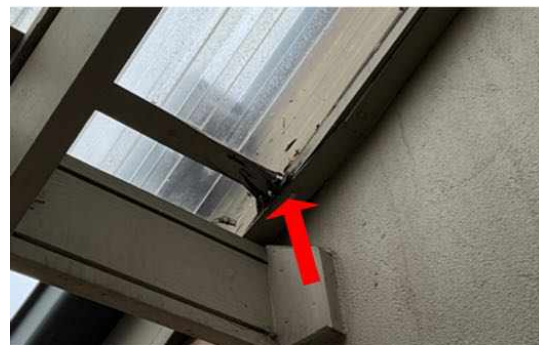
Finding 7.01

Finding: Fungal decay - conditions conducive to timber pest attack

Information: Fungal decay also known as wood decay or wood rot generally refers to the deterioration of timber elements when in contact with excessive levels of moisture for a prolonged period of time.

Generally fungal decay develops on timber elements that are in use in an external environment which are exposed to rain penetration.

Decaying timbers can create an environment conducive to timber pest attack. It is recommended that the decaying timbers be repaired / replaced to lessen the risk of timber pests.

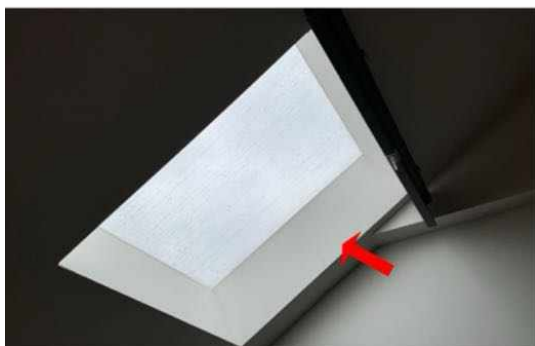
The ceilings around the skylights should be regularly monitored for any evidence of moisture leaking eg staining or bubbling of paint.

Where moisture damage becomes evident, a plumber should be appointed as soon as possible to identify the leak and perform rectification works as necessary, ensuring the moisture damage is restricted.

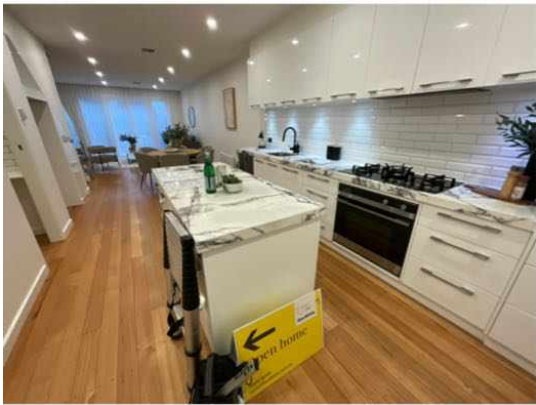
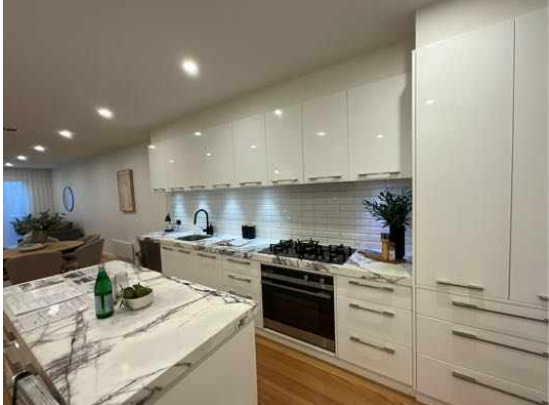
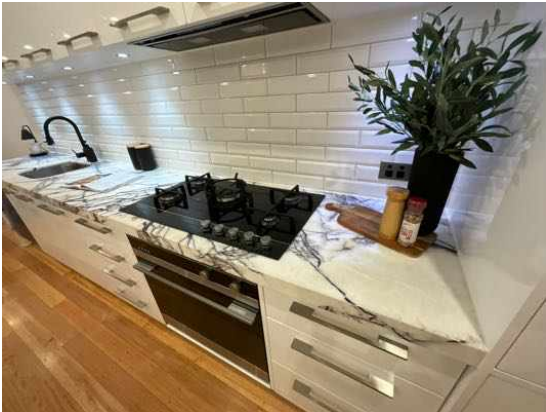
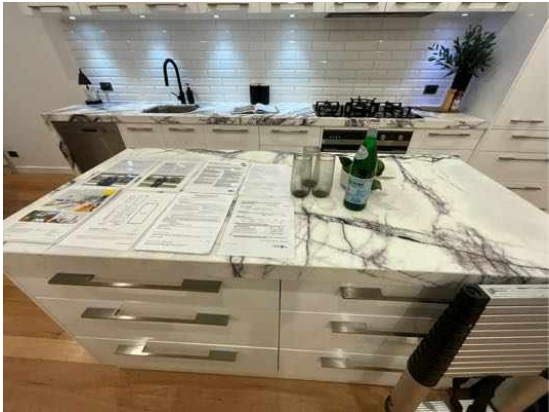
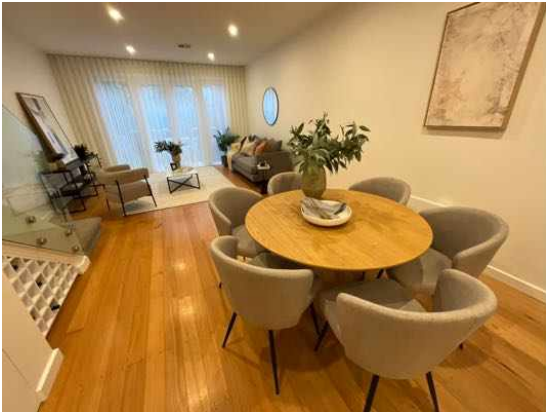
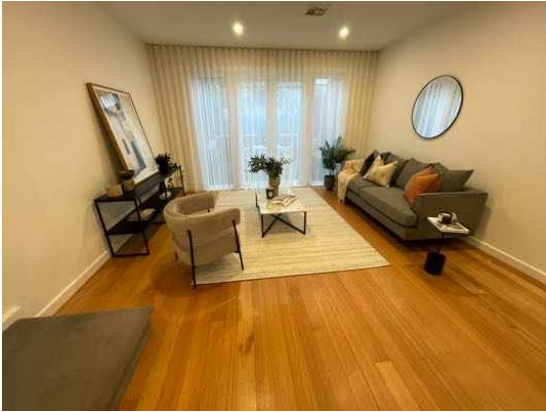
Building:
Location: All Areas
Finding: Additional Photos - Obstructions and Limitations
Information: These photographs are an indication of the obstructions and limitations which impeded full inspection of the property at the time of inspection. These obstructions can hide an array of defects and should be removed to allow full inspection to be carried out. A re-inspection is recommended once the areas are made accessible.
