# Building and Timber Pest Inspection Report VR

Inspection Date: Fri, 20 Feb 2026

Property Address: 4 Mason St, Thirroul NSW 2515, Australia

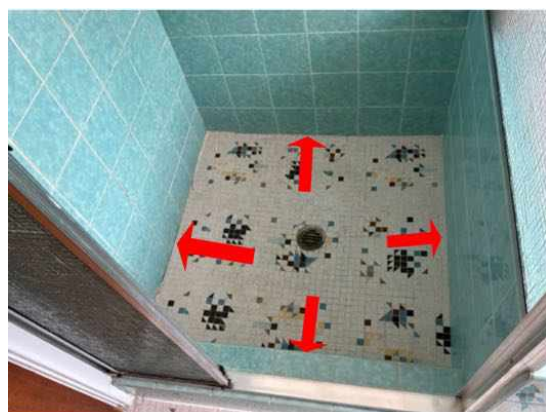
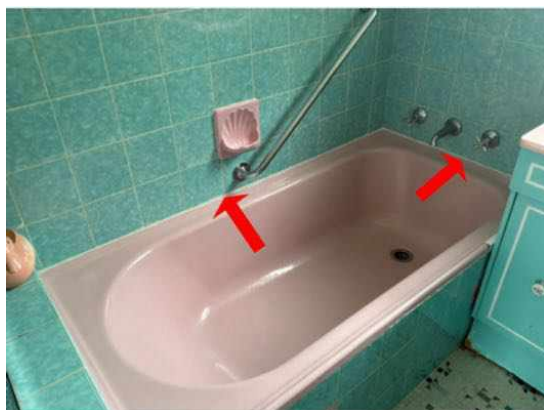
Building: Main Building  
Location: All Wet Areas  
Finding: Sealant and grouting - Missing or damaged  
Information: It was noted on inspection that sealant or grout is degraded to the tiled shower alcove and or other areas of the bathroom.

Different materials and floor areas move at different rates, generally causing cracking to grout or sealant at this point. A flexible sealant is required to allow for expected expansion and contraction, while keeping the joint water tight and protective of all associated building materials.

There appears to be excessive mould to the sealant and grout which will likely require scraping out and replacement.

Flexible and mould resistant materials should be applied to affected areas to prevent any subsequent water damage that is likely to occur. Regular maintenance and replacement of damage or missing or damaged sealant and grout is highly recommended to the wet areas, as this is a regular wear and tear defect. Sealant and grouting in areas that come into regular contact with water should be maintained for the long term care of your property.

A sealant specialist or tiling contractor should be appointed to complete these works as soon as possible

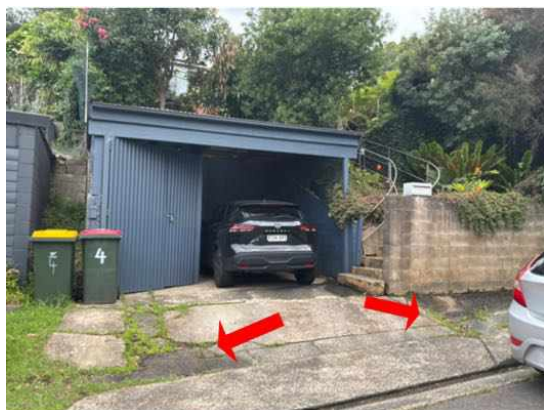
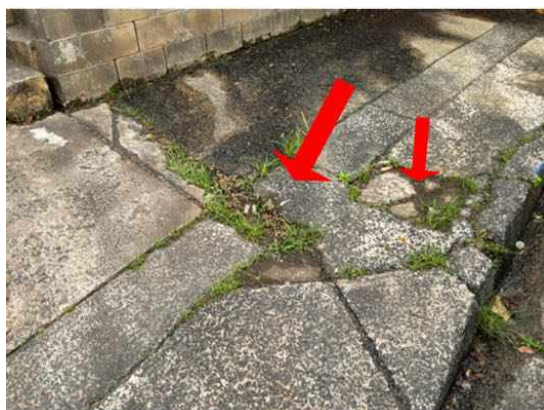
## Finding 2.02

Building:	Main Building
Location:	Driveway
Finding:	Cracking - External Concrete Paving Damage Category 4 - Gaps in Slab (4mm - 10mm +)
Information:	Gaps in the slab were identified in external concrete paving. Gaps in the slab are significant and are likely to lead to the development of safety hazards and secondary defects if left unmanaged, such as the creation of a trip hazard.

General age and expected deterioration of the paved areas is a common cause of this type of cracking. However, expansion and contraction of the slab may also have occurred due to environmental factors. Such factors include variable moisture and weather conditions, the presence of trees and their roots having a settling or lifting affect on the soil, or the effect of load bearing, e.g. heavy vehicles over a sustained period of time.

Cracking to this degree may also be due to poor original installation of the concrete. Factors such as poor compaction of the sub surface and/or inadequate reinforcing of the slab may create cracking and other secondary defects. Gaps in the concrete paving may also have a more significant structural cause, such as subsidence of soils.

Where gaps in the concrete paving are adjacent to structural elements of the building, the advice of a Structural Engineer is advisable before undertaking repairs. Significant repair and likely replacement of the concrete paving is probable.

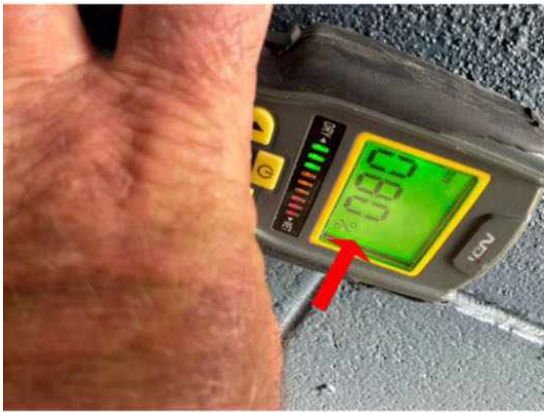
### Finding 2.03

Building:	Carport
Location:	Yard - Front
Finding:	Evidence of excessive moisture was present at the time of inspection
Information:	Excessive moisture can attract termites and produce conditions that promote termite attack, fungal growth and wood decay. Excessive moisture is generally caused by deteriorated, inadequate or missing roof drainage, leaking plumbing pipes or fixtures, poorly plumbed HWS overflows or condenser units and poor site drainage. In the case of excessive moisture being present around wet areas it is highly likely that the waterproofing membrane to these areas is or has failed and allowing water to escape the confines of these areas.

It is highly recommended that all plumbing and drainage fixtures and fittings be maintained regularly in order to prevent excessive moisture being present in the external / internal property.

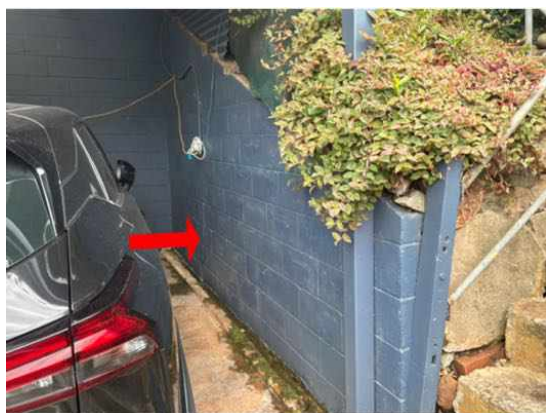
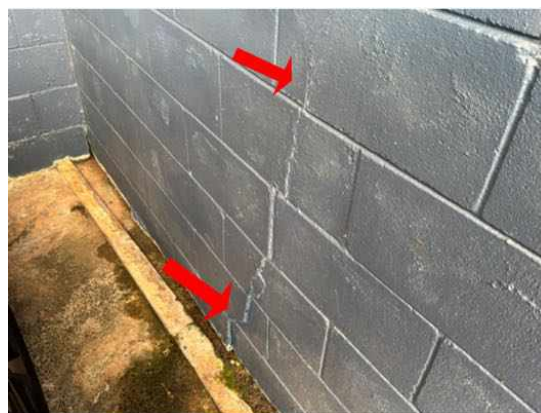
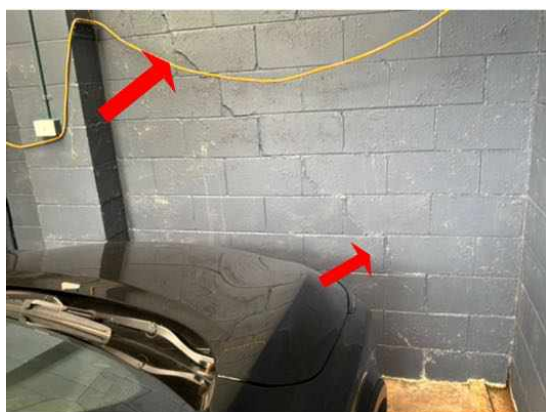
**Finding 2.04**

Finding: Blockwork - Step cracking

Information: Step cracking was identified to the blockwork in this area at the time of inspection. Step cracking, which is similar to other forms of cracking, has a variety of possible causes. However, the most common is the subsidence of adjacent footings.

Step cracking is a relatively common defect, and is most likely to occur adjacent to windows, doors and other openings. Mortar failure in the gaps between affected bricks indicates the stresses and tensions affecting the wall.

Where step cracking is extensive or severe, the client is advised to consult a structural engineer. Minor step cracking can be used as a warning sign to address factors causing stress to the wall, which can include the effect of surrounding trees, water leaks, soil erosion, or even the presence of reactive soils in the surrounding area.

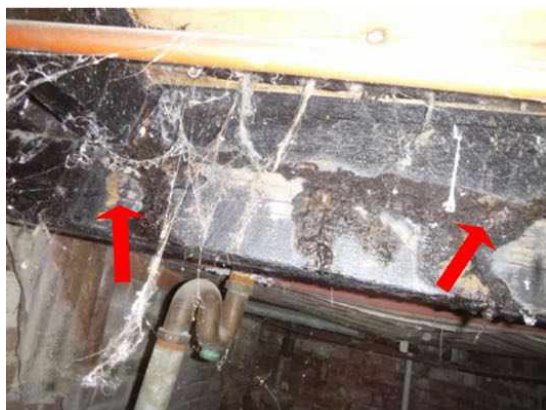
Building: Main Building  
Location: Subfloor  
Finding: Water Leak Detected to Subfloor Below Bathroom/Shower Area  
Information:

At the time of inspection of the subfloor area, evidence of active water leakage was observed beneath the bathroom shower area. Moisture was present to the subfloor framing and surrounding areas, indicating that water is escaping from the bathroom and entering the subfloor space.

This condition may indicate failure of the shower waterproofing system, leaking plumbing components, or defective seals and does not comply with the performance requirements of the National Construction Code (NCC) and AS 3740 – Waterproofing of Domestic Wet Areas, which require wet area installations to prevent the penetration of water into concealed building elements.

Continued water leakage may result in deterioration of structural timber framing, increased risk of timber rot, mould growth, and potential termite attraction due to elevated moisture levels. If left unrectified, this condition may lead to structural damage and costly repairs.

It is recommended that a suitably qualified and licensed plumber and/or waterproofing specialist carry out further investigation to determine the exact source of the leak. Rectification works should be undertaken as required to eliminate the source of moisture and prevent further water ingress. Any moisture-affected structural elements should also be assessed and repaired or replaced as necessary to ensure compliance with NCC requirements and relevant Australian Standards.

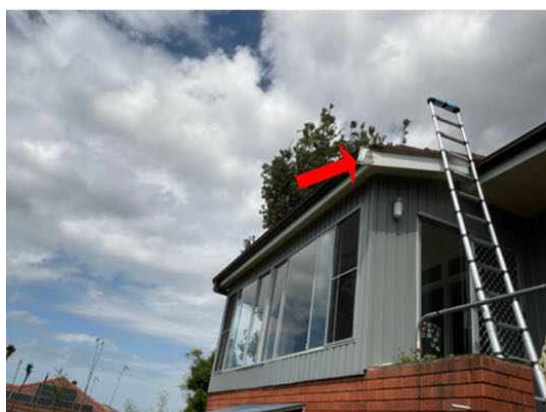
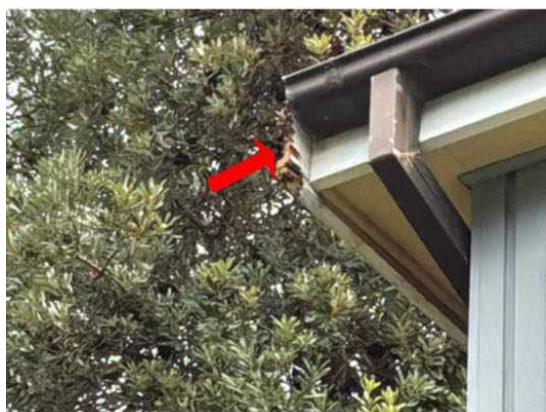
### Finding 3.01

Building:	Main Building
Location:	Exterior walls - front
Finding:	Wood rot
Information:	This building element shows evidence of wood rot. Wood rot, also known as Fungal Decay, occurs when timbers and other cellulose building materials are exposed to damp conditions on an ongoing basis. This could be the result of exposure to weathering over a prolonged period of time, or the attraction of excessive moisture from other abutting building materials. Contributing factors also include poor air ventilation in the area.

Wood rot is often associated with general damp problems and is evidenced by a

'musty' smell or mould and mildew occurring on surfaces. If left unmanaged, damp conditions can lead to further health problems and the decay of timbers will continue.

Early intervention and regular maintenance, particularly of exterior timbers, will prolong the useful life of these building elements. Prior to any works being performed, the cause of the moisture that has created the visible wood rot should be identified and addressed in a suitable manner. Replacement of affected timbers may then be a necessary step in protecting surrounding building elements from such deterioration.

A qualified plumber may be appointed to assess the cause of excessive moisture and to provide advice on any remedial works as required. A qualified carpenter or registered builder may also be required to replace affected building materials.

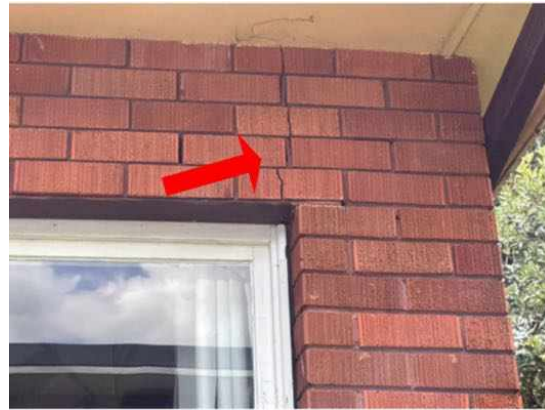
### Finding 3.02

Building:	Main Building
Location:	Exterior walls - rear
Finding:	Brickwork - Cracking noticeable
Information:	There were several cracks and or crack repairs evident to external brickwork.

Noticeable cracks are a common occurrence in external brickwork and are a likely result of age expected building movement, general expansion, and/or contraction of building materials in different weather conditions. Noticeable cracks in brickwork may develop if left unattended, with potential for necessitating major remedial works or

replacement of the brickwork.

It is highly advised that a qualified bricklayer be appointed to provide necessary works to cracked brickwork to prevent any further damage. Such works should be conducted as soon as possible.

Always monitor these cracks and contact a building inspector should cracks widen, lengthen, or become more numerous.

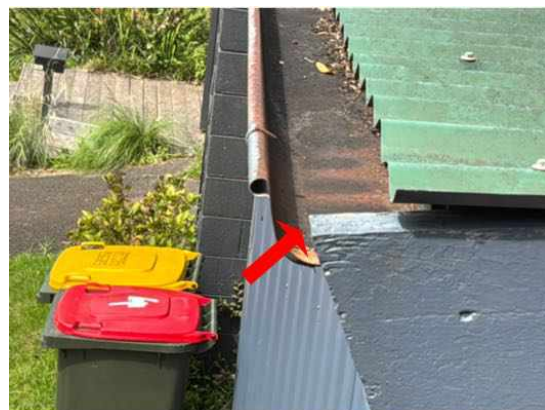
### Finding 3.03

Finding: Gutters Installation incomplete. ( Stop Ends Missing)

Information: It was noted at the time of inspection that the stop ends to the gutter was missing, this allows the water to discharge without being directed into the stormwater drainage system as required.

A licensed Roof Plumber or Builder should be appointed to perform minor rectifications work at the clients discretion.

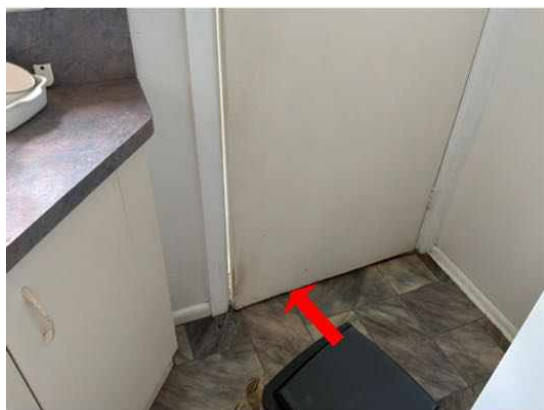
### Finding 3.04

Building:	Main Building
Location:	Kitchen
Finding:	Door - Binding/jamming
Information:	Binding and/or jamming of this door is evident during standard operation. This defect inhibits the functionality of the affected door as well as creating potential for secondary defects to associated building elements, such as damage to the floor covering.

A door that binds to flooring or to the associated door frame may have several causes, ranging from minor defects, such as poor installation of the door or deteriorated hinges, through to major structural issues, such as damage to subfloor structures.

Where door binding/jamming appears to indicate major structural issues, a registered builder should be appointed to provide an estimate on the cost of rectification.

For minor causes, a qualified carpenter or general handyman should be appointed to perform minor rectification works at client discretion.

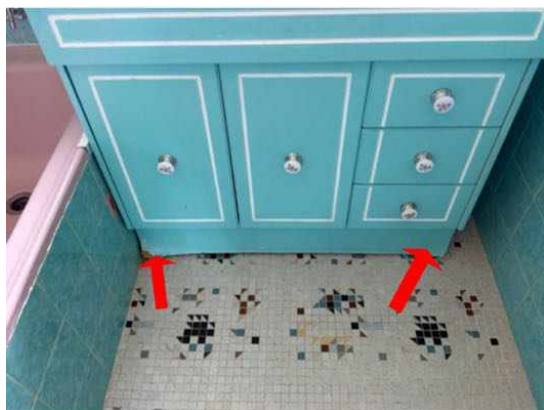
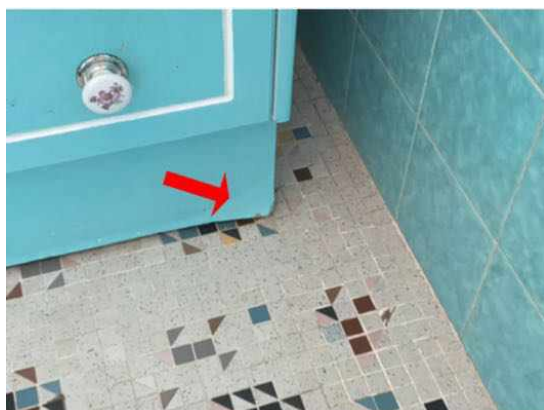
### Finding 3.05

Building:	Main Building
Location:	Bathroom
Finding:	Vanity Cabinet base - Damaged
Information:	Damage occurs generally when the building materials have either aged and decayed, or as a result of damage (accidental or deliberate).

A relevant tradesperson should be appointed to repair or replace the affected building element prior to any subsequent damage being caused.

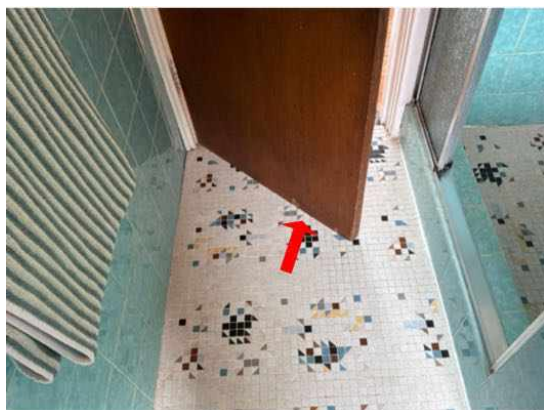
### Finding 3.06

Building:	Main Building
Location:	Bathroom
Finding:	Door - Binding/jamming
Information:	Binding and/or jamming of this door is evident during standard operation. This defect inhibits the functionality of the affected door as well as creating potential for secondary defects to associated building elements, such as damage to the floor covering.

A door that binds to flooring or to the associated door frame may have several causes, ranging from minor defects, such as poor installation of the door or deteriorated hinges, through to major structural issues, such as damage to subfloor structures.

For minor causes, a qualified carpenter or general handyperson should be appointed to perform minor rectification works at client discretion.

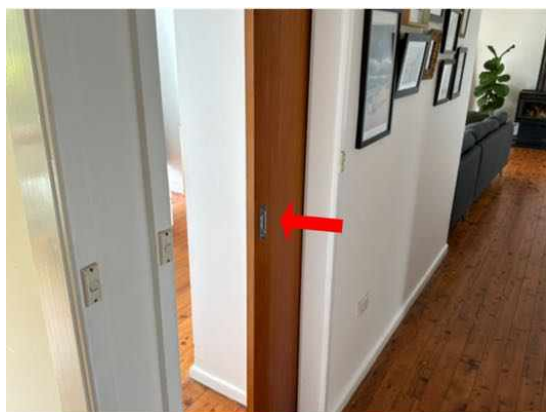
### Finding 3.09

Building:	Main Building
Location:	Bedroom 2
Finding:	Door Binding
Information:	Front door is binding on the door frame at the top right hand side when viewed from internal. Carpenter need to return to ease door from binding and then restrain the

appropriate section to an acceptable finish.

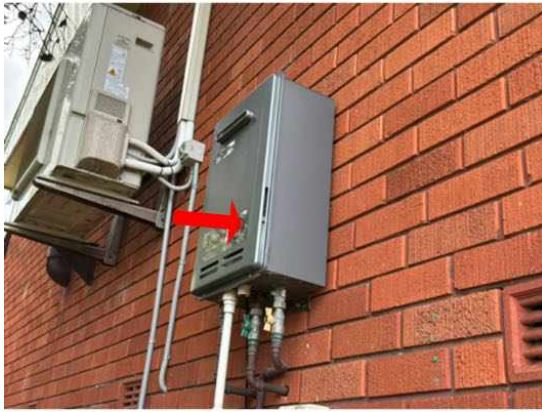
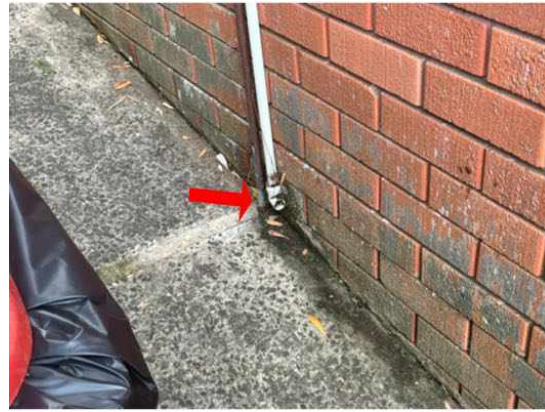
### Finding 6.02

Building:	Main Building
Location:	Exterior wall
Finding:	HWS Overflow - Not Connected
Information:	The Hot Water System (HWS) overflow was found to be disconnected from storm water drainage and is creating excessive moisture in the surrounding area.

It is highly recommended that a licensed plumber be appointed to connect the HWS overflow in order to prevent such an environment from being created. These minor works should be carried out as soon as possible.

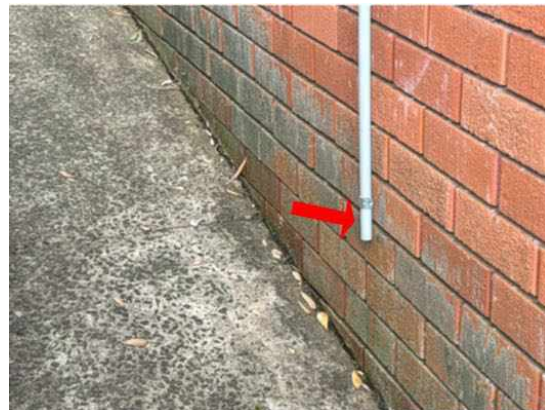
### Finding 6.03

Building:	Main Building
Location:	Exterior wall
Finding:	Air conditioner - Disconnected overflow
Information:	The Air Conditioner (A/C) overflow was found to be disconnected from storm water drainage and is creating excessive moisture in the surrounding area.

It is highly recommended that a licensed plumber be appointed to connect the A/C overflow in order to prevent such an environment from being created. These minor works should be carried out as soon as possible.

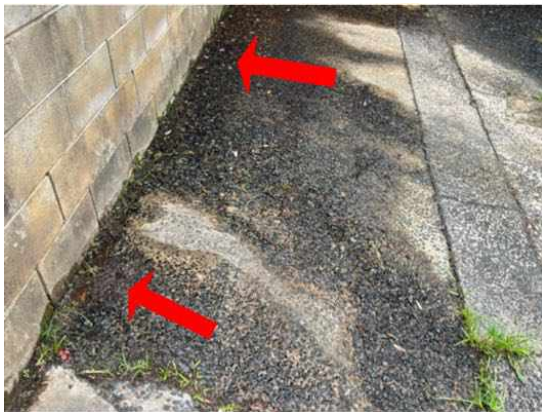
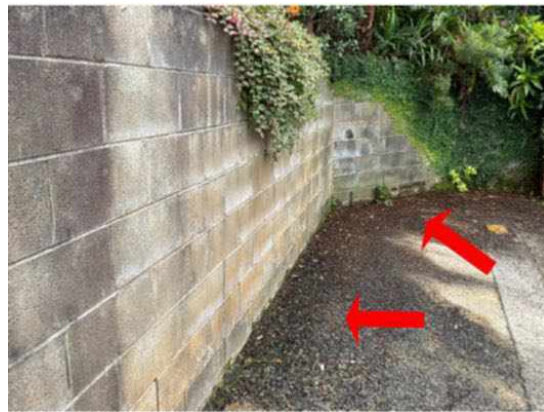
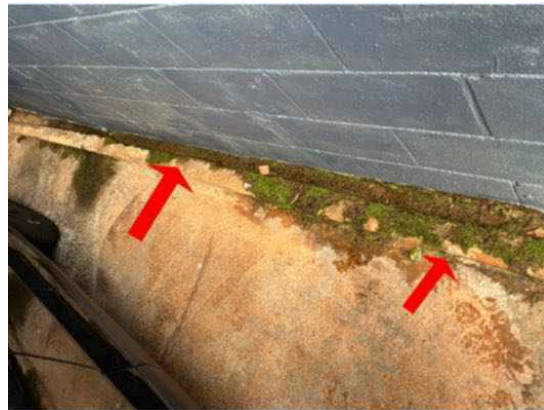
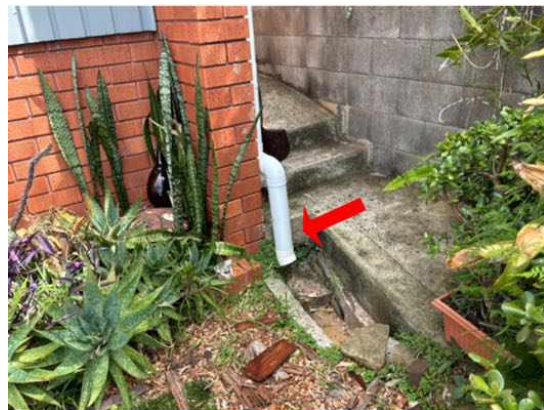
### Finding 6.04

Building:	Main Building
Location:	All Areas
Finding:	Excessive moisture - identified
Information:	Excessive moisture can attract termites and produce conditions that promote fungal growth and wood decay.

Prior to any remedial works being performed a qualified plumber should be appointed to further inspect the property and to identify the cause of the excessive moisture. Works to remove affected building elements may then be necessary and should be performed by an appropriate tradesperson.

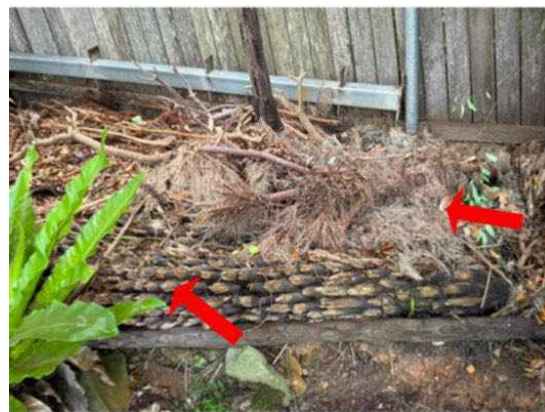
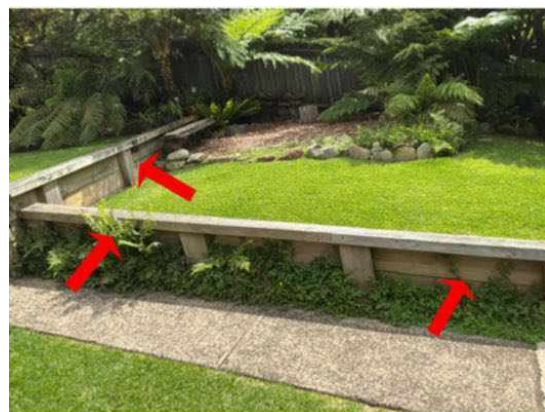
## Finding 6.05

Building:	Main Building
Location:	All Areas
Finding:	Untreated or non-durable timbers in a hazardous environment (Timber in ground contact)
Information:	To reduce the risk of timber pest attack it is essential that timber used in a hazardous environment (e.g. in direct contact with the ground or frequently exposed to damp conditions) is of sufficient durability and/or is adequately preservative treated.

If untreated or non-durable timbers are found to be in a hazardous environment it is highly advised that replacement of these building elements be performed as soon as possible to aid the protection of the property against termite / timber pest attack.

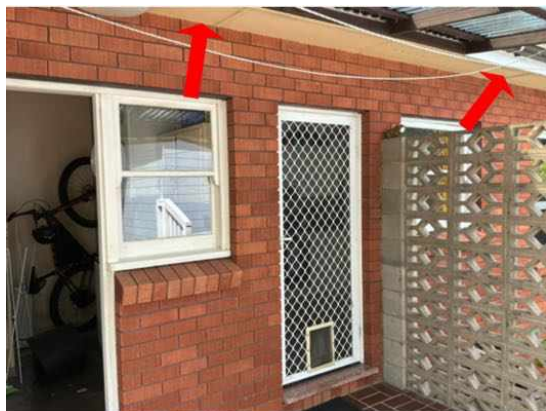
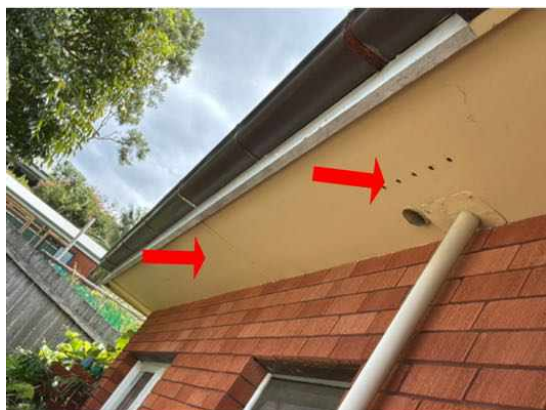
Building: Main Building  
Location: Exterior walls - front  
Finding: Previous remedial works  
Information: At the time of inspection it was identified that there was previous remedial work carried out to this area.

In the interim, the client is advised to act with caution, especially when considering any damage to building materials general wear and tear renovations extensions demolition and general maintenance activities due to the suspected presence of Asbestos.

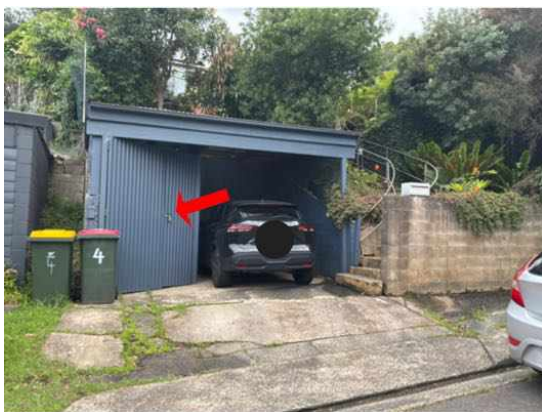
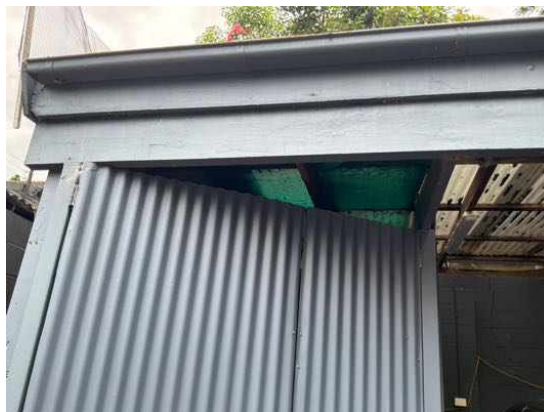
Building: Carport  
Location: Storage Cupboard  
Finding: No or Restricted Access  
Information: At the time of inspection it there was No or Restricted access provided to this area.

It is recommended that an access hole be installed in an appropriate location of the property, to gain full access for regular inspections to all areas of the building.

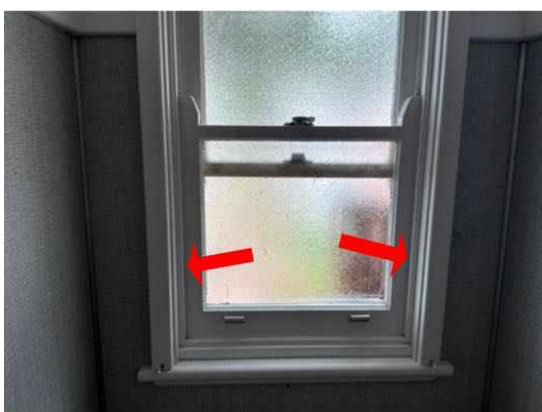
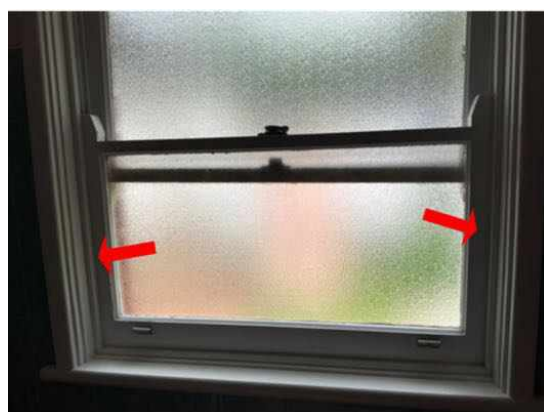
Building: Main Building  
 Location: Bathroom & Toilet (WC)  
 Finding: Windows - Sash painted shut  
 Information: Where window sashes have been painted shut, it is generally indicative of poor, rushed workmanship. The window is difficult if not impossible to open and close until remedial works have been undertaken.

Where windows have been painted shut the seal of the paint needs to be broken. This is generally done by breaking the seal of the paint and then maintaining the sash tracks clearing and lubricating them with silicone. Remedial paint work will likely be required and can be completed along with the rest of the remedial works necessary by a general handyman.

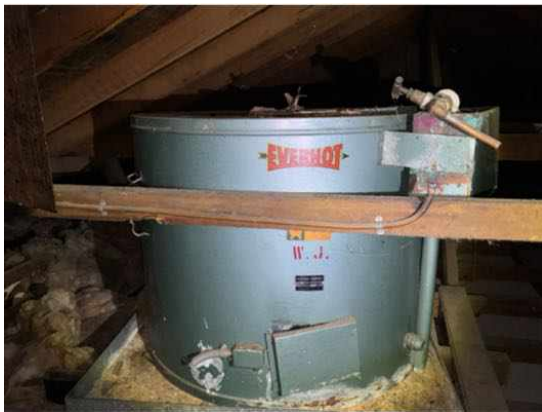
Building: Main Building  
 Location: Roof Void

While it is a costly exercise to remove the disused gravity-fed HWS, it is advisable in the short-term future to prevent any further damage to the area. Further consultation with a licensed plumber is required to gain further advice on removal of the structure.

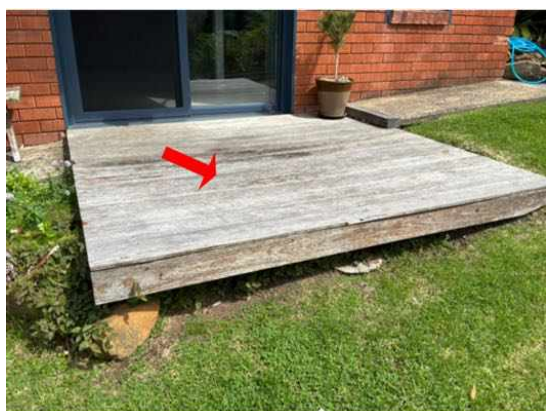
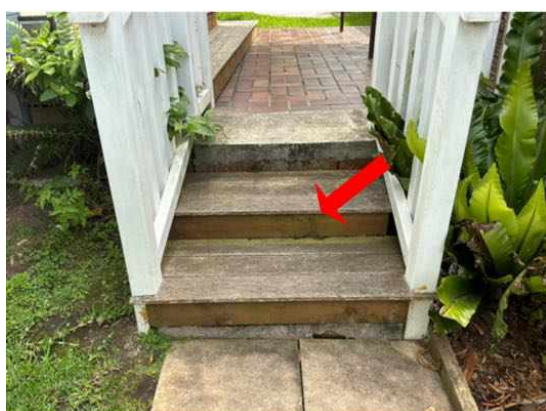
Building:	Main Building
Location:	Balcony
Finding:	Elevated Structures -Balconies or Deck Areas
Information:	Where any elevated Structure (deck, balcony, verandah etc) is present, and this elevated structure is designed to accommodate people, you MUST have this structure checked by an engineer or other suitably qualified person.
