Building and Timber Pest Inspection Report

Inspection Date: Fri, 27 Mar 2026

Property Address: 61 Pitfield Cres, Rowville VIC 3178,
Australia

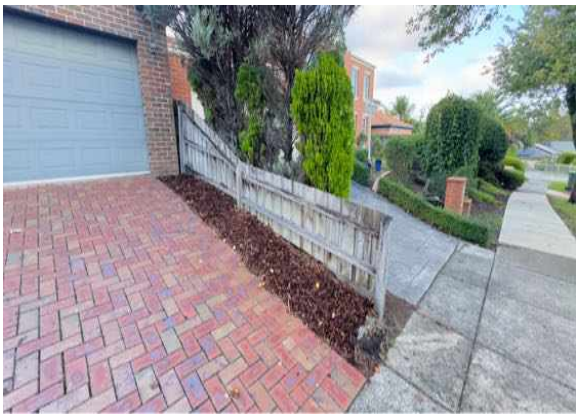
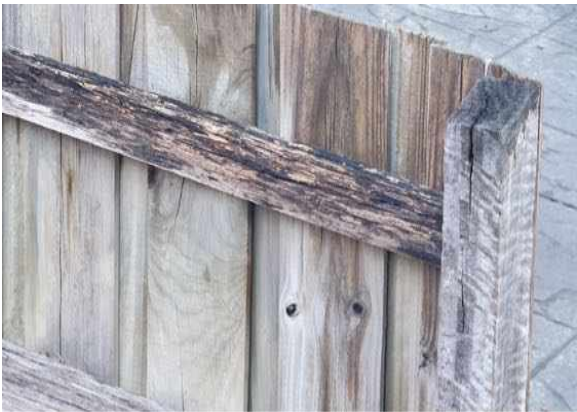
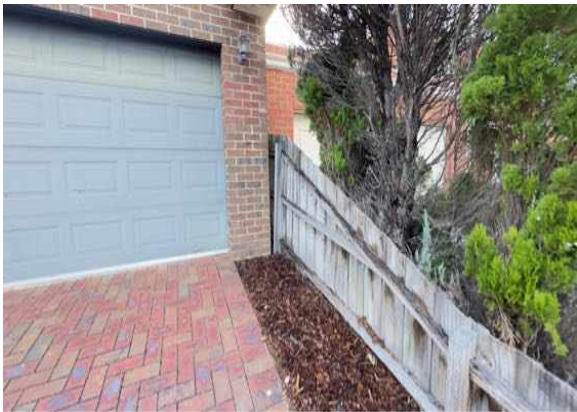
Building: Main Building
Location: Fencing All Areas
Finding: Fencing - Deteriated
Information: Timber fencing was inspected and deterioration was observed in this area. Deteriorated fencing can compromise structural stability, reduce privacy, and may allow pest ingress or accelerated decay if left unaddressed.

Possible causes include age-related timber decay, prolonged exposure to moisture or sunlight, poor maintenance, or impact damage.

When practical, a qualified carpenter or fencing specialist should be engaged to repair or replace affected sections, and a qualified painter should be engaged to restore protective finishes. Prompt rectification will maintain structural performance, improve appearance, and extend the lifespan of the fencing.

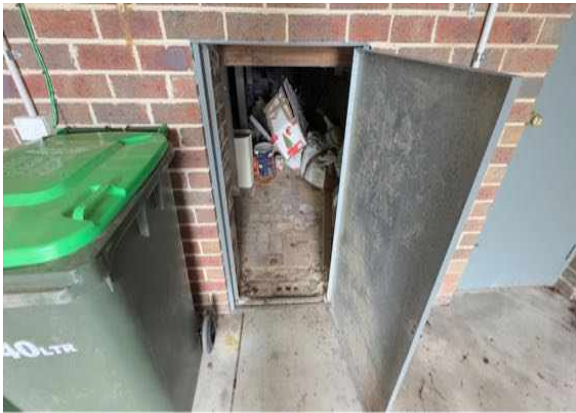
Building: Main Building
Location: Subfloor
Finding: Sub - Floor - Stored Items, Rubbish & Debris
Information: The subfloor was observed to contain stored items, rubbish, and debris. The issue is present where clutter restricts access and covers surfaces beneath the building.

This has likely occurred due to accumulation of materials over time or inadequate cleaning. Excess items can conceal defects, restrict inspections and maintenance, increase pest activity, and create fire or safety hazards.

This observation is provided for information only. When practical, a competent handyman should be engaged to remove all rubbish and clear access to ensure safe inspection, maintenance, and ongoing monitoring of the subfloor.

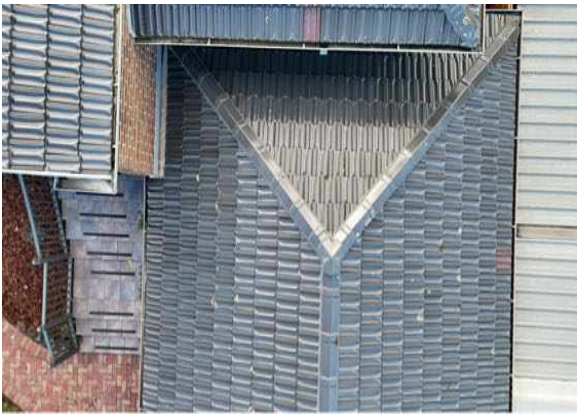
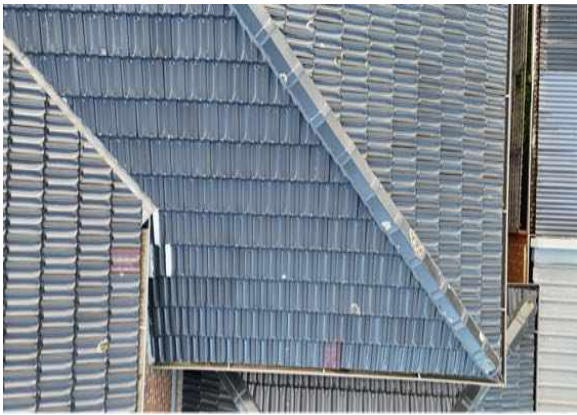
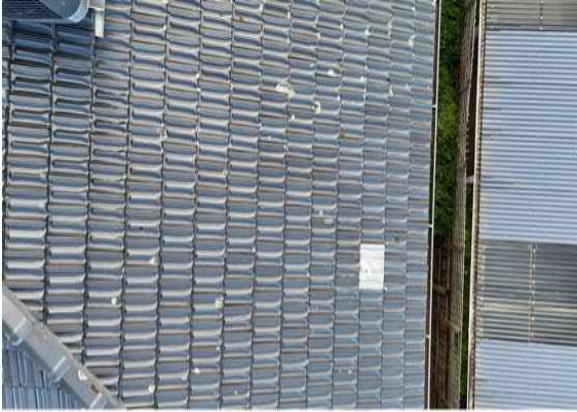
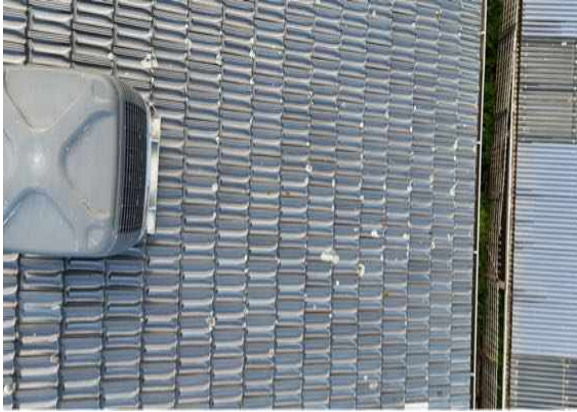
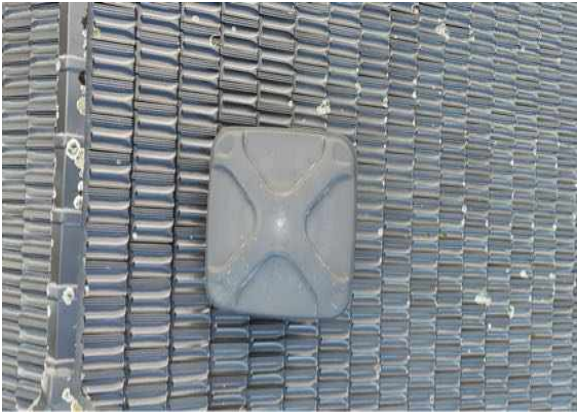
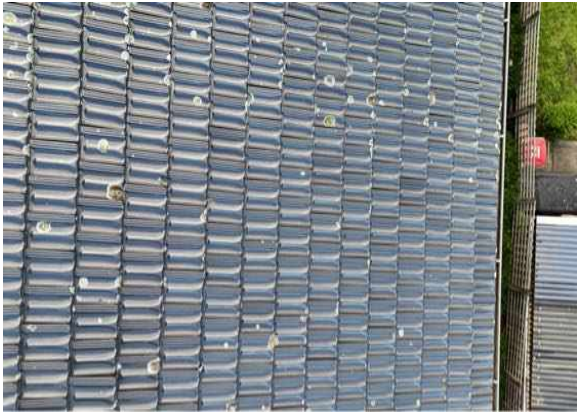
Building: Main Building
Location: Roof Exterior
Finding: Roof Plumbing - Roof Images For Your Information Only
Information: Roof Images For Your Information Only

If there are any concerns regarding the roof structure, coverings, flashings, drainage, or associated elements, further assessment by a licensed roofing contractor is recommended immediately.

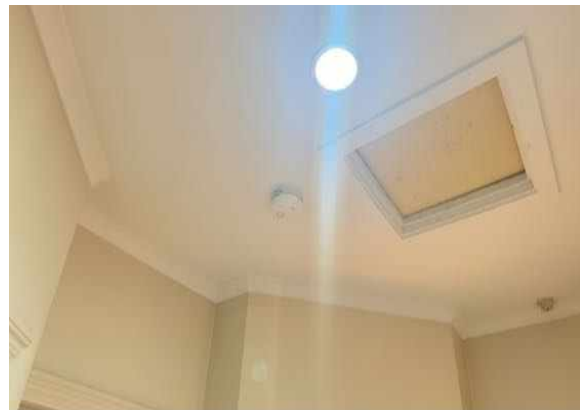
Smoke detectors are critical life-safety devices, and non-compliant, outdated, or non-operational units may not provide adequate warning in the event of a fire.

It is recommended that a licensed electrician be engaged immediately to test, service, and upgrade smoke detectors as required to ensure correct operation and compliance with current safety requirements.
