## Building Inspection Report

Inspection Date: Wed, 1 Apr 2026

Property Address: 46 Sparrow St, Cranbourne VIC 3977,  
Australia

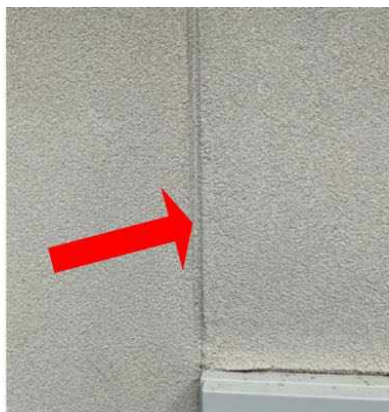
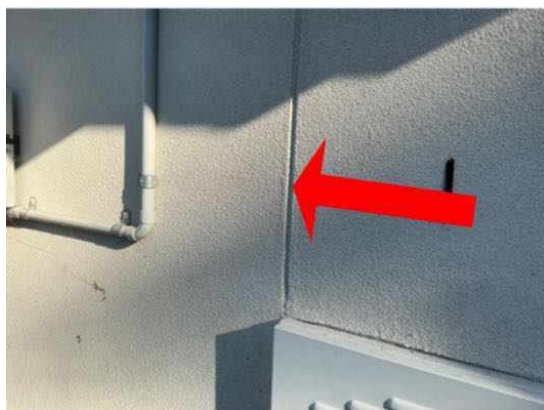
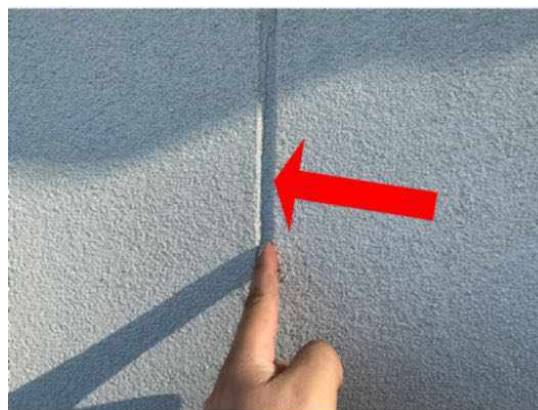
#### Defects 3.01

When these joints are covered by rigid finishes such as render, the ability of the structure to move freely is reduced. This can lead to cracking in the render or adjacent building elements over time, and may also contribute to moisture ingress if movement causes gaps or fractures in the render.

It is recommended that the rendered-over section be carefully removed to expose the expansion joint, and the joint reinstated with an appropriate flexible sealant or control joint system to ensure it continues to function as intended.

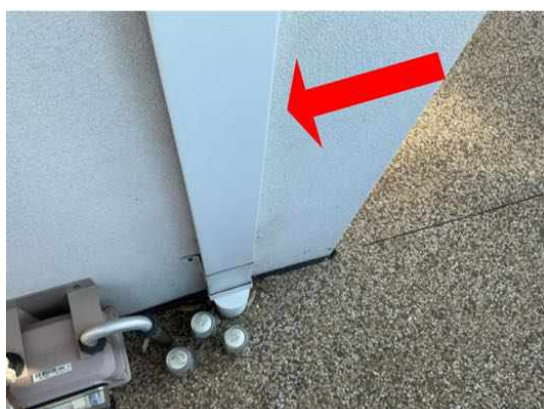
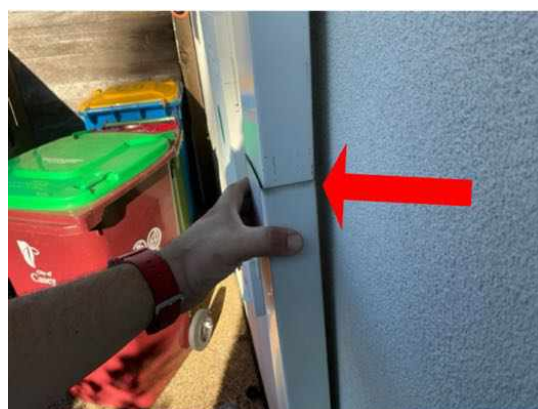
### Defects 3.02

Building: Main Building  
 Location: LHS exterior wall  
 Finding: Loose Downpipe Due to Missing Wall Bracket  
 Information:

The left-hand side downpipe was observed to be missing a required wall bracket, resulting in the downpipe being inadequately secured and loose at the time of inspection.

This condition may lead to movement of the downpipe during wind or water discharge, increasing the risk of joint separation, leakage, or damage to the pipe and adjacent building elements over time.

It is recommended that a licensed plumber install appropriate wall brackets to securely fix the downpipe to the wall in accordance with standard installation requirements.

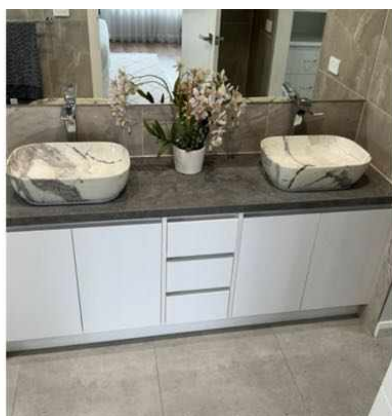
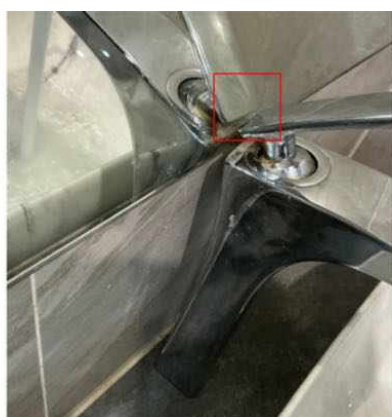
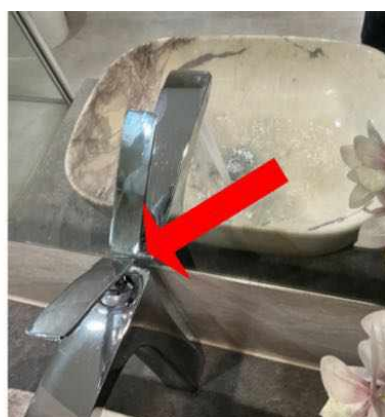
### Defects 3.03

Building: Main Building  
 Location: Ensuite - Master  
 Finding: Ensuite Tap Fixtures Impacting Mirror  
 Information: Both ensuite basin tap fixtures were observed to make contact with the mirror when

This condition may result in repeated impact during normal use, leading to potential damage to the mirror surface and premature deterioration of the tap fixtures. Continued use in this manner increases the likelihood of cracking or breakage of the mirror, posing a safety hazard.

It is recommended that a licensed plumber replace the existing tap fixtures with suitably sized or appropriately designed fittings that provide adequate clearance from the mirror, ensuring safe operation without contact or risk of damage.

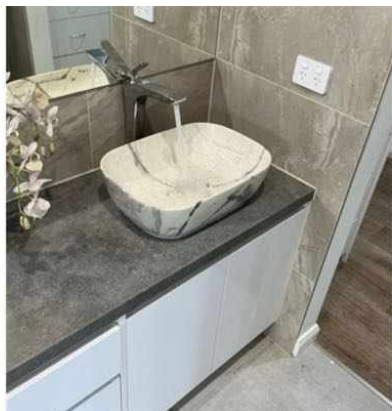
### Defects 3.04

Building:	Main Building
Location:	Bedroom - Master
Finding:	Tap - Leaking
Information:	The RHS tap in the master ensuite was found to be leaking at the time of inspection. This is a common defect that is consistent with general ageing of the building element. However, it may be indicative of substandard plumbing workmanship if the tap is relatively new.

While this defect only seems minor, if left unmanaged, it is likely to result in the

development of rust, water damage and/or extensive water usage.

It is advised that a handyman or licensed plumber be appointed to perform remedial works on the affected tap. Such works should be performed prior to the development of secondary defects to ensure adequate functionality of all associated building elements.

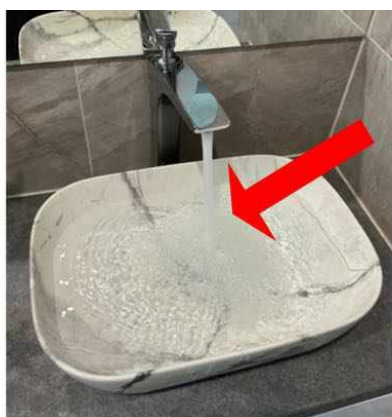
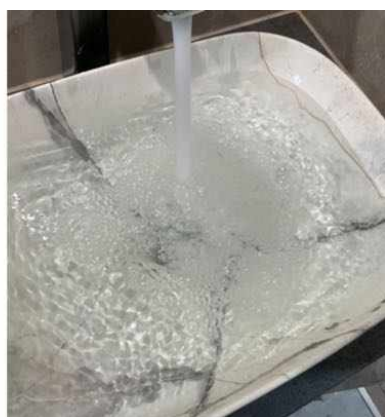
### Defects 3.05

Building:	Main Building
Location:	Ensuite - Master
Finding:	Slow Drainage in En-Suite Vanity Sink
Information:	Upon inspection, the en-suite vanity sink was found to have very slow drainage, resulting in water pooling within the basin during use. This issue is typically associated with a partial blockage within the sink drain, which may lead to further plumbing complications if left unaddressed. Additionally, prolonged pooling of water can contribute to bacterial growth and potentially cause damage to surrounding cabinetry or surfaces due to excess moisture.

It is recommended that a licensed plumber be engaged to inspect and clear any obstructions within the drainage system as soon as possible to restore proper functionality and prevent further issues. Regular maintenance of sink drains is also advised to ensure efficient water flow.

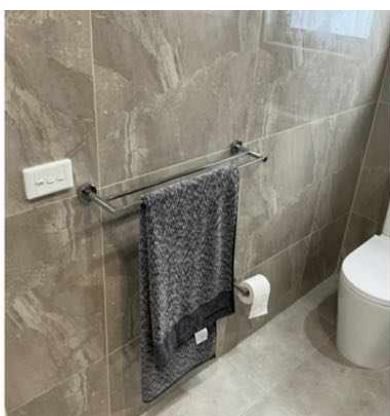
### Defects 3.06

Building:	Main Building
Location:	Ensuite - Master
Finding:	Towel rail - loose
Information:	The towel rail was found to be loose at the time of inspection. While not a major operational defect, function can deteriorate if the problem is left unmanaged.

It is advised that the homeowner performs remedial works to re-attach the towel rail to its original fixing. A general handyperson may be required to perform these works.

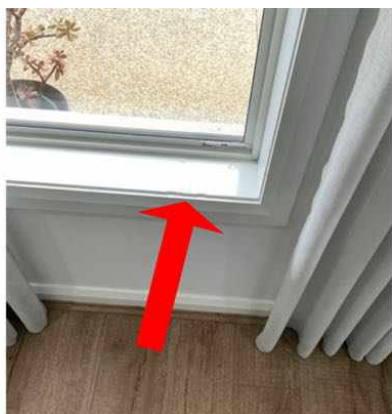
### Defects 3.07

Building:	Main Building
Location:	Ensuite - Master
Finding:	Window frame - Scuffed
Information:	Superficial scuff marks were noted to the window frame of the master bedroom at the time of inspection. Marked and scuffed surfaces, while detracting from the overall appearance of the affected building element, do not indicate any operational or structural damage. This degree of surface damage is consistent with general wear and tear.

Marked surfaces may be left at client discretion, as no repair/replacement is necessarily required. Marked surfaces are unlikely to result in the development of secondary damage; however, the client may wish to seek quotations for the cost to refurbish or replace the affected wall linings.

A general handyperson or professional painter may be appointed to rectify marked or scuffed surfaces at the client's discretion.

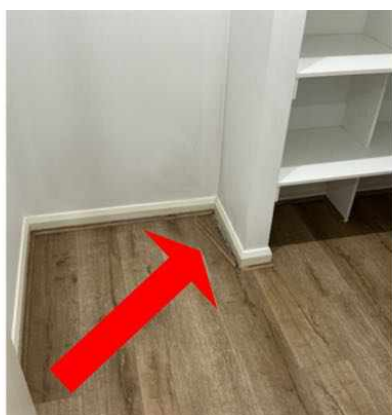
### Defects 3.08

Building:	Main Building
Location:	Pantry - Walk In
Finding:	Floor trim - Detached
Information:	The floor trim in the walk-in pantry has detached, indicating improper installation, wear and tear, or possible movement in the flooring. This defect may pose a trip hazard and affect the overall finish of the flooring. Rectification should involve securely refixing or replacing the trim using appropriate fixing methods to ensure durability and compliance with Australian Standards for flooring installation. A professional handyman can be allocated to completed this task at client's discretion.

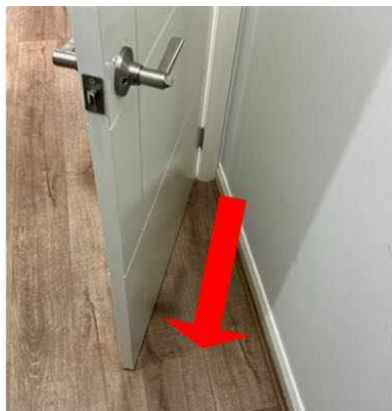
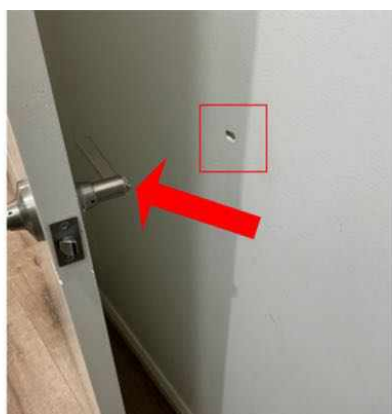
### Defects 3.09

Building:	Main Building
Location:	Pantry - Walk In
Finding:	Missing Door Stop Causing Wall Damage
Information:	No door stop was installed in the walk-in pantry, resulting in the door handle impacting the adjacent plaster wall. Minor damage to the plaster surface was observed behind the door as a result.

This condition allows ongoing contact between the door hardware and wall surface,

which may lead to further deterioration of the plaster and potential damage to the door handle over time.

It is recommended that a suitable door stop be installed by a qualified carpenter or handyman to prevent further impact. The damaged plaster wall can be patched, sanded, and repainted by a qualified plasterer or painter as required.

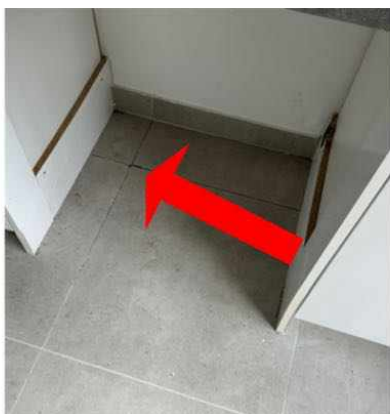
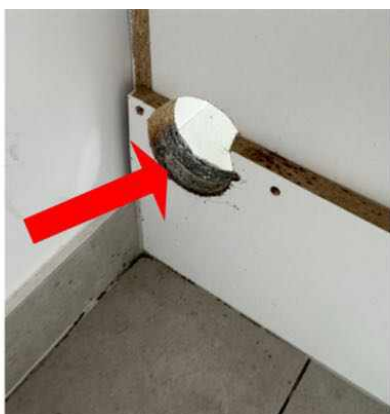
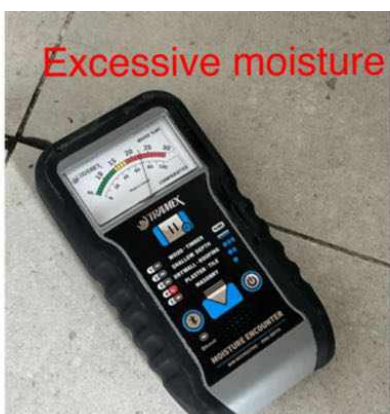
### Defects 3.12

Building: Main Building  
 Location: Laundry  
 Finding: Laundry Tap Leak and Associated Moisture Damage  
 Information: The laundry tap plumbing was observed to be leaking into the cabinetry below, with

visible water damage to the underlying shelving. Signs consistent with mould growth and a musty odour were noted within the cabinet when the tap was in use. Additionally, the adjacent tiled flooring within the washing machine recess shows indications of moisture exposure, with possible mould presence and prior water damage.

This condition indicates an ongoing or previous water ingress issue, which may lead to further deterioration of cabinetry materials, potential mould proliferation, and damage to surrounding building elements if not addressed. Prolonged moisture exposure may also impact indoor air quality and contribute to unhealthy living conditions.

It is recommended that a licensed plumber be engaged without delay to investigate and rectify the source of the leak, and to assess the extent of any concealed moisture damage. Following rectification, a suitable mould remediation specialist and/or qualified trades (such as a cabinet maker or tiler) should be engaged as required to repair or replace affected materials and ensure the area is properly dried and restored.

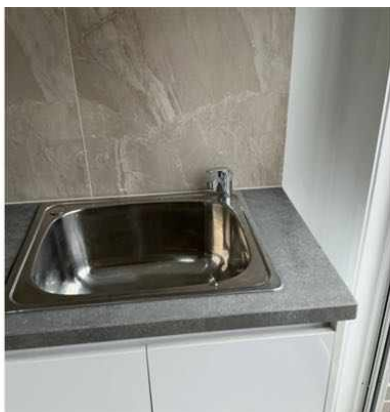
### Defects 3.15

Finding: Tap - Loose  
 Information: The tap in laundry sink has deteriorated with age, and is consequently loose. This tap being loose creates potential for water leaks and subsequent water damage to the surrounding area.

Where taps or spouts are loose, a qualified plumber should be appointed to re-fix the plumbing fitting.

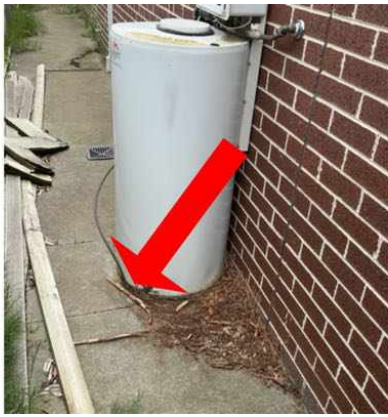
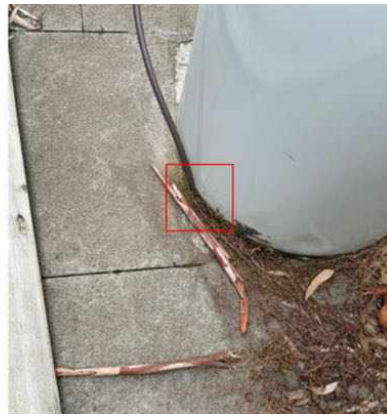
### Defects 3.16

Building: Main Building  
 Location: Yard - Side  
 Finding: HWS Overflow - Not Connected  
 Information: The Hot Water System (HWS) overflow was found to be disconnected from storm water drainage and is creating excessive moisture in the surrounding area.

These damp conditions can lead to secondary defects such as rot, rust or corrosion of associated building elements, the formation of fungal decay, or even the creation of potential slip hazards. When coupled with poor site drainage, pooling of water may also attract termite activity to this area.

It is highly recommended that a licensed plumber be appointed to connect the HWS overflow in order to prevent such an environment from being created. These minor works should be carried out as soon as possible.

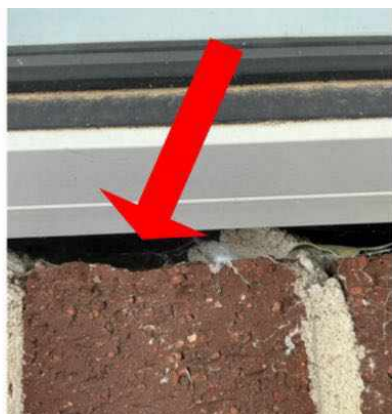
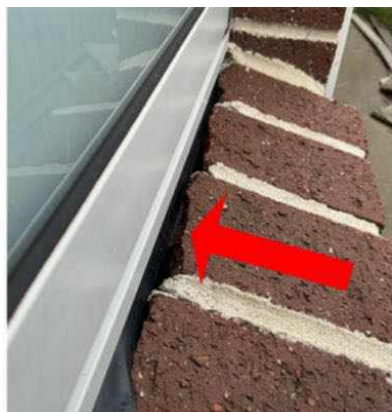
### Defects 3.17

Building: Main Building  
 Location: Exterior walls - right side  
 Finding: Inadequate Sealing to External Window Frames (RHS Elevation)  
 Information:

The two external windows located on the right-hand side of the property (when facing the house) were observed to have the bottom rubber seals tucked into the brickwork, creating a noticeable gap between the window frames and the surrounding masonry.

This condition compromises the watertightness of the window installation and may allow water ingress during rainfall, potentially leading to internal moisture damage, deterioration of building materials, and mould development if left unaddressed.

It is recommended that a qualified caulking specialist be engaged without delay to properly seal around the affected window frames, ensuring all gaps are filled and the installation is made fully watertight in accordance with standard practice.

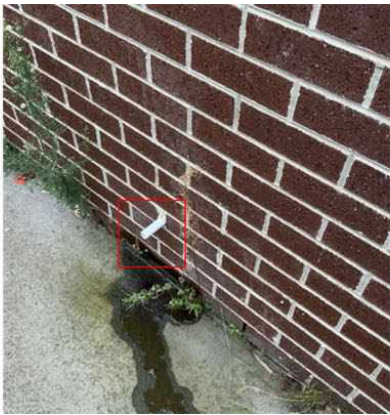
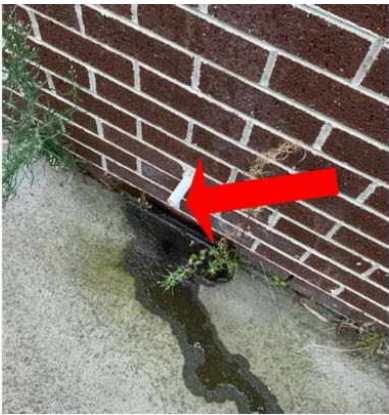
### Defects 3.18

Building:	Main Building
Location:	Yard - Side
Finding:	AC Overflows - Not plumbed to suitable drainage
Information:	Upon inspection, it was found that the AC overflow is not plumbed or connected to suitable drainage. This could lead to the surrounding area becoming excessively damp, which in turn may cause secondary defects such as rot, rust, corrosion of associated building elements, and the formation of fungal decay. In addition, prolonged damp conditions could create potential slip hazards. Poor site drainage may exacerbate the issue, potentially attracting termite activity to the area.

We recommend that a licensed plumber be appointed to properly plumb the AC overflow and connect it to suitable drainage. This will help ensure that the area remains dry and free from secondary defects.

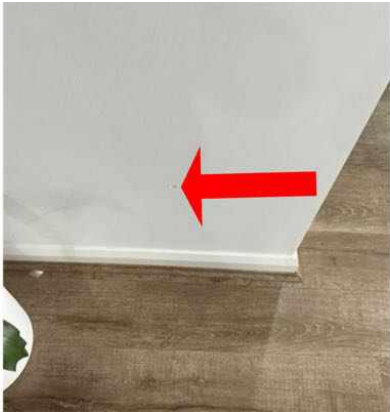
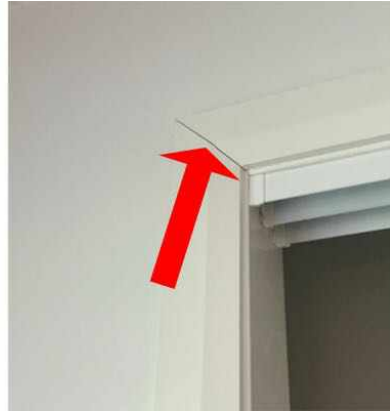
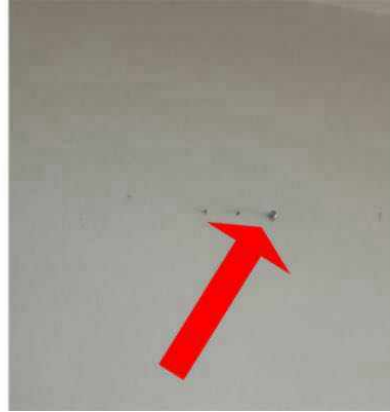
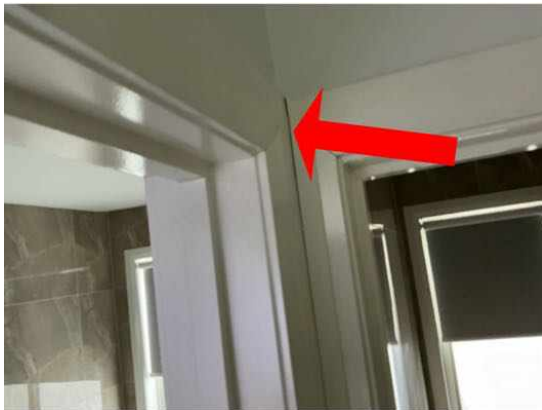
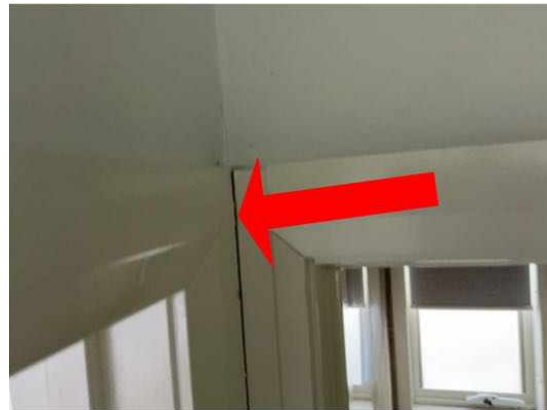
**Defects 3.19**

Building: Main Building  
Location: All Internal Areas  
Finding: General Wear and Tear to Internal Finishes  
Information:

Minor signs of wear and tear were observed at the time of inspection, including small chips to wall surfaces and minor cracking and splitting to sections of skirting boards and door frames.

These conditions are consistent with normal ageing, minor building movement, and day-to-day use, and do not represent significant structural concerns. However, they may affect the overall aesthetic condition of the property.

Repairs can be undertaken at the client’s discretion, including patching, filling, sanding, and repainting by a qualified painter or carpenter as required.

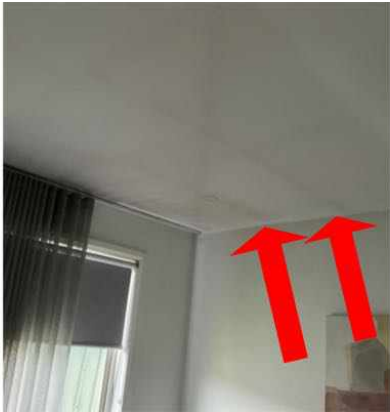
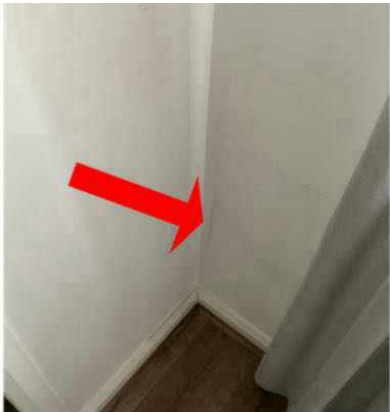
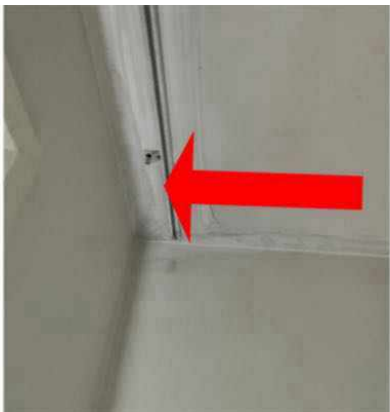
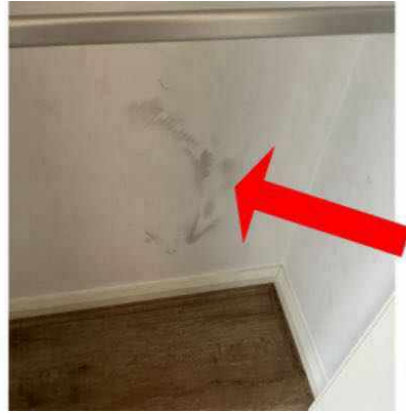
### Defects 3.20

Building: Main Building  
 Location: Bedrooms 3 and 4  
 Finding: Widespread Ceiling and Wall Staining – Bedrooms 3 and 4  
 Information:

Widespread dark staining was observed in Bedroom 3, particularly across the ceiling, within the wardrobe, and to sections of the walls. Similar staining was also noted in Bedroom 4. The exact cause of the staining could not be confirmed at the time of inspection.

This condition is generally consistent with prolonged exposure to airborne contaminants such as smoke, soot, or other environmental factors. While primarily

cosmetic, the staining may be difficult to remove fully and can affect the overall presentation and indoor environment if not addressed.

It is recommended that a professional cleaning service be engaged initially to attempt removal of the staining. If unsuccessful, repainting of the affected surfaces by a qualified painter will likely be required to restore the rooms to an acceptable condition.

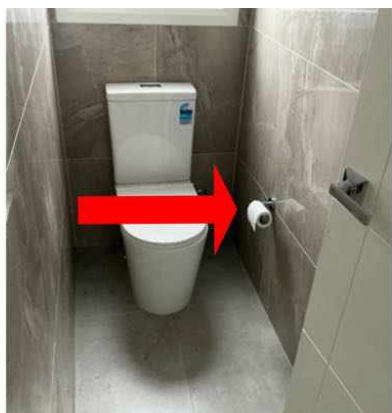
### Defects 3.22

Building: Main Building  
 Location: Toilet (WC)  
 Finding: Toilet roll holder - Loose  
 Information:

The toilet roll holder was found to be loose at the time of inspection. While not a major operational defect, function can deteriorate if the problem is left unmanaged.

It is advised that the homeowner performs remedial works to re-attach the toilet roll holder to its original fixing. A general handyman may be required to perform these works.

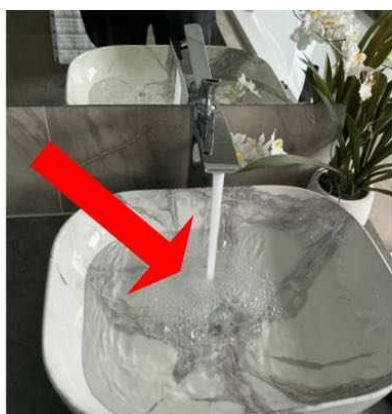
### Defects 3.23

Building:	Main Building
Location:	Bathroom 3
Finding:	Slow Drainage in bathroom 3 Vanity Sink
Information:	Upon inspection, the bathroom 3's vanity sink was found to have very slow drainage, resulting in water pooling within the basin during use. This issue is typically associated with a partial blockage within the sink drain, which may lead to further plumbing complications if left unaddressed. Additionally, prolonged pooling of water can contribute to bacterial growth and potentially cause damage to surrounding cabinetry or surfaces due to excess moisture.

It is recommended that a licensed plumber be engaged to inspect and clear any obstructions within the drainage system as soon as possible to restore proper functionality and prevent further issues. Regular maintenance of sink drains is also advised to ensure efficient water flow.

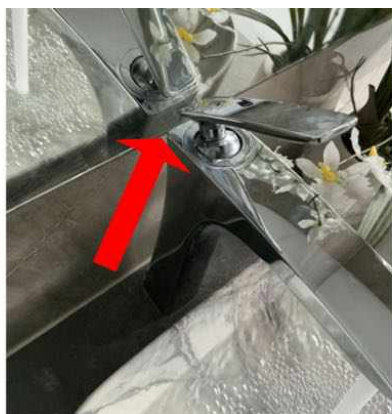
### Defects 3.24

Building:	Main Building
Location:	Bathroom 3
Finding:	Tab fixture affecting mirror
Information:	The basin tap fixtures was observed to make contact with the mirror when operated, indicating insufficient clearance between the tap fitting and the adjacent wall-mounted mirror.

This condition may result in repeated impact during normal use, leading to potential damage to the mirror surface and premature deterioration of the tap fixture. Continued use in this manner increases the likelihood of cracking or breakage of the mirror, posing a safety hazard.

It is recommended that a licensed plumber replace the existing tap fixture with suitably sized or appropriately designed fittings that provide adequate clearance from the mirror, ensuring safe operation without contact or risk of damage.

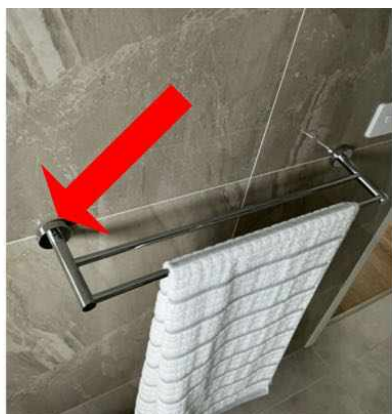
### Defects 3.25

Building:	Main Building
Location:	Bathroom 3
Finding:	Towel rail - loose
Information:	The towel rail was found to be loose at the time of inspection. While not a major operational defect, function can deteriorate if the problem is left unmanaged.

It is advised that the homeowner performs remedial works to re-attach the towel rail to its original fixing. A general handyman may be required to perform these works.

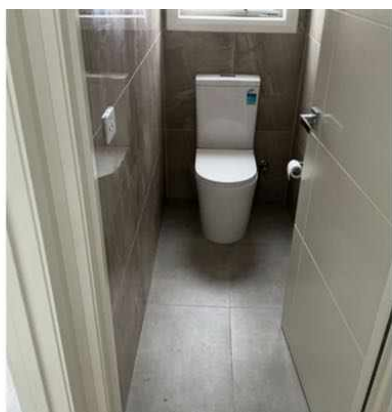
### Defects 3.26

Building: Main Building  
 Location: Toilet (WC)  
 Finding: Continuously Running WC Toilet Cistern  
 Information:

The toilet within the WC was observed to be continuously filling with water at the time of inspection, indicating that the cistern was not shutting off properly. The issue persisted until the water supply was manually isolated.

It is recommended that a licensed plumber be engaged without delay to inspect the cistern mechanism, identify the faulty components, and carry out the necessary repairs or replacements to restore proper operation.

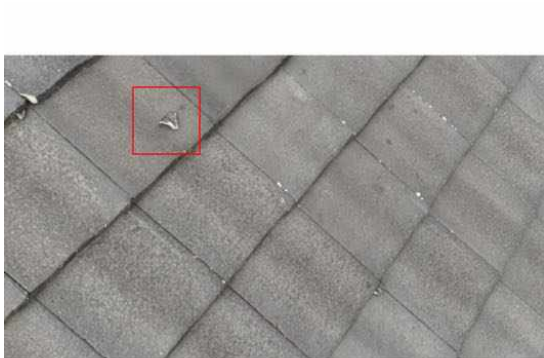
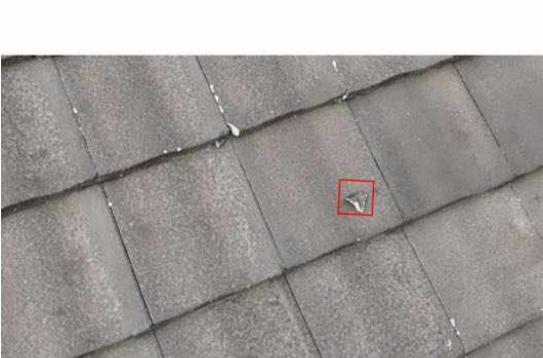
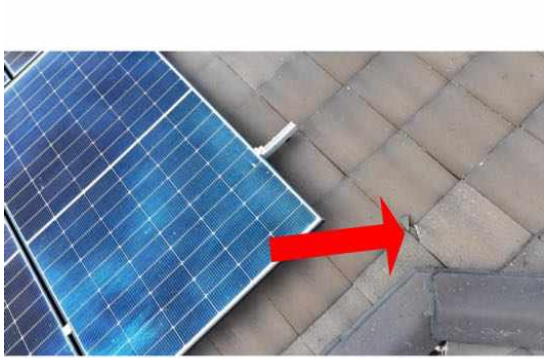
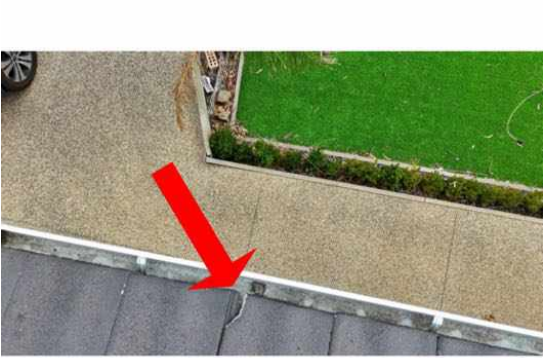
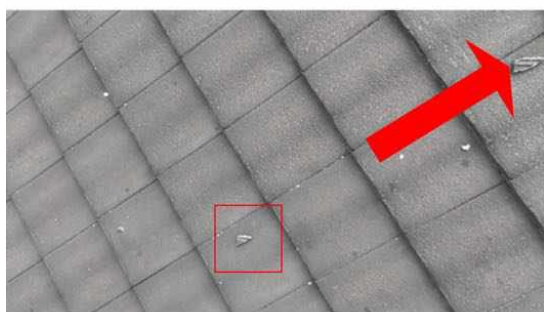
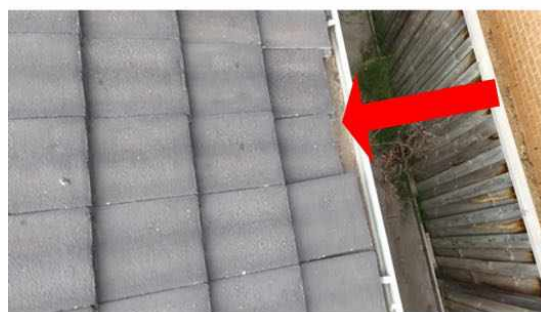
### Defects 3.27

Building: Main Building  
 Location: Roof Exterior  
 Finding: Dislodged and Damaged Roof Tiles  
 Information:

It is recommended that a qualified roof tiler be engaged to realign and properly seat the displaced tiles, and to replace all cracked and damaged tiles. The surrounding roof area should also be checked to ensure all tiles are secure and the roof is watertight.

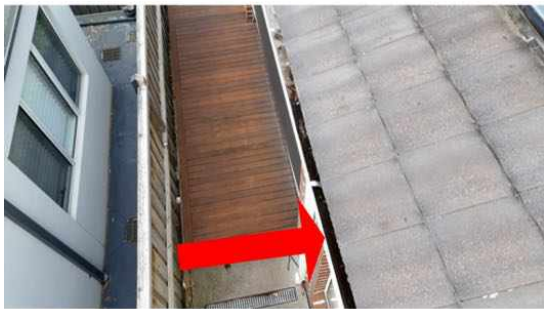
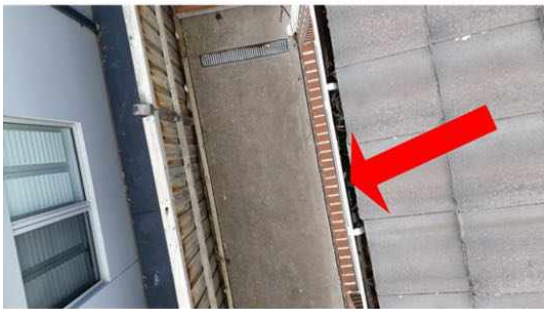
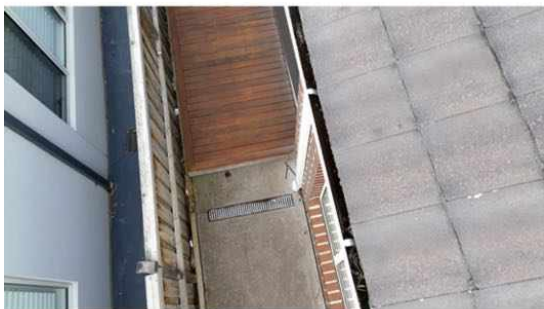
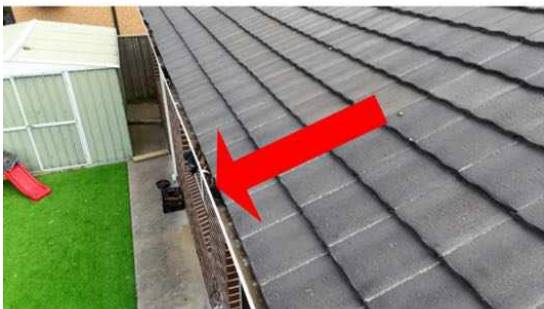
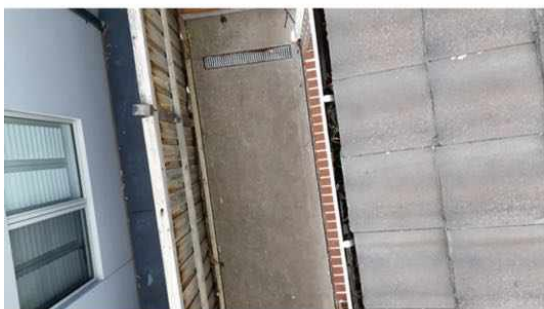
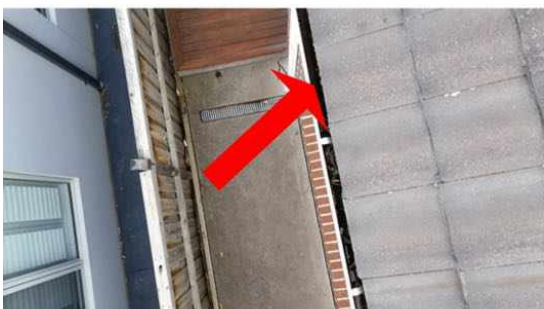
### Defects 3.28

Building:	Main Building
Location:	Gutters
Finding:	Gutters - Water pooling
Information:	Water was found to be pooling in sections of the roof guttering. This is generally a secondary defect caused by blocked or partially blocked gutters. Such blockages and subsequent water pooling are likely to lead to rust and water damage to associated structures if left unattended.

A roofing plumber should be appointed as soon as possible to rectify this issue. It is highly advised that all gutters be maintained on a frequent basis to ensure the condition of roof plumbing.

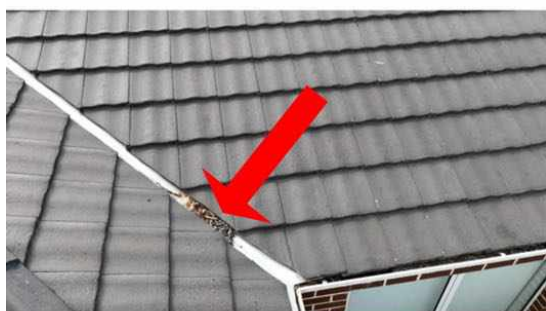
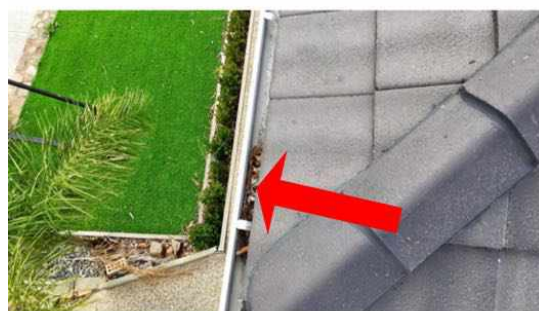
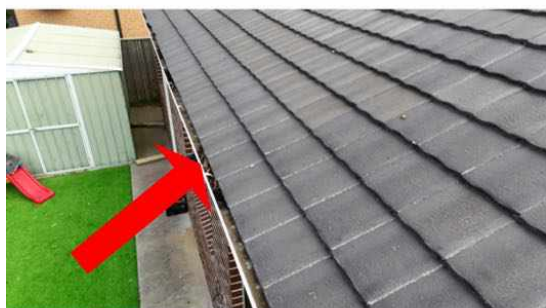
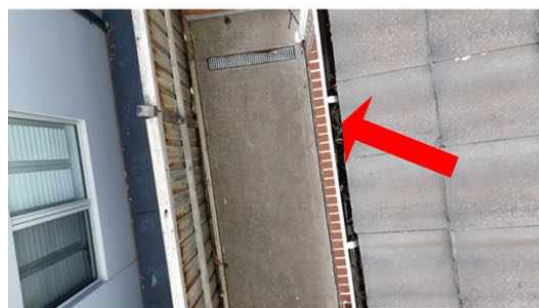
**Defects 3.29**

Building: Main Building  
Location: Gutters  
Finding: Gutters - Partially Blocked

Consult a Licensed Plumber for further specific advice on remedial works that may be required. In the interim, it is highly advised that blocked gutters be removed by the homeowner or a general handyperson as a matter of urgency.

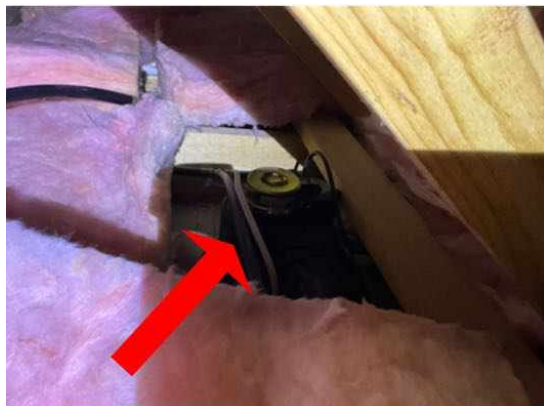
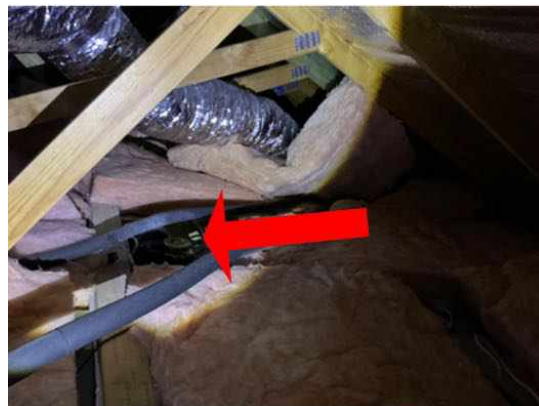
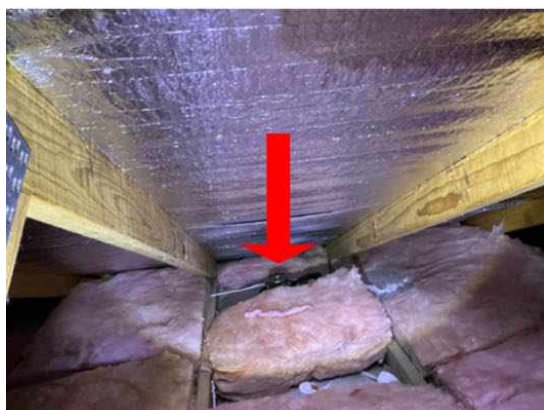
### Defects 3.30

Building:	Main Building
Location:	Roof Void
Finding:	Bathroom Exhaust Fans Not Ducted to External Atmosphere
Information:	The exhaust fans installed in the bathrooms were observed to be discharging directly into the roof cavity rather than being ducted to the external atmosphere. This configuration does not comply with best practice ventilation standards, as it allows moist air to accumulate within the roof space.

It is recommended that a licensed ventilation specialist or electrician be engaged to install compliant ducting that vents the exhaust air to the outside of the building, in accordance with current building regulations and ventilation standards.

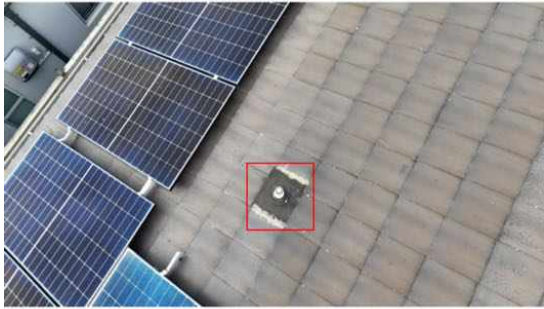
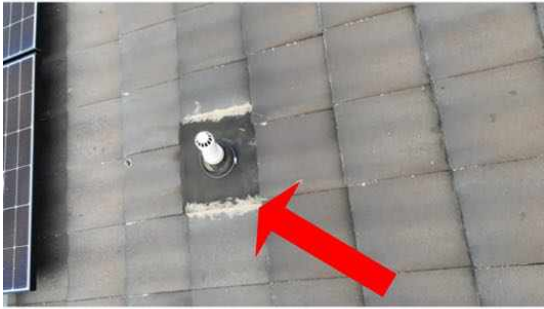
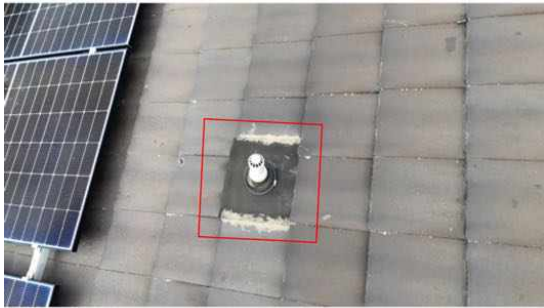
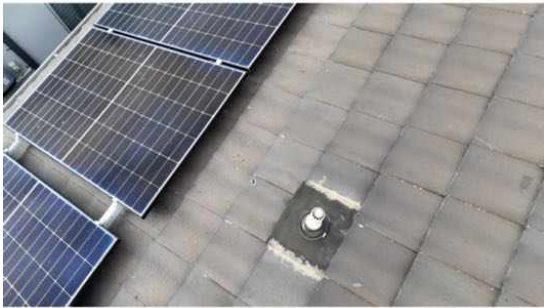
### Defects 3.31

Building: Main Building  
 Location: Roof Exterior  
 Finding: Inadequate Flashing and Sealing Around Roof Penetration  
 Information:

proper integration with the surrounding tiles and a fully watertight finish.
