Building and Timber Pest Inspection Report

Inspection Date: Fri, 27 Feb 2026

Property Address: 13 Lakelands Dr, Dapto NSW 2530, Australia

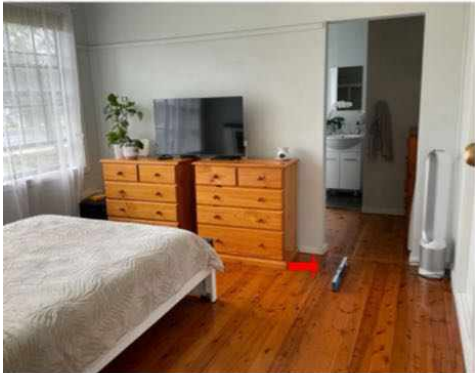
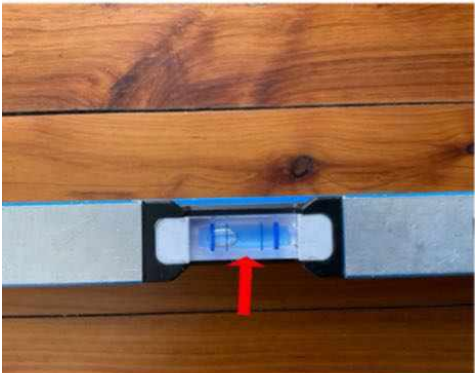
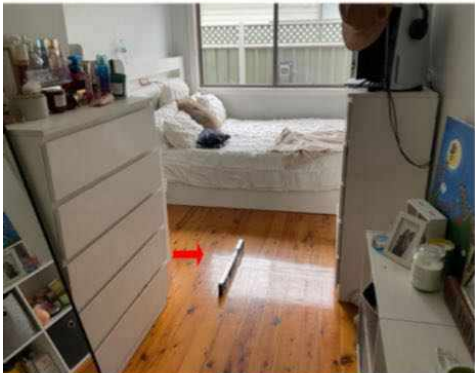
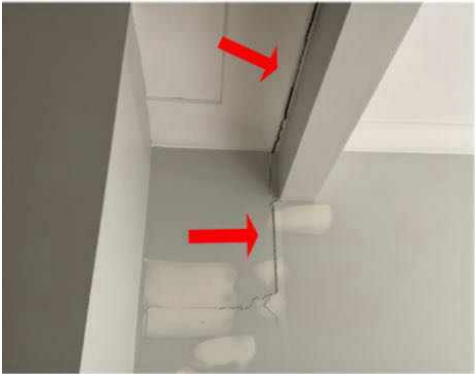
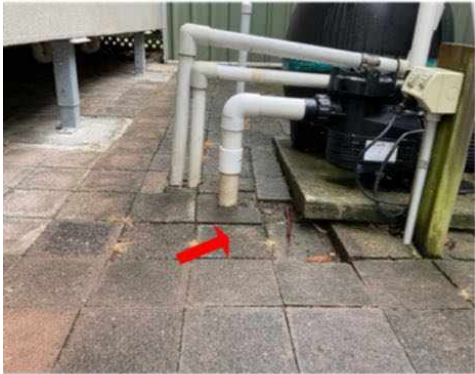
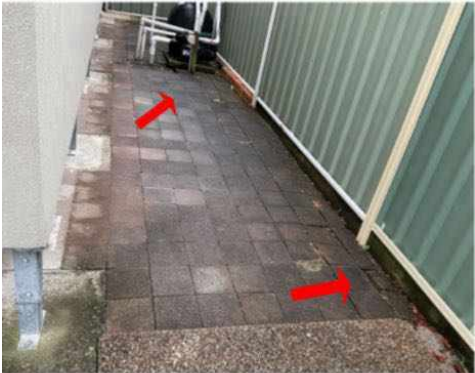
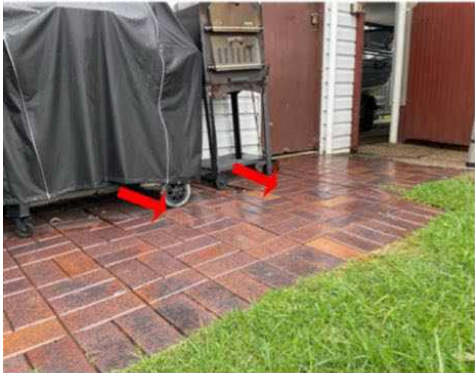
Building:	Building 1
Location:	Many areas
Finding:	Subsidence to most north east & south east rooms
Information:	It appears that the house and many other areas has been affected by movement of the foundations, often referred to as sinking or subsidence.

This is evidenced by the curvature front brickwork, very uneven flooring, bedroom wall and ceiling cracks, cracked concrete, cracked verandahs tiles, cracked render etc.

Photos 1-7 show extensive movement and photos 8-10 show minor external paving movement. Whilst a small degree of movement is expected in over time, especially as environmental conditions change and buildings 'settle' after construction, this degree of movement in the left and rear of the house requires attention.

General subsidence is usually initiated by changes in soil moisture content. The most critical factor is identifying the specific cause.

Subsidence can have complex and varying causes, which will influence the required remedial works. It is advised to begin by consulting a structural engineer to determine the required scope of works. This generally includes some form of underpinning, as well as addressing the underlying cause. Consultation with a geotechnical engineer may also be necessary where changes to soil moisture content is apparent.

A Registered Builder would then generally carry out works as advised by an Engineer.

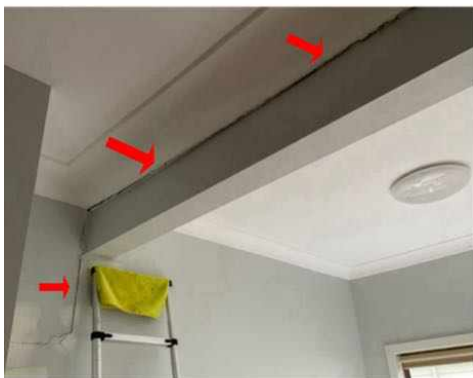
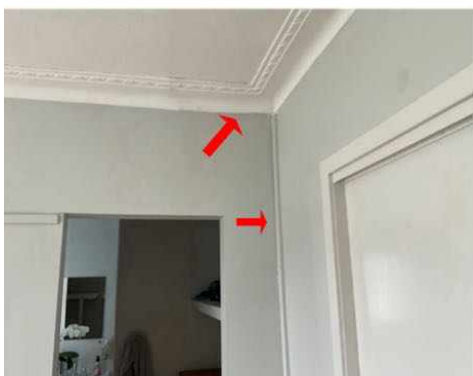
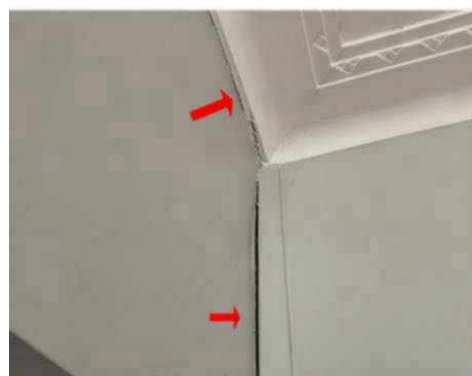
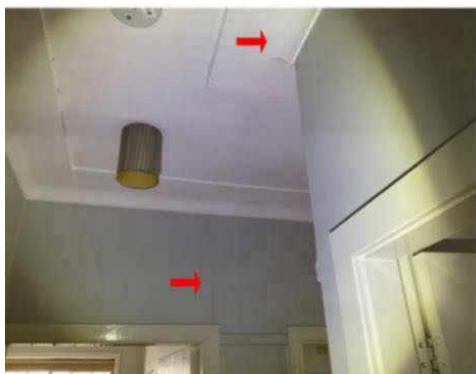
Building:	Building 1
Location:	Front bedrooms and other areas
Finding:	Cracking - Damage Category 3 - Repair Required (5mm-15mm or a grouping or cluster of cracks of 3mm or more)
Information:	Cracks of up to 8mm were evident in the front bedrooms. Cracks of this type are likely to have been caused by movement of building elements, but may also have a structural cause that is more significant. Cracking of this degree may result in doors and windows sticking or jamming, but may have more serious implications, such as fracturing service pipes. Weather tightness (the ability to resist rain and wind) is also often impaired, creating potential for the development of secondary defects.

A crack of this size may be repaired. However, these repairs may also include further works, such as easement of associated window and door frames that are jamming, as well as more extensive filling, sanding and/or repainting.

It is highly recommended to gain quotations on repair and restoration works that are required. Always contact your building inspector should cracks widen, lengthen or become more numerous.

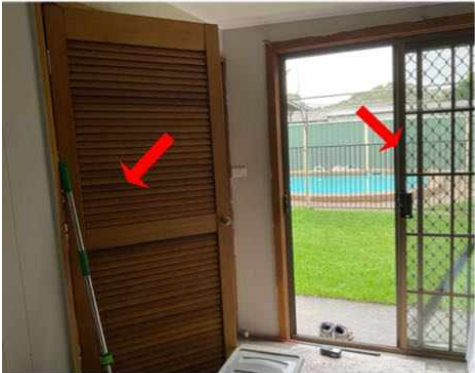
Building:	Building 1
Location:	Garage
Finding:	Doors - Binding/jamming
Information:	Binding and/or jamming of these doors is evident during standard operation. This defect inhibits the functionality of the affected doors as well as creating potential for secondary defects to associated building elements, such as damage to the floor covering or the adjoining door jamb.

A door that binds to flooring or to the associated door frame may have several causes, ranging from minor defects, such as poor installation of the door or deteriorated hinges, through to major structural issues, such as damage to subfloor structures.

Where door binding/jamming appears to indicate major structural issues, a registered builder specialising in re-stumping should be appointed to provide an estimate on the cost of rectification.

For minor causes, a qualified carpenter or general handyperson should be appointed to perform minor rectification works at client discretion.

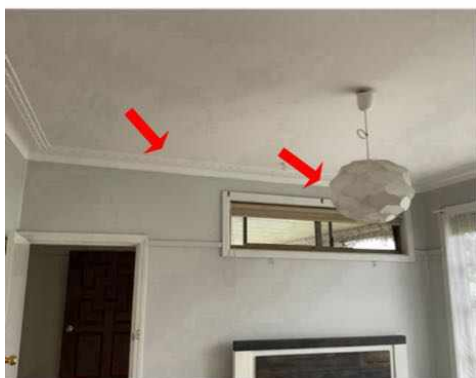
Building:	Building 1
Location:	Front & rear bedrooms
Finding:	Ceiling - Water stained
Information:	Water staining to ceiling / wall linings in these areas was evident at the time of inspection. Water staining indicates that surfaces have been exposed to excessive moisture over time. The minerals and other elements in the water lead to staining, which may graduate to corrosion and deterioration if left unmanaged.

Where water staining is active, a licensed plumber must be consulted to identify the cause of the staining and to provide advice on any reparation works that may be required. Replacement of any damaged structures is advised.

Conversely, where water staining is old and inactive, affected building materials may be repaired or replaced at client discretion.

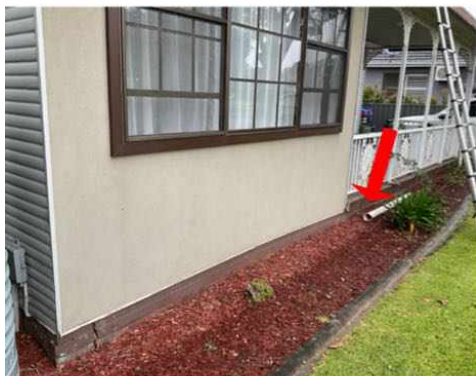
Building: Building 1
 Location: Subfloor - right front
 Finding: Water staining
 Information: Water staining was evident in this area at the time of inspection. Water staining indicates that surfaces have been exposed to excessive moisture over time. The minerals and other elements in the water lead to staining, which may graduate to corrosion and deterioration if left unmanaged.

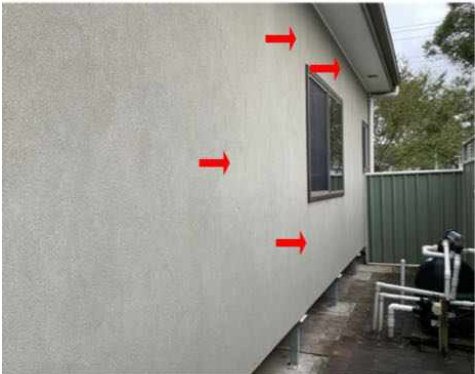
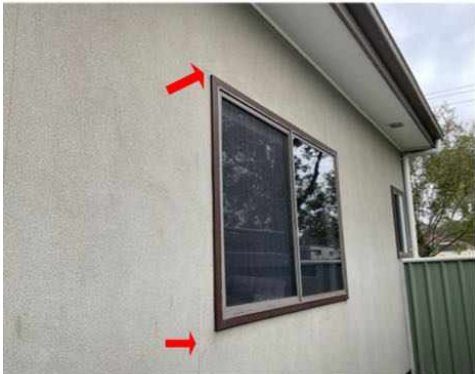
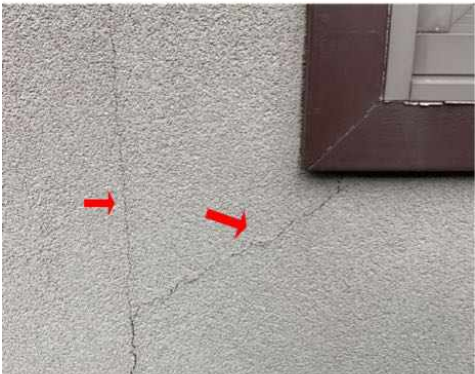
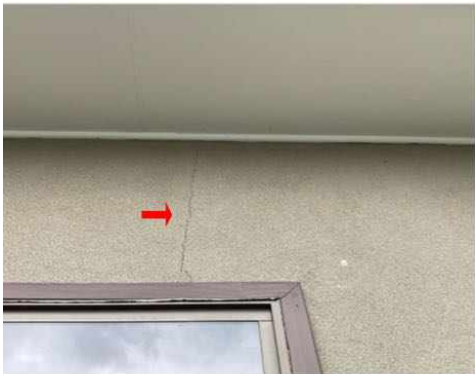
Building: Building 1
Location: Front and right wall areas
Finding: Render (external) cracking.
Information: It has been observed that cracking to some external rendered surfaces. The degree of damage is described as “slight” noticeable cracks which are easily filled. Cracking of this size are generally less than 5mm in width.

Always contact your building inspector should cracks widen, lengthen, or become more numerous.

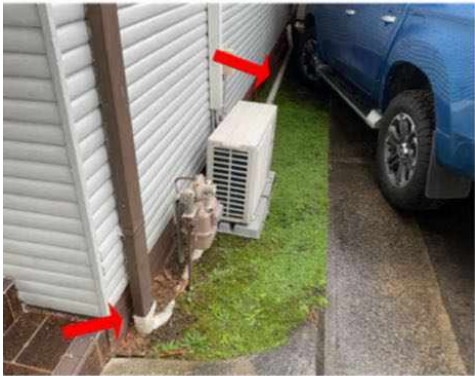
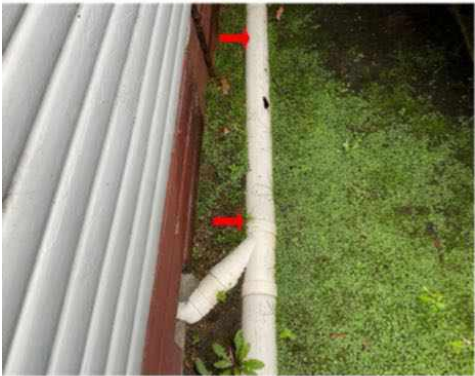
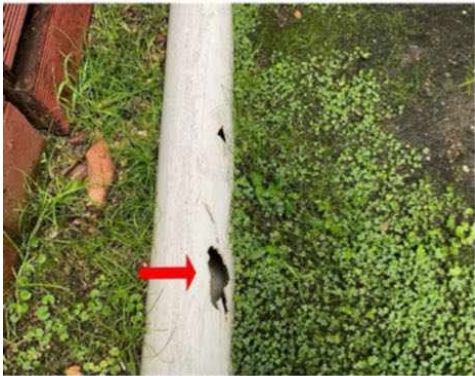
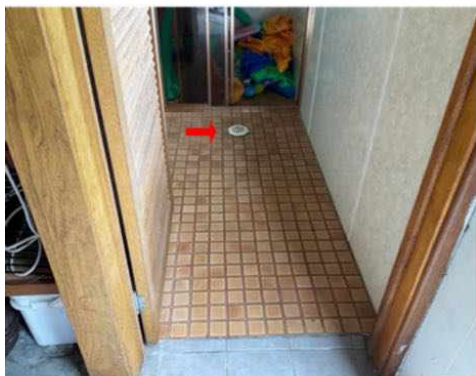
Building: Building 1
Location: Driveway and other areas
Finding: Substandard electrical and plumbing areas
Information: Sub standard and incomplete work are determined by identifying a failure to achieve the minimum requirement set out in the mandated Australian Standard as outlined in the Building Code of Australia and referenced by the Manufacturers Guideline.

Some plumbing pipes sit on the ground adjacent to the driveway. One pipe has already cracked allowing rainwater to flood the driveway. These pipes should be buried to prevent impact damage. A plumber needs to rectify the defect to stop further damage. This has already cracked allowing rainwater to flood the driveway.

The rear bathroom floor waste protrudes from the tiling preventing water from entering this drain. The kitchen sink tap also leaks into the sink at the base.

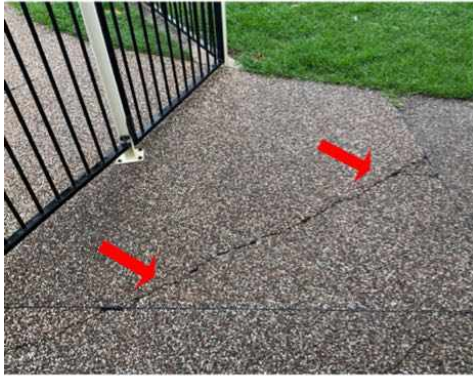
Building:	Building 1
Location:	Yard - front and rear
Finding:	Crack in concrete slabs - Category 1
Information:	Cracks coded as Category 1 was identified in front and rear slabs. A Category 1 crack is described as a fine but noticeable crack, with the slab at an otherwise reasonable level. To be considered Category 1, the approximate width of the crack is less than 1.0mm, or a less than 10mm change in offset when a 3m straight edge is placed over the defect.

Category 1 cracks should be monitored for a period of 12 months. At the end of the monitoring period, identified cracks that are rated greater than Category 2 are considered defects, and require rectification.

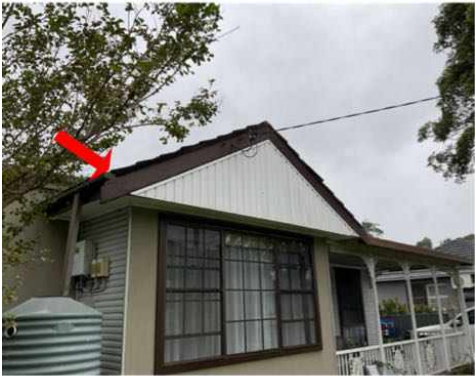
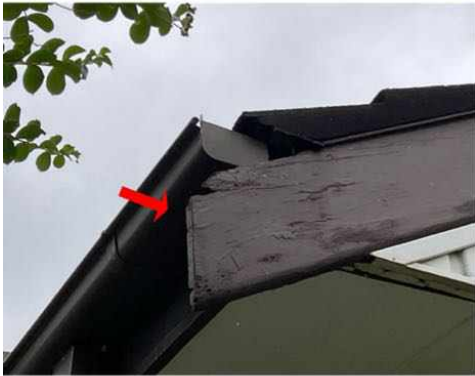
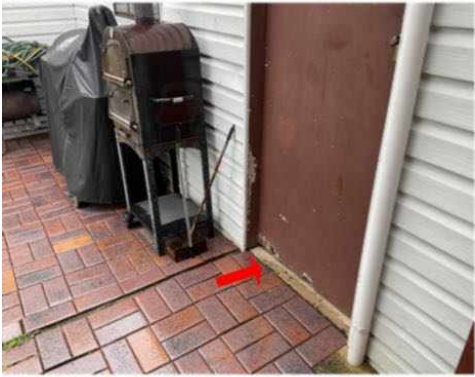
Building:	Building 1
Location:	Pictured areas
Finding:	Wood rot
Information:	The buildings shows evidence of wood rot. The rear shed roof timbers have not fallen from requiring replacement. Wood rot, also known as Fungal Decay, occurs when timbers and other cellulose building materials are exposed to damp conditions on an ongoing basis. This could be the result of exposure to weathering over a prolonged period of time, or the attraction of excessive moisture from other abutting building materials.

the useful life of these building elements. Prior to any works being performed, the cause of the moisture that has created the visible wood rot should be identified and addressed in a suitable manner. Replacement of affected timbers may then be a necessary step in protecting surrounding building elements from such deterioration.

A qualified carpenter or registered builder may also be required to replace affected building materials.

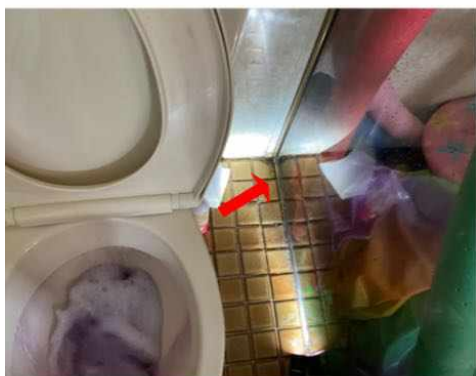
Information: Leaking was evident to the shower screening at the time of inspection. It is suspected that the leaking has occurred as a result missing sealant. Leaking from the shower , where left unattended, is likely to lead to water damage to adjoining flooring and walls. Such damage can lead to water damage and necessitate extensive remedial works being required. Active water leaks may also create an environment that is susceptible to the formation and development of mould.

Appointment of a sealant expert is required to repair or replace this missing sealant. Such works should be performed as soon as possible to ensure that no further damage occurs.
