Building and Timber Pest Inspection Report

Inspection Date: Tue, 31 Mar 2026

Property Address: 7A McGregor Cl, Adelaide SA 5000,
Australia

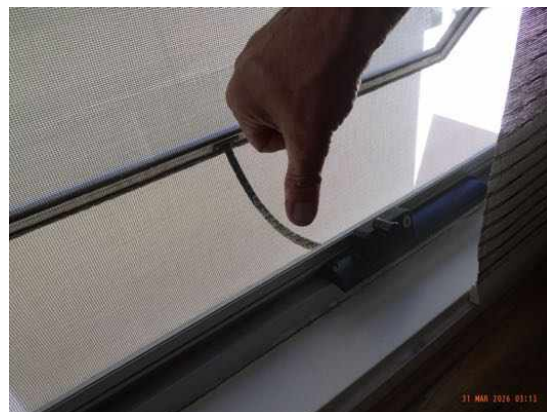
Building: Building 1
 Location: Upstairs
 Finding: Window - Opening restrictions missing Pre purchase
 Information: Upper level windows were observed to have no restriction devices fitted at the time of inspection, allowing the sashes to open beyond the currently recommended safe opening limits.

If left unaddressed, unrestricted window openings present a fall risk to occupants, particularly children, which may result in serious injury.

A suitably qualified and licensed tradesperson should be engaged to install appropriate window restriction devices where required. Although this may not be a compliance requirement based on the age of the dwelling, installation is recommended in the short term to improve safety for all occupants.

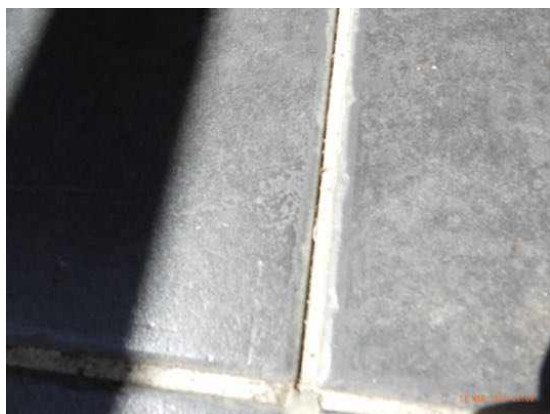
Finding 2.01

Finding: Deteriorated Tiling, sealant and grout

Information: Deterioration was observed to the balcony grout and/or sealant at the time of inspection, with associated damage evident to the ceiling beneath within the garage.

The deterioration is consistent with age-related wear and exposure to weather conditions, resulting in a breakdown of the waterproofing at surface level and allowing water penetration through the balcony structure.

If left unaddressed, continued water ingress may lead to further damage to underlying structural elements, internal finishes to the garage ceiling, and potential long-term deterioration including decay or mould.

A suitably qualified sealant specialist or tiling contractor should be engaged to remove and replace the deteriorated grout and sealant with appropriate flexible, mould-resistant materials. Rectification is recommended in the short term to prevent further water ingress and associated damage.

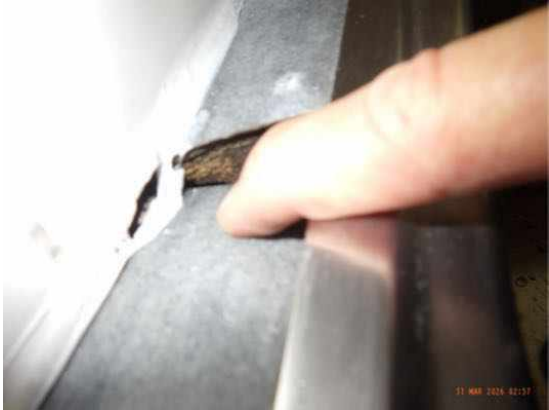
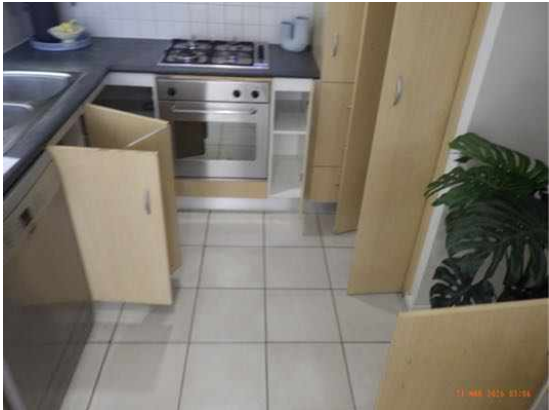
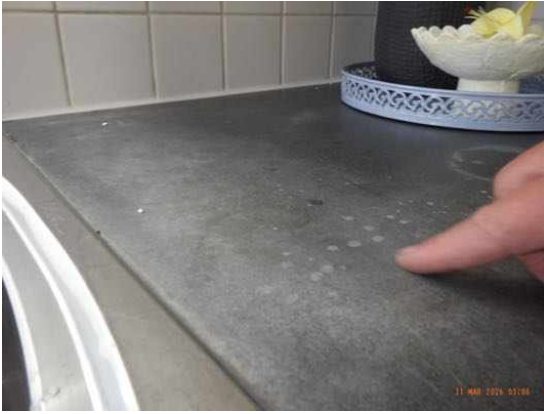
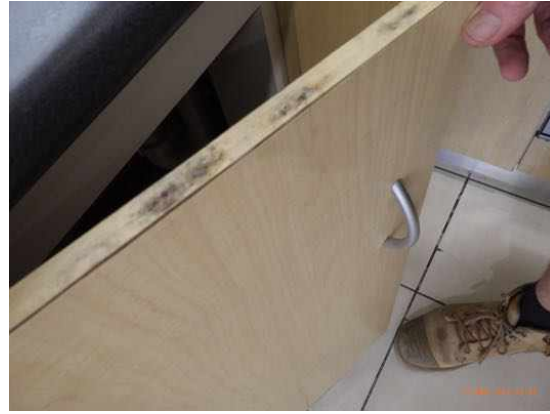
Finding 3.01

Building:	Building 1
Location:	Kitchen and laundry
Finding:	Damage, Benchtops
Information:	Damage was observed to the benchtops throughout the dwelling at the time of inspection, most notably within the laundry and kitchen areas.

In the laundry, the benchtop exhibited extensive moisture-related deterioration with rot evident, along with associated minor damage to the cabinetry below internally.

The kitchen benchtops also showed signs of deterioration including swelling and general wear, indicating they are nearing the end of their serviceable lifespan.

The damage is consistent with prolonged moisture exposure and general age-related deterioration.

If left unaddressed, continued moisture ingress and material breakdown may lead to further deterioration of cabinetry components, potential hygiene concerns, and the need for more extensive replacement works.

Repairs and/or replacement should be carried out by a suitably qualified and licensed builder or cabinetmaker to rectify the affected areas. Rectification is recommended in the short to medium term, with the laundry requiring more immediate attention due to active moisture-related damage.

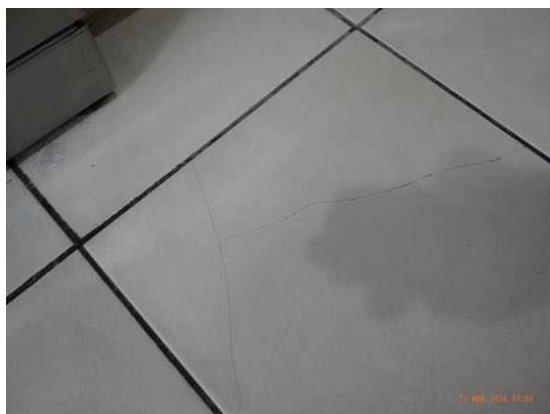
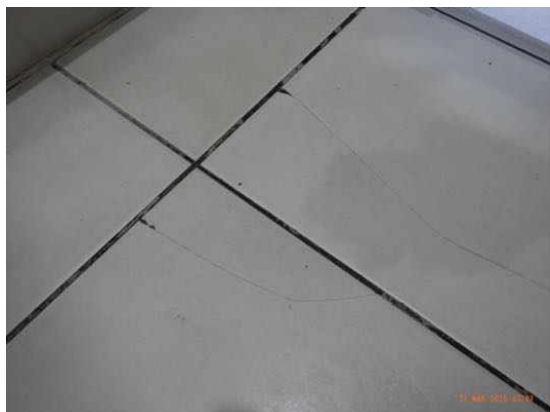
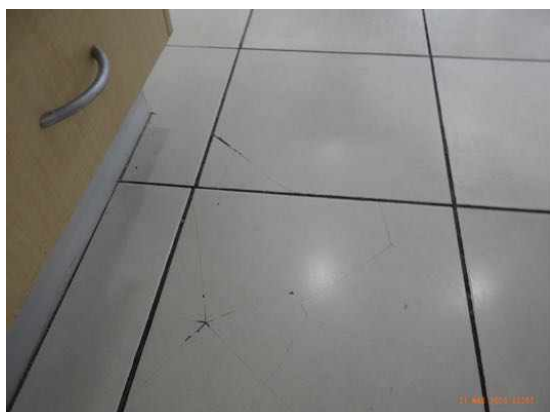
Finding 3.02

Building:	Building 1
Location:	Kitchen/ living
Finding:	Tiles - Cracked or damaged minor
Information:	Cracking was evident to approximately 10 tiles to the kitchen and living area of the home at the time of inspection. It also appears that approximately 10% of the floor tiles sound drummy, meaning they have lost their bond to the floor beneath.

The cracking appears to be minor and is likely due to general movement, settlement of the building.

As the area should not be immersed in water, no secondary defects are likely to be created and as such repairs left to the discretion of the client.

A tiling contractor could be appointed to make repairs to return the ascetics of the property.

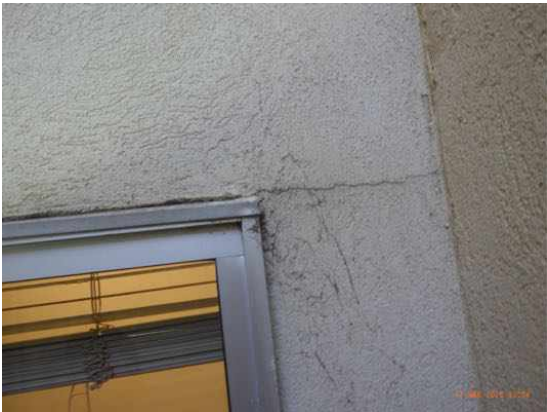
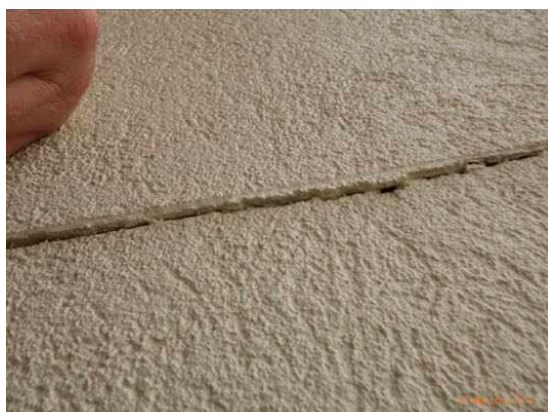
Finding 3.03

Building:	Building 1
Location:	Exterior walls
Finding:	Rendered light weight wall cladding - Hairline Cracking
Information:	Cracking was observed to the lightweight wall panelling at multiple locations throughout the dwelling at the time of inspection.

The cracking appears minor and is generally consistent with movement, shrinkage or installation-related issues.

If left unaddressed, the cracking may allow moisture ingress which can contribute to deterioration of the wall system, potential damage to internal finishes, and an increase in repair scope over time.

Repairs should be carried out by a suitably qualified and licensed builder to assess, seal and rectify the affected areas. Rectification is recommended in the short term as part of routine maintenance to prevent further progression.

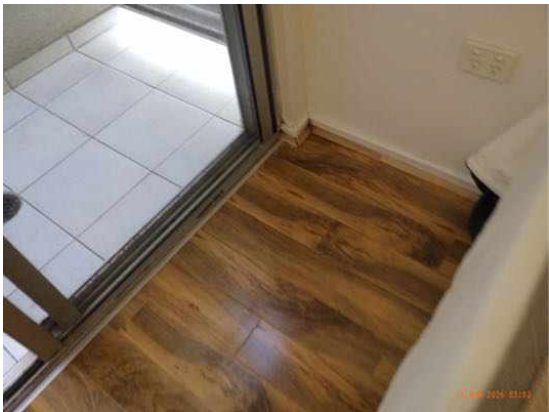
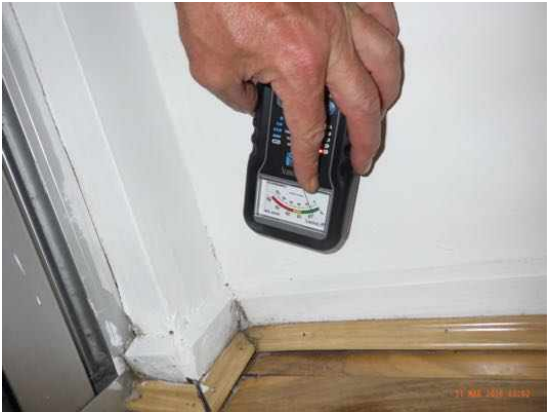
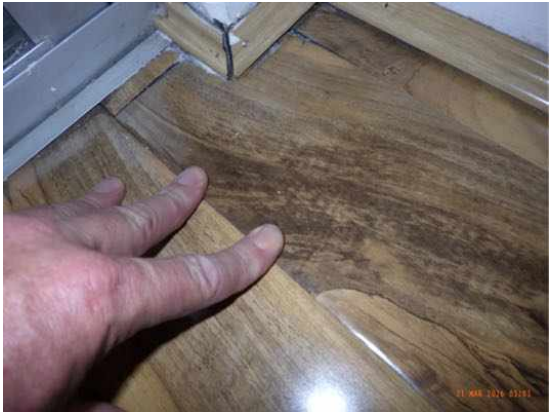
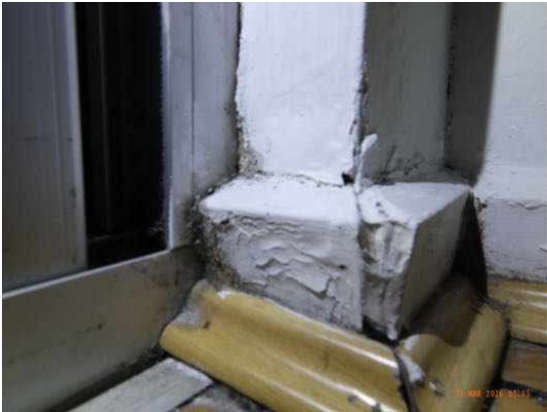
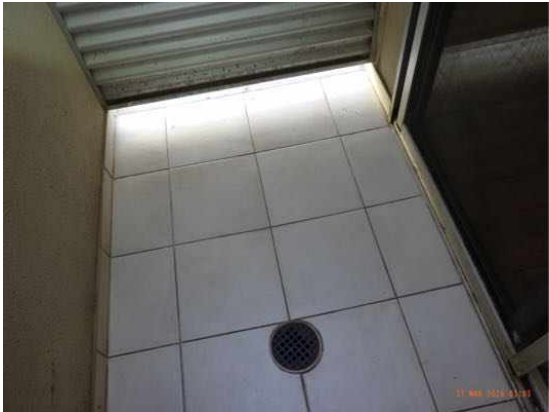
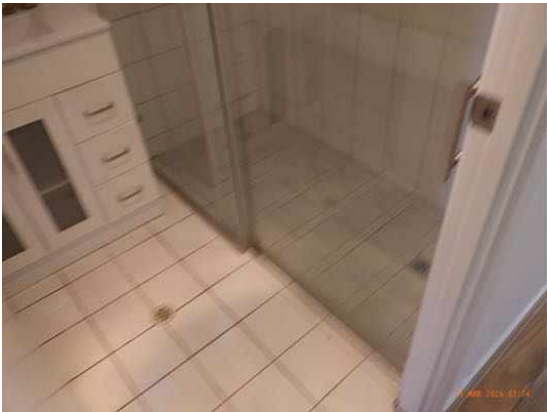
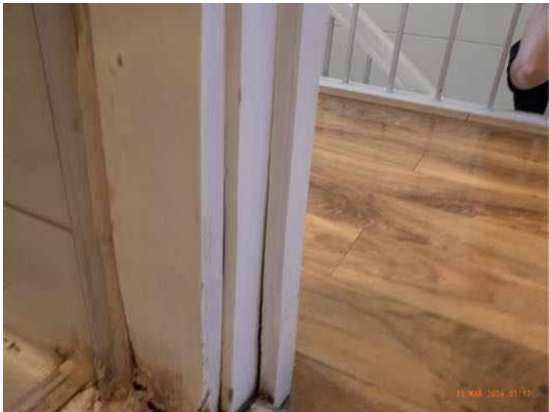
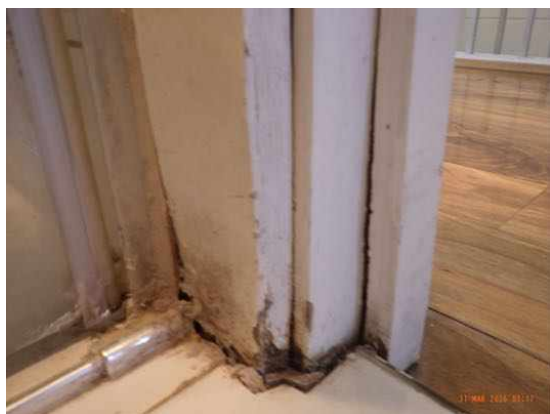
Building:	Building 1
Location:	Ensuite and ground floor bedroom
Finding:	Elements - Swollen
Information:	Swelling was observed to the architraves within the ensuite bathroom and adjacent to the sliding door in the lower bedroom at the time of inspection. No abnormal moisture readings were evident.

The swelling of these building elements is typically indicative of moisture exposure. In the ensuite, this is likely associated with the proximity to the shower area or moisture wicking from wet floor surfaces, while in the lower bedroom it is likely attributable to rainwater ingress at or around the sliding door.

If left unaddressed, continued moisture exposure may result in further deterioration of the affected timbers, potential damage to adjoining finishes, and an increased risk of concealed moisture-related issues such as decay or mould.

A suitably qualified and licensed builder should be engaged to investigate the source of moisture ingress and carry out appropriate repairs, including rectification of the moisture source and replacement of affected materials. Rectification is recommended in the short term to prevent further deterioration.

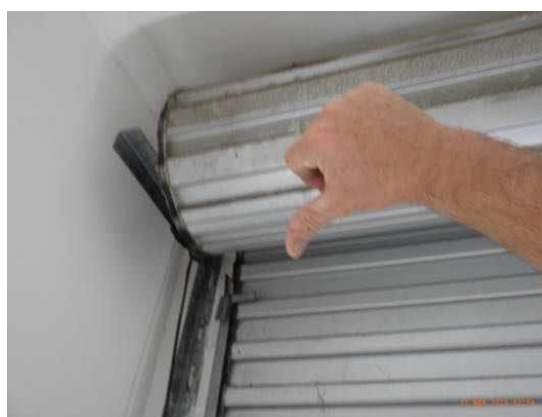
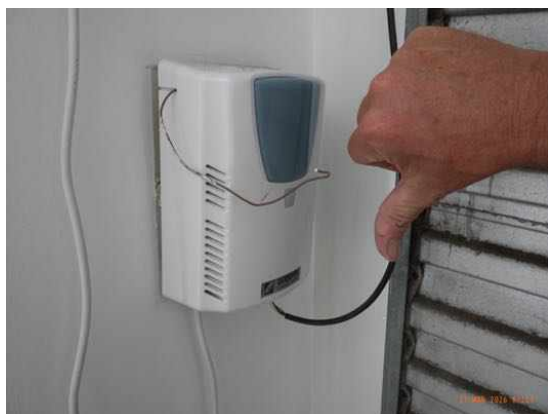
The issue is likely attributable to mechanical failure, electrical fault, or general wear and tear of the door system or motor components.

If left unaddressed, the defect may result in ongoing inaccessibility to the garage, potential security concerns, and further deterioration of the door system.

A suitably qualified garage door technician should be engaged to assess and carry out the necessary repairs to restore proper operation. It is understood and agreed that the vendor will arrange for this defect to be rectified prior to settlement.

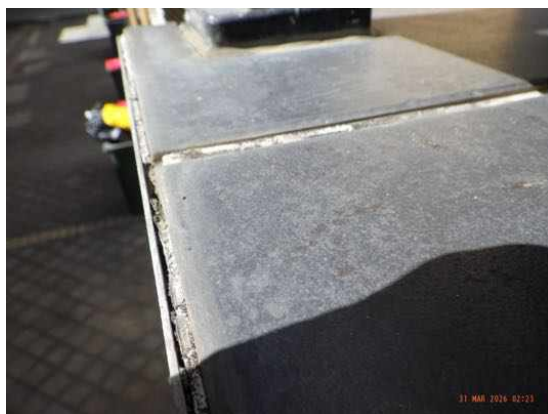
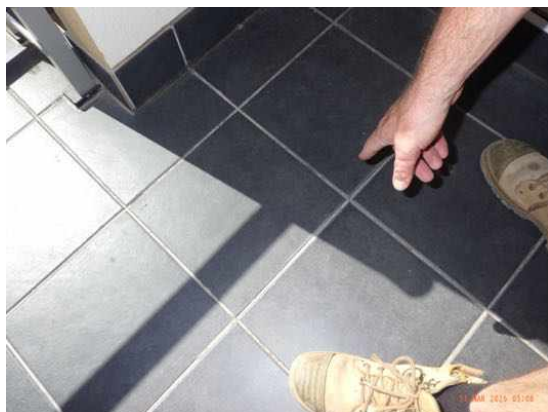
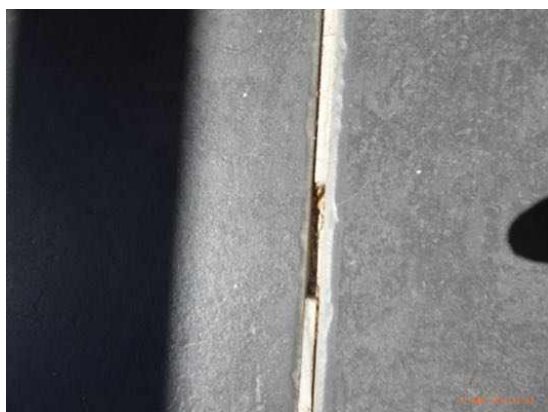
Building:	Building 1
Location:	Carport
Finding:	Ceiling - Water stained - No high moisture
Information:	Water staining to ceiling linings was evident in the garage at the time of inspection. There were no high readings for moisture however it is the start of autumn and we have had long dry spells. There is deteriorated tiling above and as such repairs are required.

Water staining indicates that surfaces have been exposed to excessive moisture over time. The minerals and other elements in the water lead to staining, which may graduate to corrosion and deterioration if left unmanaged.

While mostly an appearance defect, water staining can be indicative of more serious defects, which may be currently concealed by interior ceilings.

Where water staining is active, a licensed floor tile in this case, must be consulted to identify the cause of the staining and to provide advice on any reparation works that may be required. Replacement of any damaged structures is advised.

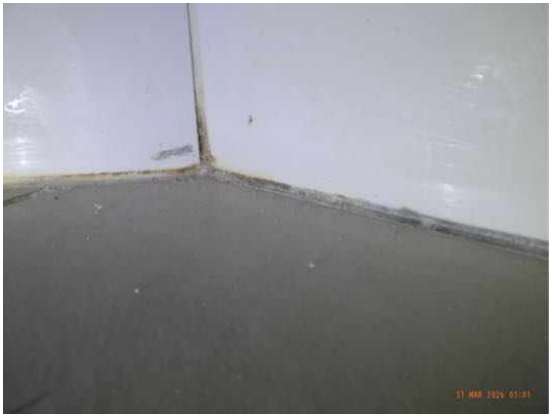
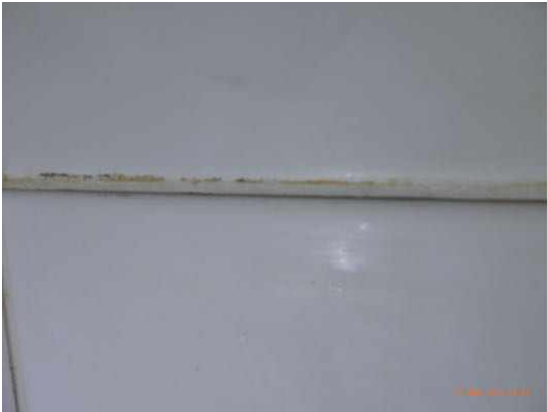
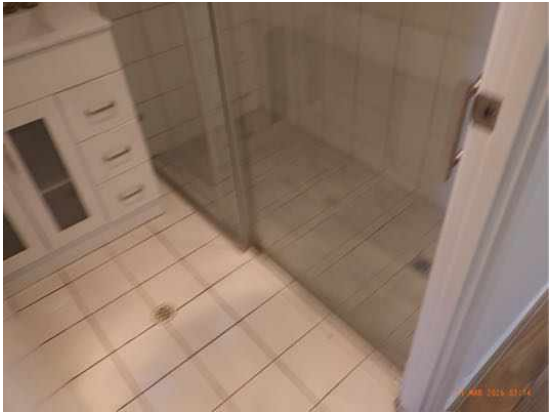
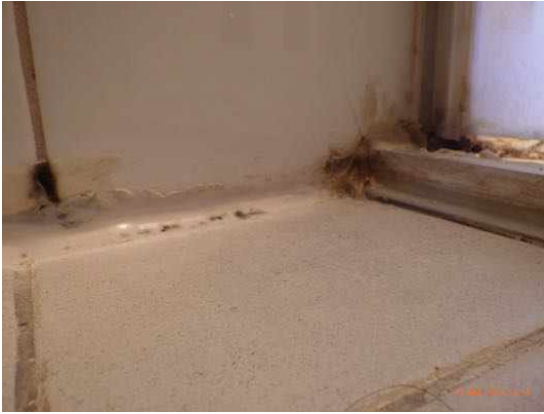
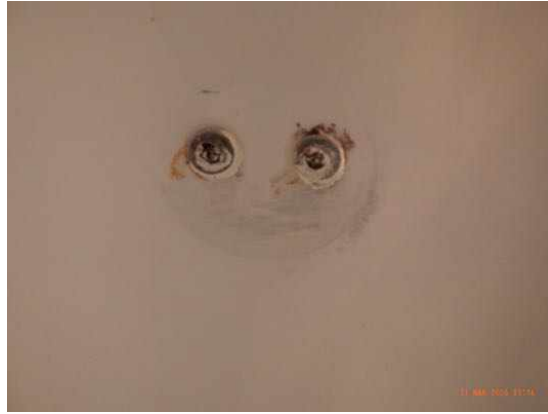
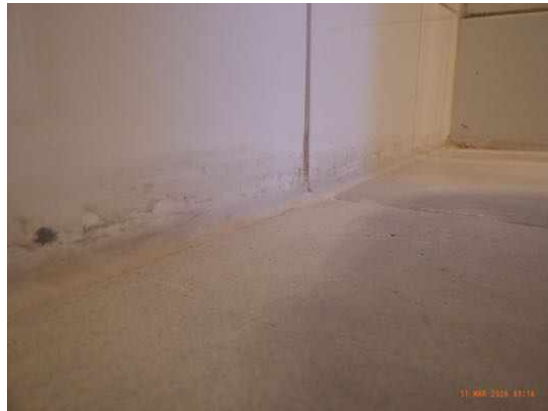
Finding 6.04

Building:	Building 1
Location:	Both bathrooms
Finding:	Sealant and grouting - Regular maintenance
Information:	It was noted on inspection that sealant and grout has small areas of deterioration evident to the shower alcove at the time of inspection.

Silicone and grout generally need repair at least every 5 years and as such close monitoring should be carried out in the future after repairs are carried out.

Different materials and floor areas move at different rates, generally causing cracking to grout or sealant at this point. A flexible sealant is required to allow for expected

Flexible and mould resistant materials should be applied to affected areas to prevent any subsequent water damage that is likely to occur. Regular maintenance and replacement of damage or missing or damaged sealant and grout is highly recommended to the wet areas, as this is a regular wear and tear defect. Sealant and grouting in areas that come into regular contact with water should be maintained for the long term care of your property.

A sealant specialist or tiling contractor should be appointed to complete these works as soon as possible
