Building Inspection Report

Inspection Date: Fri, 27 Feb 2026

Property Address: 8 Lemongrove Way, Narre Warren South
VIC 3806, Australia

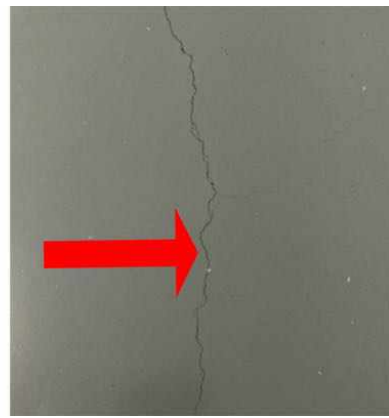
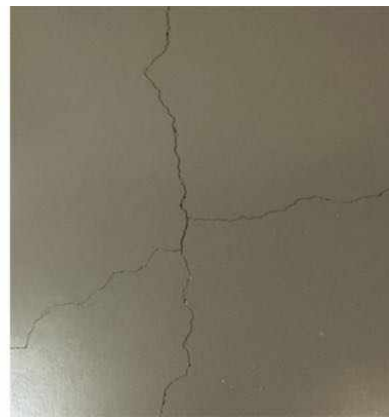
Defects 3.02

Finding: Noticeable cracks in concrete slab of the the garage floor

Information: During the inspection, multiple noticeable cracks were identified in the concrete slab of the garage floor. These cracks vary in size and location, which may indicate underlying movement or stress within the slab. While they do not currently appear to significantly impact the structural integrity, their presence suggests potential early-stage deterioration.

It is recommended that the cracks be monitored closely over the next 12 months. If any of the cracks widen or worsen during this period, it is critical to engage a structural engineer immediately to assess the situation and recommend appropriate rectification measures to prevent further damage and ensure the long-term stability of the structure.

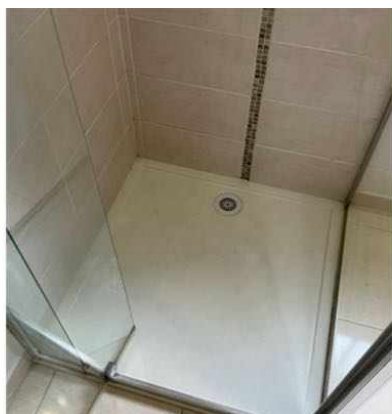
Defects 3.04

Building:	Main Building
Location:	Ensuite - Master
Finding:	Sealant and grouting - Deteriorated
Information:	It was noted on inspection that sealant or grout is degraded to the tiled shower alcove and or other areas of the bathroom.

Different materials and floor areas move at different rates, generally causing cracking to grout or sealant at this point. A flexible sealant is required to allow for expected expansion and contraction, while keeping the joint water tight and protective of all associated building materials.

Flexible and mould resistant materials should be applied to affected areas to prevent any subsequent water damage that is likely to occur. Regular maintenance and replacement of damage or missing or damaged sealant and grout is highly recommended to the wet areas, as this is a regular wear and tear defect. Sealant and grouting in areas that come into regular contact with water should be maintained for the long term care of your property.

A sealant specialist or tiling contractor should be appointed to complete these works as soon as possible

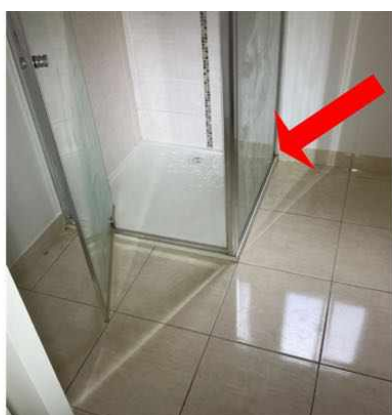
Defects 3.05

Building:	Main Building
Location:	Ensuite - Master
Finding:	Shower screen - Leaking
Information:	Leaking was evident to the ensuite's shower screen at the time of inspection. It is suspected that the leaking has occurred as a result of deteriorated or missing caulking to the shower or general ageing of the building elements.

Leaking from the shower where left unattended, is likely to lead to water damage to adjoining flooring and walls. Such damage can lead to water damage and necessitate extensive remedial works being required. Active water leaks may also create an environment that is susceptible to the formation and development of mould.

Appointment of a caulking contractor is required to repair or replace the caulking to the shower area. Such works should be performed as soon as possible to ensure that no further damage occurs.

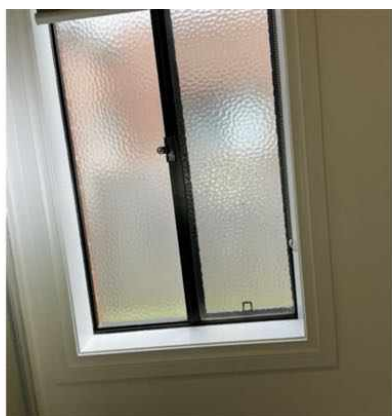
Defects 3.06

Building:	Main Building
Location:	Bathroom 2
Finding:	Window - Stiff to slide

Information: The window in the bathroom was stiff and difficult to operate at the time of the inspection. Windows provide ventilation to the adjoining area and should be at a fully operational level to ensure user comfort. Restricted function of the window may also pose as a potential safety hazard if required for emergency egress from the building.

Generally, factors such as general age of the building element and a lack of maintenance are the usual causes for this type of defect.

Replacement of window hardware or frame may be required, as well as minor repairs and cleaning. A registered builder or general handy person will be required to repair the window.

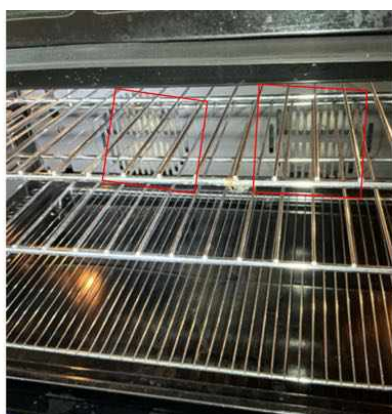
Defects 3.08

At the time of inspection, the oven was tested and observed to be operational. However, both internal oven fans were noted to be loud and producing noticeable noise during operation.

While the oven was functioning, louder-than-expected fan noise may indicate wear to the fan motor, bearings, or internal components. Over time, this condition may affect the appliance's performance or lead to further mechanical deterioration if not addressed.

It is recommended that a suitably qualified appliance technician or oven specialist be engaged to assess the oven, identify the source of the noise, and undertake any necessary servicing or repairs to ensure continued safe and proper operation.

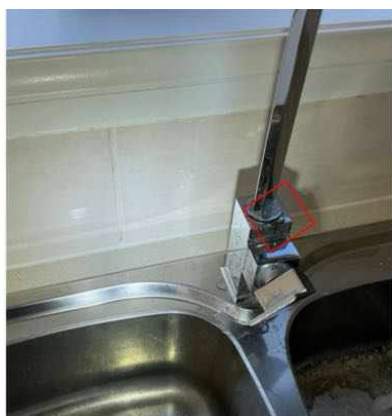
Defects 3.09

Building: Main Building
 Location: Kitchen
 Finding: Tap - Leaking

Information: The kitchen's tap was found to be leaking at the time of inspection. This is a common defect that is consistent with general ageing of the building element. However, it may be indicative of substandard plumbing workmanship if the tap is relatively new.

While this defect only seems minor, if left unmanaged, it is likely to result in the development of rust, water damage and/or extensive water usage.

It is advised that a handyman or licensed plumber be appointed to perform remedial works on the affected tap. Such works should be performed prior to the development of secondary defects to ensure adequate functionality of all associated building elements.

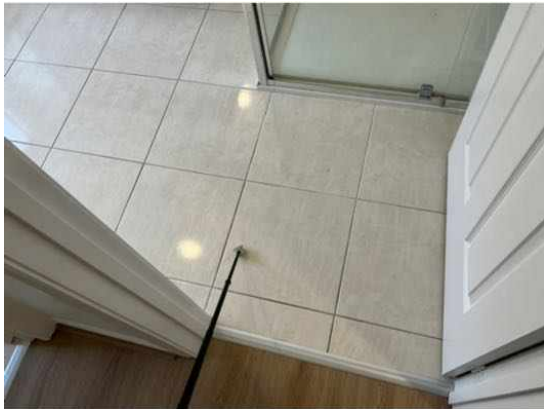
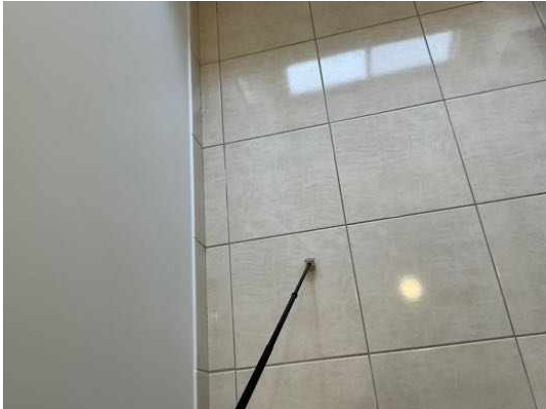
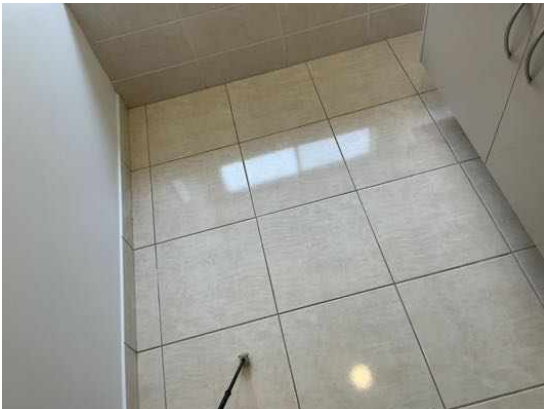
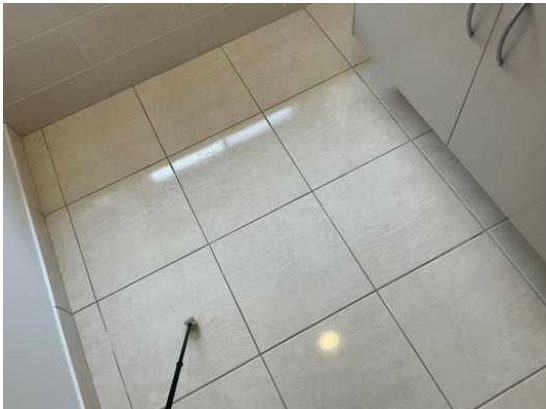
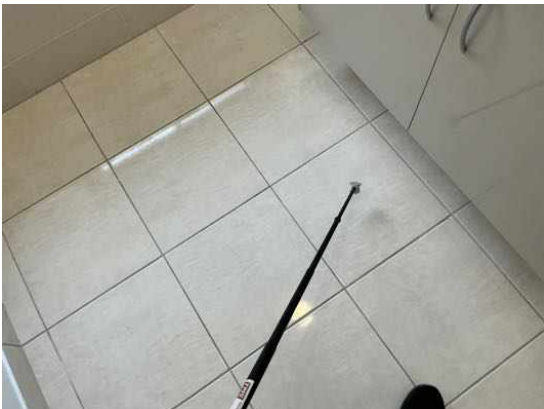
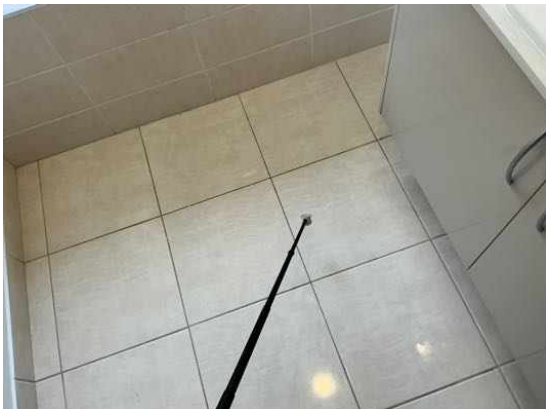
Defects 3.13

Building: Main Building
 Location: All Internal Areas
 Finding: Tiles - Drummy
 Information: Drummy tiled areas were identified at the time of inspection. The term 'drummy' refers to tiles that have become detached from their fixing, despite otherwise being in relatively good condition. Such defects are generally caused by physical or moisture damage to the area. Drummy tiled areas may also be a direct result of poor workmanship during the construction process.

Tiled areas may swell and shrink with changes in air humidity if the area has sustained

moisture damage. Any exposure to moisture is capable of causing tiled areas to become drummy and/or cracked over a prolonged period of time. Drummy tiled areas generally require removal and replacement of affected tiles, with adequate sealant and grouting.

Specialist trades are available for these types of services. A registered builder may be required to undertake works if damage is extensive or if secondary building defects have resulted. Otherwise, it is advised that a tiling contractor be appointed to perform works as necessary. Immediate action is recommended to ensure that no further damage is sustained in the affected area.

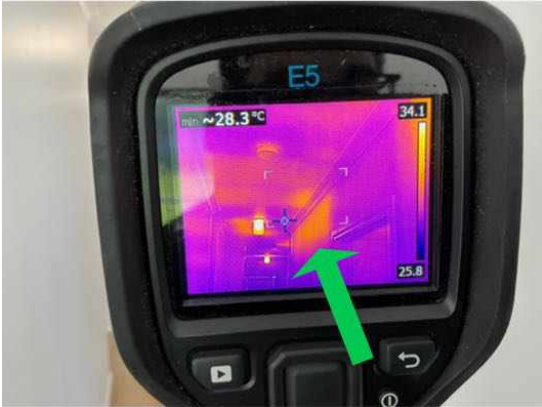
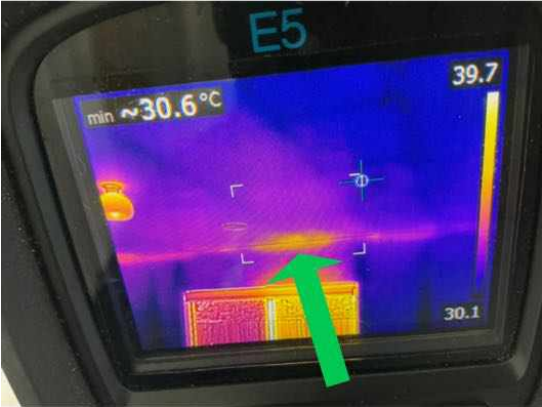
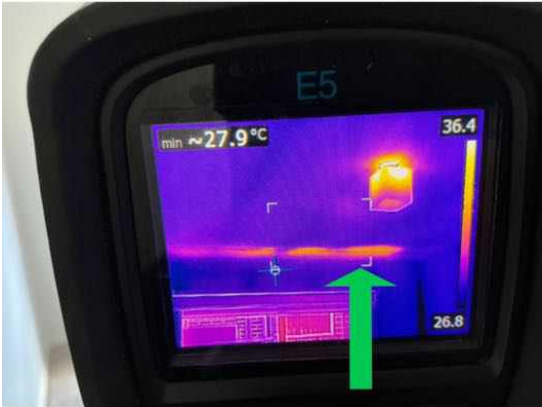
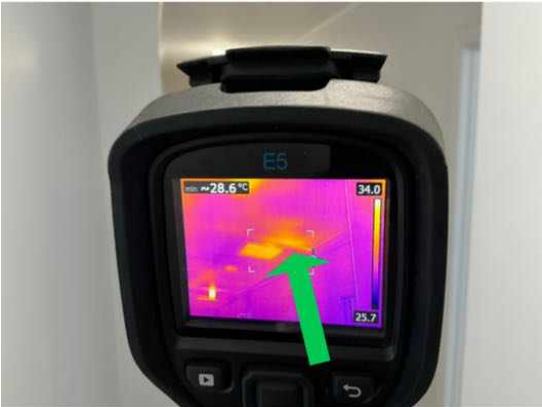
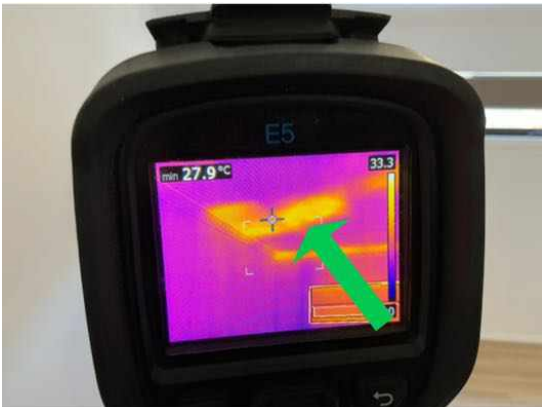
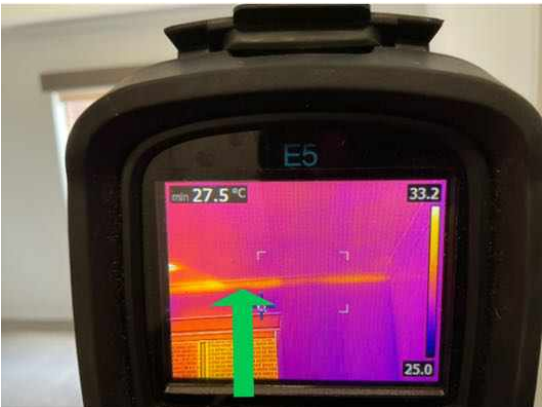
Defects 3.14

Building:	Main Building
Location:	All Internal Areas
Finding:	Inconsistent Thermal Performance to Ceiling Areas – Suspected Insulation Deficiencies
Information:	Thermal imaging conducted to internal ceiling areas at the time of inspection identified inconsistent heat patterns, which are indicative of variations in thermal performance across the roof space. These patterns are commonly associated with areas of missing, displaced, or insufficient insulation above the ceiling linings.

Inadequate or uneven insulation coverage can reduce the energy efficiency of the dwelling, contribute to heat loss in cooler periods and heat gain in warmer conditions,

and may result in reduced occupant comfort and increased heating and cooling costs. Due to the non-invasive nature of the inspection, the exact extent and condition of insulation could not be confirmed visually in all affected areas.

It is recommended that a qualified insulation contractor inspect the roof space, assess insulation coverage and condition, and top up or reinstate insulation where required to achieve consistent thermal performance throughout the property.

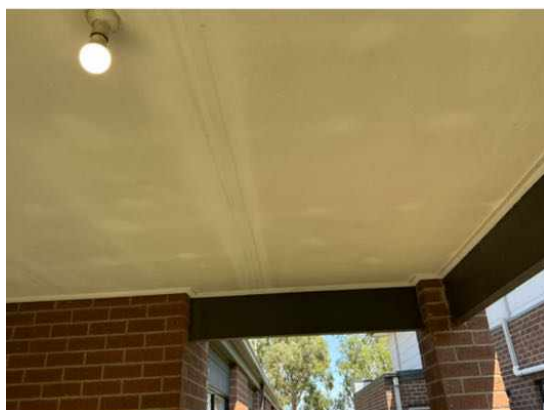
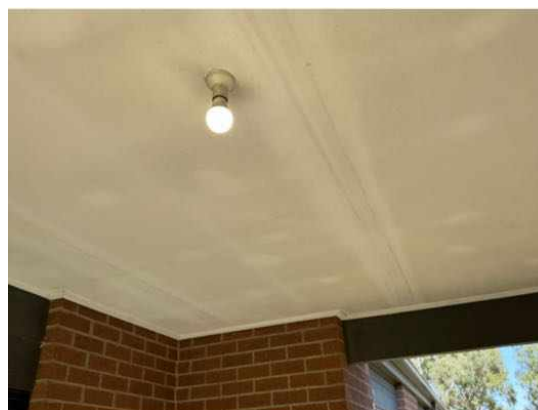
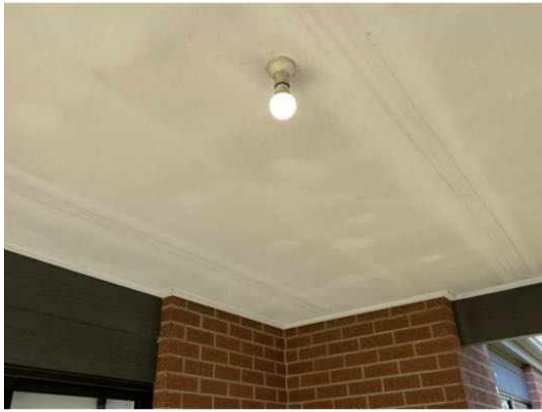
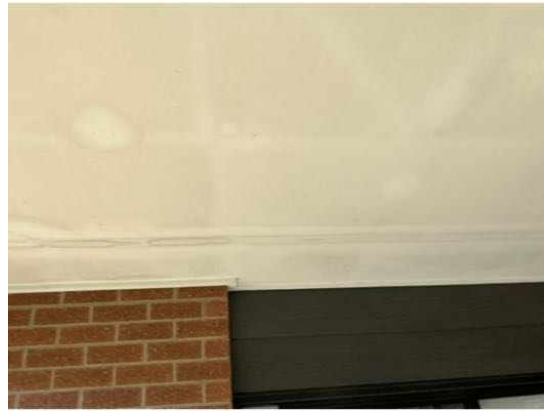
Defects 3.15

Building: Main Building
 Location: Alfresco
 Finding: Unfinished Plaster Ceiling – Alfresco Area
 Information:

At the time of inspection, the plaster ceiling lining within the alfresco area was observed to be installed and patched; however, it remains unfinished and unpainted.

Unpainted plasterboard is susceptible to moisture absorption, staining, and premature deterioration, particularly in semi-external environments such as an alfresco area where humidity and temperature fluctuations may occur. Leaving the surface unsealed may also affect the overall durability and presentation of the area.

It is recommended that a qualified painter be engaged to properly prepare, seal, and apply an appropriate exterior-grade paint system to the plaster ceiling to protect the substrate and complete the finish.

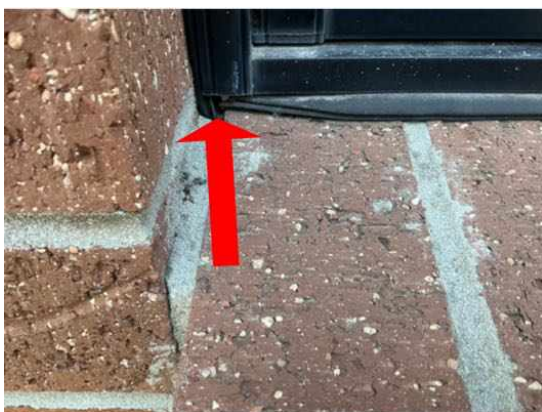
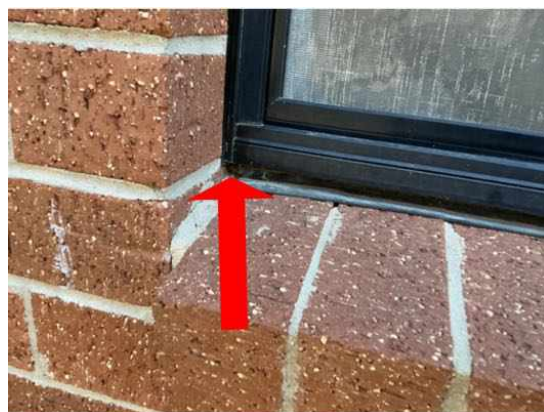
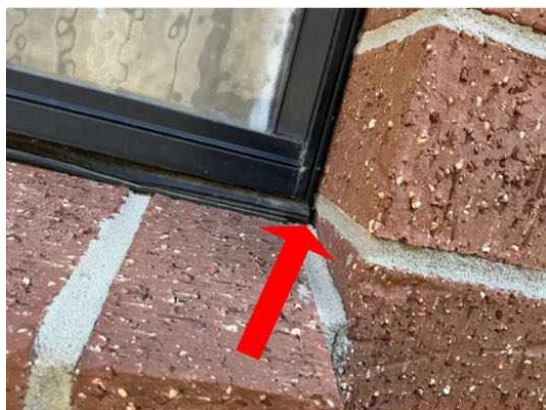
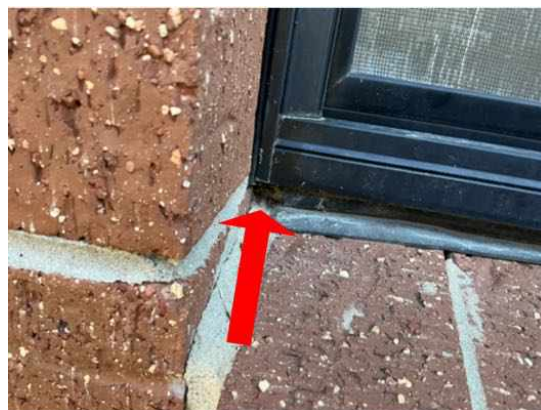
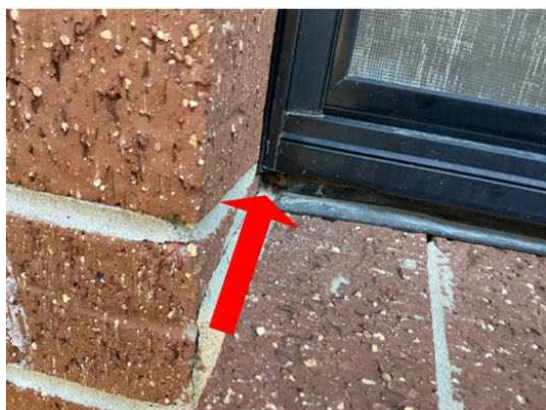
Defects 3.16

Building:	Main Building
Location:	All External Areas
Finding:	Gaps Around External Window Frames
Information:	Multiple gaps were identified between the external window frames and the adjoining brickwork across several elevations. These gaps appear to be the result of either poor or inconsistent sealant application during installation, or deterioration of the original sealant over time.

Unsealed or poorly sealed gaps can allow moisture ingress, wind-driven rain, draughts, and provide potential entry points for pests. Ongoing exposure to moisture may also contribute to internal dampness and premature deterioration of surrounding building elements.

A qualified handyman or registered builder should apply a consistent, waterproof, flexible exterior-grade sealant around all affected windows to ensure adequate weatherproofing and protection against moisture and pest entry.

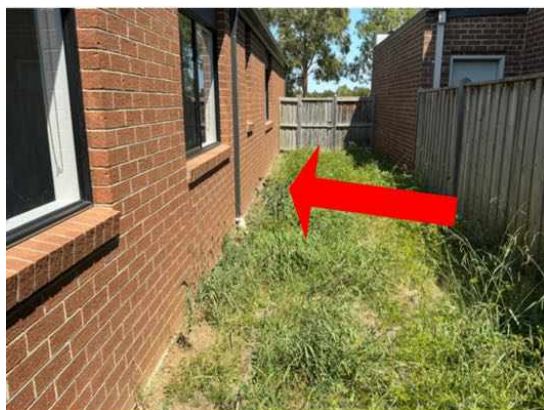
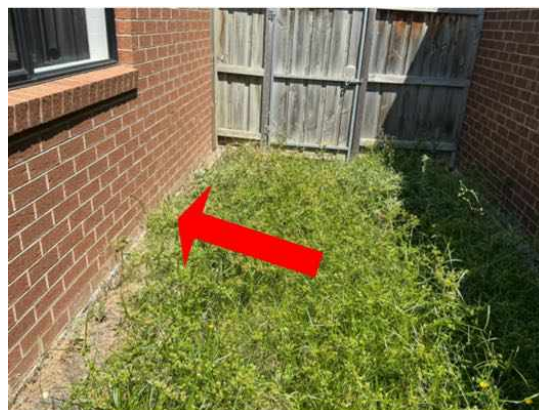
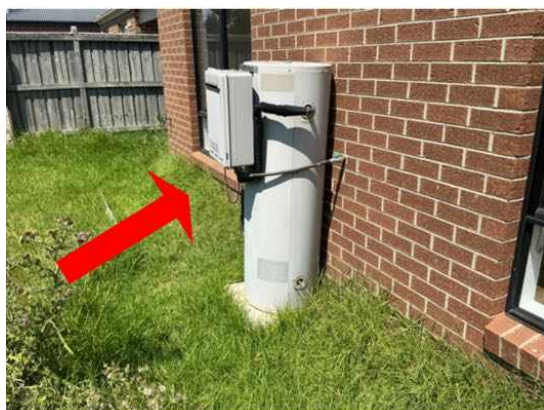
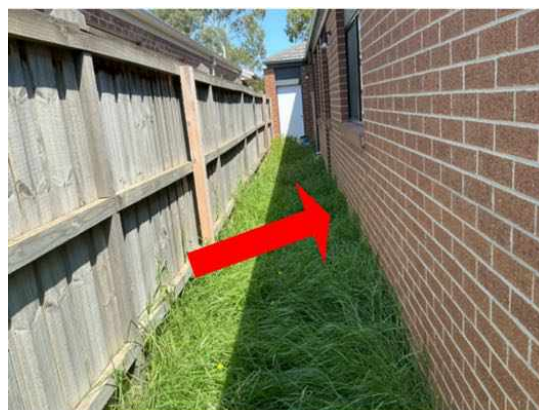
Defects 3.17

Building:	Main Building
Location:	All External Areas
Finding:	Site drainage - Inadequate
Information:	The site drainage in the yards was found to be inadequate at the time of inspection, creating potential for subsequent water damage to associated building elements.

It is important that water does not lie against the base of walls; surrounding paths and ground levels should be sloped to drain water away from walls. Downpipes should not discharge stormwater onto lower walls or plinths. Stormwater should be carried away by large, regularly cleaned drains. Ground levels may need to be lowered to expose a buried DPC.

Where site drainage is inadequate, installation of an Agricultural (Aggie) Drain may be required. A qualified plumber should be appointed to further inspect the property and perform any remedial works as necessary. Water damage and secondary defects are likely to occur if left unmanaged.

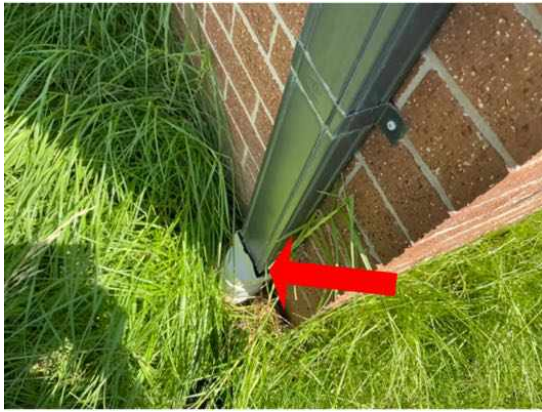
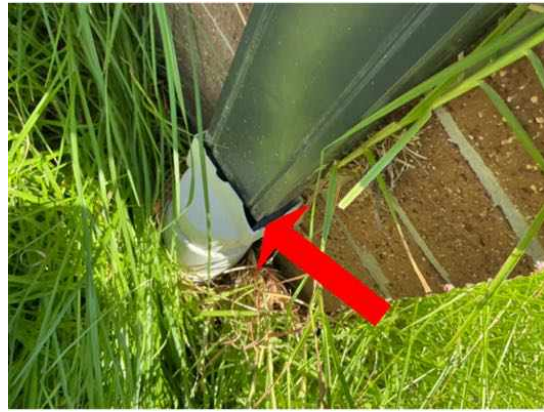
Defects 3.18

Building:	Main Building
Location:	Yard - Back
Finding:	Partially Detached Downpipe
Information:	One of the downpipes around the rear property were observed to be slightly detached from their stormwater connections at the base. This may have resulted from minor soil movement or settlement around the connection points.

Partial disconnection may cause water to discharge near the foundation, leading to potential pooling, soil erosion, or moisture ingress around the building.

A licensed plumber should be engaged to properly reconnect and secure all affected downpipes to ensure effective stormwater drainage.

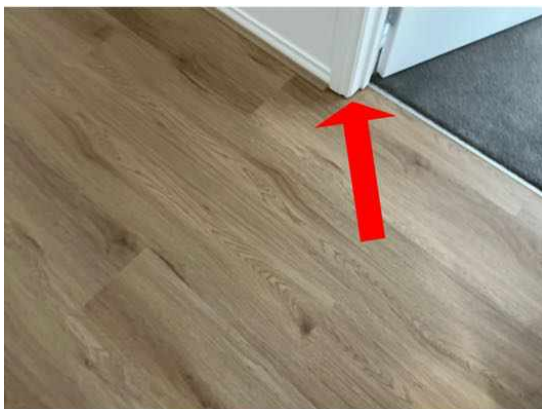
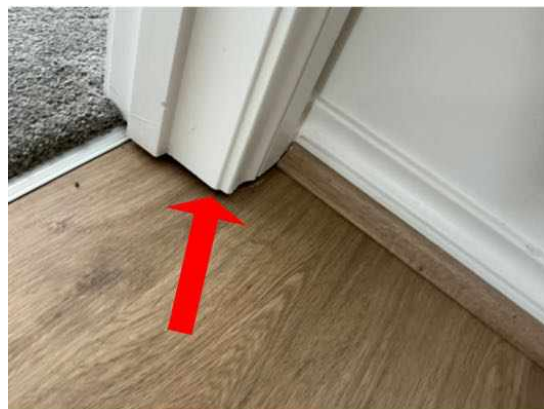
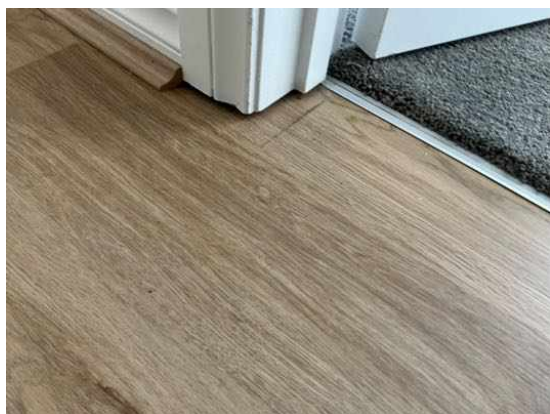
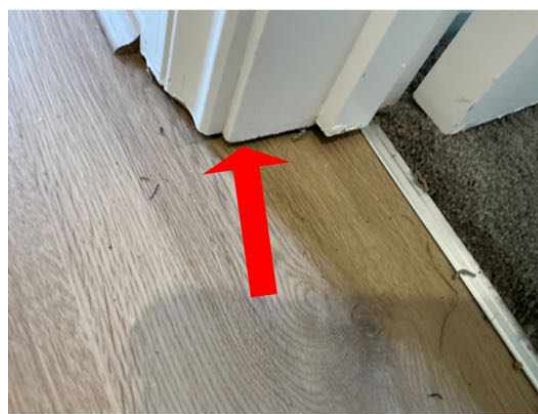
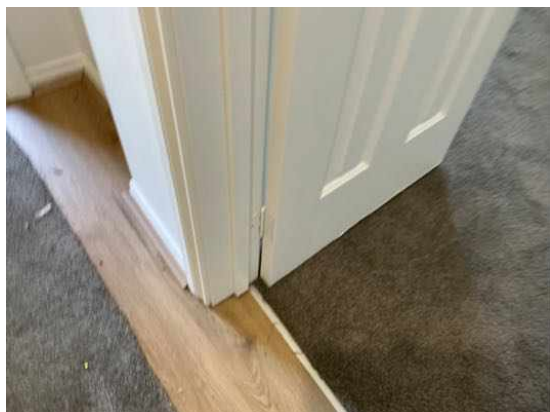
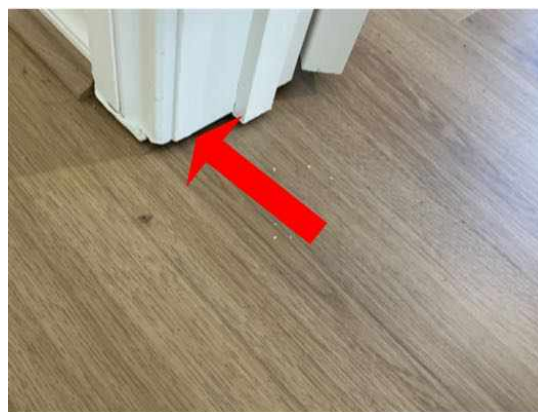
Defects 3.19

Building: Main Building
 Location: All Internal Areas
 Finding: Gaps at Door Frames and Flooring Junctions
 Information:

At the time of inspection, multiple gaps were observed at the junctions between the flooring finishes and the base of the door frames throughout various areas of the dwelling. These gaps appear to be present around several door openings and along floor-to-frame interfaces.

Such gaps commonly occur where floor coverings have been replaced or where allowance has been made for different flooring thicknesses. While this condition is generally cosmetic in nature, unsealed gaps may allow dust accumulation, minor draughts, or insect ingress and may detract from the overall finish of the internal areas.

If desired for improved presentation and sealing, it is recommended that a qualified carpenter or flooring installer be engaged to install appropriate trim mouldings or apply suitable flexible sealant to neatly close the gaps where required.

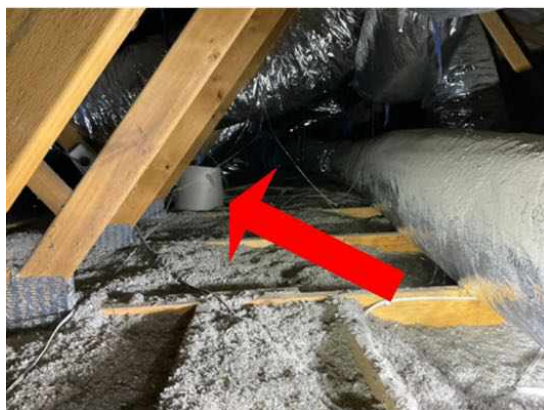
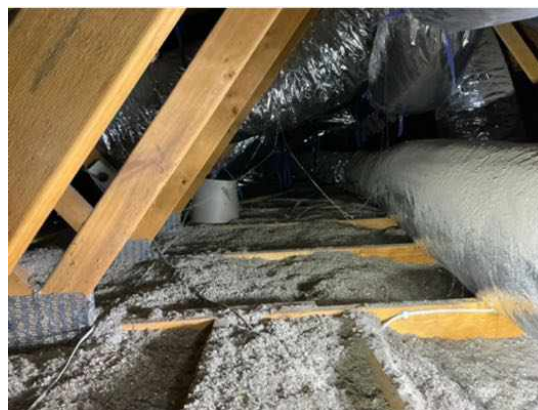
Defects 3.20

Building:	Main Building
Location:	Roof Void
Finding:	Bathroom Exhaust Fans Not Ducted to External Atmosphere
Information:	The exhaust fans installed in the bathrooms were observed to be discharging directly into the roof cavity rather than being ducted to the external atmosphere. This configuration does not comply with best practice ventilation standards, as it allows moist air to accumulate within the roof space.

Prolonged moisture build-up in the roof cavity can lead to elevated humidity levels, which may contribute to mould growth, timber decay, and potential damage to insulation or other roof components over time.

It is recommended that a licensed ventilation specialist or electrician be engaged to install compliant ducting that vents the exhaust air to the outside of the building, in accordance with current building regulations and ventilation standards.

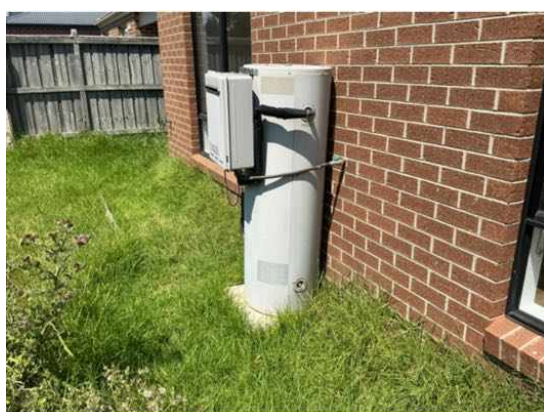
Defects 3.21

Building:	Main Building
Location:	Backyard
Finding:	HWS Overflow - Not Connected
Information:	The Hot Water System (HWS) overflow was found to be disconnected from storm water drainage and is creating excessive moisture in the surrounding area.

These damp conditions can lead to secondary defects such as rot, rust or corrosion of associated building elements, the formation of fungal decay, or even the creation of potential slip hazards. When coupled with poor site drainage, pooling of water may also attract termite activity to this area.

It is highly recommended that a licensed plumber be appointed to connect the HWS overflow in order to prevent such an environment from being created. These minor works should be carried out as soon as possible.

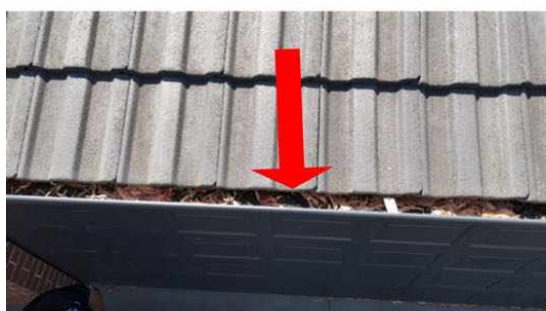
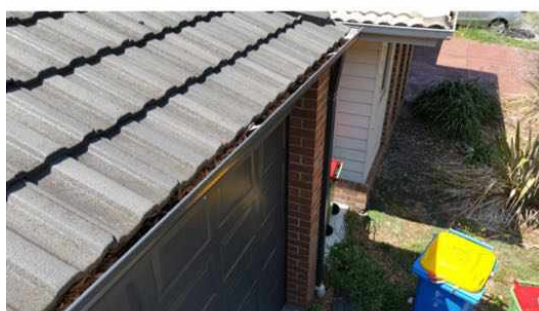
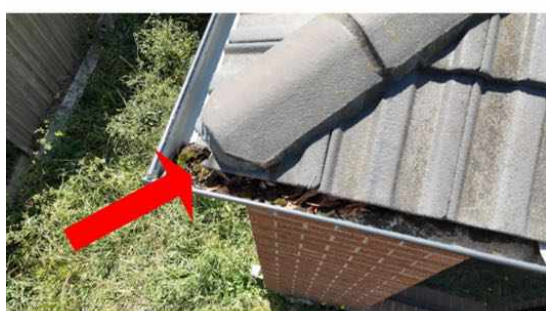
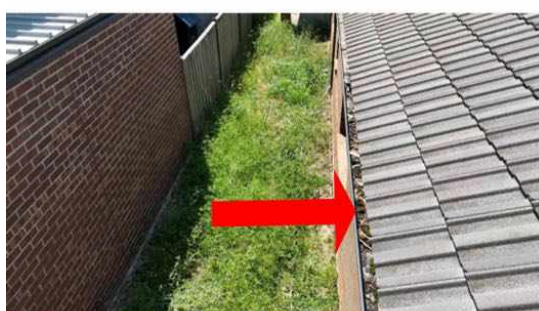
Defects 3.22

Building:	Main Building
Location:	Roof Exterior
Finding:	Gutters - Partially Blocked
Information:	Sections of the external gutters were partially blocked with debris, soil and leaves.

Blocked gutters are likely to lead to high levels of moisture in the affected areas. Such moisture will not only cause rust and decay of the associated building materials, but can also provide conditions that are conducive to termite and timber pest activity. Blockages in gutters should therefore be removed immediately to ensure dry conditions are maintained.

Consult a Licensed Plumber for further specific advice on remedial works that may be required. In the interim, it is highly advised that blocked gutters be removed by the homeowner or a general handyperson as a matter of urgency.

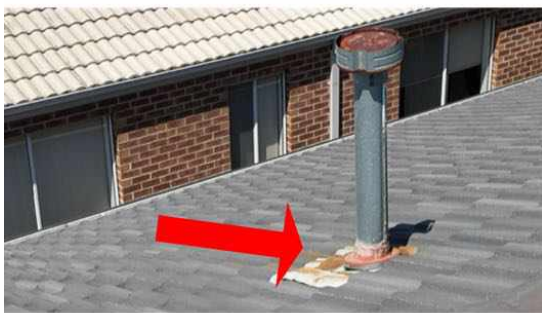
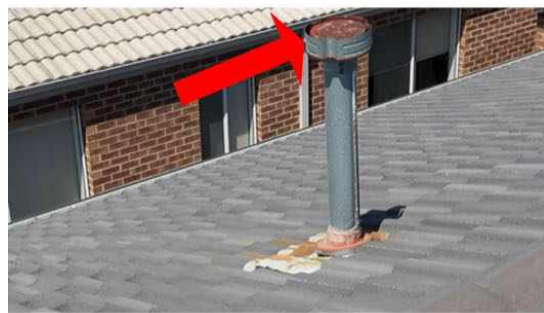
Defects 3.23

Building:	Main Building
Location:	Roof Exterior
Finding:	Corrosion to Flue and Roof Penetration
Information:

At the time of inspection, corrosion and surface rust were observed to the metal flue and its capping, with associated rust staining visible to the surrounding roof sheeting at the penetration point.

Corrosion to the flue components may lead to progressive material deterioration over time and can potentially affect the integrity of the flue assembly. In addition, rust staining and deterioration around the roof penetration may compromise the effectiveness of the flashing and increase the risk of moisture ingress if left unaddressed.

It is recommended that a qualified roofing contractor assess the flue and associated flashing, treat or replace corroded components as required, and ensure the roof penetration is properly sealed to prevent further deterioration and potential water ingress.

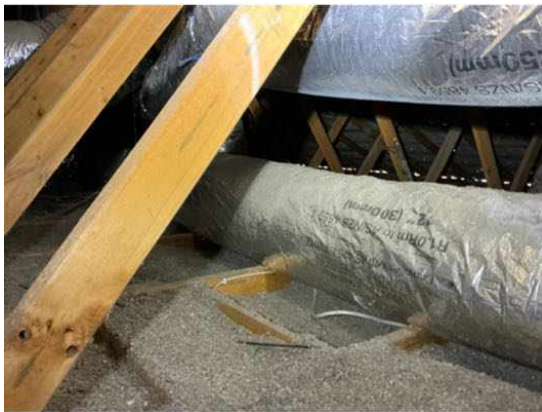
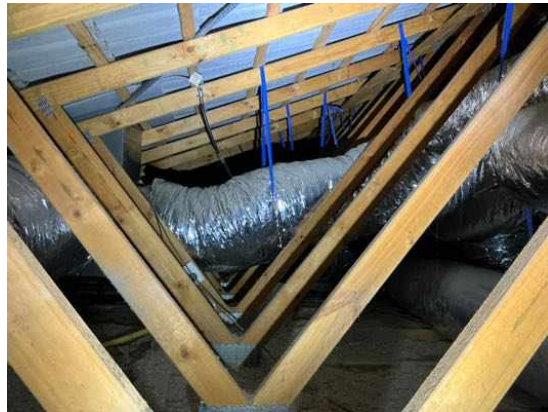
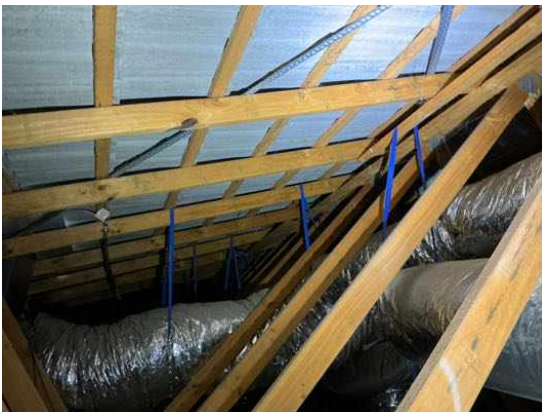
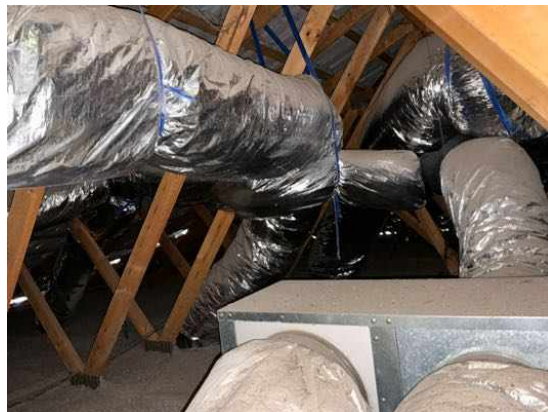
Building: Main Building
 Location: Roof Void
 Finding: Obstructions and Limitations - roof cavity
 Information: These photographs are an indication of the obstructions and limitations which impeded the inspection of the roof cavity area of the property at the time of inspection. These obstructions can hide an array of defects and should be removed to allow full inspection to be carried out. A re-inspection is recommended once the areas are made accessible.

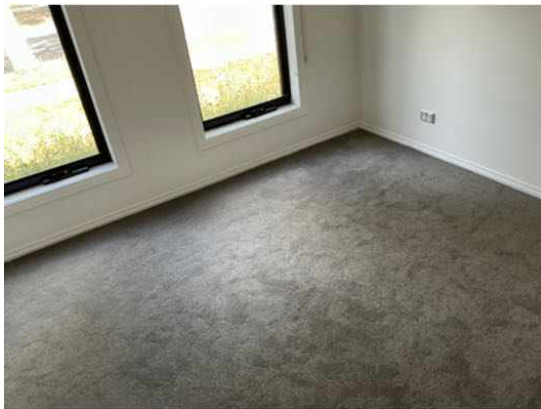
Finding: Obstructions and Limitations - Interior

Information: These photographs are an indication of the obstructions and limitations which impeded the inspection of the internal areas of the property at the time of inspection. These obstructions can hide an array of defects and should be removed to allow full inspection to be carried out. A re-inspection is recommended once the areas are made accessible.
