Building and Timber Pest Inspection Report

Inspection Date: Wed, 1 Apr 2026

Property Address: 3/80c Rathcown Rd, Reservoir VIC 3073, Australia

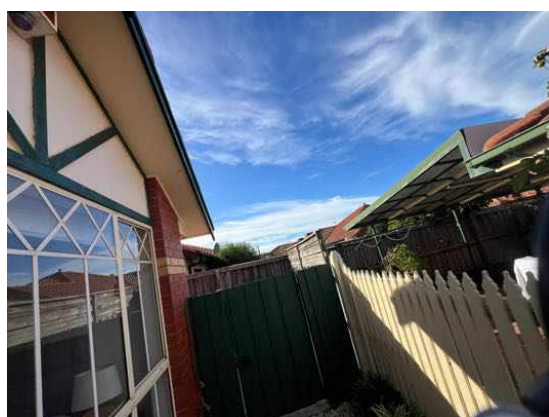
Building:	Main Building
Location:	Exterior walls - front > Front Right
Finding:	External painting deteriorated
Information:	Much of the external paintwork including but not limited to windows, fascias, guttering, veranda and other external fitments have been neglected and require attention to prepare and re-paint.

Whilst incomplete or missing paint finish is generally an appearance defect, it can also lead to the development of secondary building defects over time. Incomplete areas of paint finish expose the area to moisture, potentially accelerating the deterioration of underlying building materials.

Degraded paint finishes should be sanded back, filled, leveled and painted, as applicable. Where inadequate or missing paint protection has led to the deterioration of the associated building element, repair and/or replacement of this building element may be required.

A painting contractor should be appointed as soon as possible to perform necessary works to aid the appearance of the affected area and to ensure the area is protected against further deterioration. Alternatively, the homeowner following manufacturer instructions may perform these works.

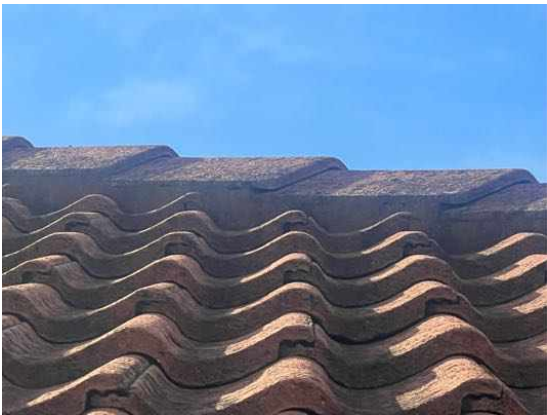
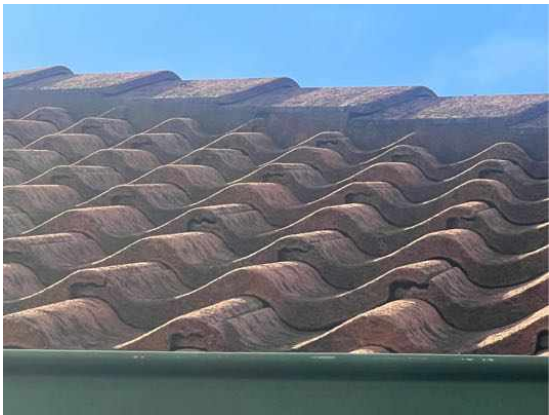
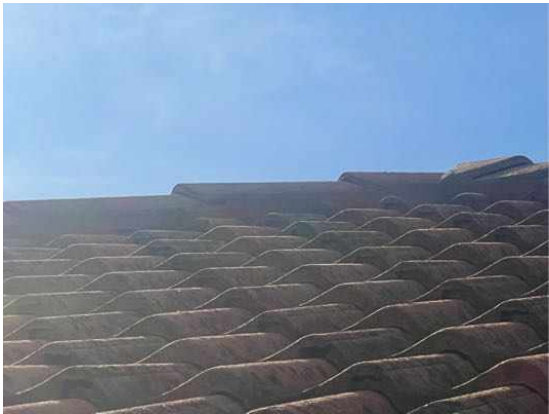
Where left unmanaged, deteriorating roof tiles are likely to lead to a number of secondary defects, including minor water leaks and weather exposure to internal roofing structures.

Consultation with a roofing contractor is highly advised to gain advice on cost of remedial works that may be required in the short to medium term. Remedial works are likely to increase the longevity of the exterior roofing structure.

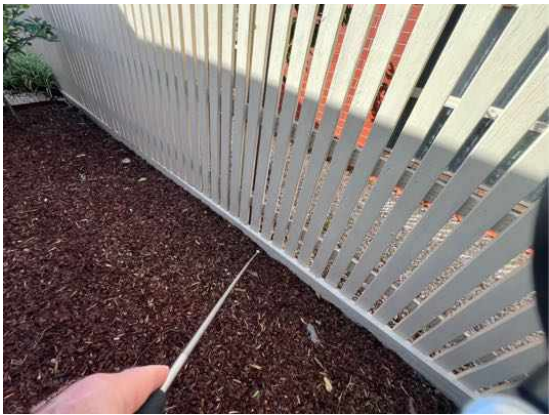
When met with excessive moisture timber begins to decay and develop wood rot. Any timbers that are in direct contact with external grounds especially if left untreated or non-durable also provide ingress for subterranean termites into that particular element.

The removal of any such materials that may be conducive to termite activity should be removed as soon as possible to minimise the risk of termite attack.

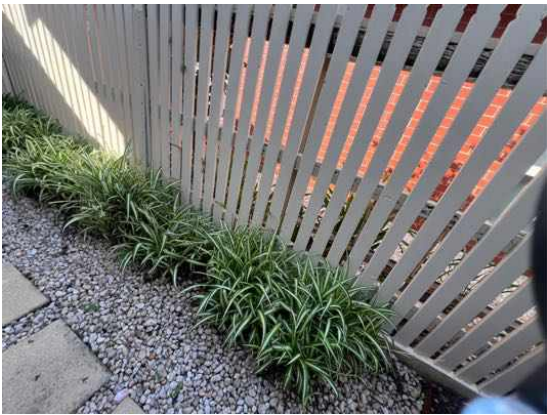
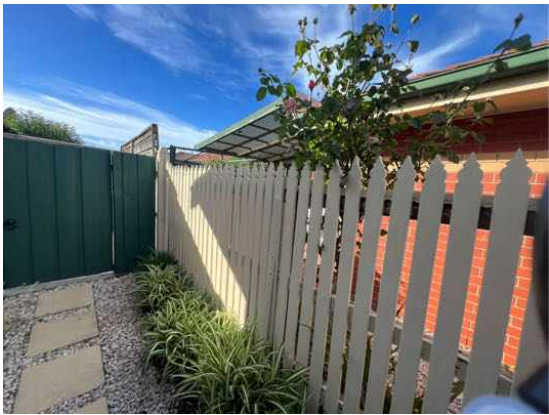
Finding 6.02

Building: Main Building
 Location: Front Elevation > All Areas
 Finding: Garden Beds - Conditions Conducive to Termites
 Information: Garden beds were found to be evident in the garden area. These garden beds can include untreated timber, and with a combination of moisture from watering hosing can make conditions conducive to termite activity and termite ingress.
