# Building and Timber Pest Inspection Report

Inspection Date: Mon, 23 Mar 2026

Property Address: 5/37 St Pauls Cres, Liverpool NSW 2170,  
Australia

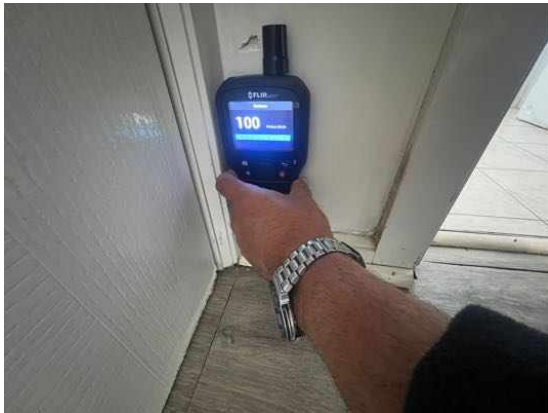
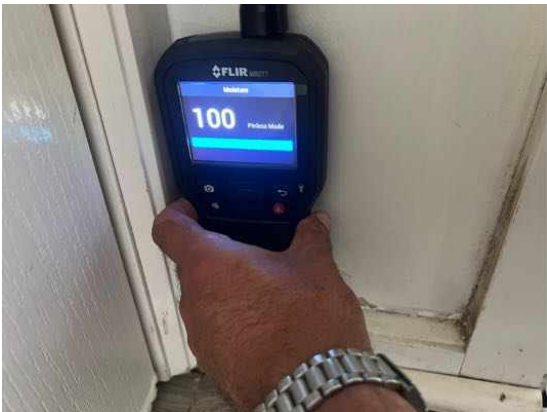
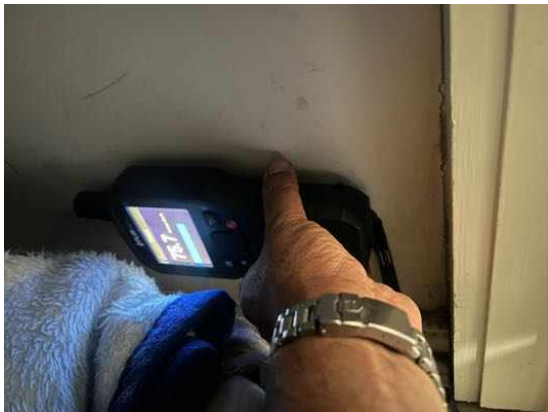
Building:	Main Building
Location:	Ensuite, main bathroom
Finding:	Wet-Area Door Jambs – Moisture Staining / Decay /Elevated Moisture
Information:	moisture staining and deterioration were observed at the base of the wet-area door jamb and architraves. This is commonly due to water splashing or moisture tracking from the bathroom floor into adjacent joinery or inadequate waterproof transition at the bathroom threshold.

Further inspection by a licensed waterproofing contractor is recommended to verify exact cause and remedial measures.

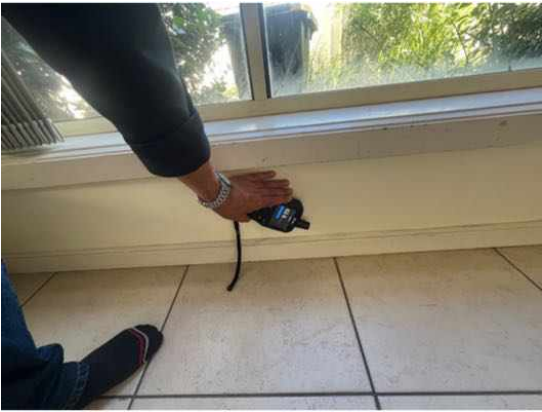
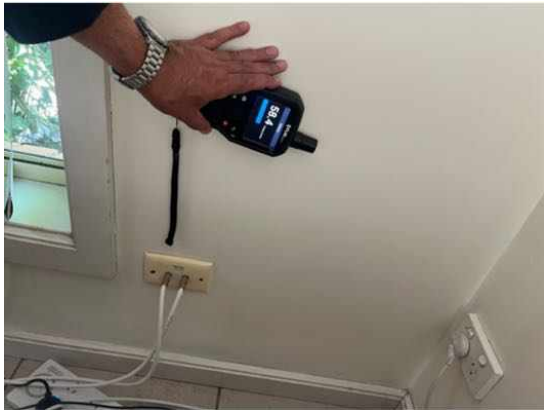
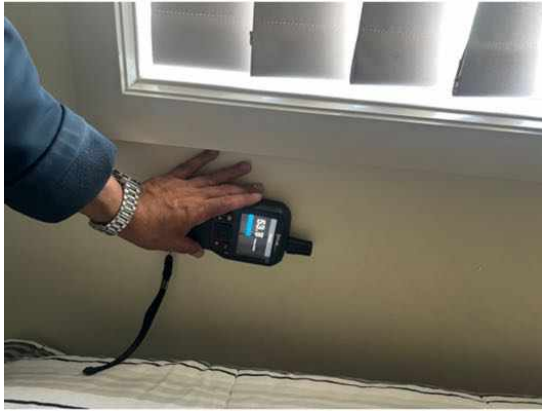
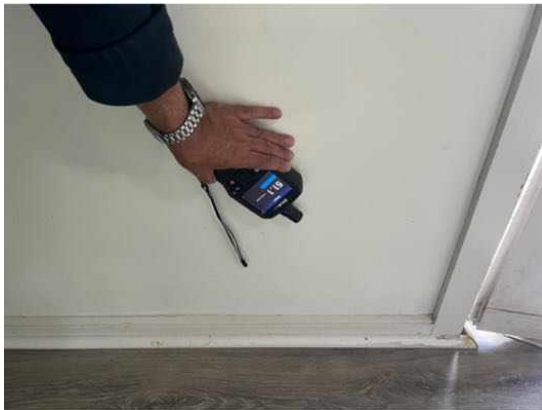
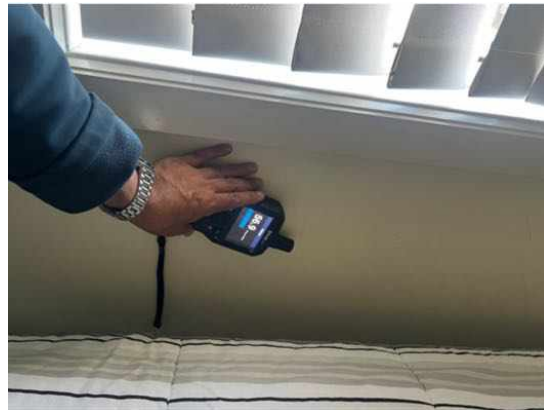
**Finding 3.02**

Building: Main Building  
 Location: All Internal Areas - External parameter walls , main bathroom/ensuite ceiling  
 Finding: Elevated Moisture – Further Investigation Recommended  
 Information: Elevated moisture readings were detected in several locations, with some areas also showing signs of dampness while others did not present visible surface issues, although no significant structural damage was evident at the time of inspection, dampness can contribute to deterioration if left unaddressed. Inspector was not able to inspect the external wall due to space constraints. A further investigation by a licensed plumber or waterproofing specialist is recommended to confirm the source and ensure no concealed issues are developing.

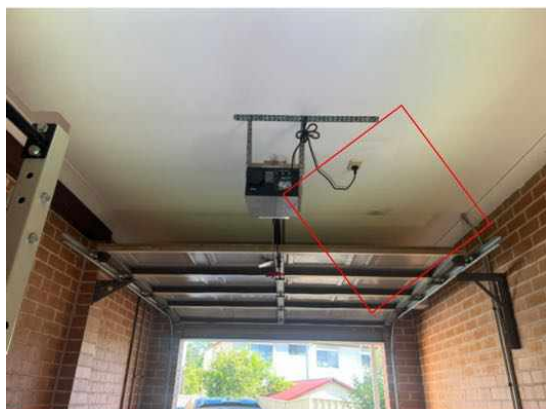
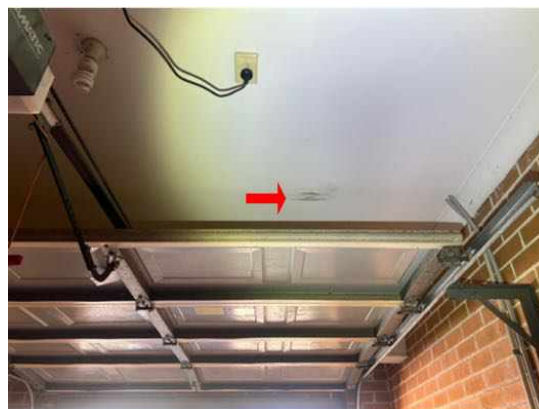
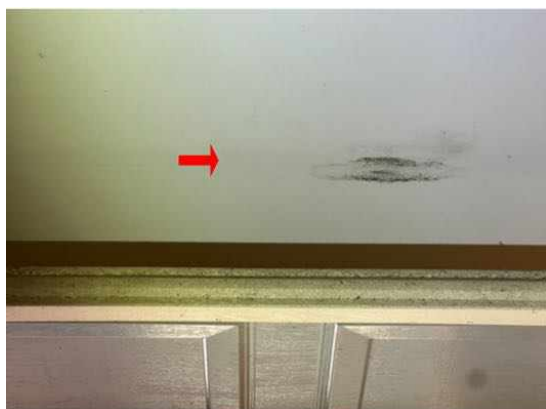
### Finding 3.03

Building:	Main Building
Location:	Garage
Finding:	Ceiling - Water damaged
Information:	Water damage to the ceiling lining is generally an indication of excessive moisture being present in the roof void, usually via a leak to the roof covering.

Where water damage is evident to the ceiling, the primary requirement is to identify and rectify the source of the leak. A roofing plumber should be appointed as soon as possible to identify the leak and perform rectification works as necessary, ensuring the water damage is restricted.

Once the leak is repaired, consultation with relevant tradespeople, including plasterers and painters, is advised. Rectification works may include replacement of ceiling lining or minor repainting, depending on the extent of the damage.

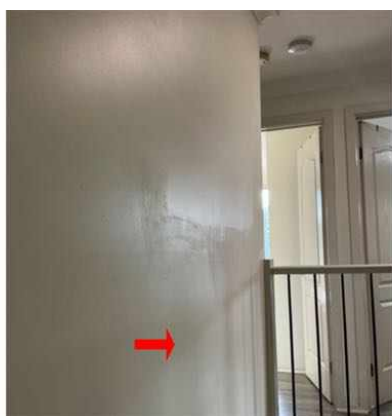
Building:	Main Building
Location:	All Internal Areas - Stair landing, stairs
Finding:	Water staining
Information:	Water staining was evident in this area at the time of inspection. Water staining indicates that surfaces have been exposed to excessive moisture over time. The minerals and other elements in the water lead to staining, which may graduate to corrosion and deterioration if left unmanaged.

While mostly an appearance defect, water staining can be indicative of more serious defects, which may be currently concealed by other building elements.

Where water staining is active, a licensed plumber must be consulted to identify the cause of the staining and to provide advice on any reparation works that may be required. Replacement of any broken or damaged structures is advised.

Conversely, where water staining is old and inactive, affected building materials may be repaired or replaced at client discretion. A qualified carpenter or registered builder may be appointed to perform these works.

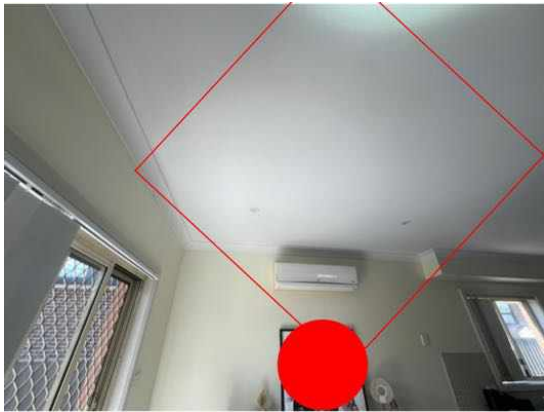
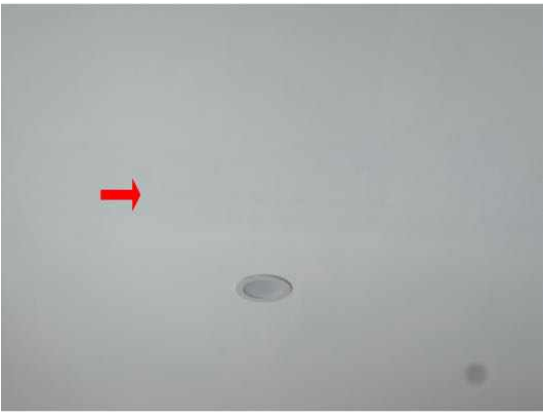
**Finding 3.33**

Building: Main Building  
Location: Kitchen/Dining  
Finding: Paint Defect - Shadowing  
Information: Minor cosmetic shadowing is visible on the alfresco ceiling, presenting as faint straight lines along the plasterboard joints, this is a common effect caused by raking light, normal thermal movement, and variations in paint or compound finish, with no signs of moisture ingress this is considered a minor defect under AS 4349.1, with improvement achievable through skim-coating and repainting if desired.

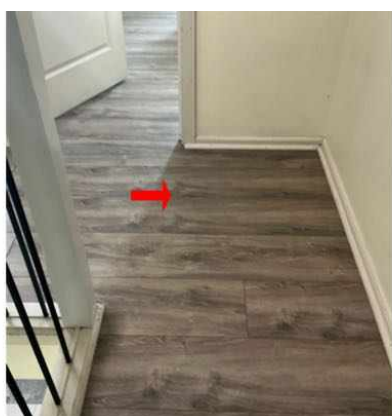
### Finding 3.34

Building: Main Building  
Location: All Internal Areas  
Finding: Flooring - Uneven to some areas  
Information: The internal flooring in this area is out of level and uneven. Uneven flooring is likely to indicate minor defects such as expected movement of the foundations of the property, but may also indicate subsidence of the associated subfloor stumps.

It is advised that the flooring be closely monitored to identify any further movement. Where flooring remains relatively unchanged for an extended period of time (i.e. several months), it is likely that this defect has been caused by expected movement of the foundations of the property.

However, where flooring is uneven further, potentially invasive inspection of the subfloor structures and stumps in this area is required. In this case, works to repair are likely to be required, and would be carried out by a registered builder specialising in re-stumping.

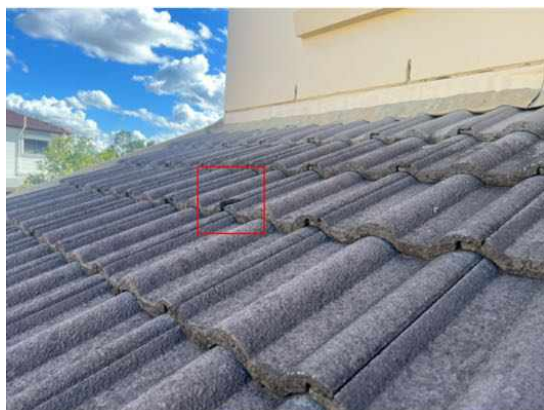
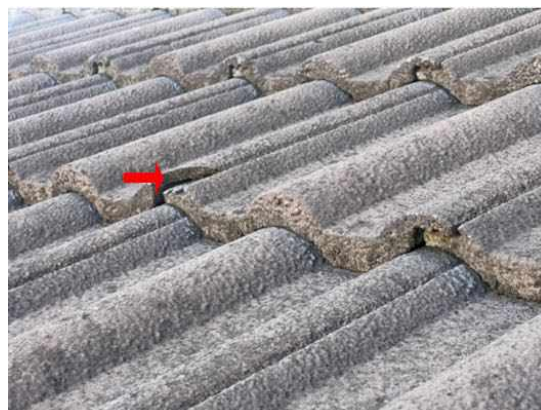
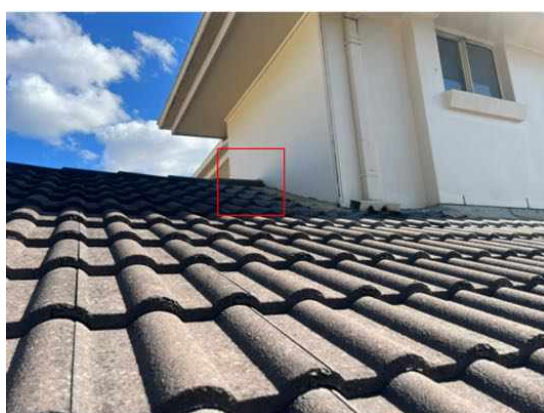
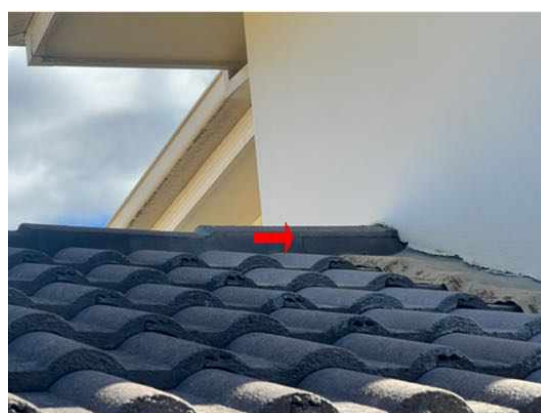
If left to further deteriorate, broken and brittle roof tiles are likely to lead to water penetration via the roof into the ceiling space, causing secondary damage to ceiling linings, insulation and roof structures. Broken roof tiles are also likely to detract from the effectiveness of the roof drainage system, creating potential for secondary damage to the exterior roof covering and roof plumbing.

Replacement of broken tiles is required and should be performed by a roofing contractor as soon as possible.

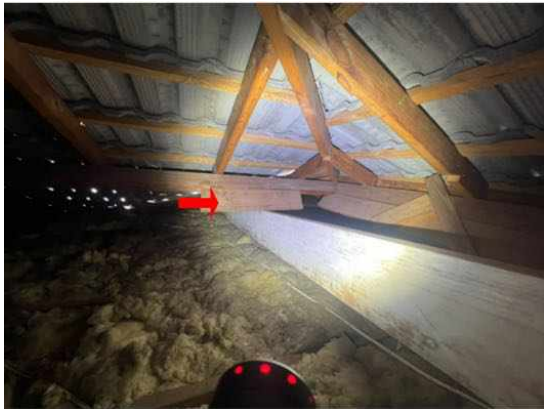
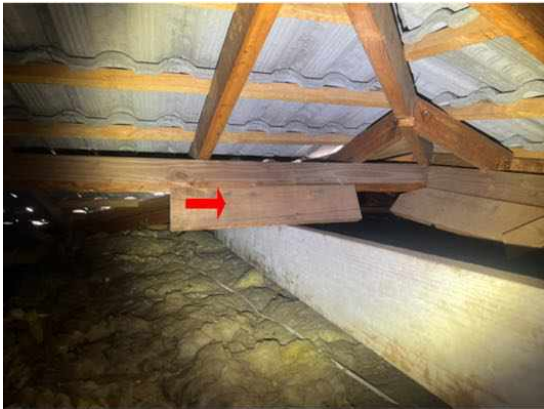
### Finding 3.37

Building:	Main Building
Location:	Roof Void
Finding:	Non-Original Roof Support/Props
Information:	Timber props and braces were observed within the roof void. These don't appear to be a part of the original roof framing and appear to have been retro-fitted to provide supplementary support, possibly due to prior movement, deflection, or remedial works. As their adequacy, structural contribution, and compliance with current standards cannot be confirmed during a visual inspection in accordance with AS 4349.1, further evaluation by a licensed builder or structural engineer is recommended to confirm whether these supports are appropriate and whether additional rectification is required.

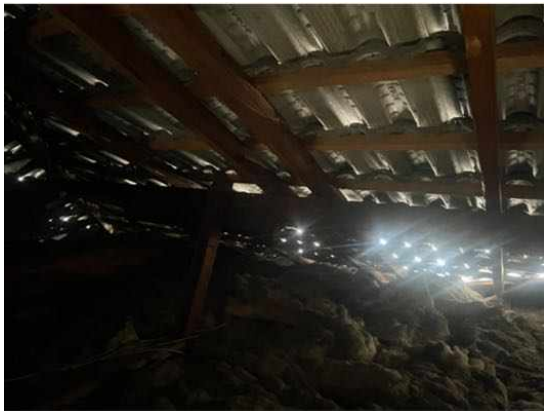
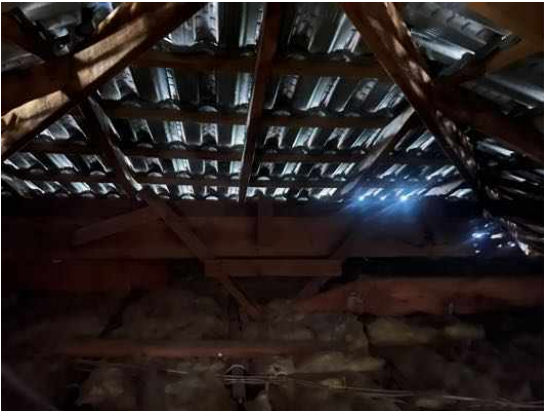
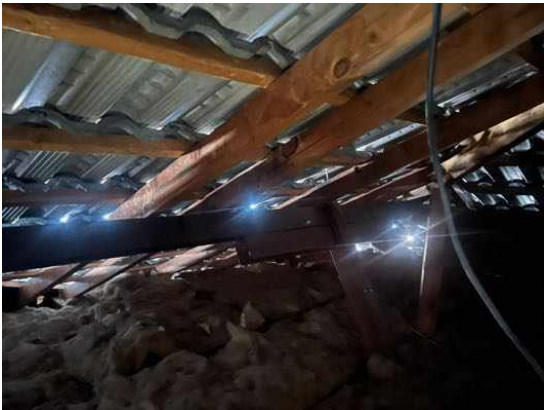
**Finding 3.38**

Building: Main Building  
Location: Roof Void  
Finding: Roof Void – No Sarking & Light Ingress  
Information: Light ingress is visible through multiple roof tile laps, which is typical of older tile roofs without sarking and may allow minor wind-driven moisture or dust into the space, though no active leaks were observed.

Consider retrofitting sarking or roof wrap in the future to improve thermal and moisture performance.

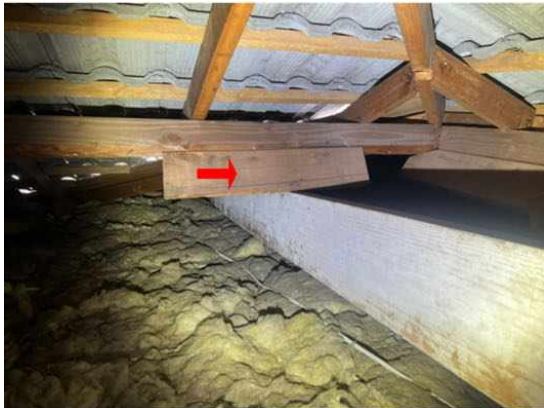
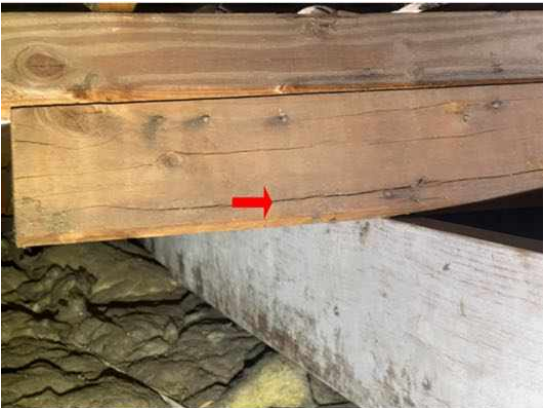
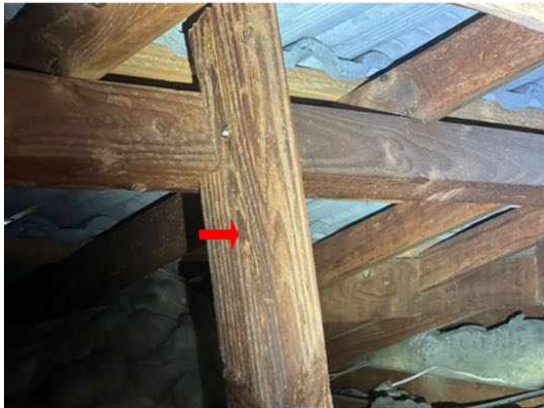
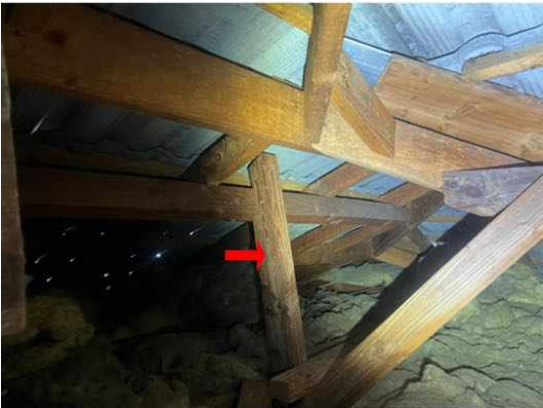
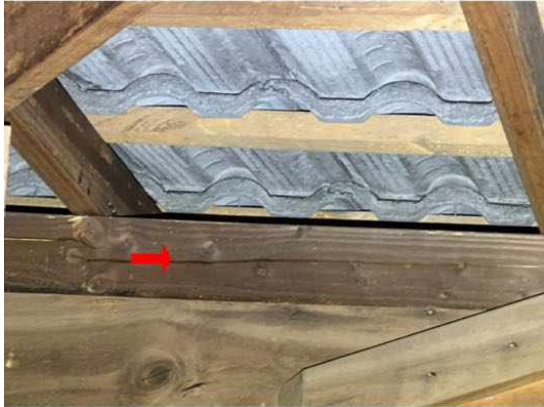
**Finding 3.39**

Building: Main Building  
Location: Roof Void  
Finding: Roof Void Observation – Timber Splitting in Roof Framing  
Information: longitudinal splits were observed in roof framing members within the roof void. No signs of significant distortion, bowing, deflection were evident at the time of inspection. Current structural integrity does not appear compromised. A licensed carpenter should be consulted to access further.

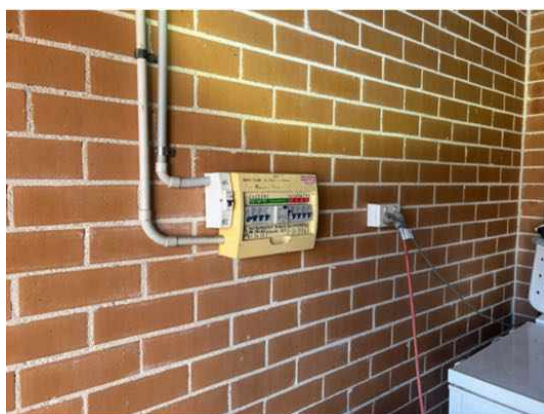
A durable notice should be placed in the switchboard unit to indicate current termite barriers. At the time of inspection, it appeared as though no termite management system has been installed, with no evidence to suggest preventative works taking place.

The client may consider gaining further advice from a pest controller as to the costs and procedures involved with this application. It is recommended that obtaining such advice be a short-term priority.

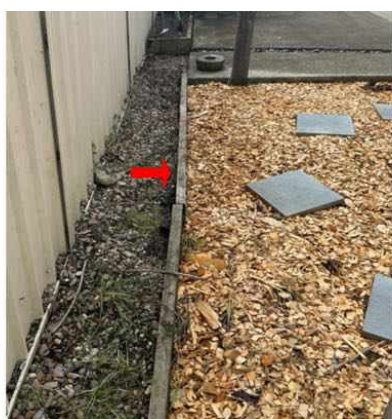
Building:	Main Building
Location:	All External Areas
Finding:	In ground contact - Timber to some areas
Information:	Any timbers in direct ground contact provide opportunity for concealed termite entry and are likely to be subject to premature rot and decay as the soil retains moisture or damp conditions against the timbers.

Remove untreated timber that is in direct contact with external grounds. Consider replacement with more durable materials i.e. treated timber or non timber elements. Frequent pest inspections are advised to readily identify any termite activity in these areas.

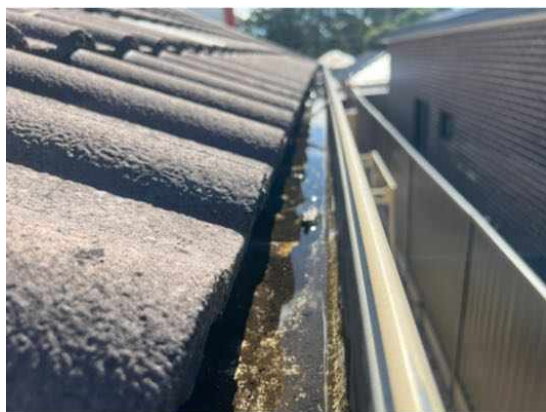
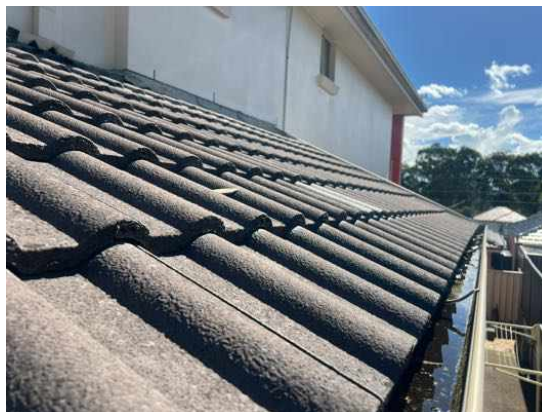
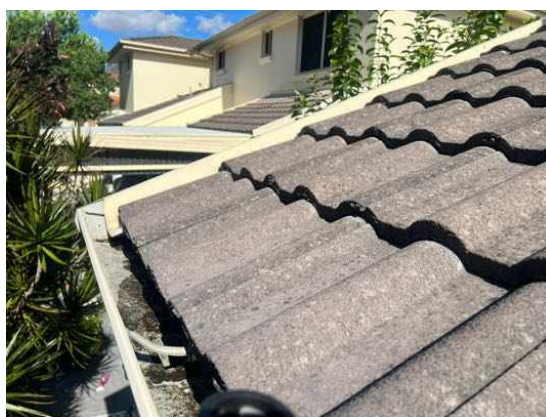
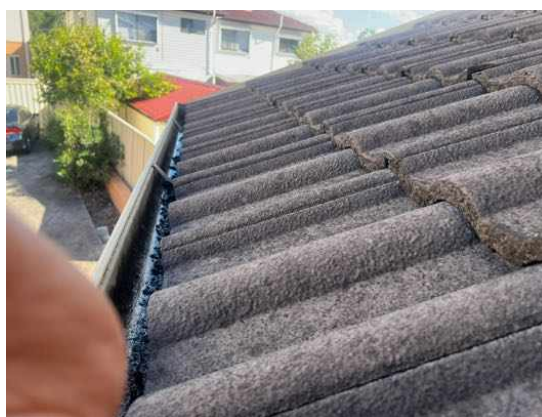
## Finding 6.05

Building:	Main Building
Location:	All External Areas
Finding:	Gutters - Blocked
Information:	Roof plumbing structures, such as guttering and downpipes, should be free of all debris to prevent blockages. Blockages of the guttering and downpipes will lead to pooling and accumulated water overflows, which is likely to subsequently flood eaves and exterior walls.

Consult a Licensed Plumber for further specific advice on remedial works that may be

required. In the interim, it is highly advised that blocked gutters be removed by the homeowner or a general handyperson as a matter of urgency.
