# Building and Timber Pest Inspection Report

Inspection Date: Fri, 6 Mar 2026

Property Address: 9 Stirbeck St, Holbrook NSW 2644,  
Australia

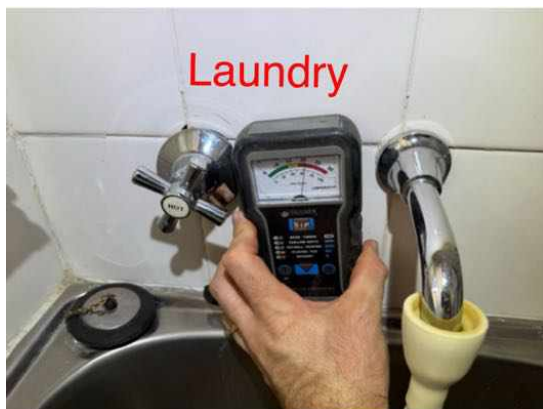
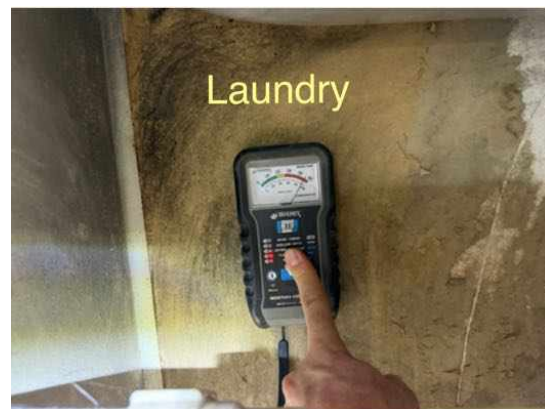
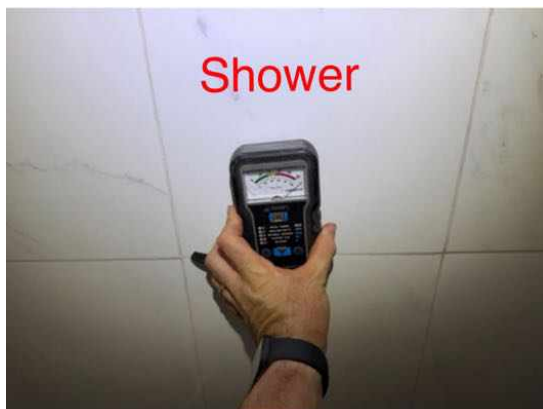
#### Finding 2.01

Building: Main Building  
 Location: Shower, Laundry Tap  
 Finding: Shower & Laundry Tap - Leaking / High Moisture  
 Information: It appears that high moisture is present at but not limited to, beneath the laundry tap & sink, and to the base of the shower walls. Potential causes of leaking include but are not limited to loose or damaged plumbing fittings and fixtures, and/or deteriorated seals or waterproofing.

Areas of leaking and high moisture create an environment conducive to termite activity and should not be neglected. Recommend engaging a licensed plumber promptly to provide remedial works, to avoid the development of secondary building defects.

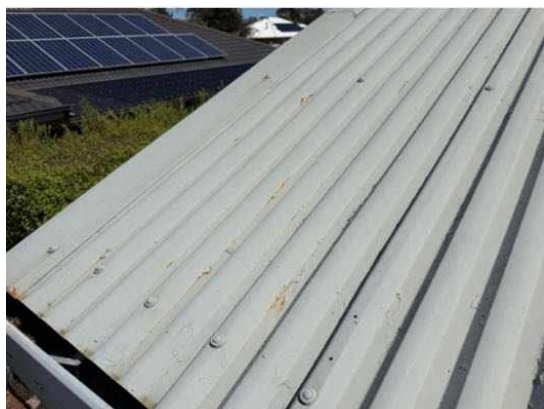
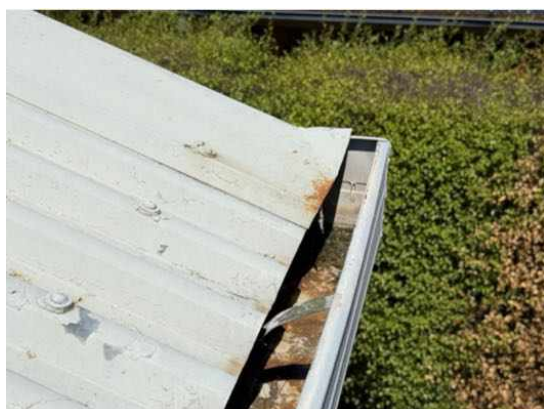
### Finding 3.01

Building:	Main Building
Location:	Roof Exterior
Finding:	Roof Exterior - Weathered, Rust
Information:	Areas of rust and deterioration were noted to the roof exterior. While weathering of the roof exterior is consistent with the age of the property, maintenance works are advised. Where left unmanaged, deteriorating and damaged roof sheeting and plumbing is likely to lead to secondary defects.

It is advised that the client consult with a licensed roofing contractor in the short term, to provide further advice on maintenance works that may be required.

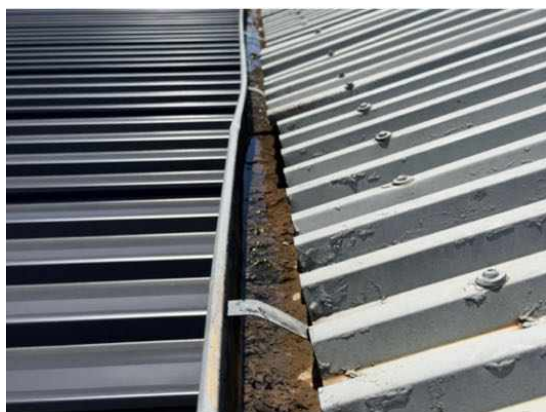
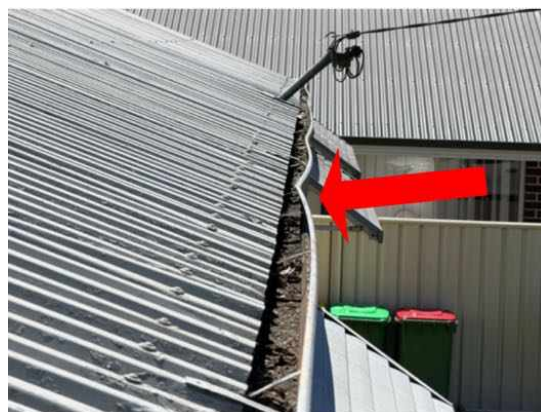
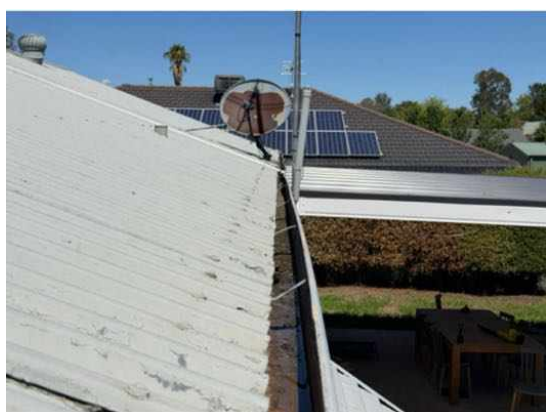
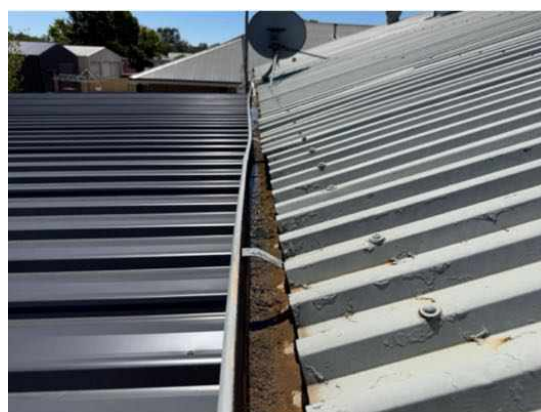
### Finding 3.02

Building:	Main Building
Location:	Gutters
Finding:	Gutters - Debris, Water Pooling & Rust
Information:	Areas of water pooling, debris and rust were identified throughout the guttering. Some areas of the gutters were also found to be bent & sagging.

Water pooling & rust of the gutters is likely to lead to deterioration and overflows of the roof plumbing if neglected.

Recommend engaging a licensed roof plumber in the short term, to provide further advice to ensure adequate roof drainage is achieved. All debris should be removed from the gutters promptly to avoid overflows.

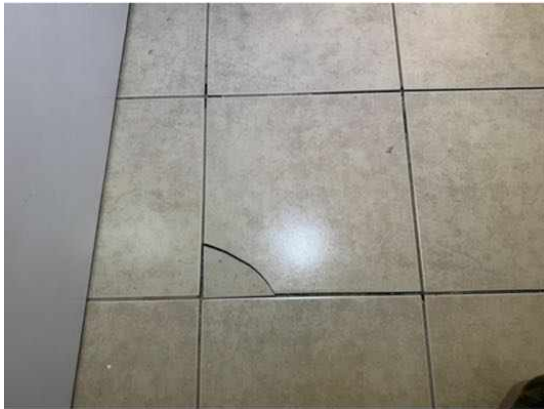
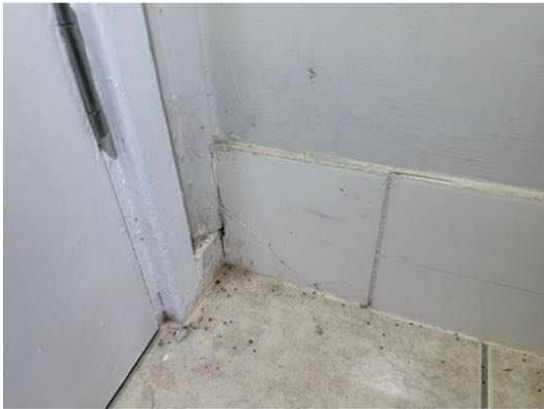
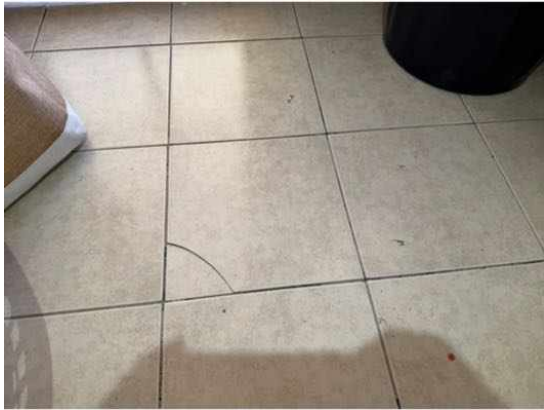
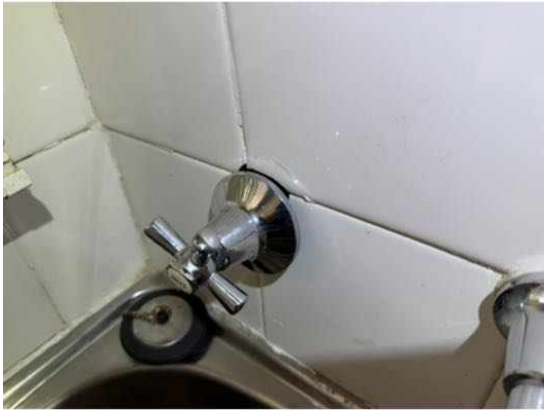
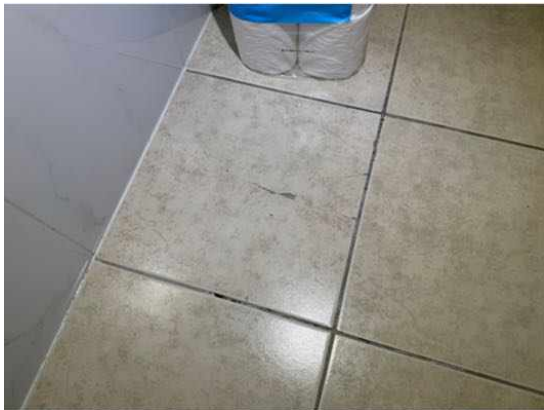
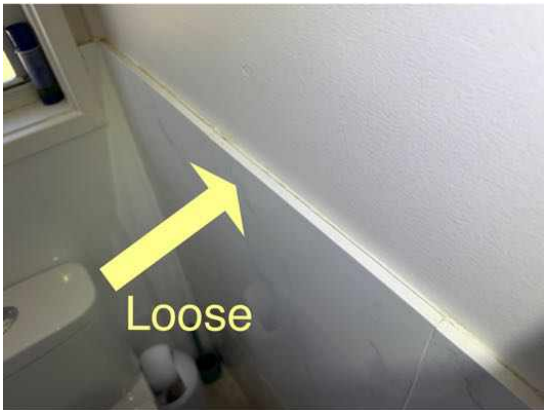
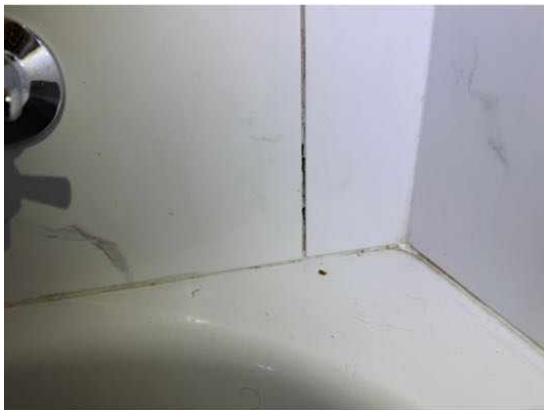
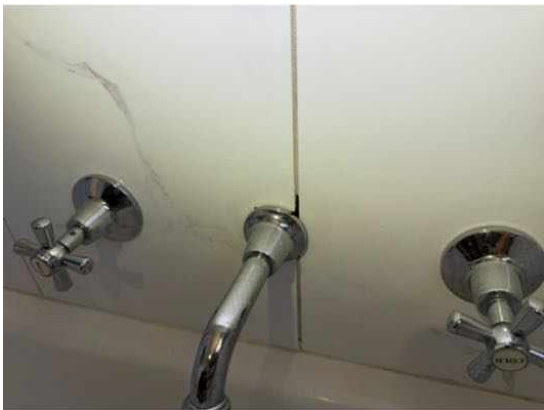
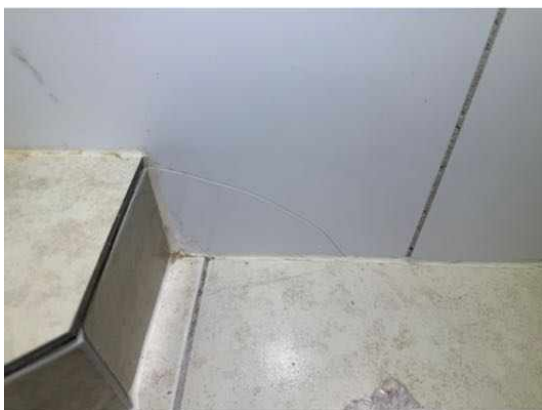
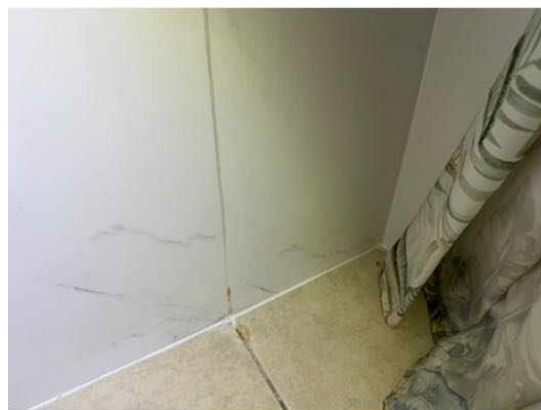
### Finding 3.03

Building:	Main Building
Location:	Tiled Areas
Finding:	Sealant / grouting - deteriorated or missing & Cracked/Loose Tiles
Information:	It appears that the sealant and grout has deteriorated in some tiled areas, a common defect in buildings of a similar age. Areas of cracked & drummy/loose tiles were also noted, which can allow for moisture ingress behind the tiles, if neglected.

Sealant and grouting in areas that come into regular contact with water should be maintained for the long term care of your property.

Recommend engaging a licensed tiling contractor in the short term, to provide maintenance works where necessary.

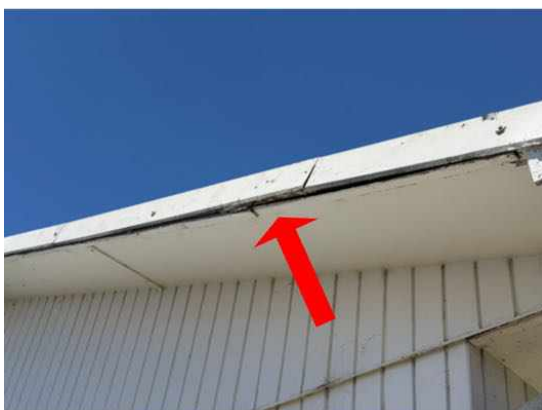
### Finding 3.04

Building:	Main Building
Location:	Eaves
Finding:	Eaves - Sagging
Information:	It appears that areas of the eaves were found to be sagging at the time of inspection. Sagging of eaves generally indicates that the fixings (e.g. nails or glue) have become loose and require refixing. Recommend engaging a licensed carpenter in the short term, to provide maintenance works where necessary.

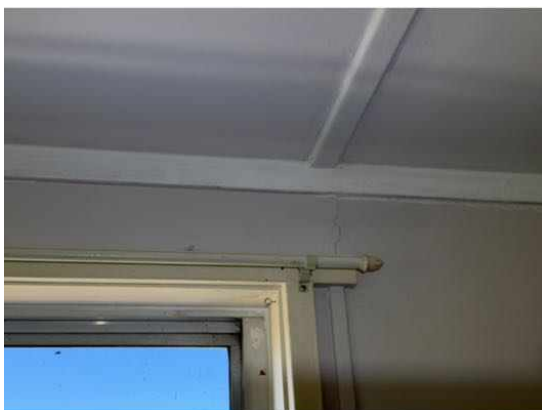
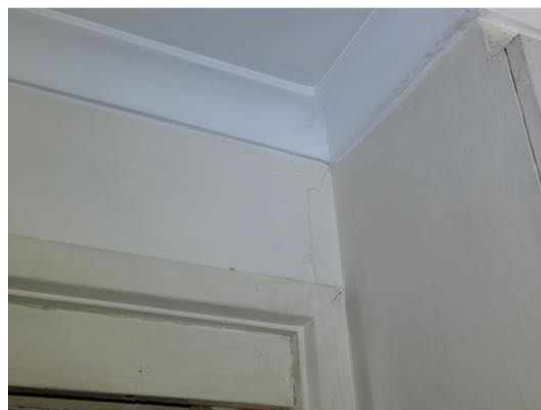
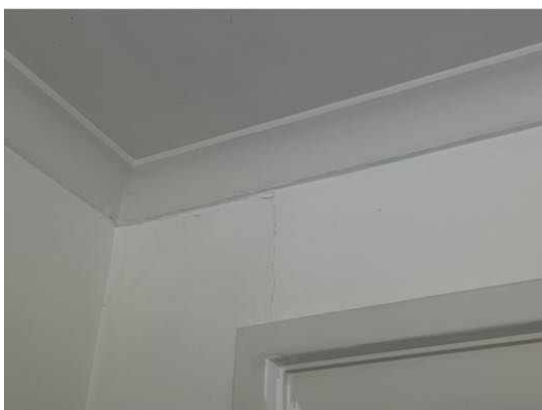
### Finding 3.05

Building:	Main Building
Location:	All Internal Areas
Finding:	Plaster - Cracking
Information:	There appears to be minor cracking in some areas of the plaster linings throughout the building. Cracking of this type is common in buildings of a similar age. Although this is mostly a visual defect, it is advised that the client monitor these areas.

Should cracking widen, lengthen, or become more numerous, the client should consult with their building inspector promptly, for further evaluation.

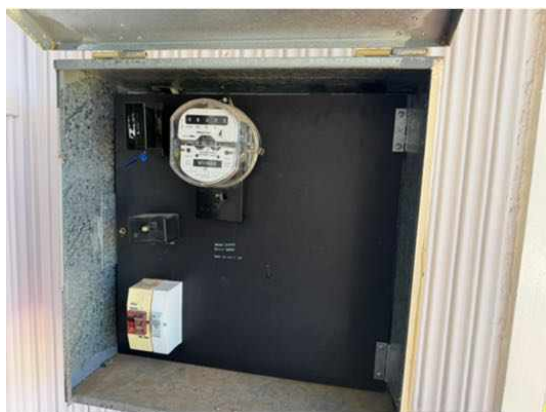
#### **Finding 6.01**

Building:	Main Building
Location:	Switchboard
Finding:	Termite Management System - no evidence of a chemical installation
Information:	The application of a termite barrier is strongly recommended, as it appears no termite management system has been installed, with no evidence or durable notice to suggest works taking place. Generally, a durable notice is placed in the meter box to indicate current termite barriers.

Such barriers are highly effective in preventing termite attack on the building and therefore should be installed.

Recommend seeking further advice from a licensed pest controller.

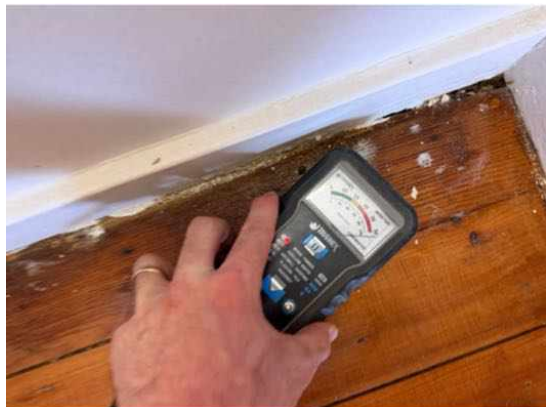
### Finding 6.02

Building:	Main Building
Location:	Dining Room Floor, Bedroom Carpet
Finding:	Floorboards & Carpet - High Moisture Reading
Information:	It appears high moisture readings were present at, but not limited to the dining room floorboards, and the rear bedroom carpet. This creates an environment conducive to termite activity. Recommend engaging a licensed plumber promptly, to identify the cause of the moisture and provide remedial works where necessary.

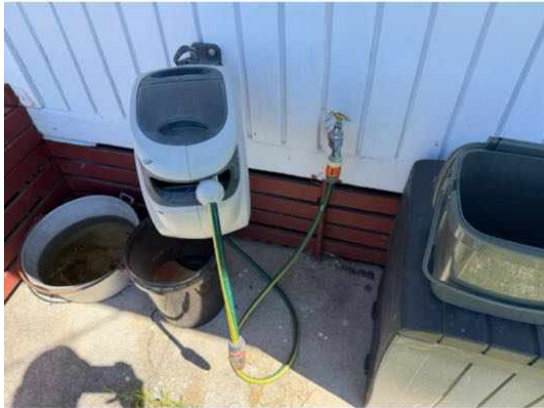
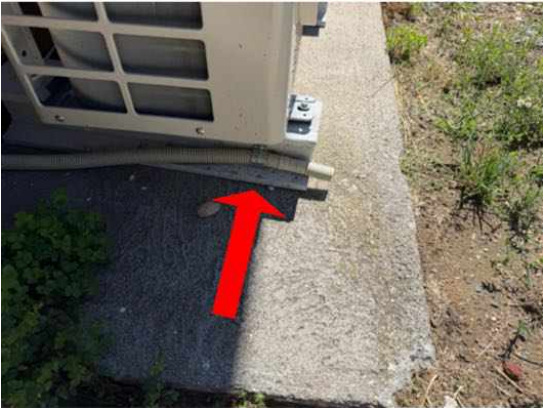
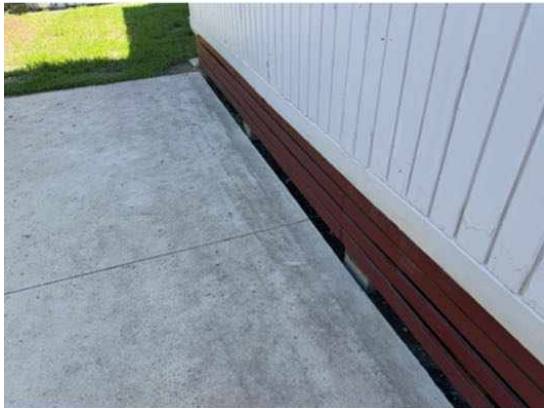
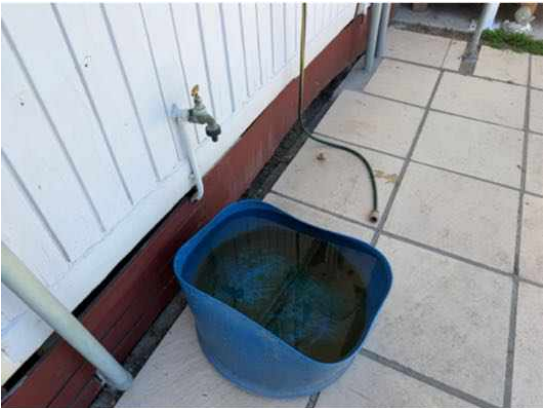
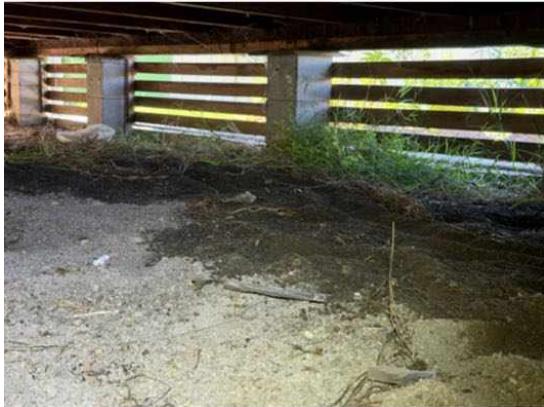
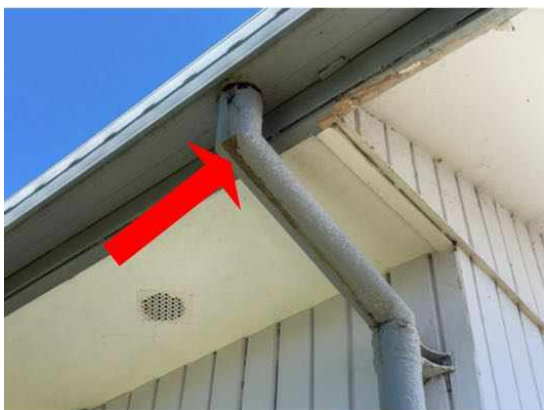
### Finding 6.03

Building:	Main Building
Location:	All external areas, Subfloor
Finding:	Potential Water pooling against property & Moist Conditions in Subfloor & Piers
Information:	It appears that there are potential areas around the perimeter of the property that could be susceptible to water pooling. Areas of high moisture & water pooling were also identified throughout the subfloor and piers, creating an environment conducive to termite activity.

Where insufficient site drainage, leaking down-pipes, and insufficient drainage of taps

& aircon overflows are present, water pooling is likely to occur, and can create areas conducive to timber pests and potential damage to the subfloor structure overtime, if neglected.

Recommend consulting with a licensed plumber in the short term to provide further advice & remedial works, to ensure sufficient drainage is achieved.

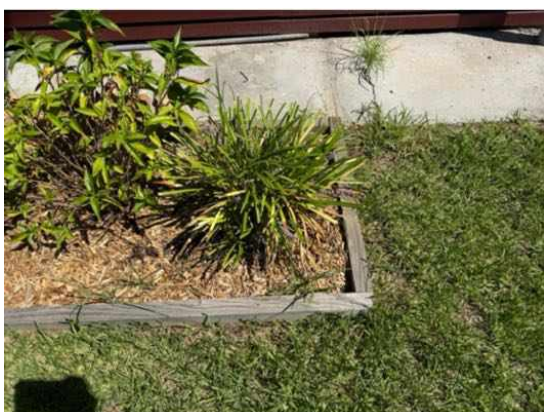
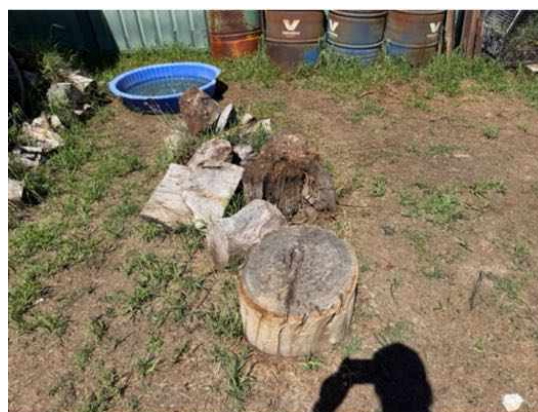
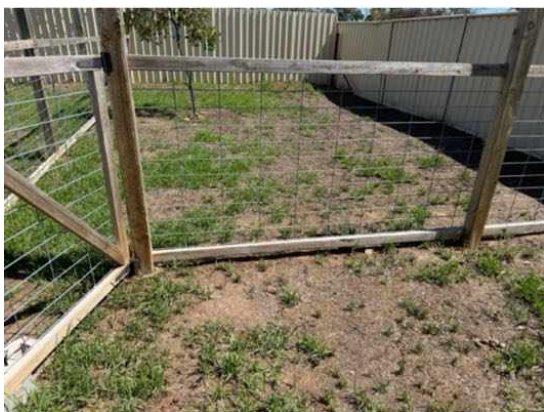
### Finding 6.04

Building:	Main Building
Location:	All External Areas
Finding:	Timber in direct ground contact & trees - conducive to termites
Information:	Where timber materials are in direct contact with the ground and consequently moisture, they become conducive to termite activity. The landscaping timbers, fence posts, and trees surrounding the building create an environment conducive to termite infestation.

Where feasible, any timbers in direct contact with the ground should be removed and any trees in close proximity to the building should be removed or test drilled (inspected) at least annually to reduce the risk of termite infestation & detect any early signs of termite activity.

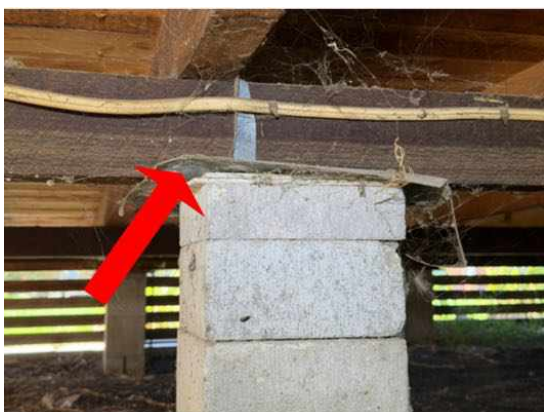
### Finding 6.05

Building:	Main Building
Location:	Subfloor
Finding:	Ant caps - Inadequate
Information:	It was found that several ant caps that have been installed are inadequate. Ant caps are designed to easily identify termite or pest ingress from stumps to the adjoining bearers.

Where ant caps are inadequate, this poses as an obstruction to the inspection and frequent monitoring of these areas should be carried out in order to identify any early signs of termite workings. Recommend engaging a licensed carpenter to install adequate ant caps to the subfloor.

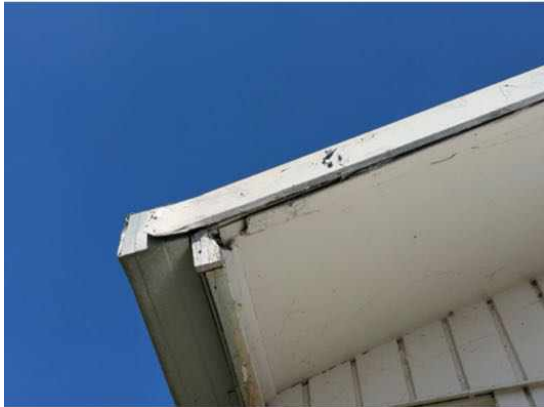
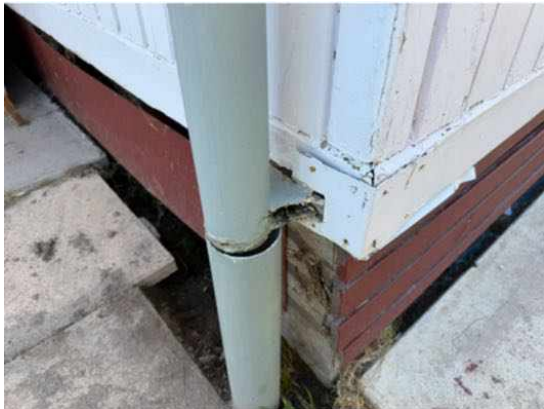
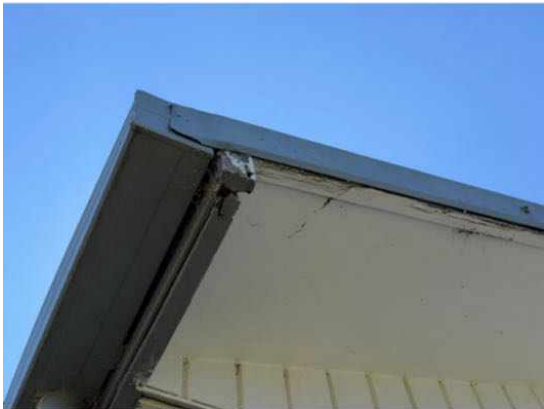
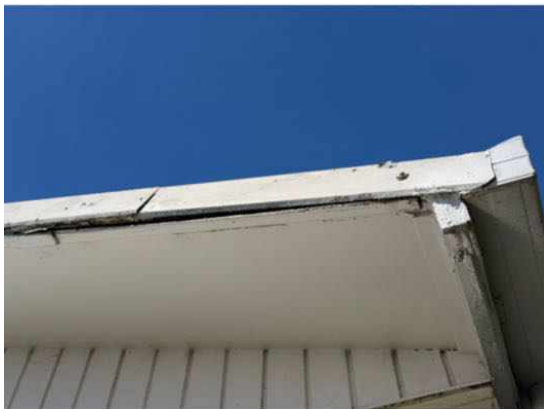
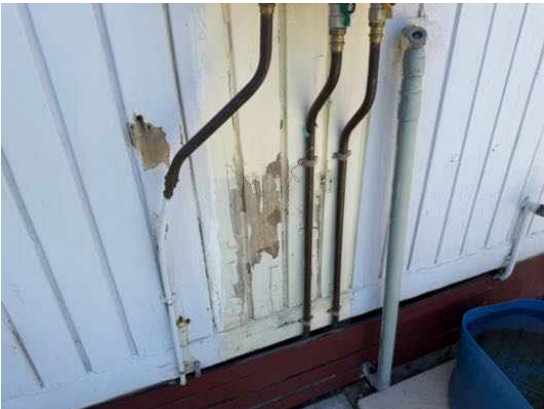
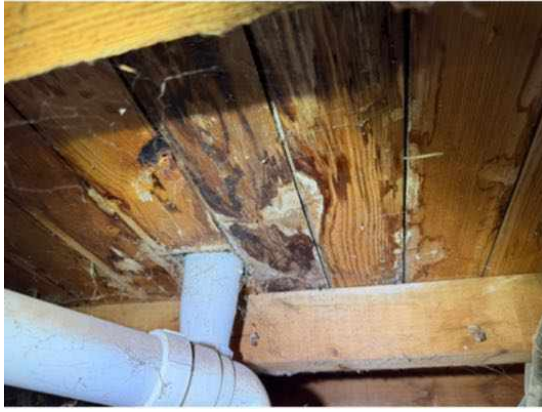
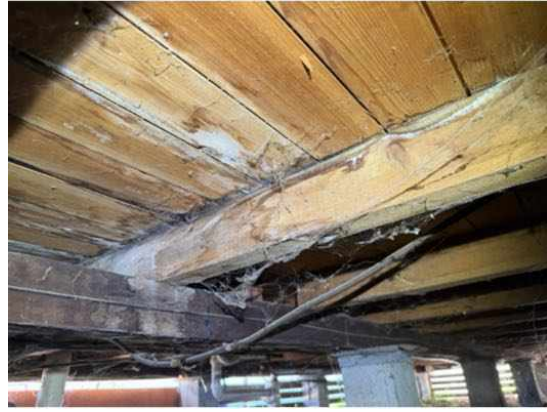
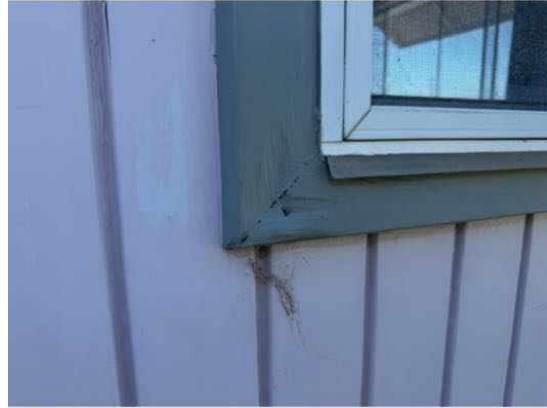
### Finding 7.01

Building:	Main Building
Location:	Cladding, window frames, floorboards, subfloor timbers, fascias, external trims.
Finding:	Fungal decay & weathering
Information:	Areas of fungal decay (wood rot) & weathering were identified at but not limited to

areas of the cladding, some window frames, floorboards, subfloor timbers, fascias and external trims.

For areas of fungal decay, the client can engage a licensed carpenter at their discretion to replace affected materials. For areas of general weathering, it is advised the client engage a licensed painter to apply protective sealant or coating to areas of weathered external timbers.

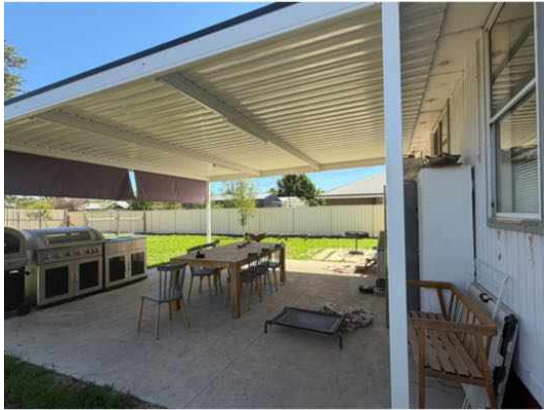
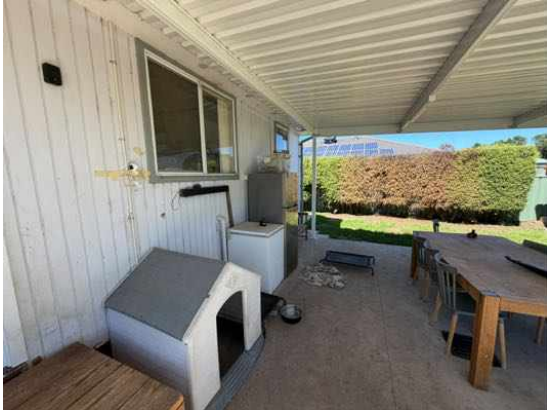
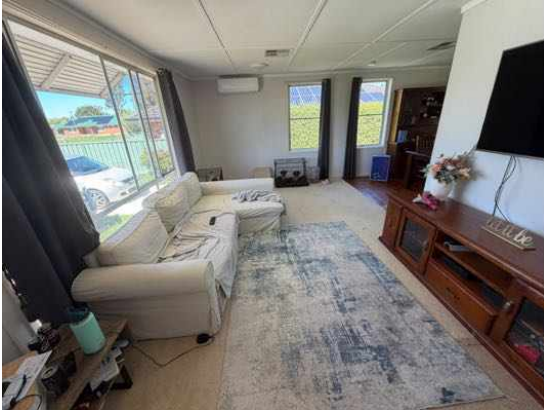
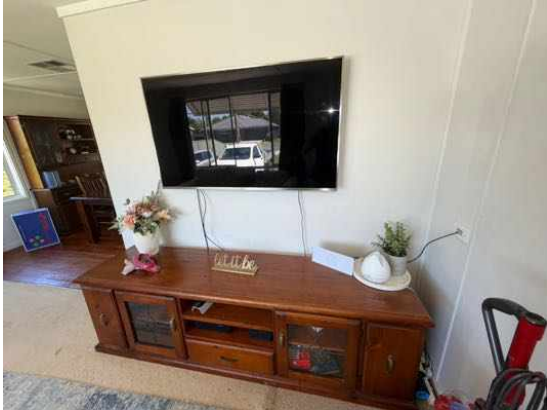
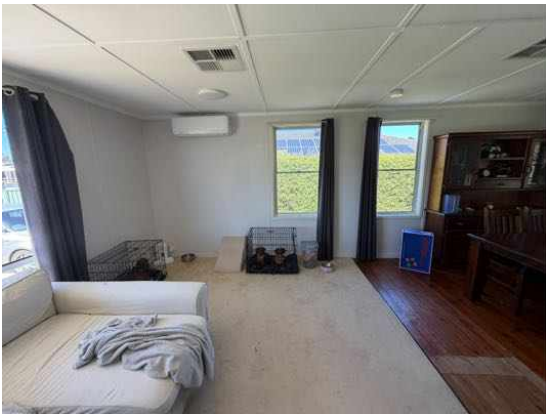
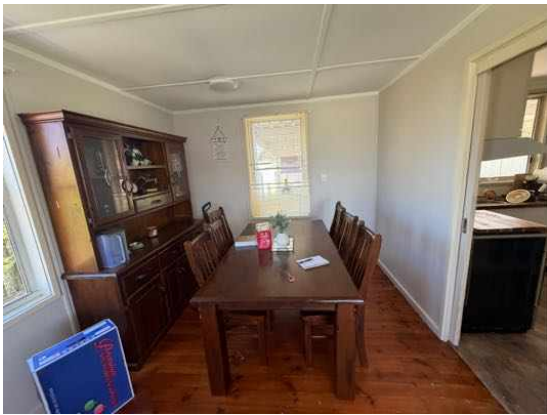
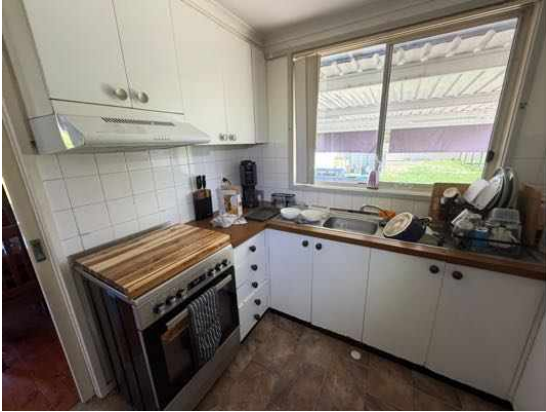
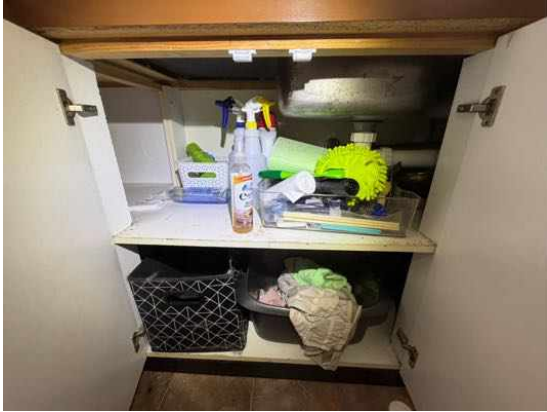
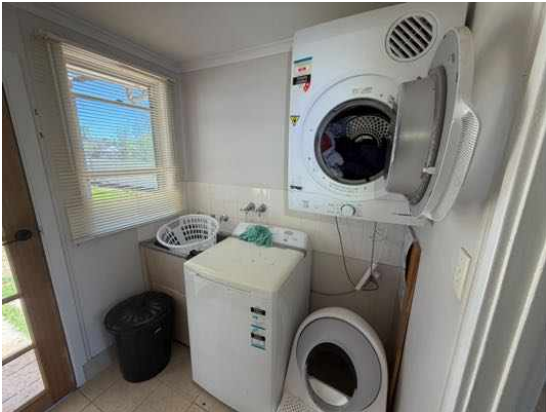
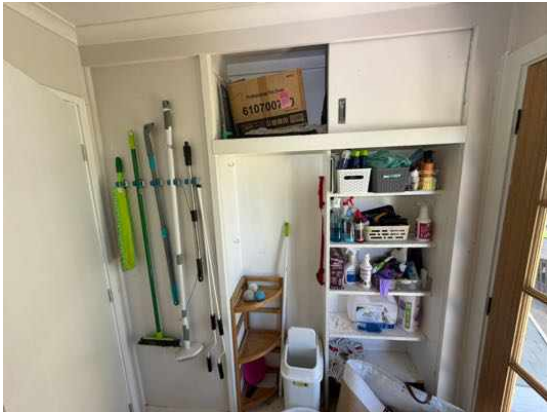
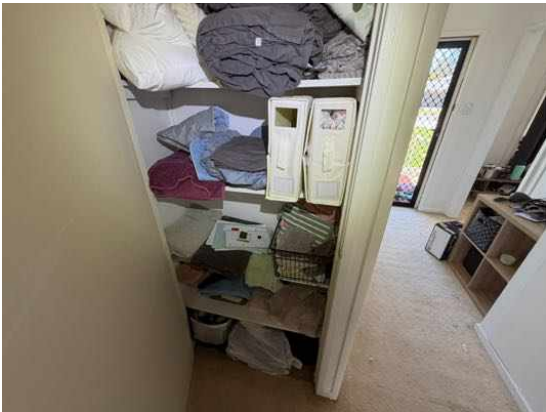
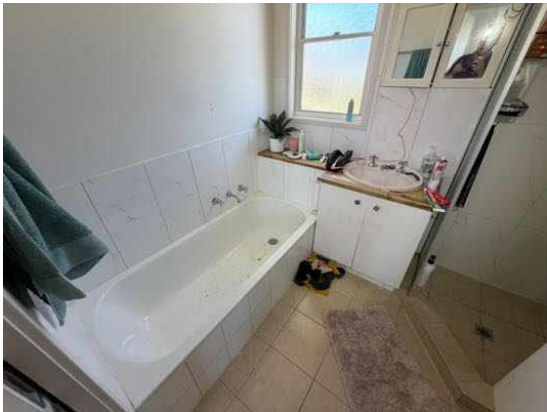
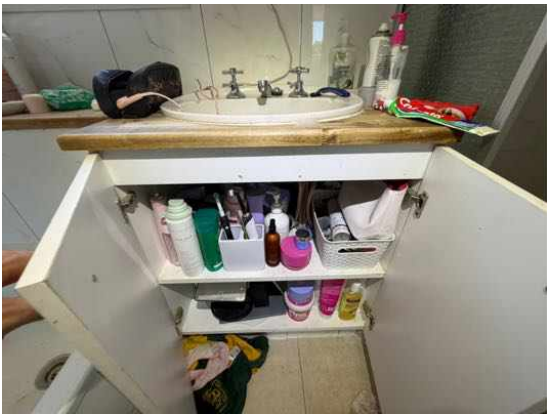
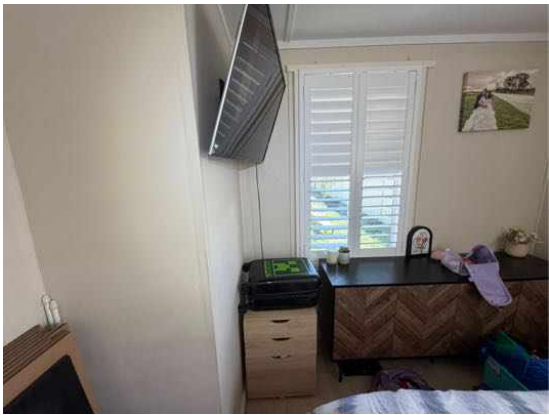
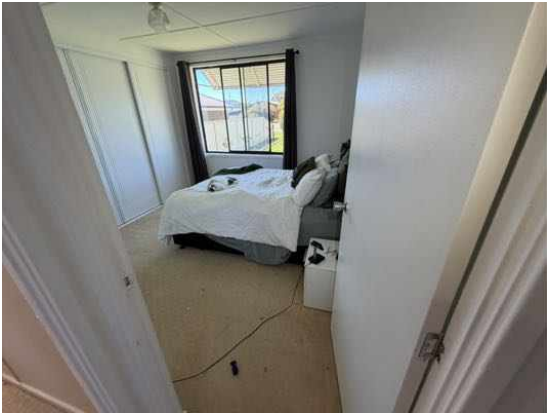
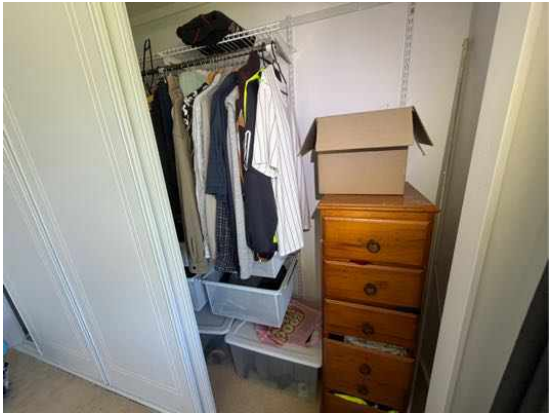
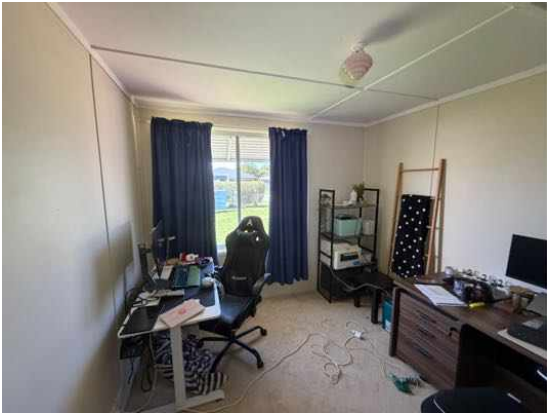
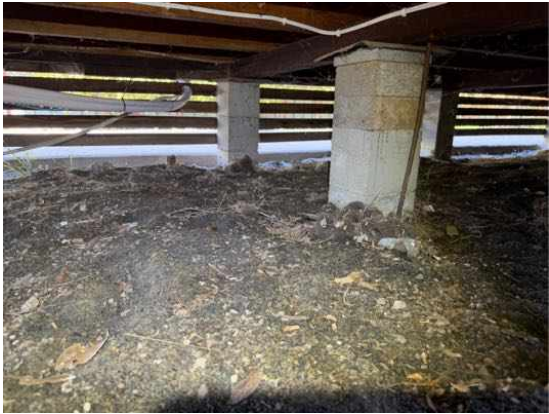
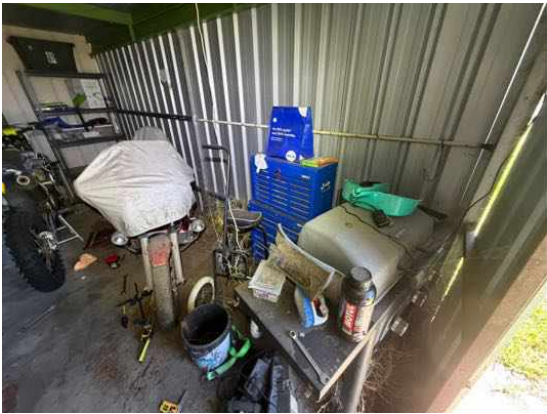
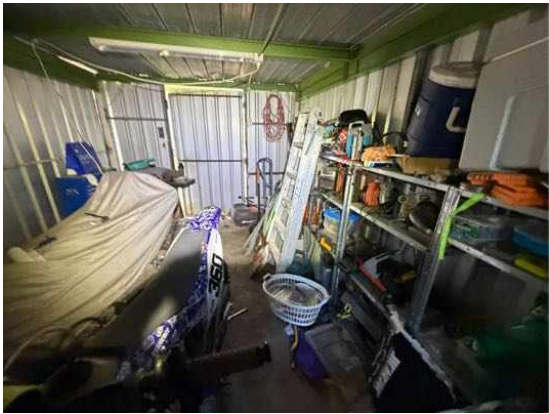
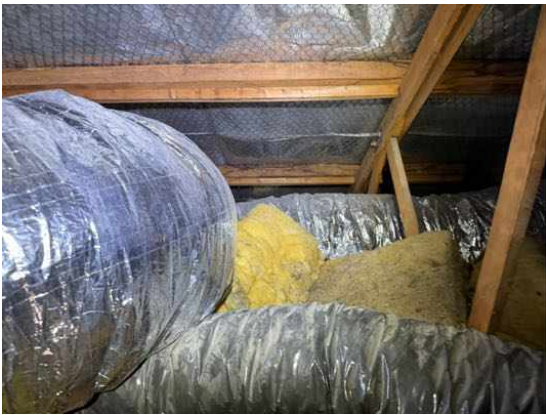
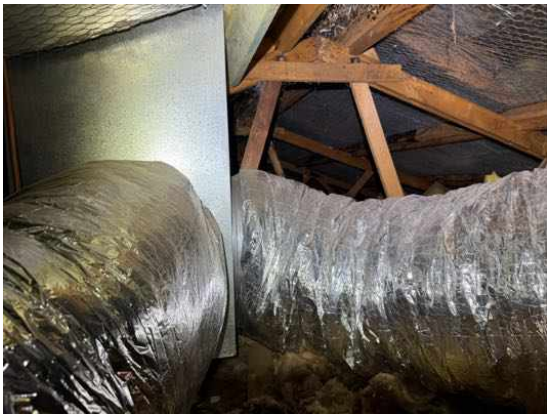
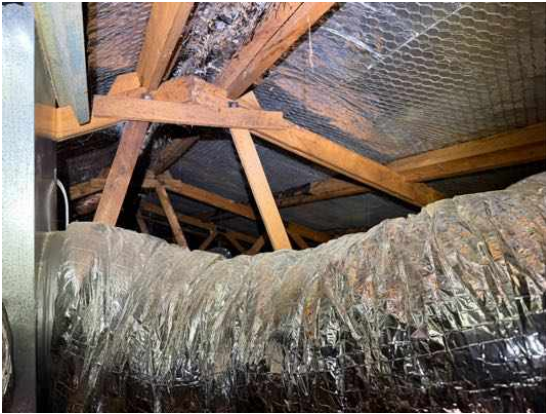
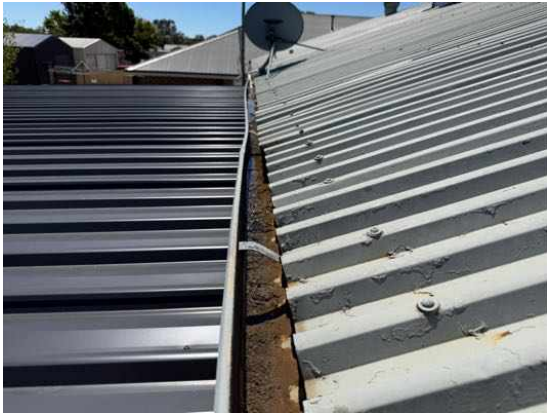
Building: Main Building  
Location: All Areas  
Finding: Additional Photos - Obstructions and Limitations  
Information: These photographs are an indication of the obstructions and limitations which impeded full inspection of the property at the time of inspection. These obstructions can hide an array of defects and should be removed to allow full inspection to be carried out. A re-inspection is recommended once the areas are made accessible.

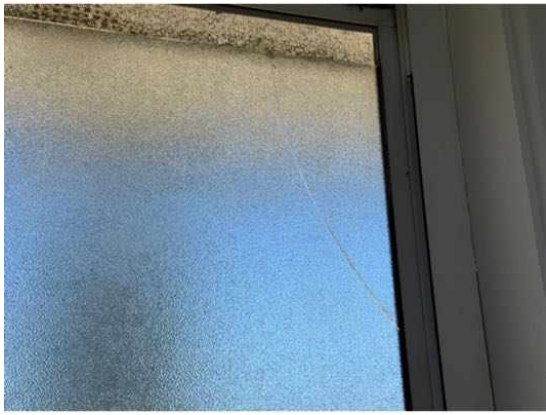
Building: Main Building  
Location: Toilet Window  
Finding: Window - Cracked  
Information: A minor crack was evident at but not limited to, the toilet window. Further impact may lead to additional cracking. It is advised that the client monitor the condition of the window. Should further cracking occur, a qualified glazier should be engaged to replace the window

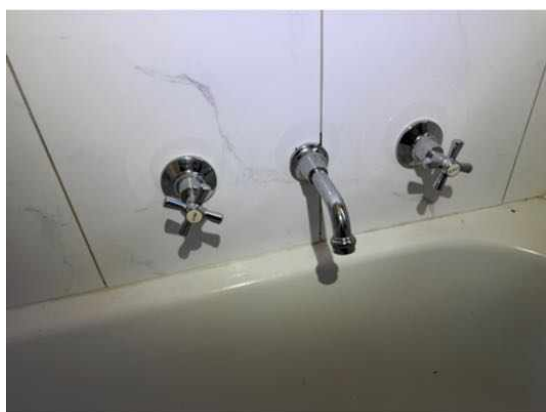
Building: Main Building  
Location: Bathroom  
Finding: Taps - Water hammer  
Information: It appears water hammer is present at, but not limited to the bathroom taps. Water hammer is a pressure surge resulting when water is forced to suddenly change direction. This is a common defect in plumbing fittings and is evidenced by a faint banging noise when operating the tap.

A licensed plumber can be appointed at clients discretion to provide further advice & maintenance works where necessary.

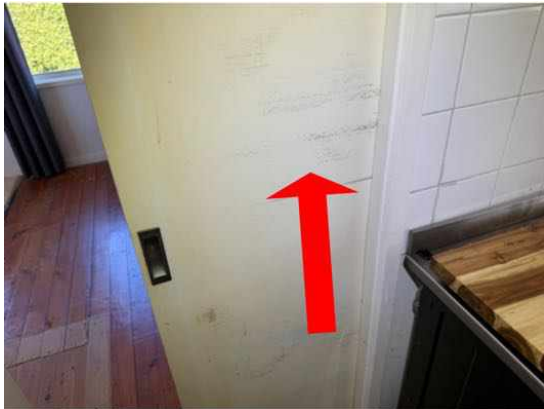
Building: Main Building  
Location: Kitchen  
Finding: Cavity Slider - Stiff to Slide  
Information: It appears that the cavity slider to the kitchen was binding and stiff to slide. A general handyman or licensed carpenter can be engaged at clients discretion, to provide minor maintenance works where necessary.
