Building and Timber Pest Inspection Report

Inspection Date: Thu, 5 Mar 2026

Property Address: 1 Gino Cl, Flagstaff Hill SA 5159, Australia

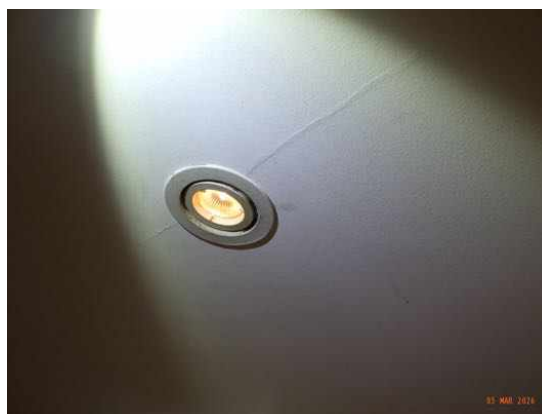
Building:	Building 1
Location:	Kitchen
Finding:	Down-lights, Halogen no protective covers
Information:	There is potentially several lights that appear to be halogen down lights noted throughout the property.

Alternatively the lights could be swapped for LED equivalents which burn cooler and use considerably less power.

A qualified electrician should be appointed to provide further advice and quotation for replacement.

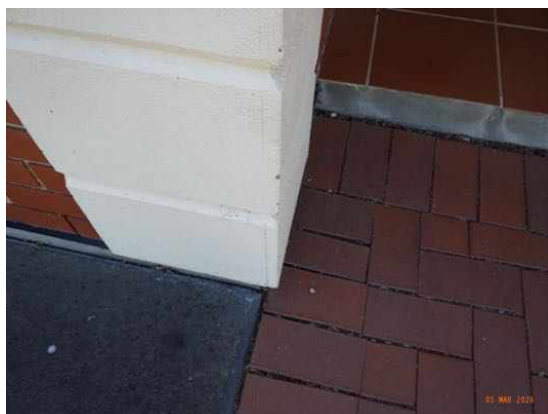
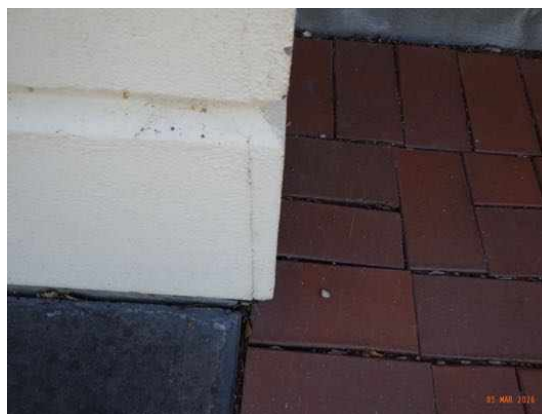
Building: Building 1
Location: Front Elevation
Finding: Render - Cracking

Information: There were several cracks evident to the render around the property at the time of inspection likely due to general expansion and contraction and or general old age. Most cracks were found to be less than 1 mm wide.

Moisture can penetrate the cracks and as such regular maintenance is required in these older properties.

A licensed painting contractor can be appointed to repair minor cracking and repaint the walls however a plasterer would be required if cracks were found to be in excess of 2 mm.

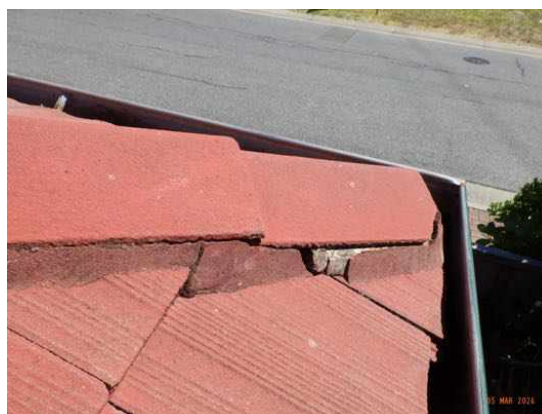
Finding 3.02

Finding: Mortar - Deterioration

Information: Mortar, or 'bedding', is the material which fills joins and intersections between tiles and other building elements on the exterior roof covering, such as gable ends, hip capping and valleys. Upon inspection of the exterior roof, it was noted that sections of the mortar show low levels of deterioration.

Mortar generally deteriorates as a result of frequent exposure to weather conditions over a prolonged period of time. Mortar that is deteriorating may allow water ingress into the roof void, putting associated building elements and roofing structures at risk of water damage.

Mortar deterioration can be attended to by a handyperson where areas of deterioration are localised and easily accessible. Otherwise, consultation with a roofing contractor is advised where greater works are required.

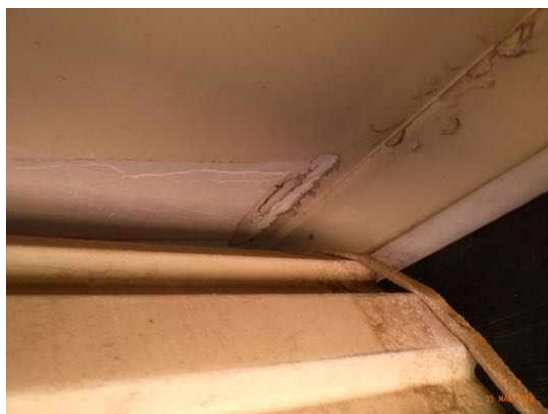
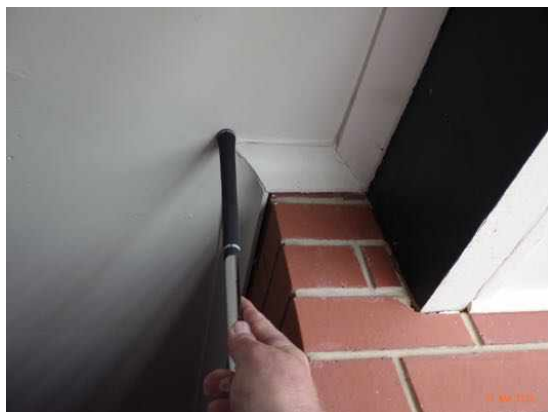
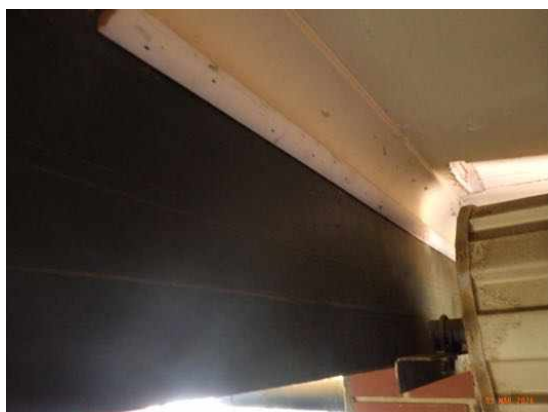
A very common defect found in garages is that the ceiling can sag over time, due to their lack of insulation and or their susceptibility to moisture. Condensation builds up in the roof and rests on the plasterboard softening it somewhat which makes it more likely to sag and release from its fixing points. Moisture evaporating from cars can also contribute to this issue.

Therefore we recommend that you insulate your garage and also apply a good coat of washable paint to the ceiling of the garage to prevent any moisture entering the plasterboard and creating issues in the future. A licensed building insulation installer and licensed painting contractor could be appointed to carry out these works at the discretion of the client.

Repair Ceiling to garage

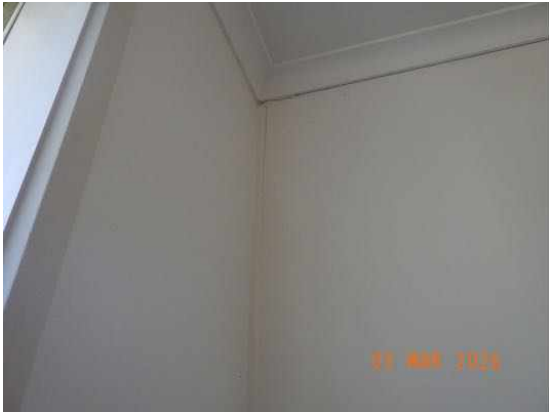
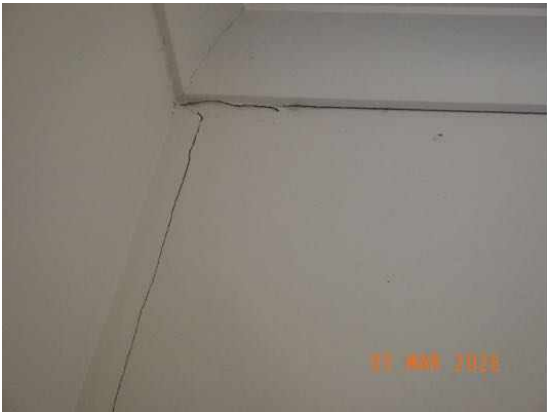
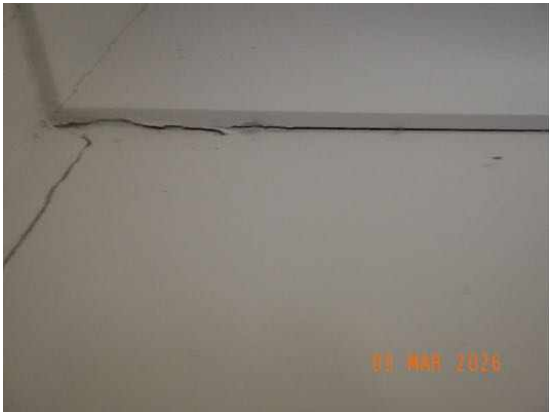
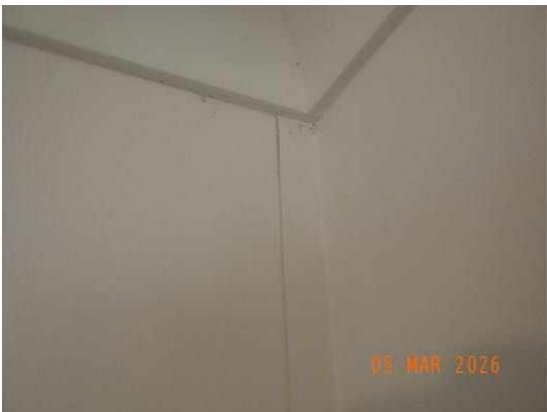
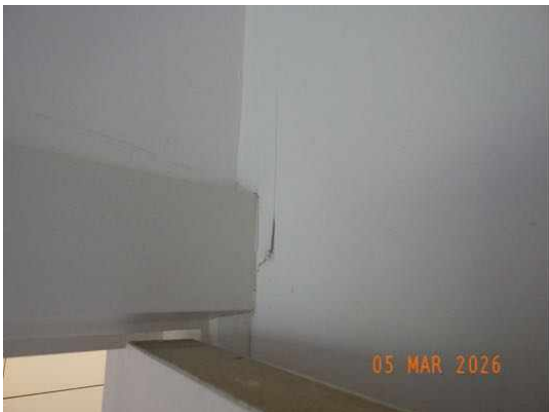
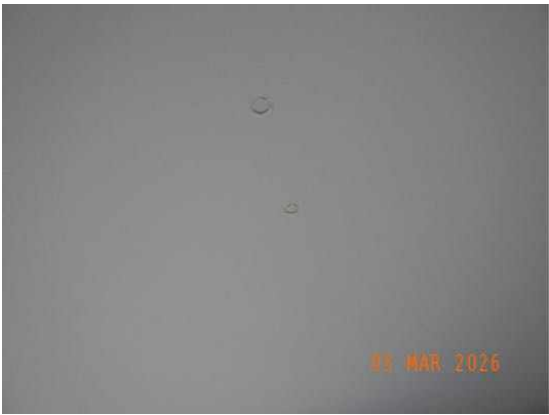
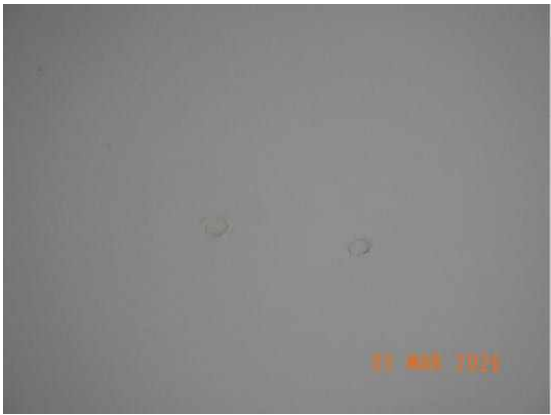
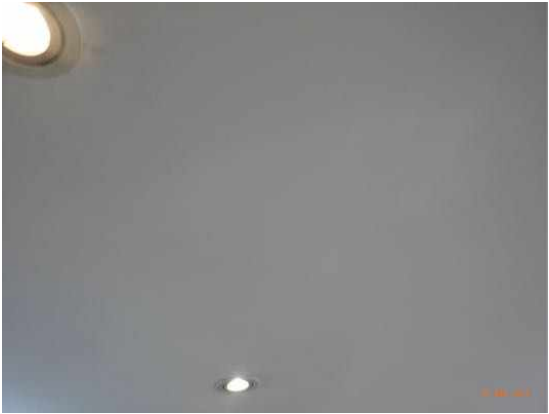
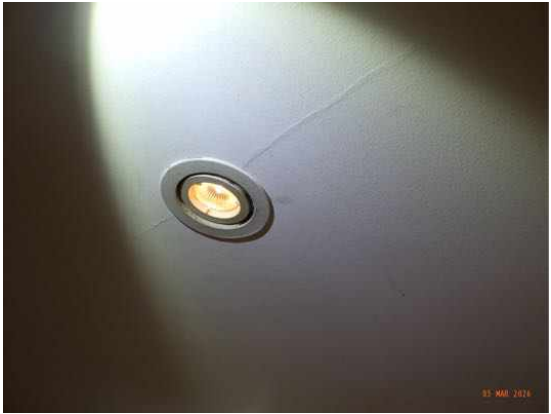
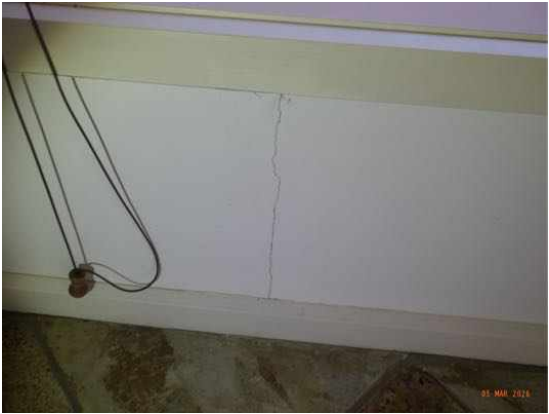
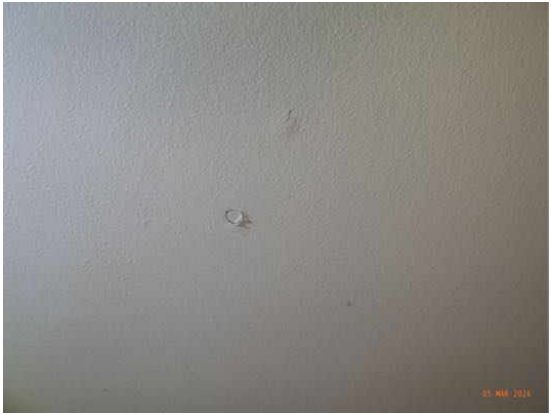
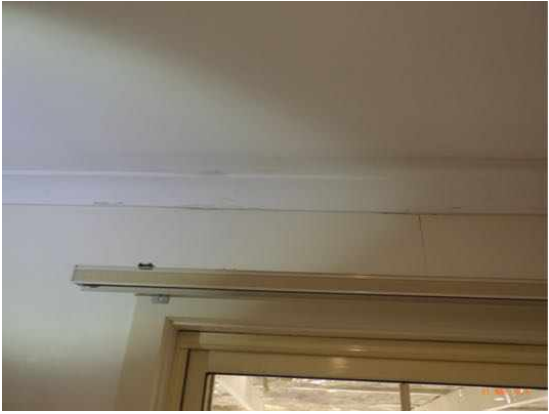
Finding 3.05

Building:	Building 1
Location:	All Internal Areas
Finding:	Cracking - Damage Category 1 - Fine (up to 1mm)
Information:	There were fine cracks evident to the walls and ceilings throughout the dwelling at the time of inspection.

Although fine cracks are quite noticeable, they are often only considered to be an appearance defect, and usually do not indicate any structural damage. Generally, the cause of a fine crack is indicative of a separation between building materials and finishes (e.g. paint, plaster, etc.) along joins.

Cracking of this nature can generally be repaired with minor sanding, filling and/or repainting. Such works should be performed by a qualified painter or a general handyman.

Monitoring of all cracking should be conducted frequently. Always contact a building inspector should cracks widen, lengthen, or become more numerous.

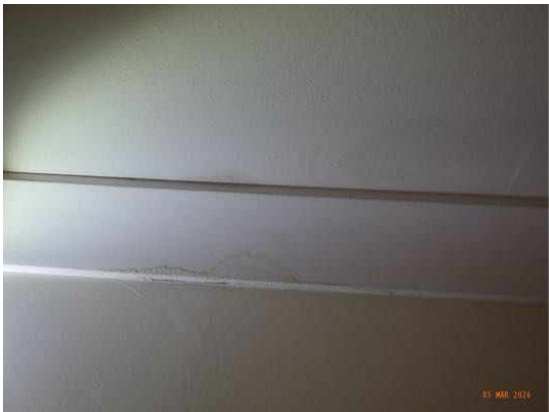
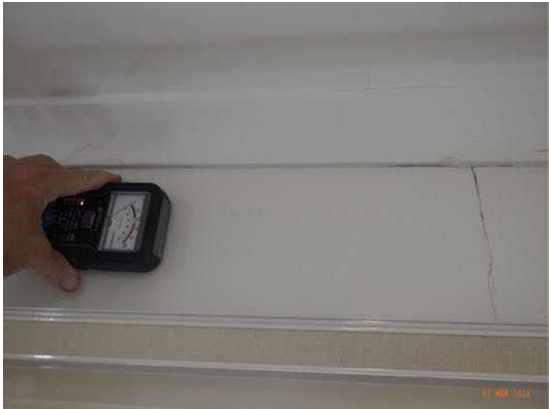
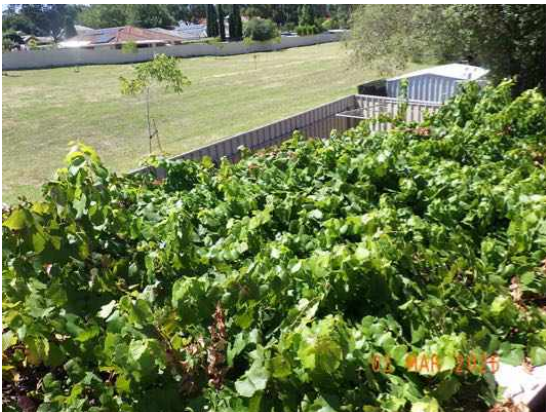
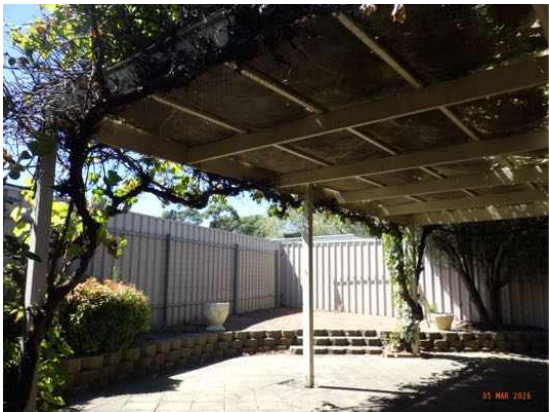
Building:	Building 1
Location:	Living Room
Finding:	Ceiling - Water stained
Information:	Water staining to ceiling linings in the living room was evident at the time of inspection. There were no high readings for moisture in the area and the staining is likely due to previously blocked gutters and water entry possibly due to the Grapevine on the Pagola blocking gutters.

Water staining indicates that surfaces have been exposed to excessive moisture over time. The minerals and other elements in the water lead to staining, which may graduate to corrosion and deterioration if left unmanaged.

The owner indicated that a tile was broken in the area several years ago during the solar installation and was repaired immediately once recognised.

Where water staining is active, a licensed plumber must be consulted to identify the cause of the staining and to provide advice on any reparation works that may be required. Replacement of any damaged structures is advised.

Conversely, where water staining is old and inactive, affected building materials may be repaired or replaced at client discretion.

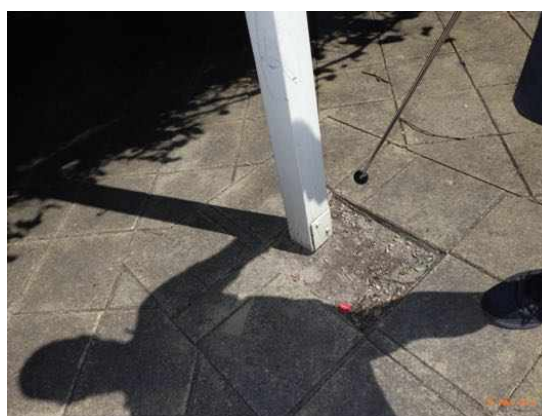
Finding: Untreated or non-durable timbers in a hazardous environment
Information: To reduce the risk of timber pest attack it is essential that timber used in a hazardous environment (e.g. in direct contact with the ground or frequently exposed to damp conditions) is of sufficient durability and/or is adequately preservative treated. Additionally any timber lying around or timber stumps should be removed.

Untreated timbers in direct contact with the ground are likely to develop severe wood rot and/or fungal decay if left unattended creating attraction for subterranean termites to infest the timbers from surrounding areas.

If untreated or non-durable timbers are found to be in a hazardous environment it is highly advised that replacement of these building elements be performed as soon as possible to aid the protection of the property against termite / timber pest attack. Failing this close monitoring is recommended in an attempt to identify termite infestation at an early stage.

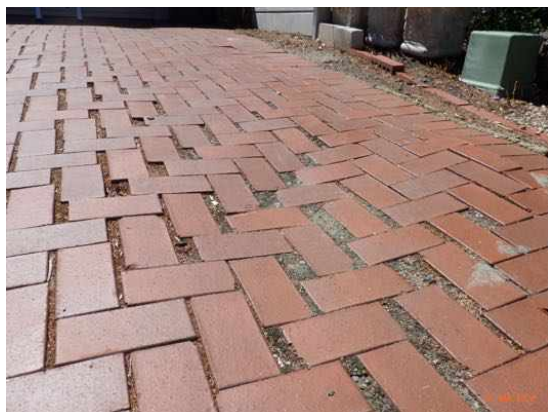
Finding 6.03

Building: Building 1
Location: Driveway
Finding: Paving - Uneven
Information: Sections of the external paved area at the front of the building are uneven, creating a potential trip hazard.

Where paving creates a trip hazard, personal injury may ensue if due caution is not taken by persons within this area.

Movement paving is likely due to heavy traffic from vehicles and potentially inadequate installation.

Re-paving of the area is required as soon as possible to remedy this situation. Further consultation with a specialist paving contractor is advised.

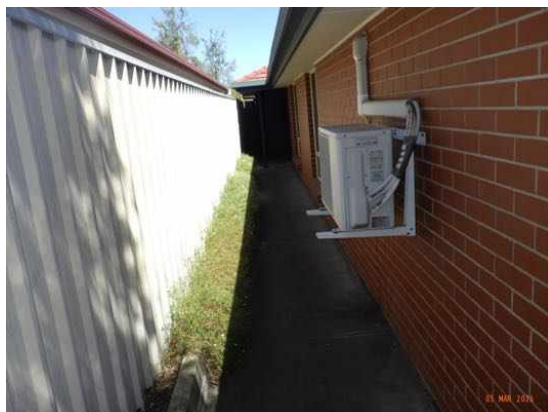
Finding 6.04

Building:	Building 1
Location:	All External Areas
Finding:	Air conditioner and or external tap - No drainage
Information:	Moisture around the perimeter of the building should be minimised to ensure that the area is kept dry and stable which in turn reduces the risk of water damage and termite infestation.

There appears to be no drainage points set up to the air conditioning unit, and or the external tap. While this is not a legal requirement it is recommended to reduce the risk of moisture related issues and the creation of an environment conducive to termite activity.

It is recommended that a licensed plumber be appointed to set up drainage in order to prevent such an environment from being created.
