Building and Timber Pest Inspection Report

Inspection Date: Wed, 11 Mar 2026

Property Address: 20 Bunyip walkway, Melonba NSW 2765,
Australia

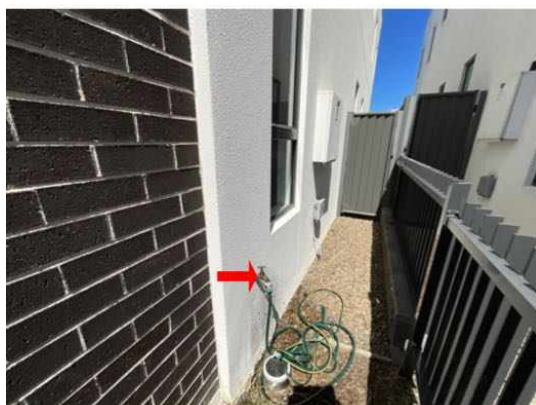
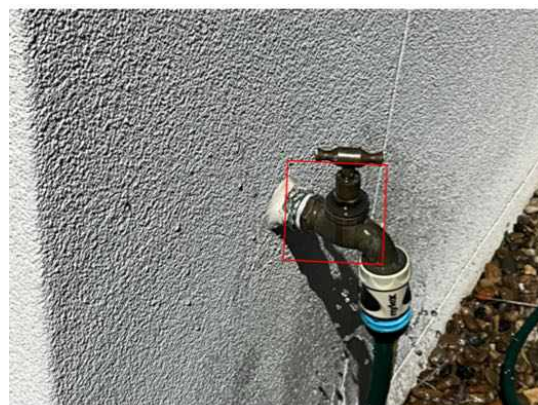
Finding 3.01

Building: Main Building
Location: Front left corner
Finding: Tap - Leaking
Information: The tap in this area was found to be leaking at the time of inspection. This is a common defect that is consistent with general ageing of the building element. However, it may be indicative of substandard plumbing workmanship if the tap is relatively new.

While this defect only seems minor, if left unmanaged, it is likely to result in the development of rust, water damage and/or extensive water usage.

It is advised that a handyman or licensed plumber be appointed to perform remedial works on the affected tap. Such works should be performed prior to the development of secondary defects to ensure adequate functionality of all associated building elements.

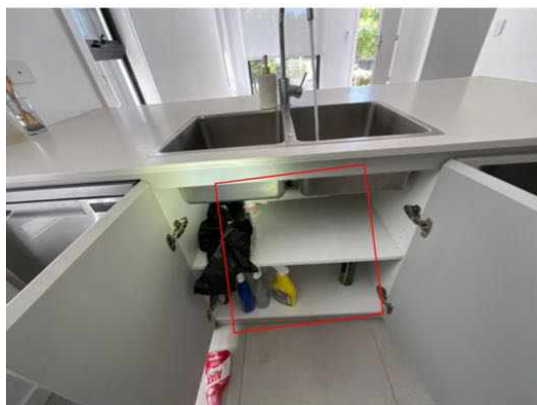
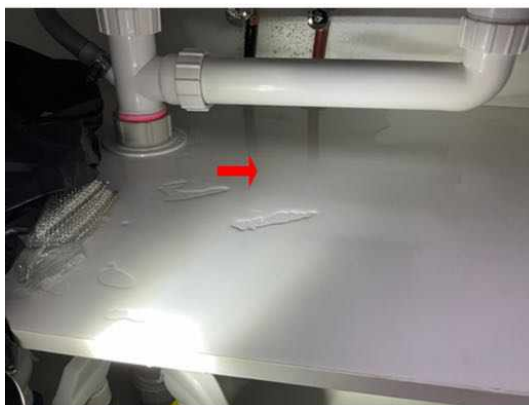
Finding 3.02

Building: Main Building
Location: Kitchen

Finding: Damp or wet - leak
 Information: Damp or wet conditions are generally a direct result of an active leak. Dry conditions should be maintained to prevent secondary building defects from developing.

If left unattended damp or wet conditions may have many consequences including the development of fungal decay and/or wood rot as well as providing an environment that may be conducive to termite or timber pest attack.

A licensed plumber should be appointed immediately to identify the cause of the excessive moisture in order to prevent further damage. The water leak should be resolved prior to any repairs of the damaged area which may require localised replacement of building materials and refinishing.

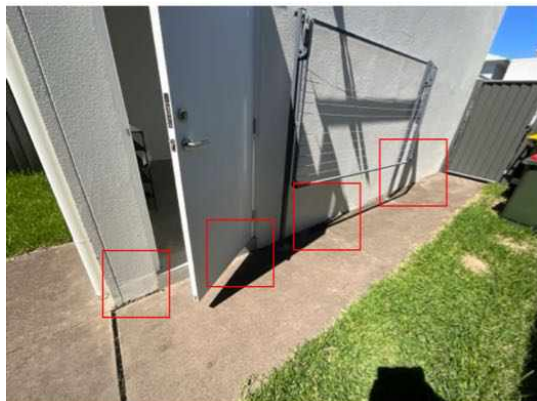
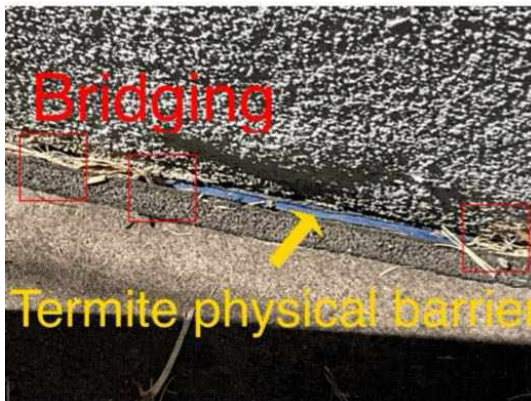
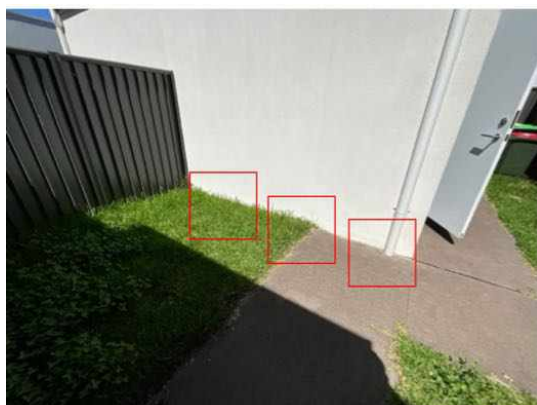
Finding 6.01

Building: Main Building
 Location: Multiple areas
 Finding: Bridging of termite barrier
 Information: Bridging of termite barriers occurs when termites bridge (usually by building a mud tunnel) a termite barrier or inspection zone or where termites have a passage allowing them to bridge the barrier.

Generally this takes the form of finished ground levels external paving or concrete

being retrospectively installed above the damp course level the adjacent internal floor level or weep and ventilation holes.

Where bridging has occurred full inspection is prevented and termites may enter a property in a concealed or undetectable manner.

- Lower raised ground levels where necessary and remove any bridging
- Regular inspections every 12 months

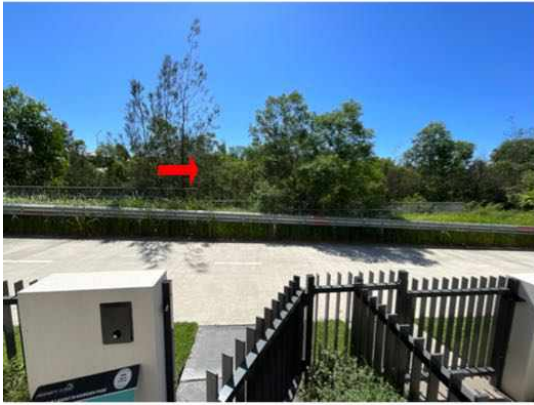
Finding 6.02

Building: Main Building
 Location:
 Finding: Surrounding bushland - Conducive
 Information: Home and or building is situated in a high risk area for termite activity, due to close proximity to surrounding bushland.

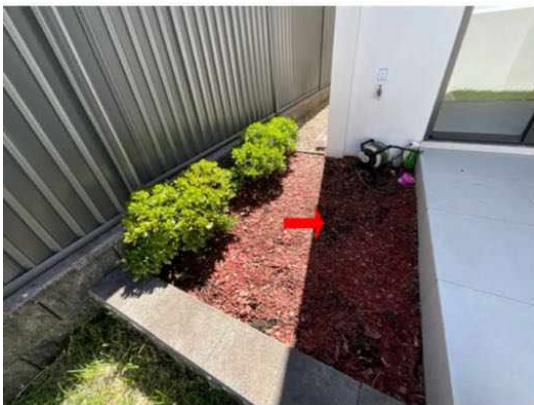
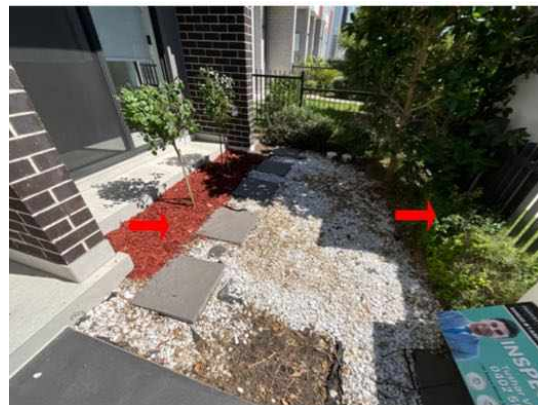
Finding 6.03

Building:	Main Building
Location:	Garden beds
Finding:	Garden Beds
Information:	Garden beds were found to be evident in the garden area. These garden beds can include untreated timber, and with a combination of moisture from watering or hosing can make conditions conducive to termite activity and termite ingress.

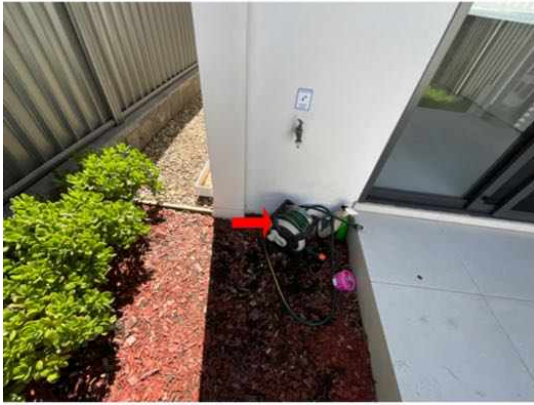
Finding 6.04

Building:	Main Building
Location:	External tap
Finding:	Tap - No drain
Information:	The external tap in this area was noted to have no drain at the time of inspection.

This keeps the surrounding surfaces damp while using the tap, which becomes conducive to termite activity.

A licensed plumber must be appointed to ensure an appropriate drain is installed.

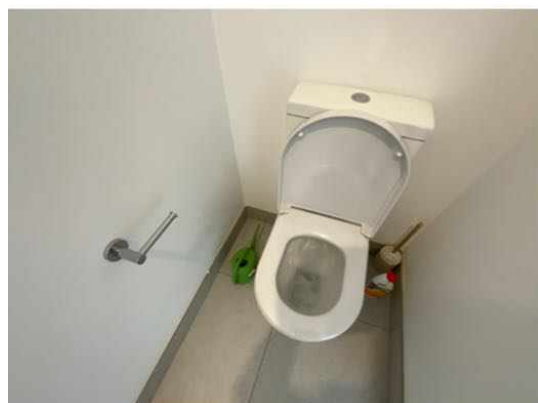
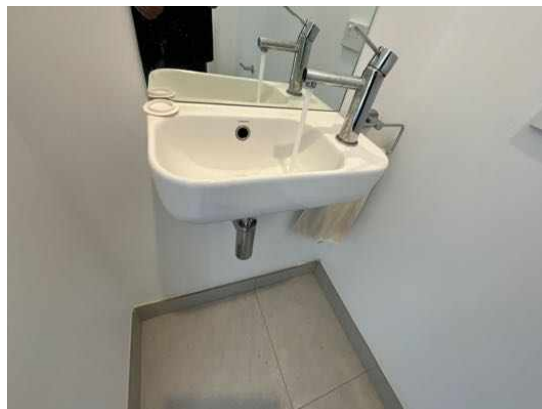
Building: Main Building
 Location: All Wet Areas
 Finding: Waterproofing
 Information:

All taps, mixers and toilets were tested for operation, except for those obstructed. The waterproofing to the shower recess was assessed by checking the walls in and around the shower recess for varying moisture content. There were no significant variations across the tested areas. No sign of recent water damage was evident upon a visual inspection of the surrounding walls, where the visual nature of the inspection was possible.

Consequently, there is no conclusive evidence of any current shower recess leakage other than those which may have already been mentioned earlier in this report. It is reasonable to assume the shower waterproofing is sound. Note that if the shower is not used, or has not been used for some time, moisture readings would not vary significantly and this can lead to erroneous results. It is not possible under the visual inspection criteria (under which a prepurchase inspection is carried out) to categorically determine if there are leaks. If a more accurate assessment is required, a special purpose inspection should be requested. Alternatively, the assumption should be made that the shower may leak.

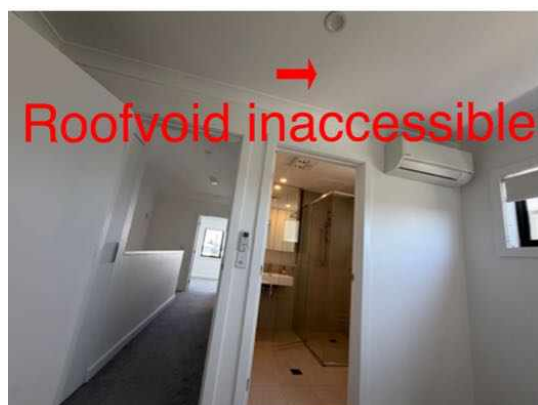
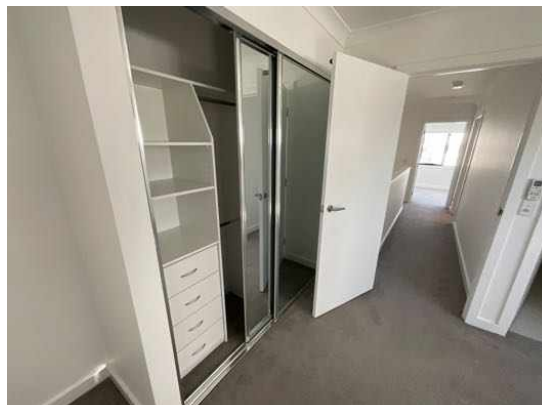
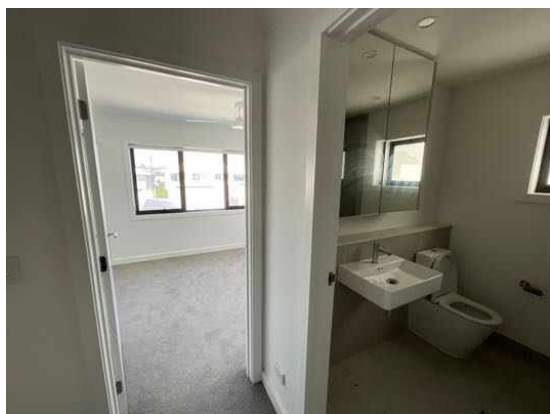
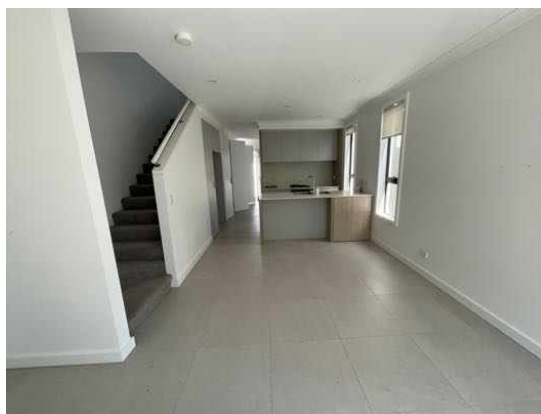
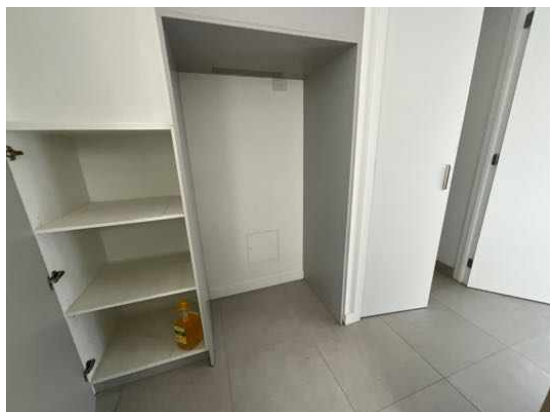
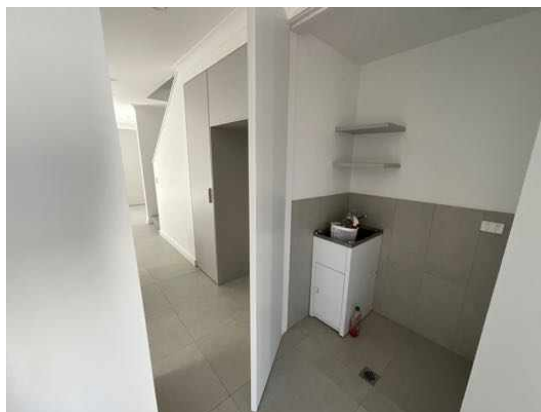
Building: Main Building
Location: All Areas
Finding: Additional Photos - Obstructions and Limitations
Information: These photographs are an indication of the obstructions and limitations which impeded full inspection of the property at the time of inspection. These obstructions can hide an array of defects and should be removed to allow full inspection to be carried out. A re-inspection is recommended once the areas are made accessible.

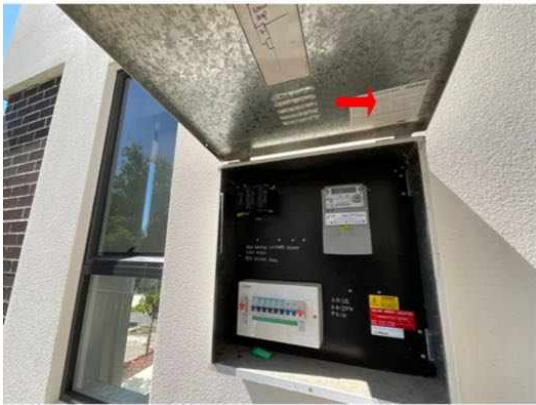
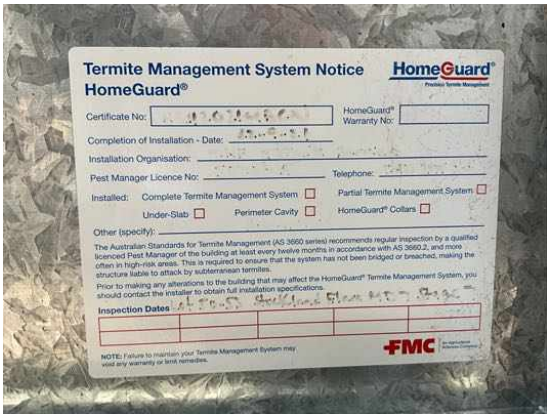
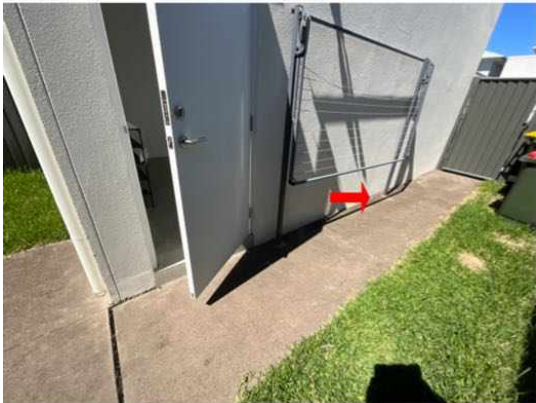
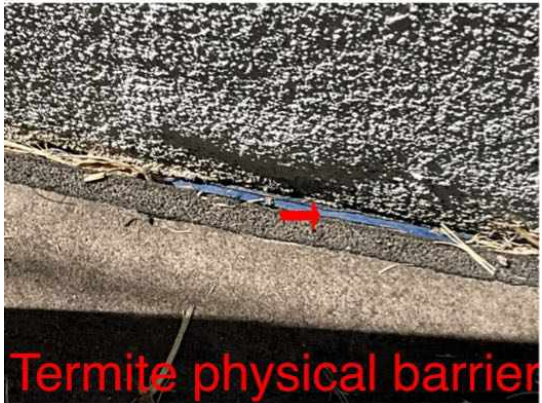
Building:	Main Building
Location:	Meterbox
Finding:	Evidence of a previous termite management system was identified
Information:	There are a number of factors which indicate the presence of a previously installed or applied termite barrier. The most common are a durable notice (to the inside of your meter box) observable physical barriers installed to building perimeter and in ground reticulation systems.

Where a Termite Management System has been identified you should refer to the type of barrier date of installation warranty conditions and any documentation provided by a builder or past owner. Consult the company who installed the barrier to confirm whether the system is still under warranty.

Most chemical termite management systems expire and require replenishment and all physical systems are primarily designed to prevent concealed entry.
