# Building and Timber Pest Inspection Report

Inspection Date: Thu, 5 Feb 2026

Property Address: 20 Poinciana Ave, Victoria Point QLD 4165, Australia

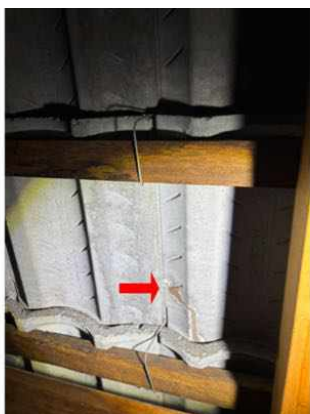
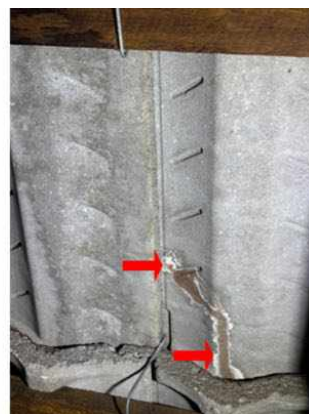
#### Finding 3.01

Building: Main Building  
 Location: Roof Void  
 Finding: Roof tile - pinhole  
 Information: At the time of the inspection, it was noted that a roof tile had a pinhole in it which allows moisture to enter the roof void. There is no evidence of moisture damage to the ceiling or timber framing directly below this area. The staining to the underside of the roof tile suggests that moisture tracks along the underside of the roof tile to the top of the next roof tile down.

A roofing contractor could be engaged to replace this roof tile. This can be done at the clients discretion.

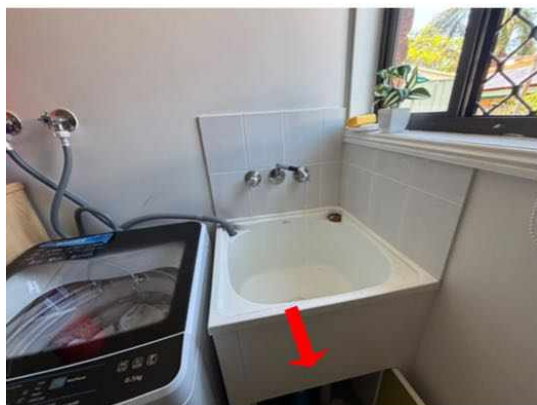
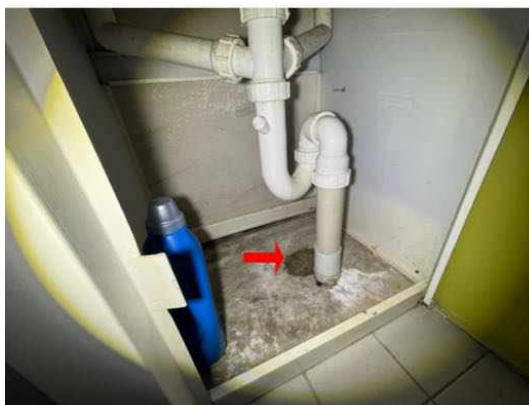
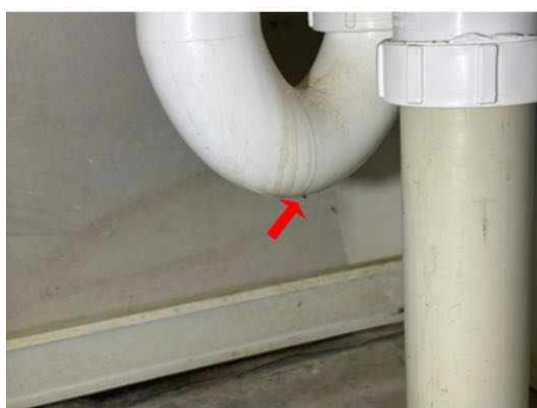
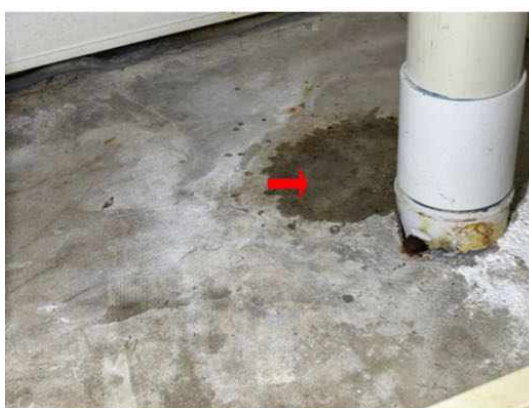
#### Finding 3.02

Building: Main Building  
 Location: Laundry  
 Finding: Laundry - tub drain leak  
 Information: At the time of the inspection, it was noted that there was a minor leak from the laundry tub drain. If left unaddressed, this leak will become bigger.

A licensed plumber should be engaged to repair this leak. This should be done as a matter of urgency.

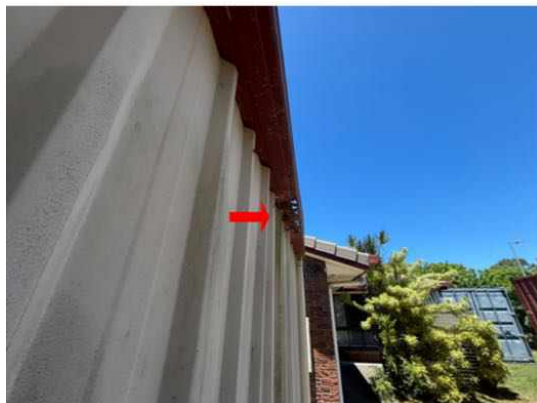
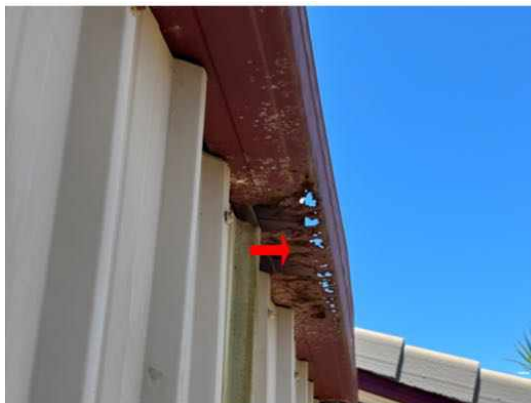
### Finding 3.03

Finding: Garage - gutter rusting

Information: At the time of the inspection, it was noted that the gutters to the garage were rusting and as such leaking in numerous areas. Gutters need to be in good working order to drain the roof properly.

If gutters are leaking, moisture may get to areas of the building that are meant to be kept dry. Damage to building elements may result of moisture ingress.

A licensed roof plumber should be appointed to inspect the gutters and advise on necessary rectification works. This should be done as a matter of urgency.

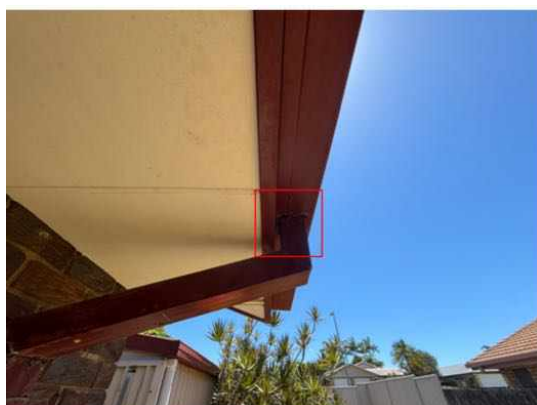
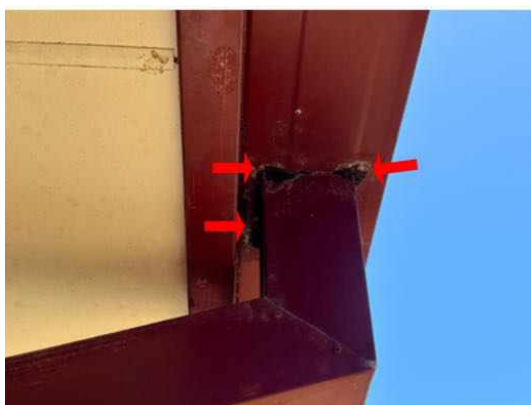
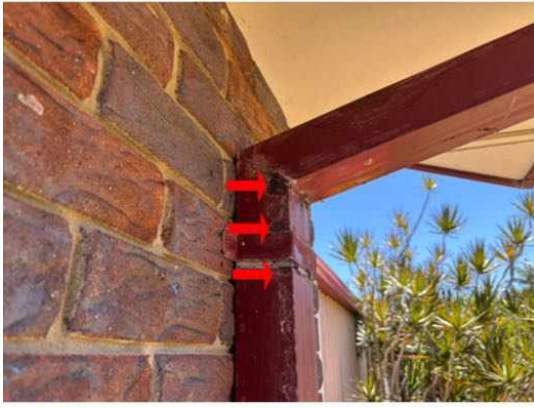
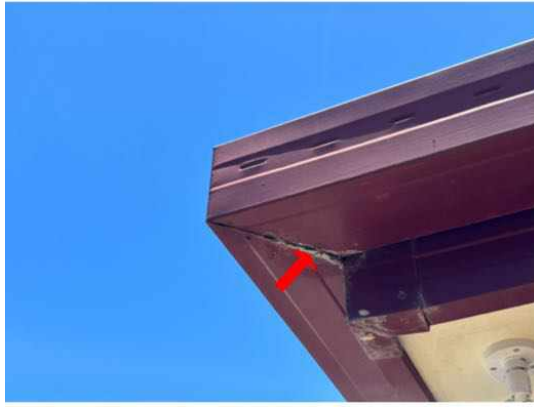
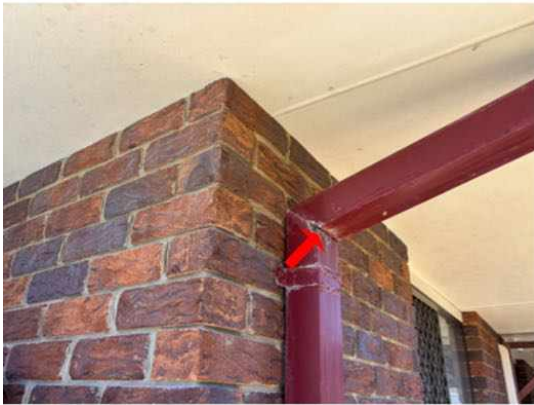
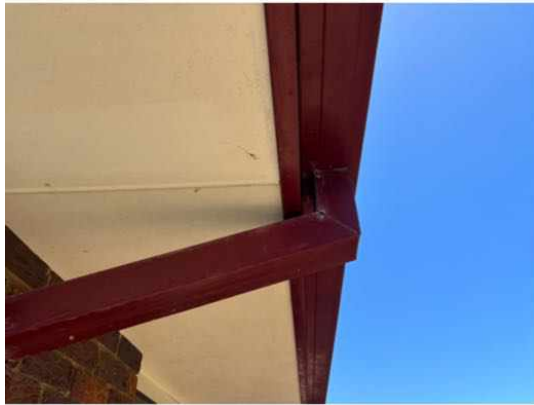
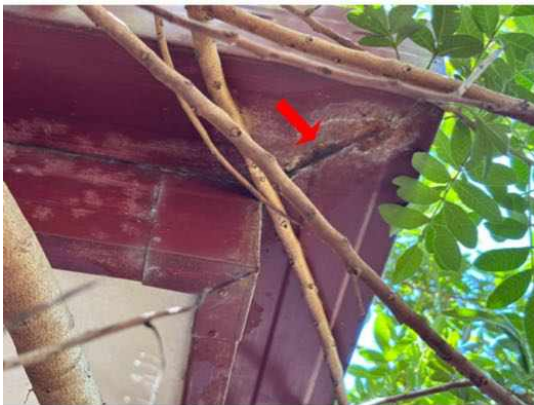
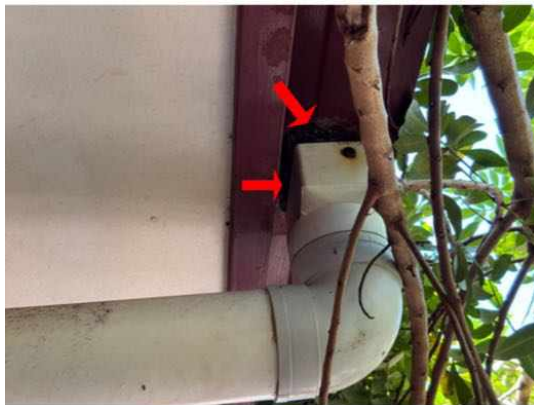
### Finding 3.04

Finding: House - gutters rusting

Information: At the time of the inspection, it was noted that the metal gutters and down pipes to the house were rusting in several areas and as such could be leaking in numerous areas. It was not raining on the day of the inspection, so leaking of the gutters and down pipes could not be confirmed. Gutters need to be in good working order to drain the roof properly.

If gutters are leaking, moisture may get to areas of the building that are meant to be kept dry. Damage to building elements may result of moisture ingress.

A licensed roof plumber should be appointed to inspect the gutters and advise on necessary rectification works. This should be done as a matter of urgency.

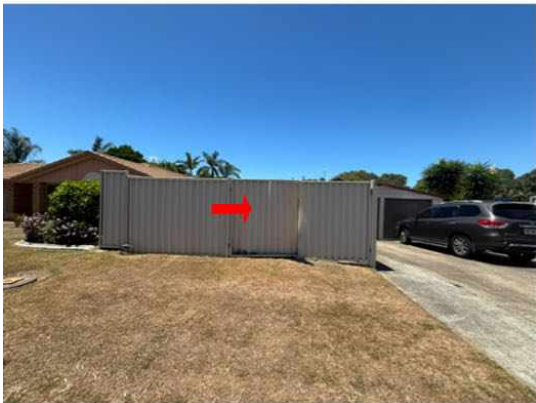
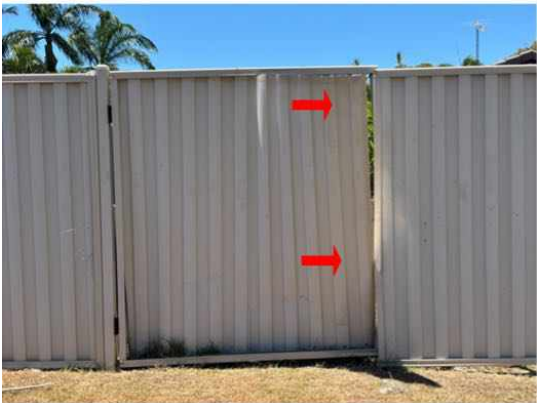
### Finding 3.05

Building:	Main Building
Location:	Metal fence
Finding:	Metal fence gate - damaged
Information:	At the time of the inspection, it was noted that the left hand panel on the metal fence gate near the driveway was damaged.

A fencing specialist could be engaged to replace this damaged panel. This can be done at the clients discretion.

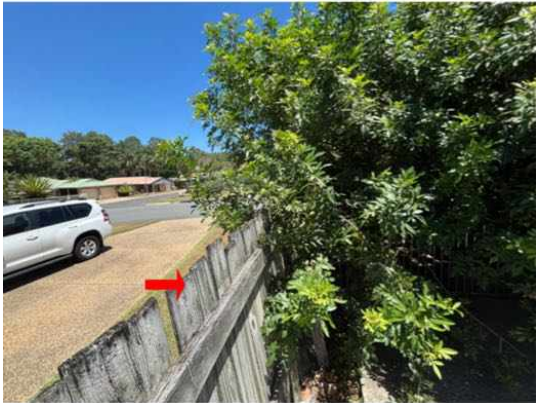
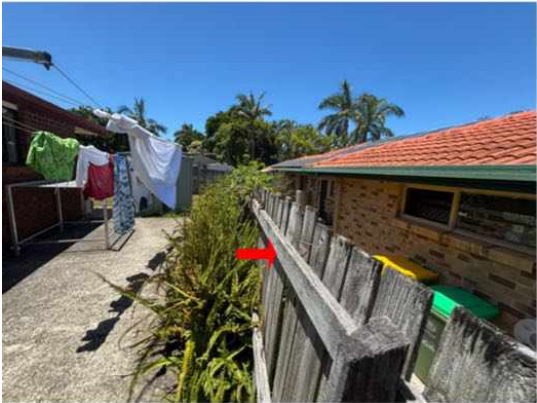
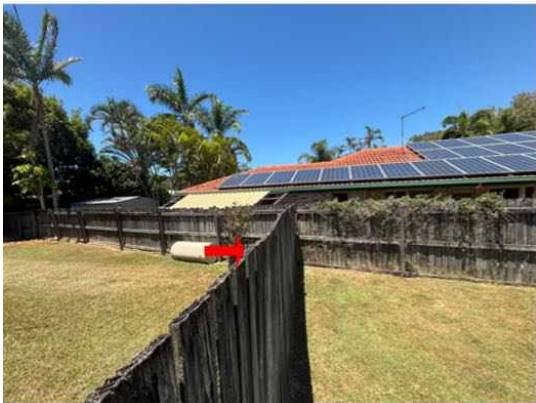
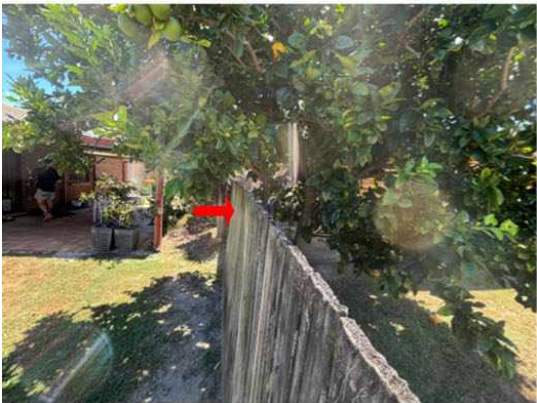
**Finding 3.06**

Building: Main Building  
 Location: Timber boundary fences  
 Finding: Boundary fences - deteriorating  
 Information: At the time of the inspection, it was noted that the left hand side and rear timber boundary fences were deteriorating. The rear fence is leaning into the neighbours yard. The left hand side fence is currently upright however there is movement to sections of it when pressure is applied to it.

A fencing contractor should be engaged to assess the fences and provide a solution to rectify this issue. This can be done at the clients discretion.

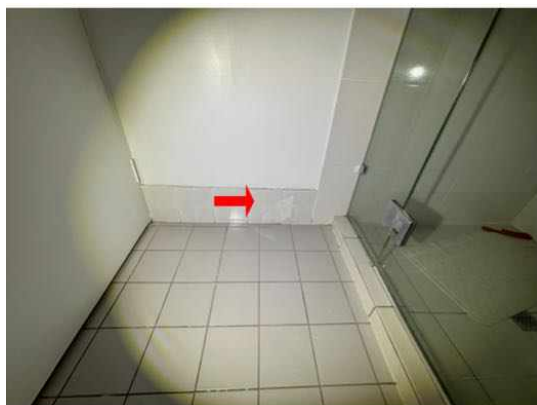
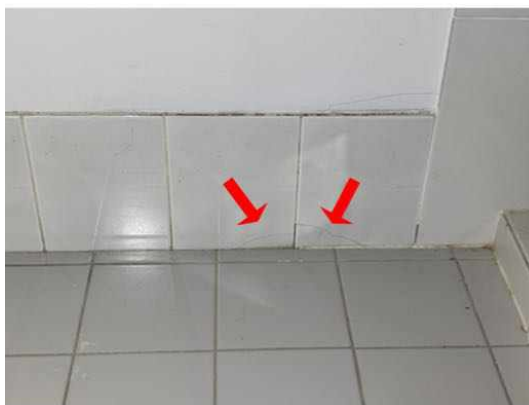
### Finding 3.07

Building: Main Building  
 Location: Bathroom  
 Finding: Bathroom - cracked tiles  
 Information: At the time of the inspection it was noted that several skirt tiles were cracked in the bathroom. The cause of this cracking could not be determined. This appears to be purely an aesthetic issues and could be attended to at the clients discretion.

A tiler or building maintenance professional would be able to carry out the necessary works.

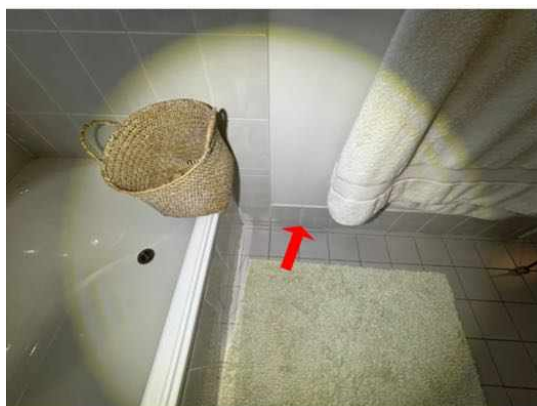
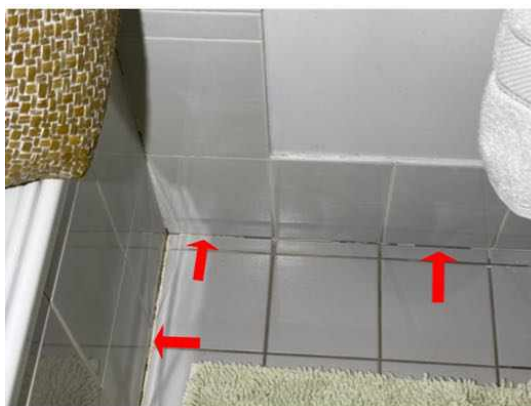
### Finding 3.08

Building: Main Building  
 Location: Bathroom  
 Finding: Bathroom - sealant deteriorating  
 Information: At the time of the inspection it was noticed that the sealant to the wall and floor junction in the bathroom was deteriorating.

Sealant is used in tiled areas to prevent moisture from entering the wall cavity and causing damage to the building elements. A moist environment in the wall cavity may also be a conducive condition for termite activity.

If it is not addressed, damage to building elements will occur and would require invasive works to rectify any damage.

A building maintenance professional or sealant applicator should be appointed to replace all sealant as a matter of urgency.

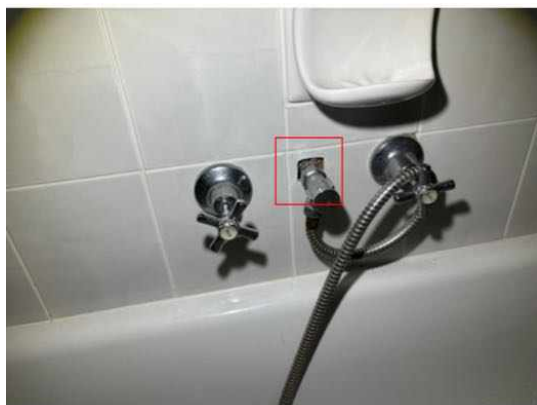
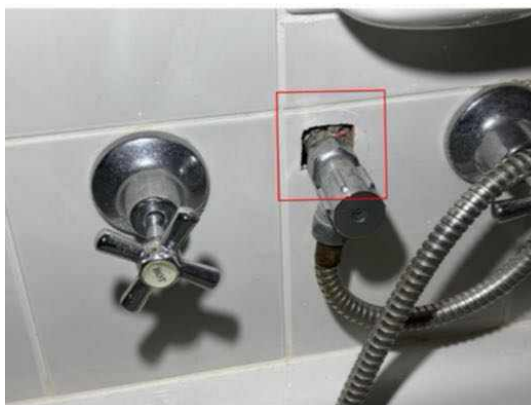
### Finding 3.09

Finding: Bathroom - bath tub spout has no sealant

Information: At the time of the inspection, it was noted that there was no sealant to the bath tub spout penetration. This can allow moisture to enter the wall cavity.

Moisture in wall cavities can create a conducive environment for termite activity and can cause undetected damage to the associated building materials.

A building maintenance professional should be engaged to apply sealant to the bath tub spout penetration. This should be done as a matter of urgency.

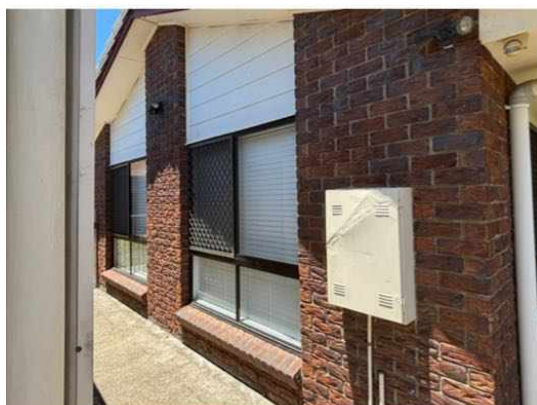
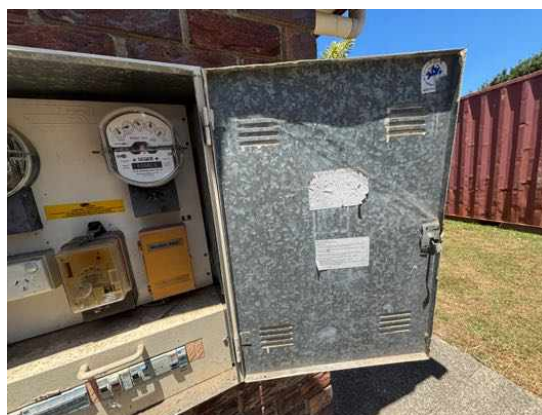
### Finding 6.01

Building:	Main Building
Location:	All External Areas
Finding:	Termite Management System - no evidence of a chemical installation
Information:	At the time of the inspection, no evidence of a chemical termite management system was found. There is no durable notice in the meter box.

The application of a post-construction chemical termite barrier is highly recommended for all properties, particularly if live termite activity has been found on the site previously. Such barriers are highly effective in preventing termite attack on any timber building elements throughout the property.

The client may consider gaining further advice from a pest controller as to the costs and procedures involved with this application. It is recommended that obtaining such advice be a short-term priority.

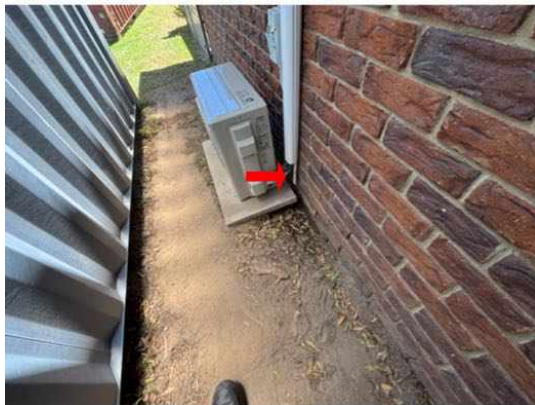
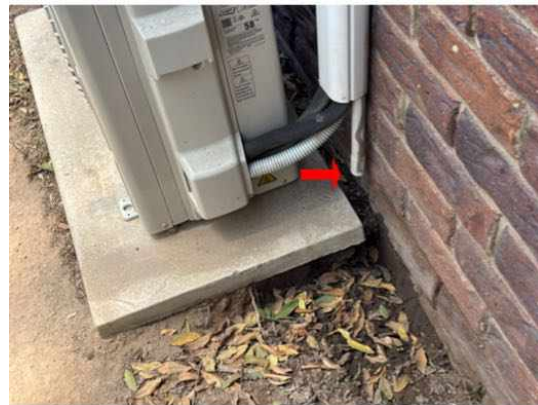
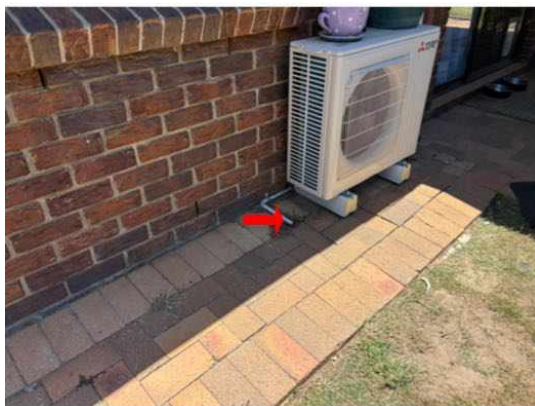
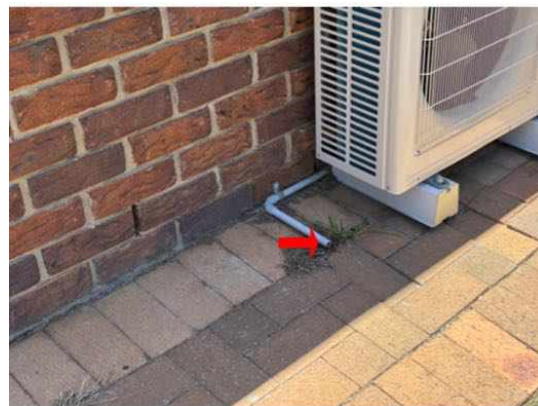
### Finding 6.02

Building:	Main Building
Location:	All External Areas
Finding:	Air conditioner - Disconnected overflows
Information:	At the time of the inspection, it was noted that the air conditioner drain overflows to all the units were not connected to the storm water drainage and as a result are draining

next to the foundations of the dwelling.

Air conditioning overflows that are not connected to the storm water drainage and are draining near the foundation can create excessive moisture in the surrounding area.

Such leaking creates an environment which is conducive to an array of defects, including water damage to associated building elements and the attraction of termite or timber pest infestation.

It is highly recommended that a licensed plumber be appointed to connect the A/C overflow in order to prevent such an environment from being created. These minor works should be carried out as soon as possible.

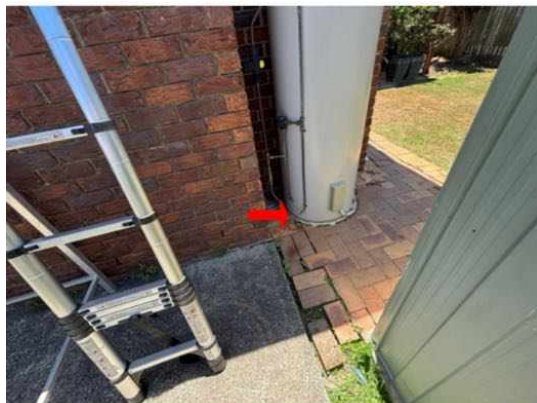
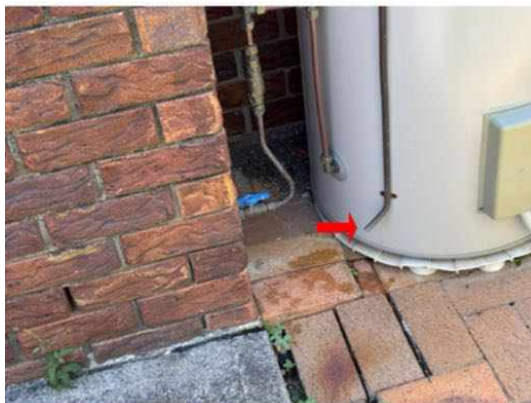
### Finding 6.03

Building:	Main Building
Location:	Side yard
Finding:	Hot water tank - not plumbed to stormwater
Information:	At the time of the inspection, it was noted that the overflow for the hot water tank was not plumbed to the storm water system.

Moisture draining next to the foundations of the dwelling can create a conducive environment for termite activity. Moisture may also damage the associated building materials.

A licensed plumber should be engaged to plumbing the overflow into the storm water system. This should be done as a matter of urgency.

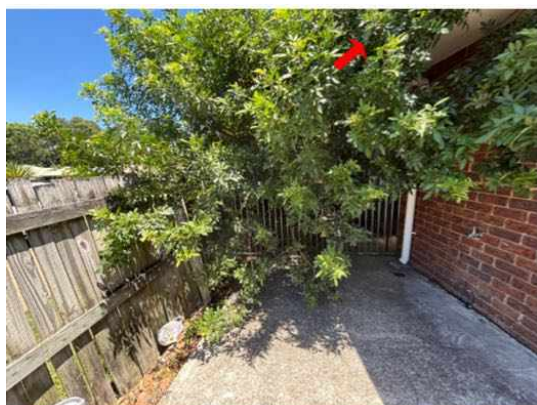
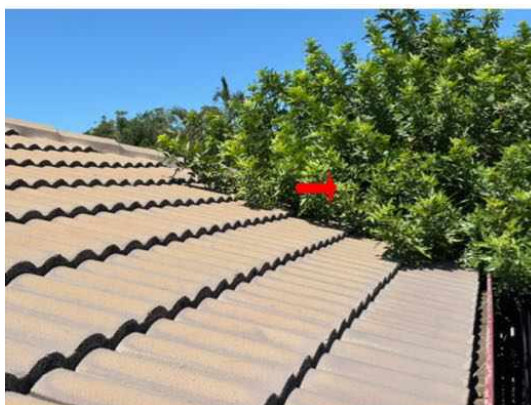
### Finding 6.04

Finding: Vegetation touching the building

Information: At the time of the inspection, it was noted that there was vegetation touching the building at the rear right hand of the building. This creates a potential access point for termites to enter the building undetected. This is a conducive condition for termite activity.

The client is to ensure that the vegetation is trimmed back to prevent undetected termite entry to the building. This should be done as a matter of urgency.

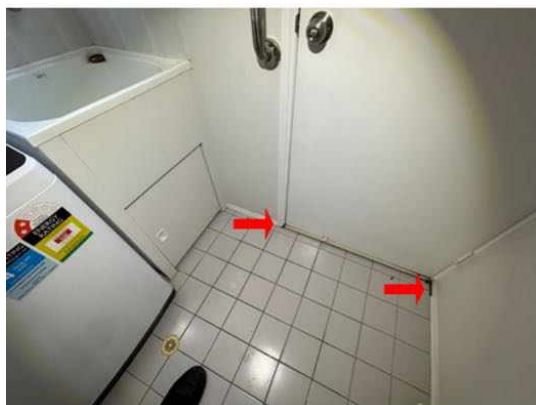
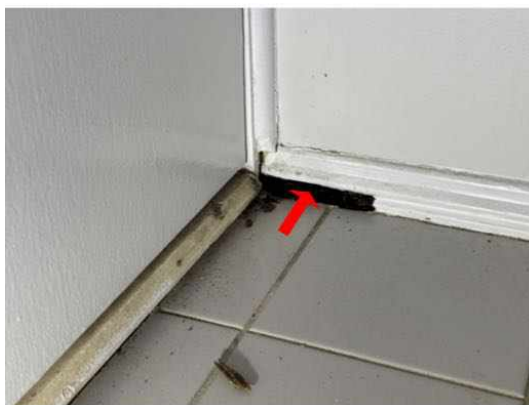
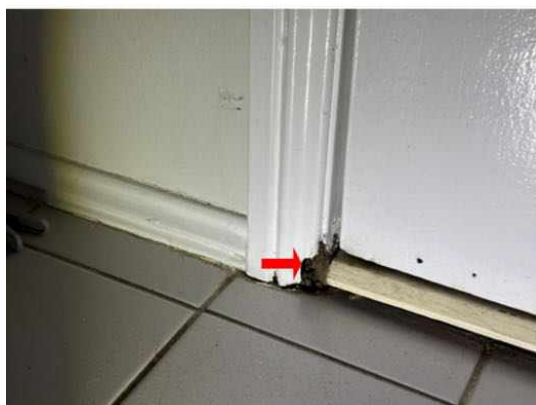
### Finding 7.01

Finding: Laundry - wood rot

Information: At the time of the inspection, it was noted that there was evidence of wood rot to either side of the external door in the laundry. There is no weather seal to the underside of the door and no awning to the top of this door which could allow moisture from rain to enter the laundry causing the wood rot. A building maintenance professional should be engaged to install a weather seal to the underside of the door.

This building element shows evidence of wood rot. Wood rot, also known as Fungal Decay, occurs when timbers and other cellulose building materials are exposed to damp conditions on an ongoing basis.

Wood rot is often associated with general damp problems and is evidenced by a 'musty' smell or mould and mildew occurring on surfaces. If left unmanaged, damp conditions can lead to further health problems and the decay of timbers will continue.

Early intervention and regular maintenance, particularly of exterior timbers, will prolong the useful life of these building elements. Prior to any works being performed, the cause of the moisture that has created the visible wood rot should be identified and addressed in a suitable manner. Replacement of affected timbers may then be a necessary step in protecting surrounding building elements from such deterioration.

A qualified carpenter or registered builder may also be required to replace affected building materials.

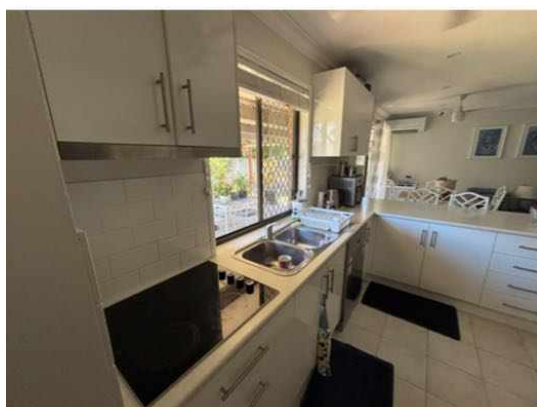
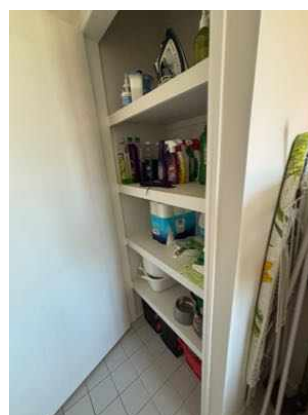
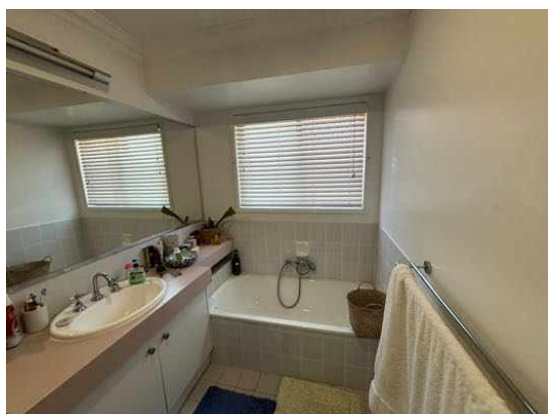
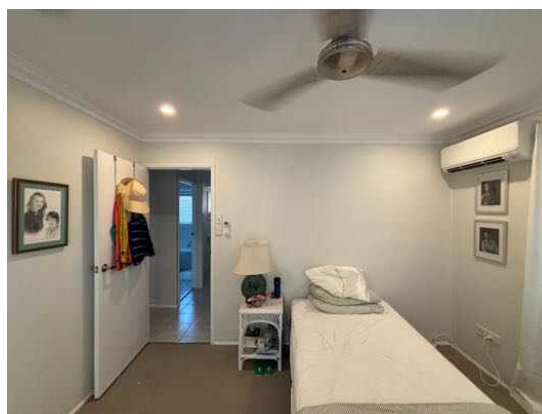
Building: Main Building  
 Location: All Internal Areas  
 Finding: Obstructions and Limitations - Internal areas  
 Information: These photographs are an indication of the obstructions and limitations which impeded full inspection of the property of the internal areas at the time of inspection. These obstructions can hide an array of defects and should be removed to allow full inspection to be carried out. A re-inspection is recommended once the areas are made accessible.

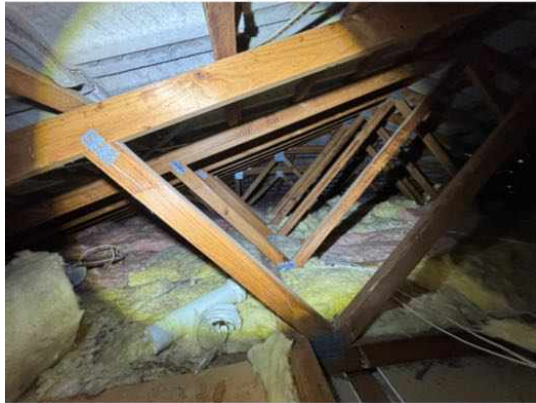
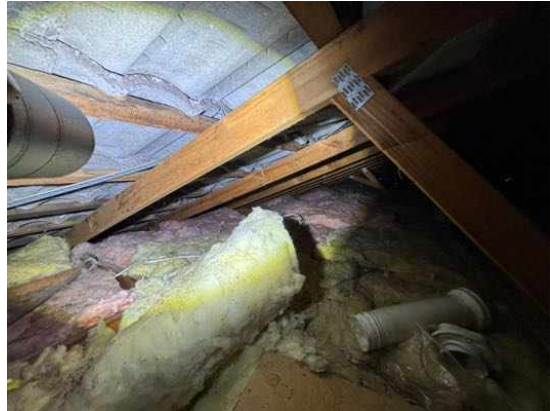
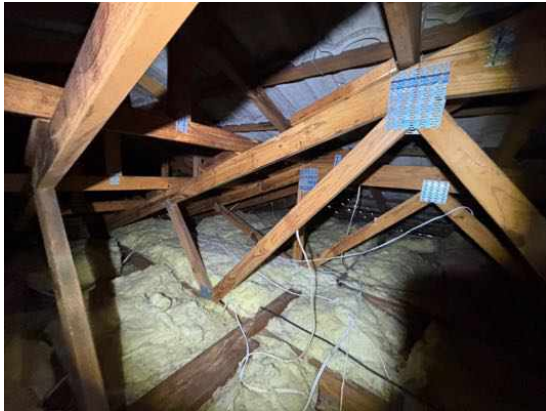
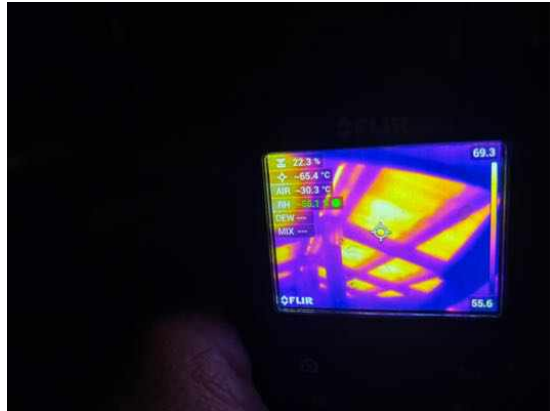
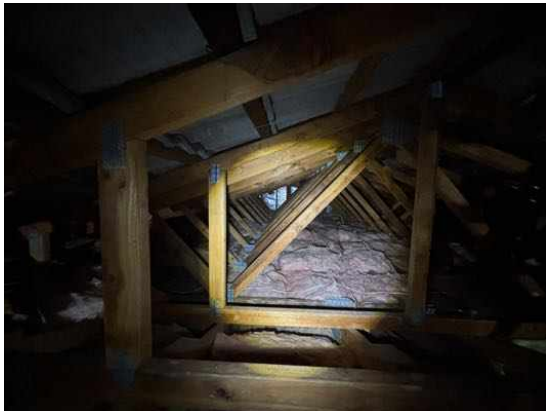
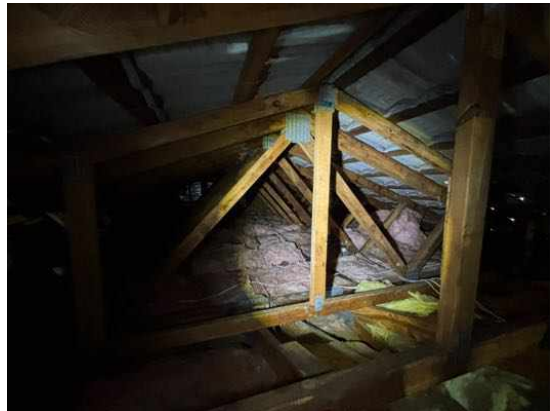
Building: Main Building  
 Location: Roof Void  
 Finding: Obstructions and Limitations - Roof cavity  
 Information: These photographs are an indication of the obstructions and limitations which impeded full inspection of the property of the roof cavity

at the time of inspection. These obstructions can hide an array of defects and should be removed to allow full inspection to be carried out. A re-inspection is recommended once the areas are made accessible.
