Building and Timber Pest Inspection Report

Inspection Date: Thu, 19 Mar 2026

Property Address: 9 Flametree Dr, Melonba NSW 2765, Australia

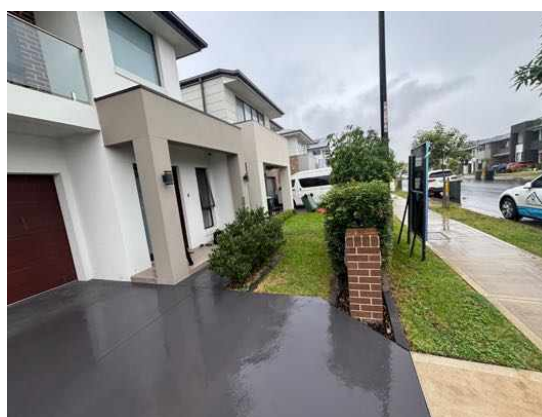
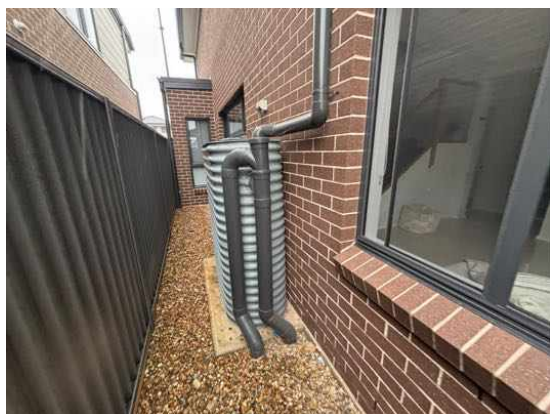
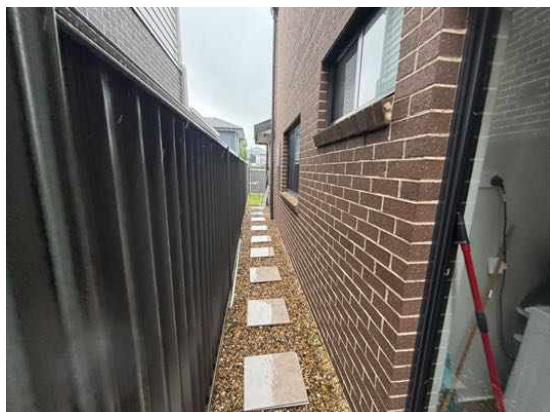
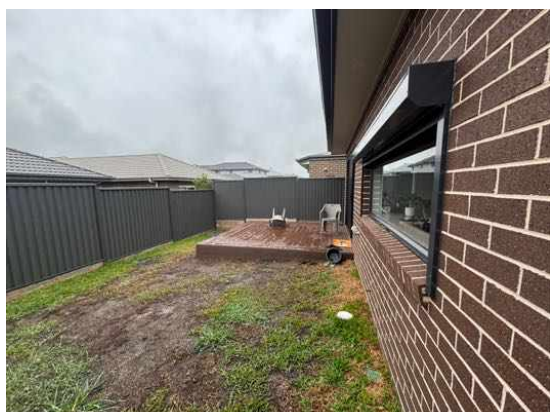
Building: Main Building
Location: All External Areas
Finding: Obstructions and Limitations - External Areas
Information: The attached photographs provide a visual representation of the obstructions and limitations that impeded a full inspection of the external areas of the property at the time of assessment. These obstructions, which may include vegetation, stored items, debris, or other physical barriers, can obscure potential defects and prevent a thorough evaluation of the property's condition. Obstructions of this nature can conceal a wide range of issues, such as structural damage, water ingress, pest infestations, or deteriorating building materials, which may not be visible during the initial inspection.

It is essential that these obstructions be cleared to allow for a comprehensive inspection of the external areas. Removing these barriers will enable a more accurate assessment of the property's condition and allow any hidden defects to be identified and addressed promptly. Failure to do so could result in undetected issues worsening over time, potentially leading to more costly repairs in the future.

Therefore, it is strongly recommended that the obstructions be removed and a re-inspection be scheduled once the affected areas are made fully accessible. This will ensure a complete evaluation of the property's exterior and provide the client with a clear understanding of any potential issues that may have been concealed during the initial inspection.

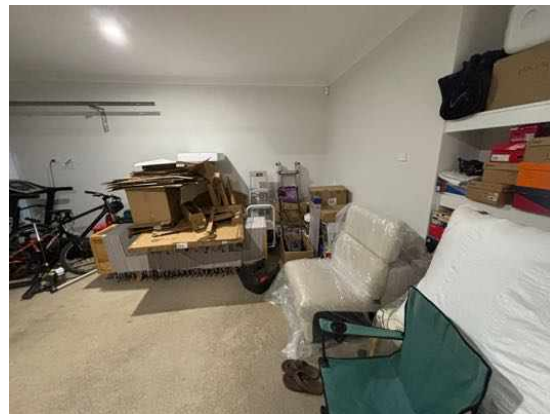
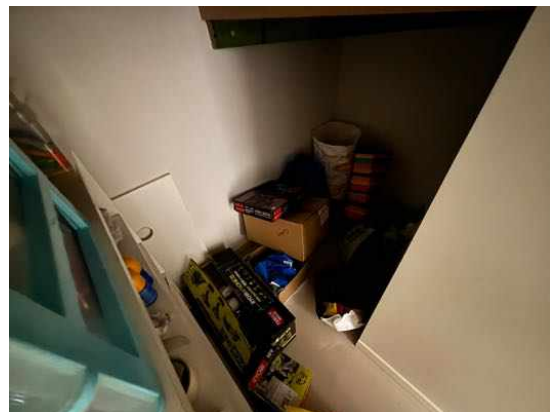
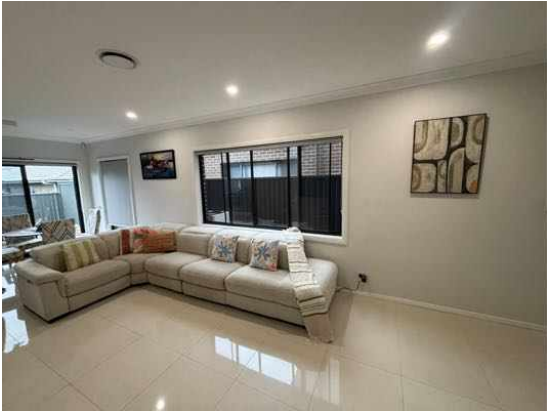
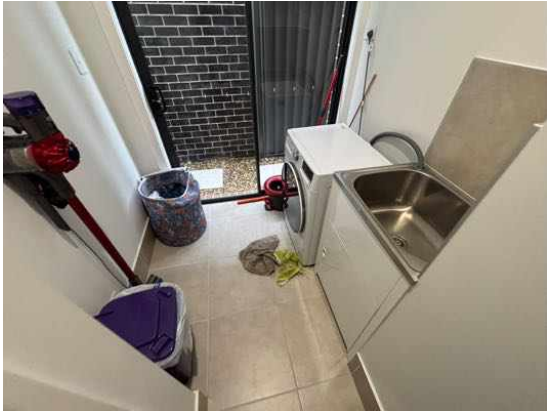
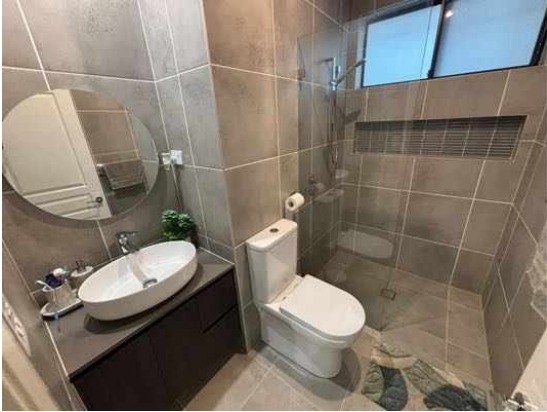
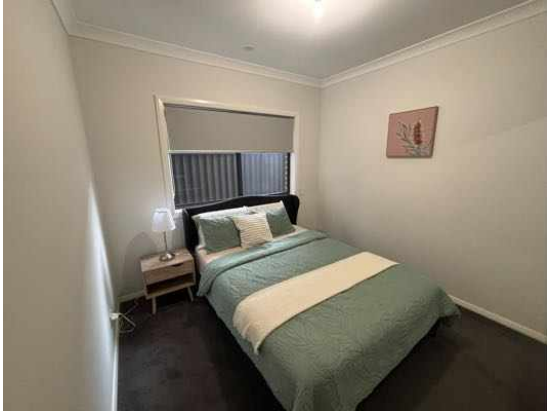
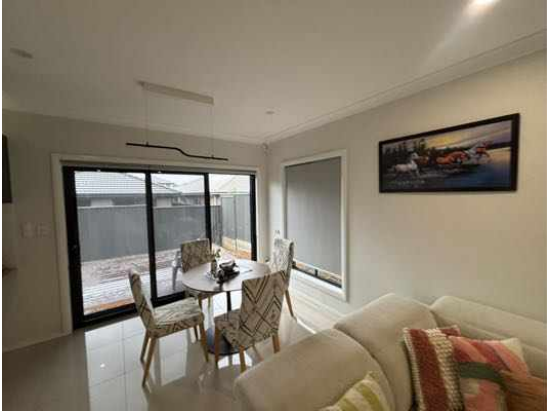
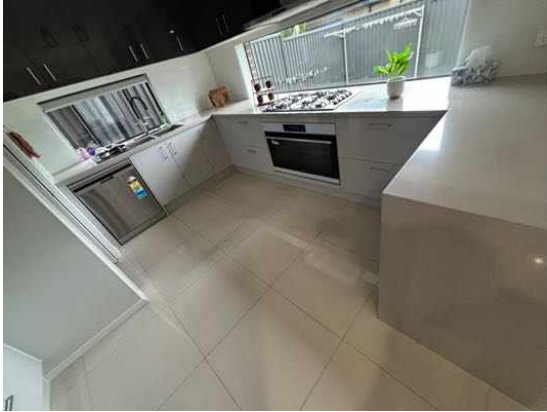
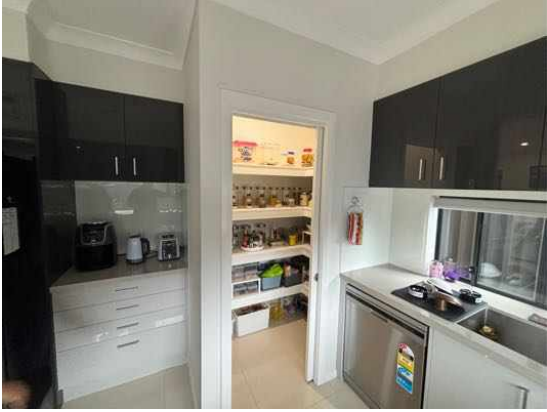
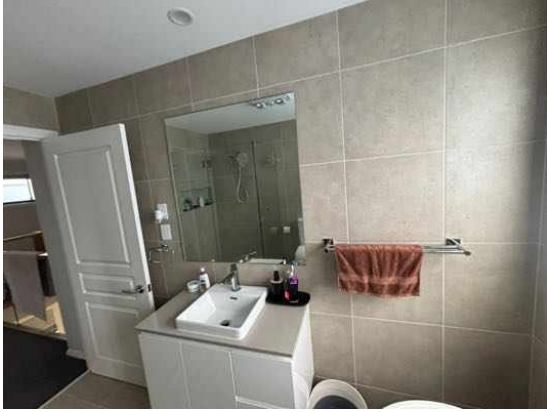
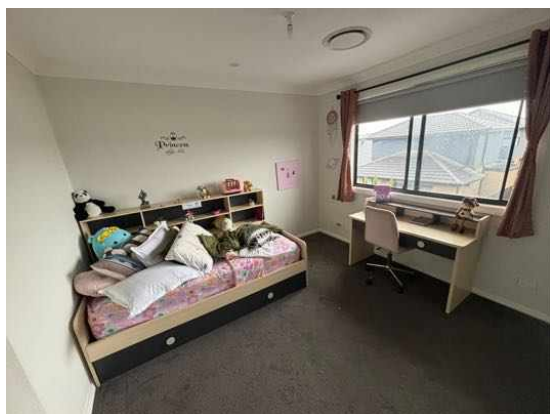
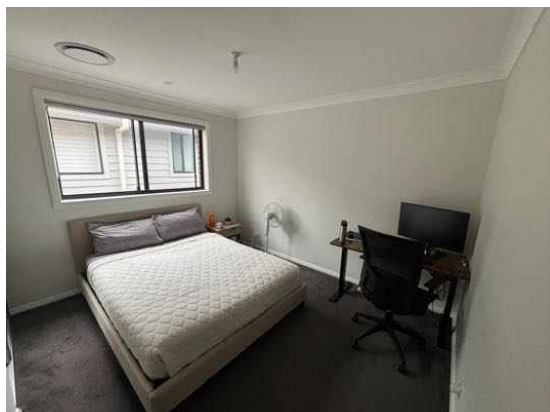
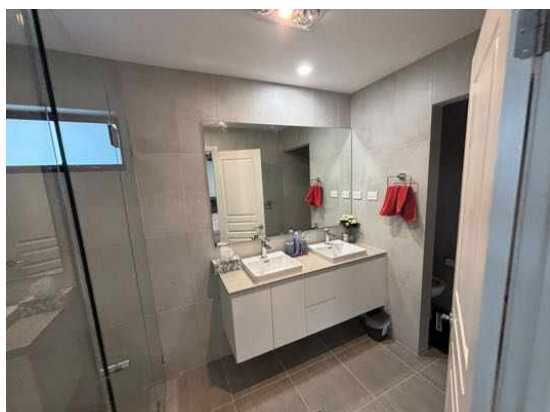
Building:	Main Building
Location:	All Internal Areas
Finding:	Obstructions and Limitations - Internal Areas
Information:	The accompanying photographs provide clear evidence of the obstructions and limitations that restricted a comprehensive inspection of the internal areas of the property at the time of assessment. These obstructions, which may include furniture, personal belongings, stored items, or structural elements such as wall coverings and built-ins, significantly hindered the ability to thoroughly evaluate these areas. It is important to note that such obstructions can potentially conceal a wide array of defects, ranging from hidden structural damage, water leaks, pest infestations, or

electrical issues, to deteriorating materials that may not be visible during the initial inspection.

The presence of these impediments means that critical areas of the property were not accessible, and therefore, any underlying defects that may affect the integrity and safety of the property could remain undetected. These hidden defects, if left unaddressed, could worsen over time and may result in costly repairs or pose potential safety hazards to the occupants.

It is highly recommended that all obstructions be cleared to facilitate a complete and thorough inspection of the internal areas. Once the obstructions have been removed and full access is available, a re-inspection should be carried out to ensure that any previously concealed issues can be properly identified and rectified. This follow-up inspection will provide a more accurate assessment of the property's internal condition and help the client make informed decisions about any necessary repairs or maintenance.

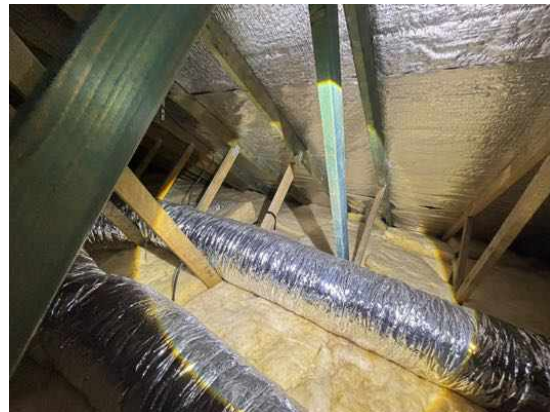
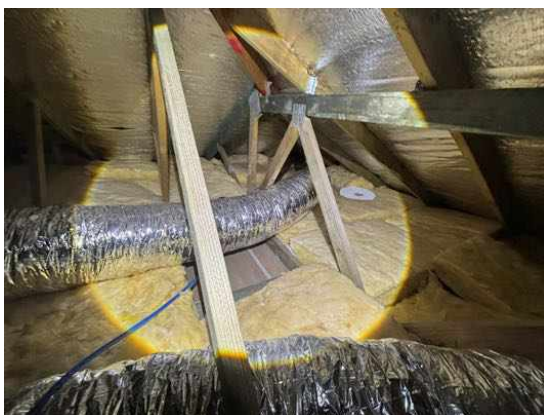
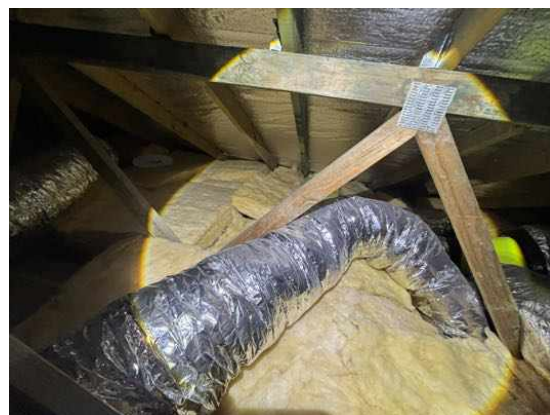
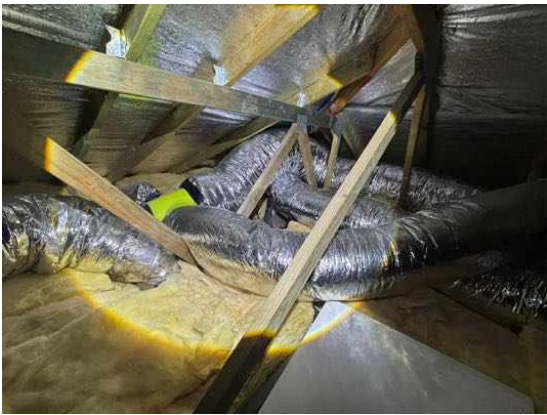
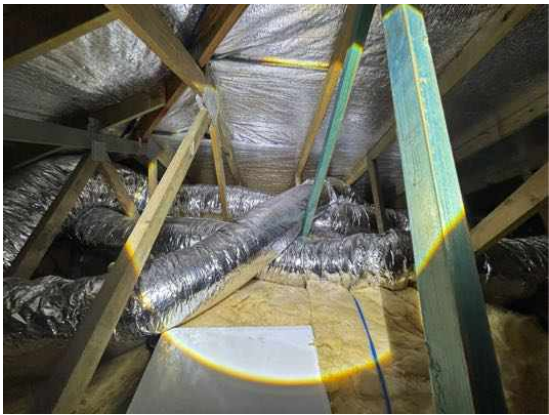
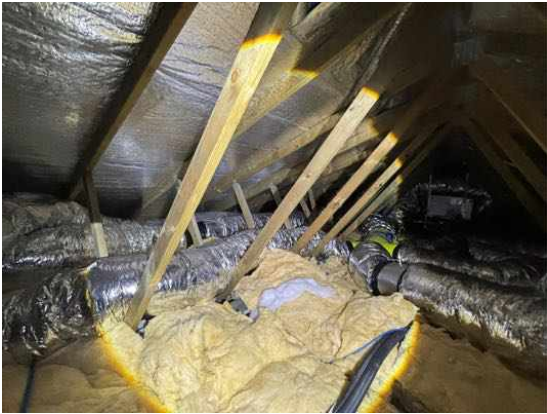
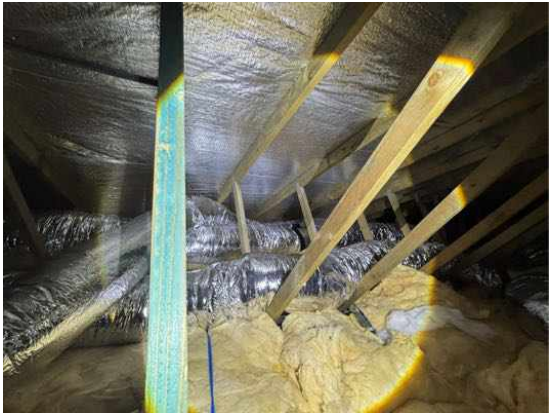
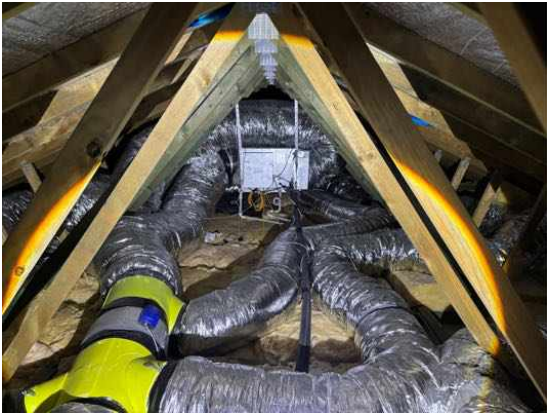
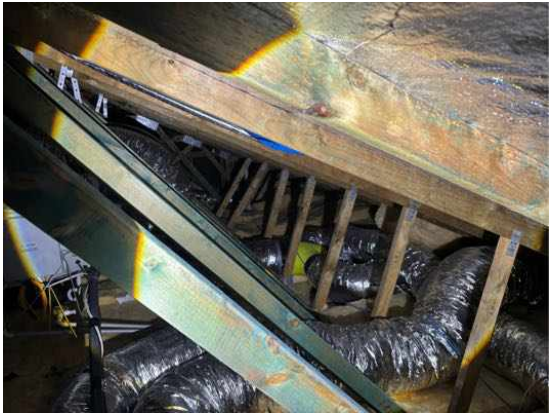
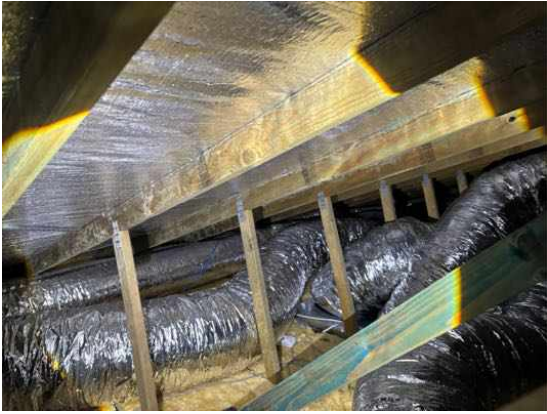
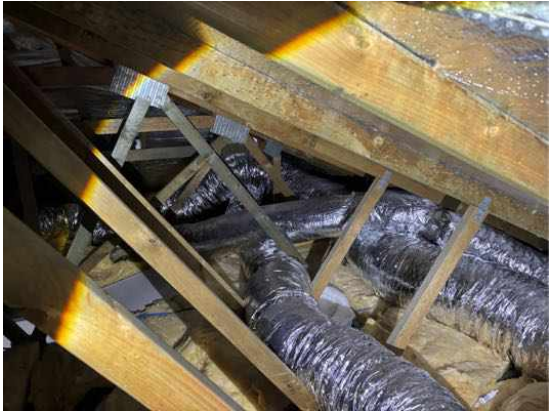
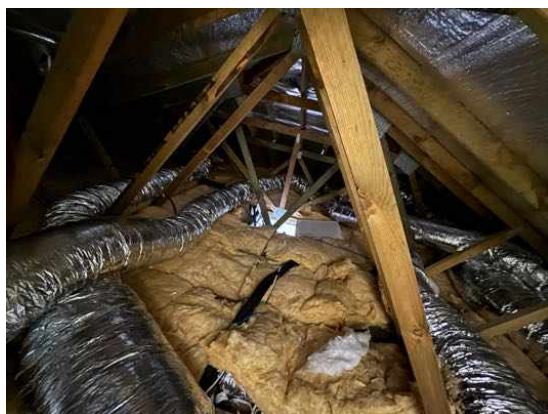
Building: Main Building
 Location: Roof Void
 Finding: Obstructions, Limitations, and General Roof Space Condition
 Information: The photographs provided document both the general condition and the obstructions and limitations that were present in the roof cavity of the main building at the time of inspection. These obstructions—such as insulation materials, stored items, structural elements, or electrical wiring—restricted safe and adequate access to key areas within the roof space. As a result, a comprehensive inspection of all components could not be completed.

Obstructions of this nature may conceal a variety of potential defects, including

damaged framing, compromised insulation, evidence of moisture ingress, pest activity, or electrical hazards. While no major issues were observed in the visible areas, the presence of these limitations means that some defects may remain undetected.

It is recommended that these barriers be removed or repositioned to facilitate full and safe access to the roof space. Once clear, a follow-up inspection should be conducted to allow for a thorough assessment of all concealed areas. This will help ensure that the condition of the roof cavity is accurately evaluated and any hidden issues are appropriately identified and addressed.

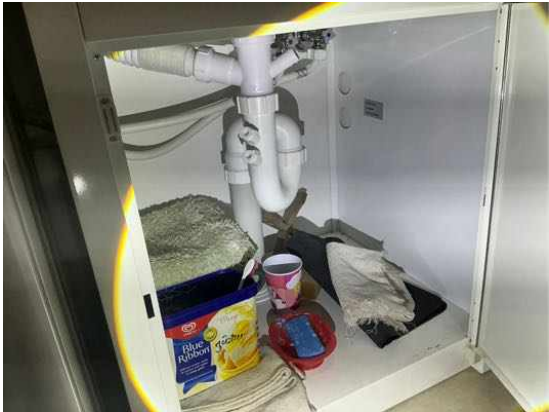
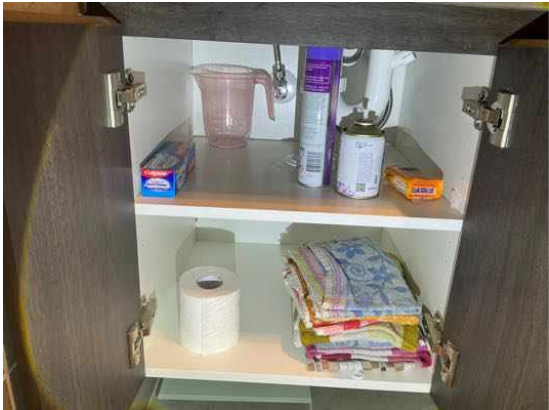
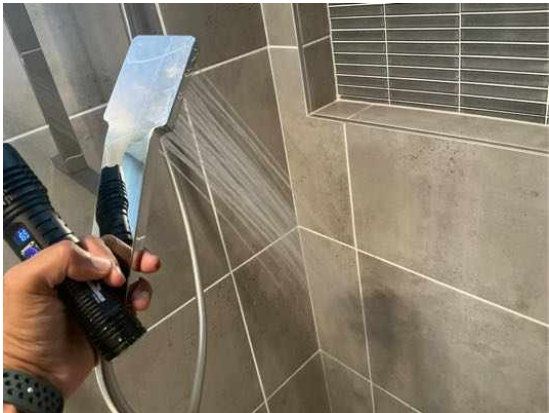
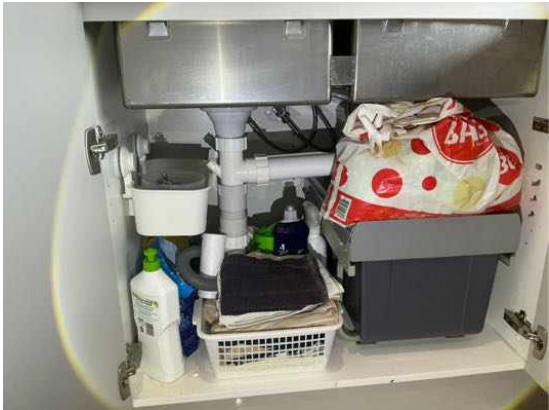
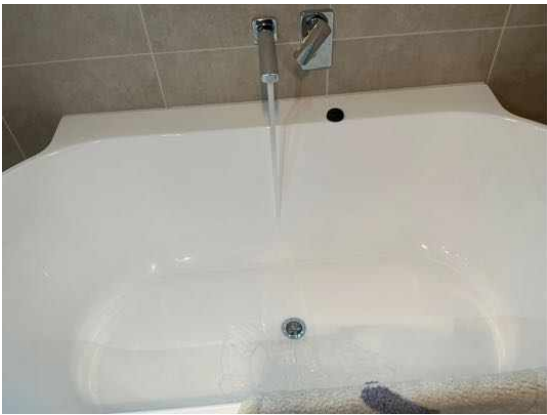
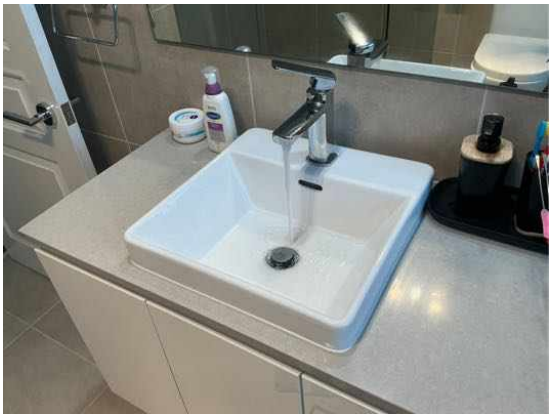
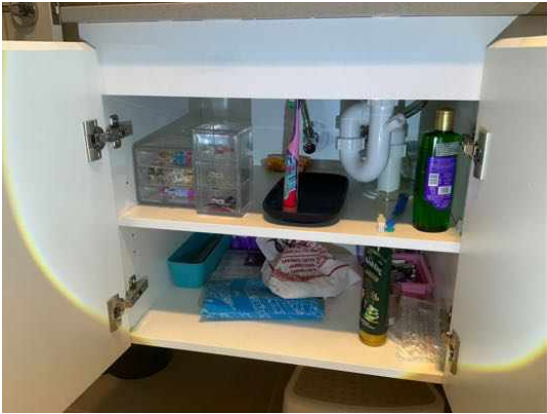
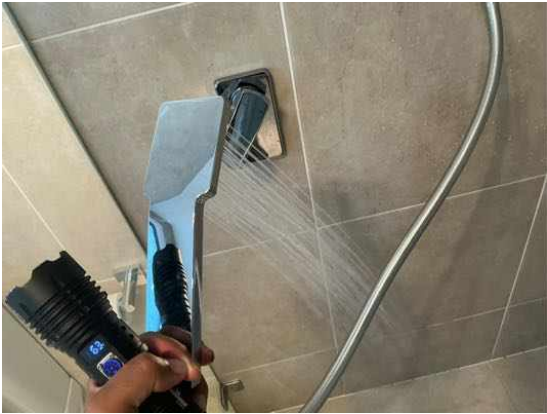
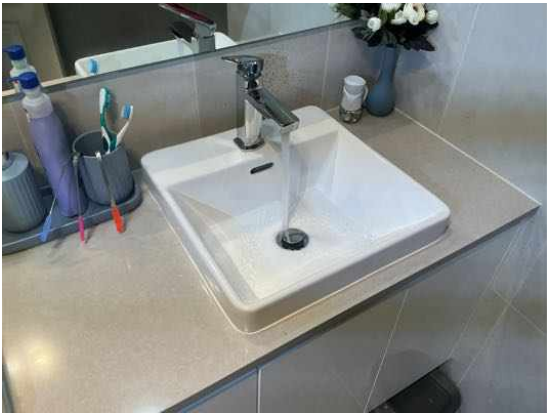
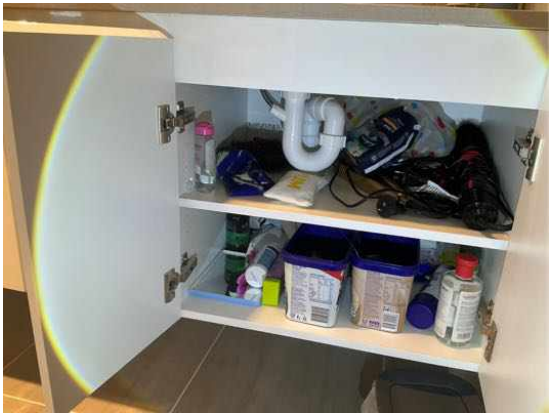
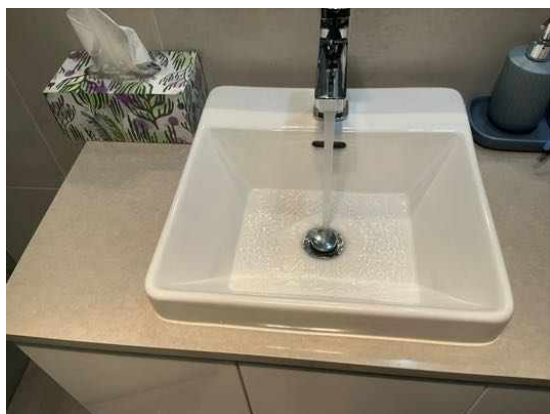
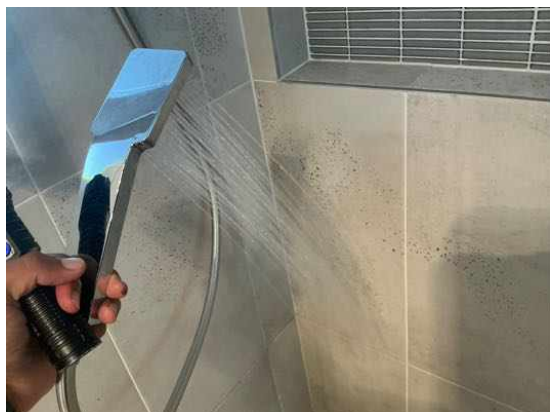
It is important to note that while a visual inspection of cupboards and cabinetry beneath sinks and vanities was undertaken, stored personal items and fixtures presented obstructions that limited full visibility of the internal areas. As per standard inspection practices, inspectors are not permitted to move or disturb personal belongings during the inspection process. Therefore, only visible and accessible sections were inspected, and concealed water damage or plumbing defects may not have been detected.

Given this, a re-inspection is recommended after all obstructions have been cleared to allow for a comprehensive assessment of these areas. Regular maintenance and monitoring of plumbing and drainage systems is also advised to ensure ongoing functionality and early detection of potential issues.

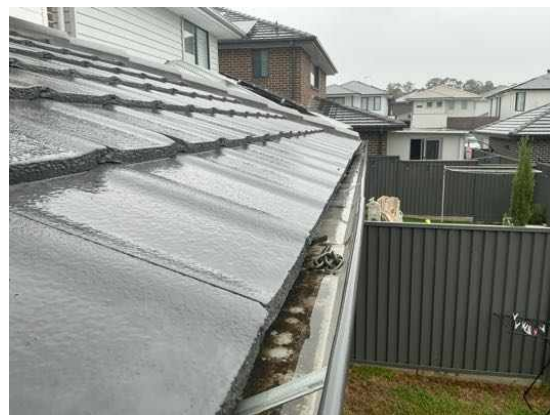
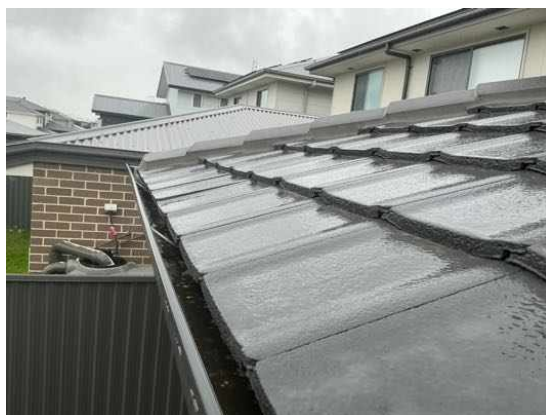
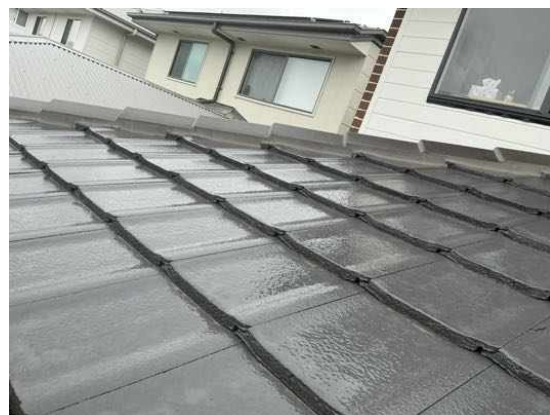
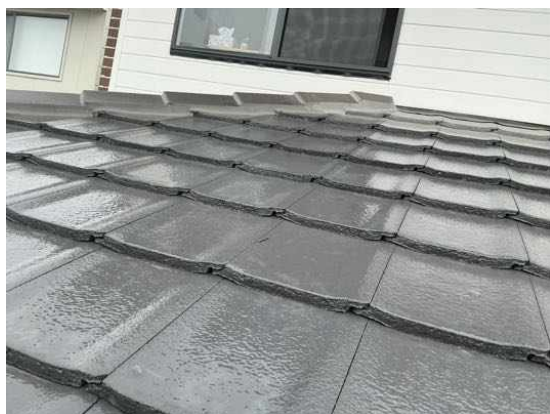
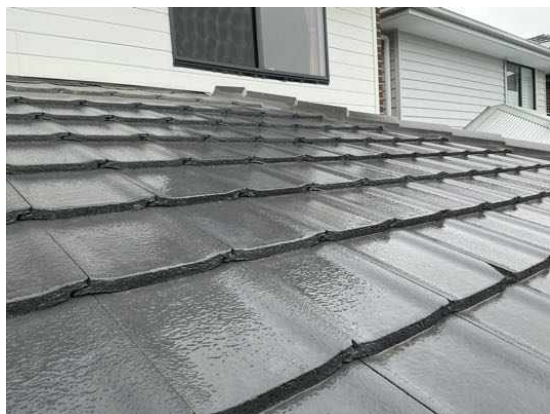
Building: Main Building
Location: Roof Exterior
Finding: Additional Roof Photos
Information:

As part of the information provided, please note that the attached roof photos represent the condition of the roof at the time of inspection. These photos are for visual reference only and do not constitute a detailed roofing assessment. Any defects or issues identified with the roof are mentioned separately in the defect statements. It is strongly recommended that the client engage a qualified roofer to conduct a thorough inspection of the roof, ensuring that any potential issues, such as leaks, structural integrity, or wear and tear, are properly identified and addressed.
