Building and Timber Pest Inspection Report

Inspection Date: Tue, 7 Apr 2026

Property Address: 26/293 Alison Rd, Coogee NSW 2034,
Australia

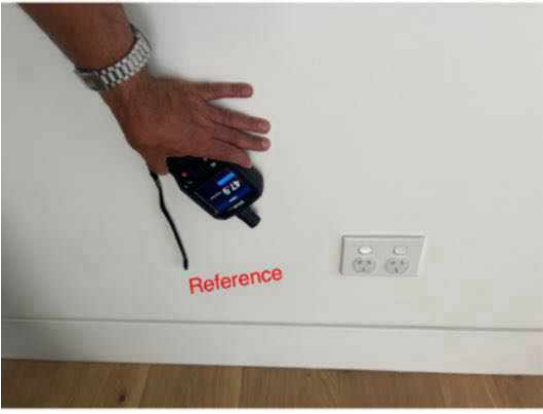
Building:	Main Building
Location:	All Internal Areas - Hallway ceiling and master bedroom ceiling , master Bedroom rear wall , external awning, Floor near kitchen area
Finding:	Elevated Moisture – Further Investigation Recommended
Information:	Elevated moisture readings were detected in several locations, although no significant structural damage was evident at the time of inspection, dampness can contribute to deterioration if left unaddressed. A further investigation by a licensed plumber/licensed waterproofing contractor is recommended to confirm the source and ensure no concealed issues are developing. Given the walls are adjacent to the shaded structure , it also increases the likelihood of moisture ingress to the dwelling.

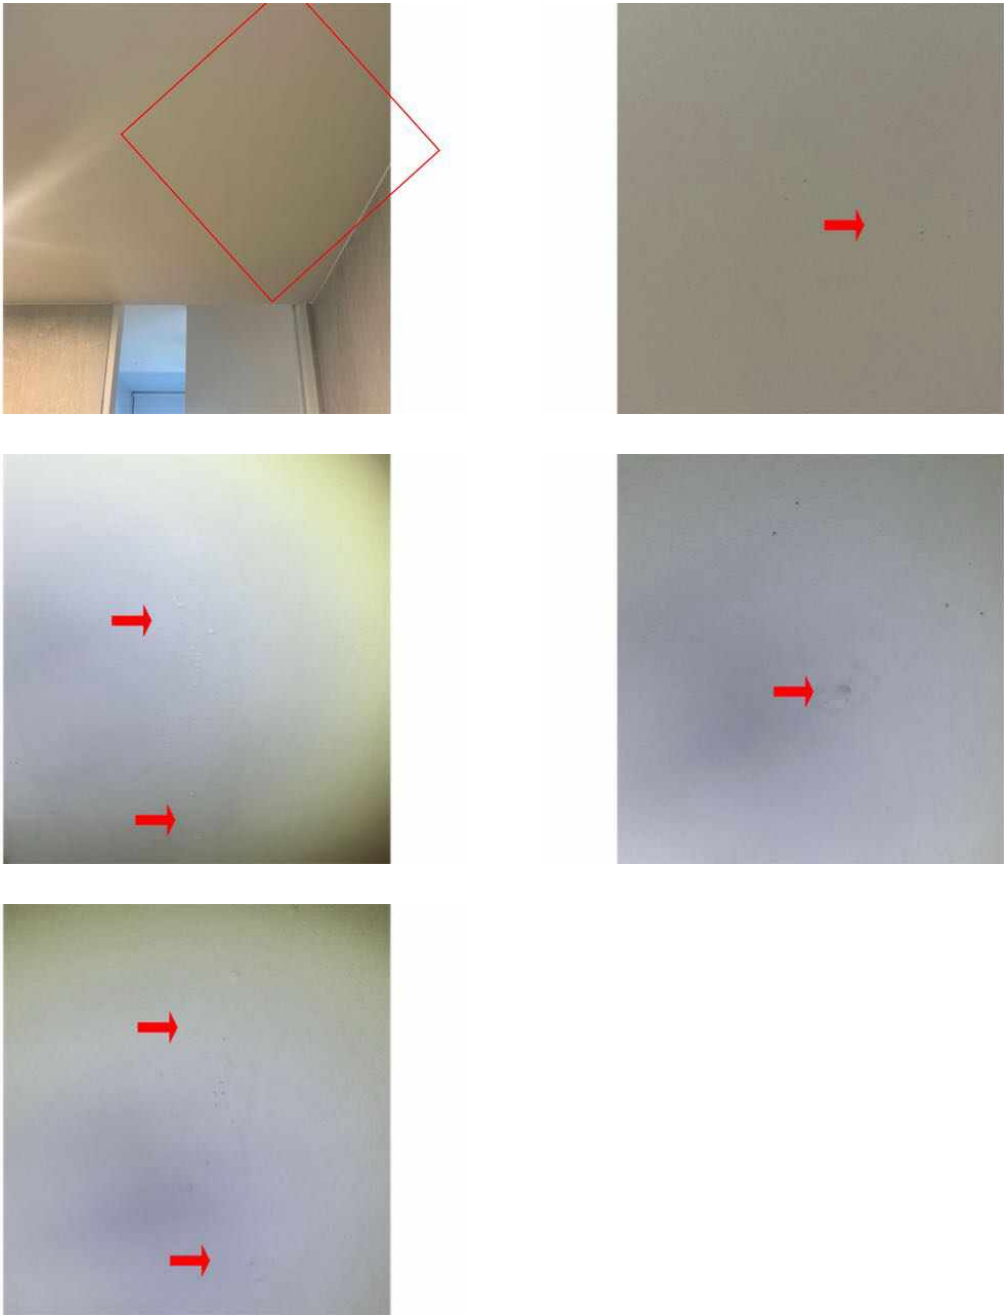
Finding 3.02

Information: Sections of paint in this area was found to have bubbled and deteriorated. Paint bubbling is generally an indication of excessive moisture in the area, that is currently hidden by the painted surface.

The presence of excessive moisture can have major implications on associated building elements if left unattended. While only seemingly minor at this stage, the damage cannot be determined due to the paint obstructing any further inspection of the damage.

It is highly advised that the affected paint be cleaned to allow a further, more invasive inspection by a licensed plumber. Failure to act on this defect may necessitate major works in the future.

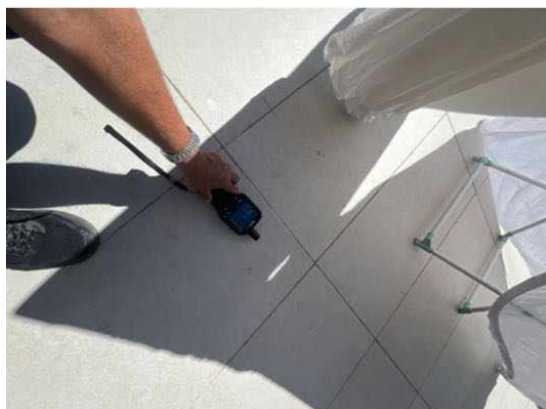
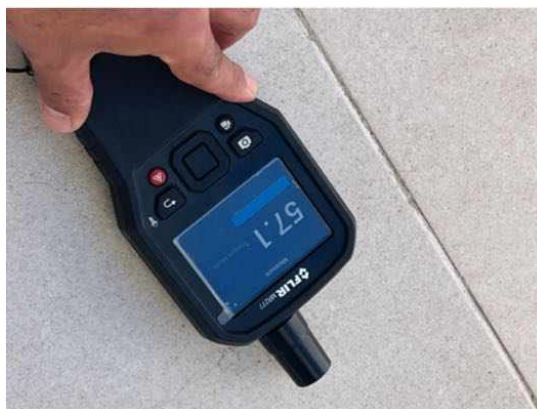
Finding 3.03

Building: Main Building
Location: Balcony
Finding: Balcony Elevated Moisture - Strata
Information: Slightly elevated moisture was recorded at the base of the balcony tiles, with associated dark staining within the grout consistent with water exposure.

The readings were relatively consistent across the tested areas. While no internal damage was visible at the time of inspection, balconies in multi-unit dwellings are high-risk areas for waterproofing failure, which can lead to leaks into adjoining units and significant rectification costs. Further investigation by a licensed waterproofing contractor is strongly recommended.

Depending on the strata plan, this area may form part of the common property, in which case remedial responsibility may rest with the owners corporation (strata). Purchasers should seek clarification from the strata manager and legal adviser prior to purchase.

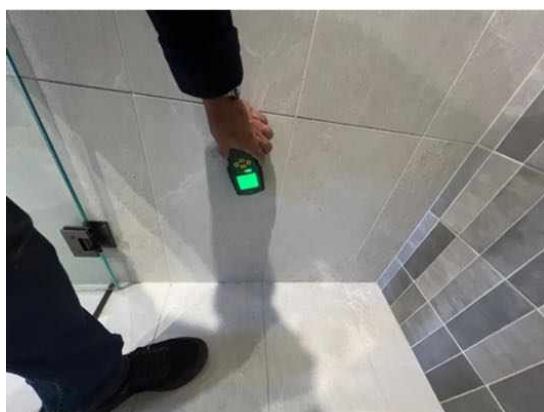
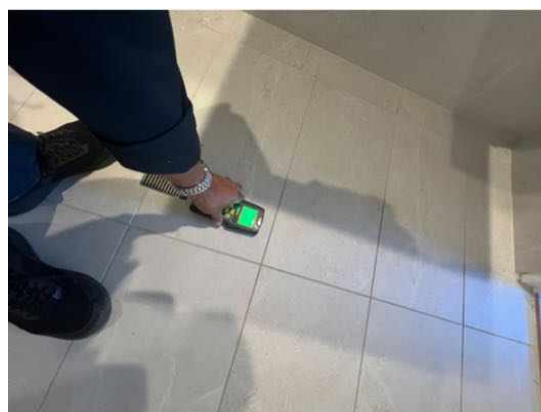
Finding 3.04

Building:	Main Building
Location:	All Internal Areas
Finding:	Elevated Moisture Bathroom (No visible deterioration noted)
Information:	Slightly elevated moisture levels were detected to tiled surfaces in bathroom/shower areas. Persistent moisture ingress can lead to concealed damage, including timber rot and mould growth.

Elevated moisture readings in tiled wet areas can occur from normal shower use, age/deterioration of waterproofing membranes, plumbing leaks or moisture absorption through grout lines. While no damage was visible, elevated readings may indicate

moisture retention behind tiles, which can be a conducive condition for future deterioration if not monitored.

Monitor the area over time for signs of drumming, efflorescence, tile movement, or grout deterioration. A further inspection by a licensed waterproofing specialist is recommended to determine cause of elevated moisture (e.g., pressure testing, membrane assessment).

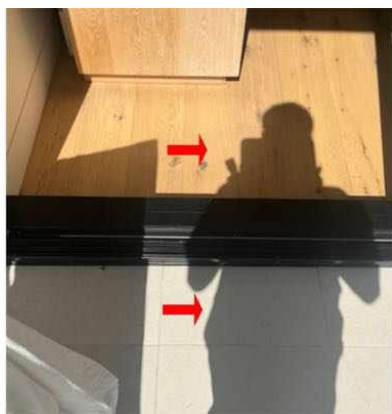
Finding 3.05

Building:	Main Building
Location:	All Internal Areas
Finding:	Balcony Floor Level Differential
Information:	The balcony finished surface appears to be close to, or at the same level as, the internal floor. Standard construction practice requires a step-down of approximately 50 mm unless a fully engineered threshold drainage system is provided. No such drainage features were visible during inspection. This configuration increases the risk of water ingress, and confirmation of the balcony waterproofing detail through strata/building management is recommended.

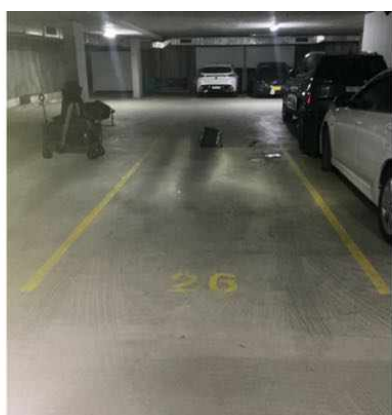
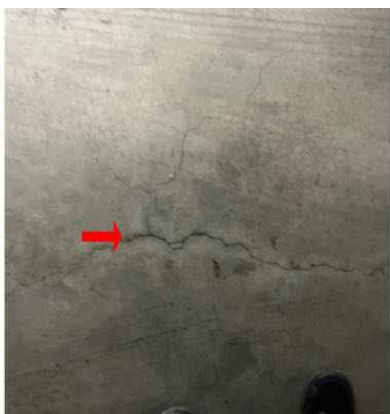
Finding 3.06

Building:	Main Building
Location:	All Internal Areas
Finding:	Cracking - External Concrete Paving Damage Category 1 - Fine (less than 2mm)
Information:	Fine cracks were identified in external concrete paving. Although fine cracks are quite noticeable, they are often only considered to be an appearance defect, and usually do not indicate any structural damage. To be considered a Category 1 or fine crack, the crack is found to be less than 2mm in width.

Generally the cause of a hairline crack in existing concrete paving such as driveways and pathways is indicative of the expansion and contraction of the concrete. Such causes are generally due to environmental factors, such as moisture levels, weather conditions, root systems of nearby trees or the soil types on which they are laid.

Fine cracks may also be due to poor original installation of the concrete. Factors such as poor compaction of the sub surface and/or inadequate reinforcing of the slab may create cracking and other secondary defects.

Monitoring of all cracking should be conducted frequently. Always contact a building inspector should cracks widen, lengthen, or become more numerous.

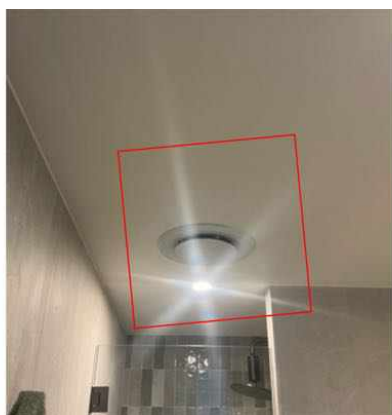
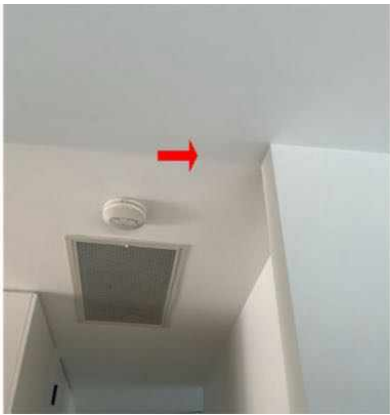
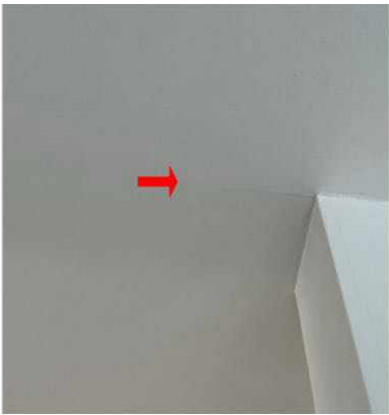
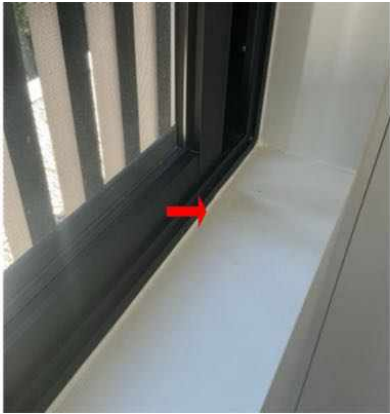
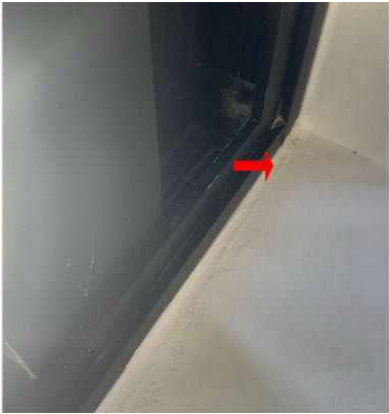
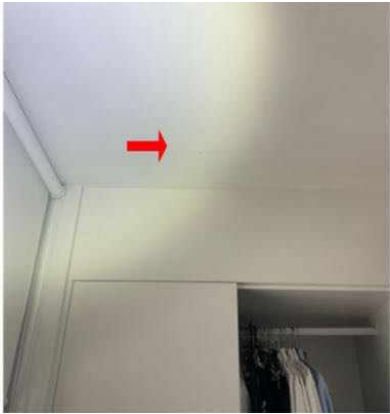
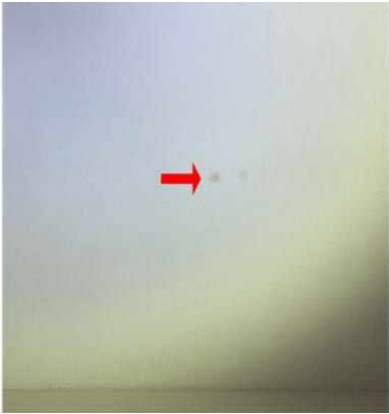
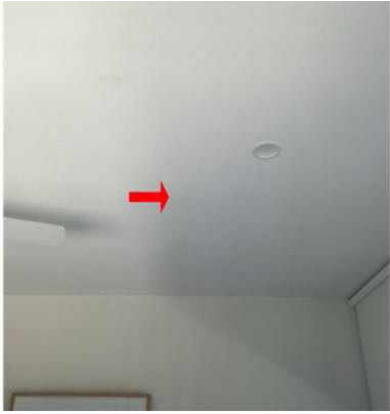
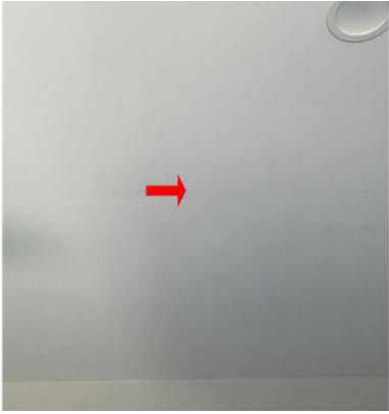
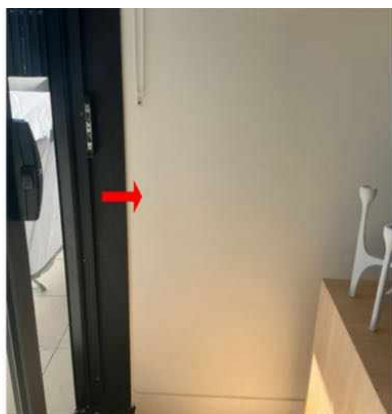
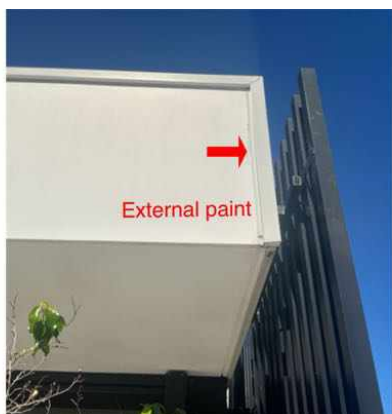
Finding 3.07

Building:	Main Building
Location:	All Internal Areas
Finding:	Paint finish and hairline cracking
Information:	The paint finish in this area was identified as being incomplete at the time of inspection including some hairline minor cracking.

Whilst incomplete or missing paint and minor cracking and imperfections in finish is generally an appearance defect, it can also lead to the development of secondary building defects over time. Incomplete areas of paint finish expose the area to moisture, potentially accelerating the deterioration of underlying building materials.

Incomplete paint finishes should be sanded back, filled, leveled and painted, as applicable. Where inadequate or missing paint protection has led to the deterioration of the associated building element, repair and/or replacement of this building element may be required.

A painting contractor should be appointed as soon as possible to perform necessary works to aid the appearance of the affected area and to ensure the area is protected against further deterioration. Alternatively, the homeowner following manufacturer instructions may perform these works.

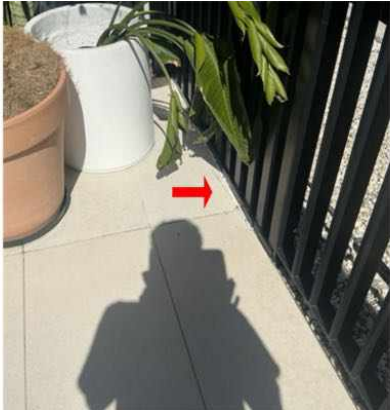
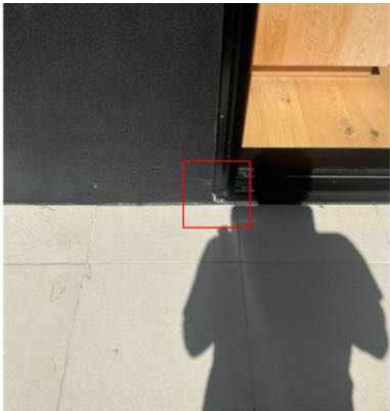
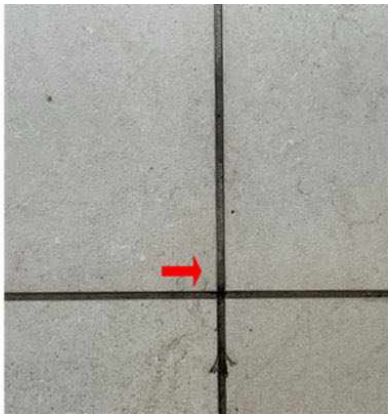
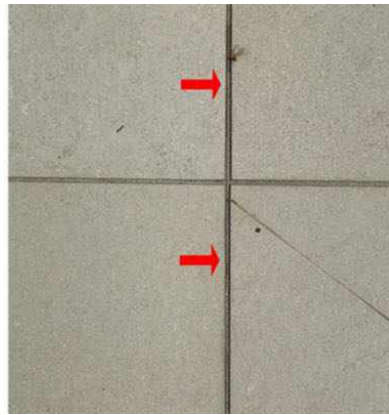
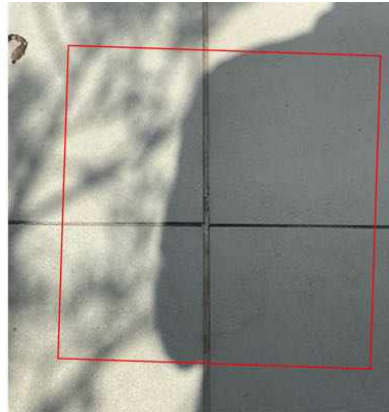
Finding 3.08

Building:	Main Building
Location:	All Internal Areas
Finding:	Sealant and grouting - Missing or degraded
Information:	It was noted on inspection that sealant or grout is degraded. There is also evidence of poor workmanship and excessive use of sealant. Silicone should never be used as a first line of defence against waterproofing. Further inspection by a licensed waterproofing contractor is highly recommend

Different materials and floor areas move at different rates, generally causing cracking to grout or sealant at this point. A flexible sealant is required to allow for expected expansion and contraction, while keeping the joint water tight and protective of all associated building materials.

There appears to be excessive mould to the sealant and grout which will likely require scraping out and replacement.

Flexible and mould resistant materials should be applied to affected areas to prevent any subsequent water damage that is likely to occur. Regular maintenance and replacement of damage or missing or damaged sealant and grout is highly recommended to the wet areas, as this is a regular wear and tear defect. Sealant and grouting in areas that come into regular contact with water should be maintained for the long term care of your property.

A sealant specialist or tiling contractor should be appointed to complete these works as soon as possible

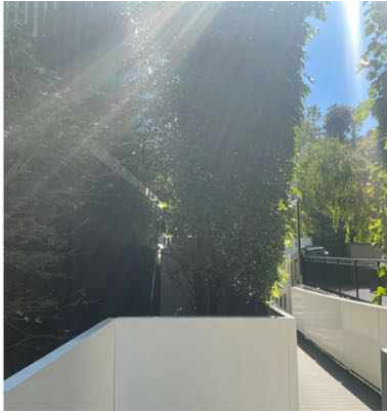
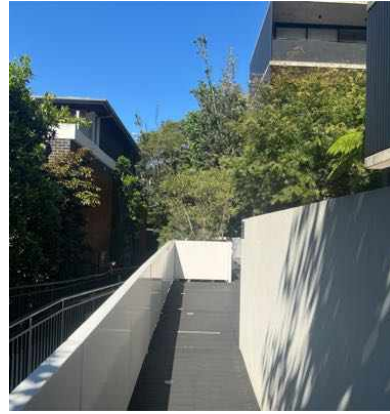
Finding 6.01

Building: Main Building
Location: All External Areas
Finding: Trees within 50m
Information: Trees in proximity to the property may contribute to termite risk. Ongoing monitoring and regular inspections are recommended.

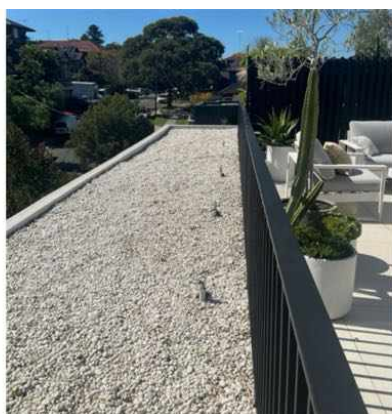
Building:	Main Building
Location:	All Internal Areas
Finding:	Pebbles on Roof Structure
Information:	The flat roof area is finished with loose pebble ballast, which is commonly used to protect waterproofing membranes from UV exposure and mechanical damage, the loose stones may conceal roof drainage points, increasing the risk of water pooling or blocked outlets if not regularly maintained. The use of pebble ballast also introduces significant dead load—typically between 80–100 kg/m ² —which must be accounted for in the structural design in accordance with AS/NZS 1170.1, the waterproofing detail can't be verified during a visual inspection.

it is recommended that the adequacy of structural support for this loading be verified if not already certified.

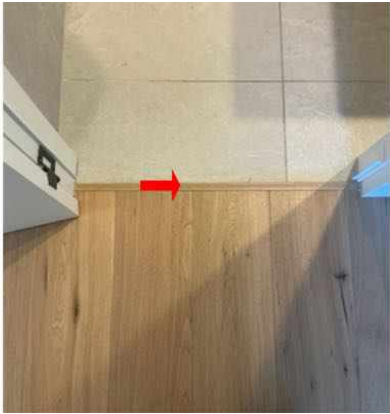
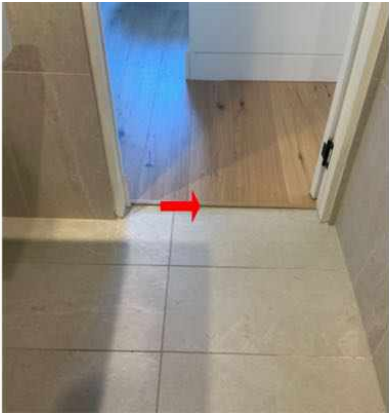
Building:	Main Building
Location:	All Internal Areas
Finding:	Bathroom & external floor threshold
Information:	The bathroom floor is almost the same level as the adjoining timber flooring. This configuration is typical in modern apartments and is permitted where compliant waterproofing and floor falls are provided. No evidence of moisture damage was observed at the time of inspection; however, waterproofing performance cannot be confirmed without invasive inspection.

Care should be taken to avoid excessive water migration beyond the bathroom during use.
