Building and Timber Pest Inspection Report

Inspection Date: Thu, 12 Feb 2026

Property Address: 19 Robert Rd, Cherrybrook NSW 2126,
Australia

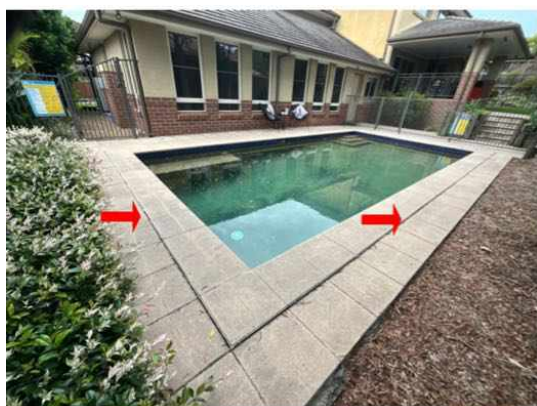
Building:	Main Building
Location:	Pool area
Finding:	Paving -- Uneven (Safety hazard)
Information:	Sections of the external paved area are uneven, creating a potential trip hazard. It appears as though the area has been subject to rough installation, or that paving sections have lifted due to movements in the foundation.

Where paving creates a trip hazard, personal injury may ensue if due caution is not taken by all persons within this area.

Re-paving of the area is required urgently by a landscaper to remedy this situation.

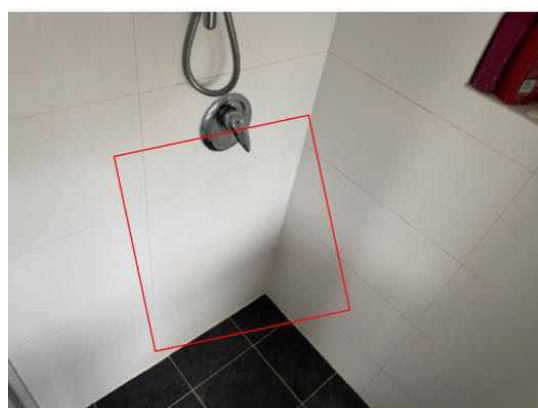
Building:	Main Building
Location:	Bathroom
Finding:	Water leak - Suspected
Information:	A water leak is suspected in this area as excessive moisture was detected at the time of inspection. Another potential cause maybe moisture ingress behind the tiles from around the wall fittings and penetrations.

Internal water leaks can be detrimental to surrounding building elements; their potential causes include damage to plumbing fittings and fixtures, through to water damage and deterioration of associated building elements.

Attracting termites, corrosion, mould, decay and water damage are potential outcomes where a minor water leak is left unattended. More serious defects may also result, such as electrical hazards, or water damage to structural building elements.

In extreme cases, structural damage may develop due to a prolonged water leak. It is highly advised that internal water leaks be addressed by a licensed plumber as a matter of relative urgency.

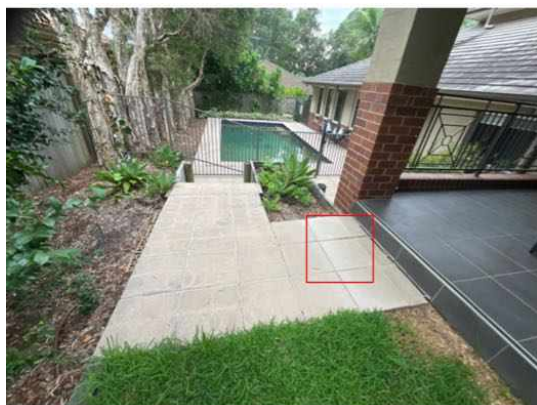
Sections of the external paved area are uneven, which may develop into a trip hazard. It appears as though the area has been subject to rough installation, or that paving sections have lifted due to movements in the foundation.

Left unmanaged, the May develop into a safety hazard due to trip and fall.

Re-paving of the area is required to remedy this situation. Further consultation with a specialist concreter is advised.

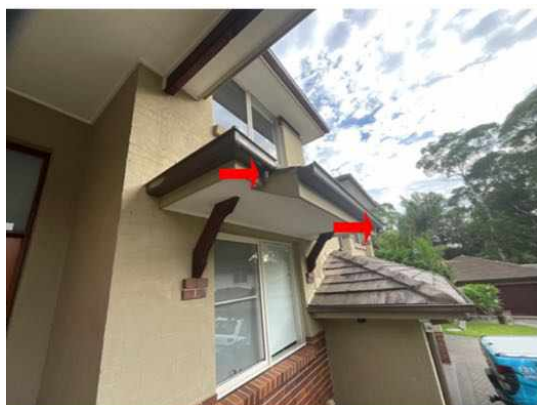
Where roof plumbing doesn't drain adequately, the area at the base perimeter can become excessively damp, potentially creating an environment that is susceptible to rust and corrosion of surrounding building elements, as well as attracting termites and other pests.

It is highly recommended that a plumber be appointed to further inspect the area and to install adequate drainage equipment where necessary.

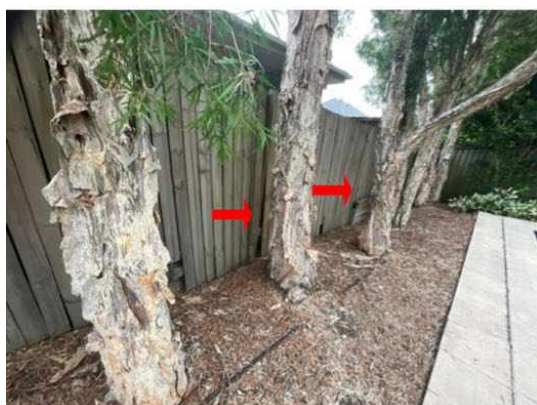
Finding 3.05

Finding: Fencing - Deteriorated

Information: It was noted at the time of inspection that sections of the fencing in this area has deteriorated. Typically fencing deteriorates due to age and or wear, rot and or rust which is generally expected for a structure of this age, due to prolonged exposure to weather conditions. Sometimes inadequate installation or maintenance can be to blame.

If left unattended, it is likely that further damage will occur. It is suspected that repair of several elements of the fencing may be required however replacement may be a consideration of the client also.

A licensed fencing contractor should be appointed to provide further advice and perform rectification works as necessary.

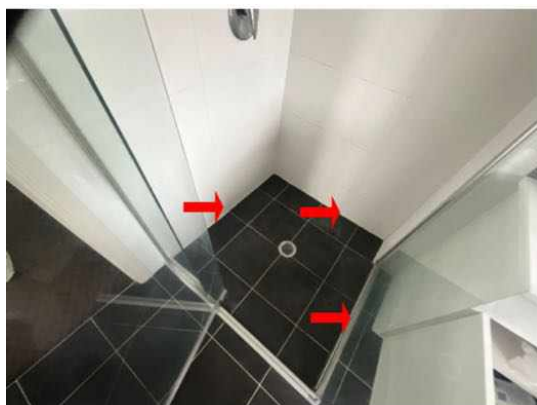
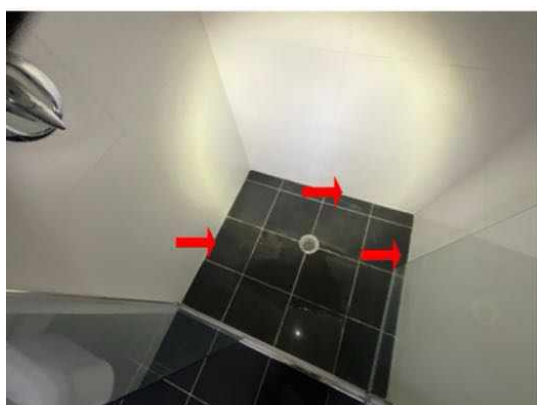
Building: Main Building
Location: All Wet Areas
Finding: Sealant and grouting - Missing or damaged
Information:

It was noted on inspection that sealant or grout is degraded to this area.

Different materials and floor areas move at different rates, generally causing cracking to grout or sealant at this point. A flexible sealant is required to allow for expected expansion and contraction, while keeping the joint water tight and protective of all associated building materials.

Flexible and mould resistant materials should be applied to affected areas to prevent any subsequent water damage that is likely to occur. Regular maintenance and replacement of damage or missing or damaged sealant and grout is highly recommended to the wet areas, as this is a regular wear and tear defect. Sealant and grouting in areas that come into regular contact with water should be maintained for the long term care of your property.

A sealant specialist should be appointed to complete these works as soon as possible.

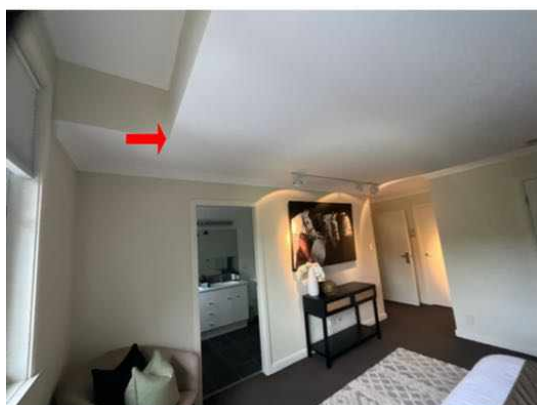
Finding 3.09

Building:	Main Building
Location:	Bedroom - Master
Finding:	Cracking - Damage Category 1 - Fine (up to 1mm)
Information:	Although fine cracks are quite noticeable, they are often only considered to be an appearance defect, and usually do not indicate any structural damage. Generally, the cause of a fine crack is indicative of a separation between building materials and finishes (e.g. paint, plaster, etc.) along joins.

Cracking of this nature can generally be repaired with minor sanding, filling and/or repainting. Such works should be performed by a qualified painter or a general handyman.

Monitoring of all cracking should be conducted frequently. Always contact a building inspector should cracks widen, lengthen, or become more numerous.

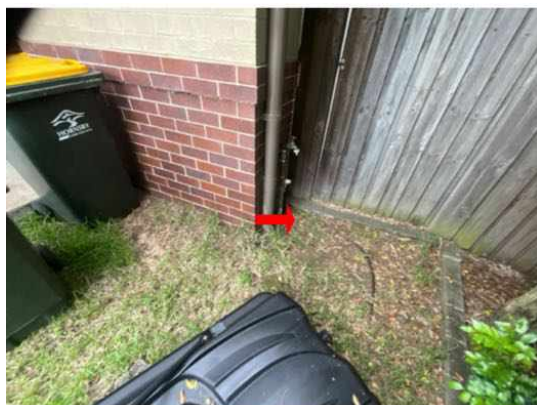
Location: External tap
 Finding: Tap - No drain
 Information: The external tap in this area was noted to have no drain at the time of inspection.

This keeps the surrounding surfaces damp while using the tap, which becomes conducive to termite activity.

A licensed plumber must be appointed to ensure an appropriate drain is installed.

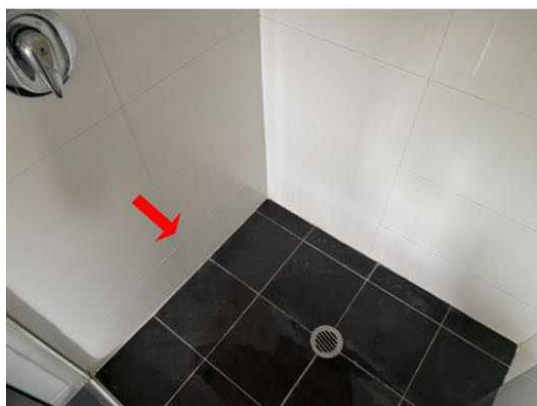
Building:	Main Building
Location:	Ensuite
Finding:	Shower damp - Sealant and grout
Information:	Damp is evident to the lower 400mm of wall to the shower alcove. This defect is quite common, and is suspected to have been caused by moisture permeating or leaching through the grouting and sealant in this area, which shows evidence of deterioration. Leaking pipes within the wall is also a possible cause however this seems unlikely in this instance as there is no moisture build up around the taps or transferring to the other side of the wall. There appears to be no sealant around the tap spindles which may be a small contributing factor.

Damp (or structural damp) refers to the presence of unwanted moisture in the structure of a building, either as the result of intrusion from outside, or condensation from within the structure. In the shower area, internal water leaks, degraded materials or other sources of excessive moisture are generally the cause of damp.

Unmanaged damp in the shower recess is likely to facilitate the formation and development of mould and fungi growth, decaying associated building materials and compromising their structural integrity of associated elements. It is important to address damp conditions, as the World Health Organisation notes that excess moisture leads - on almost all indoor materials - to growth of microbes such as moulds, fungi and bacteria, which subsequently emit spores and other matter into the indoor air. Exposure to these contaminants is associated with a wide range of respiratory and other health-related problems. Damp conditions also create a conducive environment for termite infestation.

Consultation with a bathroom sealant specialist is advised immediately to identify the cause of damp and to perform remedial works as required.

Always ensure that sealant and grout is in good condition to prevent any moisture issues occurring in the future.
