Building and Timber Pest Inspection Report

Inspection Date: Mon, 16 Feb 2026

Property Address: 57 Lady Jamison Drive, Glenmore Park
NSW 2745

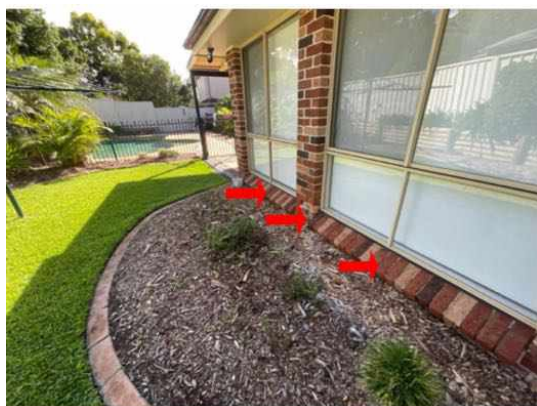
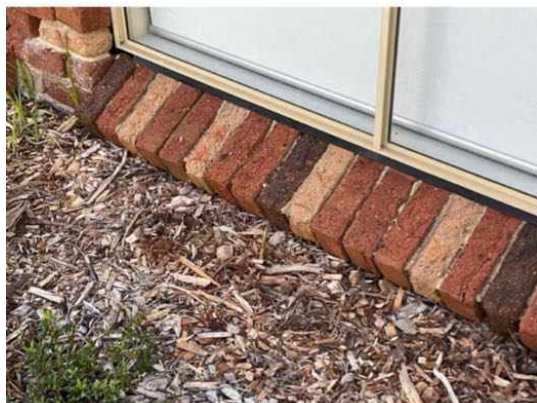
Building: Main Building
 Location: Exterior walls - rear
 Finding: Deterioration to Lower Brickwork
 Information: Location: Lower sections of rear external brickwork

Category: Material Deterioration / Moisture-Related Damage

Defect Rating: Currently minor in extent; risk of progression to major structural defect if not rectified

Deterioration consistent with brick fretting was observed to sections of the lower external masonry walls at the time of inspection. The affected areas exhibited surface erosion, flaking and loss of face material to individual bricks. Mortar joints in isolated locations were brittle and powdery, indicating moisture-related degradation.

This condition is typically associated with prolonged exposure to ground moisture and salt crystallisation within the masonry. As moisture rises through porous brickwork, soluble salts are transported to the surface. When moisture evaporates, salt crystals expand within the brick matrix, resulting in progressive breakdown of the brick face and mortar joints.

The deterioration was most evident at the base of the walls, which is consistent with rising damp and/or inadequate site drainage.

Although presently localised and assessed as minor, brick fretting is a progressive condition. If moisture sources are not addressed, continued salt attack and saturation may result in:

- Reduction in compressive strength of affected masonry units
- Increased risk of rising damp affecting internal finishes
- Secondary deterioration to adjacent materials, including render, paint systems and internal wall linings

Over time, untreated fretting can transition from a cosmetic defect to a structural concern requiring partial wall reconstruction.

While the observed fretting is currently moderate and localised, the underlying moisture mechanism presents a risk of continued degradation. Early intervention is recommended to prevent escalation into a major structural masonry defect.

Engage a licensed drainage plumber to assess site drainage conditions and implement corrective measures where required. This may include improving surface water runoff, ensuring ground levels are appropriately graded away from the dwelling, and confirming that damp-proof courses are not bridged.

Where brick and mortar deterioration is advanced, affected bricks should be carefully removed and replaced, and mortar joints re-pointed by a licensed bricklayer experienced in salt-damage remediation.

The affected areas should be monitored, particularly following periods of heavy rainfall, to assess whether deterioration is accelerating.

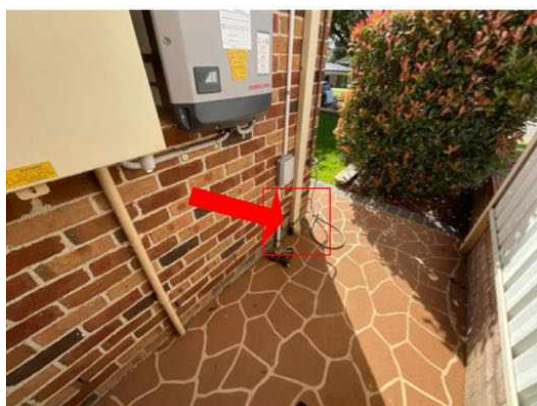
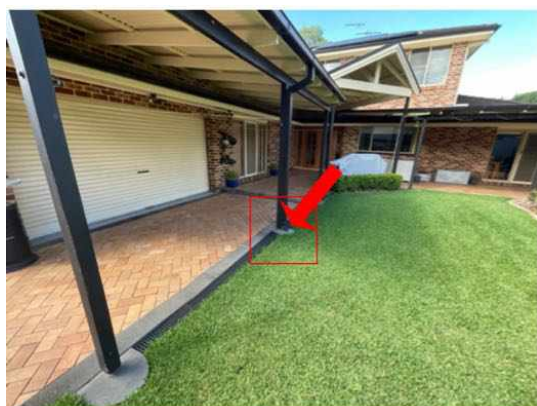
Finding 3.01

Building:	Main Building
Location:	Exterior walls - left side
Finding:	Downpipe - Damaged
Information:	Damaged Downpipe connection – Stormwater Drainage Concern

- The roof plumbing (downpipe) in this location has been damaged and/or is not fully sealed at the connection point.
- This may suggest impact damage and soil subsidence.

- Poorly sealed or disconnected downpipes can result in:
 - Water pooling around the base of the building
 - Excessively damp conditions at the foundation or subfloor level

- Increased risk of foundation movement.
- Water runoff may also be diverted to a neighbouring property, which is non-compliant with building codes and may create legal or council-related issues.

- Rectification is recommended.
- A licensed plumber may be appointed to:
 - Inspect the area thoroughly and repair, replace or properly connect all downpipes to ensure compliant and effective drainage

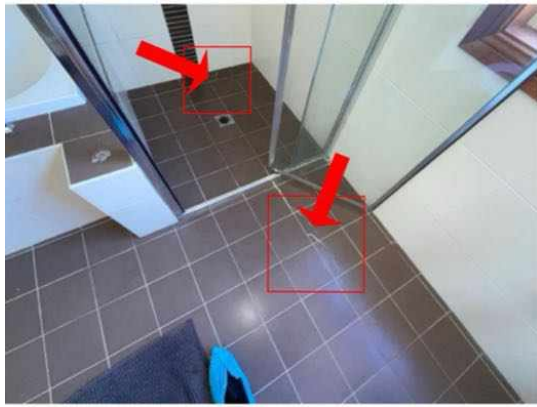
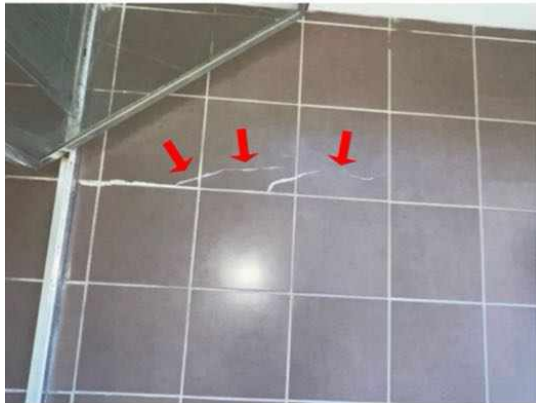
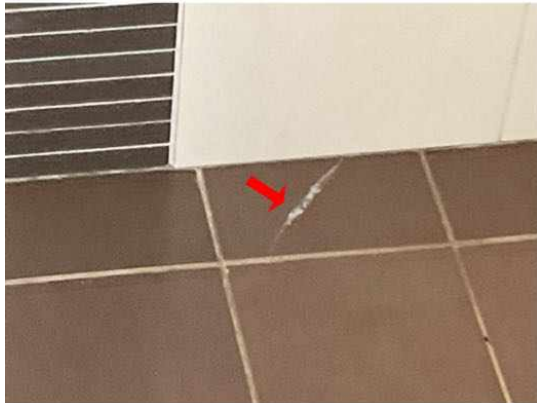
Finding 3.02

Building: Main Building
 Location: Bathroom
 Finding: Floor tiles - Cracked
 Information: Location: Upstairs Bathroom – Shower Area and Entrance

Cracking to floor tiles was observed within the upstairs bathroom at the time of

inspection. One cracked tile was noted inside the shower recess and three cracked tiles were identified externally at the shower entrance.

The bathroom floor is constructed over suspended timber framing. Tile cracking in this type of construction is commonly associated with minor structural movement, deflection of the timber substrate, shrinkage, or inadequate tile underlay support. No invasive inspection was undertaken to confirm the exact cause; however, minor settlement or movement within the suspended floor system is considered a likely contributing factor.

At present, the defect is considered minor and primarily cosmetic. However, cracked tiles—particularly within the shower recess—may allow water to penetrate beneath the tiled surface. Over time, this can result in:

- Deterioration of the tile bedding and waterproof membrane
- Moisture damage to the timber subfloor and framing
- Mould growth within concealed areas
- Progressive loosening of surrounding tiles

Replacement of the cracked tiles is recommended to maintain the integrity of the waterproofing system and prevent potential moisture ingress.

A licensed builder should be engaged to assess the substrate for movement or deflection issues. Rectification works should be carried out by a qualified tiling contractor or bathroom renovation specialist to ensure compliance with current waterproofing and tiling standards.

Ongoing monitoring for additional cracking is advised, as further movement may indicate underlying structural or substrate concerns requiring more extensive remediation.

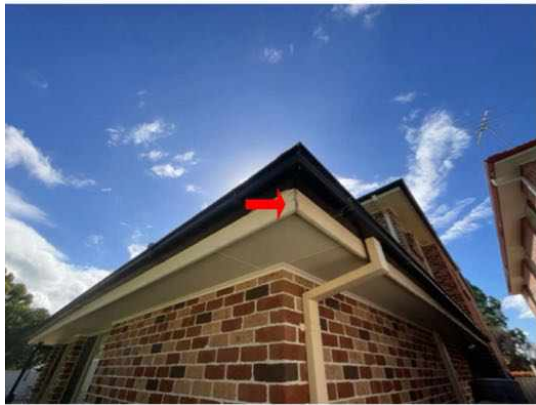
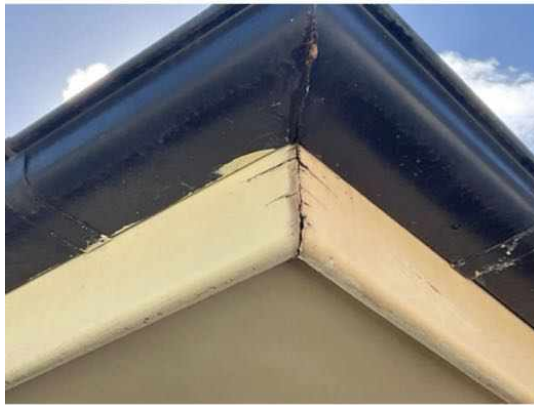
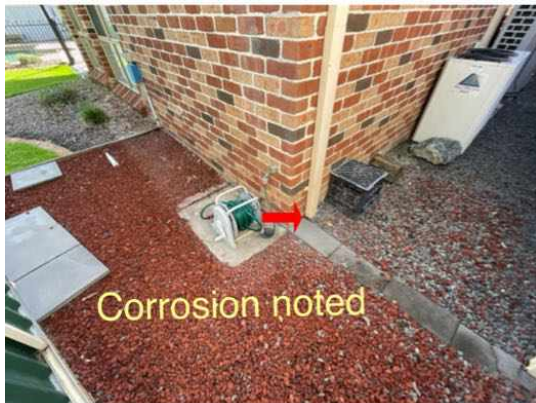
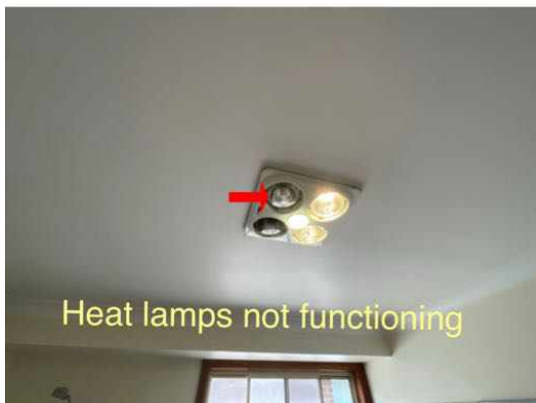
Finding 3.03

Building: Main Building
Location: All Areas
Finding: Photographic Reference Note.
Information: Additional photos have been provided for your general reference.

Arrows have been included in the images to highlight areas where minor defects or general wear and tear are present.

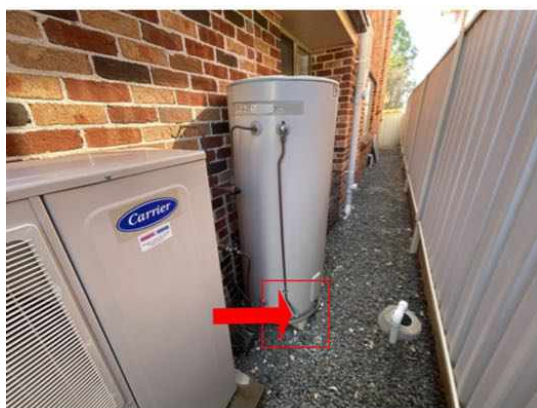
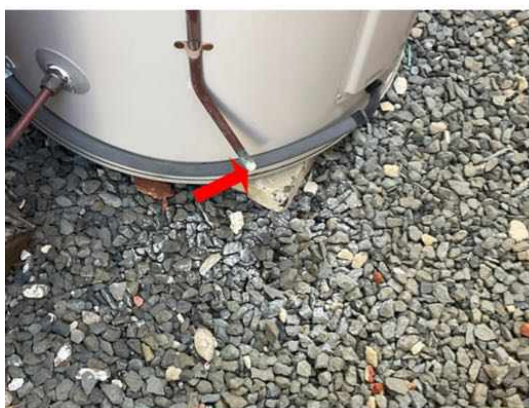
Building: Main Building
 Location: All External Areas
 Finding: Overflow Management – Risk of Termite Activity..
 Information: Observation: Water Pooling from HWS and Air Conditioning Overflows

Water discharge from the Hot Water System (HWS) pressure relief valve and air conditioning unit overflows was observed discharging close to the base of the structure, contributing to water pooling around the building perimeter.

Persistent moisture near the foundation or subfloor area significantly increases the likelihood of termite activity. Termites are highly attracted to damp environments, and stagnant water near structural elements provides ideal conditions for foraging and infestation.

It is highly recommended that all overflows from the HWS and air conditioning units be redirected away from the building, preferably via fixed drainage or extension piping, to prevent water accumulation near the structure.

These minor corrective works should be undertaken promptly to minimise the risk of both termite ingress and potential structural damage due to ongoing moisture exposure.

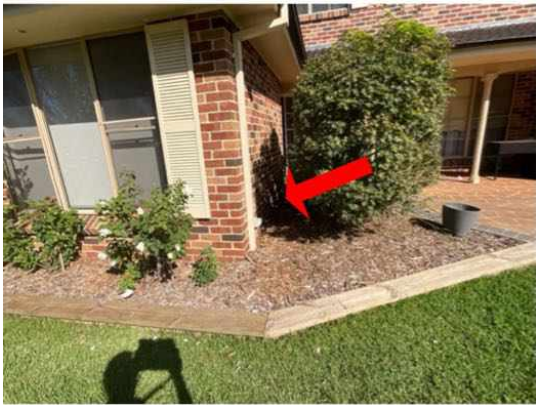
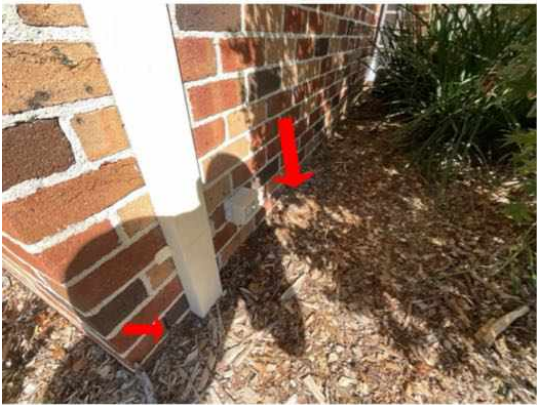
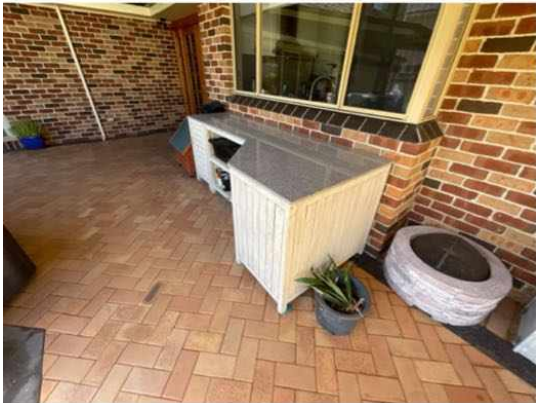
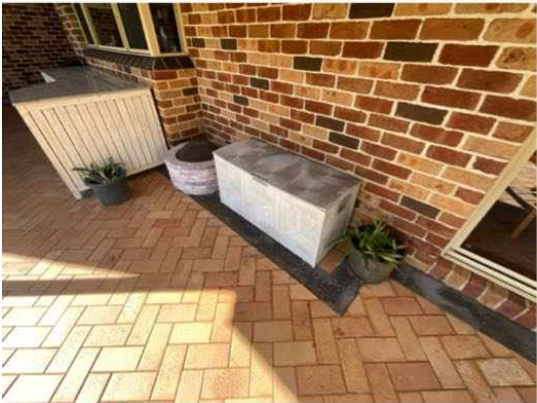
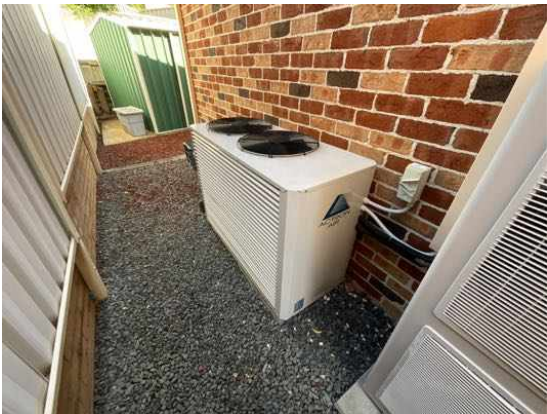
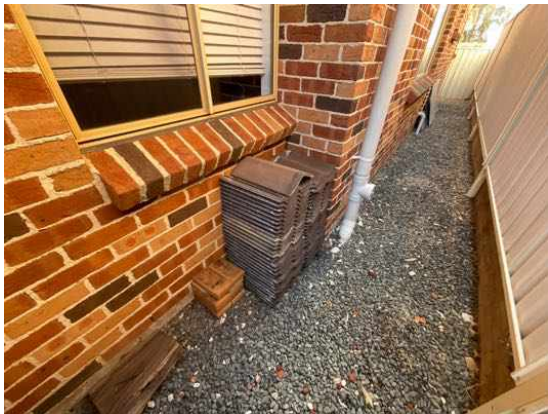
Finding 6.03

Building: Main Building
 Location: All External Areas
 Finding: Bridging of Termite Barriers – Concealed Weep Holes..

At the time of inspection, it was noted that the weep holes in the external brickwork of the property are concealed by adjacent garden bed, cabinetry, stored building materials. This creates a bridging point for termites, allowing undetected access over or around the termite barrier system and into the structure. As a result, a full inspection of this area could not be achieved.

- Concealed termite entry becomes possible when weep holes are obstructed by ground levels, paving, concrete slabs, footpaths, garden beds, or built-up landscaping.
- These obstructions also provide moist, shaded environments that are attractive to termite activity.
- Moisture build-up due to covered weep holes further increases the risk of timber pest infestation and wood decay.

- All weep holes should remain exposed and unobstructed across the entire property to allow for effective drainage and visual termite inspections.
- It is strongly advised that any material or structure covering weep holes be removed promptly, and a re-inspection carried out to ensure termite entry is not occurring undetected.
- Where removal of obstructions is not feasible, it is recommended that the area be inspected regularly, ideally every 3 to 6 months, to monitor for signs of termite activity or moisture-related damage.

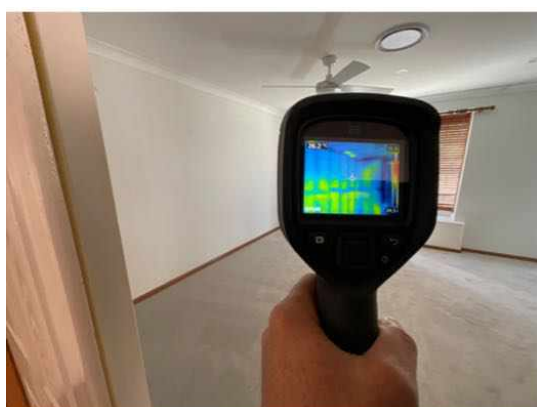
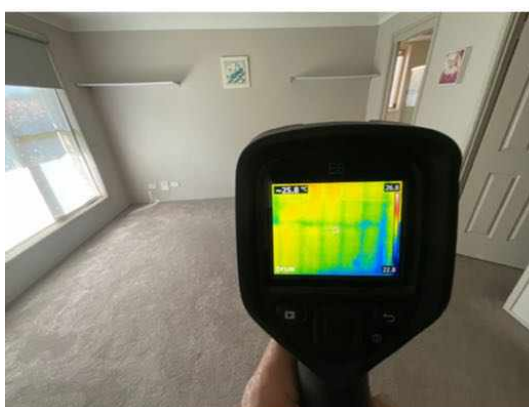
Termites release heat in the form of carbon dioxide and build mud tubes with high moisture content, which can create irregular heat patterns on surfaces such as walls, ceilings, and floors.

At the time of the inspection, no abnormalities indicating live termite activity were observed. However, it's important to note that various factors—such as obstructions, ambient temperature, and wall material/thickness—can impact the accuracy of thermal readings. In cases where surfaces are visually restricted or obstructed, a comprehensive thermal scan may not always be feasible.

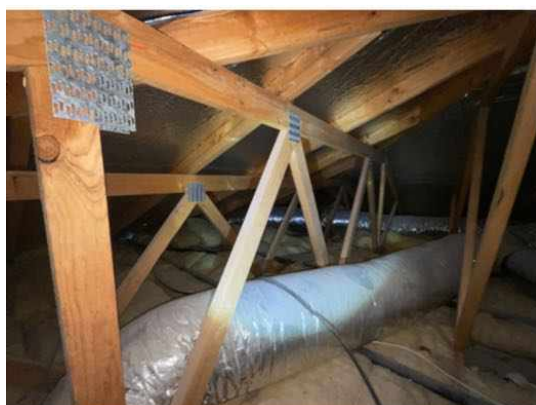
Building: Main Building
 Location: Roof Void
 Finding: Roof Void – Limited Accessibility..
 Information: Observation:

Installation of an additional manhole is recommended to facilitate a re-inspection and enable a more thorough assessment of the roof void in the future. This will help ensure that all structural elements and concealed areas are properly evaluated.

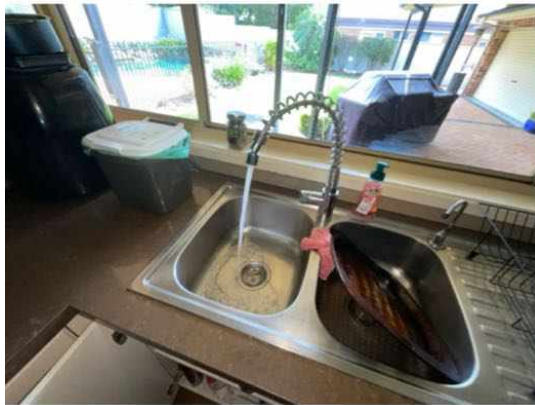
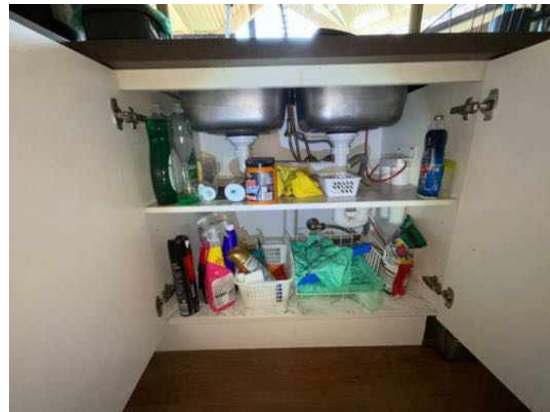
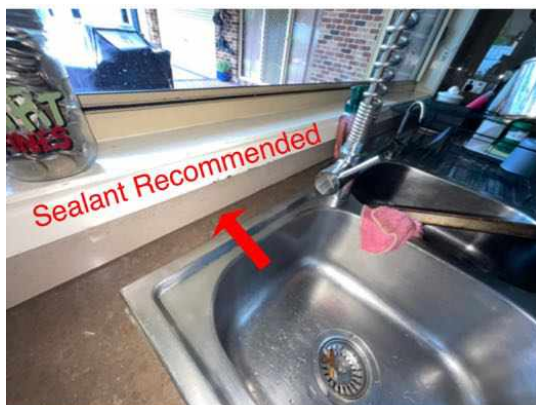
Building: Main Building
 Location: Kitchen
 Finding: Kitchen Sink – Overall Condition & Recommendations.
 Information: Observations:

routine maintenance, and damaged or missing sealant should be replaced as needed.

- For long-term property care, it is advised that sealant and grouting in water-exposed areas be regularly inspected and maintained. A sealant specialist or tiling contractor may be engaged to carry out these works where necessary.
- It is recommended that the stored items beneath the sink be removed to allow for a full re-inspection of the plumbing and cabinetry, ensuring no concealed defects are present.

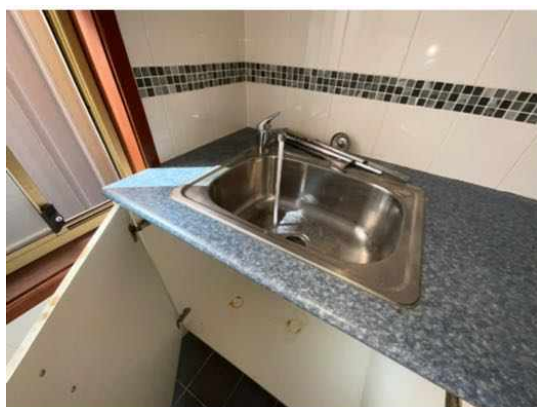
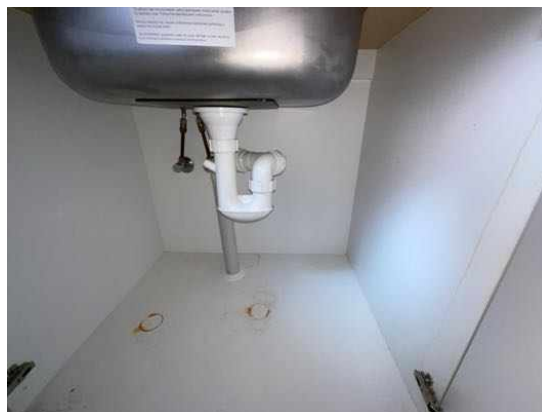
Building: Main Building
 Location: Laundry
 Finding: Laundry - Taps/Plumbing/Drainage.
 Information: Observation: Laundry Tub – Taps, Plumbing, and Cabinetry

- Further monitoring or testing is recommended once the taps are placed into regular use, to ensure no leaks develop over time and that the drainage system continues to perform adequately.
- Sealant and grouting in wet areas should be maintained as part of the long-term care and upkeep of the property.
