Building and Timber Pest Inspection Report

Inspection Date: Thu, 29 Jan 2026

Property Address: 19/71 Elkhorn St, Enoggera QLD 4051,
Australia

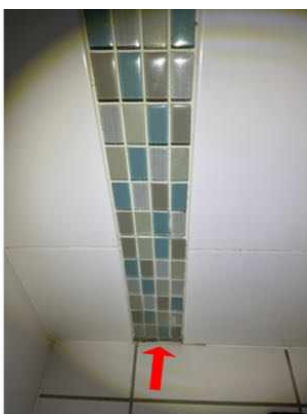
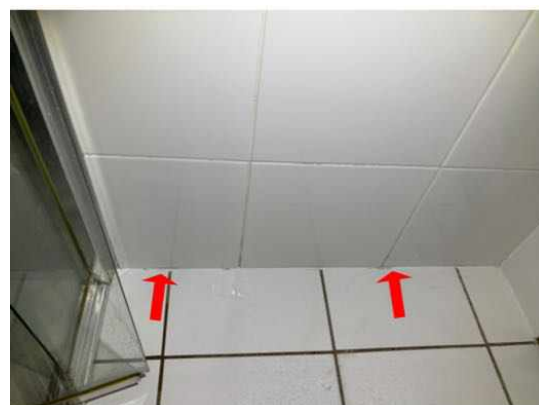
Finding 3.01

Building: Main Building
 Location: Family bathroom
 Finding: Family bathroom - sealant deteriorating
 Information: At the time of the inspection it was noticed that the sealant in the shower cubicle of the family bathroom was deteriorating.

Sealant is used in tiled areas to prevent moisture from entering the wall cavity and causing damage to the building elements. A moist environment in the wall cavity may also be a conducive condition for termite activity.

If it is not addressed, damage to building elements will occur and would require invasive works to rectify any damage.

A building maintenance professional or sealant applicator should be appointed to replace all sealant as a matter of urgency.

The grout and sealant needs to be replaced to the shower cubicle in the family bathroom.

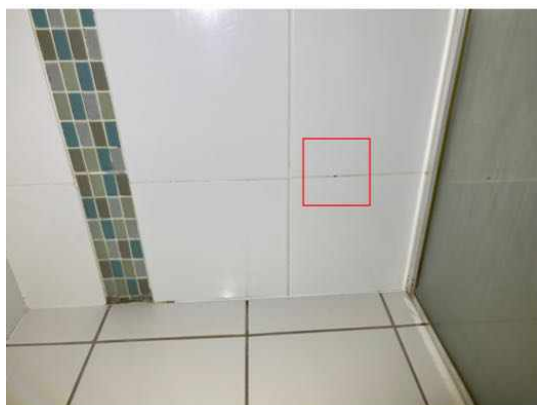
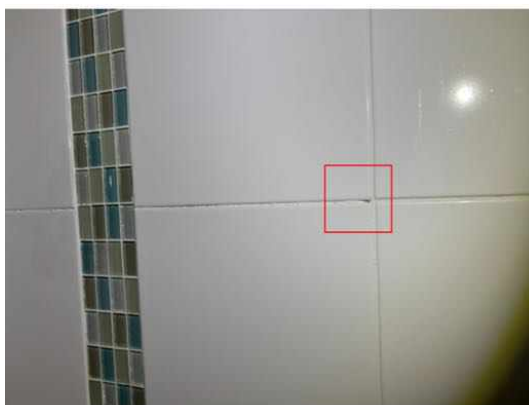
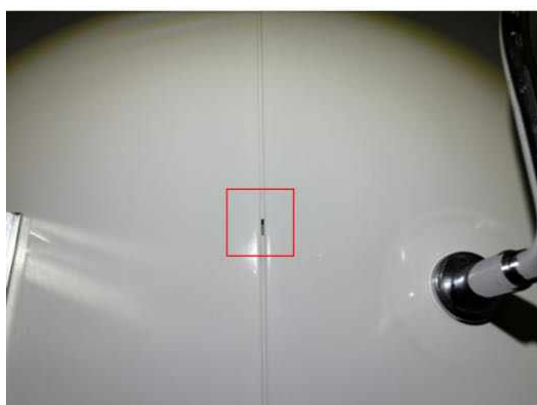
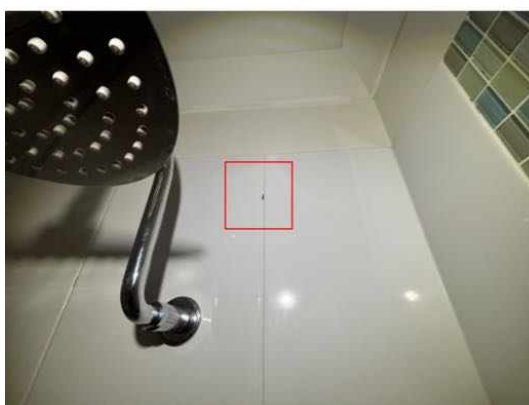
Finding 3.02

Building: Main Building
 Location: Family bathroom

Finding: Family bathroom - grout missing

Information: At the time of the inspection, it was noted that there were sections of grout missing from the wall tile joints in the family bathroom. This may be due to general wear and tear.

Continued deterioration of the grout may lead to moisture penetrating behind the wall tiles.

A building maintenance professional or bathroom specialist could be engaged to replace the affected grout. This should be done as a short term priority.

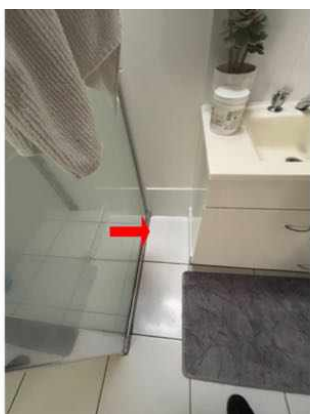
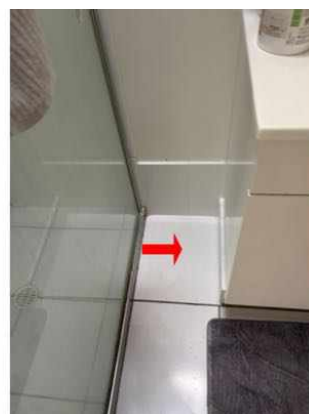
Finding 3.03

Building: Main Building

Location: Family bathroom

Finding: Family bathroom - drummy floor tile

Information: At the time of the inspection, it was noted that a tile in the family bathroom was drummy. The floor tile may crack if something was dropped on it.

The term 'drummy' refers to tiles that have become detached from their fixing, despite otherwise being in relatively good condition. Such defects are generally caused by physical or moisture damage to the area. Drummy tiled areas may also be a direct result of poor workmanship during the construction process.

Tiled areas may swell and shrink with changes in air humidity if the area has sustained moisture damage. Any exposure to moisture is capable of causing tiled areas to become drummy and/or cracked over a prolonged period of time. Drummy tiled areas generally require removal and replacement of affected tiles, with adequate sealant and grouting.

Specialist trades are available for these types of services. A registered builder may be required to undertake works if damage is extensive or if secondary building defects have resulted. Otherwise, it is advised that a tiling contractor be appointed to perform works as necessary. Immediate action is recommended to ensure that no further damage is sustained in the affected area.

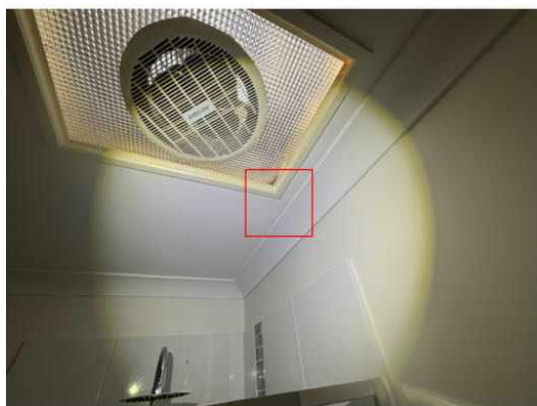
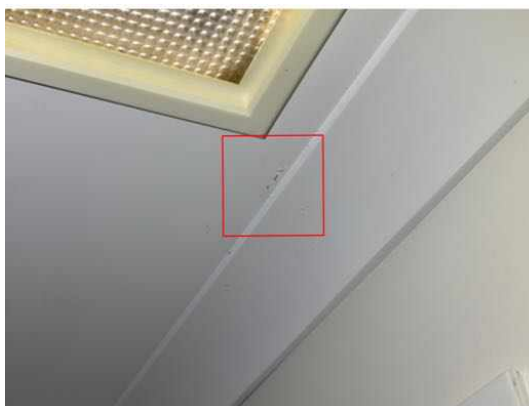
Finding 3.04

Building:	Main Building
Location:	Family bathroom
Finding:	Family bathroom - paint peeling
Information:	At the time of the inspection, it was noted that there was minor peeling of the paint to a section of the ceiling in the family bathroom.

Peeling paint can be caused by moisture, poor preparation or age. There was no evidence of moisture found.

A painter or building maintenance professional could be engaged to rectify this issue. This can be done at the clients discretion.

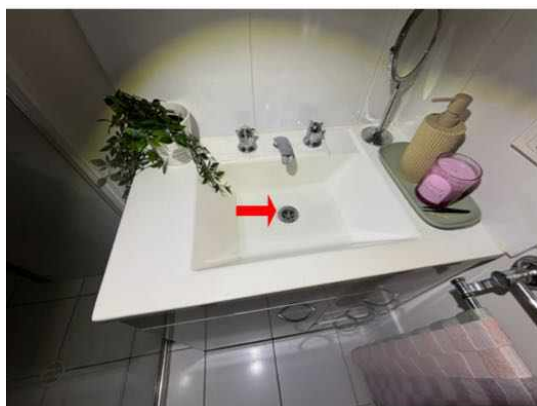
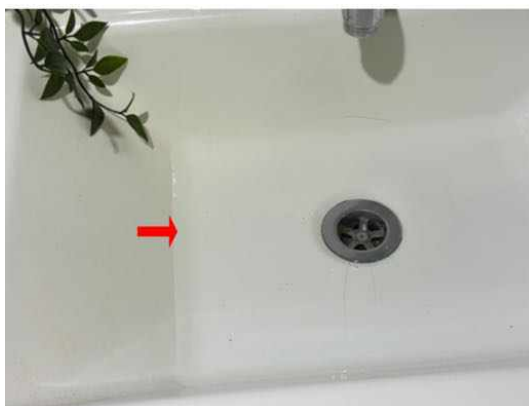
Finding 3.05

Building: Main Building

Location: Ensuite

Finding: Ensuite - slow draining hand basin

Information: At the time of the inspection, it was noted that the hand basin in the ensuite was slow draining. This appears to be caused by a partial blockage of the plumbing below the hand basin.

A licensed plumber could be engaged to check the associated plumbing and clear the blockage. This can be done at the clients discretion.

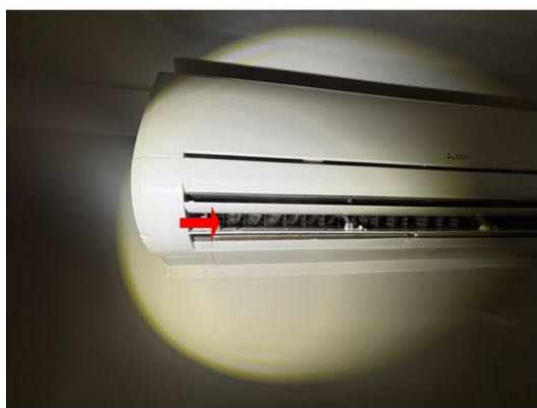
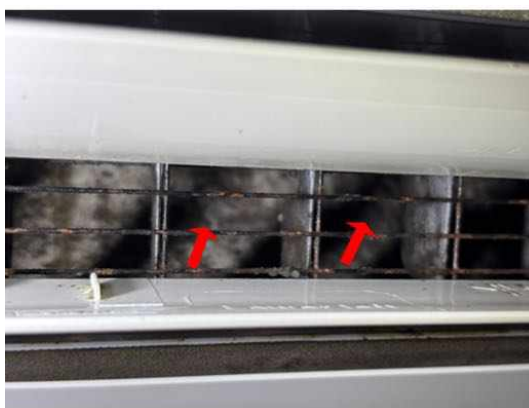
Finding 3.06

Building: Main Building

Location: Lounge

Finding: Lounge - Mould in air conditioning unit

Information: At the time of the inspection, it was noted that there was a build up that appears to be mould to the wall mounted air conditioning unit in the lounge. Lack of maintenance may be a contributing factor.

The air conditioner should not be used until it is cleaned.

A specialist air conditioning cleaning company should be engaged to carry out a full

clean to the unit in the dwelling. This should be done as a matter of urgency.

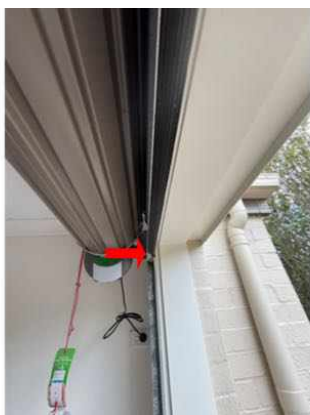
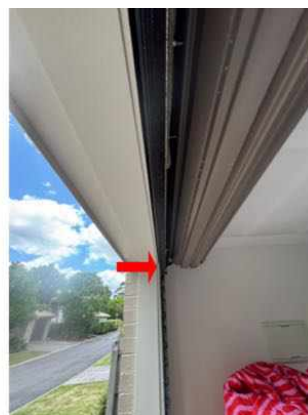
Finding 3.07

Building: Main Building
 Location: Garage
 Finding: Garage - weatherstrip to garage door worn
 Information: At the time of the inspection, it was noted that the weatherstrip to the underside of the garage door is worn and does not extend the full length of the door. This is due to general wear and tear and may allow moisture to enter the garage.

A garage door specialist could be engaged to replace the garage door weatherstrip and carry out a general service. This can be done at the clients discretion.

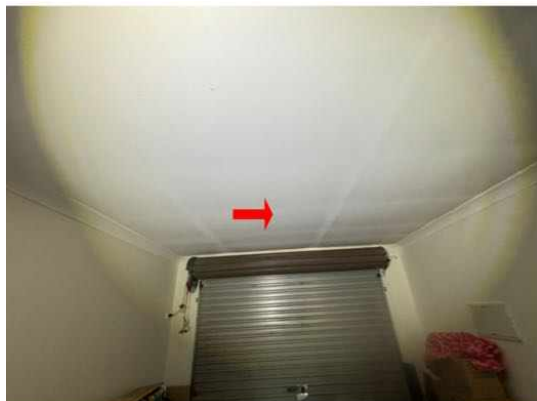
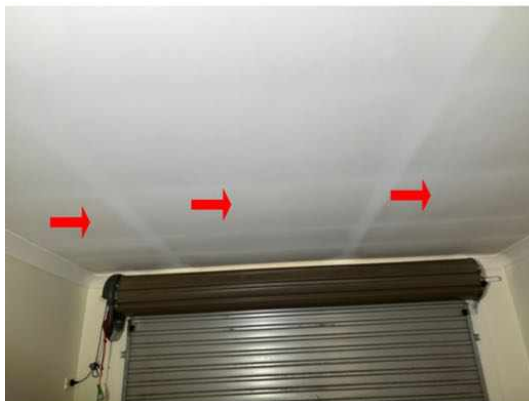
Finding 3.08

Building: Main Building
 Location: Garage
 Finding: Garage - staining to garage ceiling
 Information: At the time of the inspection, it was noted that there was some staining to the ceiling in the garage. There is no insulation to the ceiling in the garage. The change in temperature between the garage and ceiling void above will cause this staining.

The client may wish to have insulation installed to the ceiling void above the garage. The ceiling can then be cleaned and painted with a stain blocker.

A building maintenance professional could be engaged to carry out this work. This can be done at the clients discretion.

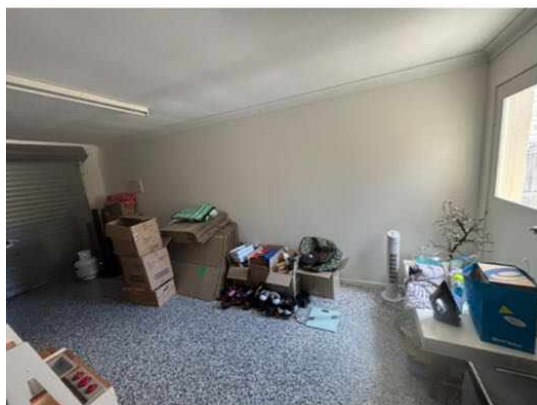
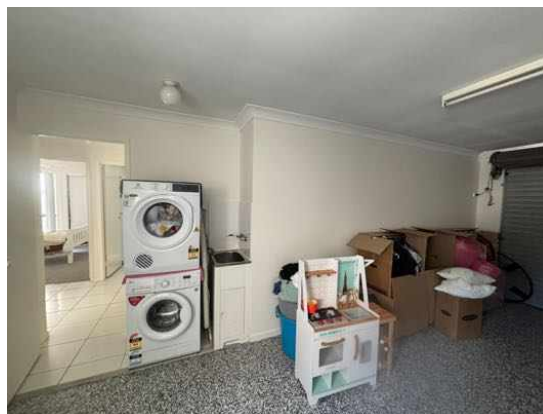
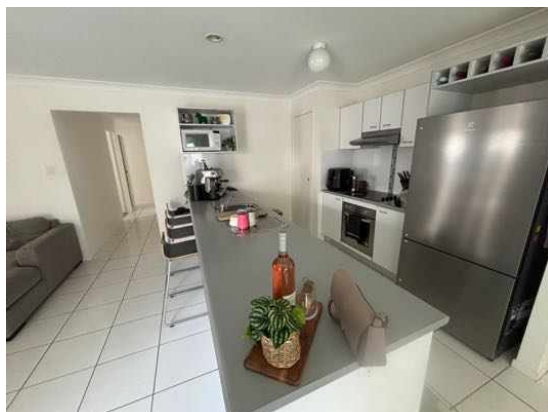
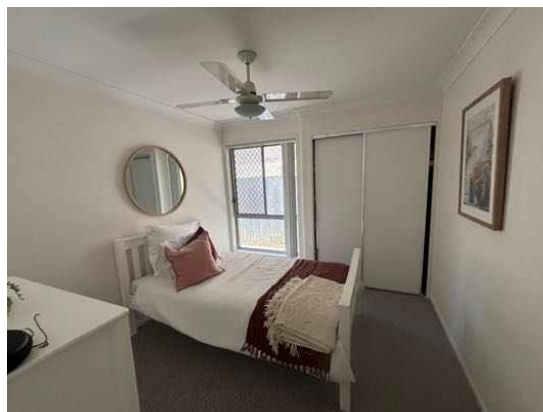
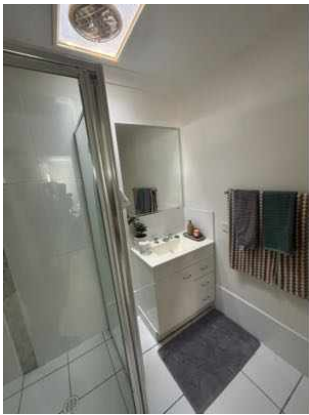
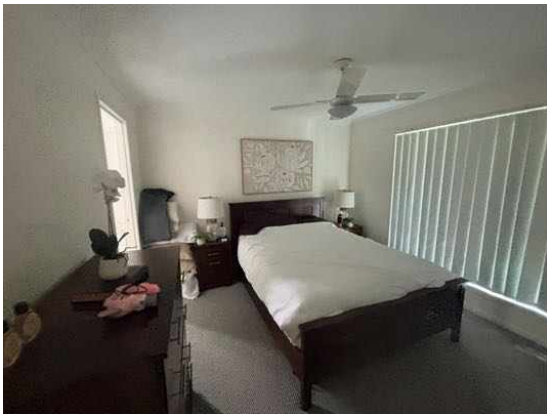
Building: Main Building
Location: All Internal Areas
Finding: Obstructions and Limitations - Internal areas
Information: These photographs are an indication of the obstructions and limitations which impeded full inspection of the property of the internal areas at the time of inspection. These obstructions can hide an array of defects and should be removed to allow full inspection to be carried out. A re-inspection is recommended once the areas are made accessible.

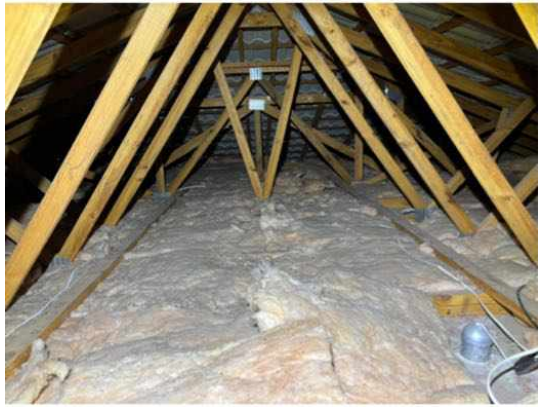
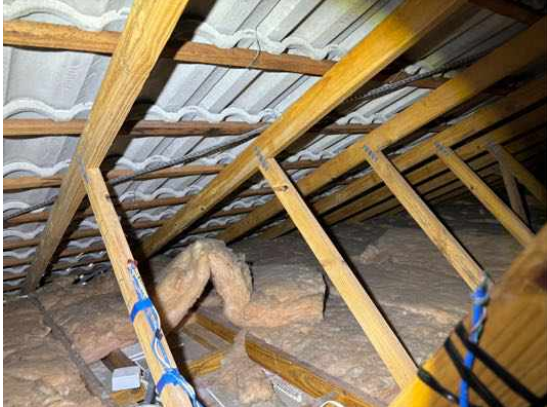
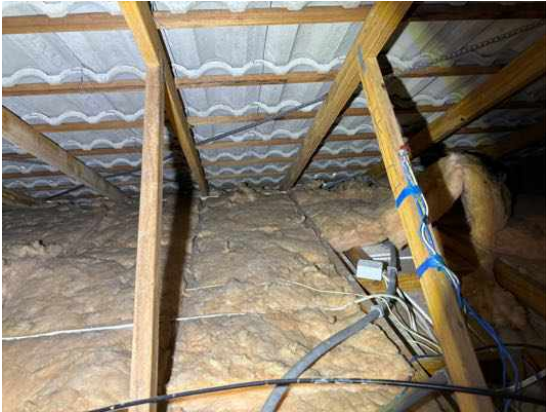
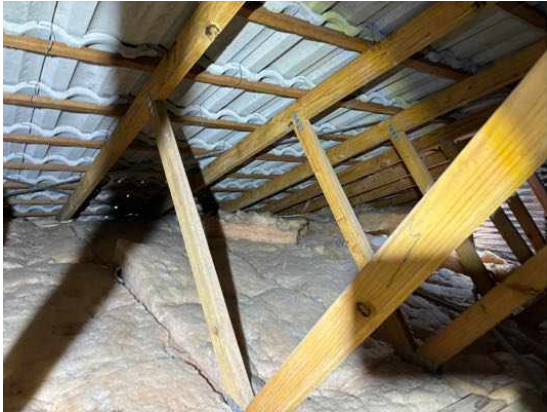
Building: Main Building
Location: Roof Void
Finding: Obstructions and Limitations - Roof cavity
Information: These photographs are an indication of the obstructions and limitations which impeded full inspection of the property of the roof cavity

at the time of inspection. These obstructions can hide an array of defects and should be removed to allow full inspection to be carried out. A re-inspection is recommended once the areas are made accessible.

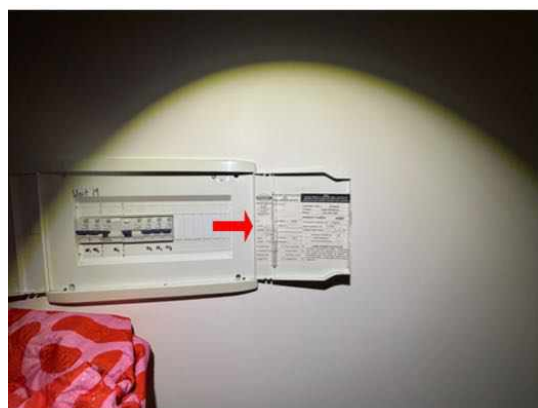
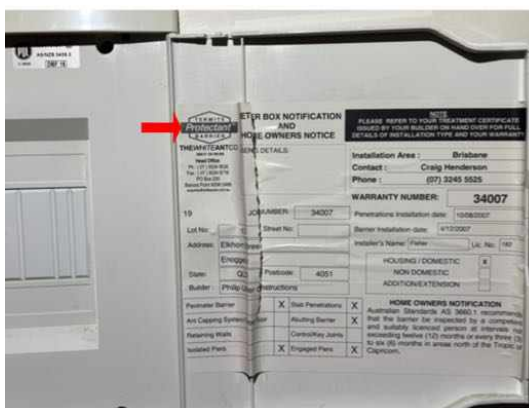
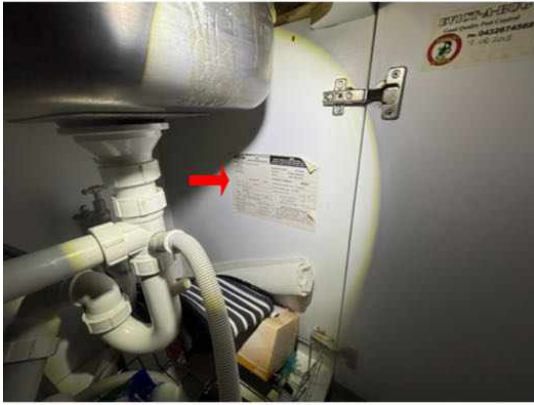
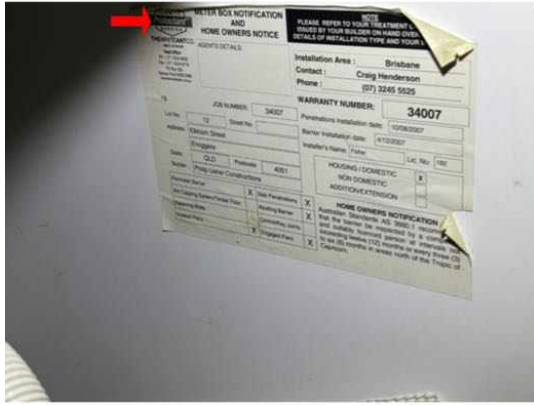
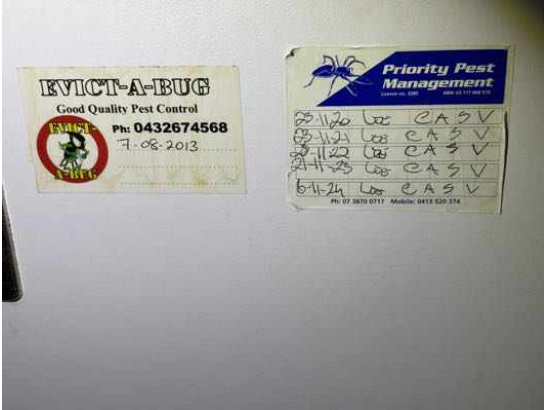
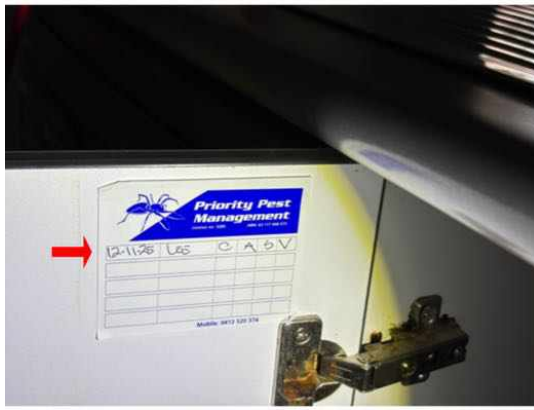
Building: Main Building
 Location: All External Areas
 Finding: Evidence of a physical termite management system was identified.
 Information: At the time of the inspection, evidence of a physical termite management system was found by way of a durable notice in the electricity meter box and the kitchen sink cabinet.

A physical termite barrier was installed to the slab penetrations, perimeter, brick piers and abutting barrier during construction. The durable notice is dated the 04/12/2007. The last recorded annual termite inspection appears to have been carried out on the 12/11/2025.

The client may wish to enquire of the body corporate as the nature of the termite management plan for the complex and the individual dwellings. Also, are annual termite inspections being carried out and up to date.

A termite and timber pest technician should be engaged to carry out annual termite inspections as per AS 3660 in order to further protect the dwelling. Annual termite inspections must be carried out in partnership with any termite treatment system, physical or chemical, as no termite treatment system can be expected to be 100% effective.
