Building Inspection Report

Inspection Date: Mon, 12 Jan 2026

Property Address: 13/125 Lake Entrance Rd, Barrack Heights
NSW 2528, Australia

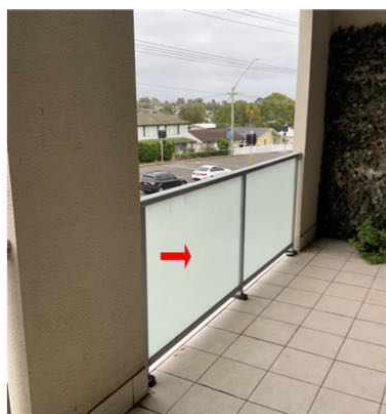
Defects 1.01

Building:	Building 1
Location:	Balcony railing
Finding:	Railing glass - Cracked
Information:	Cracks were identified in the balcony glass. Cracking in glass is generally the result of impact damage, and is likely to develop further when left unmanaged.

The likelihood of further cracking and shattering is increased exponentially, providing a safety hazard in the area.

A qualified glazier is required to repair the glass. Please be advised that any persons coming into contact with the cracked glass should do so with due caution.

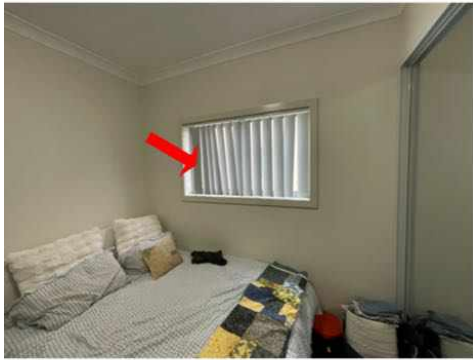
Defects 1.02

Building:	Main Building
Location:	Some rooms
Finding:	Window opening restrictors missing.
Information:	The Building Code of Australia rules require all openable windows (where the internal floor is more than 2m above the ground outside) in residential rooms to be fitted with a suitable screen or restrictor. Windows located 1.7m above the floor level do not require protection.

Window restrictors are required where people who are vulnerable to the risk of falling have access to windows. This means all windows above ground level which do not have another fall prevention safety measure in place, such as a balcony or balustrade should have a restrictor.

These need to be added urgently for the safety of all persons and pets.

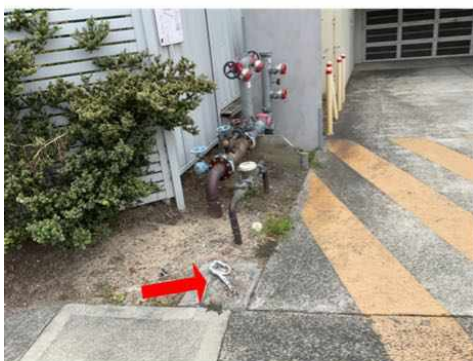
Defects 1.03

Location: Front path

Finding: Electrical junction box - Missing

Information: This front cable is not protected by a junction box. Junction boxes provide a second insulation barrier to adequately seal off and protect the wires, increasing the safety of the immediate environment and ensuring that the wiring is not damaged.

The absence of a junction box poses as an electrical safety hazard to any nearby persons providing risk of electrocution. It appears as though wiring in this area has been damaged and not repaired. The possibility of rain also poses an increase threat of electrocution.

Appointment of a licensed electrician is highly advised to provide additional information on the risks of unprotected wiring and to install junction boxes and any other elements as required. Such works should be carried out as a matter of urgency; until this time, any persons near this path area should exercise a high level of caution.

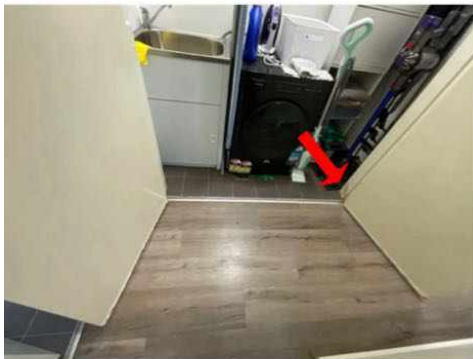
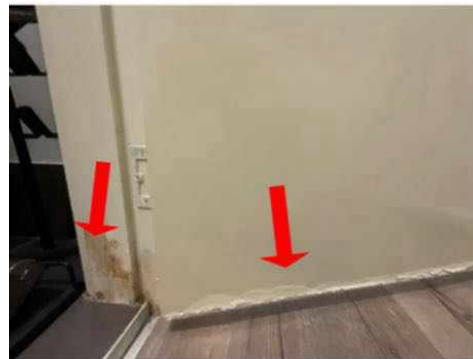
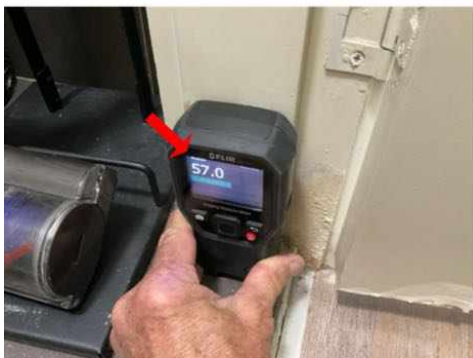
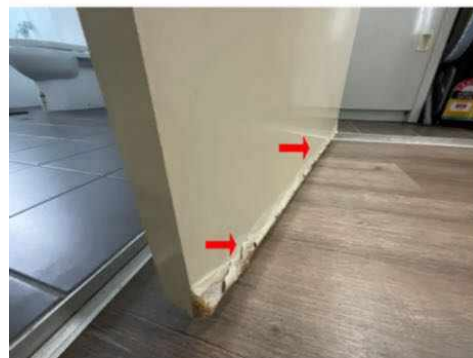
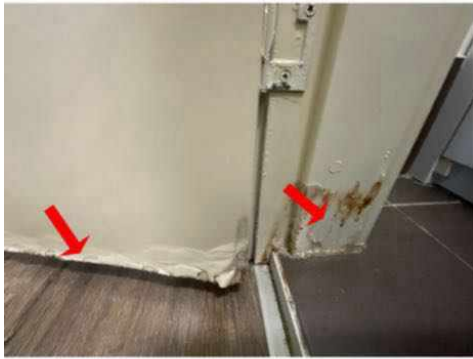
Defects 3.01

Building: Main Building
Location: Laundry
Finding: Evidence of excessive moisture & moisture damage was present at the time of inspection
Information: Excessive moisture and moisture damage was found in the laundry door frame. A medium moisture reading of 57 was recorded at the time of the Inspection.

It is suspected a recent repair may still be leaking. This moisture can attract termites and produce conditions that promote termite attack, fungal growth and wood decay. Excessive moisture is generally caused by leaking plumbing pipes or fixtures, poorly plumbed HWS overflows or condenser units and poor site drainage. It is highly recommended that all plumbing and drainage fixtures and fittings be maintained regularly in order to prevent excessive moisture being present in the internal property.

Minor moisture damage was also evident to the bathroom rear cornice areas. The owner mentioned a previous roof leak was repaired in this area.

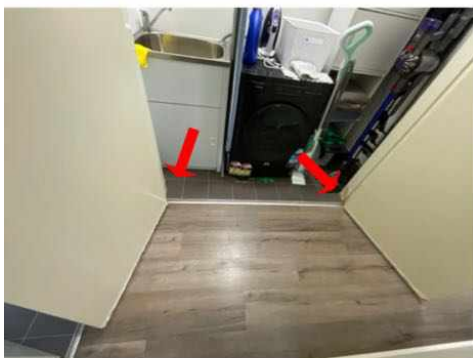
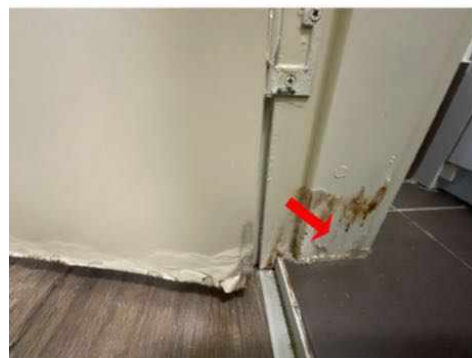
Defects 3.02

Building:	Main Building
Location:	Laundry
Finding:	Waterproofing membranes
Information:	Internal Water Proofing Membranes, are crucial in preventing water ingress into the property is important to know that the Membrane System used is to Australian Standards and has been installed correctly. Please refer to the original Building Documents or Maintenance Schedule for the relevant information including the membrane used and Manufacturers Specifications. - The Installer and Installation Certification. With older propertys where this information is unavailable all wet areas should be monitored.

It appears the stained, bubbling and damaged paint in both sides of the laundry door frame indicate the waterproofing membrane in the laundry has failed.

A licensed plumber or waterproofing specialist is recommended to investigate further. Expensive repairs and replacement of damaged laundry areas may be required.

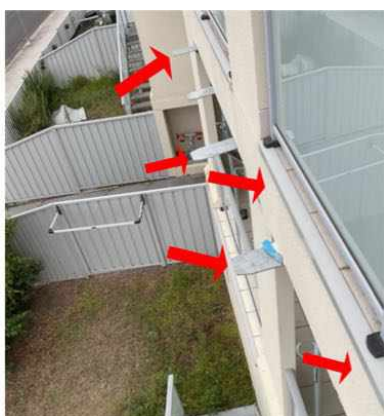
Defects 3.03

Building:	Building 1
Location:	Balcony and other areas

Finding: Unfinished construction and damaged cladding
 Information: Incomplete and unfinished work was found to some front verandah areas. It is not known if the damaged cladding is also getting removed and repaired as part of the scope of this front verandah work. It is possible due to the use of timber in these balconies that wood rot and timber replacement may also be required.

Note - if the fall to balcony tiling is also not rectified, further render and possible timber joist damage may occur. It is suspected water is entering the cladding under the aluminium corner angle under the balustrade.

The scope and timing of all these verandah and other repairs needs to be checked as part of due diligence in purchasing this unit (see also damage to common areas).

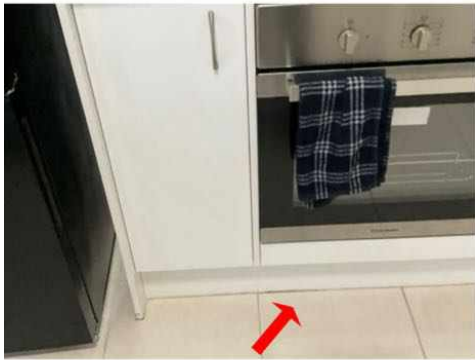
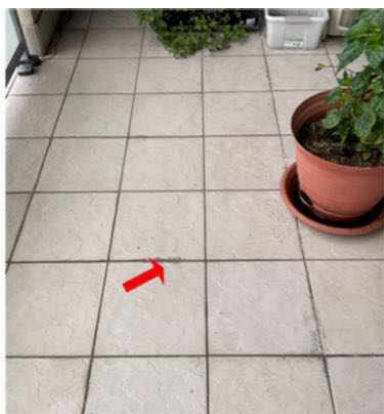
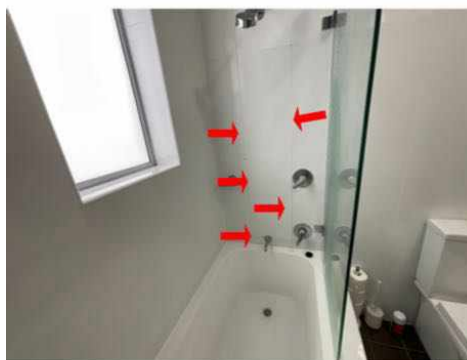
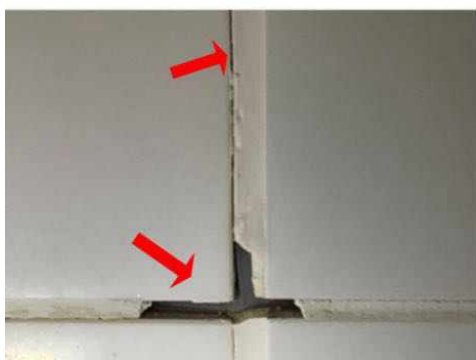
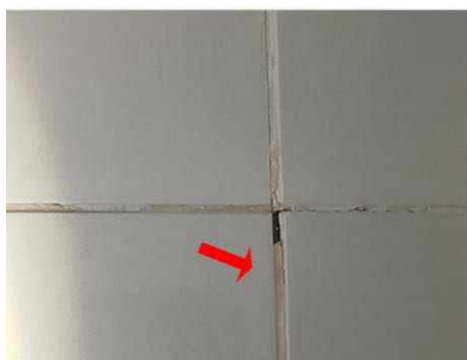
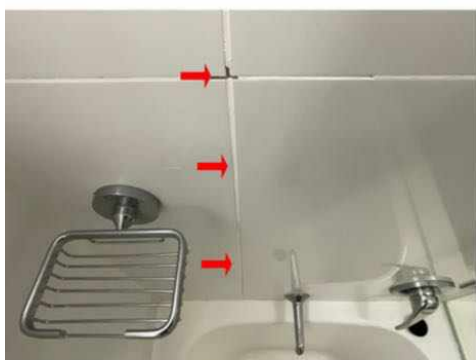
Defects 3.06

Building: Building 1
Location: Pictured kitchen, balcony, bathroom areas
Finding: Sealant and grouting - Missing, damaged, substandard balcony repairs
Information: It was noted on inspection that sealant or grout is missing to these pictured areas of the building. Some verandah grout repairs appears to be of a substandard nature.

A flexible sealant is required to allow for expected expansion and contraction, while keeping the joint water tight and protective of all associated building materials.

Flexible and mould resistant materials should be applied to affected areas to prevent any subsequent water damage that is likely to occur.

A tiling contractor or sealant expert is required to repair these tiled areas.

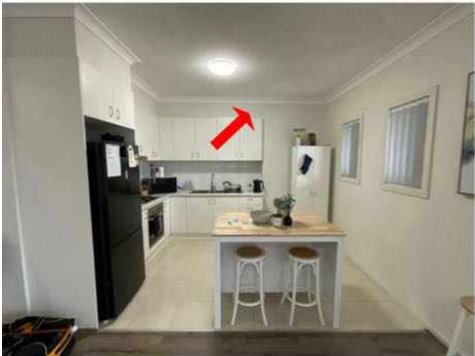
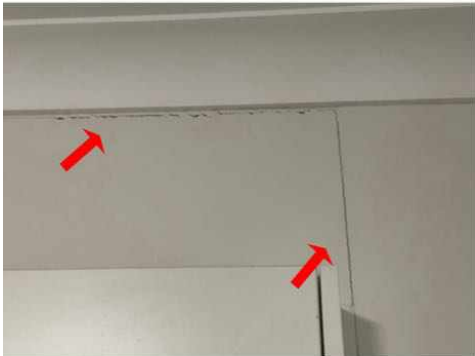
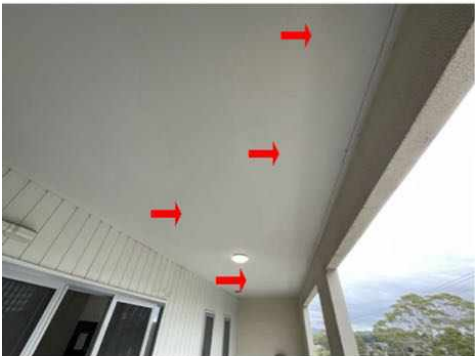
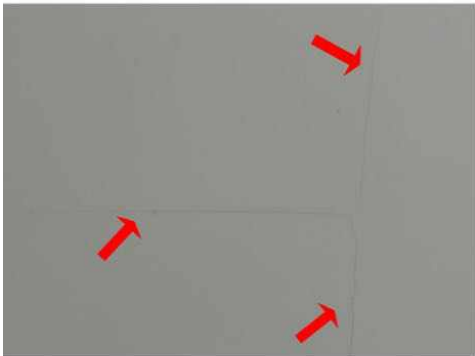
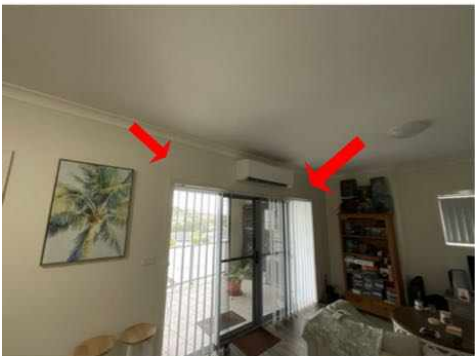
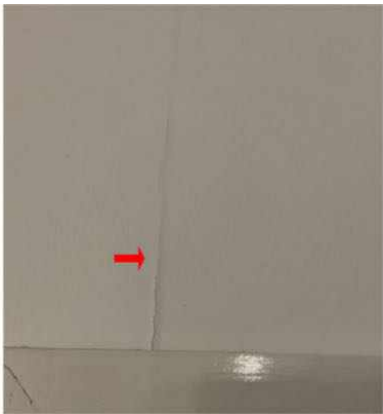
Defects 3.07

Building:	Building 1
Location:	Kitchen, balcony, loungeroom,
Finding:	Cracking - Damage Category 1 - Fine (up to 1mm)
Information:	Although fine cracks (1mm in kitchen) are quite noticeable, they are often only considered to be an appearance defect, and usually do not indicate any structural damage. Generally, the cause of a fine crack is indicative of a separation between building materials and finishes (e.g. paint, plaster, etc.) along joints.

Cracking of this nature can generally be repaired with minor sanding, filling and/or repainting. Such works should be performed by a qualified painter or a general handyman.

Monitoring of all cracking should be conducted frequently. Always contact a building inspector should cracks widen, lengthen, or become more numerous.

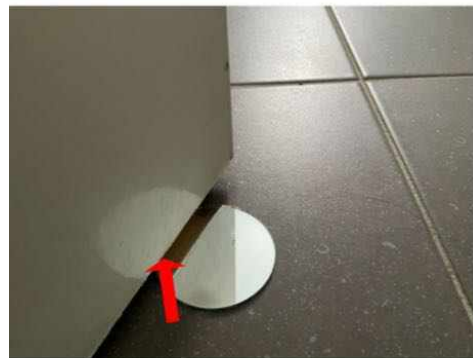
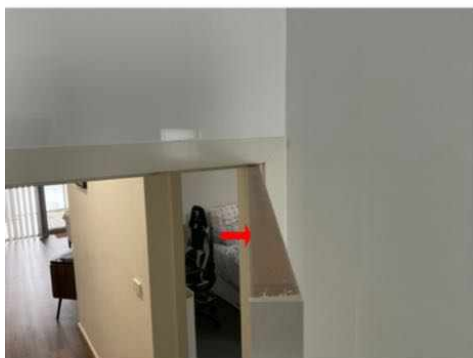
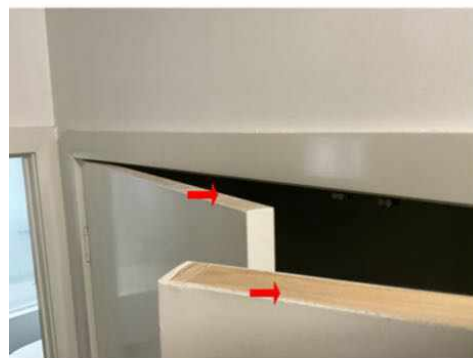
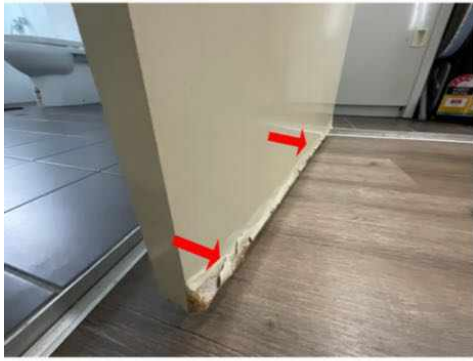
Defects 3.08

Building: Main Building
Location: Wet area doors
Finding: Paint finish on doors - Incomplete
Information: The paint finish to many doors was identified as being incomplete at the time of inspection.

NSW Guide to Standards and Tolerances 9.6 states that “door leaves are defective if they do not have all sides, top and bottom edges sealed/painted

in accordance with the manufacturers specifications”

Whilst incomplete or missing paint finish is generally an appearance defect, it can also lead to the development of secondary building defects over time. Incomplete areas of paint finish expose the area to moisture, potentially accelerating the deterioration of underlying building materials. The laundry doors now require replacement to to swelling damage.

A painting contractor should be appointed as soon as possible to perform necessary works to aid the appearance of the affected area and to ensure the area is protected against further deterioration. Alternatively, the homeowner following manufacturer instructions may perform these works.

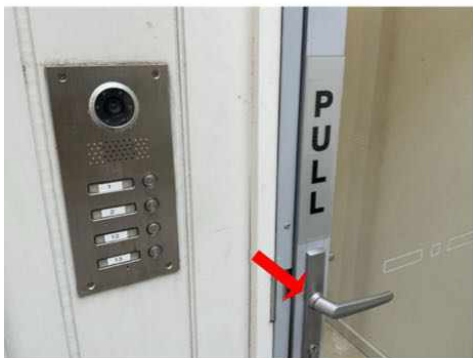
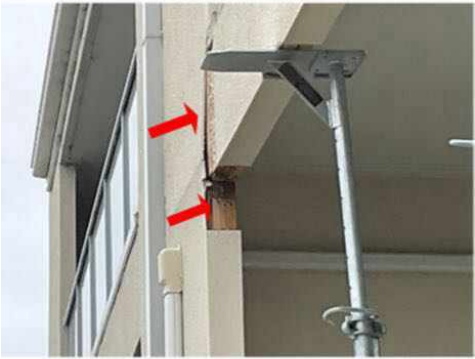
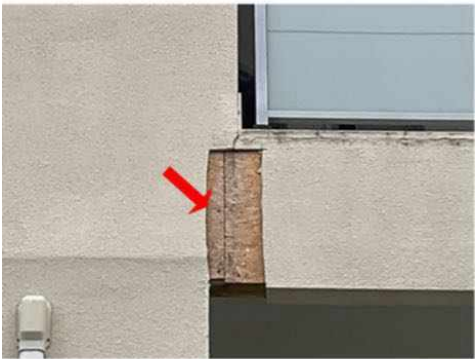
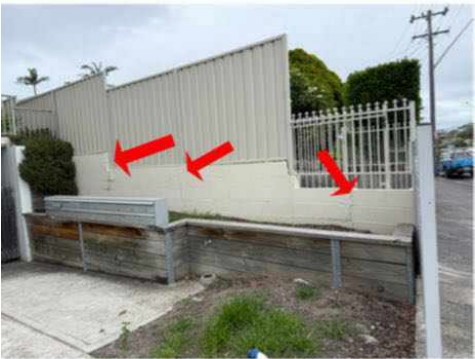
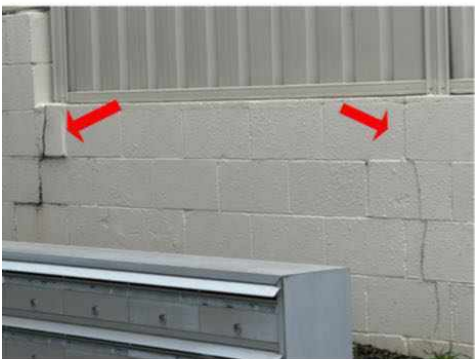
Defects 3.09

Building: Building 1
 Location: Pictured Areas
 Finding: Building elements - Damaged in common areas
 Information: Evidence of damage to common areas was identified as follows -

1. The front door remote lock did not work meaning it needed to be opened internally for visitors
2. The rear path concrete has numerous cracks evident despite being repaired in the past, this is thought to be due to no fall to allow rainwater to drain away.
3. Other units have cladding damage under repair.
4. The driveway wall has minor step cracking and damaged fencing.
5. Rear wall areas have popped nails requiring repair then repainting.
6. The rear entry had moisture damage in the bottom right wall.

Various trades are required to repair these areas in the future.
