Building and Timber Pest Inspection Report

Inspection Date: Fri, 30 Jan 2026

Property Address: 20 Dundee Dr, West Wodonga VIC 3690,
Australia

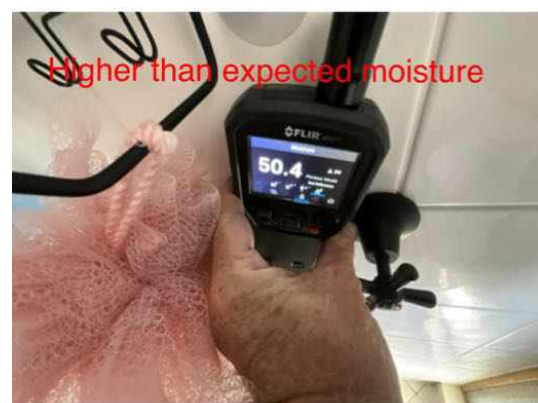
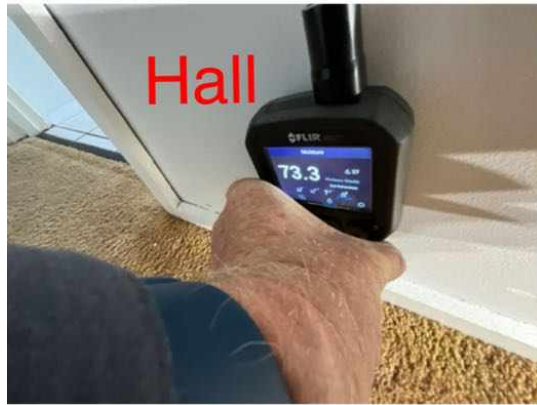
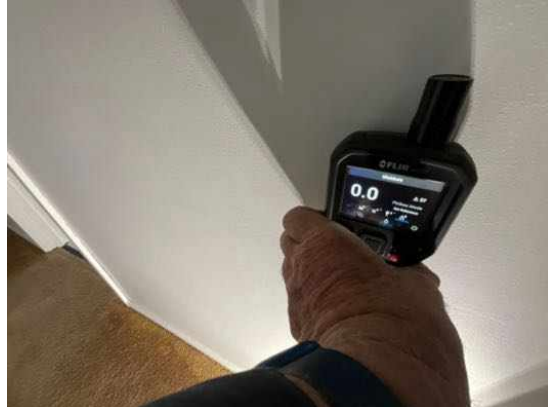
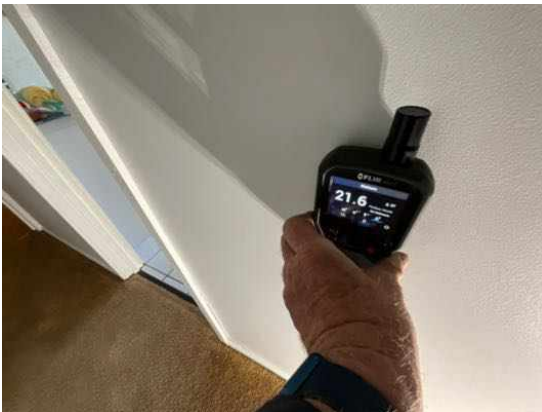
Building: Building 1
Location: Bathroom
Finding: Shower Damp- Major
Information: Damp is evident to the lower 300mm of wall to the Shower Alcove. This is suspected to have been caused by moisture permeating through the grouting in this area, which shows evidence of deterioration.

High levels of moisture were observed on the outside of the shower walls in the opposite wall.

Damp (or structural damp) refers to the presence of unwanted moisture in the structure of the building, either as a result of intrusion from outside, or condensation from within the structure. In the Shower area, internal water leaks or other sources of excessive moisture are generally the cause of damp.

A major defect is noted. The shower wall has a high moisture reading. A plumber should be contacted to conduct a pressure test and determine whether a leak is present. If a leak, plumber to fix. If a failure of the waterproof membrane, a bathroom specialist is advised to perform all needed works and prevent further deterioration.

Consultation with a qualified Plumber or Bathroom Specialist is advised immediately to identify the cause of damp and to perform remedial works as required.

Always ensure that sealant and grout is in good condition to prevent any moisture issues occurring in the future.

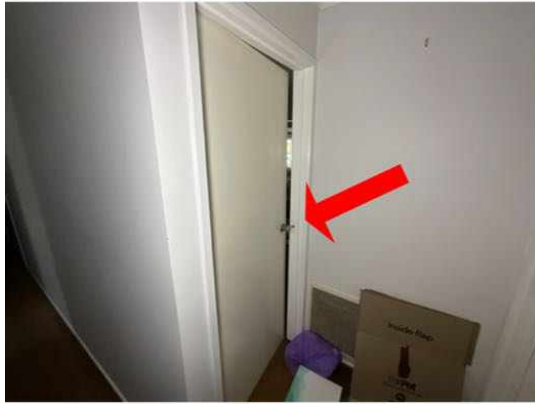
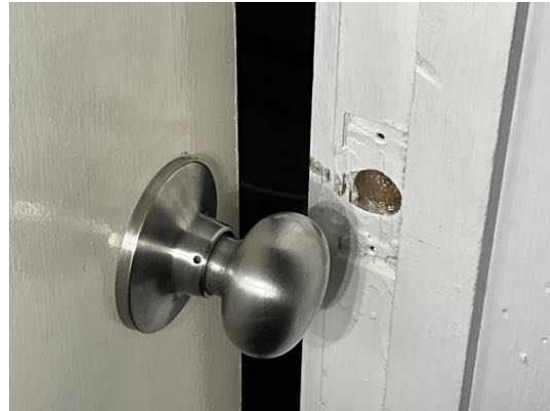
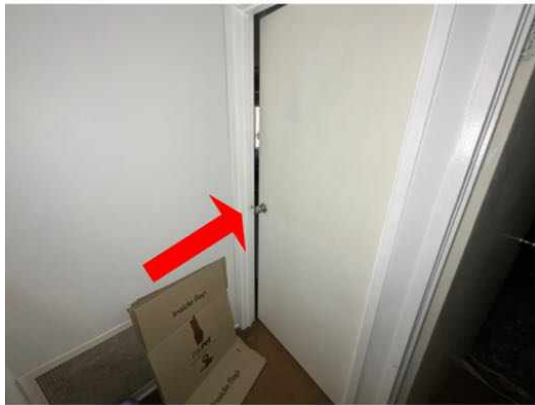
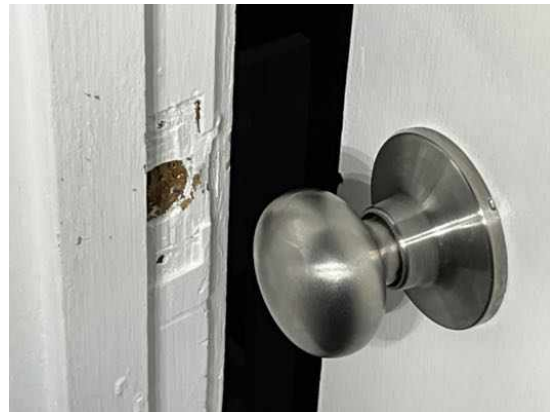
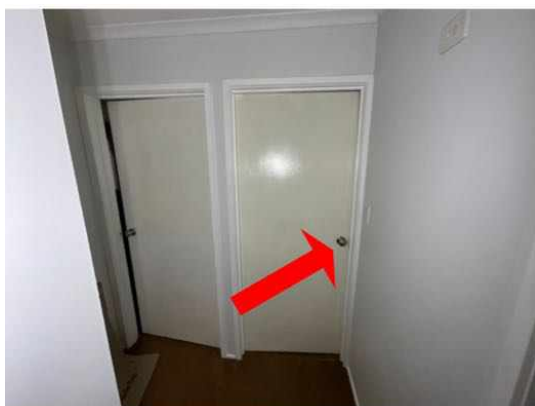
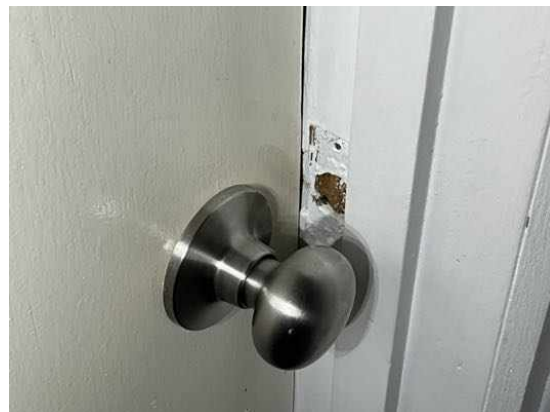
Finding 3.01

This is a common defect and is expected in a property of this age, whether being due

to substandard installation or general deterioration of the door hardware.

Readjustment of the striker plate is recommended at client discretion. Works such as these can be completed by a general handyman or qualified carpenter.

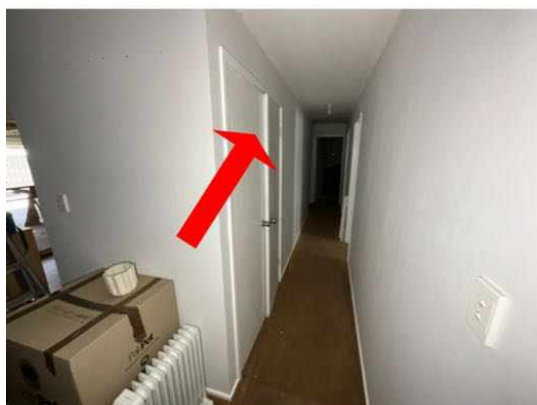
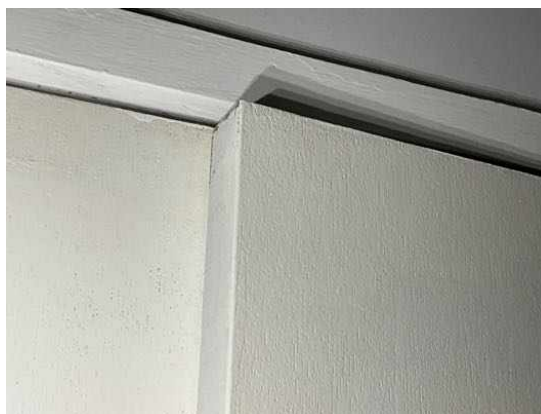
Finding 3.02

Building:	Building 1
Location:	Hall
Finding:	Door- Binding
Information:	Binding and/or jamming of this door is evident during standard operation. This defect inhibits the functionality of the affected door as well as creating potential for secondary

defects to associated building elements, such as damage to the floor covering.

A door that binds to flooring or to the associated door frame may have several causes, ranging from minor defects, such as poor installation of the door or deteriorated hinges, through to major structural issues, such as damage to subfloor structures.

A qualified carpenter or general handyperson should be appointed to perform minor rectification works at client discretion.

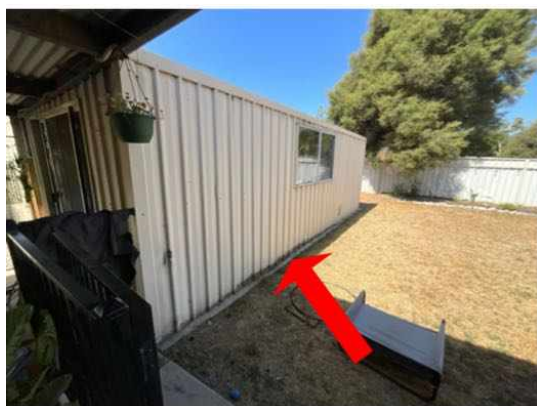
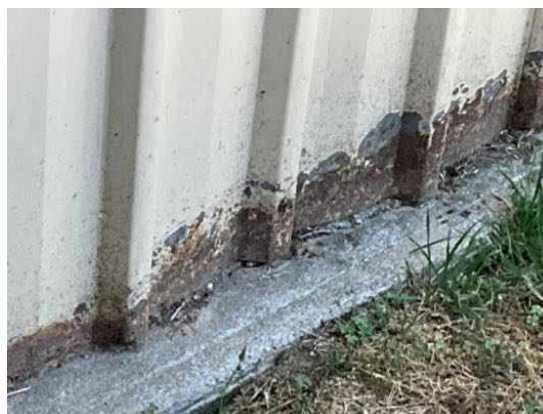
Finding 3.03

Building:	Building 1
Location:	Shed
Finding:	Building element - Rusted or corroded
Information:	This building element shows evidence of rusting and corrosion, which is likely to have developed as a result of excessive exposure to moisture and or inadequate coatings.

As surface rust provides no protection to the underlying iron, the deteriorating condition is likely to worsen if not addressed in the short-term future.

Where possible, the use of galvanized (treated) metals or aluminium coated metals aid in rust prevention, as does regular general maintenance. Rust formation can be controlled with coatings, such as paint, that isolate the iron from the environment.

Rusting and corrosion should be managed by ideally removing or limiting the affected surface from exposure to moisture. A registered builder may be appointed to replace any building elements that have been severely affected by rust or water damage.

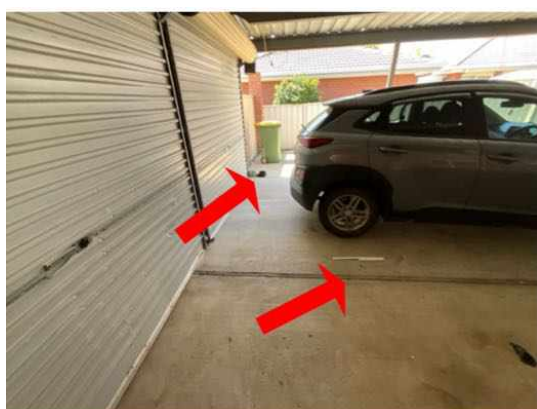
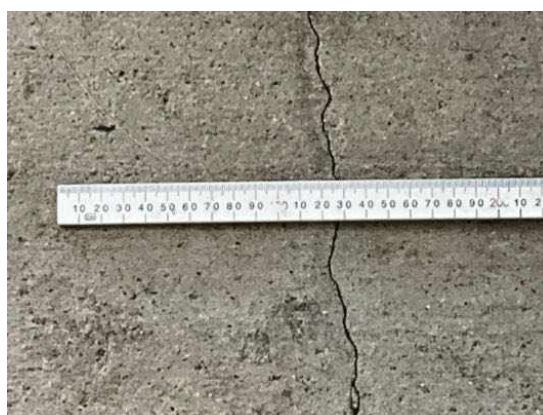
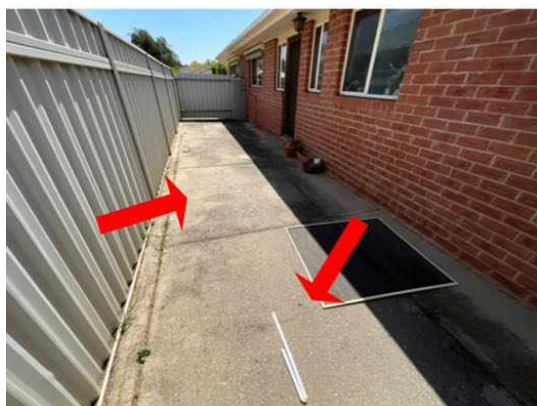
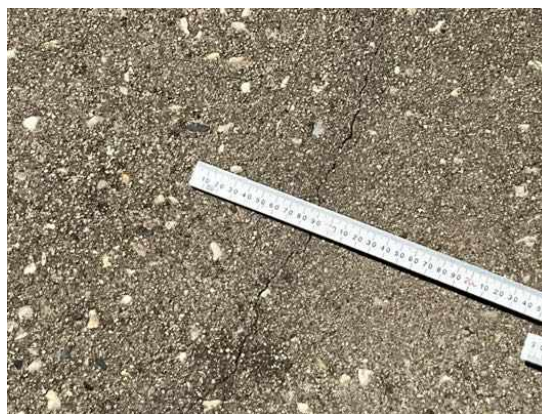
Finding 3.04

Building: Building 1
Location: Carport, side yard
Finding: Cracking - External Concrete Paving Damage Category 1 - Fine (less than 2mm)
Information: Fine cracks were identified in external concrete paving. Although fine cracks are quite noticeable, they are often only considered to be an appearance defect, and usually do not indicate any structural damage. To be considered a Category 1 or fine crack, the crack is found to be less than 2mm in width.

Generally the cause of a hairline crack in existing concrete paving such as driveways and pathways is indicative of the expansion and contraction of the concrete. Such causes are generally due to environmental factors, such as moisture levels, weather conditions, root systems of nearby trees or the soil types on which they are laid.

Fine cracks may also be due to poor original installation of the concrete. Factors such as poor compaction of the sub surface and/or inadequate reinforcing of the slab may create cracking and other secondary defects.

Monitoring of all cracking should be conducted frequently. Always contact a building inspector should cracks widen, lengthen, or become more numerous.

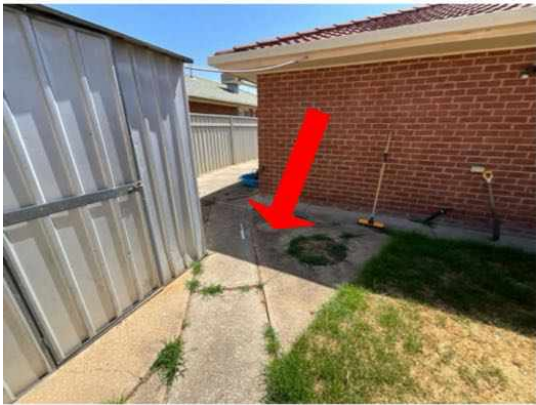
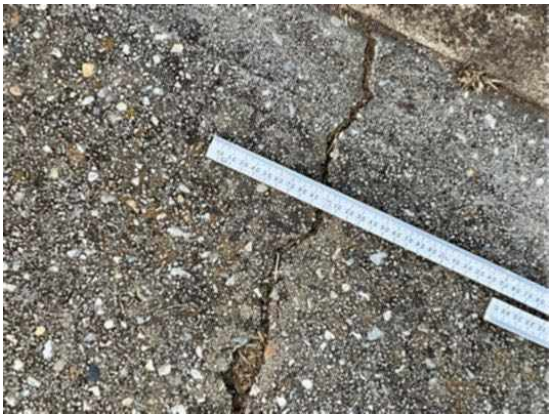
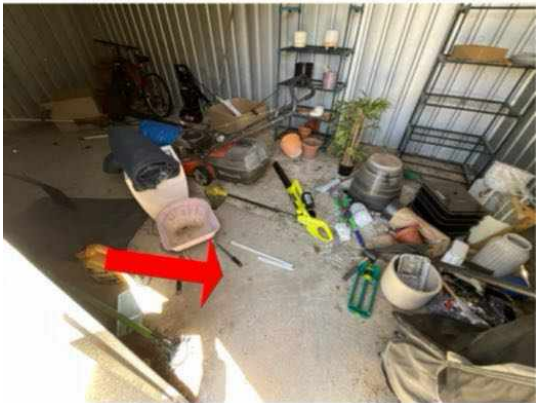
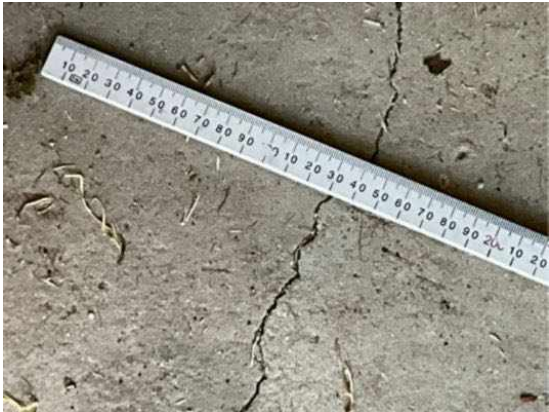
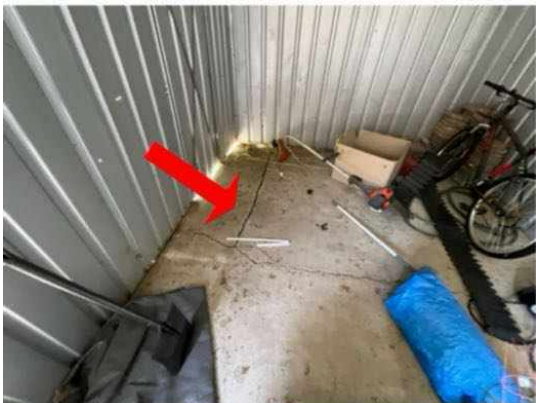
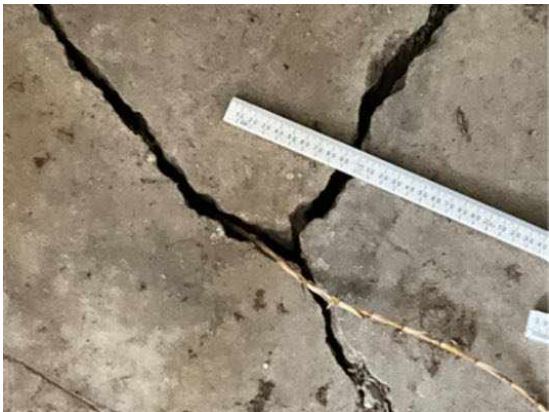
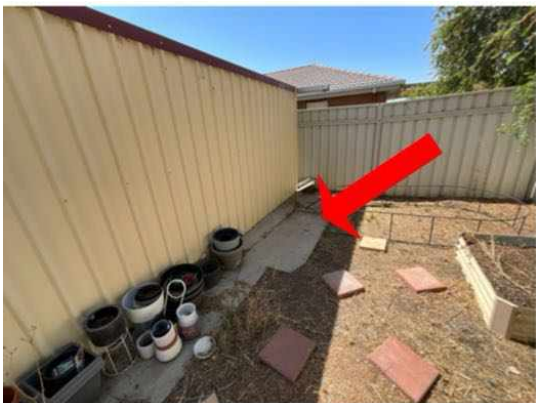
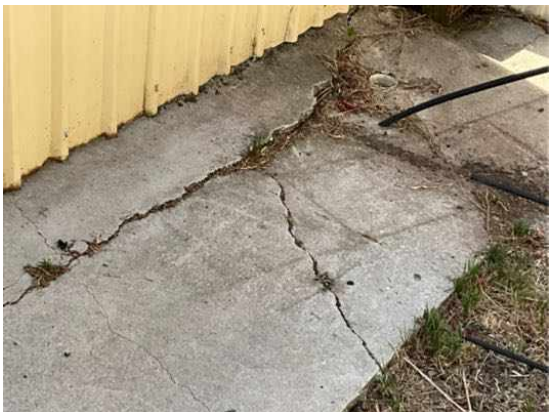
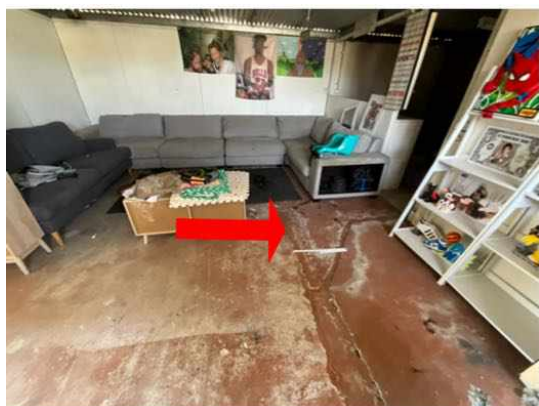
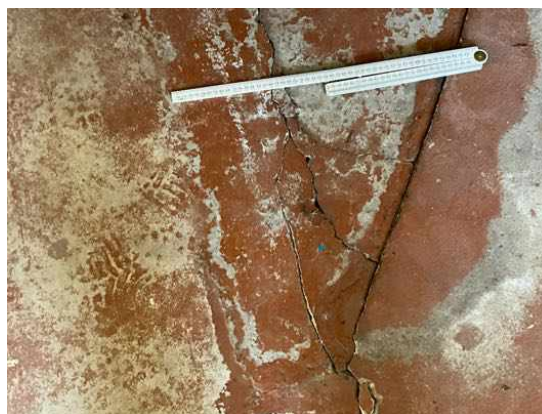
Finding 3.05

Building:	Building 1
Location:	Yard - Back, shed
Finding:	Cracking - External Concrete Paving Damage Category 4 - Gaps in Slab (4mm - 10mm +)
Information:	Gaps in the slab were identified in external concrete paving. Gaps in the slab are significant and are likely to lead to the development of safety hazards and secondary defects if left unmanaged, such as the creation of a trip hazard.

General age and expected deterioration of the paved areas is a common cause of this type of cracking. However, expansion and contraction of the slab may also have occurred due to environmental factors. Such factors include variable moisture and weather conditions, the presence of trees and their roots having a settling or lifting affect on the soil, or the effect of load bearing, e.g. heavy vehicles over a sustained period of time.

Cracking to this degree may also be due to poor original installation of the concrete. Factors such as poor compaction of the sub surface and/or inadequate reinforcing of the slab may create cracking and other secondary defects. Gaps in the concrete paving may also have a more significant structural cause, such as subsidence of soils.

Where gaps in the concrete paving are adjacent to structural elements of the building, the advice of a Structural Engineer is advisable before undertaking repairs. Significant repair and likely replacement of the concrete paving is probable.

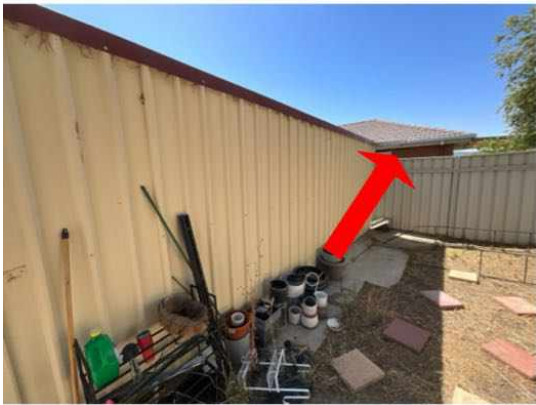
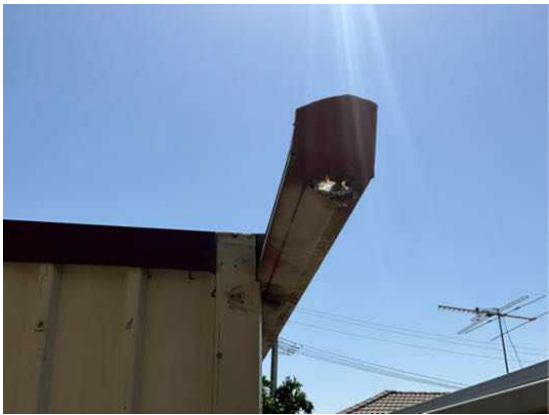
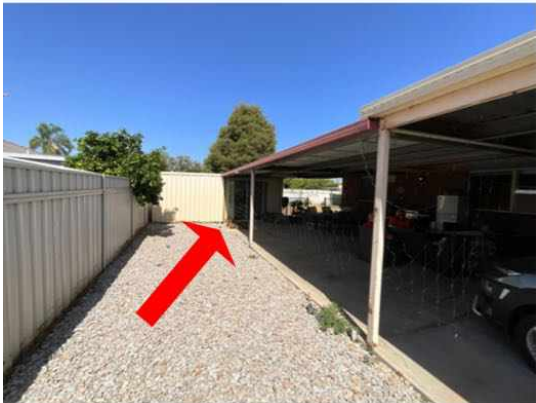
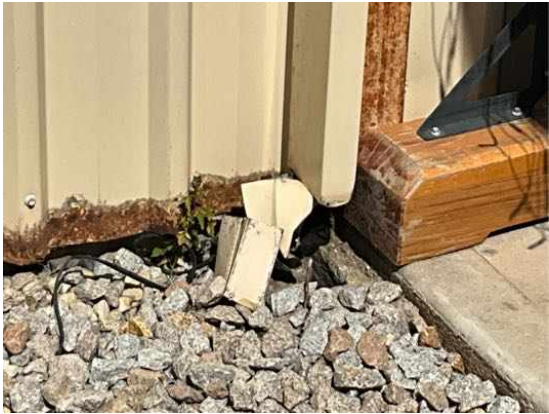
Where roof plumbing doesn't drain adequately, the area at the base perimeter can become excessively damp, potentially creating an environment that is susceptible to rust and corrosion of surrounding building elements, as well as attracting termites and other pests.

It is highly recommended that a plumber be appointed to further inspect the area and to install adequate drainage equipment where necessary.

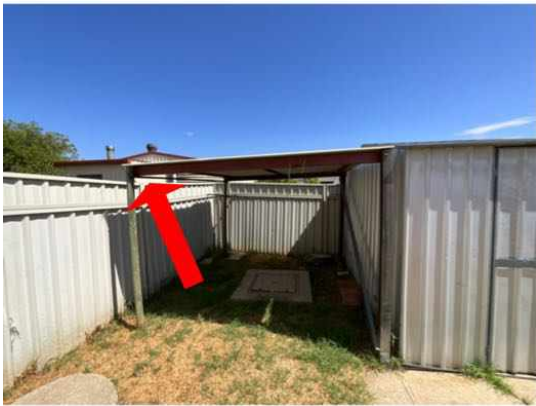
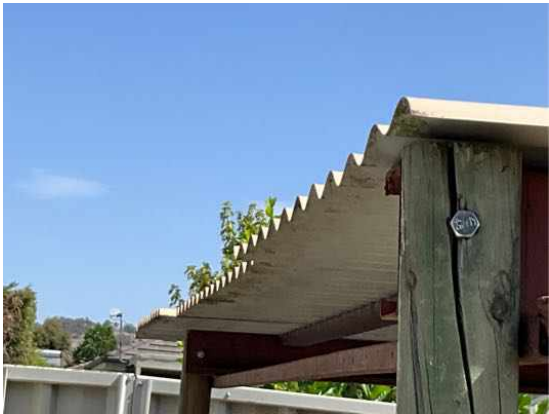
Finding 6.02

Building: Building 1
 Location: Shed,
 Finding: Guttering Missing
 Information: The Guttering in this area was missing at the time of inspection. Guttering, Downpipes and Stormwater drainage are vital to protect the integrity of the structure and to prevent an environment conducive to Timber Pest attack.

A Plumber should be contacted as soon as possible to replace and connect to drainage the missing Guttering.

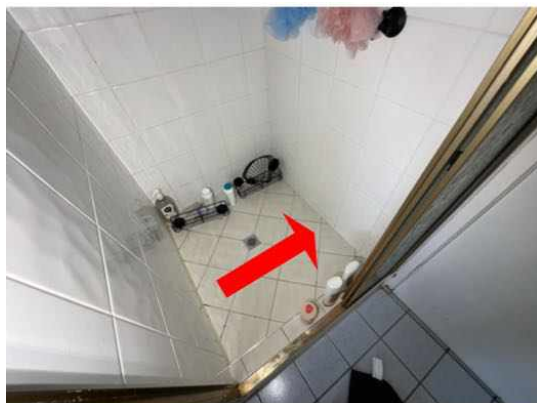
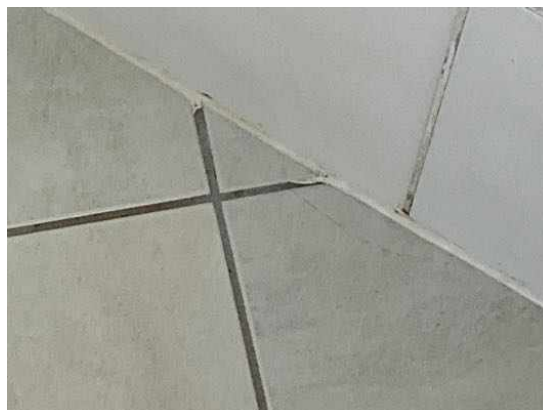
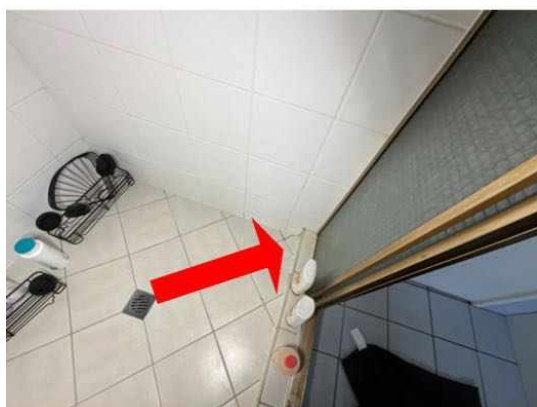
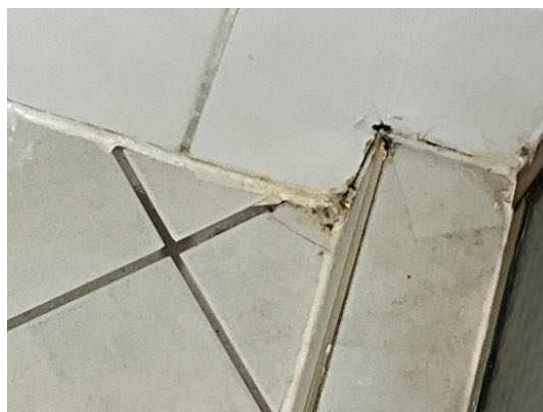
Finding 6.03

Building:	Building 1
Location:	Bathroom
Finding:	Cracked floor tiles
Information:	Cracking in the floor tiles was evident in this area at the time of inspection. It is suspected that this cracking has occurred as a result of minor settlement or impact damage.

Cracked tiles throughout the household detract from the overall appearance of the affected areas however it is unlikely to create or lead to any secondary defects.

While not considered a matter of urgency, replacement of cracked floor tiles is recommended at the clients discretion. A tiling contractor may be appointed to perform these works. Where cracks become more numerous, contact a licensed building inspector for further investigation.

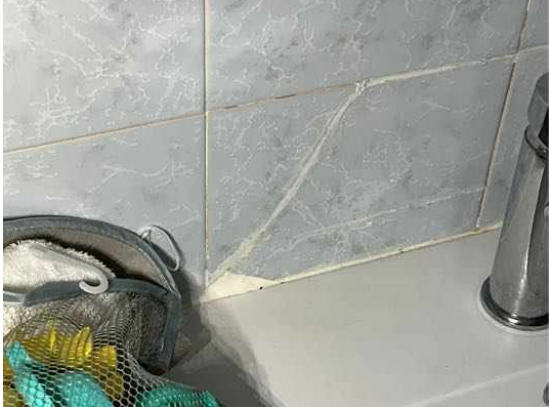
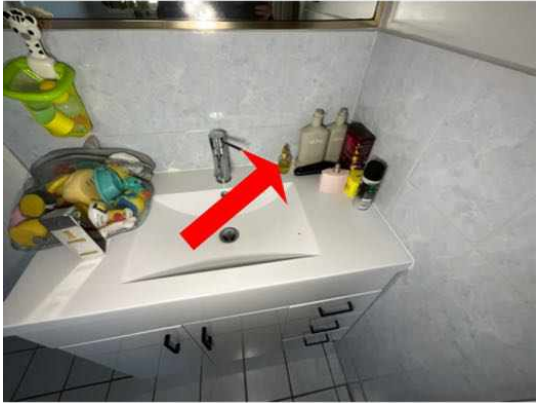
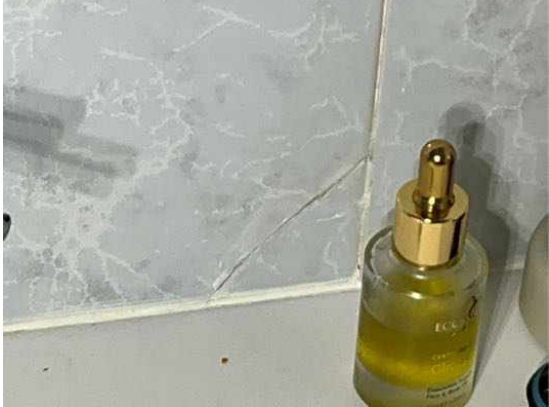
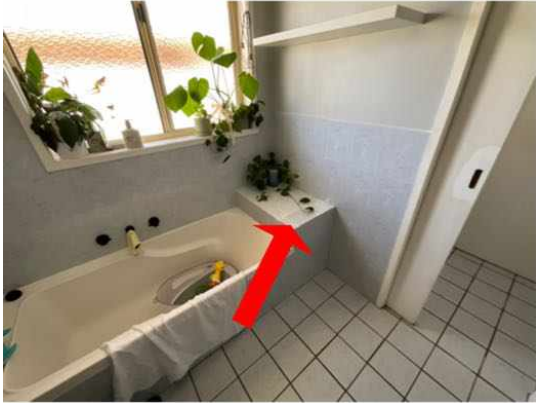
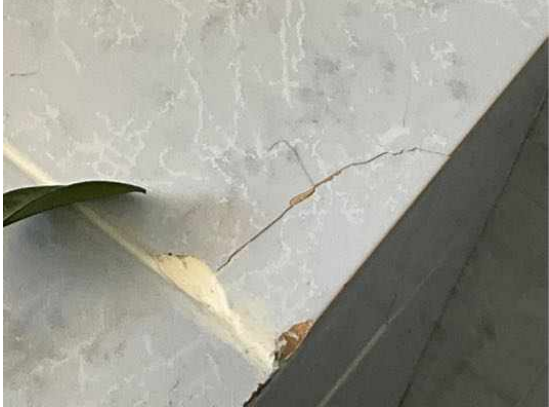
Finding 6.04

Building:	Building 1
Location:	Bathroom
Finding:	Wall Tiles- Cracked
Information:	Cracked tiles within the household detract from the overall appearance of the affected

areas, as well as creating potential for water penetration to adjoining building elements. If left unmanaged, water damage may occur as a result of constant water penetration over a prolonged period of time.

While not considered a matter of urgency, replacement of tiles is advised as a solution. A Tiling Contractor may be appointed to perform these works at client discretion.

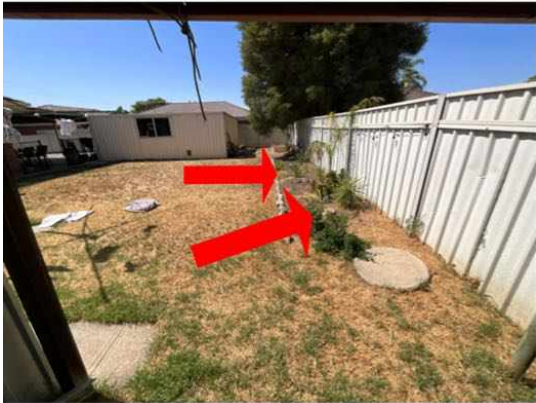
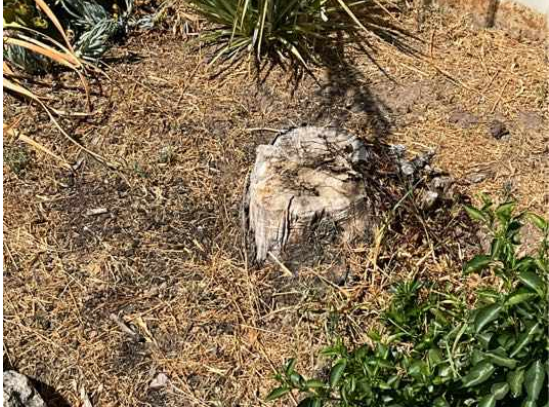
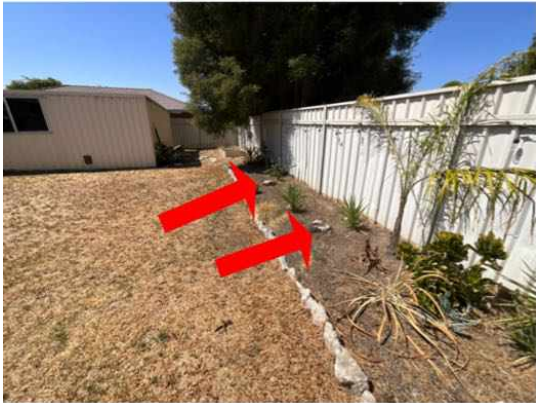
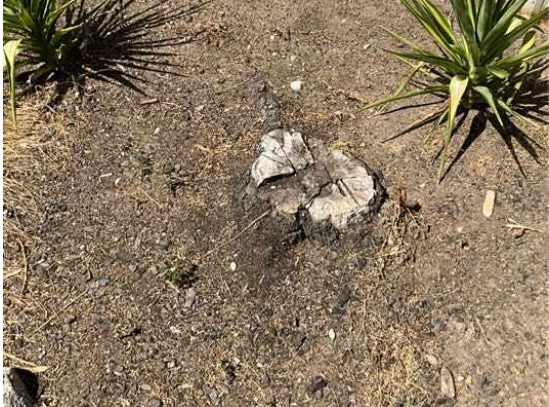
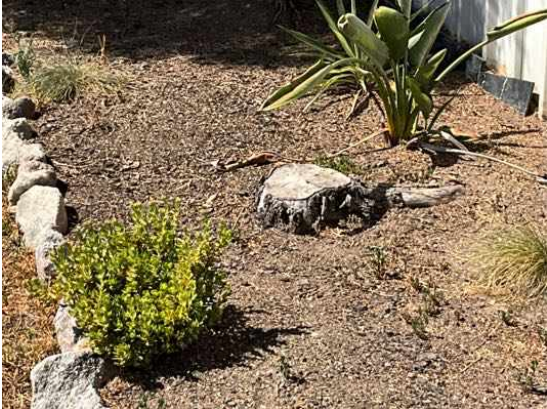
Finding 6.05

Building: Building 1
Location: Yard - Back
Finding: Tree Stump in Ground

Any tree stumps in the yard not removed during the tree removal process provides the opportunity for Termite infestation and is likely to be subject to decay from damp conditions against the stump.

All tree stumps should be removed by professional tree removal services where possible. Meanwhile regular inspections are advised to identify any termite activity in the areas identified.

Services for tree stump removal should be contacted as soon as possible to reduce the risk of timber pest attack.

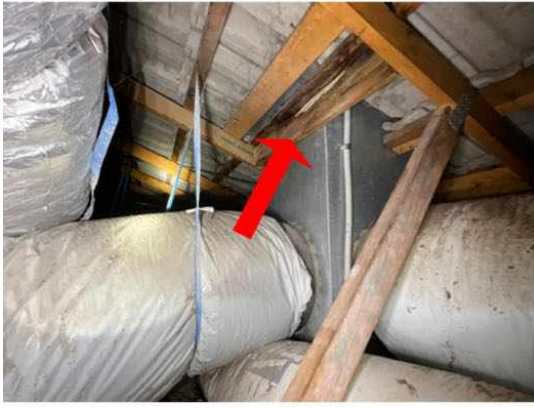
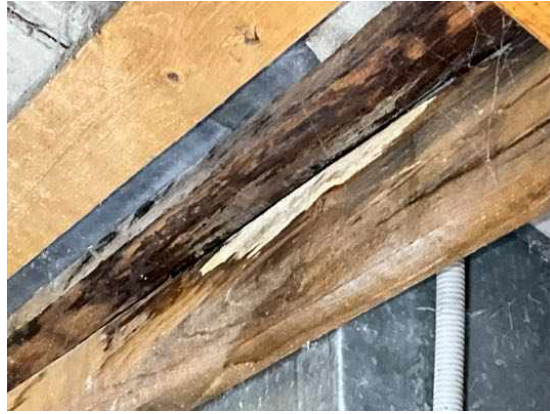
Finding 7.01

Building:	Building 1
Location:	Roof Void
Finding:	Fungal decay - present (localised)
Information:	Fungal decay also known as wood decay or wood rot generally refers to the deterioration of timber elements when in contact with excessive levels of moisture for a prolonged period of time.

The development of fungal decay is accelerated by temperatures in the range of 5degreeC to 40degreeC as well as the presence of oxygen. Generally fungal decay develops on timber elements that are in use in an external environment which are exposed to rain penetration.

In this case although the affected timber element is in a decaying state the extent of any visible damage appears to be localised to a specific area and is yet to spread to other parts of the building element or affect adjoining structures. The fungal decay is therefore likely to be of a relatively superficial nature with minimal impact on the structural integrity or tensile strength of the timber element.

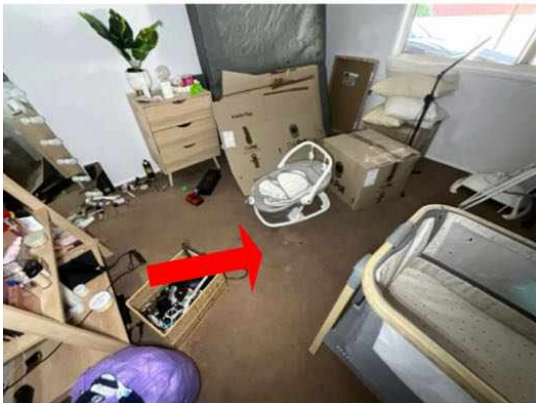
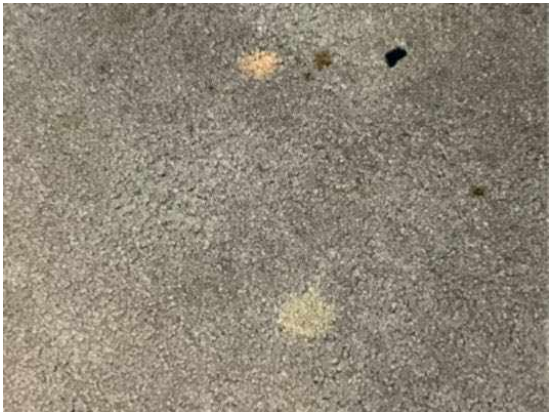
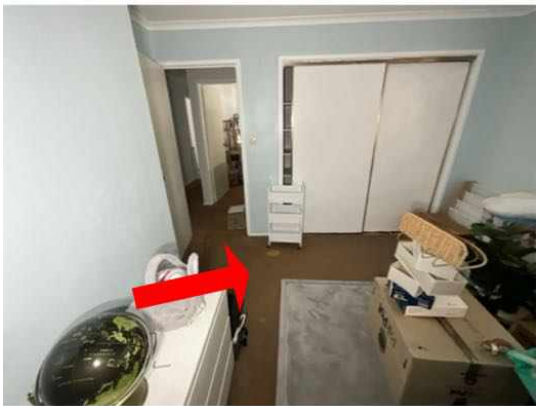
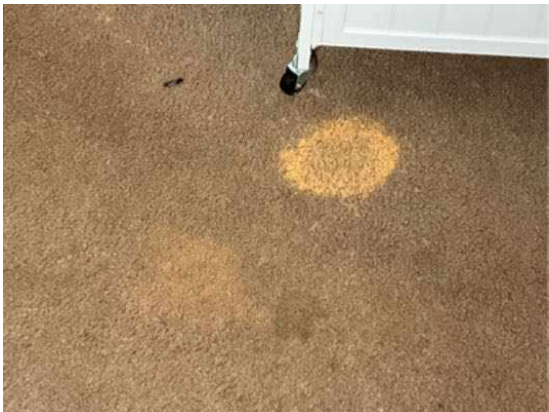
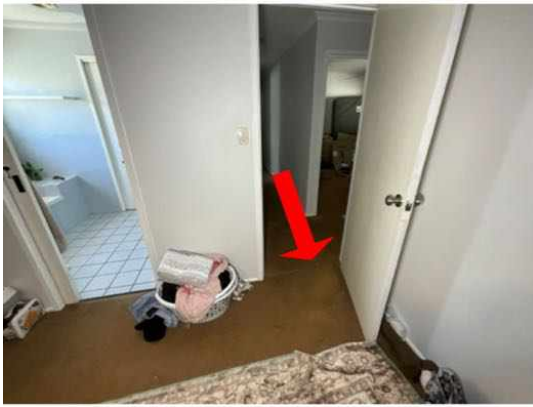
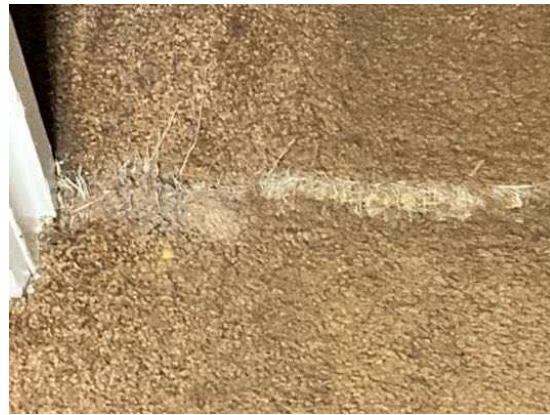
Building: Building 1
Location: Carpets
Finding: Carpet -deterioration
Information: The carpet in these areas is deteriorated. Sections can be seen to be frayed or worn.

Staining can also be seen.

A carpet specialist should be contacted at the discretion of the client to make any improvements and prevent further deterioration.

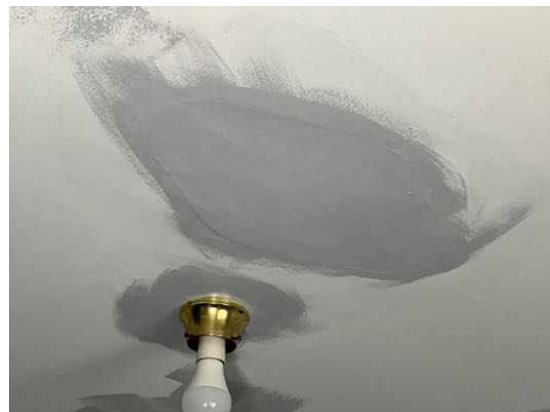
Building:	Building 1
Location:	Bathroom
Finding:	Paint finish - Incomplete
Information:	The paint finish in this area was identified as being incomplete at the time of inspection.

Whilst incomplete or missing paint finish is generally an appearance defect, it can also lead to the development of secondary building defects over time. Incomplete areas of paint finish expose the area to moisture, potentially accelerating the deterioration of underlying building materials.

Incomplete paint finishes should be sanded back, filled, leveled and painted, as applicable. Where inadequate or missing paint protection has led to the deterioration of the associated building element, repair and/or replacement of this building element may be required.

A painting contractor should be appointed as soon as possible to perform necessary works to aid the appearance of the affected area and to ensure the area is protected against further deterioration. Alternatively, the homeowner following manufacturer instructions may perform these works.

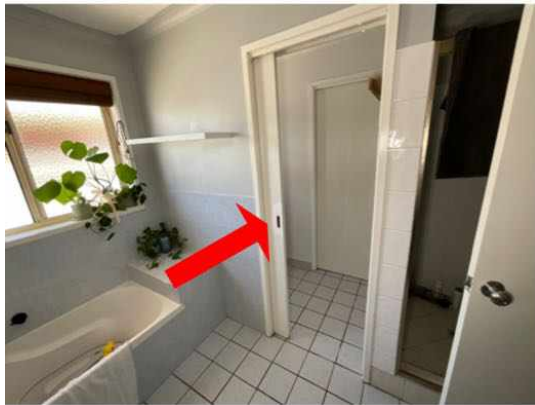
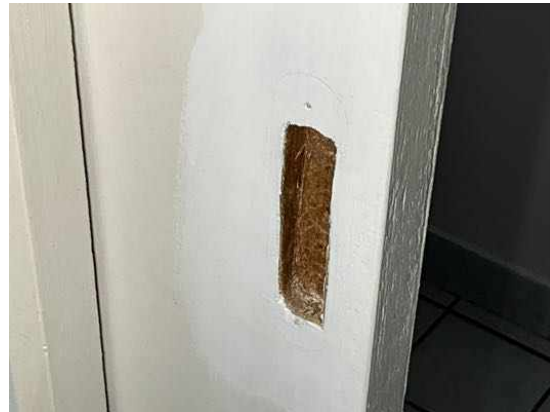
Building: Building 1
 Location: Bathroom
 Finding: Door handle - missing
 Information: During the visual inspection it was found that there are handles missing from the door. This negatively effects their operation.

A General handy person or cabinetmaker should be appointed at the discretion of the client to replace the handles and restore full operation.

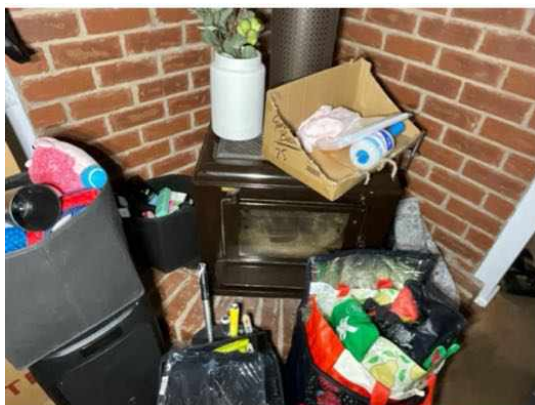
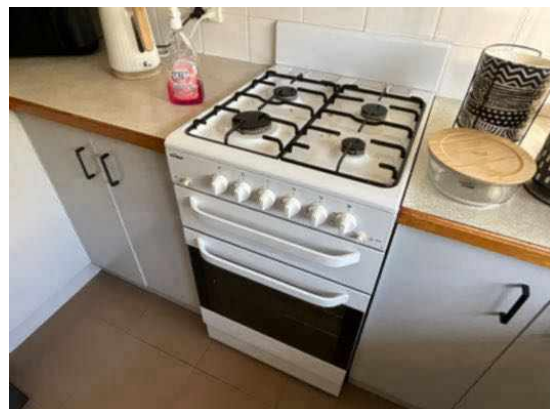
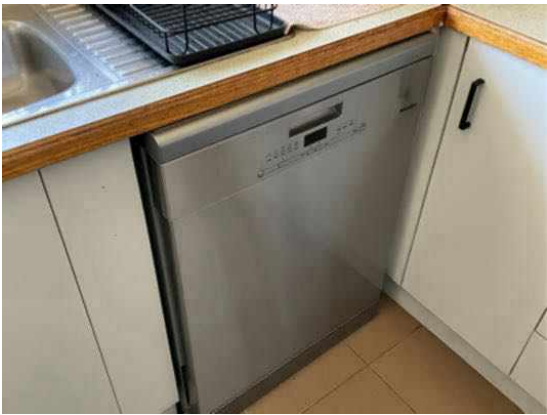
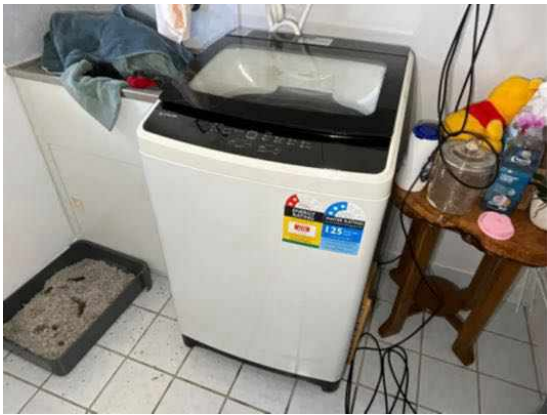
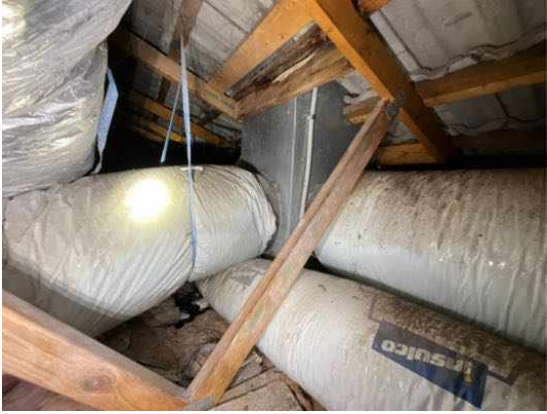
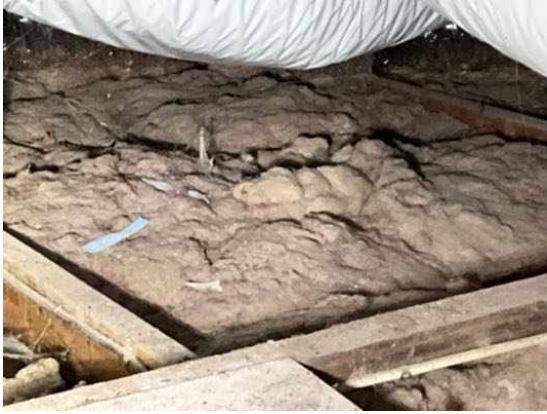
Building: Building 1
 Location: All Areas
 Finding: Additional Photos - Obstructions and Limitations
 Information: These photographs are an indication of the obstructions and limitations which impeded full inspection of the property at the time of inspection. These obstructions can hide an array of defects and should be removed to allow full inspection to be carried out. A re-inspection is recommended once the areas are made accessible.
