Building and Timber Pest Inspection Report VR

Inspection Date: Tue, 17 Feb 2026

Property Address: 8/12-16 Blaxcell St, Granville NSW 2142,
Australia

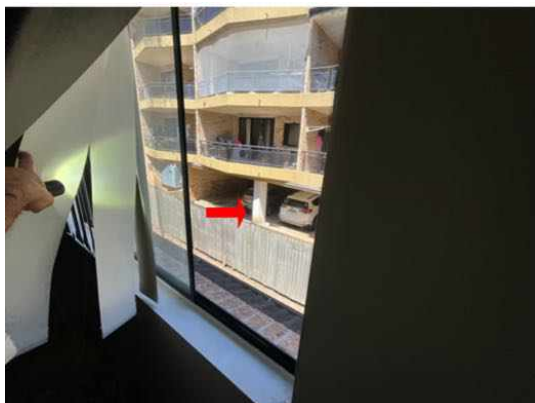
Building: Main Building
Location: Bedroom 2
Finding: Window restrictions - Missing
Information:

Window restrictors were found to be missing.

The window safety device standards can be found in clause 30 of the Strata Schemes Management Regulation 2016, and are based on National Construction Code (NCC) requirements that were introduced in 2013. The NCC requirements apply to all openable bedroom windows in residential buildings, including hotels, motels and for all windows in early childhood centres.

Windows need to be locked at 12.5cm when the devices are engaged. The safety devices must be robust and child proof. The alternative is security screens such as bars or grills on the windows so long as they have gaps no bigger than 12.5cm. Flyscreens do not comply unless they are the reinforced security type and capable of resisting the very strong outward pressure which would prevent a child falling through. The laws apply to openable windows in a building within 1700mm of the internal floor and if the internal floor is more than 2m above the ground floor outside.

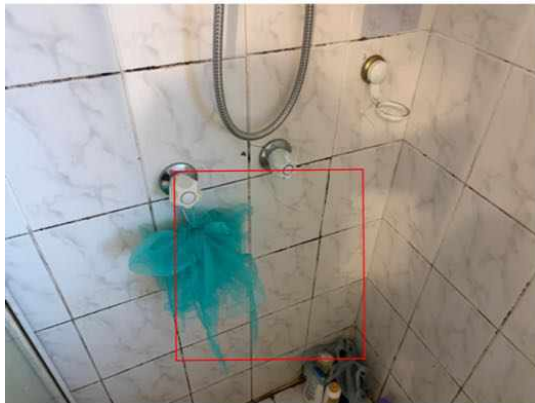
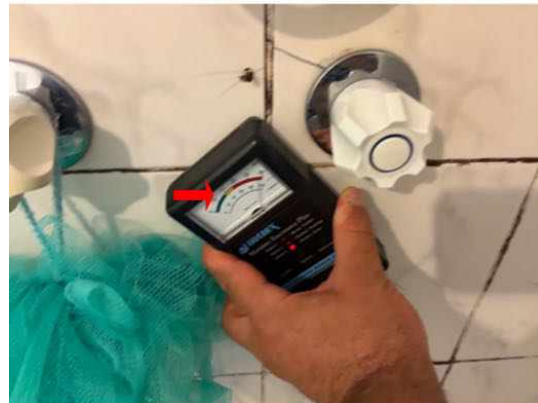
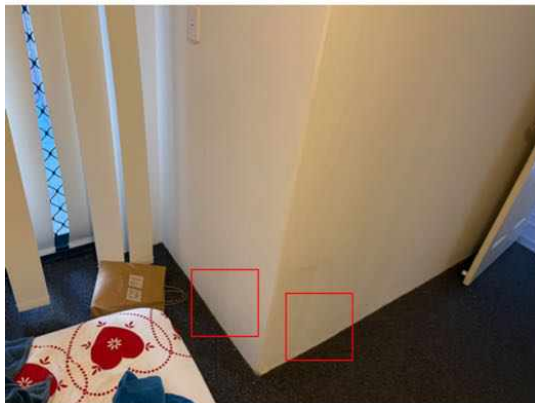
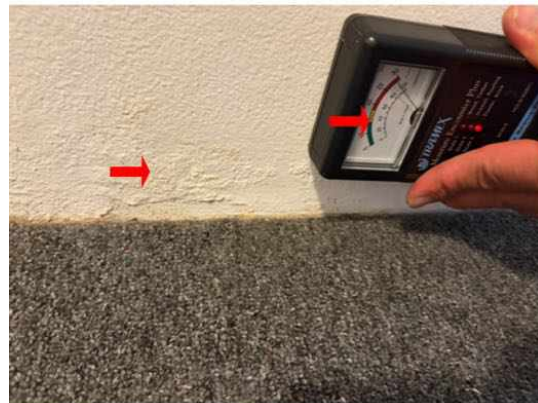
Finding 2.01

Building: Main Building
Location: Bathroom

Finding:	Waterproofing damage - Suspected
Information:	Excessive moisture was detected in these areas at the time of inspection. Internal water leaks can be detrimental to surrounding building elements. The potential cause in this area is damage to the waterproofing membrane inside the shower recess.
	Attracting termites, corrosion, mould, decay and water damage are potential outcomes where a minor water leak is left unattended. More serious defects may also result, such as electrical hazards, or water damage to structural building elements.
	In extreme cases, structural damage may develop due to a prolonged water leak. It is highly advised that this issue be addressed immediately by a bathroom specialist as a matter of relative urgency.

Waterproofing damage is suspected to the main bathroom, requiring urgent attention by a bathroom specialist. Excess moisture and water damage was identified behind the shower.

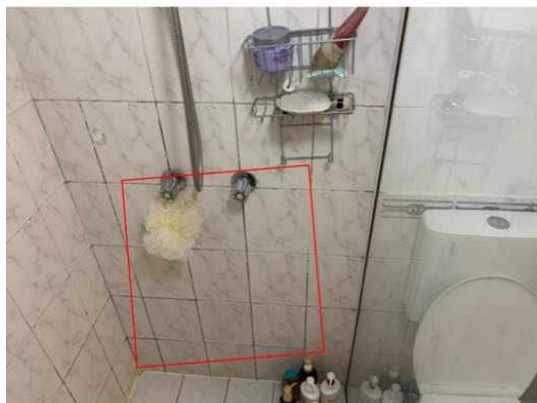
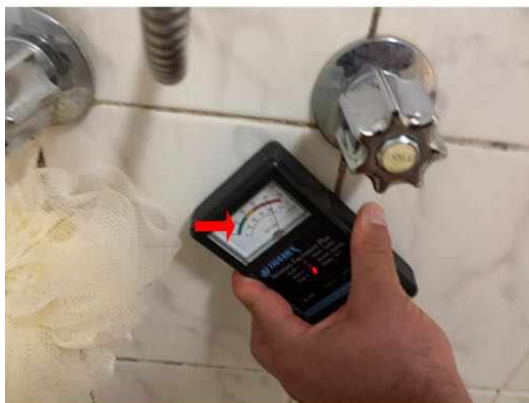
Finding 2.02

Building:	Main Building
Location:	Ensuite
Finding:	Water leak - Suspected
Information:	A water leak is suspected in this area as excessive moisture was detected at the time of inspection. Another potential cause maybe moisture ingress behind the tiles from around the wall fittings and penetrations.

Internal water leaks can be detrimental to surrounding building elements; their

potential causes include damage to plumbing fittings and fixtures, through to water damage and deterioration of associated building elements.

Attracting termites, corrosion, mould, decay and water damage are potential outcomes where a minor water leak is left unattended. More serious defects may also result, such as electrical hazards, or water damage to structural building elements.

In extreme cases, structural damage may develop due to a prolonged water leak. It is highly advised that internal water leaks be addressed by a licensed plumber as a matter of relative urgency.

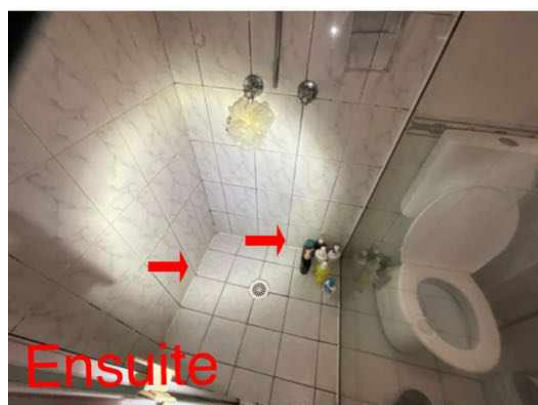
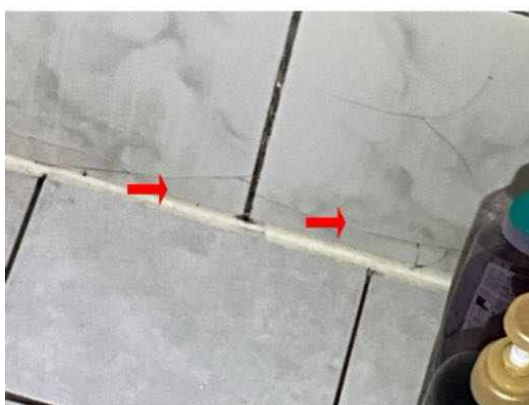
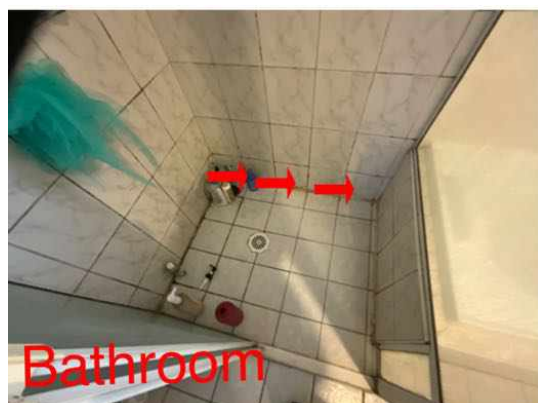
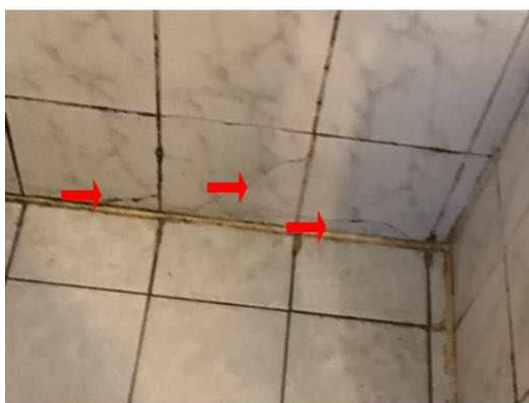
Finding 2.03

Building:	Main Building
Location:	Bathroom, ensuite
Finding:	Wet area tiles - Cracked or damaged
Information:	Cracking was evident to the tiling in this area at the time of inspection. While the cracking appears to be minor, this area is frequently exposed to water, allowing potential for water penetration into adjoining sections of walls or flooring.

If left unmanaged, water penetration to these areas may lead to subsequent water damage, which is likely necessitate repair work to affected building elements.

A bathroom specialist should be appointed to determine the integrity of the bathroom waterproofing membrane. If the membrane was found to be intact then relatively minor works to replace the cracked tiles should be carried out to ensure no further damage occurs. The re-application of silicone and grouting throughout remaining tile work is also advised, to further protect the area against water penetration.

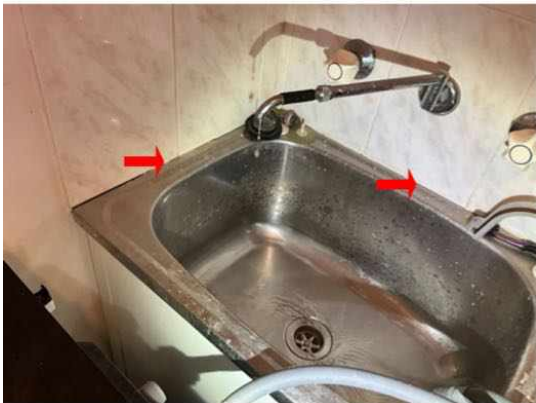
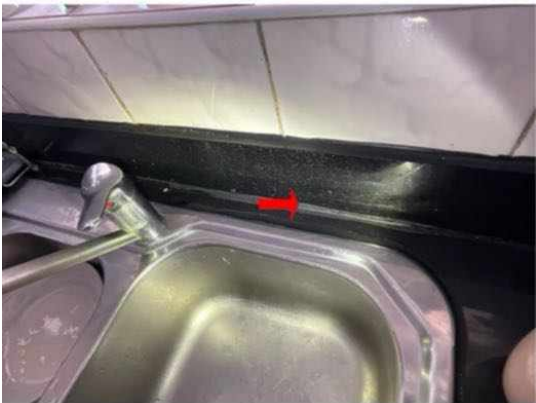
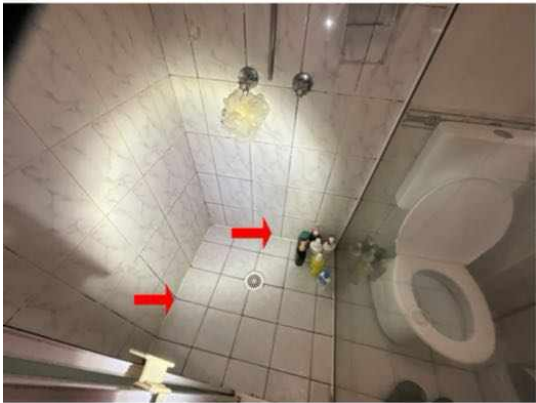
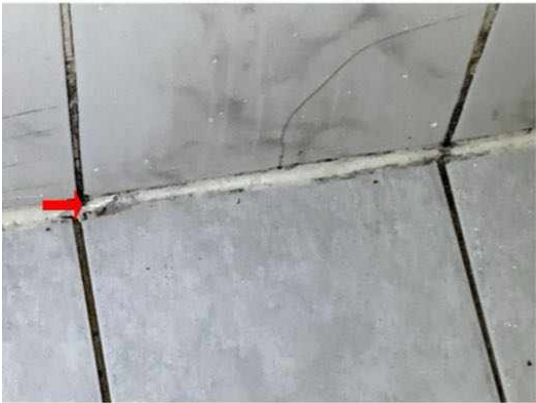
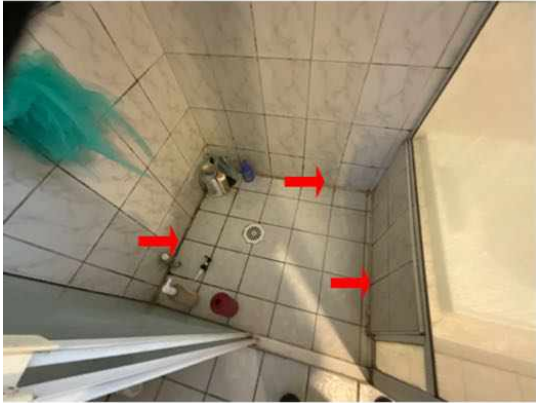
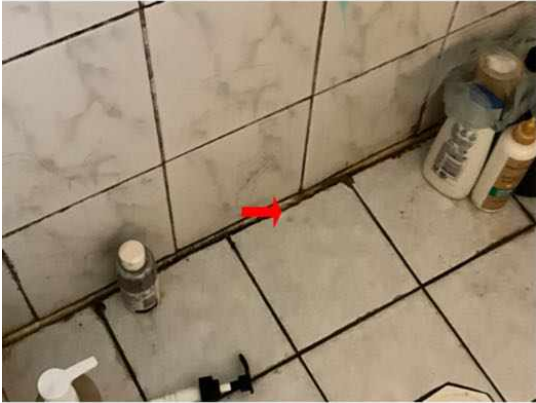
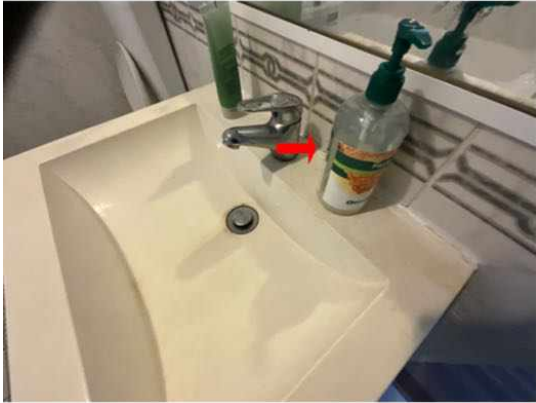
Finding 3.01

Building:	Main Building
Location:	All Wet Areas
Finding:	Sealant and grouting - Missing or damaged
Information:

It was noted on inspection that sealant or grout is degraded to this area.

Different materials and floor areas move at different rates, generally causing cracking to grout or sealant at this point. A flexible sealant is required to allow for expected expansion and contraction, while keeping the joint water tight and protective of all associated building materials.

Flexible and mould resistant materials should be applied to affected areas to prevent any subsequent water damage that is likely to occur. Regular maintenance and replacement of damage or missing or damaged sealant and grout is highly recommended to the wet areas, as this is a regular wear and tear defect. Sealant and grouting in areas that come into regular contact with water should be maintained for the long term care of your property.

A sealant specialist should be appointed to complete these works as soon as

possible.

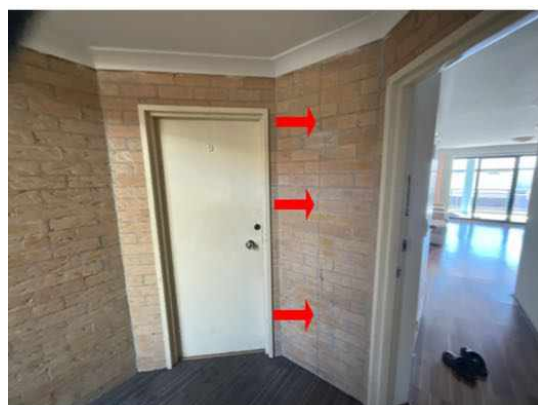
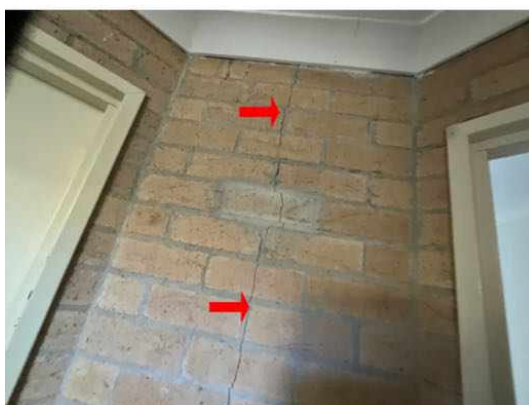
Finding 3.02

Building: Main Building
 Location: Entry
 Finding: Damage to Masonry Walls (Cracks)- Category 2
 Information: It has been observed that damage to masonry walls caused by movement of slabs, footings, or other causes, has occurred. The degree of damage falls within Category 2, described as noticeable cracks which are easily filled. Such cracking may cause doors and/or windows to stick slightly, and are generally less than 5mm in width.

Damage of this category is required to be monitored for a period of 12 months, after which time a crack rated at Category 2 or above is considered a defect requiring rectification, such as minor repairs and repointing. Always contact your building inspector should cracks widen, lengthen, or grow more numerous.

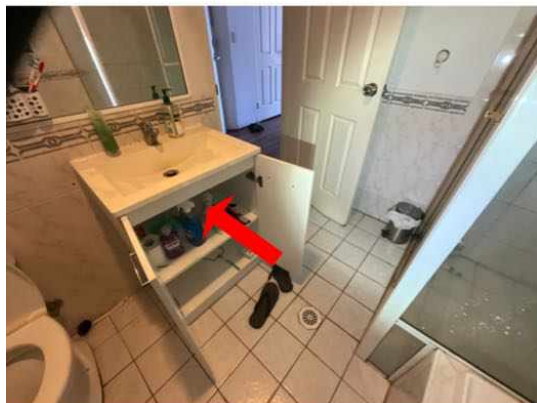
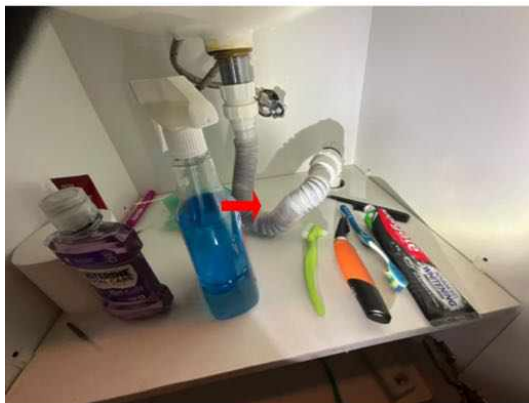
Finding 3.03

Building: Main Building
 Location: Bathroom
 Finding: Plumbing traps -- Non Compliant AS 2887
 Information: The plumbing trap in this area appears not to be installed to the current Australian standards at the time of inspection. It must be removed and replaced to comply with AS 2887 urgently by a licensed plumber to avoid any failure or secondary defects.

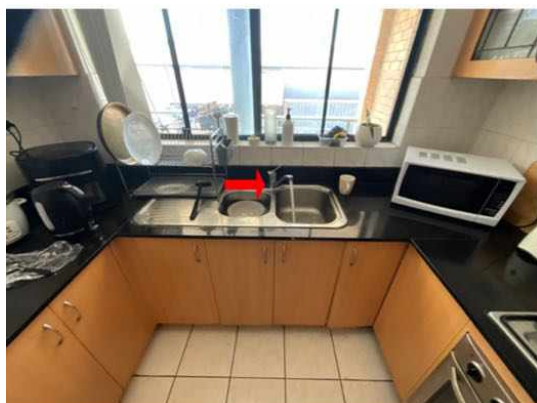
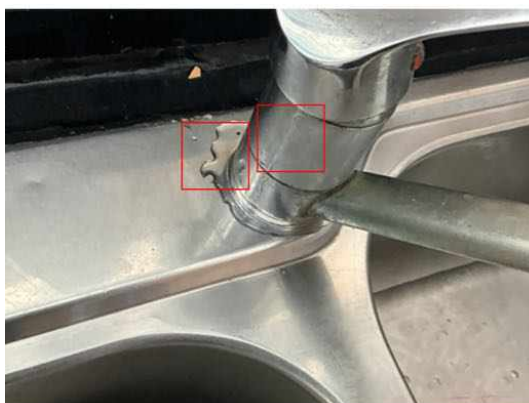
Finding 3.04

Finding: Tap - Leaking

Information: The tap in this area was found to be leaking at the time of inspection. This is a common defect that is consistent with general ageing of the building element. However, it may be indicative of substandard plumbing workmanship if the tap is relatively new.

While this defect only seems minor, if left unmanaged, it is likely to result in the development of rust, water damage and/or extensive water usage.

It is advised that a handyman or licensed plumber be appointed to perform remedial works on the affected tap. Such works should be performed prior to the development of secondary defects to ensure adequate functionality of all associated building elements.

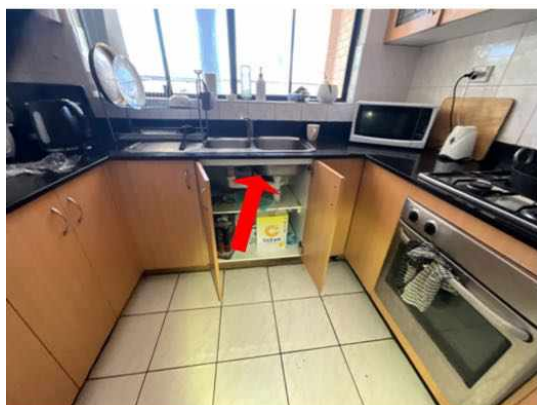
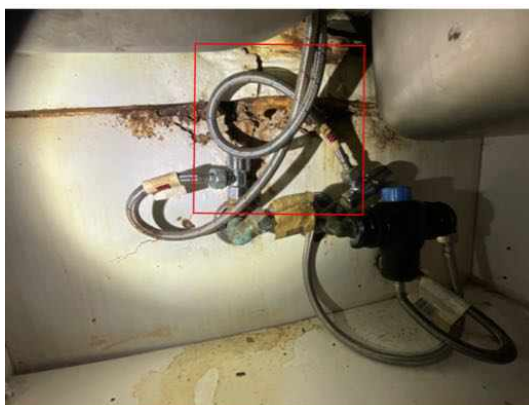
Finding 3.05

Information: Swollen building elements generally indicate that the building materials have been affected by excessive moisture over a prolonged period of time, and have swollen as a result. The formation and development of mould/fungi or mildew is also a likely consequence of excessive moisture.

The structural integrity of swollen building elements can not be guaranteed, and further damage is likely to develop if left unmanaged. Excessive moisture is likely to lead to the development of secondary damage to any associated building elements, which may necessitate major repair works if prolonged.

Rectification of the cause of the water leak should be addressed prior to any remedial works to the swollen building elements. A licensed plumber should be appointed immediately to identify the cause of the leak and provide advice on remedial works as necessary, Repair and/or replacement of swollen building elements should be conducted by a licensed cabinetmaker.

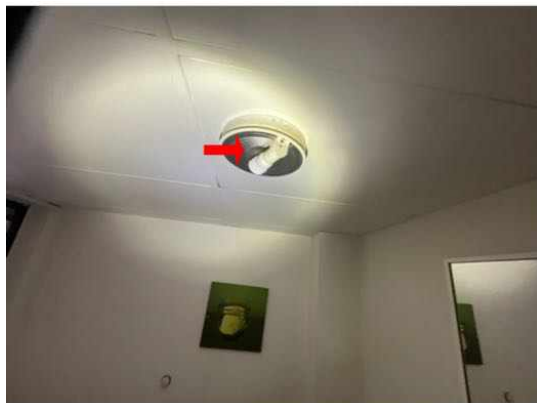
Finding 3.06

Building: Main Building
 Location: Bathroom
 Finding: Light cover - Missing (Cosmetic)
 Information: The light cover in this area was found to be missing at the time of inspection. Breakage occurs generally when the building materials have aged and decayed, but may also be indicative of impact damage to the building element (accidental or deliberate). This is mainly a cosmetic defect which can be replaced by the home owner.

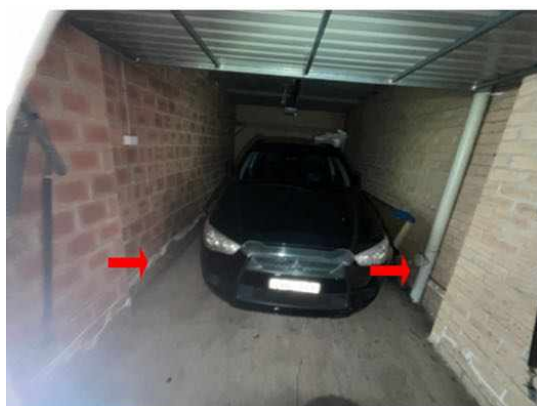
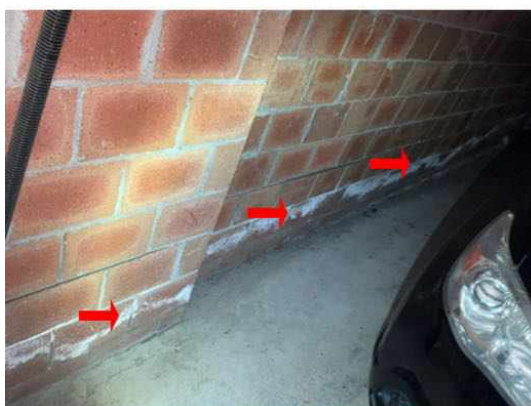
Finding 3.07

Building:	Main Building
Location:	Garage
Finding:	Brickwork - Efflorescence
Information:	Efflorescence appears to be affecting the brickwork, concrete or tiles in this area. Efflorescence typically occurs when excess salts within the concrete or cement mortar is leached to the surface due to water transfer.

It is typically seen as white salt deposits on the surfaces of concrete pavement or mortar between bricks or tiles. While detracting from the overall appearance of the affected area, efflorescence is not likely to develop into secondary damage if left unmanaged.

Generally, soluble salt deposits can be removed by dry brushing with a stiff-bristled brush. Repeated dry brushing is an ideal treatment for eliminating this forming of efflorescence. A cleaning contractor or general handyperson may be appointed to perform these works at the discretion of the client.

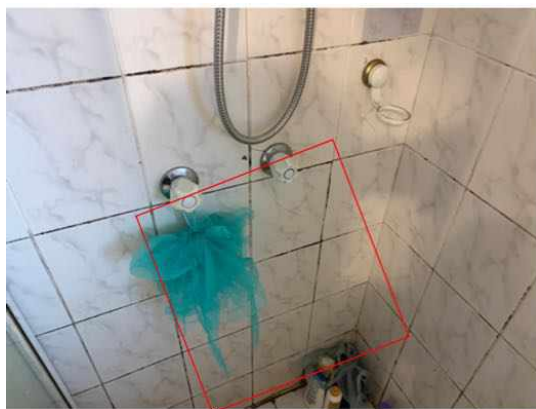
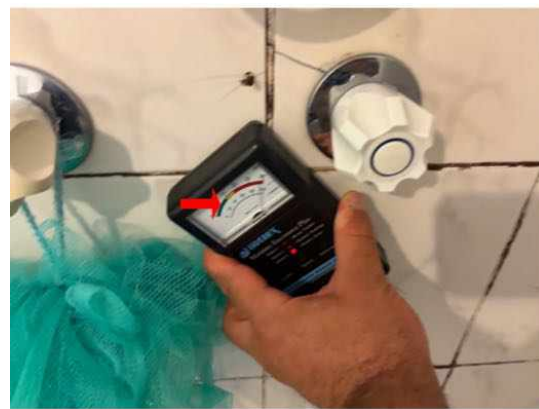
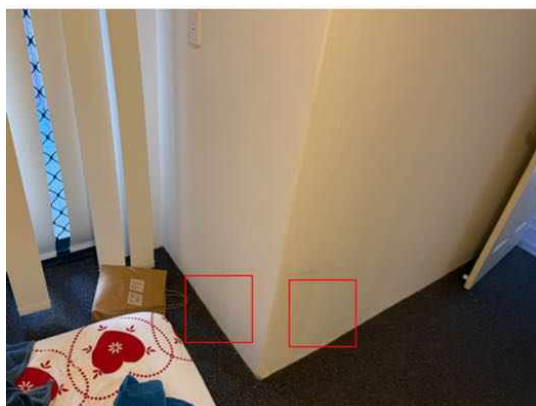
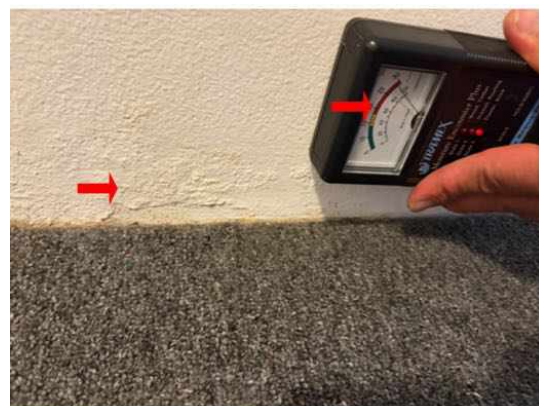
Building: Main Building
 Location: Bathroom
 Finding: Waterproofing damage - Suspected
 Information: Excessive moisture was detected in these areas at the time of inspection. Internal water leaks can be detrimental to surrounding building elements. The potential cause in this area is damage to the waterproofing membrane inside the shower recess.

Attracting termites, corrosion, mould, decay and water damage are potential outcomes where a minor water leak is left unattended. More serious defects may also result, such as electrical hazards, or water damage to structural building elements.

In extreme cases, structural damage may develop due to a prolonged water leak. It is highly advised that this issue be addressed immediately by a bathroom specialist as a matter of relative urgency.

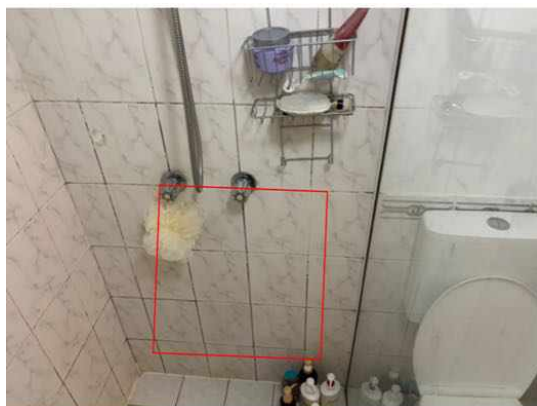
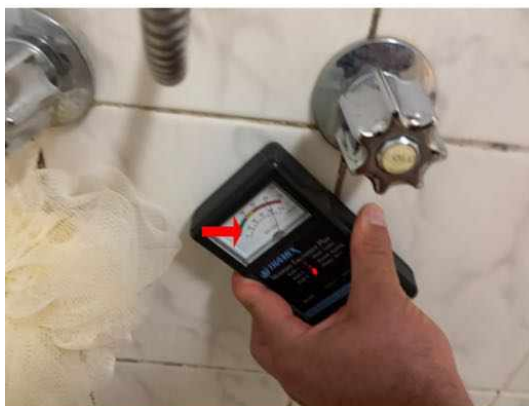
Finding 6.02

Building:	Main Building
Location:	Ensuite
Finding:	Water leak - Suspected
Information:	A water leak is suspected in this area as excessive moisture was detected at the time of inspection. Another potential cause maybe moisture ingress behind the tiles from around the wall fittings and penetrations.

Internal water leaks can be detrimental to surrounding building elements; their potential causes include damage to plumbing fittings and fixtures, through to water damage and deterioration of associated building elements.

Attracting termites, corrosion, mould, decay and water damage are potential outcomes where a minor water leak is left unattended. More serious defects may also result, such as electrical hazards, or water damage to structural building elements.

In extreme cases, structural damage may develop due to a prolonged water leak. It is highly advised that internal water leaks be addressed by a licensed plumber as a matter of relative urgency.
