Building and Timber Pest Inspection Report

Inspection Date: Mon, 8 Dec 2025

Property Address: 19 Mariana Ave, Croydon South VIC 3136,
Australia

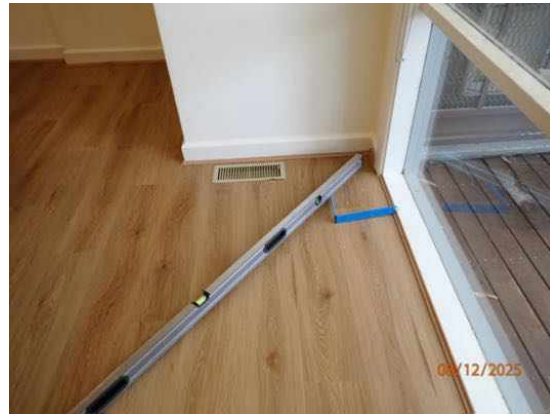
Building: Main Building
Location: Kitchen and dining
Finding: Subsidence - stumps
Information: Significant subfloor movement was noted during the inspection, consistent with foundation movement such as sinking or subsidence. While some settlement over time is expected, the degree of movement observed in this property requires attention and is classified as a major defect.

The property is supported on timber stumps, and the condition of these stumps below ground cannot be assessed within the scope of this inspection. However, deterioration of some stumps is suspected due to secondary signs such as uneven flooring and observable settlement. Even in the absence of visible secondary defects, deteriorated timber stumps may still be present, as timber is prone to decay and long-term breakdown.

Ongoing subfloor movement or failing stumps can lead to structural instability, further subsidence, and damage to other building elements if left unmanaged.

It is recommended to engage a structural engineer to assess the extent of movement and determine the required rectification works. A registered builder specialising in re-stumping should also be appointed to conduct a more invasive inspection of the stumps and soil conditions and provide quotations for required repairs based on the engineer's advice.

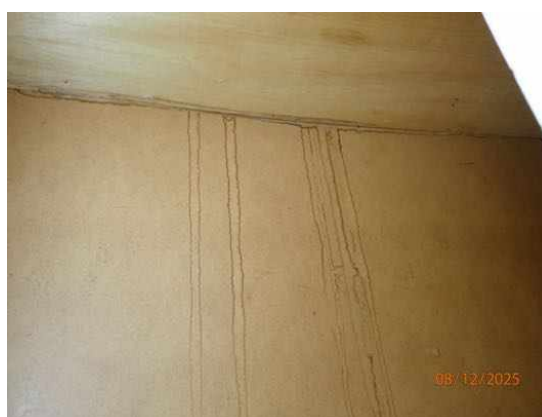
Finding 3.01

Building: Main Building
Location: Bedroom 1
Finding: Wardrobe - Water staining
Information: Water staining was evident in this area at the time of inspection. No moisture ducted during inspection.

Water staining indicates that surfaces have been exposed to excessive moisture over

time. The minerals and other elements in the water lead to staining, which may graduate to corrosion and deterioration if left unmanaged.

While mostly an appearance defect, water staining can be indicative of more serious defects, which may be currently concealed by other building elements.

Where water staining is active, a licensed plumber must be consulted to identify the cause of the staining and to provide advice on any reparation works that may be required. Replacement of any broken or damaged structures is advised.

Conversely, where water staining is old and inactive, affected building materials may be repaired or replaced at client discretion. A qualified carpenter or registered builder may be appointed to perform these works.

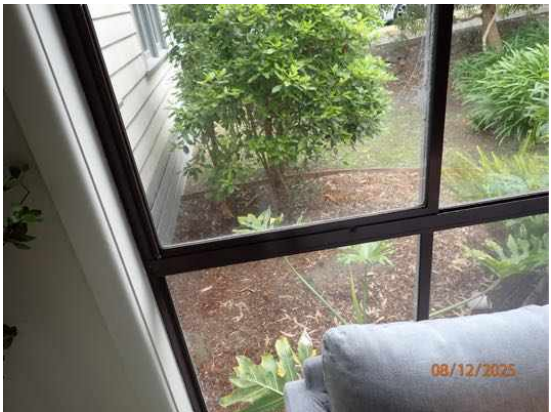
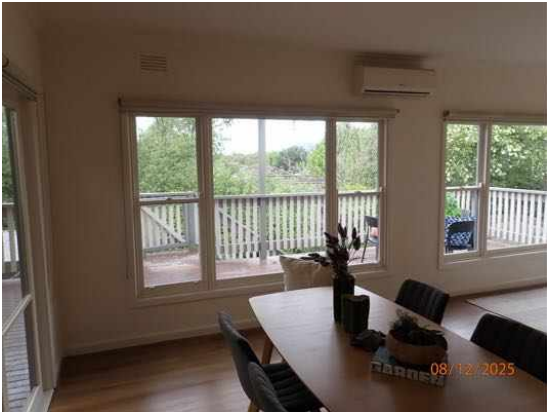
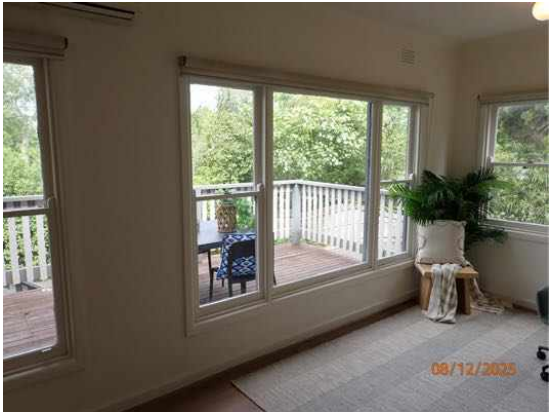
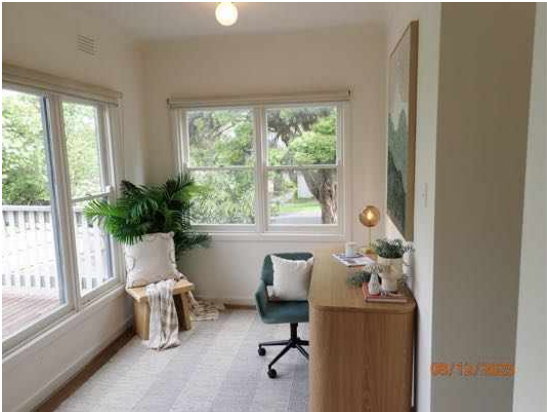
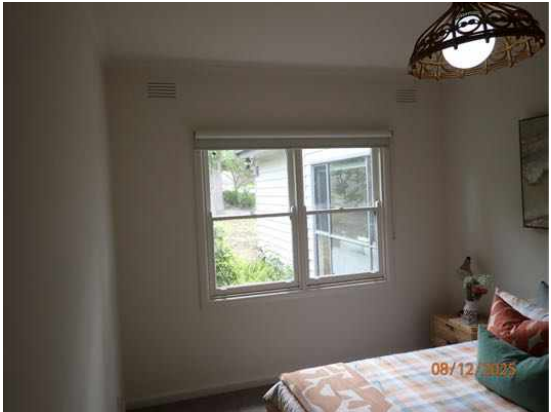
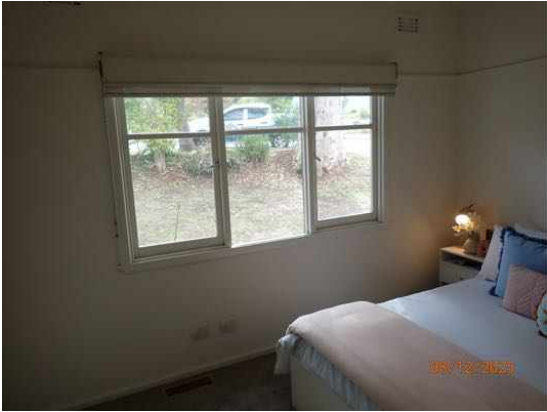
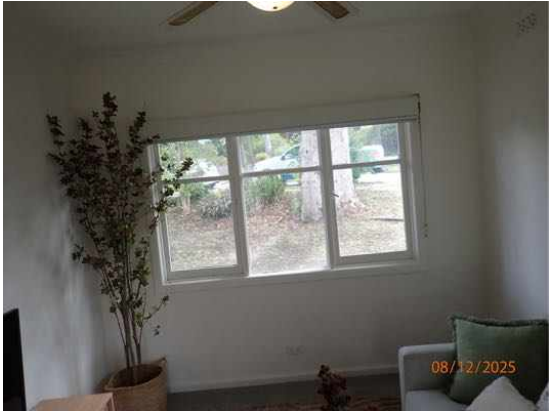
Finding 3.02

Building:	Main Building
Location:	All Internal Areas
Finding:	Window - jammed
Information:	The window in this area was jammed and difficult to operate at the time of the inspection. Windows provide ventilation to the adjoining area and should be at a fully operational level to ensure user comfort. Restricted function of the window may also pose as a potential safety hazard if required for emergency egress from the building.

Generally, factors such as general age of the building element and a lack of maintenance are the usual causes for this type of defect.

Replacement of window hardware or frame may be required, as well as minor repairs and cleaning. A registered builder or general handy person will be required to repair the window.

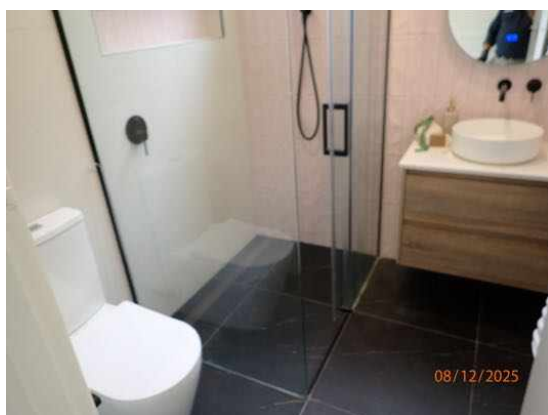
Building:	Main Building
Location:	Bathroom
Finding:	Sealant and grouting - Missing or damaged
Information:	During inspection, degradation of the sealant or grout was noted in the tiled shower alcove.

Differential movement between materials and floor areas can lead to cracking of grout or sealant, compromising the water tightness of the joint. This deterioration increases the risk of water penetration and subsequent damage to associated building materials.

To prevent further water damage, flexible and mould-resistant materials should be applied to the affected areas. Regular maintenance and replacement of damaged sealant and grout are essential to ensure long-term protection of wet areas. Prompt engagement of a sealant specialist or tiling contractor is advised to address this defect

and prevent potential structural issues in the future.

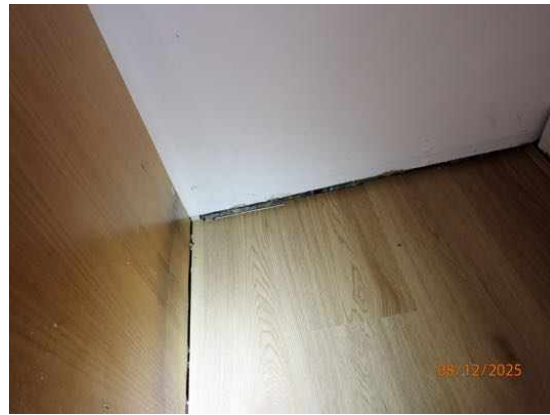
Finding 3.05

Building:	Main Building
Location:	Laundry
Finding:	Floor Skirting - Gaps to edges
Information:	Considerable gaps were noted around the edges of the flooring in this area. Beading is typically used to cover such gaps and provide a finished appearance while preventing drafts.

These gaps are suspected to have developed due to foundation movement or subsidence affecting the flooring over time. It is recommended that the gaps be filled with coloured caulking or covered with beading to restore appearance and maintain a draft-free environment.

A qualified carpenter or general handyperson should carry out the remedial works at the client's discretion. Prompt attention will help maintain both the functionality and visual appeal of the flooring. ealing.

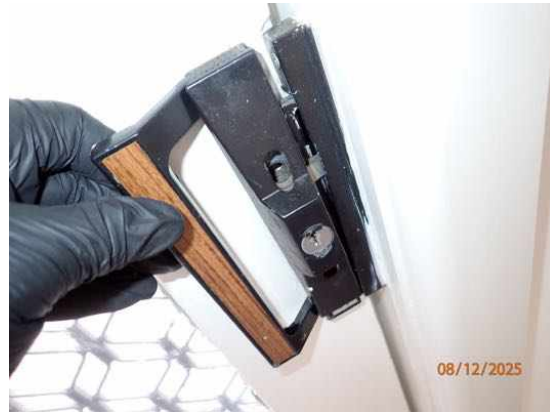
Building: Main Building
 Location: Rumpus Room
 Finding: Door need maintenance
 Information: The external sliding door to the backyard was noted difficult to slide during the inspection, and the door handle was found to be loosely attached. This affects the proper operation of the door and may result in further damage to the door frame or handle if left unattended.

It is recommended to engage a qualified carpenter or handyperson to adjust the sliding mechanism and securely fix the handle to restore smooth and safe operation.

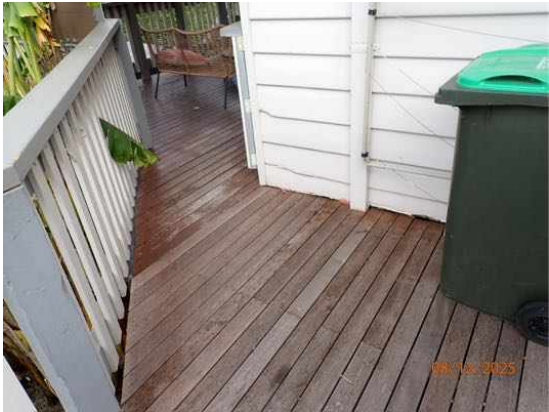
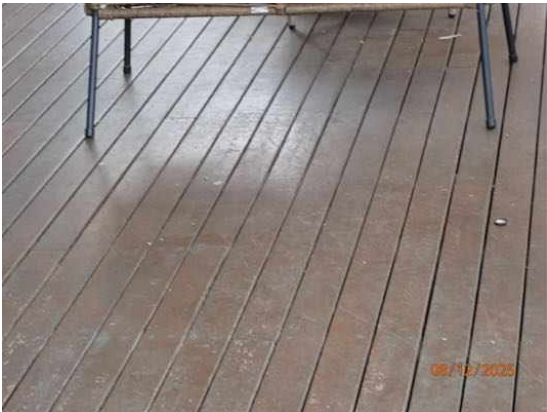
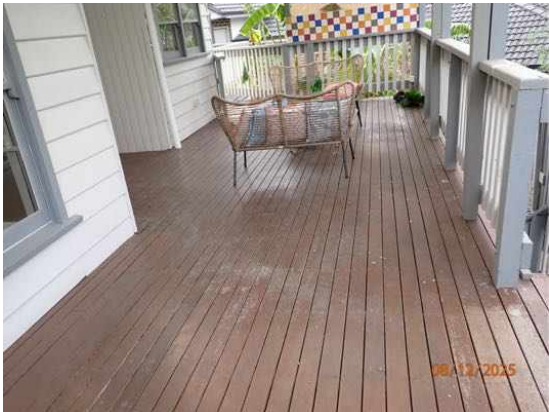
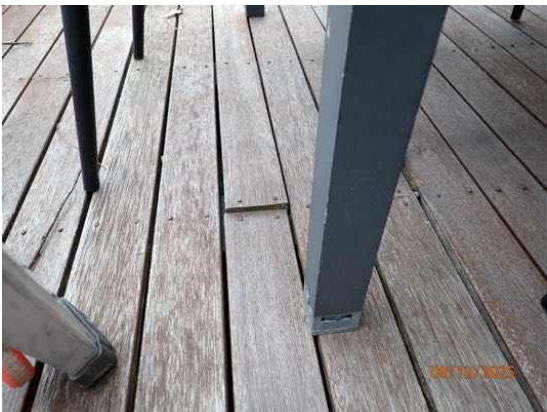
coming loose from the joists that they are installed on. Bouncy flooring may also be the result of gaps between flooring and stumps or joist structures, which require packing.

The client is advised to seek quotations for required repairs from a qualified carpenter. The potential resolution may range from packing gaps in subfloor structures through to replacement of subfloors structure and refixing of flooring.

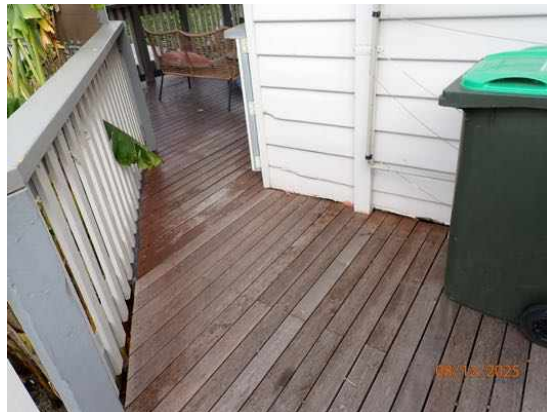
Finding 3.14

Building: Main Building
Location: Exterior walls - rear
Finding: Deck uneven and Un supported

It is highly recommended to engage a registered builder to assess the structure and carry out necessary rectification works to ensure the deck is properly supported and compliant with current building standards.

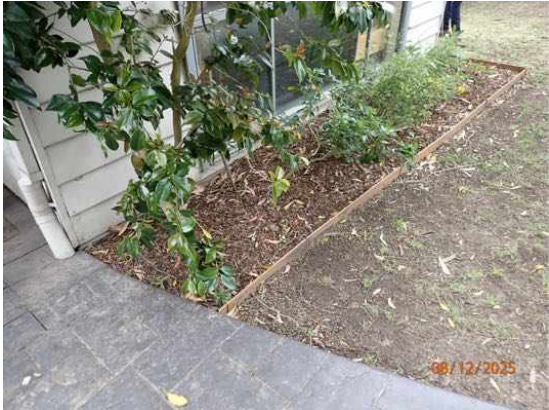
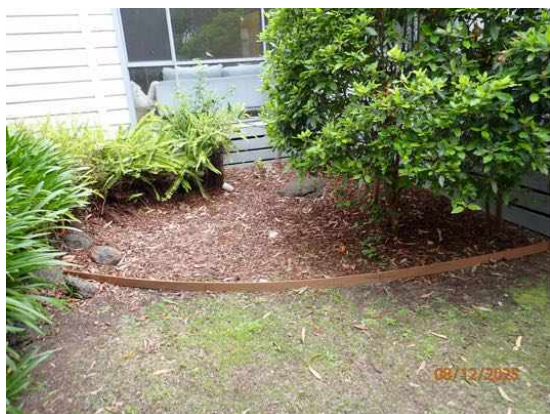
Finding 6.02

Building: Main Building
 Location: All External Areas
 Finding: Garden Beds - Conditions Conducive to Termites
 Information: Garden beds were found to be evident abutting the external walls of the property. These garden beds can include untreated timber, and with a combination of moisture from watering hosing can make conditions conducive to termite activity and termite ingress.

It is recommended that the property owner be vigilant in reducing conducive conditions around the property where possible. If conducive conditions are present and not removable periodically inspections should be conducted by a licensed pest controller.

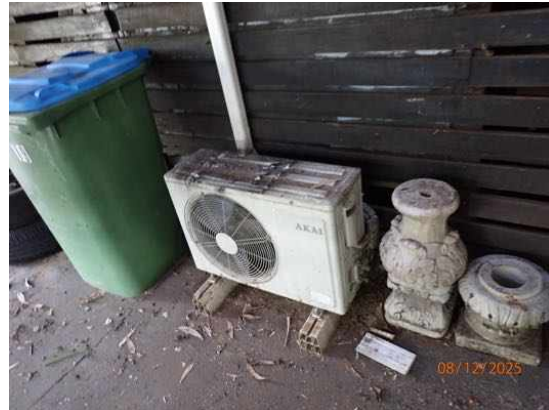
has resulted in the surrounding area becoming excessively damp. These damp conditions can lead to secondary defects such as rot, rust or corrosion of associated building elements, the formation of fungal decay, or even the creation of potential slip hazards. When coupled with poor site drainage, pooling of water may also attract termite activity to this area. It is highly recommended that a qualified plumber be appointed to install adequate drainage to the overflow. These works will ensure that the area remains dry and free of any secondary defects.

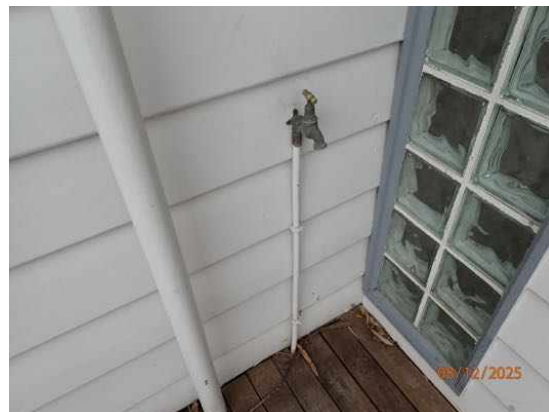
Finding 6.05

Building: Main Building
 Location: All External Areas
 Finding: Tap - No Drain
 Information: It was found at the time of inspection the tap at this section of the property have no drain or basin below them. This can cause excess water next to the foundation of the property and can also attract termites.

A licensed plumber should be engaged for rectification as soon as possible.

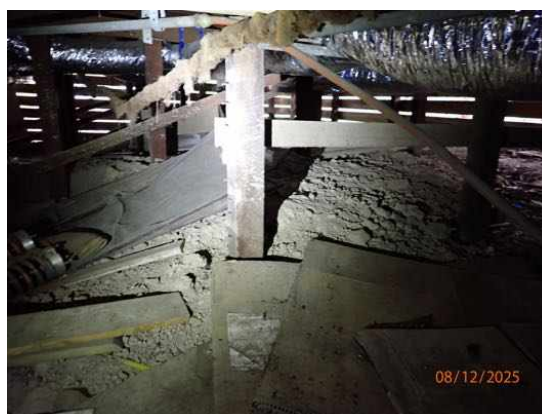
Finding 6.06

Building: Main Building
 Location: Subfloor

Immediate action is necessary to mitigate the risk of termite infestation and structural damage. The property owner should be proactive in reducing conducive conditions by removing any timber materials in direct contact with the ground and addressing moisture issues. Periodic inspections by a licensed pest controller are essential to monitor and address any potential termite activity. Treatment should be administered promptly to protect the property from further damage. Engaging a registered builder or pest control expert specializing in timber pest management is advised to assess the extent of the risk and implement necessary preventive measures. Timely intervention is crucial to safeguard the property against termite infestation and preserve its structural integrity.

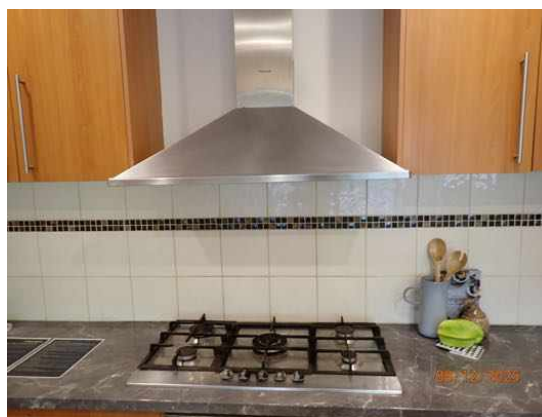
While checking appliances is not part of the inspection, it is noted here for your reference. It is recommended to replace the light bulb or consult a licensed electrician if further issues are suspected.

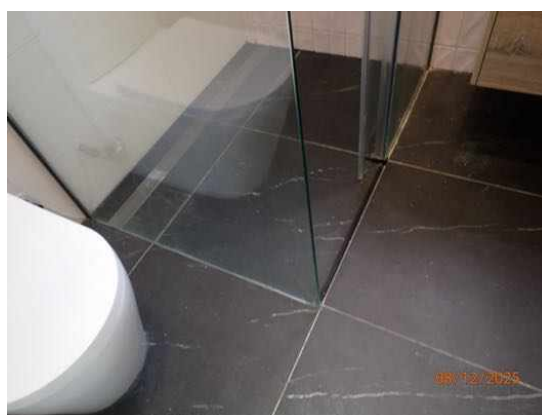
This observation is noted for your reference. Depending on the time the house was built, current regulations may not have been applicable. However, it is recommended to further investigate the waterproofing system of the shower areas to ensure they meet appropriate standards and to address any deficiencies promptly to prevent water damage issues in the future. If necessary, consulting a qualified building inspector or waterproofing specialist for an assessment and potential remediation is advised.

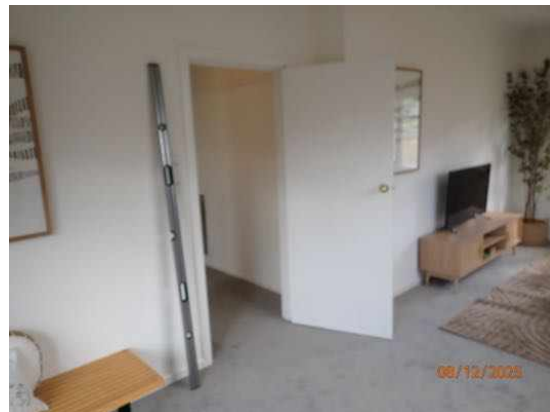
Building:	Main Building
Location:	Bedroom 3
Finding:	Door Handle - loose
Information:	During inspection, the door handle in this area was found to be loose, indicating potential age-related decay or impact damage.

It is recommended to engage a qualified carpenter or general handyperson to perform repairs and restore proper operation, preventing further damage.

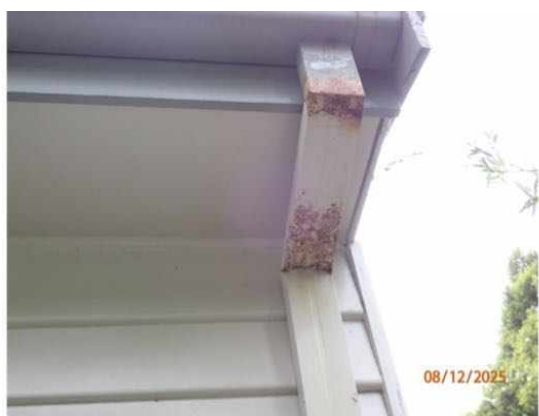
Building: Main Building
 Location: Exterior walls - front
 Finding: External wall - Gaps
 Information: Considerable gaps were noticeable in the weatherboard installation in this part of the house, allowing water to enter the cavity. These gaps make the adjoining building elements prone to water penetration, creating potential for the development of secondary damage.

Rusting and corrosion should be managed by ideally removing or limiting the affected surface from exposure to moisture. A registered builder may be appointed to replace any building elements that have been severely affected by rust or water damage.

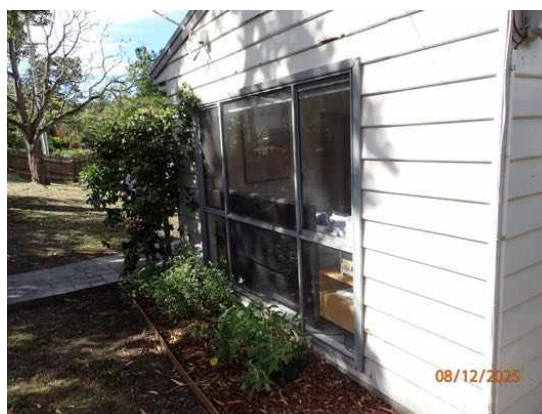
Building: Main Building
 Location: Exterior walls - rear
 Finding: Fence - Deteriorated
 Information: During the inspection, it was noted that this section of the fencing has deteriorated, likely due to age, weather exposure, or possible inadequate installation or maintenance.

It is recommended that all deteriorated window seals be replaced by a general handyman or sealant expert to prevent any further damage and to restore the window to a fully functional level.

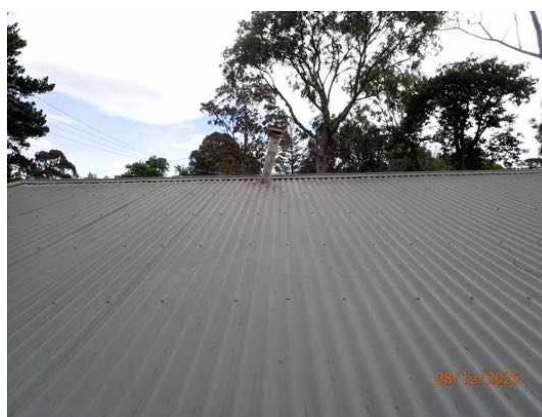
Building: Main Building
 Location: Roof Exterior
 Finding: Flue install substandard
 Information: The installation of the flue through the roof in this section was noted to be

It is recommended to engage a licensed roof plumber to assess the installation and carry out necessary rectification works to ensure the flue and flashing are weatherproof and compliant.
