Building and Timber Pest Inspection Report

Inspection Date: Wed, 28 Jan 2026

Property Address: 188 Bernhardt St, East Albury NSW 2640,
Australia

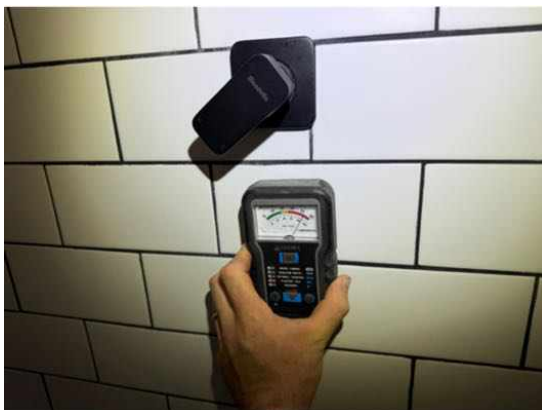
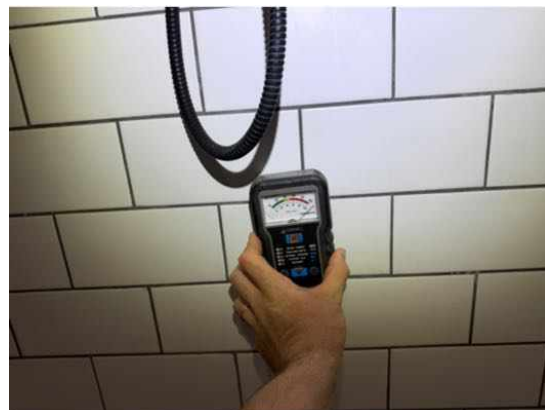
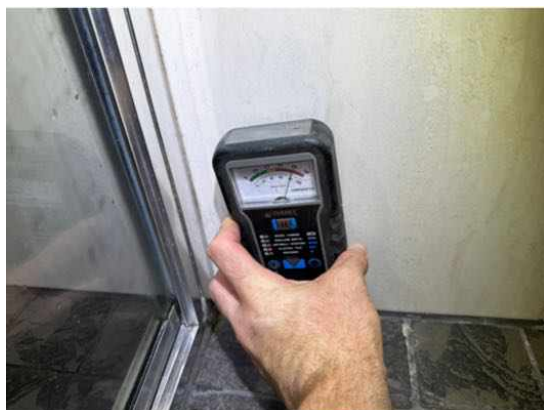
Finding 3.01

Building: Main Building
Location: Ensuite Shower & Main Shower
Finding: Showers - High Moisture
Information: It appears that high moisture is present at but not limited to, below the ensuite shower taps, & at the base of the shower walls. Potential causes of leaking include but are not limited to loose or damaged plumbing fittings and fixtures, and/or deteriorated seals or waterproofing.

Areas of leaking and high moisture create an environment conducive to termite activity & water damage to surrounding materials.

Recommend engaging a licensed plumber and/or tiling contractor promptly, to provide remedial works, to avoid further damage.

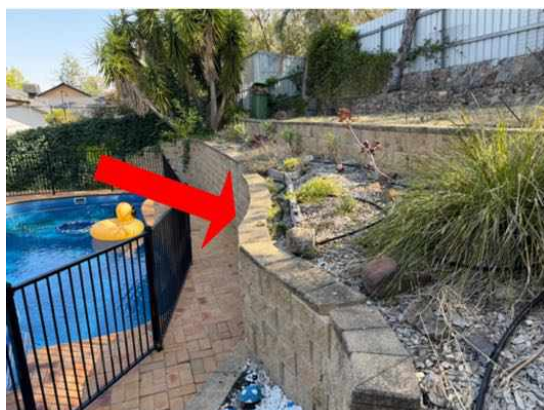
Finding 3.02

Building:	Main Building
Location:	Rear of property
Finding:	Retaining Wall - Leaning
Information:	It appears that the rear retaining wall was leaning at the time of inspection. It is recommended that the client monitor the retaining wall. Should further movement occur, a structural engineer should be engaged promptly, to provide further advice & remedial works.

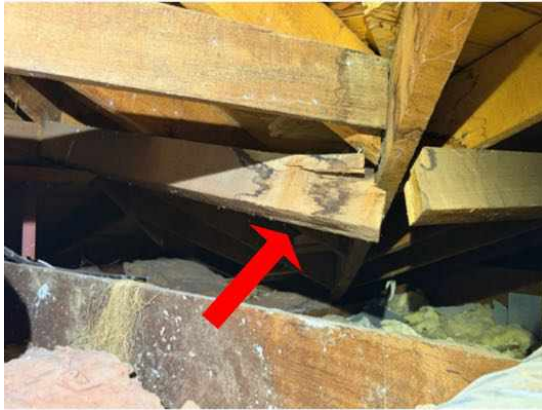
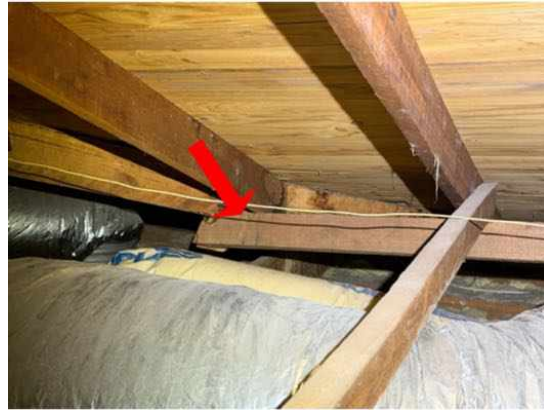
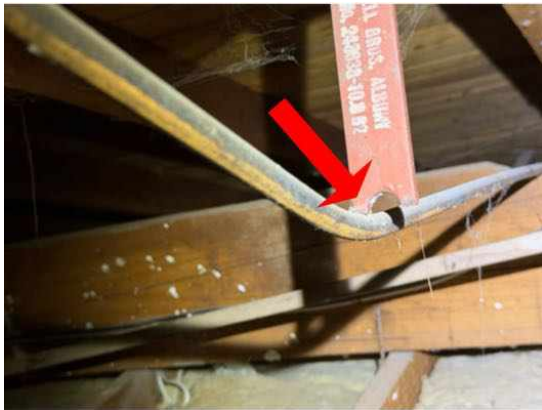
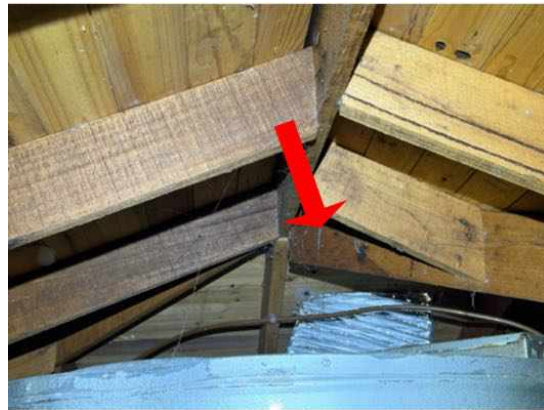
Finding 3.03

Building:	Main Building
Location:	Roof Void
Finding:	Roof Framing - Additional Fixings / Support Required
Information:	It appears that an under-purlin in the roof has moved from its original position, which appears to have caused the associated hip to move slightly. A BARAP strap also appears to have come loose and should be re-aligned.

Although it is suspected this defect has been present for an extended period of time, it is recommended that a registered builder be engaged in the short term, to install additional support/fixings to avoid further sagging and ensure the longevity of the roof void.

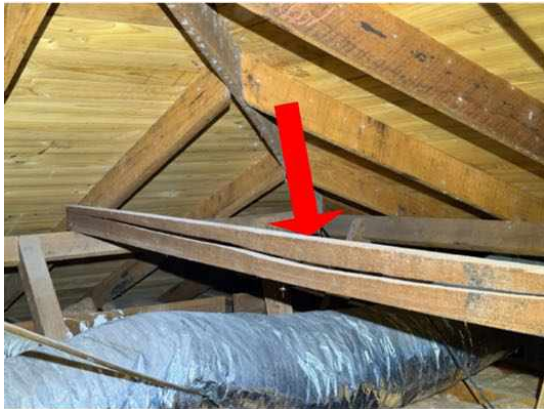
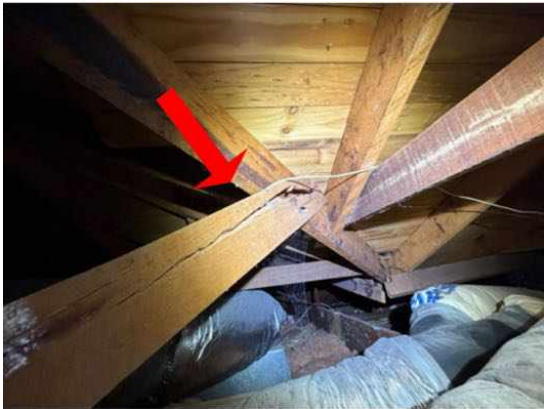
Finding 3.04

Building:	Main Building
Location:	Roof Void
Finding:	Collar Tie & Timber Prop - Split
Information:	It appears that some roof framing members have split including a collar tie and timber prop. Although this defect appears to have been present for an extended period of time, reinforcement or replacement of the timbers is advised to ensure the longevity of the roof structure.

Recommend engaging a licensed carpenter to provide maintenance works where necessary, to avoid further splitting.

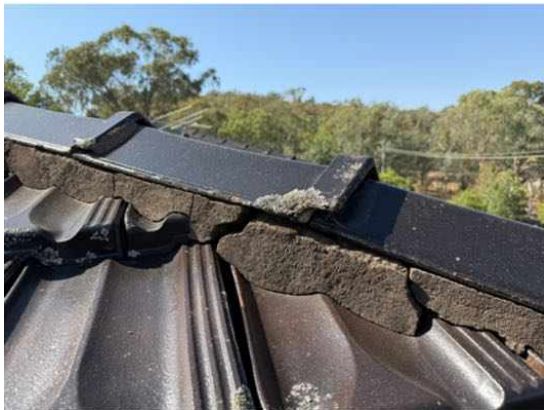
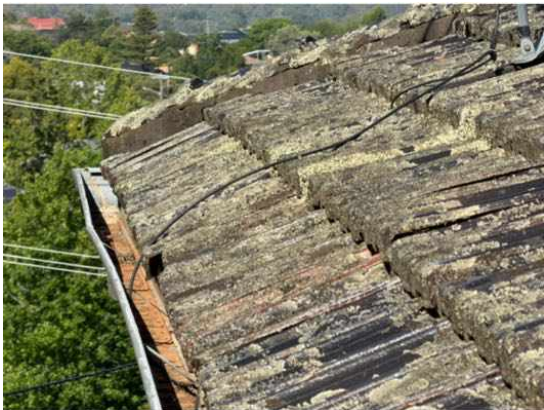
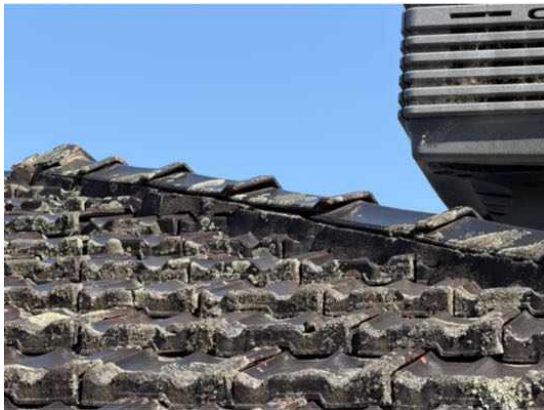
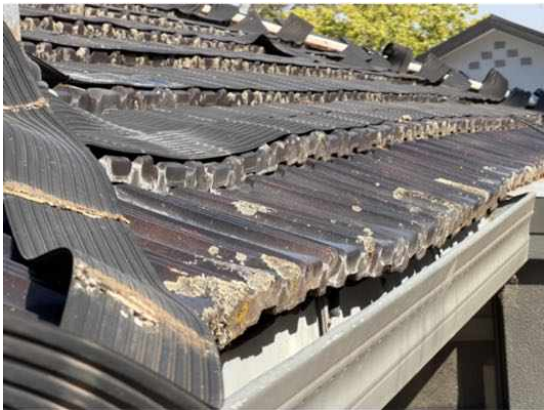
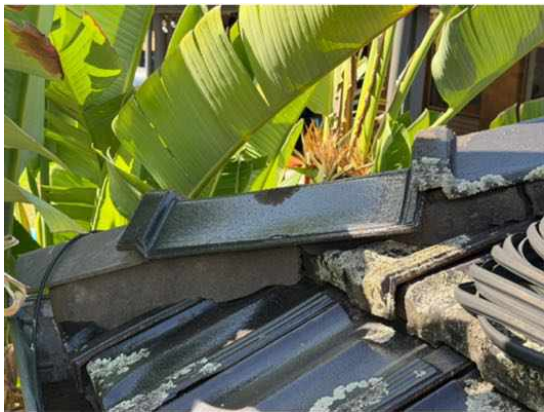
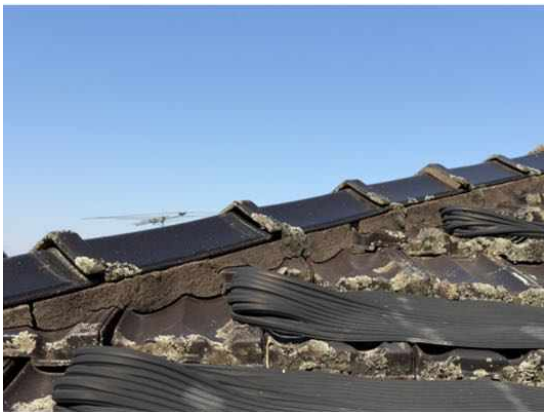
Finding 3.05

Building: Main Building
 Location: Roof Exterior
 Finding: Roof Exterior - Cracking, Slippage
 Information: Areas of chipped and slipped roof tiles and cracking in the tile pointing were identified to the roof exterior. While weathering of the tiles is consistent with the age of the property, maintenance works are required.

Where left unmanaged, deteriorating roof tiles are likely to lead to secondary defects, including water leaks. Recommend consulting with a licensed roofing contractor in the short term, to provide further advice on maintenance works needed.

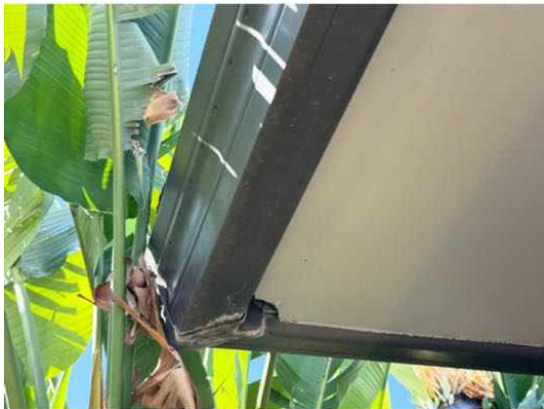
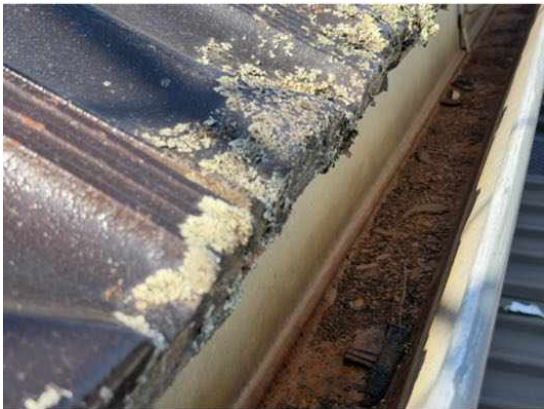
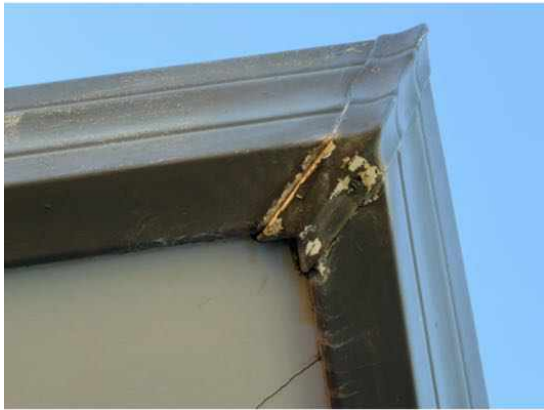
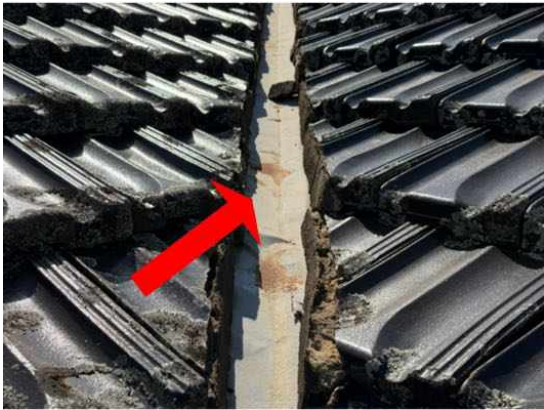
Finding 3.06

Building: Main Building
Location: Roof Plumbing
Finding: Roof Plumbing - Rust/Corrosion
Information: It appears that areas of the roof plumbing have areas of general rust/ corrosion. Deteriorated roof plumbing can eventually develop holes and leaks overtime, if neglected. Recommend consulting with a licensed roof plumber at clients convenience, to provide further advice & maintenance works.

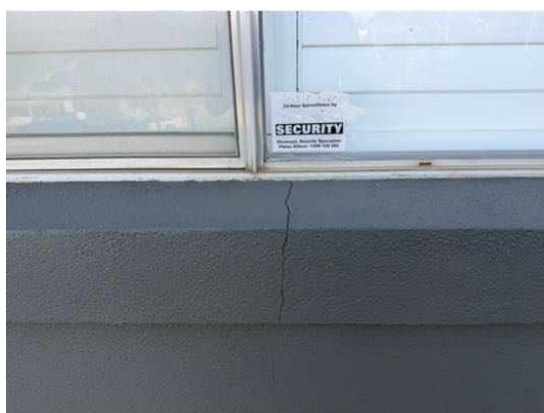
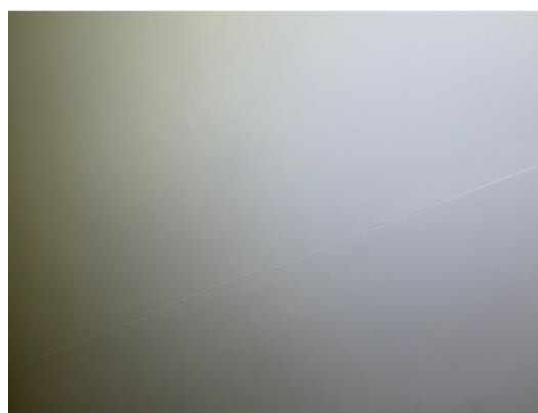
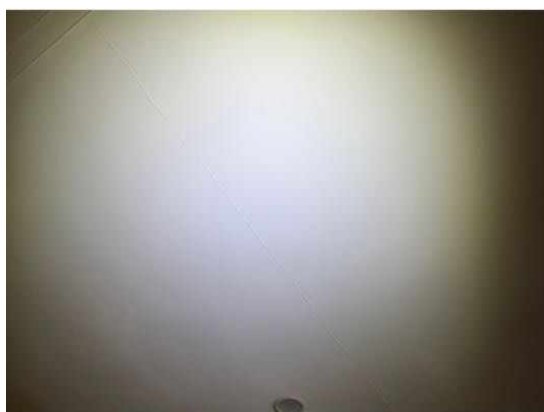
Finding 3.08

Building:	Main Building
Location:	All Areas
Finding:	Cracking - External & Internal
Information:	Cracking was identified to areas of the brickwork & internal linings. The most common cause is general movement of adjacent footings and/or expansion / contraction of building materials. Cracking is a relatively common defect.

The client should monitor the cracking. Should the cracking lengthen, widen or become more numerous, the client should consult with a structural engineer to provide further advice.

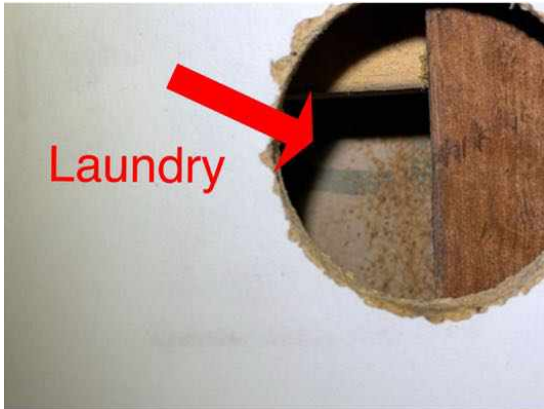
Finding 5.01

Location: Subfloor, Laundry, Roof Void
Finding: Evidence of termite workings & damage
Information: Evidence of previous termite workings were identified at, but not limited to, areas of the subfloor, laundry and roof void.

The client should engage a licensed pest controller promptly to provide further advice regarding installation of a termite treatment.

6 monthly ongoing termite inspections, conducted by a qualified termite inspector, and a more invasive inspection, to identify the extent of the damage are also recommended.

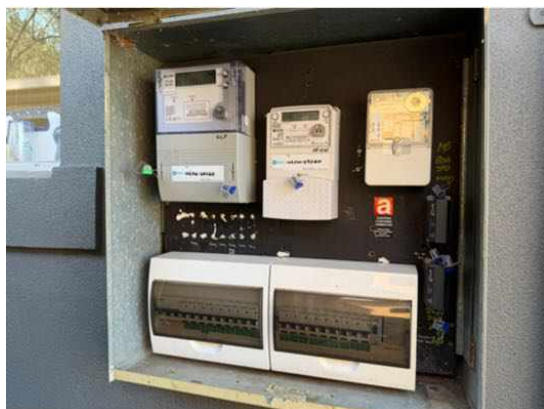
Finding 6.01

Building:	Main Building
Location:	Switchboard
Finding:	Termite Management System - no evidence of a chemical installation
Information:	The application of a termite barrier is strongly recommended, as it appears no termite management system has been installed, with no evidence or durable notice to suggest works taking place. Generally, a durable notice is placed in the meter box to indicate current termite barriers.

Such barriers are highly effective in preventing termite attack on the building and therefore should be installed.

Recommend seeking further advice from a licensed pest controller.

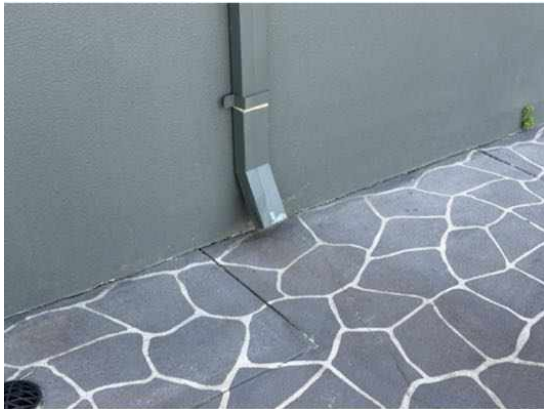
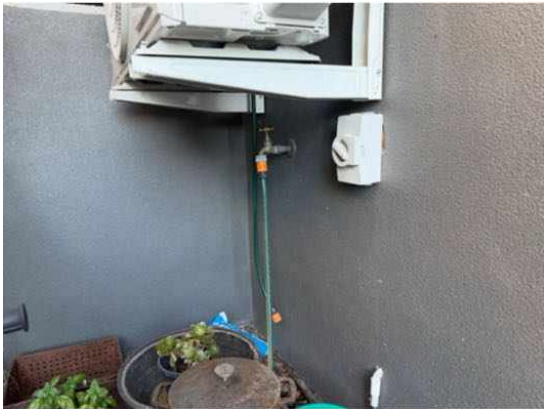
Finding 6.02

Building:	Main Building
Location:	External areas
Finding:	Potential Water pooling - against property
Information:	It appears that there are potential areas around the perimeter of the property that could be susceptible to water pooling. Where insufficient drainage of taps, roof plumbing & aircon overflows is present, water pooling is likely to occur, and can create areas conducive to timber pests and create moist conditions in the subfloor overtime, if neglected.

Recommend consulting with a licensed plumber in the short term to further assess and provide remedial advice.

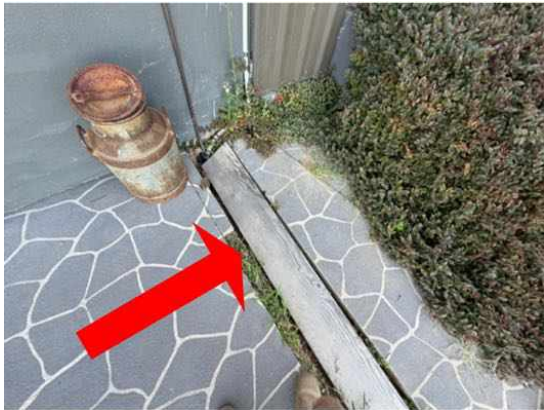
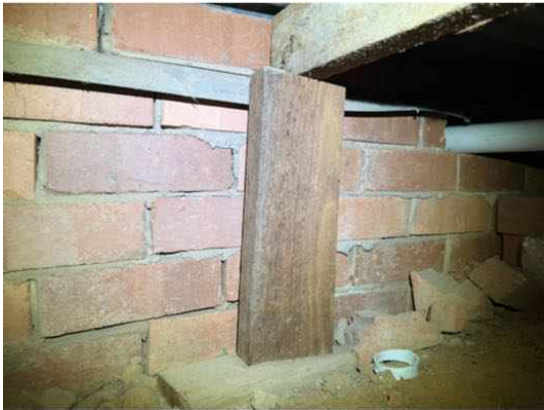
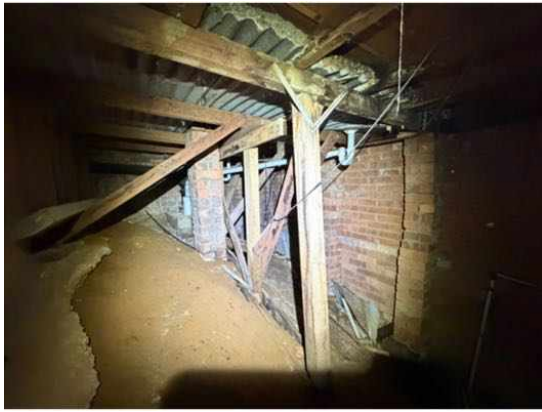
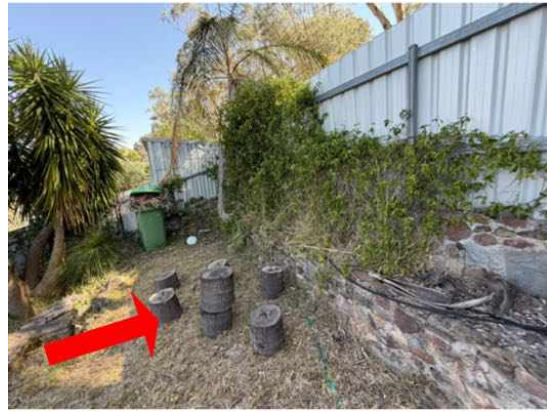
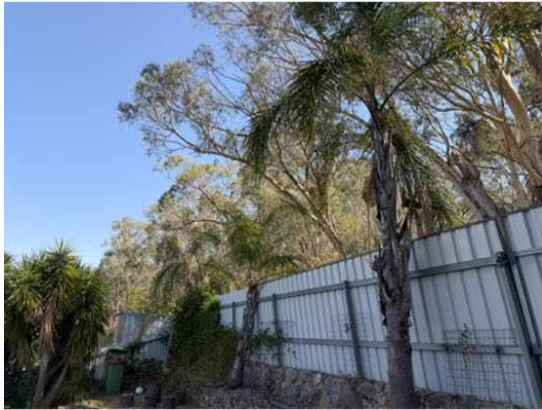
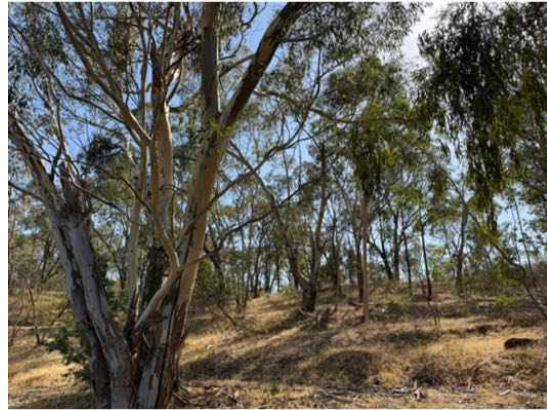
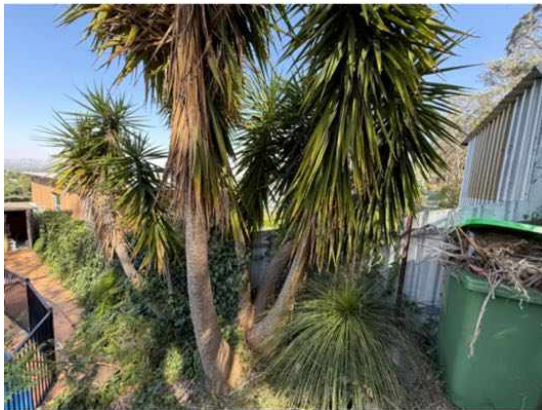
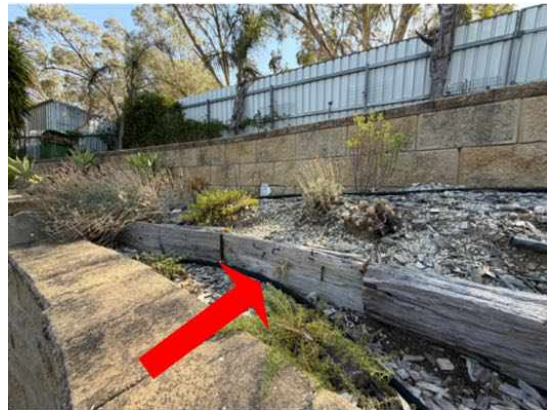
Finding 6.03

Building: Main Building
Location: All External Areas
Finding: Timber in direct ground contact & trees - conducive to termites
Information: Where timber materials are in direct contact with the ground and consequently moisture, they become conducive to termite activity. The tree stumps, timber debris in the subfloor, and trees surrounding the building create an environment conducive to termite infestation.

Where feasible, any timbers in direct contact with the ground should be removed and any trees in close proximity to the building should be removed or test drilled (inspected) at least annually to reduce the risk of termite infestation & detect any early signs of termite activity.

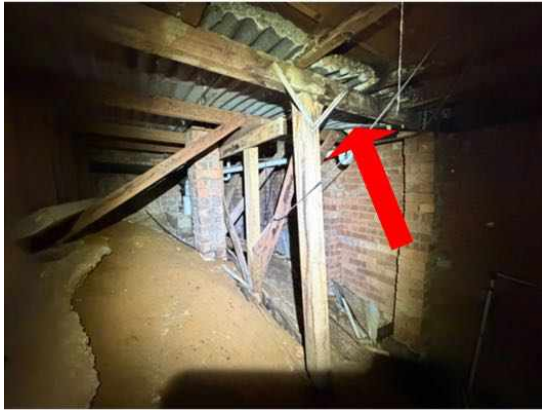
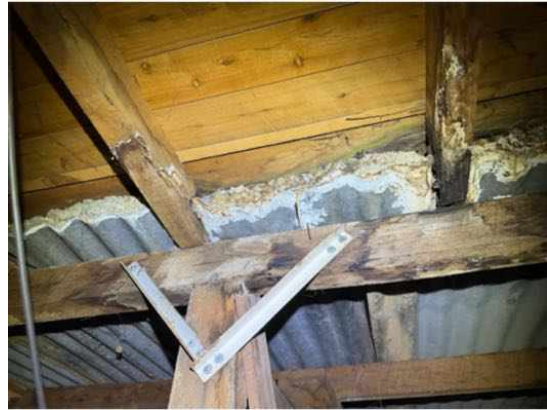
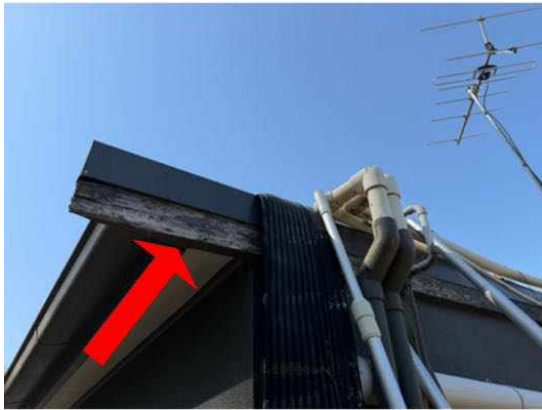
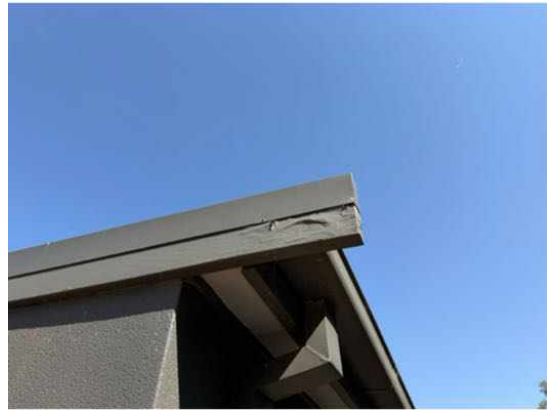
Finding 7.01

Building: Main Building
Location: Subfloor, Fascia's
Finding: Fungal decay & weathering
Information: Areas of fungal decay (wood rot) were identified at but not limited to the subfloor framing beneath the bathroom and fascia boards.

Recommend consulting with a registered builder to provide remedial works to the

subfloor timbers, where necessary. For areas of general weathering, it is advised the client engage a licensed painter to apply protective sealant or coating to areas of weathered external timbers.

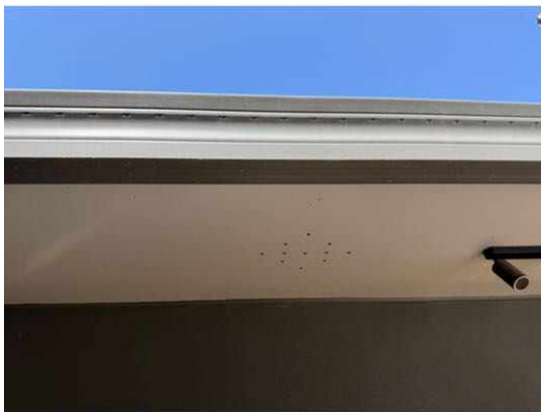
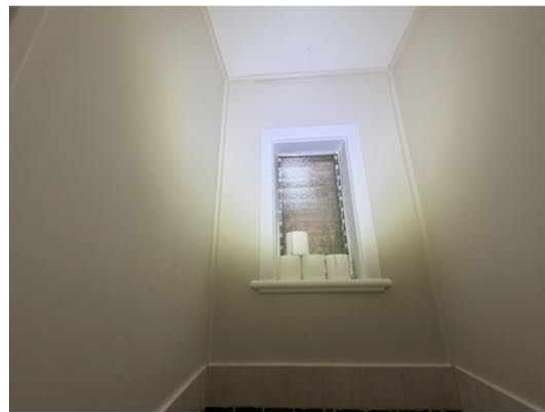
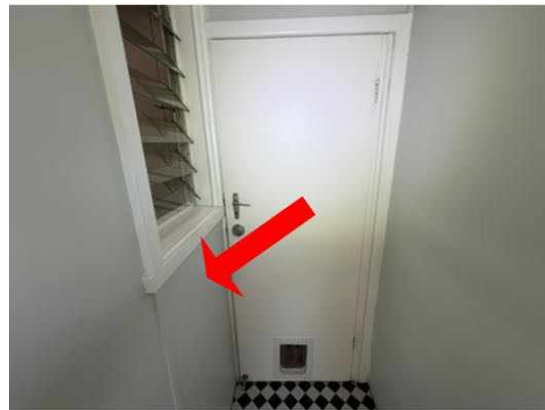
Building: Main Building
 Location: Eaves, Toilet, Laundry, Rear Entry
 Finding: Asbestos - Suspected ACM Identified on Site
 Information: This suspected defect is highlighted as a caution only as reporting on asbestos is outside the scope of this report. It is suspected that the materials including but not limited to the eave sheets, laundry, toilet & rear entry sheeting may be an ACM (Asbestos containing material)

It is advised that the client consider a separate Asbestos Inspection and Condition Audit, which can include the taking of samples for definitive confirmation of the presence of Asbestos, carried out by a licensed Asbestos Inspector. In the interim, no works should be conducted to these areas without further specialist advice.

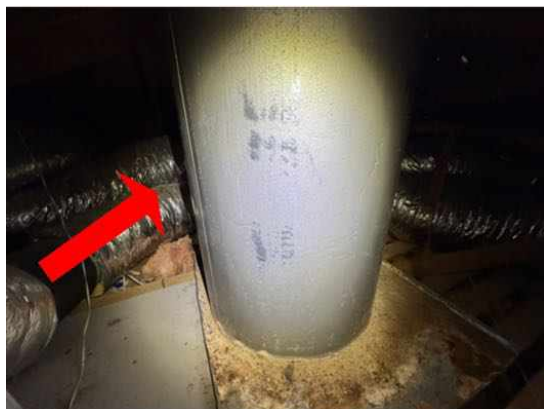
Building: Main Building
 Location: Roof Void
 Finding: Gravity-Fed HWS - Disconnected
 Information: A disconnected gravity-fed hot water system (HWS) remains in the roof void. Despite this plumbing system being unused, it may contain residual water. If neglected, rust of the system overtime, may lead to residual water leaking.

Recommend that the client either monitor the condition of the system or get the

system drained by a licensed plumber to prevent any potential future leaks.

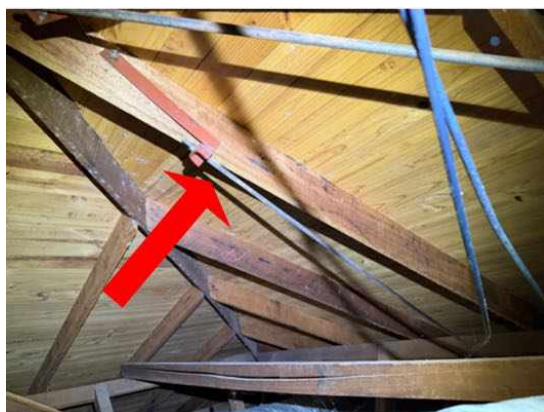
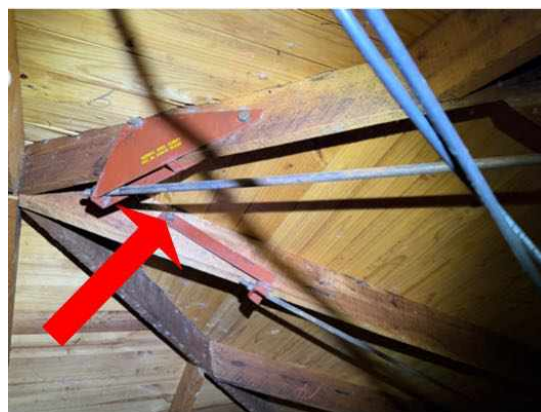
Building: Main Building
 Location: Roof Void
 Finding: BARAP Straps
 Information: It is noted for the clients information that barap straps have been used in the construction of the roof framing. While this is a common construction method used in houses of a similar age, it is advised that the straps be inspected annually to ensure all nuts and bolts are taut and haven't loosened.

Loosening of bolts can cause the roof framing to sag overtime, if neglected.

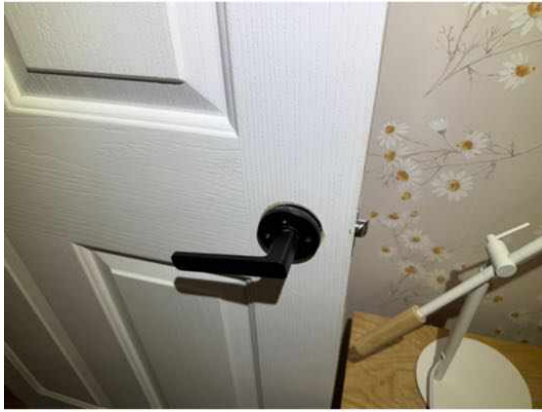
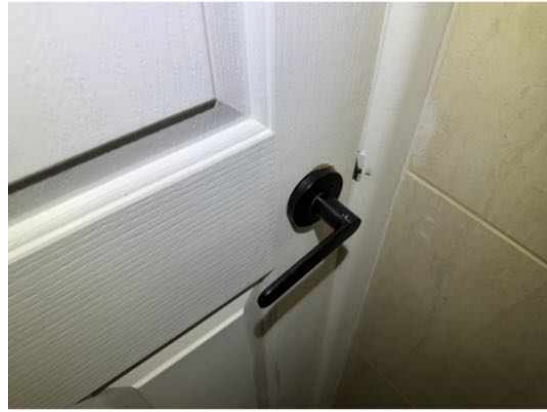
Building: Main Building
 Location: Internal Doors
 Finding: Door Handles - Loose
 Information: It appears that some door handles are loose and require adjustment to tighten. A general handyman may be appointed to perform these minor works at the clients discretion.

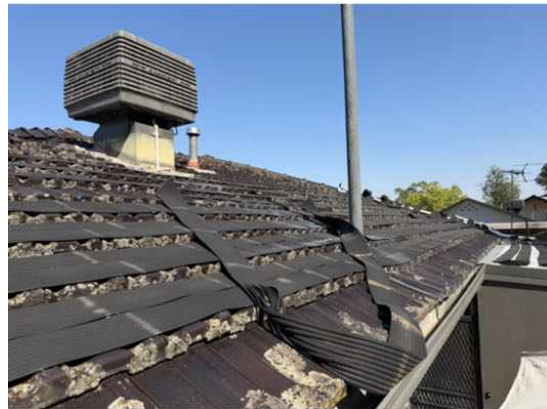
Finding: Solar Heating

Information: It appears that the solar heating is not operational. The client can engage a licensed solar plumber at their discretion to provide remedial works where necessary.

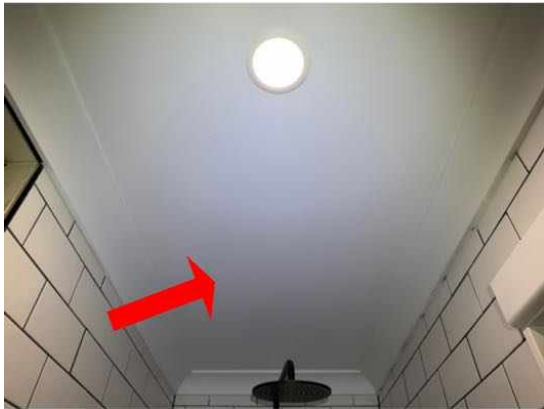
Finding: Exhaust fan - Not Installed

Information: It was noted that an exhaust fan has not been installed to the ensuite shower. Although there is an open window installed, installation of an exhaust fan will assist with ventilation & prevent mould growth. A licensed electrician can be engaged at clients discretion, to install an exhaust fan where necessary.

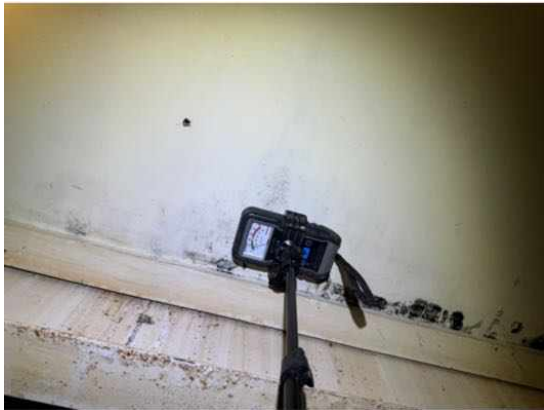
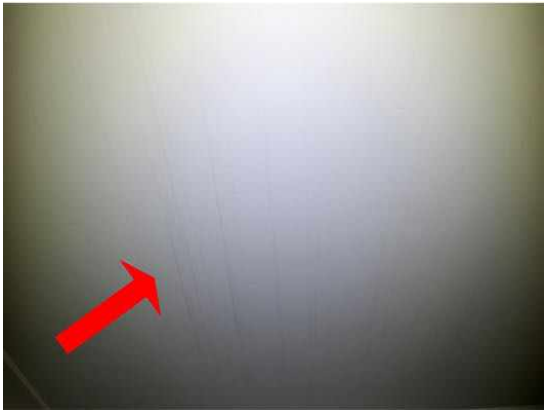
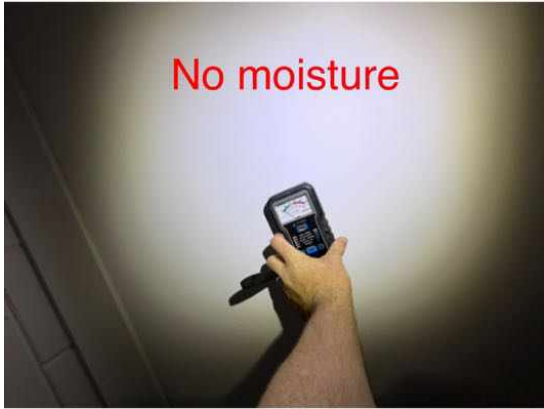
Building: Main Building
Location: Basement Ceiling, Downstairs Ceiling
Finding: Staining Present
Information: It is noted for your information that it appears areas of staining are present at, but not limited to the basement ceiling and downstairs bedroom ceiling.

No high moisture was evident in these areas at the time of inspection.

It is recommended that the client monitor these areas. Should further staining occur, a licensed roof plumber should be engaged to provide remedial works.
