# Building and Timber Pest Inspection Report

Inspection Date: Mon, 23 Mar 2026

Property Address: 9/1 Virginia St, Springvale VIC 3171,  
Australia

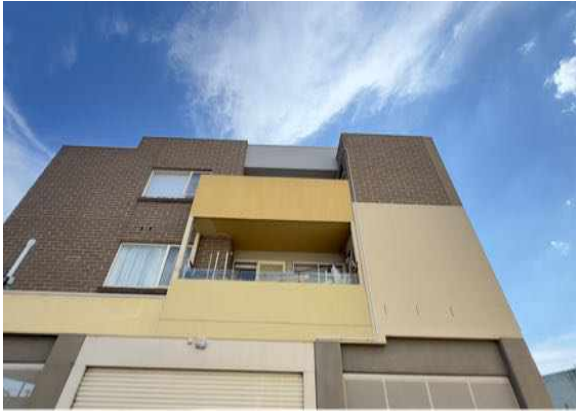
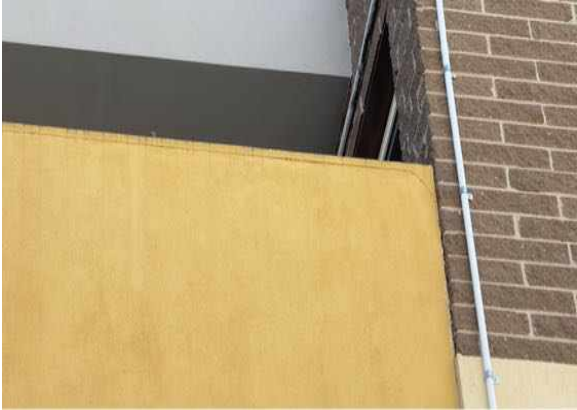
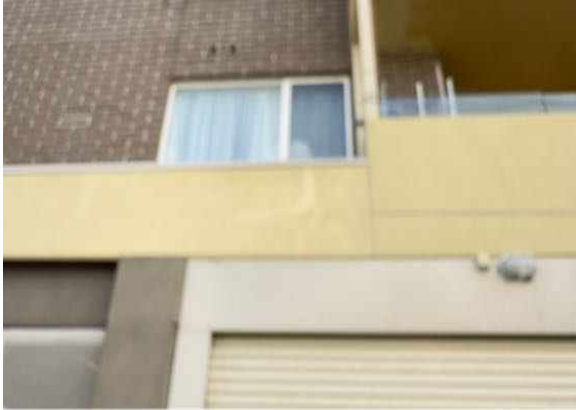
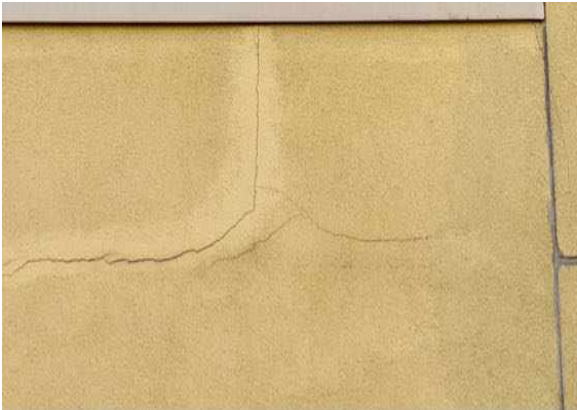
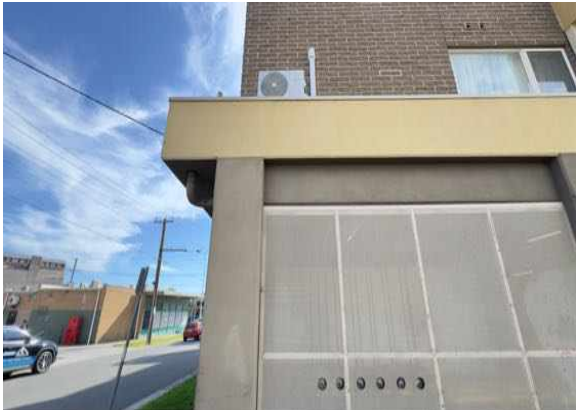
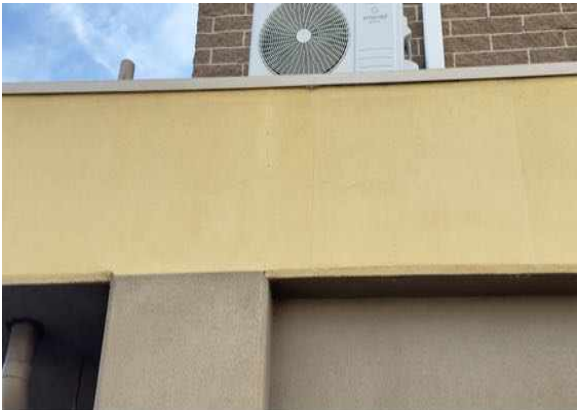
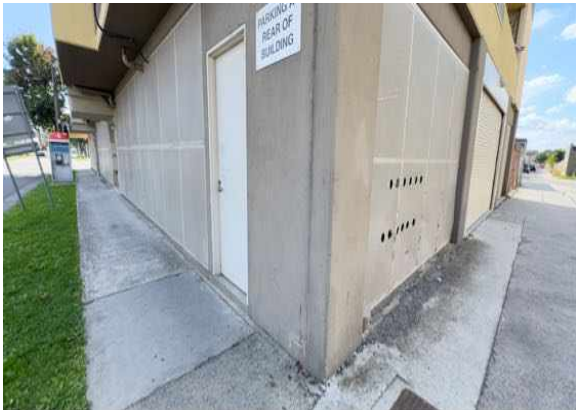
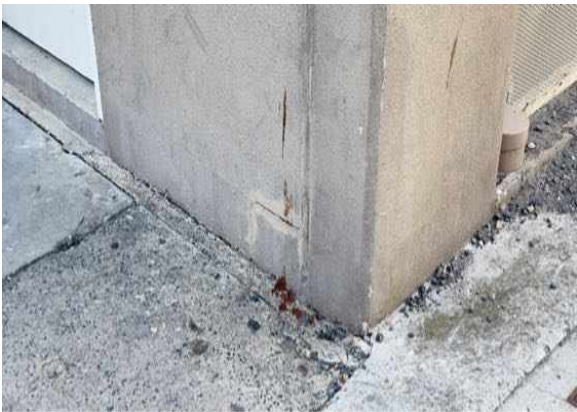
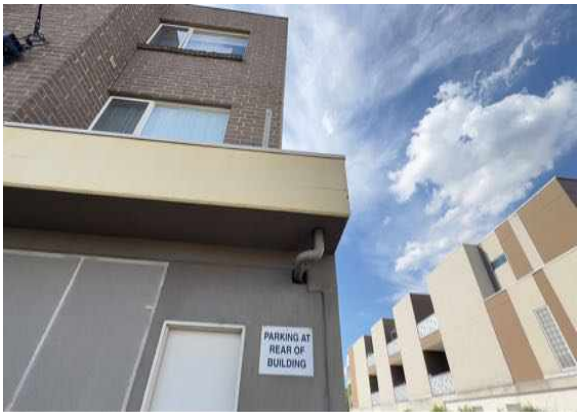
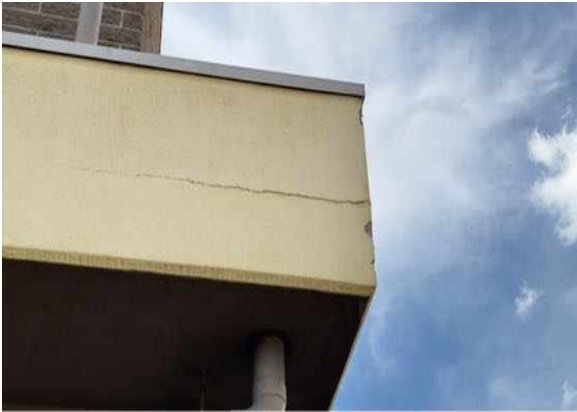
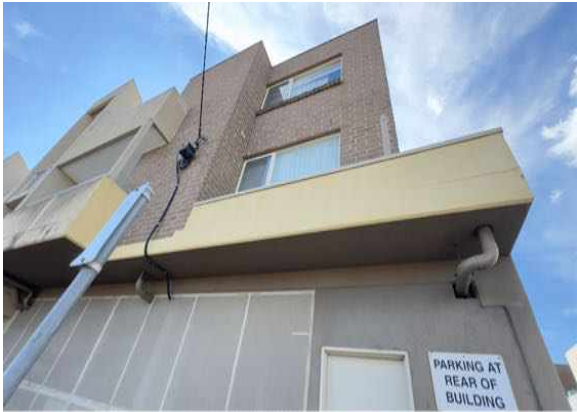
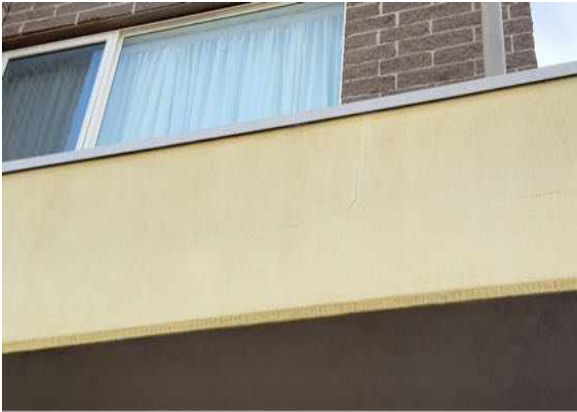
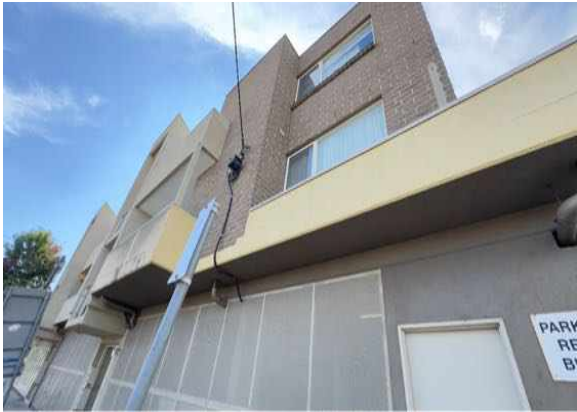
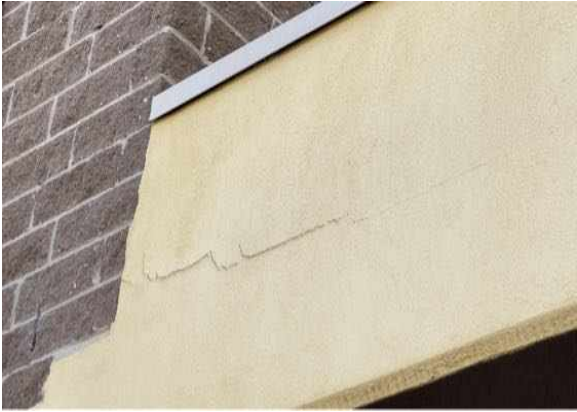
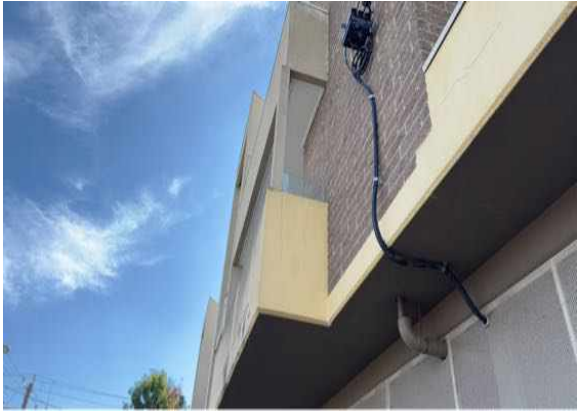
**Building:** Main Building  
**Location:** All External Areas >  
**Finding:** External Walls - Minor Cracking To Wall Claddings  
**Information:** Minor cracking was observed to the external walls in this area. The cracking appeared superficial and did not indicate significant structural movement; however, such cracking can allow moisture ingress if left unaddressed.

The cracking is likely due to building movement or minor settlement.

When practical, a registered builder should assess and repair the cracking, which may include sealing and repainting. The area should be monitored, and any increase in cracking or signs of movement should be further investigated immediately by a Structural Engineer.

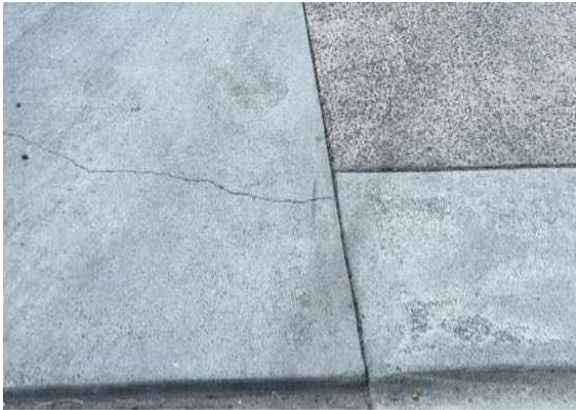
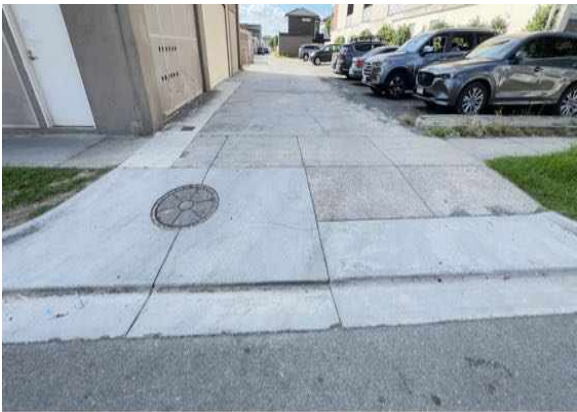
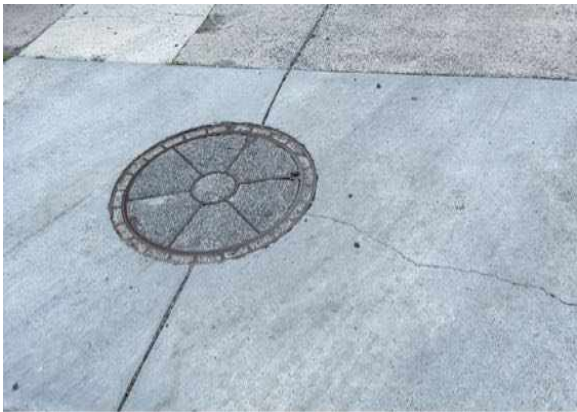
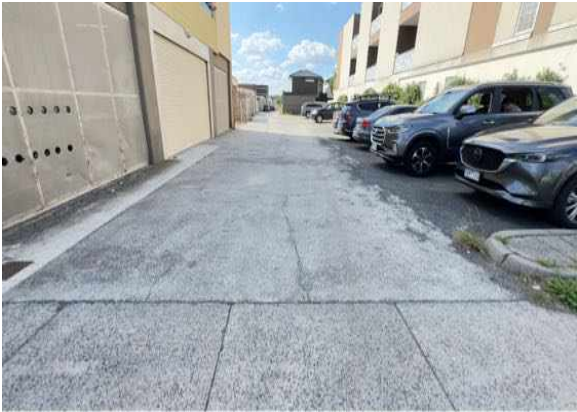
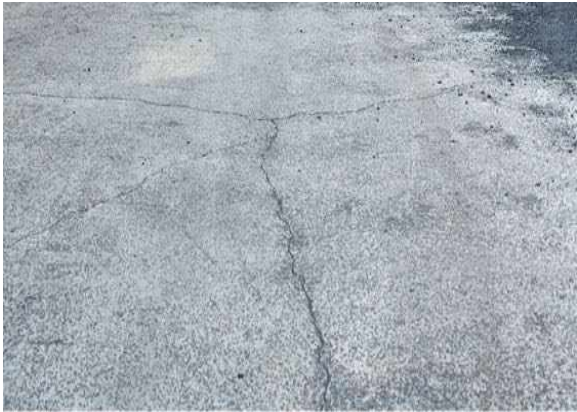
Building: Main Building  
Location: Driveway >  
Finding: Driveway - Minor Cracking & Surface Imperfections  
Information: The external driveway was visually inspected. Minor cracking, surface settlement, and minor unevenness was observed in this area. While these defects do not currently compromise structural safety, they may affect long-term durability, appearance, and vehicle access.

These issues may be caused by age-related wear, soil movement or settlement beneath the driveway, possible tree root intrusion, or inadequate original construction or reinforcement.

A qualified concreter should be engaged when practical to repair or resurface affected areas. Prompt rectification will restore a smooth surface, improve appearance, and prevent further deterioration.

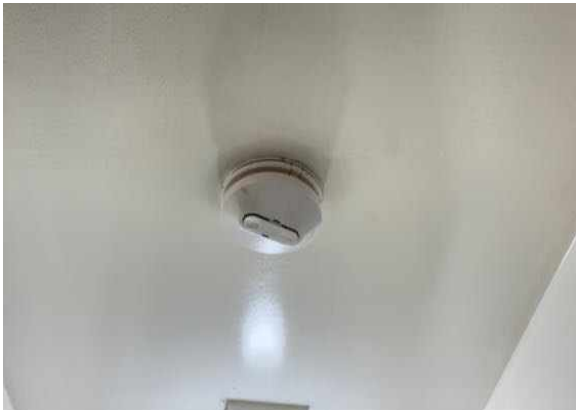
Building: Main Building  
 Location: All Internal Areas  
 Finding: Smoke Detectors - Advisory  
 Information: During the inspection, smoke detectors were noted for advisory purposes only. The operation, age, type, and compliance of smoke detectors could not be fully verified as part of this inspection.

Smoke detectors are critical life-safety devices, and non-compliant, outdated, or non-operational units may not provide adequate warning in the event of a fire.

It is recommended that a licensed electrician be engaged immediately to test, service, and upgrade smoke detectors as required to ensure correct operation and compliance with current safety requirements.

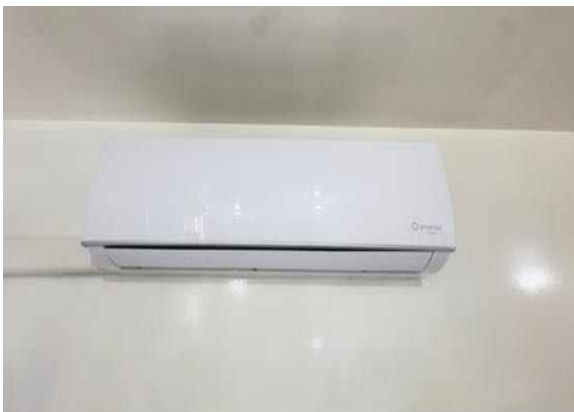
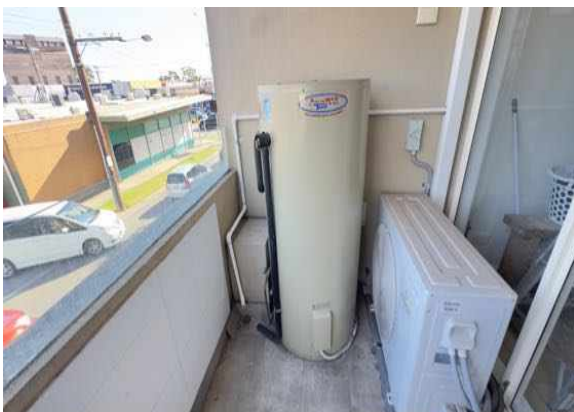
Observations and images of appliances are for informational purposes only and do not form part of the formal building inspection.

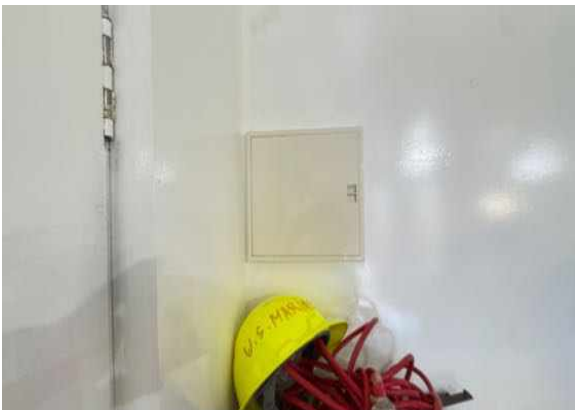
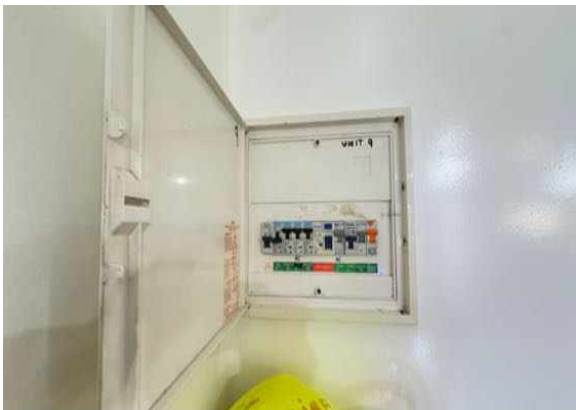
Building: Main Building  
 Location: All External Areas  
 Finding: Electrical Switch Board - Location  
 Information: For your information, the main electrical switchboard was visually inspected. No intrusive testing or detailed electrical assessment was performed as part of this inspection.

For full compliance and safety verification, a licensed electrician should be engaged to inspect the switchboard, test all circuits, and ensure all components are functioning correctly. This will help maintain electrical safety and prevent potential hazards.
