Building and Timber Pest Inspection Report VR

Inspection Date: Mon, 2 Feb 2026

Property Address: 37 Orion Dr, Yamba NSW 2464, Australia

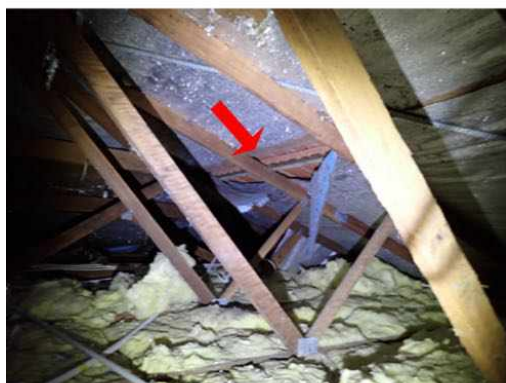
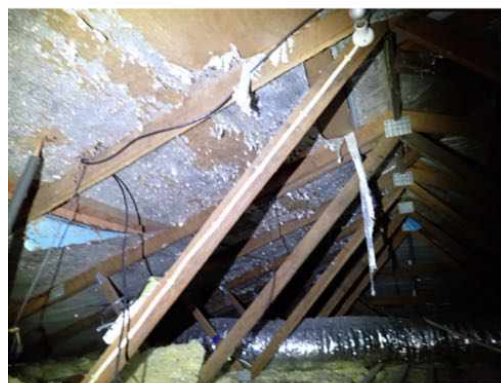
Finding 3.01

Building:	Main Building
Location:	Roof Void
Finding:	Deteriorated Roof Sarking
Information:	Deterioration was identified to the roof sarking. This condition is a common defect for a property of this age. The deterioration may reduce the effectiveness of the sarking in providing a secondary weather barrier and may contribute to moisture ingress, dust penetration and reduced thermal performance if left unaddressed. Repair or replacement of the affected sarking as required is recommended. Works should be carried out by a suitably qualified roofing contractor or tradesperson.

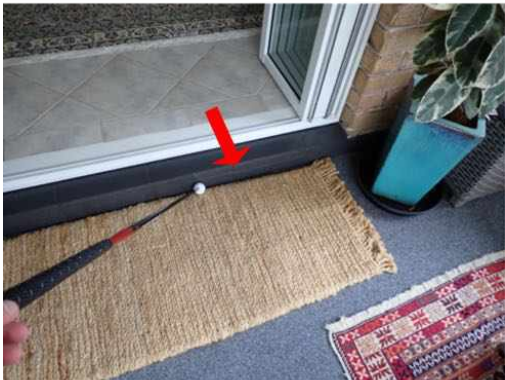
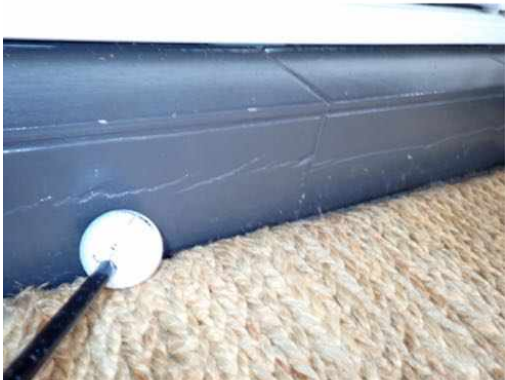
Finding 3.02

Building:	Main Building
Location:	Alfresco area
Finding:	Cracked Tiles To Bifold Threshold Step
Information:	Cracked tiles were identified to the bifold threshold step. This condition may be associated with movement, impact damage or inadequate support beneath the tiles and may affect the appearance and serviceability of the step if left unaddressed. Repair or replacement of the affected tiles as required is recommended. Works should

be carried out by a suitably qualified tiler or tradesperson.

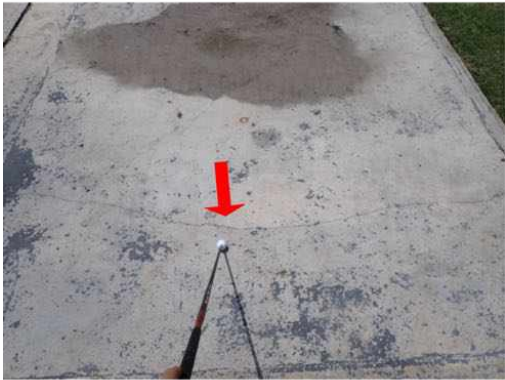
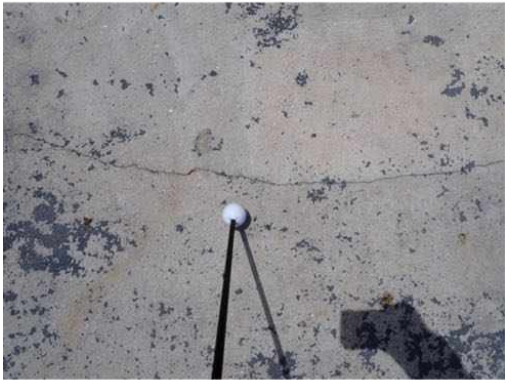
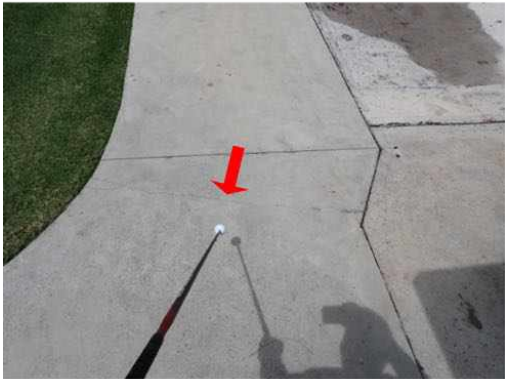
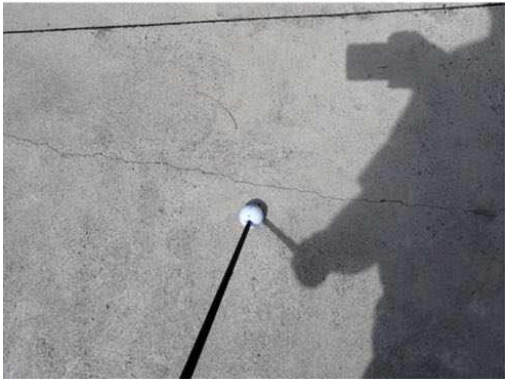
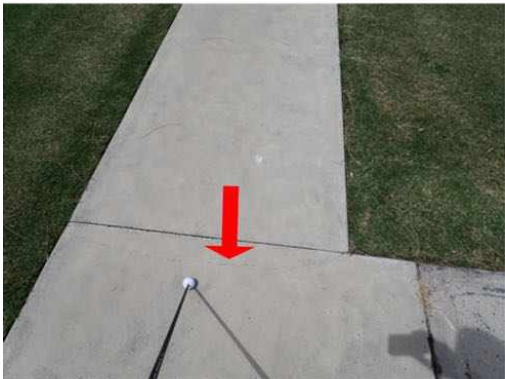
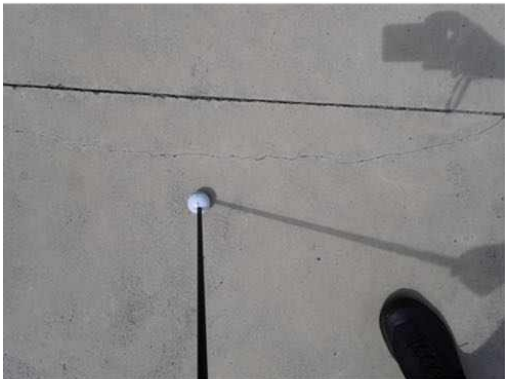
Finding 3.03

Building: Yard
Location: Concrete path
Finding: Minor Cracks In Concreted Areas And Paths
Information: Minor cracking was identified within the external concreted areas and paths. This condition is a common defect and is commonly associated with shrinkage, minor movement or age-related wear and is typical for concrete of this type. Monitoring and repair as required is recommended to reduce the risk of further deterioration. Works should be carried out by a suitably qualified concreter or tradesperson.

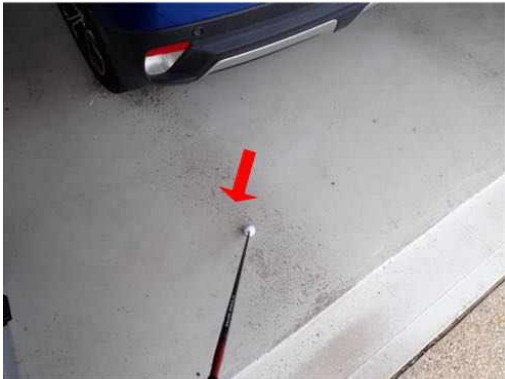
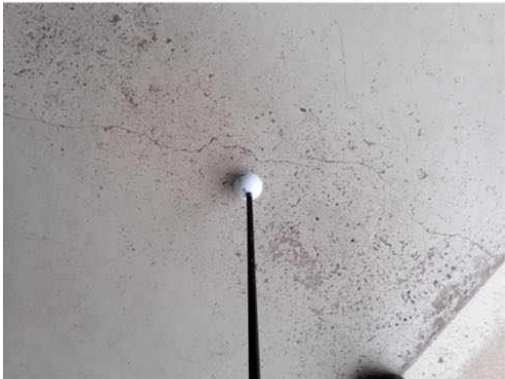
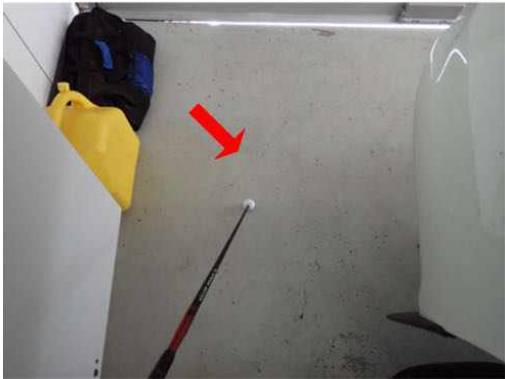
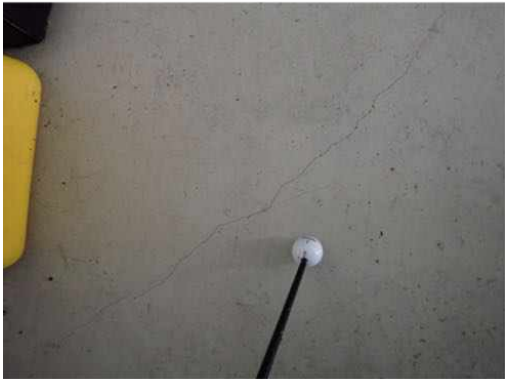
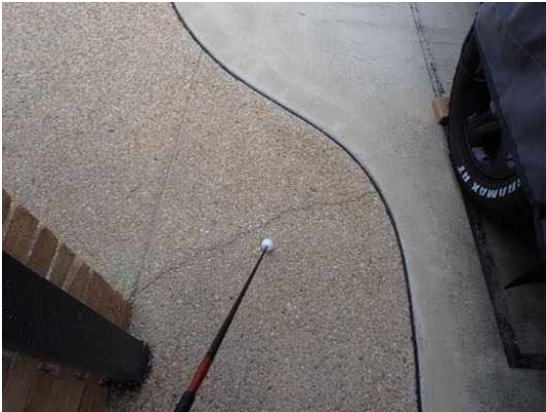
Finding 3.04

Building: Main Building
Location: Garage
Finding: Minor Cracks In Garage Concrete Slab
Information: Minor cracking was identified within the garage concrete slab. This condition is a common defect and is typically associated with shrinkage, minor movement or age-related wear. Monitoring and repair as required is recommended to help limit further deterioration. Works should be carried out by a suitably qualified concreter or tradesperson.

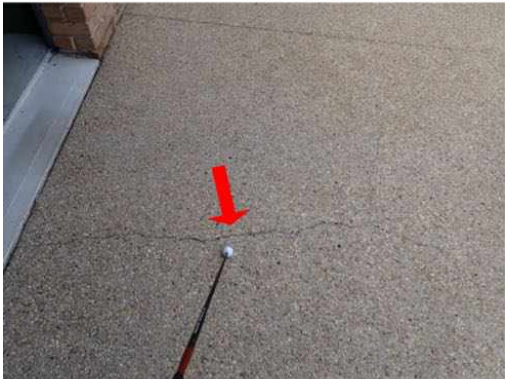
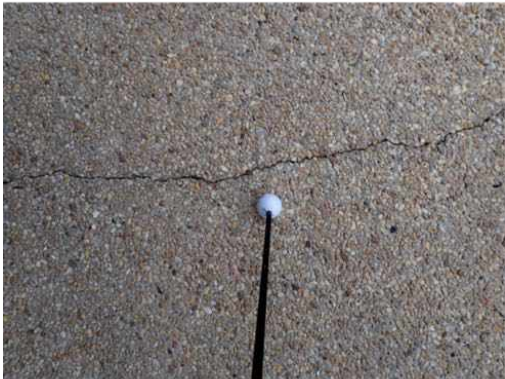
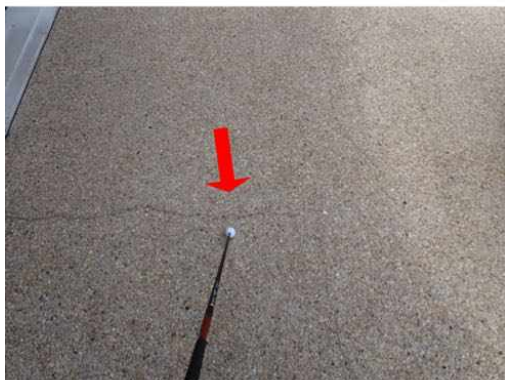
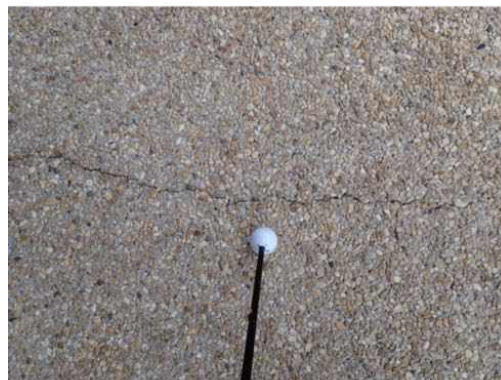
Finding 3.05

Building: Yard
Location: Driveway
Finding: Minor Cracks In Concreted Driveway
Information: Minor cracking was identified within the concreted driveway. This condition is a common defect and is typically associated with shrinkage, minor movement or age-related wear. Monitoring and repair as required is recommended to help limit further deterioration. Works should be carried out by a suitably qualified concreter or tradesperson.

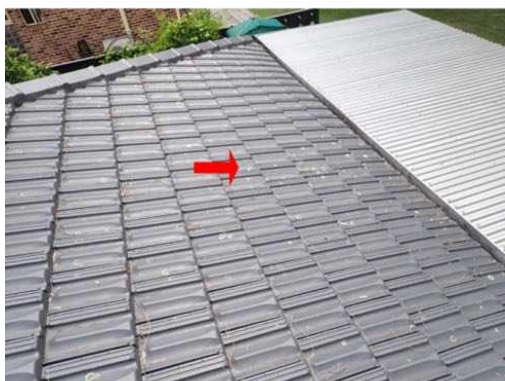
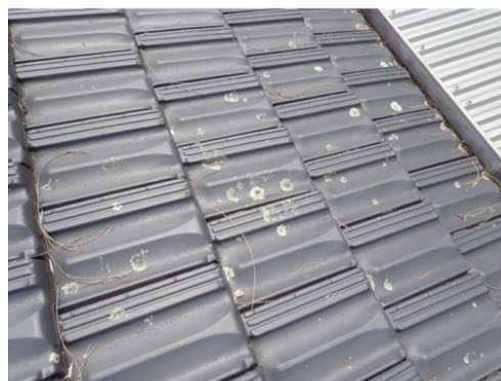
Finding 3.06

Building:	Main Building
Location:	Roof
Finding:	Minor Lichen Growth To Roof Tiles
Information:	Minor spots of lichen growth were identified on the roof tiles. This condition is commonly associated with age and environmental exposure and may contribute to surface deterioration if left unaddressed. Cleaning and maintenance as required is recommended to help maintain the condition of the roof tiles. Works should be carried out by a suitably qualified roofing or maintenance contractor.

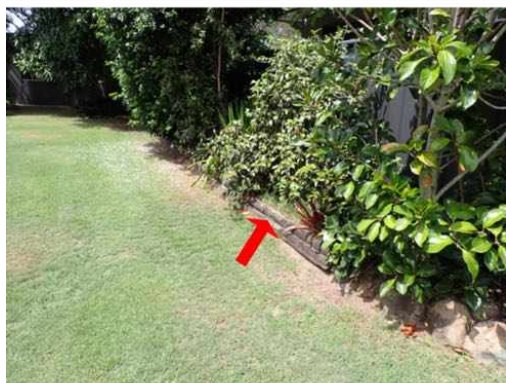
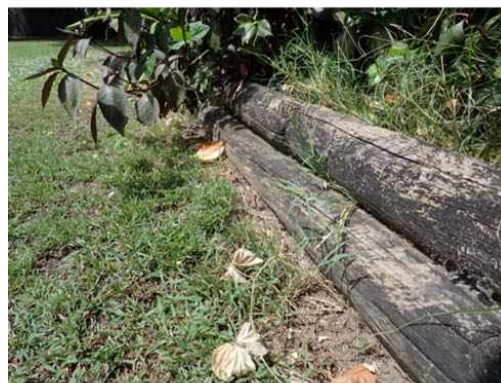
Finding 6.01

Building:	Yard
Location:	Garden beds
Finding:	Timber Garden Beds In Contact With Ground Conducive To Termite Attack
Information:	Timber garden beds were identified in direct contact with the ground. This condition is conducive to termite activity and may increase the risk of concealed termite entry into nearby timber elements if left unaddressed. Removal, separation from the ground or replacement with non-timber materials as required is recommended to reduce termite risk. Works should be carried out by a suitably qualified tradesperson.

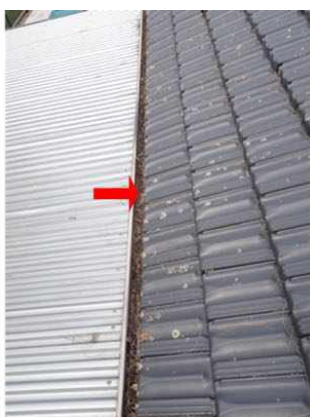
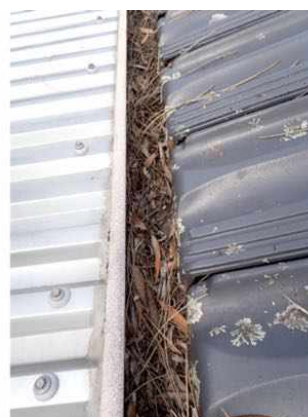
Building: Main Building
Location: Roof
Finding: Leaves And Debris Within Gutters
Information: Leaves and minor debris were identified within the gutters. This condition is common and generally associated with surrounding vegetation. Routine cleaning and ongoing maintenance as required is recommended to maintain effective roof water drainage. Works should be carried out by a suitably qualified tradesperson or general handyman.

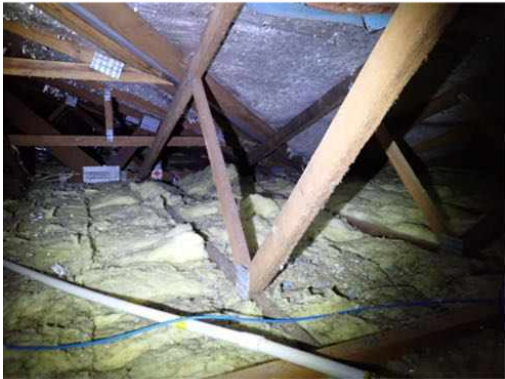
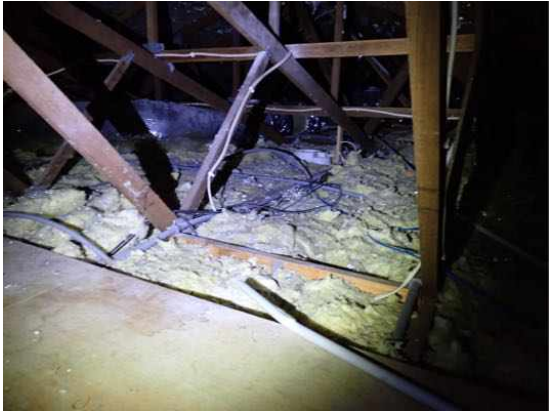
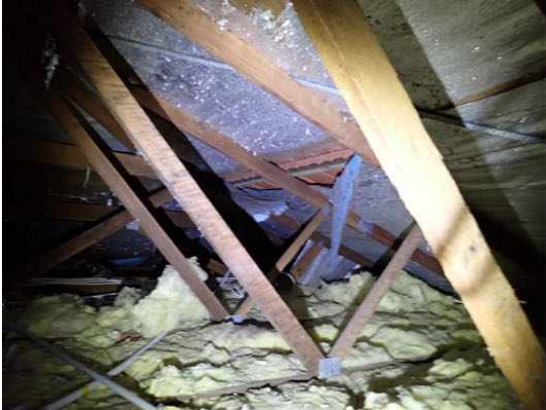
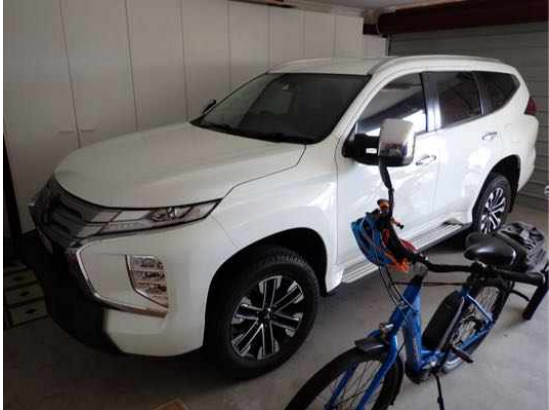
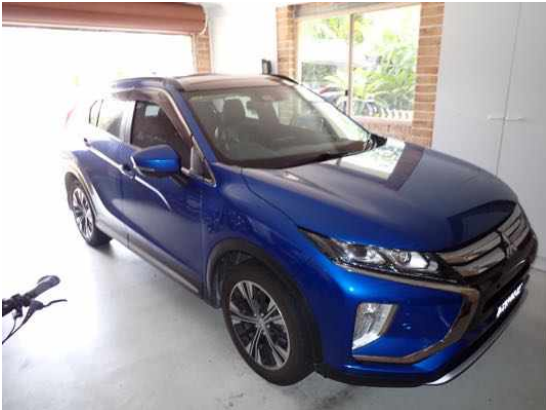
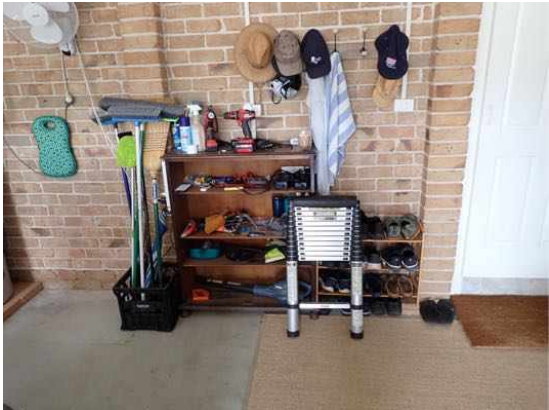
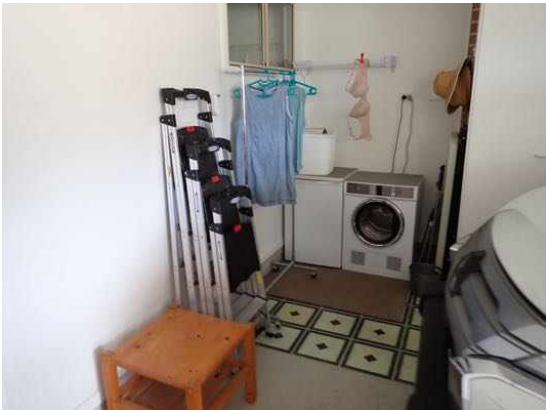
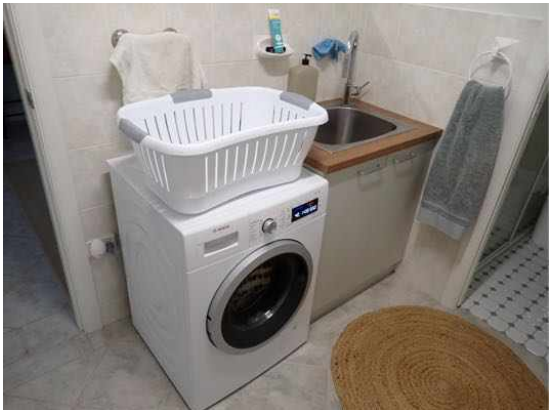
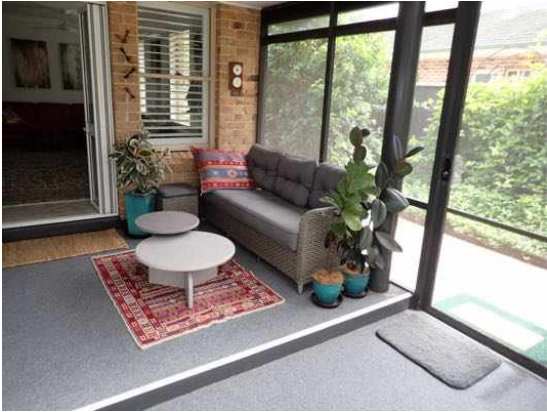
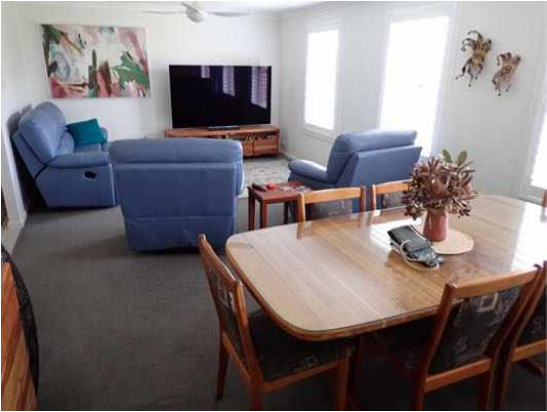
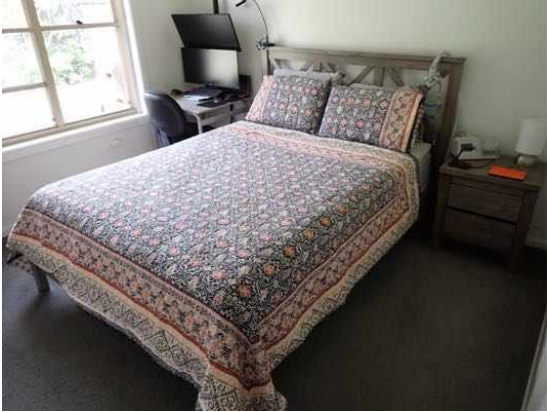
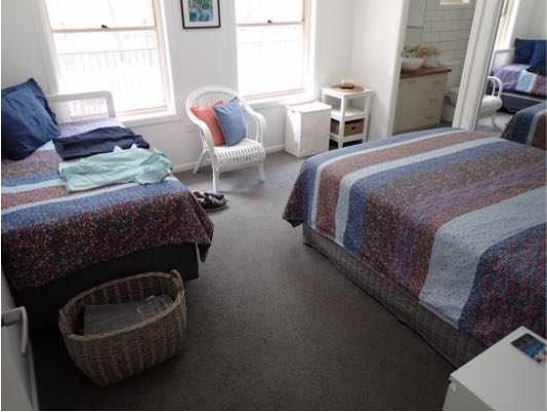
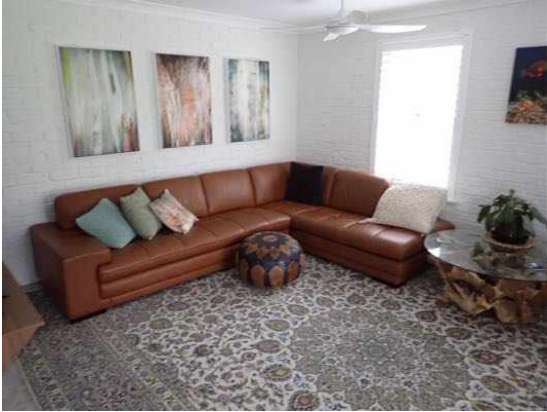
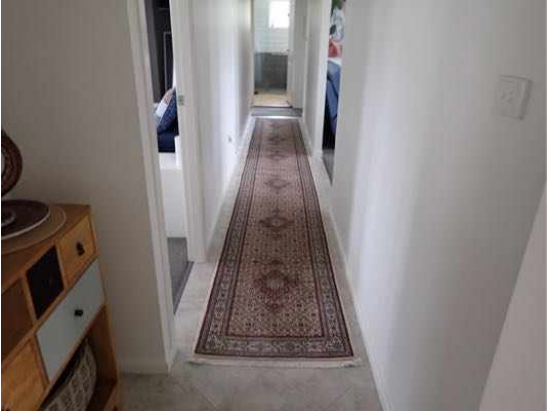
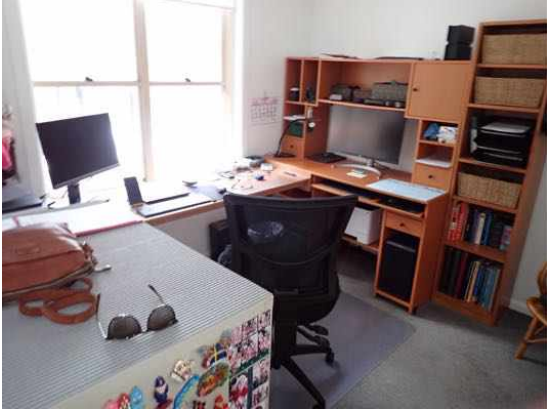
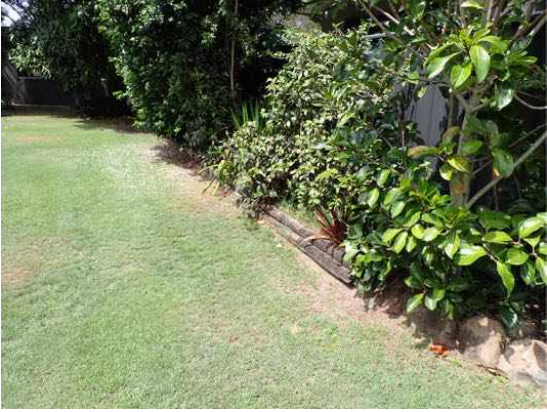
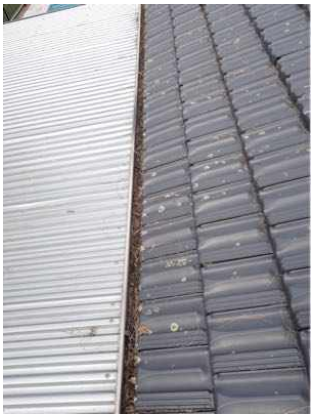
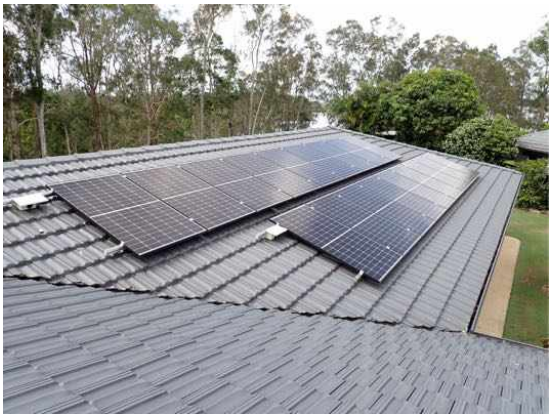
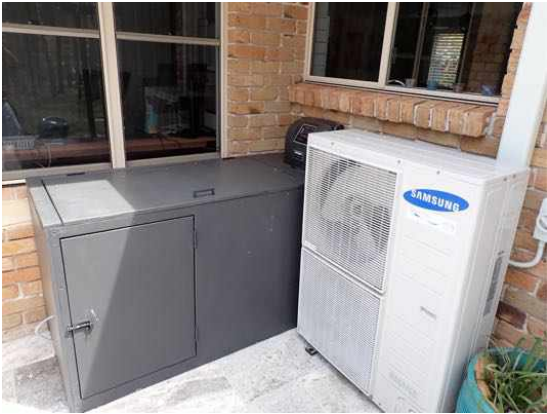
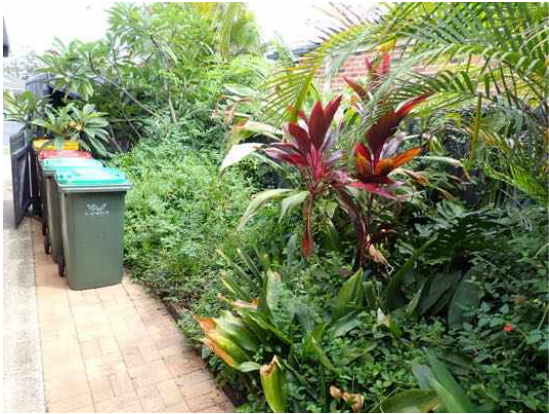
Building: Main Building
Location: All Areas
Finding: Additional Photos - Obstructions and Limitations
Information: These photographs are an indication of the obstructions and limitations which impeded full inspection of the area at the time of inspection. These obstructions can hide an array of defects and should be removed to allow full inspection to be carried out. A re-inspection is recommended once the areas are made accessible.

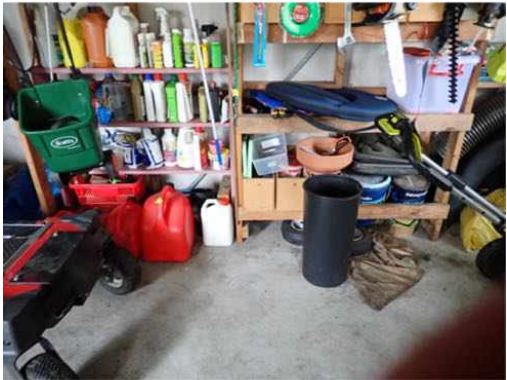
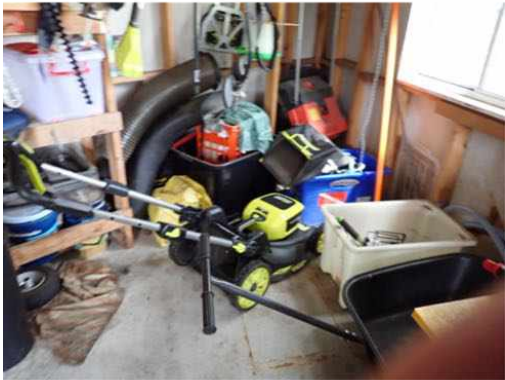
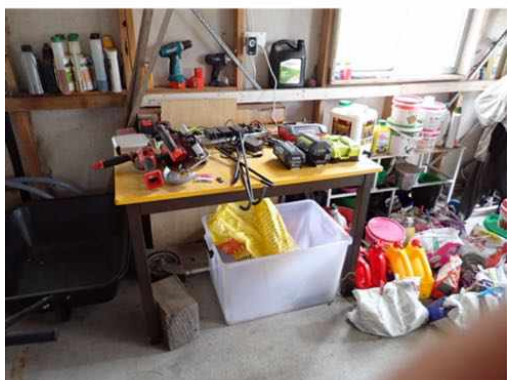
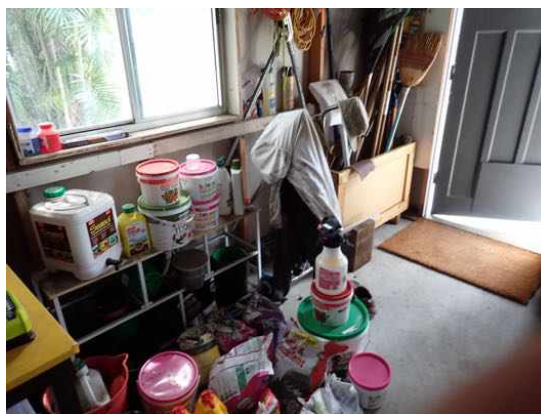
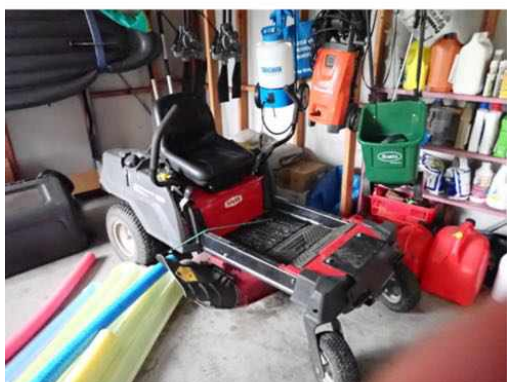
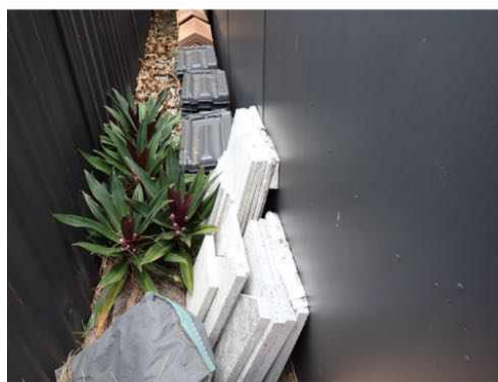
Building: Shed
 Location: All Areas
 Finding: Additional Photos - Obstructions and Limitations
 Information: These photographs are an indication of the obstructions and limitations which impeded full inspection of the area at the time of inspection. These obstructions can hide an array of defects and should be removed to allow full inspection to be carried out. A re-inspection is recommended once the areas are made accessible.

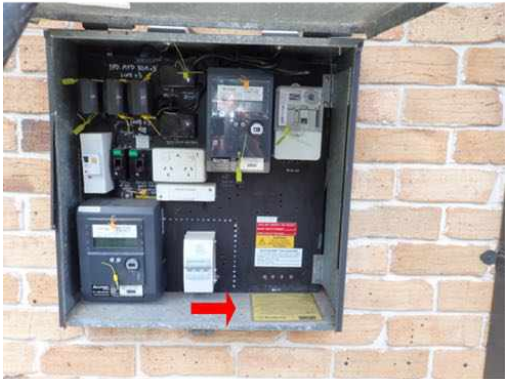
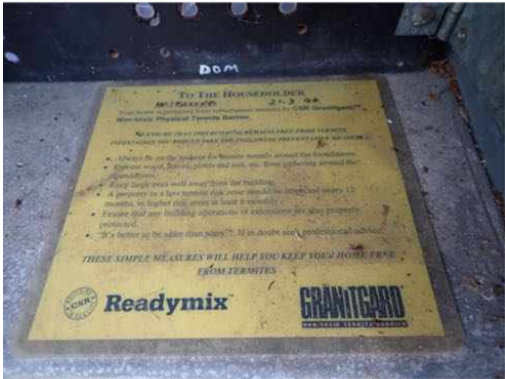
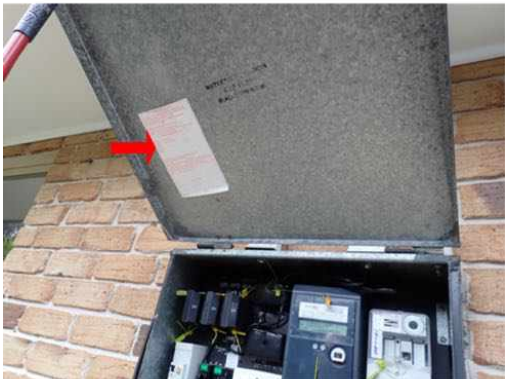
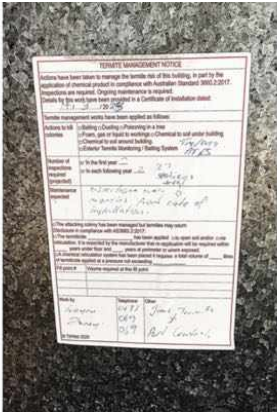
Building:	Main Building
Location:	Electrical meter box
Finding:	Termite Identification Stickers Located In Meter Box
Information:	Termite identification stickers were located within the meter box. The first sticker relates to the installation of a termite protection system installed at the time of construction, while the second sticker refers to a separate termite protection system installed more recently. It is recommended that the relevant installation companies be contacted to confirm current warranty coverage and maintenance requirements.

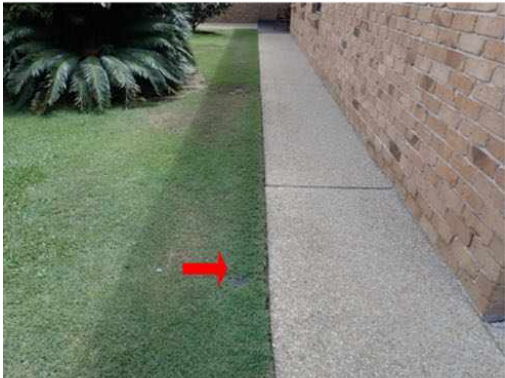
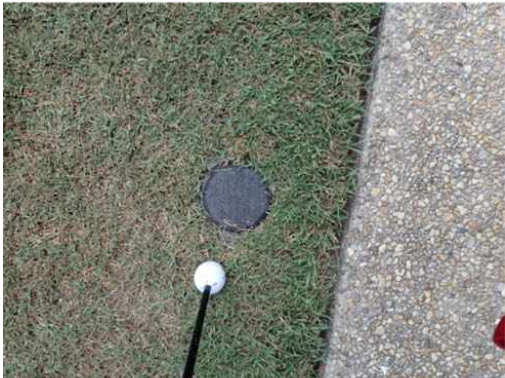
Building: Main Building
 Location: Perimeter of building
 Finding: Termite Protection Baiting System Installed Around Perimeter Of Building
 Information: A termite protection baiting system was observed installed around the perimeter of the building. This system is designed to assist in the management of termite activity. It is recommended that the installation company be contacted to confirm current warranty coverage, servicing intervals and ongoing maintenance requirements.
