## Building Inspection Report

Inspection Date: Thu, 15 Jan 2026

Property Address: 65 Maraket Ave, Blaxland NSW 2774,  
Australia

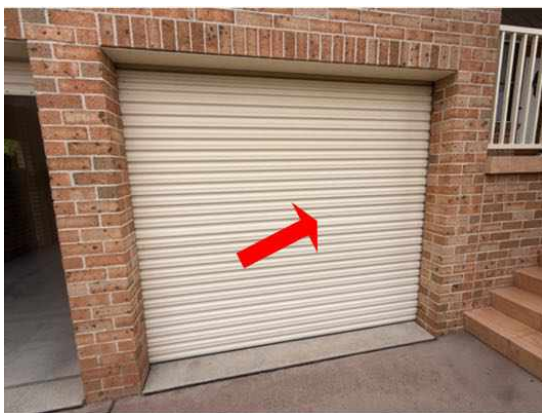
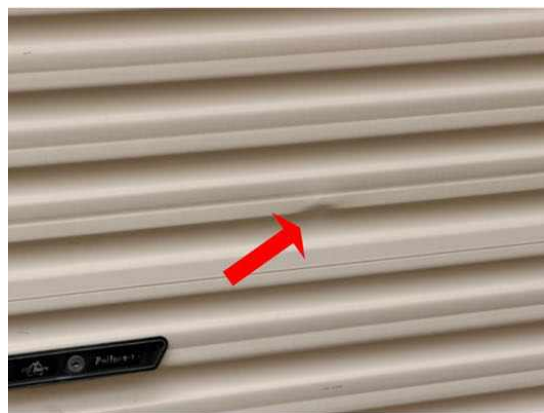
#### Defects 3.01

Building:	Main Building
Location:	Garage Door
Finding:	Garage door - Superficial markings
Information:	The garage roller door has a dent likely to have resulted from impact damage be it accidental or deliberate impact at sometime.

Garage roller doors can fail when the building materials have aged but may be indicative of impact damage (accidental or deliberate). While superficial markings detract from the aesthetics of the building element, the functionality has not been hindered in any way.

Repair and/or replacement of the garage door would improve the condition of the garage but certainly not an urgent item

A qualified roller door installer or supplier should be engaged to check out the operation and overall condition of the doors to determine if repair is an option otherwise replacement may need to be considered.

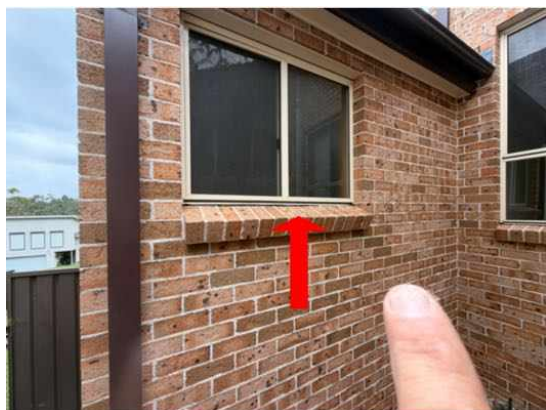
#### Defects 3.02

Building: Main Building  
 Location: Bedroom window ext  
 Finding: Window seal  
 Information: The window seal on this window has been pushed behind the brick sill.

This can lead to water ingress potentially causing further damage to other building elements.

I recommend a general handy man be appointed rectify this at the owners discretion.

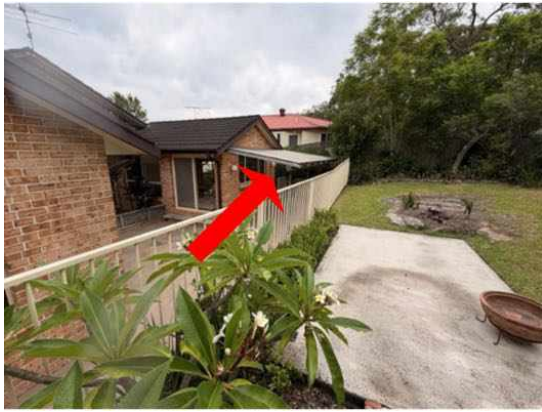
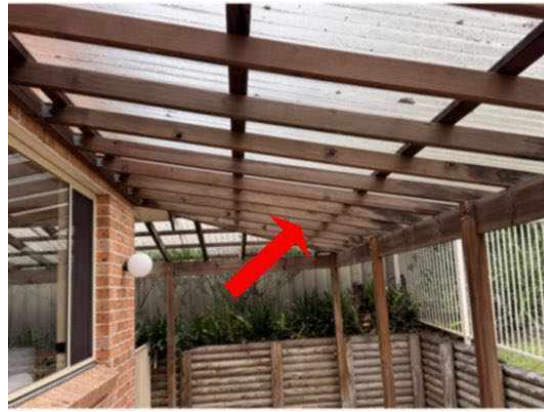
### Defects 3.03

Building: Main Building  
 Location: Living Room  
 Finding: Pergola - Unsealed  
 Information: The rear pergola was found to be deteriorating as it has no seal/paint finish. Whilst it is built from treated pine it should still be painted to prevent deterioration.

Also I recommend the roof sheeting be replaced as it is not in a good condition and doesn't extend past the end of the rafters.

This is causing accelerated decay of the timber structure.

At the moment the structure is sound but I highly recommend a protective coating be applied asap.

Recommend a carpenter be appointed to rectify this asap.

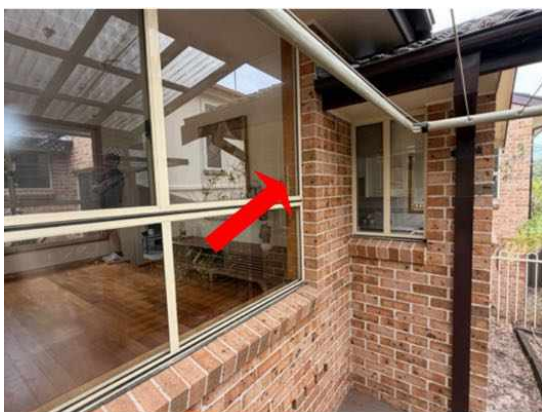
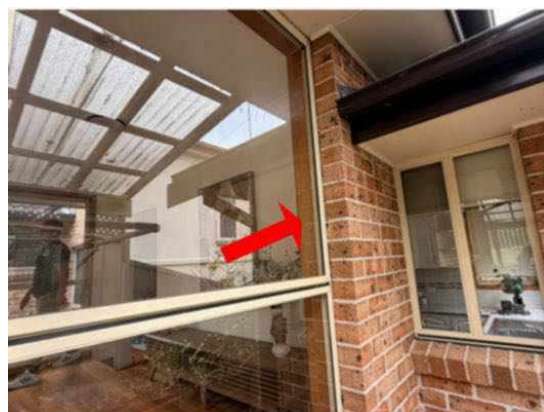
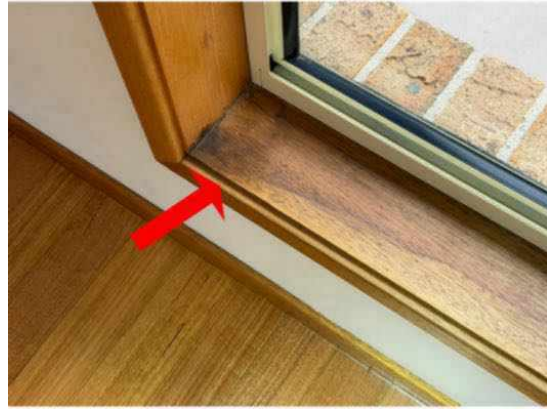
### Defects 3.04

Building:	Main Building
Location:	All Areas
Finding:	Gutters - Blocked
Information:	At the time of inspection it was found that this gutter was completely blocked with debris, leaves and silt.

It does look as though this has caused water ingress to the window previously.

The area was checked for high readings of moisture in the area and no high levels were recorded.

Blocked gutters are likely to lead to high levels of moisture in the affected areas. Such moisture will not only cause rust and decay of the associated building materials, but can also provide conditions that are conducive to termite and timber pest activity.

Blockages in gutters should therefore be removed immediately to ensure dry conditions are maintained.

Consult a Licensed Plumber for further specific advice on remedial works that may be required. In the interim, it is highly advised that blocked gutters be removed by the homeowner or a general handyperson as a matter of urgency.

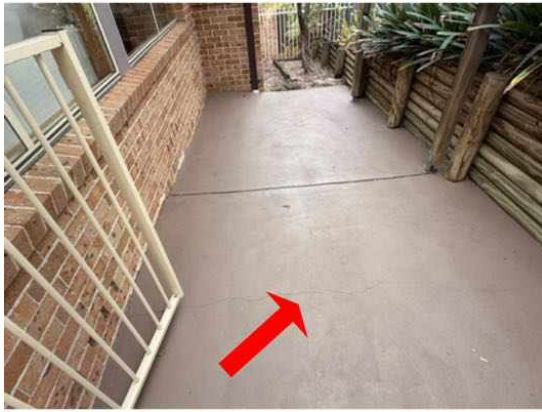
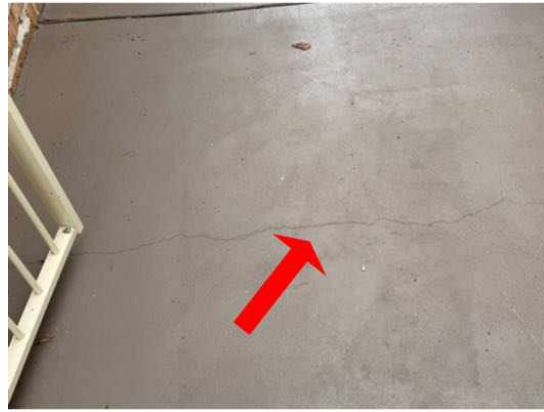
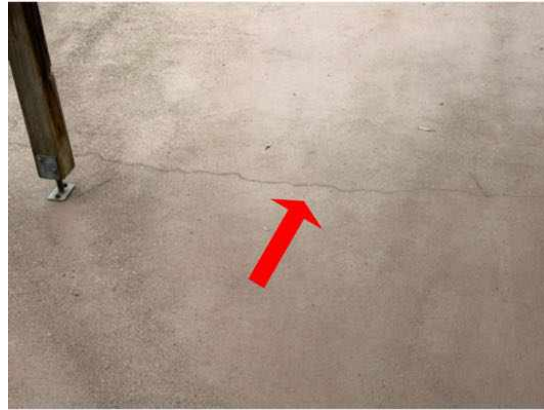
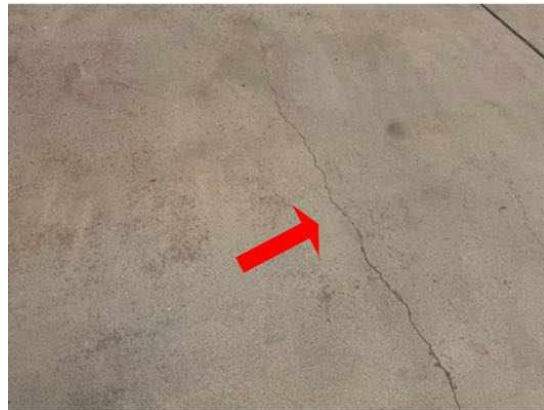
### Defects 3.05

Building:	Main Building
Location:	All External Areas
Finding:	Crack in concrete slab - Category 1
Information:	A crack coded as Category 1 was identified in the slab. A Category 1 crack is described as a fine but noticeable crack, with the slab at an otherwise reasonable level.

To be considered Category 1, the approximate width of the crack is less than 1.0mm, or a less than 10mm change in offset when a 3m straight edge is placed over the defect.

Category 1 cracks should be monitored for a period of 12 months. At the end of the monitoring period, identified cracks that are rated greater than Category 2 are considered defects, and require rectification.

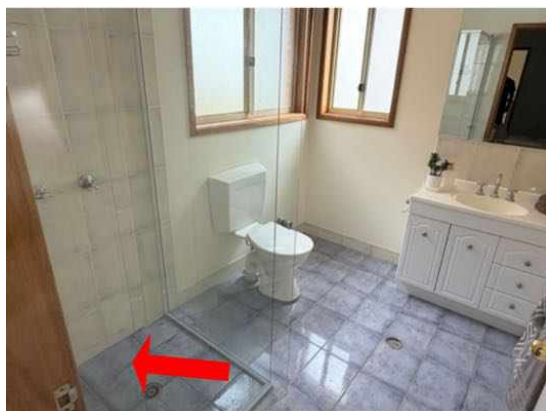
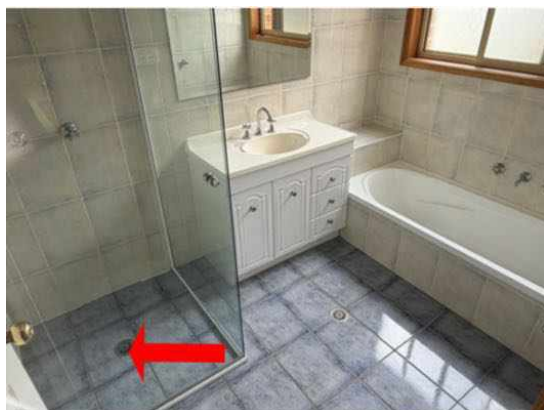
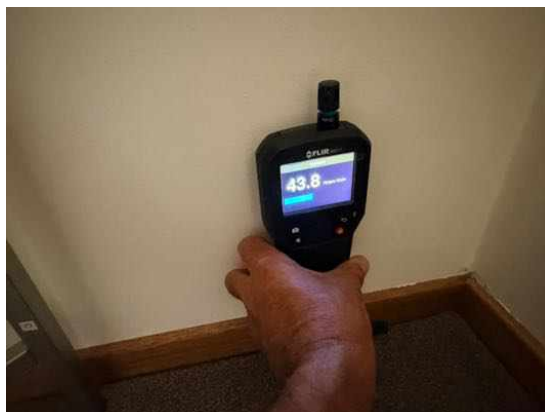
### Defects 3.06

Building: Main Building  
 Location: Showers  
 Finding: Shower seal repairs required  
 Information: The shower recess was flood tested and no visible leaks were noted at time of inspection.

However grout and silicone is missing from wall to floor tiled junctions. These areas of missing grout should be re-instated and silicone applied to all internal corners to maintain a good overall seal and to prevent water from penetrating under the tiled surface.

High moisture readings in adjacent walls was noted. Past water damage to nearby timber building elements was also present. Water is pooling around the floor-waste indicating inadequate fall.

Further inspection is recommended.

If a more accurate assessment is required, a special purpose inspection should be requested. Alternatively, the assumption should be made that the shower may leak.

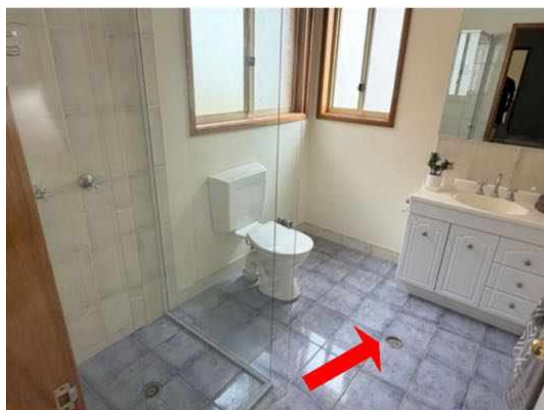
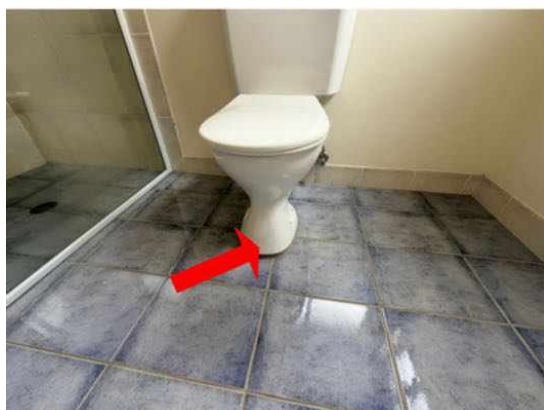
### Defects 3.07

Building:	Main Building
Location:	Bathroom
Finding:	Bathroom defects
Information:	Some minor defects were found in this area at the time of inspection.

The toilet pan has a crack in it. Again this does not cause any functional issues it is cosmetic but does deter from the general appearance of the bathroom. The toilet was checked for leaks and none were noted at the time of inspection.

A plumber could be appointed to replace the toilet at the owners discretion and a tiler be appointed to reinstall the floor waste at the owners discretion.

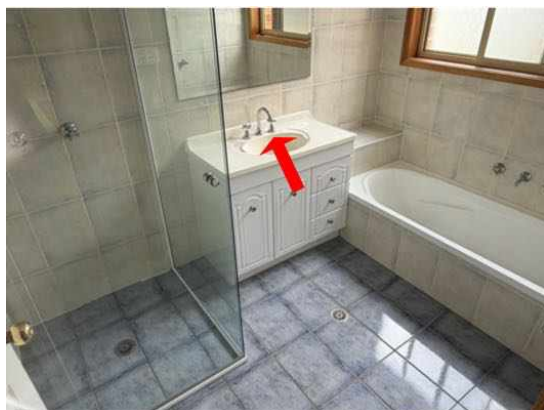
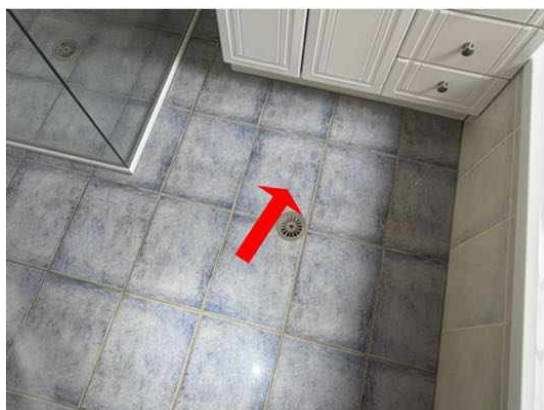
### Defects 3.08

Building:	Main Building
Location:	Bathroom
Finding:	Bathroom defects
Information:	Some minor defects were found in this area at the time of inspection.

The vanity basin has a small crack in it. Whilst this is cosmetic it does deter from the general appearance of the area.

Floor tiles in this area are cracked. Again they function as intended but do deter from the general appearance of the bathroom and could eventually lead to water ingress into the substrate which can lead to secondary defects.

A plumber could be appointed to replace the vanity basin at the owners discretion and a tiler be appointed to replace the cracked floor tiles at the owners discretion.

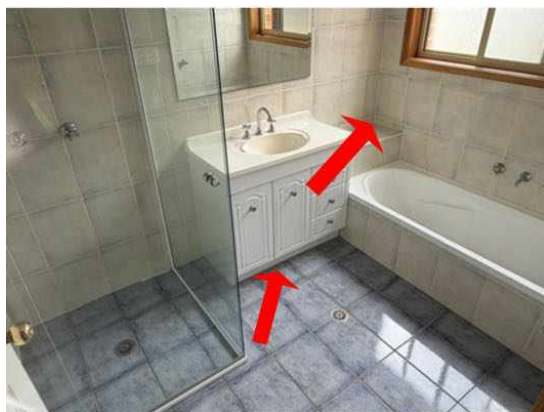
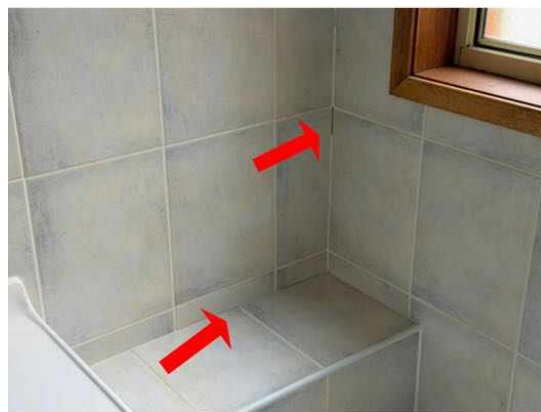
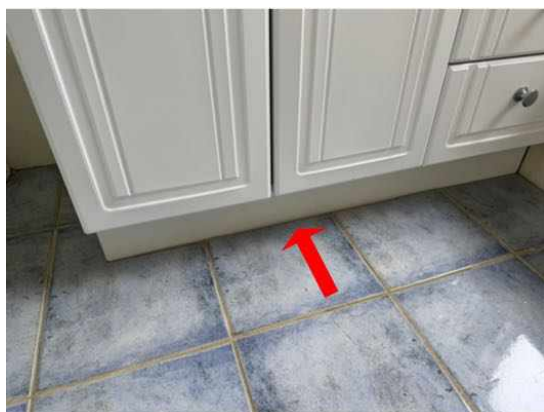
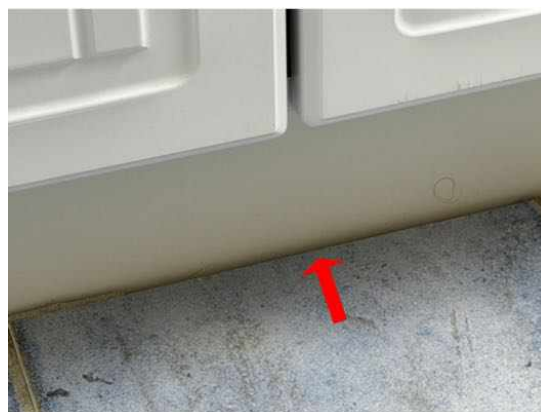
### Defects 3.09

Building:	Main Building
Location:	Bathroom
Finding:	Sealant - Missing
Information:	It was noted on inspection that sealant was missing to these areas

Different materials and floor areas move at different rates, generally causing cracking to grout or sealant at this point. A flexible sealant is required to allow for expected expansion and contraction, while keeping the joint water tight and protective of all associated building

Flexible and mould resistant materials should be applied to affected areas to prevent any subsequent water damage that is likely to occur. Regular maintenance and replacement of damage or missing or damaged sealant and grout is highly recommended to the wet areas, as this is a regular wear and tear defect. Sealant and grouting in areas that come into regular contact with water should be maintained for the long term care of your property.

A sealant specialist or tiling contractor should be appointed to complete these works as soon as possible

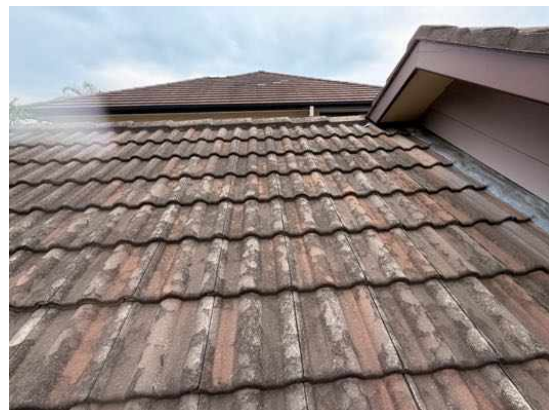
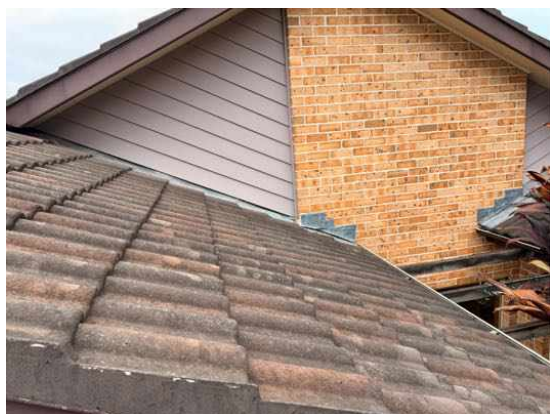
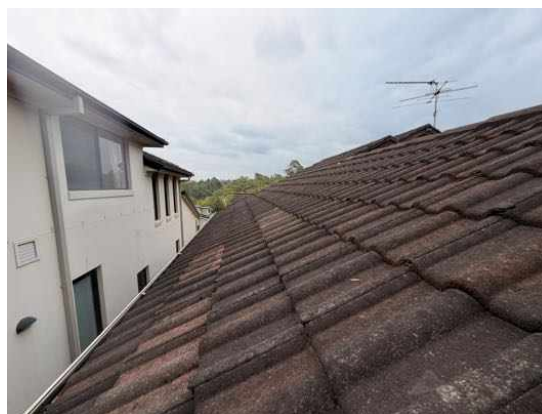
### Defects 3.11

Building:	Main Building
Location:	Roof Exterior
Finding:	Roof tiles - Weathered
Information:	Upon inspection of the exterior roofing, the majority of roof tiles were considered to be in a fair condition. While weathering of the tiles is consistent with the age of the property, maintenance works are required.

Isolated areas of mortar have come loose and minor cracking is also present. Repointing and re-sealing these areas may be considered as an interim solution by the client to help preserve and extend the life span of the tiles.

Where left unmanaged, deteriorating roof tiles are likely to lead to a number of secondary defects, including minor water leaks and weather exposure to internal roofing structures.

Consultation with a roofing contractor is highly advised to gain advice on cost of remedial works that may be required in the short to medium term. Remedial works are likely to increase the longevity of the exterior roofing structure.

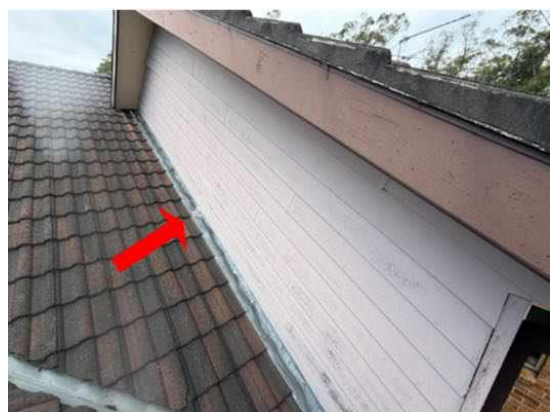
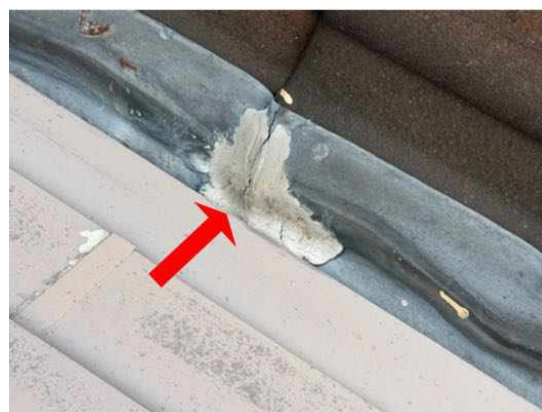
### Defects 3.12

Building:	Main Building
Location:	Roof Exterior
Finding:	Roof plumbing - Flashing cracked
Information:	Water leaks generally occur when a particular area of the property is not weather or water tight. Cracks were evident to the roof flashings at the time of inspection.

Regardless of the location, if left unmanaged, even minor leaks can lead to serious damage of associated building elements, potentially resulting in the need for replacement of building materials. Damage to ceilings, wood rot, mould and other hazards, such as electrical hazards, may also arise if left unmanaged.

The cause of the water leak should be identified and addressed immediately to prevent further damage. The water leak should be resolved prior to any repairs of the damaged area, which may require localised replacement of building materials and refinishing.

Further inspection by a qualified carpenter or licensed plumber is advised to adequately rectify the potential leak.

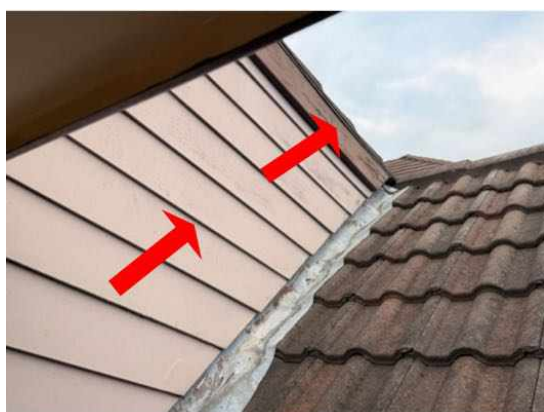
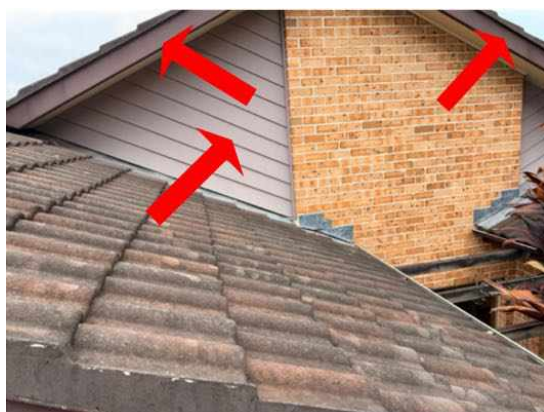
### Defects 3.13

Location:	All External Areas
Finding:	External painting deteriorated/weathered
Information:	Much of the external paintwork including but not limited to eaves, fascias and cladding have been neglected and require attention to prepare and re-paint.

Whilst incomplete or missing paint finish is generally an appearance defect, it can also lead to the development of secondary building defects over time. Incomplete areas of paint finish expose the area to moisture, potentially accelerating the deterioration of underlying building materials.

Degraded paint finishes should be sanded back, filled, leveled and painted, as applicable. Where inadequate or missing paint protection has led to the deterioration of the associated building element, repair and/or replacement of this building element may be required.

A painting contractor should be appointed as soon as possible to perform necessary works to aid the appearance of the affected area and to ensure the area is protected against further deterioration. Alternatively, the homeowner following manufacturer instructions may perform these works.

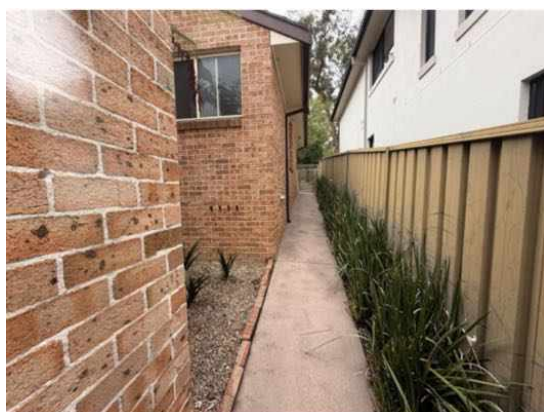
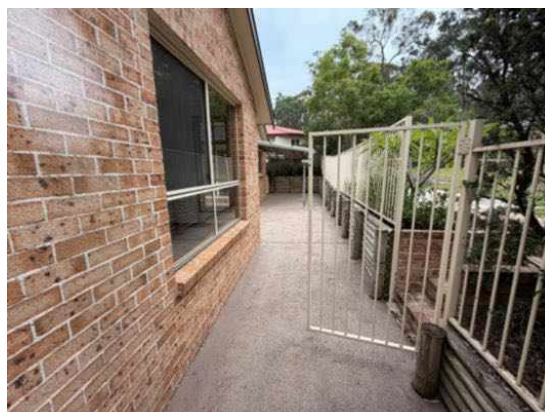
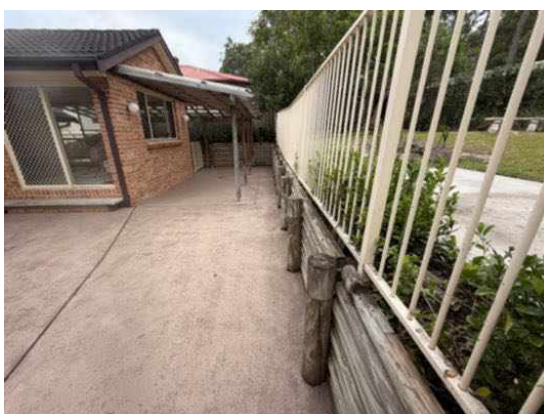
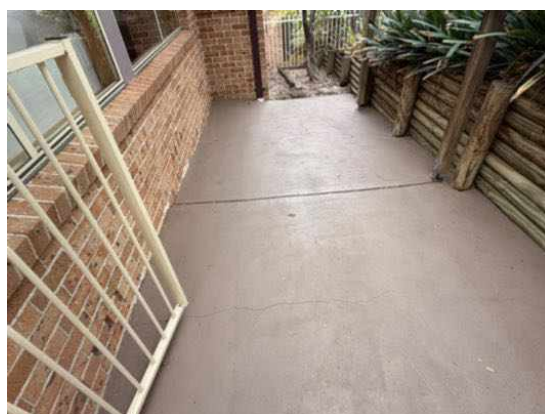
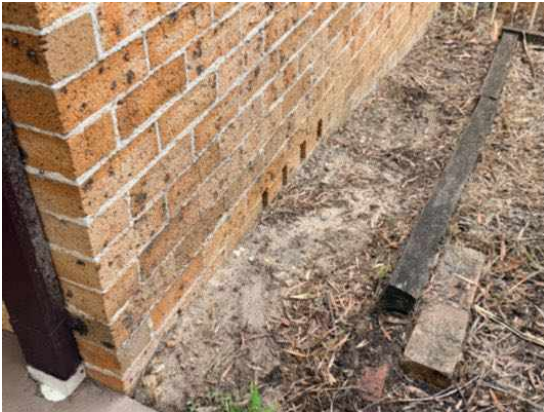
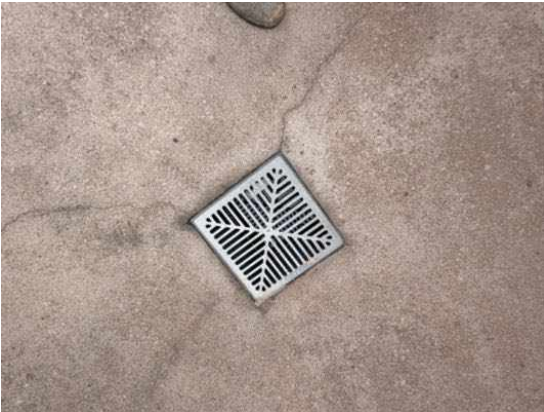
### Defects 3.14

The general adequacy of site drainage is not included in the standard property inspection report. Comments on surface water drainage are limited as where there may have been either little or no rainfall for a period of time, surface water drainage may appear to be adequate during the inspection but then during periods of heavy rain may be found to be inadequate.

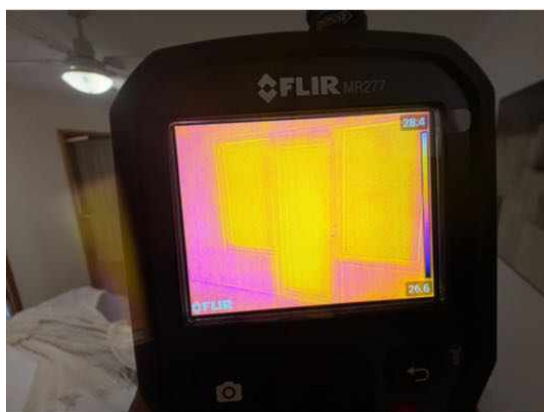
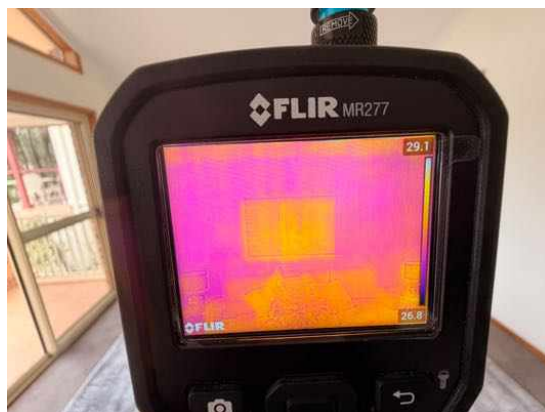
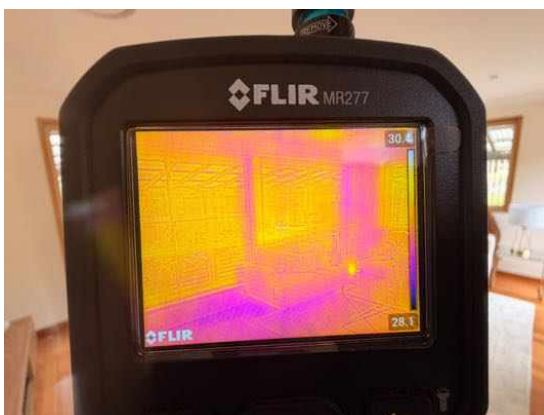
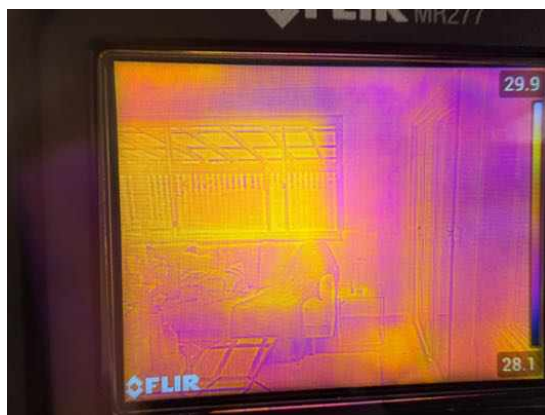
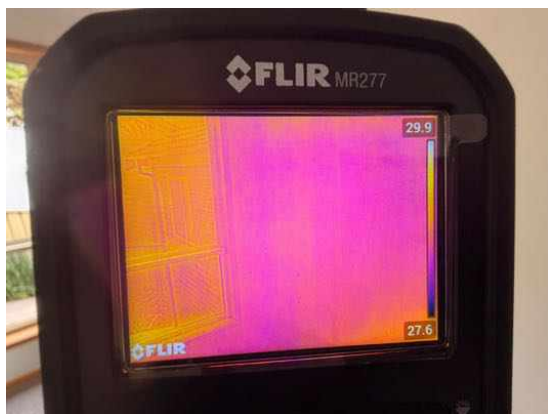
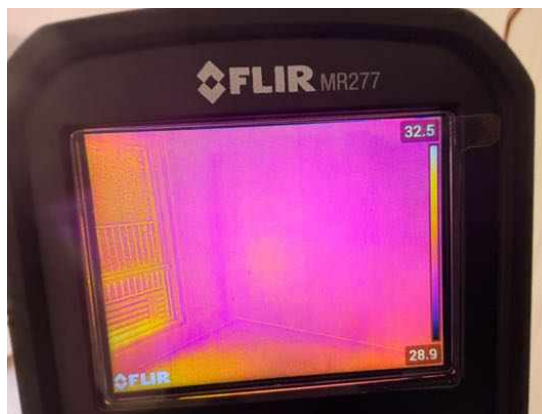
#### Noted Item

Building: Main Building  
Location: All Internal Areas  
Finding: For your information-Thermal camera  
Information: AS 3660.2:2017 is the recommendation for the carrying out of 'Additional Tests' using specialist non-destructive tools:

A thermal imaging inspection was carried out throughout the interior of the house using a Flir MR277 thermal camera. No thermal anomalies were noted that would be consistent with any current termite activity, however various factors must be taken into effect which may hamper or impede the reading obtainable by the imager. These factors include obstructions, ambient temperature, wall material and thickness etc. If any surface is restricted visually or otherwise, a proper thermal reading is not possible and is not within the scope of this inspection. Any findings or otherwise is reported on at the time of the inspection only.

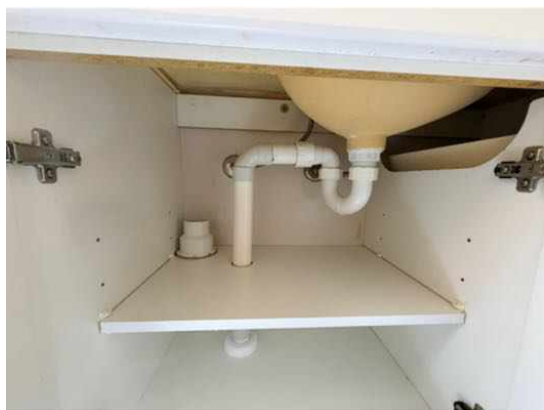
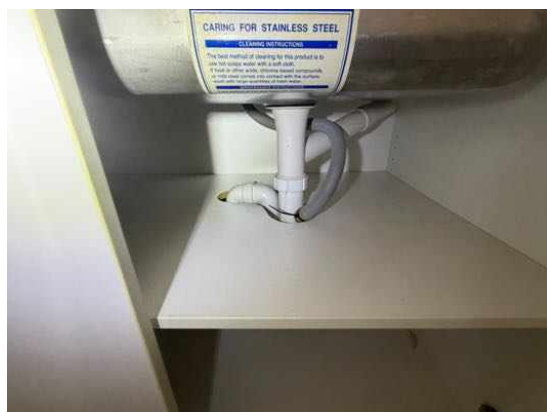
### Noted Item

Building: Main Building  
 Location: Cabinetry Plumbing  
 Finding: FYI-Cabinetry Plumbing  
 Information: All cupboards where sinks and basins with drainage plumbing were inspected no evidence of leaks were present at the time of inspection.

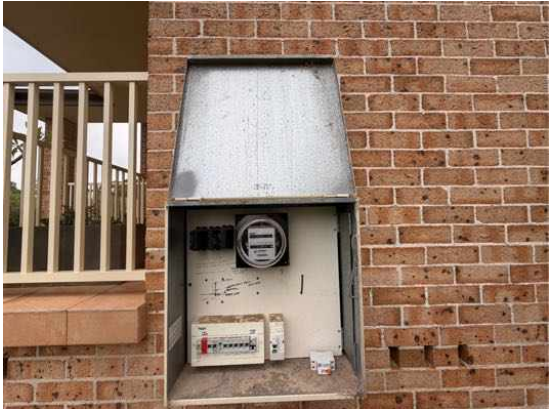
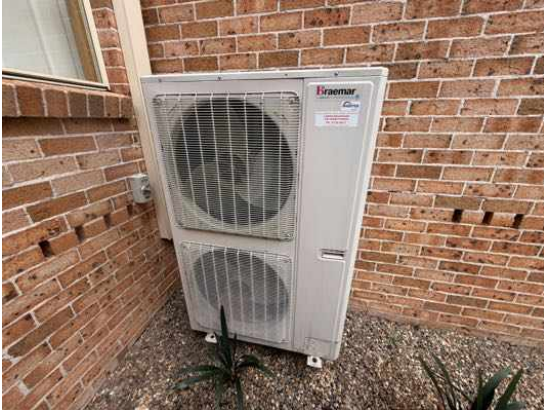
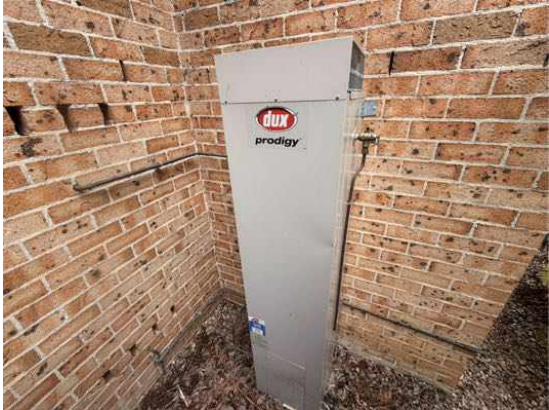
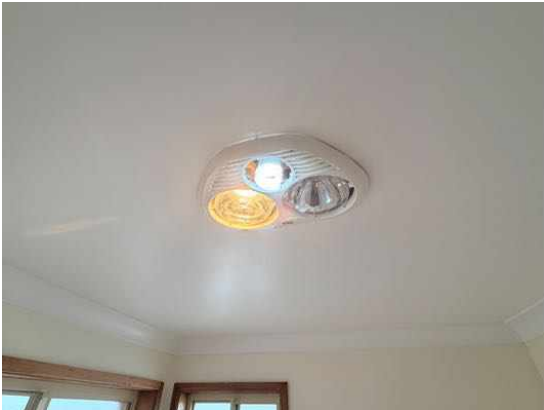
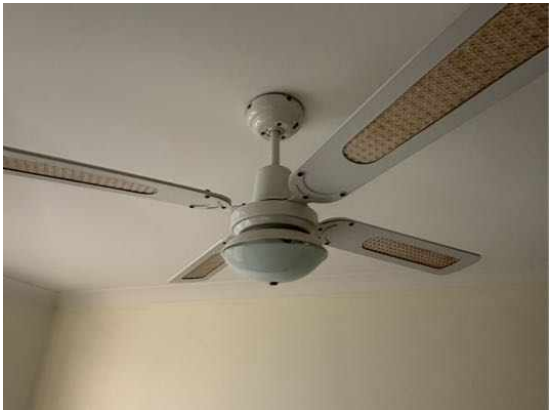
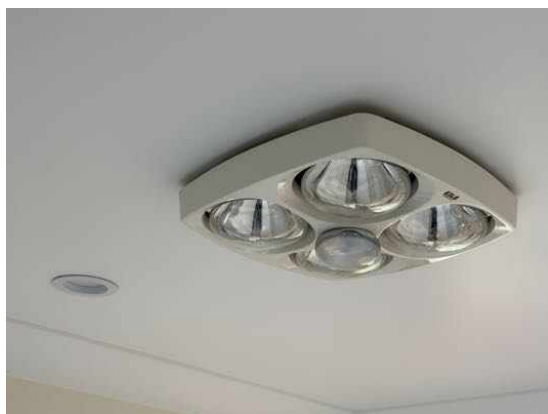
### Noted Item

Building:	Main Building
Location:	Plumbing/electrical/gas/aircon/pool equipment etc
Finding:	FYI-Plumbing and Electrical
Information:	Plumbing and Electrical inspections are outside the scope of the building inspection and must be conducted by a licensed and registered trades person.

It is highly recommended that the client makes immediate arrangements to have the gas appliances checked by a licensed gas plumber to ensure that the appliances are working safely and efficiently.

We recommend all other installations be checked also.

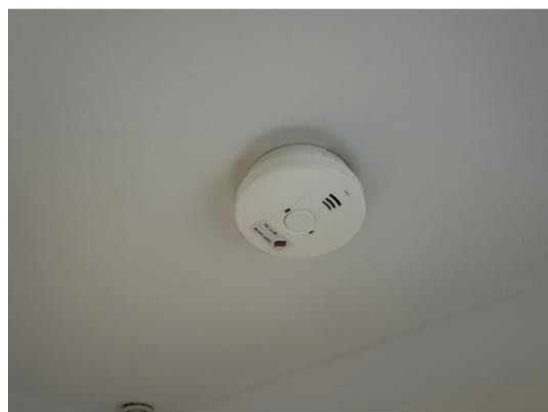
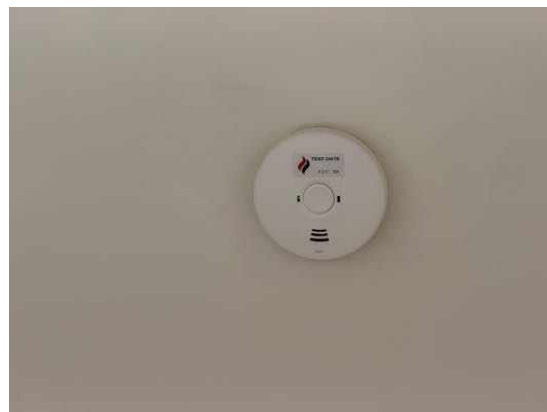
**Noted Item**

Building: Main Building  
Location: Smoke Detectors  
Finding: FYI-Smoke Detectors and Alarms  
Information: Reporting on Smoke Detectors or Alarms, including hard wired smoke detection systems and their legislative requirements, is outside the Scope of this Report.

Please note that this is highlighted as a caution only. We suspect, based on our experience in the building industry, that the absence of smoke detectors, or their poor condition, should be addressed as a matter of urgency to improve occupant safety.

Always ensure sufficient working and suitable smoke detectors are installed prior to occupying any building. Additionally, it is advised that all smoke detectors be tested by the homeowner on a monthly basis.
