Building Inspection Report

Inspection Date: Fri, 27 Mar 2026

Property Address: 5/7 Mockridge Ave, Newington NSW 2127,
Australia

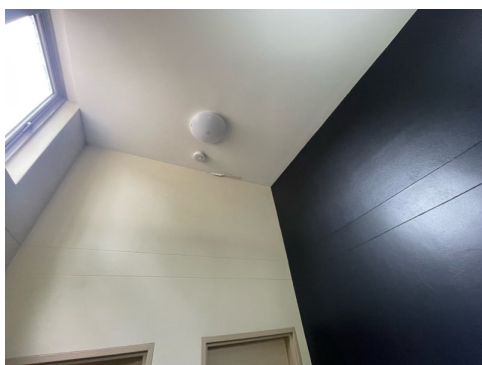
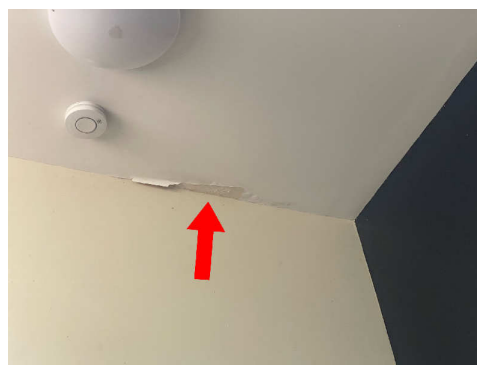
Defects 3.01

Location: Strata / Stair Landing

Finding: Ceiling - Water damaged

Information: Water damage to the ceiling lining is generally an indication of excessive moisture being present in the roof void, usually via a leak to the roof covering.

Externally and within the accessible strata/common areas, water damage to the ceiling at the stair landing was noted. As this area appears to relate to common property, responsibility for further investigation and rectification would typically rest with the owners corporation/strata management, subject to confirmation of strata boundaries and records. Buyers should review the current strata report carefully and make their own enquiries regarding any past, current, or proposed repairs, waterproofing issues, or building defects affecting common property.

Where water damage is evident to the ceiling, the primary requirement is to identify and rectify the source of the leak.

A roofing plumber should be appointed as soon as possible to identify the leak and perform rectification works as necessary, ensuring the water damage is restricted.

Once the leak is repaired, consultation with relevant tradespeople, including plasterers and painters, is advised. Rectification works may include replacement of ceiling lining or minor repainting, depending on the extent of the damage.

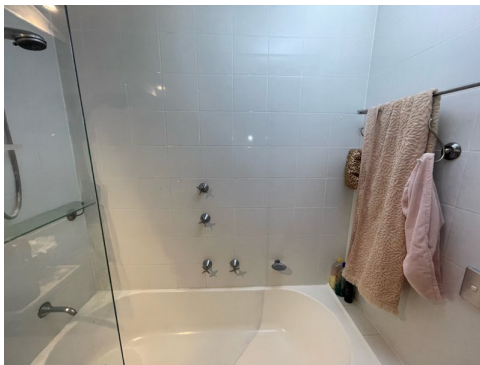
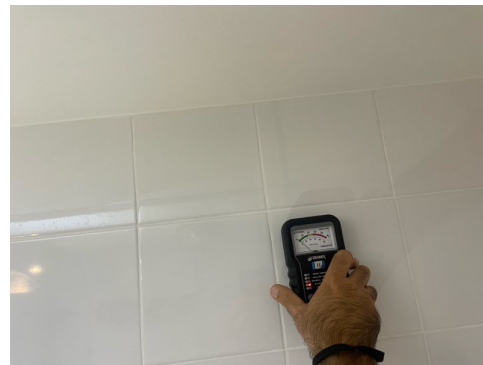
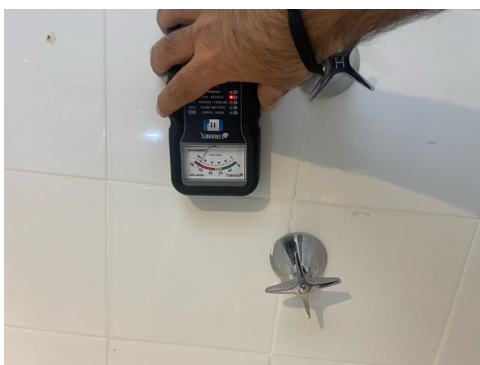
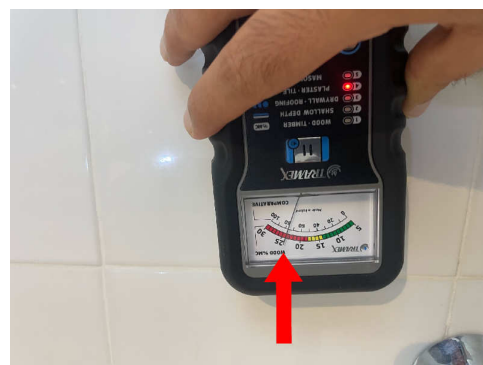
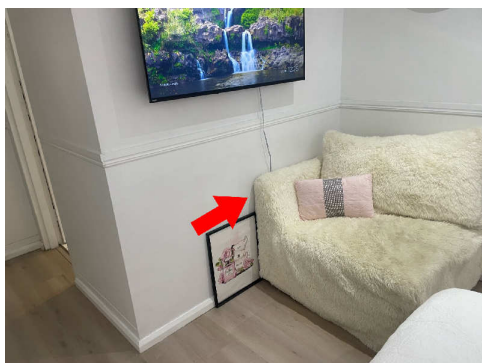
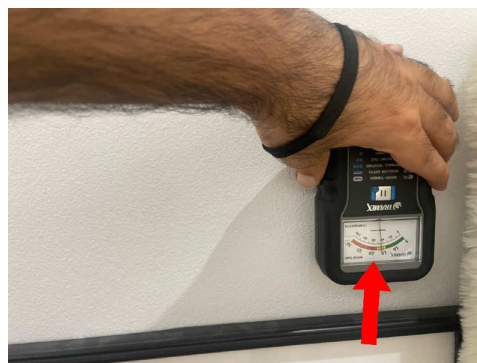
Defects 3.02

Location: Ensuite - Master

Finding: Bathroom – Localised Moisture Ingress at Bath Wall

Information: Moisture testing to the bathroom wall identified elevated readings to the wall surface located between the bathtub tap assembly and the bathtub, together with localised high moisture readings to the adjoining wall. These findings are consistent with active or intermittent moisture ingress affecting the wall lining and possibly concealed building elements.

The condition is commonly associated with leakage from plumbing penetrations, defective sealant, or failure of waterproofed junctions in the bath area. Ongoing moisture intrusion may result in concealed material deterioration and fungal growth.

Internally, the main issues noted included localised moisture ingress to the master ensuite bath wall, together with cracked or damaged tiles in the same area. These findings may indicate water penetration, deterioration of finishes, or failed sealing/waterproofing to the bathroom area. Moisture-related defects should be attended to promptly, as prolonged exposure may result in concealed damage, deterioration of wall linings, and conditions conducive to mould growth.

Further assessment by a licensed plumber is recommended to confirm the source and extent of the defect.

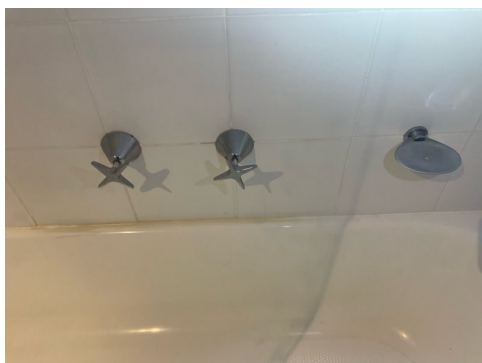
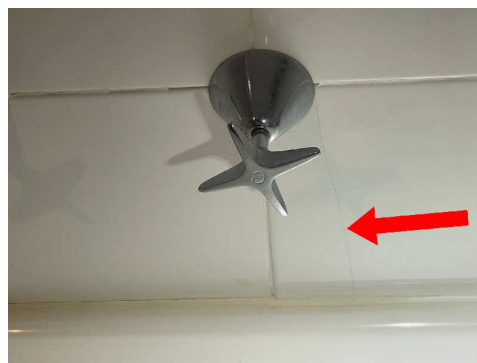
Defects 3.03

Location: Ensuite - Master

Finding: Tiles - Cracked or damaged

Information: Cracking was evident to the tiling in this area at the time of inspection. While the cracking appears to be minor, this area is frequently exposed to water, allowing potential for water penetration into adjoining sections of walls or flooring.

If left unmanaged, water penetration to these areas may lead to subsequent water damage, which is likely necessitate repair work to affected building elements.

A tiling contractor should be appointed to ensure that no further water damage occurs.

The re-application of silicone and grouting throughout remaining tile work is also advised, to further protect the area against water penetration.

Where water penetration has led to water damage, appointment of a relevant tradesperson may be required to repair damaged building elements.

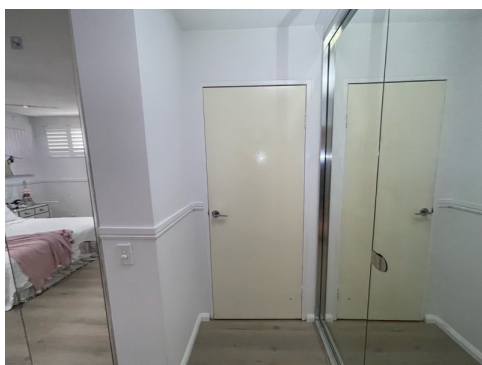
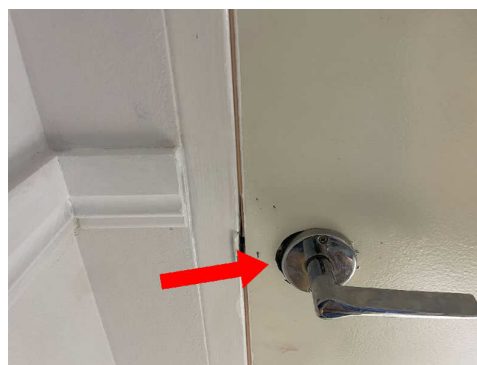
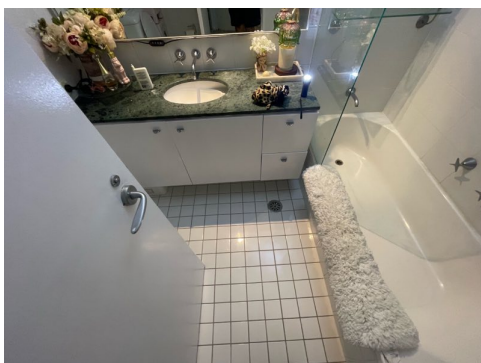
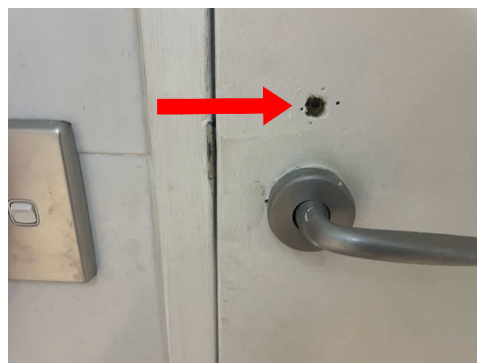
Defects 3.04

Location: All Internal Areas

Finding: Door – Damaged

Information: Damage was noted to the door, including visible holes and/or surface deterioration. The defect appears consistent with impact damage or wear and tear and affects the presentation and serviceability of the door. Repair or replacement is recommended as needed.

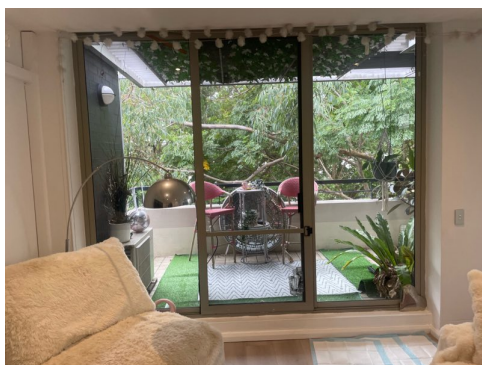
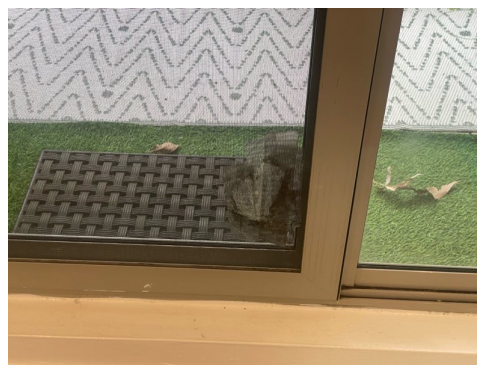
Defects 3.06

Location: Living Room

Finding: Damaged Flyer Screen Door – Replacement Required

Information: The flyer screen door was observed to be broken and significantly damaged. The door hinge is not properly connected, compromising its functionality. There is no existing log or record of prior damage.

The condition reduces the usability and security of the door and may worsen if left unaddressed.

Immediate replacement of the flyer screen door is recommended to restore proper function and ensure safety.

Repairs should be carried out by a qualified tradesperson to ensure correct installation and operation.
