Building and Timber Pest Inspection Report

Inspection Date: Tue, 3 Feb 2026

Property Address: 33 Ringrose Ave, Greystanes NSW 2145,
Australia

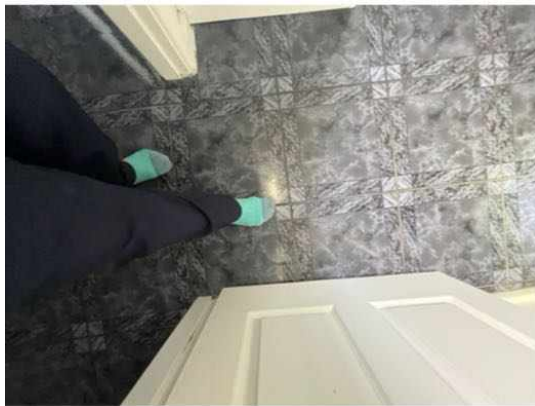
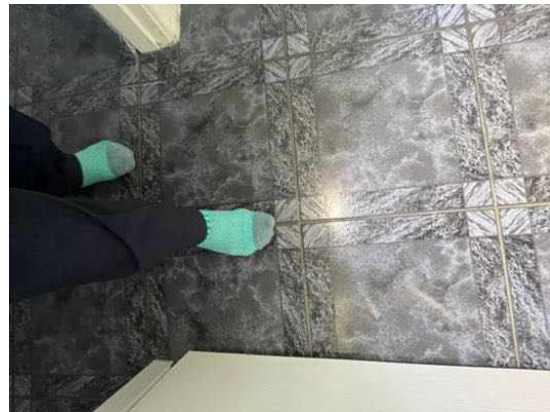
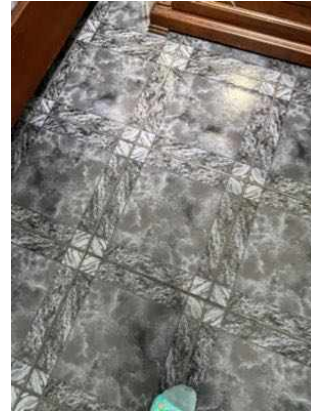
Finding 3.01

Building:	Main Building
Location:	All Areas
Finding:	Crackling or creaking sound on the tiles floor
Information:	Small but noticeable crackling or creaking sound was detected when walked on the tiles in the area. The cause of the crackling sound can be from number of the reasons including inadequately bonded tiles to the the substrate base for the tiled area, degraded or deflected plywood under the tile or inadequately installed control joint for expanded tiles. Further monitoring to the area is recommended and if the crackling sounds intensifies or the area being further deteriorates, licensed builder should be appointed to inspect further and repair the areas.

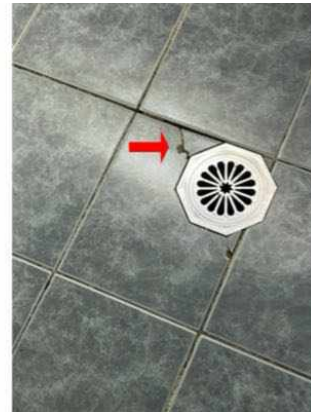
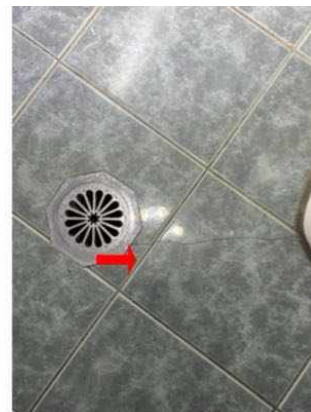
Finding 3.02

Location: Bathroom

Finding: Tiles - Cracked

Information: During the inspection, it was observed that the tiles in this area had visible cracks. Typically, cracked tiles are a result of underlying issues such as incorrect installation, temperature changes, cracks in the substrate, excessive weight on the tiles, or accidental impact. Since the cracked tiles detract from the overall appearance of the area, it is advisable to hire a professional tiling contractor to address the issue.

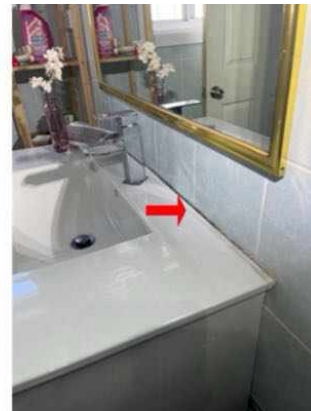
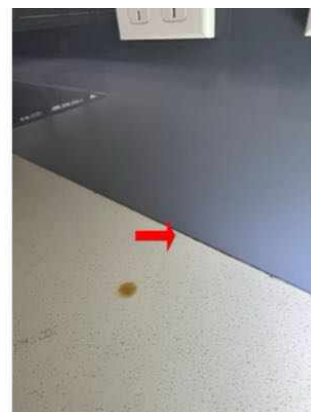
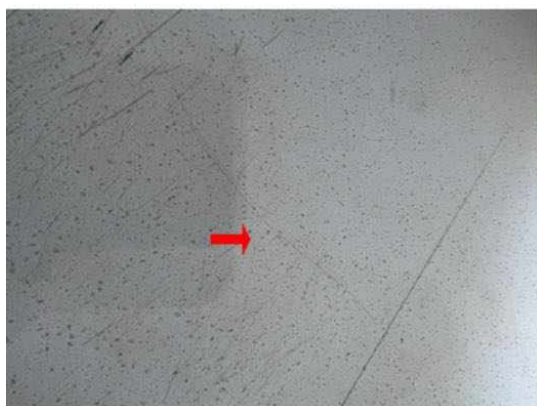
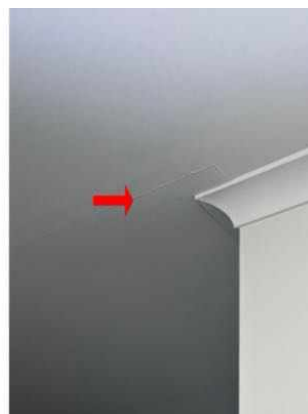
Finding 3.03

Building: Main Building
Location: All Areas
Finding: Deterioration caused by Fair and Wear and Tear
Information: Certain forms of deterioration commonly associated with fair wear and tear may not be specifically itemised within this report. At the time of inspection, minor hairline cracking was observed to plaster linings and junctions consistent with normal building movement over time, together with a bathroom door that exhibited a slight rattle when operated, indicative of minor hardware or alignment adjustment being required rather than a structural defect. Deterioration to some areas of sealant, particularly around wet area junctions and joinery interfaces, was also noted as being aged and serviceable but nearing the end of its effective life, which is typical for a property of this type and age. A small superficial crack was further observed on the surface of the bathroom benchtop; this appeared cosmetic in nature and did not show signs of active movement, displacement, or moisture-related failure.

In accordance with the pre-inspection agreement, these minor and cosmetic conditions are generally excluded from detailed reporting unless they constitute a major defect, safety issue, or significant structural concern. Accordingly, the presence of such age-related items should be viewed as normal wear and tear rather than evidence of defective workmanship or structural failure.

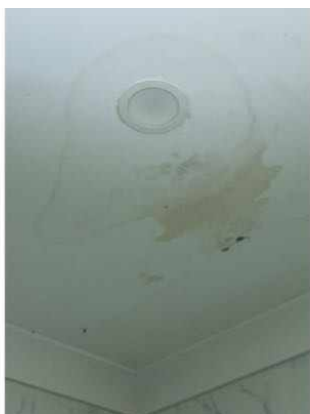
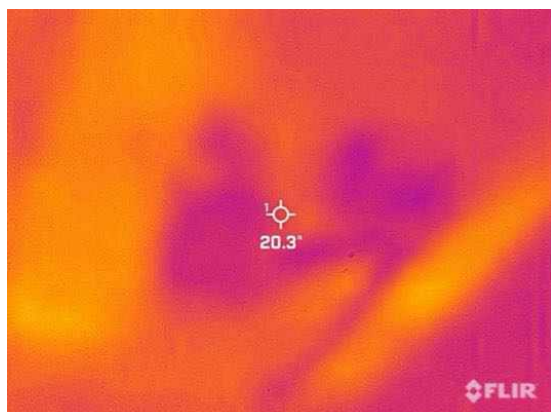
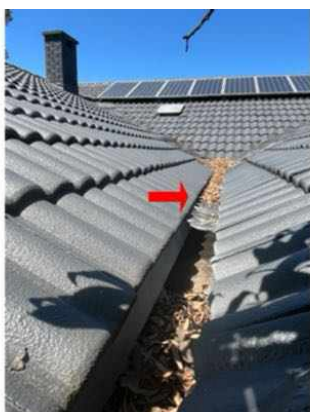
Finding 3.04

Location: All Areas

Finding: Ceiling - Water Stained

Information: At the time of inspection, water staining and associated surface deterioration were clearly evident to the ceiling linings in this area, consistent with ongoing or recent water ingress. The pattern, extent, and distribution of staining indicate that moisture has migrated through the ceiling substrate rather than being a superficial or historic blemish. Thermal imaging assessment and moisture meter testing confirmed the presence of elevated moisture levels in the affected area, supporting the conclusion that the defect is active rather than solely residual from a past event.

Given the location of the staining directly beneath a box gutter, it is reasonably suspected that the source of water ingress is associated with the box gutter system above, likely due to blocked drainage, defective flashing, membrane failure, or compromised waterproofing detailing. Continued exposure to moisture in this manner has the potential to degrade ceiling linings, promote mould growth, and, if left unaddressed, may lead to damage of concealed structural elements such as ceiling battens or framing.

It is therefore recommended that a licensed plumber or appropriately qualified roofing contractor be engaged to inspect the box gutter, associated flashings, and drainage components to identify the precise source of leakage and carry out necessary remedial works. Following rectification of the leak, damaged ceiling linings should be repaired or replaced as required to restore the integrity and appearance of the affected area.

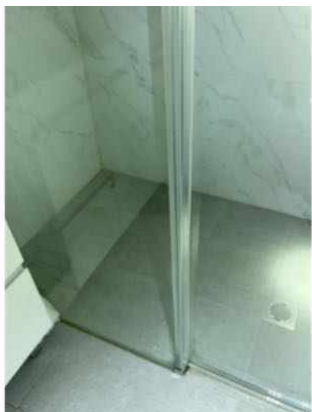
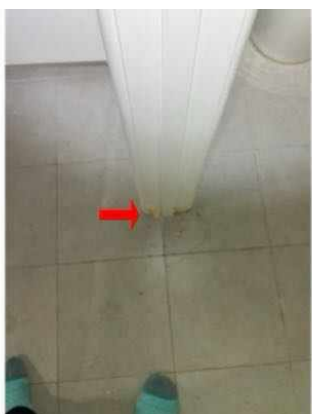
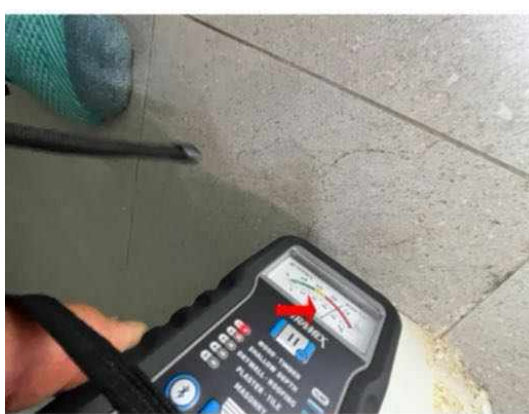
Finding 3.05

Building:	Main Building
Location:	Bathroom 2
Finding:	High Moisture Metre Readings - inadequate waterproofing is suspected
Information:	High moisture metre readings were identified in the area at the time of the inspection. The high moisture metre readings may implies that water proofing to the wet area/s may not comply with Australian Standards. Incorrect application of waterproofing materials and poor or substandard application of water proofing methods are common minor defects, but can have serious implications if left unattended.

resistant buildings materials. Failure to prevent excessive moisture in these areas may lead to the development of water damage and other secondary defects to associated building elements.

Although there was no noticeable water damages found around the area, it is recommended to assume that the area leaks and repair the waterproofing or carry out an invasive inspection.

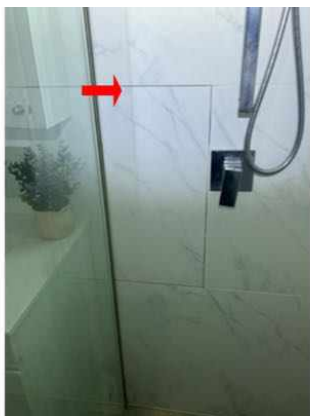
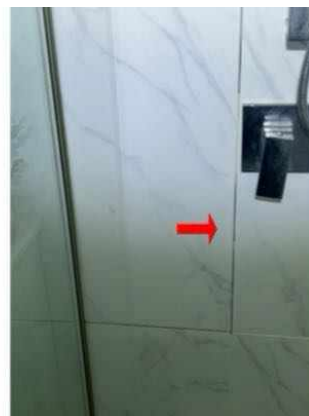
Finding 3.06

Finding: Missing Grout

Information: At the time of inspection, it was noted that grout is missing along the vertical and horizontal tile junctions adjacent to the shower screen and within the tiled wall area. The absence of grout leaves the tile joints exposed, reducing the effectiveness of the tiled lining as a water-resistant barrier and increasing the likelihood of moisture penetration behind the tiles. Over time, this condition may contribute to water ingress into concealed substrates, potential deterioration of backing materials, and conditions conducive to mould growth or tile debonding. The affected areas should be properly cleaned and re-grouted by a suitably qualified tiler to restore the integrity of the tiled surface and maintain adequate moisture resistance in the wet area.

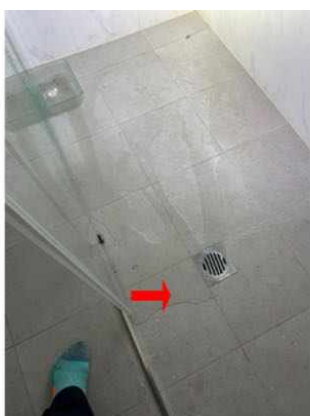
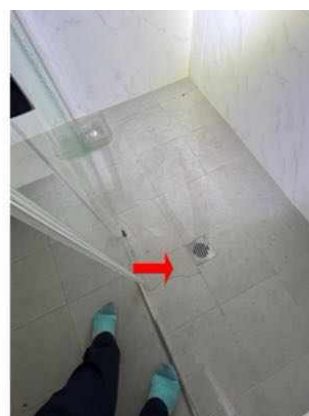
Finding 3.07

Building:	Main Building
Location:	Bathroom 2
Finding:	Shower base - Water pooling
Information:	Evidence of water pooling around the floor waste in the shower recess was noticed at the time of inspection. It is suspected that this excessive moisture is attributed to insufficient fall in the shower floor tiles.

This pooling is minor overall but is still considered unsatisfactory, as standard tiling practices would not permit this situation to occur. Pooling water around floor wastes can create a slip hazard in extreme cases and create conditions that are conducive to mould growth over time. Where left unmanaged, the degradation of sealant and grouting is also likely to occur, possibly necessitating further repair works.

Remedial works may involve some sections of tiling and flooring repair and replacement. A tiling contractor or bathroom specialist should be appointed to provide further advice on reparation options and to perform works as necessary.

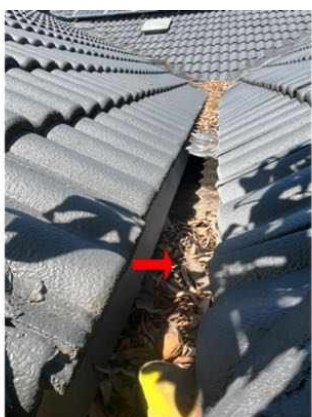
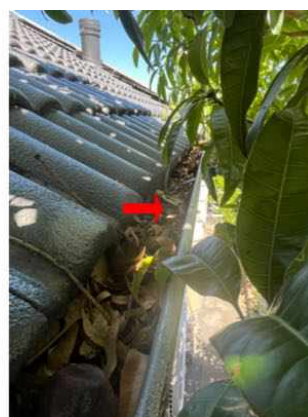
Finding 3.08

Building:	Main Building
Location:	Roof Exterior

Blocked gutters are likely to lead to high levels of moisture in the affected areas. Such moisture will not only cause rust and decay of the associated building materials, but can also provide conditions that are conducive to termite and timber pest activity. Blockages in gutters should therefore be removed immediately to ensure dry conditions are maintained.

Consult a Licensed Plumber for further specific advice on remedial works that may be required. In the interim, it is highly advised that blocked gutters be removed by the homeowner or a general handyperson as a matter of urgency.

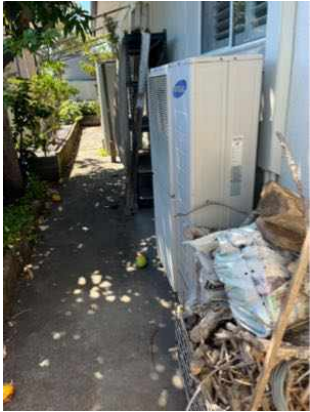
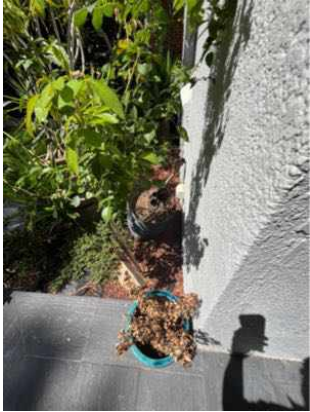
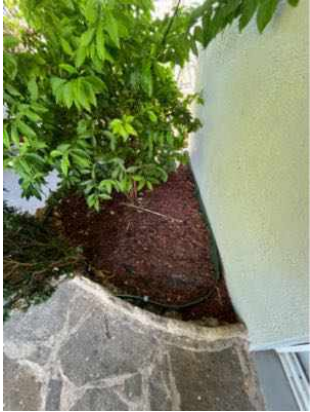
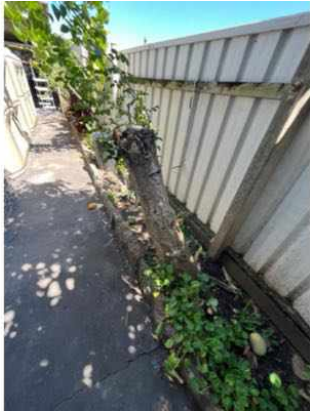
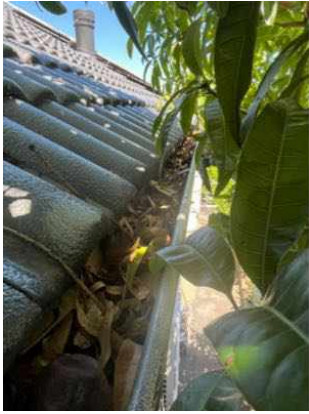
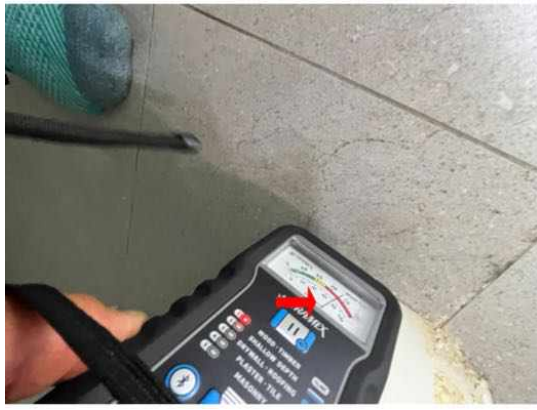
Finding 6.01

Finding: Conditions Conducive to Termite Activity

Information: The following areas and environmental conditions were identified as conducive to termite activity. These conditions increase the risk of concealed termite entry and should be addressed through appropriate maintenance, repairs, improved drainage, additional monitoring, or the installation of a compliant termite management system.

Inadequate Hot Water System (HWS) Overflow

The HWS overflow discharges directly to ground, resulting in constant moisture at the building perimeter. Excess moisture provides conditions favourable to termite activity.

Inadequate Air Conditioner Overflow Drainage

Air conditioner condensation lines discharging near walls can cause damp soil conditions, attracting termites.

External taps without drainage provisions allow pooling at the base of walls, increasing moisture levels.

Blocked gutters were noted to cause overflow, directing water onto walls and foundations. Excess moisture increases termite attractivity.

Stumps and garden beds near the dwelling provide both moisture and cellulose, creating ideal termite feeding sites.

Higher-than-normal moisture readings in wall or timber elements indicate hidden moisture sources and increased susceptibility.

Recommendation: Where no system exists, install a compliant termite management system and retain all documentation for future reference.

Recommendation: Connect the overflow to suitable stormwater drainage to divert water away from all structural elements.

Recommendation: Ensure AC overflow pipes are connected to appropriate stormwater drainage.

Recommendation: Install a drainage system or concrete plinth that directs runoff away from the structure.

Recommendation: Clean and maintain gutters and downpipes regularly.

Recommendation: Remove decaying stumps and avoid positioning garden beds directly against walls.

Recommendation: Maintain a minimum of 75 mm slab edge exposure in accordance with relevant standards.

Recommendation: Cut render back to create a continuous inspection zone.

Recommendation: Investigate all sources of moisture and undertake immediate rectification.

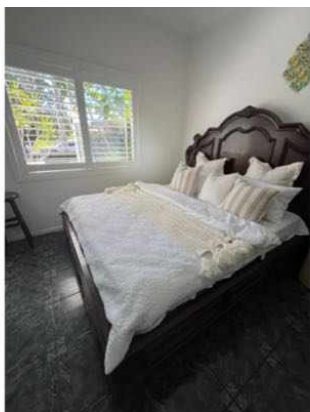
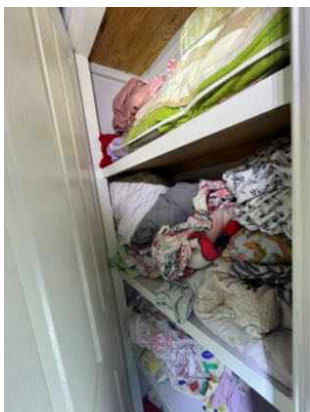
Building: Main Building
Location: All Areas
Finding: Note Regarding Mould and Staining
Information: It should be noted that the presence of furniture or stored items within the dwelling may restrict airflow and ventilation, particularly behind such items, creating conditions conducive to condensation and subsequent mould or staining.

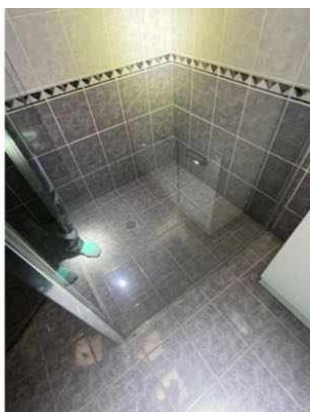
Building: Main Building
Location: Bathrooms
Finding: Minimum Moisture Readings Detected
Information: After assessing the shower recess, the moisture content of the walls within and surrounding the wet area was examined. The readings showed no significant variation between the walls behind the shower and other internal walls, and there were no visible signs of recent moisture-related damage on the surrounding accessible wall surfaces. Based on these findings, the waterproofing system appears to be performing adequately at the time of inspection, with no current evidence of active leakage.

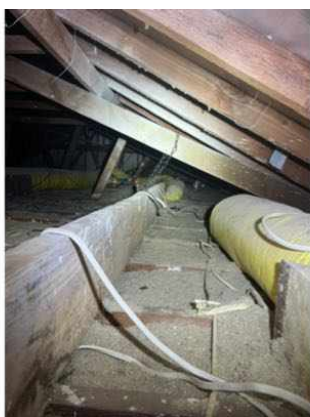
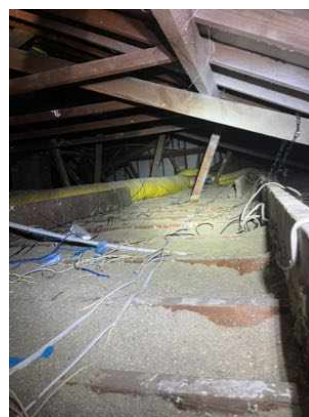
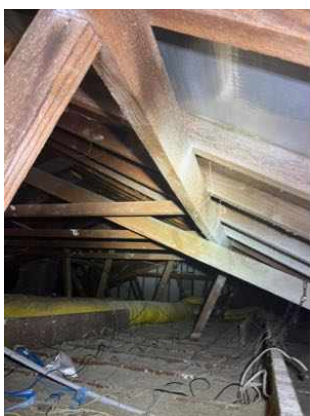
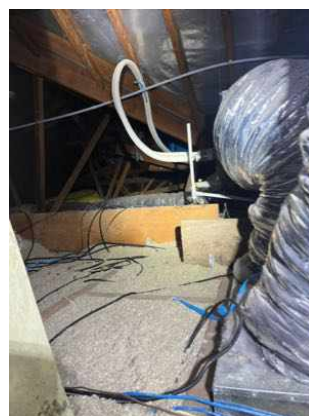
Building: Main Building
 Location: Roof Void
 Finding: Condition of Building Elements in the Roof Void
 Information: At the time of inspection, the roof void was visually assessed in accessible areas and was found to contain a combination of timber roof framing, reflective foil sarking, bulk insulation, flexible ducting associated with the AC system, and various electrical and data cabling. The primary timber roof structure, including rafters, ceiling joists, strutting, and bracing, generally appeared to be intact and performing its intended structural function, with no obvious signs of major structural failure, widespread deflection, or significant deterioration observed in the areas that were reasonably

However, the roof space was heavily congested with AC ducting, insulation, and services, which significantly restricted access and visibility to many parts of the cavity, increasing the risk that concealed defects or issues may be present in areas that could not be directly inspected. The flexible ducting was observed to be resting on insulation and timber framing in multiple locations, and while this is commonly seen in residential properties, the lack of consistent support and clear pathways may reduce airflow efficiency and could contribute to compression of insulation over time.

Electrical and data cabling were noted to be loosely laid across ceiling joists and insulation without consistent securing or segregation, which is considered untidy and not best practice, as it can increase the risk of damage to cables during future maintenance activities. The reflective foil sarking to the underside of the roof sheeting appeared generally continuous, but its condition could not be fully verified due to access limitations and obstruction from ductwork. Bulk ceiling insulation was present; however, it was uneven in places and displaced around services, which may reduce its thermal performance in affected areas.

Overall, while the roof framing appeared generally serviceable, the roof void exhibited a high level of congestion, disorganised services, and access limitations, and it would be prudent to improve duct support, cable management, and insulation distribution to enhance long-term performance and maintainability of the roof space.
