Building and Timber Pest Inspection Report

Inspection Date: Tue, 7 Apr 2026

Property Address: 98 Baanya St, Wurtulla QLD 4575, Australia

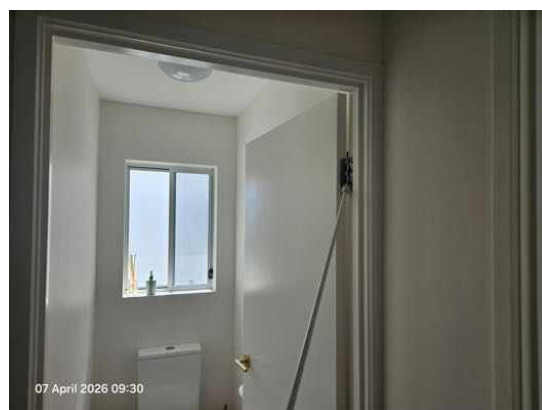
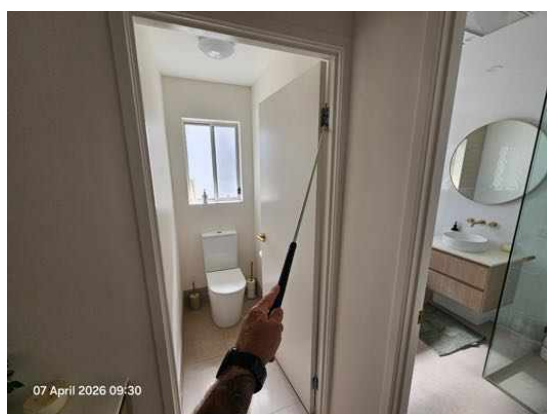
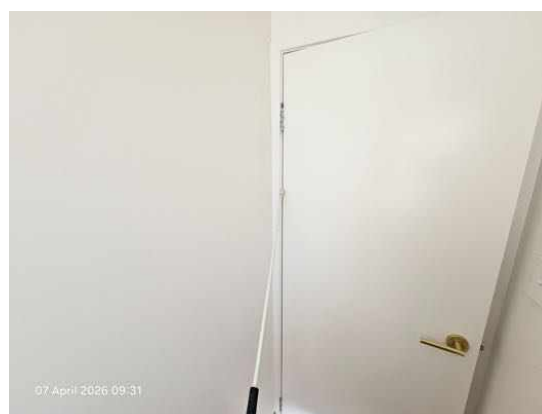
The BCA requires that the door to a fully enclosed sanitary compartment (WC or toilet) must either open outwards slide or be readily removable from the outside of the compartment. This requirement applies unless there is clear space of at least 1.2 m between the closet pan within the sanitary compartment and the nearest doorway.

The client could employ a licensed carpenter or suitably qualified handy person to replaced the hinges its compliant hardware.

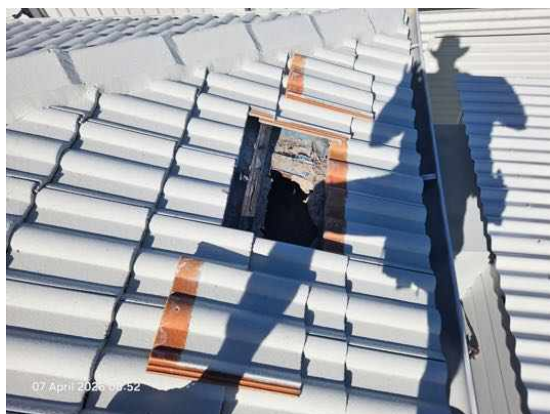
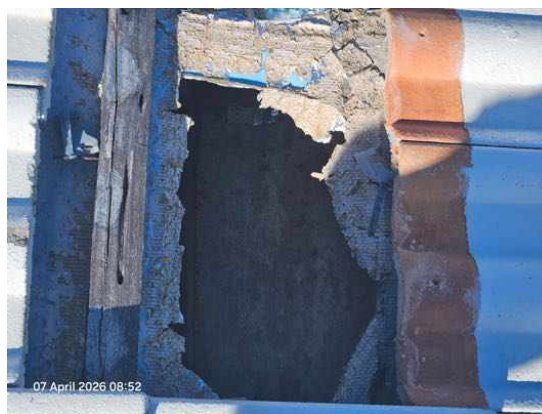
Building: Main Building
Location: As shown
Finding: Roof, opening in tiles
Information: During the inspection of the roof surface, it was noted that the roof had been opened to carry out work and was exposed on the day.

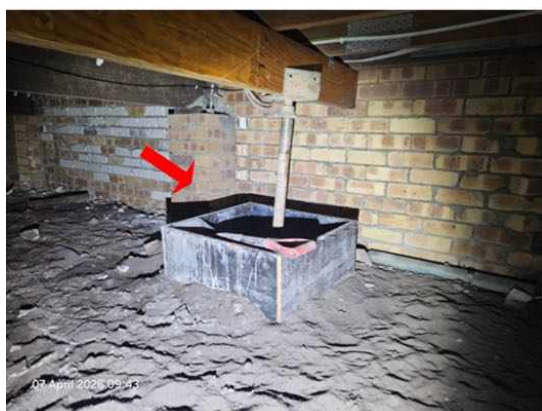
Finding 3.03

Building:	Main Building
Location:	As shown
Finding:	Subfloor, incomplete work, stumps / piers
Information:	During the inspection of the subfloor it was noted that two temporary props (acro props) and two insufficient timber props have been used during the construction of the subfloor structural framing.

As shown in the photos, it appears that the two temporary steel props are set up ready for the stumps / columns to be installed and the formwork is in place for the foundation pads. Two of the bearers are supported by undersized timbers, it is assumed that these are awaiting the stumps / columns to be fitted, and should be replaced by compliant sized timbers or steel columns.

At the time of inspection the structure appears to sound and no movement was noted or observed. These works should be completed by a licensed carpenter or builder in the short term.

A minor defect rating has been applied at this time; however, this has the potential to become a major defect if not rectified.

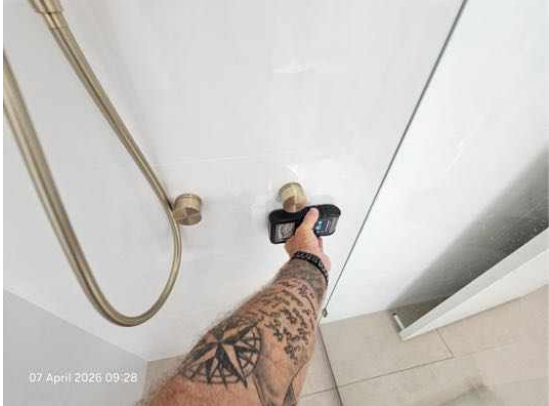
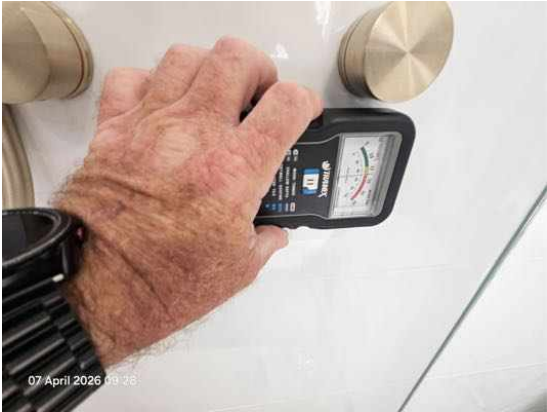
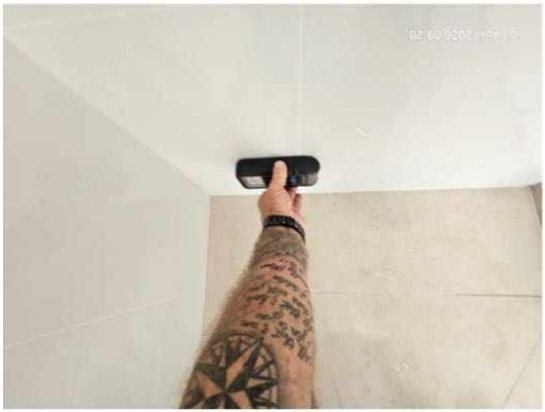
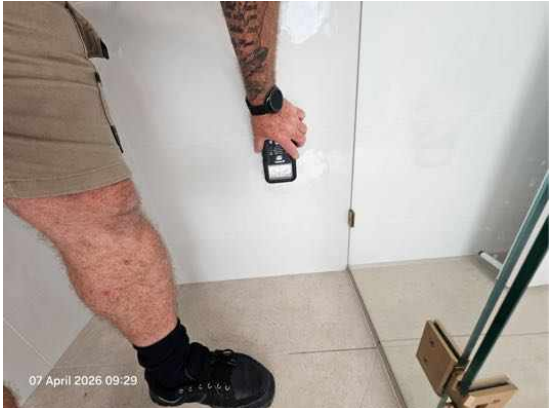
Building:	Main Building
Location:	Bathroom, house
Finding:	Elevated moisture present at the time of inspection - bathroom
Information:	Elevated moisture was noted in the lower tiled wall surfaces of the bathroom shower.

The levels varied at differing points throughout the recess. This could possibly be due to deteriorated grout and silicone sealants and / or plumbing fittings and fixtures. The grouts and sealants can break down over time and become porous, allowing moisture to enter the wall sheet surface behind the tiles. Although no obvious grout defects could be seen careful monitoring of the tile surface and checking of the fittings for adequate sealing is strongly advised.

Plumbing, and shower fittings and fixtures, can be areas of water penetration if not installed correctly and sealed completely. Whenever a fitting is screwed / fitted to the tiled shower walls , the holes and fittings should be sealed with an appropriate sealant to prevent water from entering the wall cavity. This is a common fault. A moisture reading was noted directly beneath the cold tap, checking the silicone seal at the penetration is recommended.

Elevated moisture can attract timber pests and vermin, and produce conditions that promote timber pest attack, fungal growth and wood decay.

It is recommended that the moisture levels in these areas be monitored over time and the grout and silicone could be renewed, if visible signs of elevated moisture are noted, to possibly eliminate any further moisture penetration.

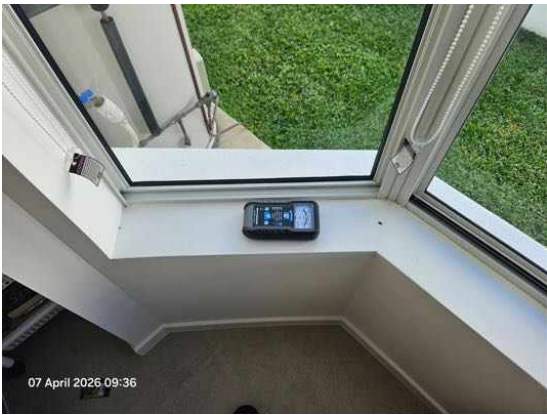
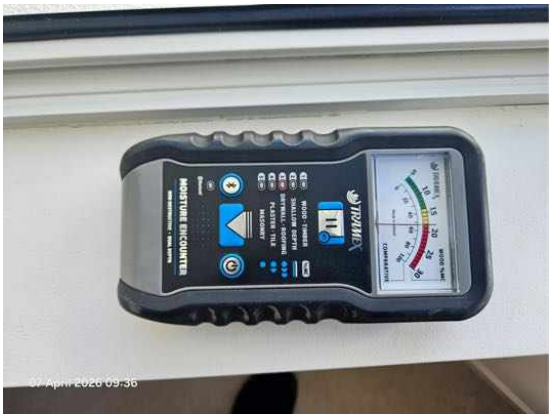
Finding 3.05

Building: Main Building
Location: Bedroom 2, dining
Finding: Window sill / reveal moisture
Information: During the inspection minor moisture readings were noted in the plastered reveals of the windows shown.

Damage is isolated to the bottom sills and internal corners, which would indicate that moisture may be entering through the joint between the bottom aluminium profile and the rendered sill. Alternatively, it may be due to the windows being left open for extended periods and sea air and rain moisture having an effect. Bay windows do experience this issue more often than standard windows, possibly due to the increased exposure of the window surface externally.

This should be monitored and there is a change in the reveal appearance, a licensed plasterer or painter should be engaged to carry out the necessary repairs.

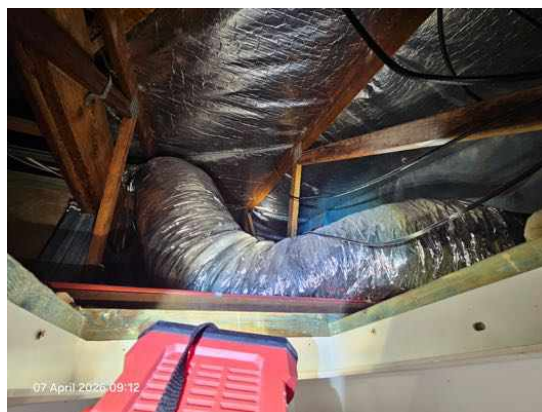
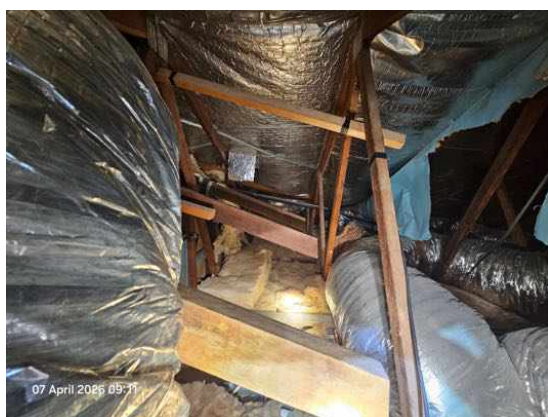
Normally accessing a roof space via diminishing truss roof framing can be challenging; however, when services such as air conditioning ducting are run near the available opening, it can make it unsafe or impractical to attempt to traffic the framing.

Only a visual inspection from the garage ceiling and the immediate area of the house ceiling space was possible. Should a full inspection be desired, an alternative ceiling access may have to be installed to provide unhindered access to the balance of the roof void.

Please rebook an inspection if desired when access is clear. No issues were observed at the time of inspection.

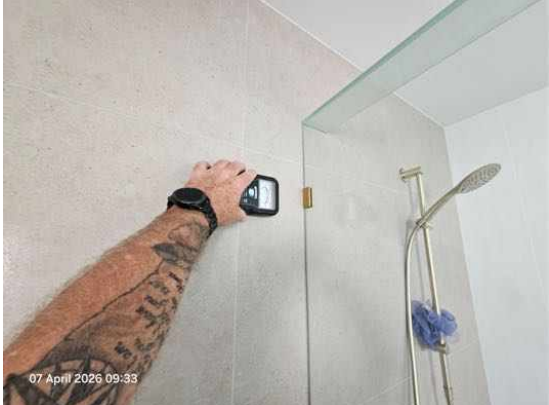
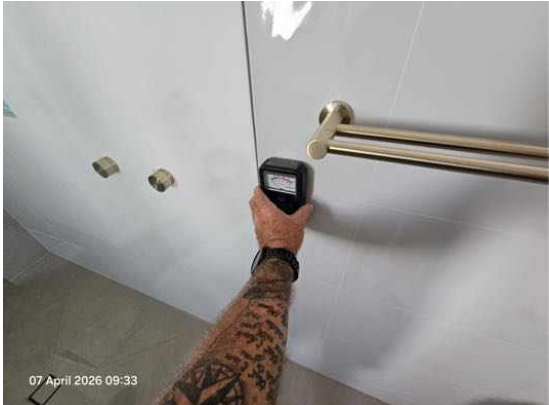
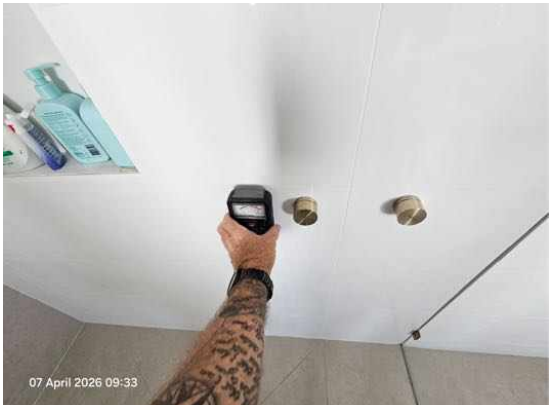
Building: Main Building
Location: Ensuite - Master
Finding: No moisture detected in ensuite
Information: On the day of inspection the shower in the ensuite was measured for moisture using a "Tramex" moisture meter. During this inspection no moisture was detected in these areas and the tiled / sheeted surfaces appear to be in good order.

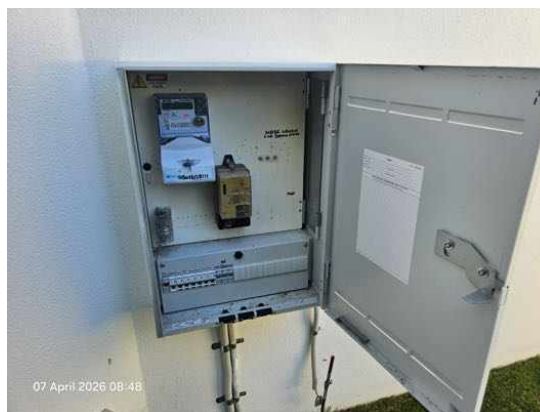
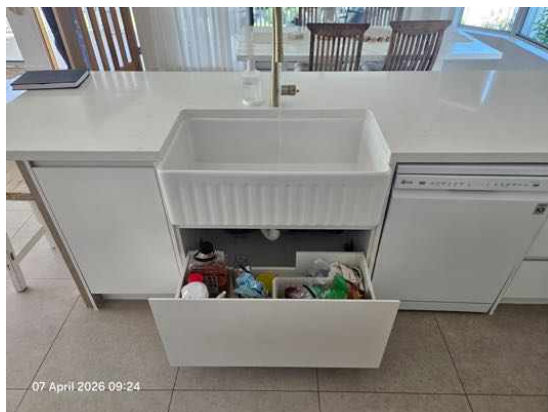
Building:	Main Building
Location:	Meter box, kitchen cupboard
Finding:	Durable pest inspection notice - not assessable
Information:	On the day of inspection it was noted that the durable timber pest inspection / treatment notice was missing, not visible or out of date. These notices / stickers are to verify the timber pest inspection dates, the inspector, the currency and type of timber pest system / barrier in place or being used in and around the property.

Annual, or more regular, inspections are crucial in maintaining and managing the properties timber pest risk profile. By not having regular inspections of the property raises the properties risk of undetected defects and damage. Without regular inspection at intervals of not greater than annually the buildings risk profile will categorised as high. Properties with trees within 50m and with gardens close to the building are at greater risk and will have a high risk profile.

It is recommend that a licensed timber pest controller be contacted to assess the properties needs and provide costings for an annual inspection programme.
