# Building and Timber Pest Inspection Report

Inspection Date: Wed, 14 Jan 2026

Property Address: 54B Hillier Rd, Evanston SA 5116, Australia

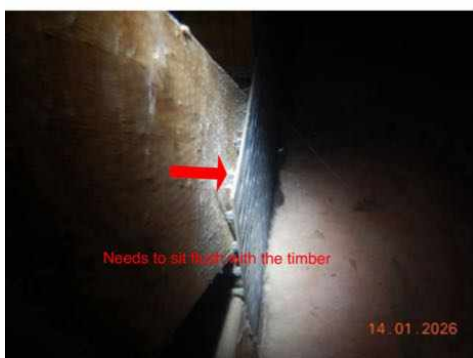
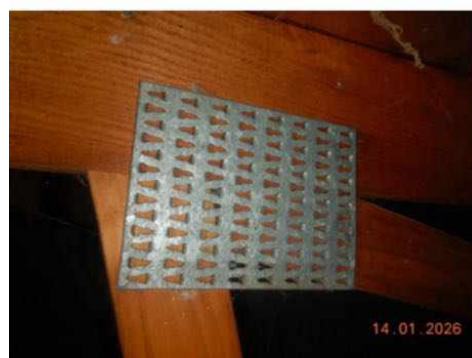
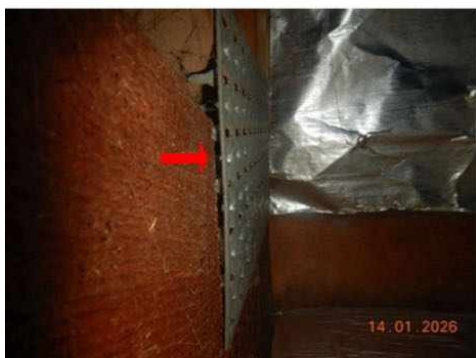
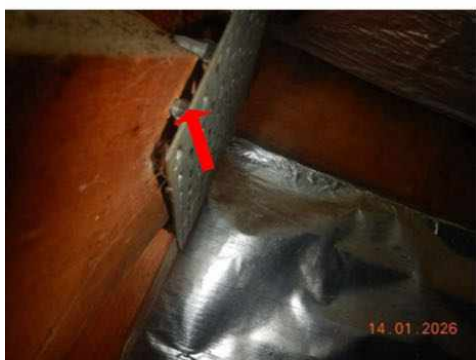
## Finding 2.02

Building:	Main Building
Location:	Roof Void
Finding:	Trusses - Nail plate back out
Information:	There were nail plates showing evidence of backing out of its original positions on timbers in the roof at the time of inspection.

This could be due to one or more of several reasons including faulty, nail plates, varying moisture levels, and slight movement of timber elements. Secondary defects can be created, ranging from damage to ceiling linings through to structural failure.

The back out appears to be minimal to the majority of plates and as such, repair is certainly possible.

A structural engineer would be required to provide recommendations to be carried out by a licensed builder ASAP to prevent any further deterioration and to prevent a hazard being created.

Repair truss nail plate back out.

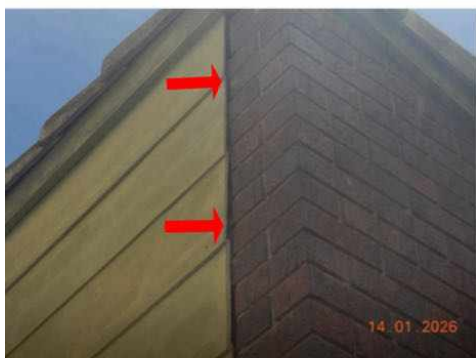
### Finding 3.01

Building:	Main Building
Location:	Roof Exterior
Finding:	Timber Cladding Not Weather-Sealed
Information:	It was found at the time of inspection that the timber cladding to the rear of the dwelling has not been adequately weather-sealed.

The absence of appropriate sealing increases the risk of moisture or pest ingress, which may lead to timber deterioration, mould growth, and damage to the underlying wall framing and building fabric.

A qualified carpenter or cladding contractor should assess the affected areas and apply appropriate weather-sealing measures

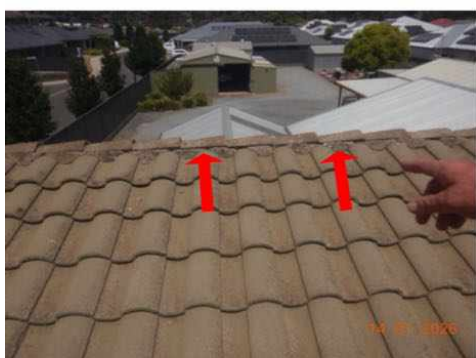
### Finding 3.02

Building:	Main Building
Location:	Roof Exterior
Finding:	Mortar - Deterioration
Information:	Mortar, or 'bedding', is the material which fills joints and intersections between tiles and other building elements on the exterior roof covering, such as gable ends, hip capping and valleys. Upon inspection of the exterior roof, it was noted that sections of the mortar show varying levels of deterioration.

Mortar generally deteriorates as a result of frequent exposure to weather conditions over a prolonged period of time. Mortar that is deteriorating may allow water ingress into the roof void, putting associated building elements and roofing structures at risk of water damage. Deteriorated mortar also detracts from the functionality of roof tiles and other roofing elements, potentially decreasing weather tightness and roof drainage.

Mortar deterioration can be attended to by a handyperson where areas of deterioration are localised and easily accessible. Otherwise, consultation with a roofing contractor is advised where greater works are required.

Repair roof mortar

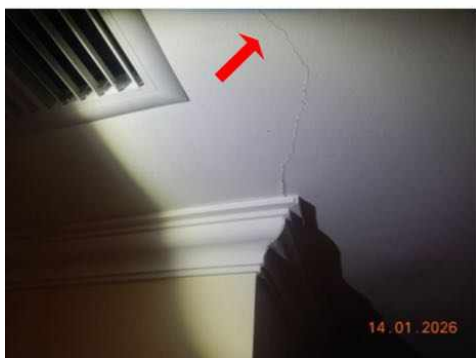
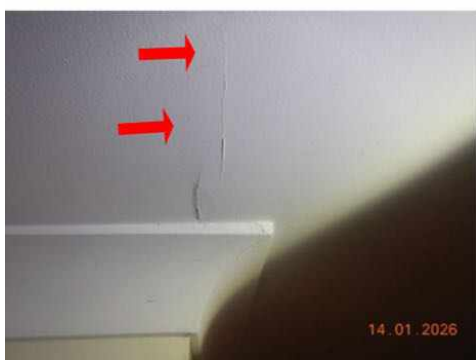
### Finding 3.03

Building:	Main Building
Location:	All Internal Areas

Finding: Cracking - Minor  
 Information: Various minor cracks were found throughout the interior of the dwelling at the time of inspection. Although minor cracks are noticeable, they are often only considered to be an appearance defect, and usually do not indicate any structural damage.

Generally, the cause of a fine crack is indicative of a separation between building materials and finishes (e.g. paint, plaster, etc.) along joints.

Cracking of this nature can generally be repaired with minor sanding, filling and/or repainting. Such works should be performed by a qualified painter or a general handyman.

Monitoring of all cracking should be conducted frequently. Always contact a building inspector should cracks widen, lengthen, or become more numerous.

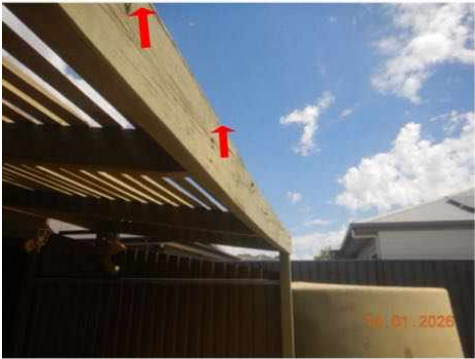
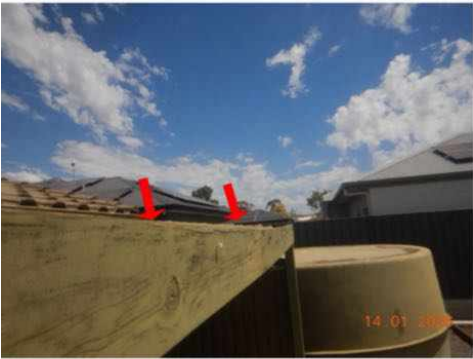
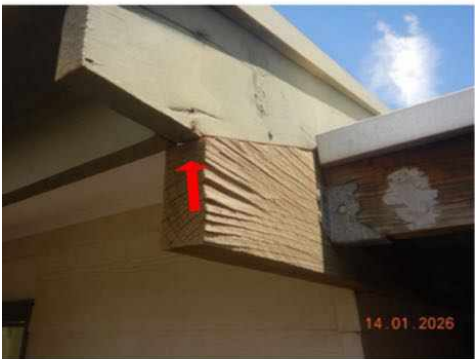
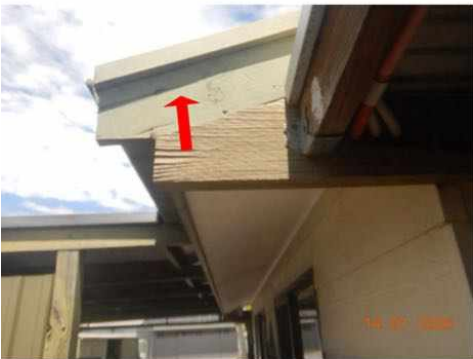
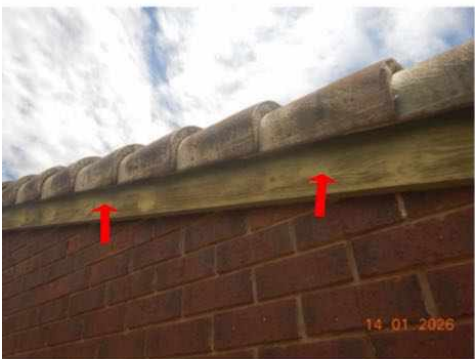
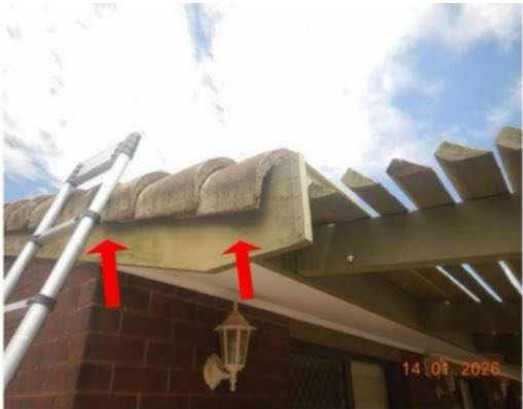
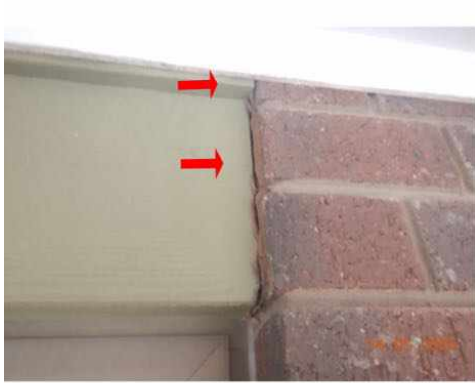
### Finding 3.04

Building: Main Building  
 Location: All Areas  
 Finding: Minor defects present  
 Information: There were a multitude of minor defects throughout the dwelling in which presented as primarily cosmetic issues, these were

- Deteriorated paint throughout various parts of the exterior
- Deteriorated sealant
- Various weathered timber elements

A qualified tradesperson should review the affected areas and undertake routine maintenance or repairs as required to address the minor defects.

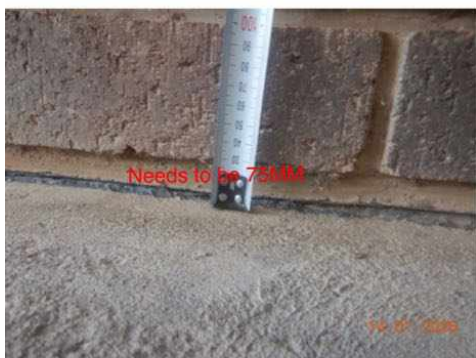
### Finding 6.01

Building:	Main Building
Location:	All External Areas >
Finding:	Slab Edge - Exposure
Information:	It can be seen that at the time of inspection multiple areas throughout the slab edge of the dwelling failed to adhere to the minimum requirements of 75MM exposure.

If the slab edge is not properly exposed there is a high risk of termite attack. Sometimes, in order to determine the type of slab, a suitably qualified person such as an architect or builder may be required to consult the construction plans.

This inspection zone should be maintained in order to force termites into the open where they can be detected more readily during regular inspections. The slab edge should not be concealed by anything that may prevent inspection of the area, including render, landscaping, soil, turf, paving, concrete cladding or other structures.

Where the slab edge cannot be properly inspected, it is highly recommended that termite or timber pest inspections be carried out every 6-12 months to aid protection of the property against infestation.

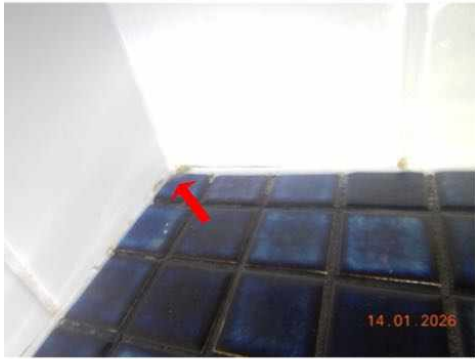
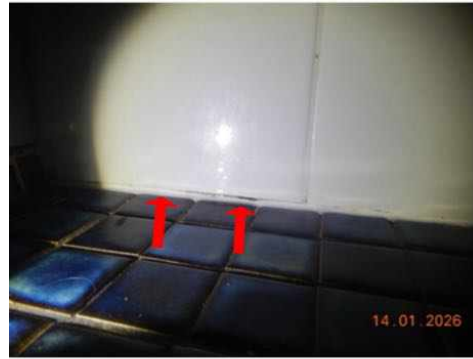
## Finding 6.02

Building:	Main Building
Location:	Bathroom
Finding:	Sealant and grouting - Missing or damaged
Information:	It was noted on inspection that sealant or grout is degraded to the tiled shower alcove and or other areas of the bathroom.

Different materials and floor areas move at different rates, generally causing cracking to grout or sealant at this point. A flexible sealant is required to allow for expected expansion and contraction, while keeping the joint water tight and protective of all associated building materials.

There appears to be minor mould to the sealant and grout which will likely require scraping out and replacement.

Flexible and mould resistant materials should be applied to affected areas to prevent any subsequent water damage that is likely to occur. Regular maintenance and replacement of damage or missing or damaged sealant and grout is highly recommended to the wet areas, as this is a regular wear and tear defect. Sealant and grouting in areas that come into regular contact with water should be maintained for the long term care of your property.

A sealant specialist or tiling contractor should be appointed to complete these works in the short to mid term.

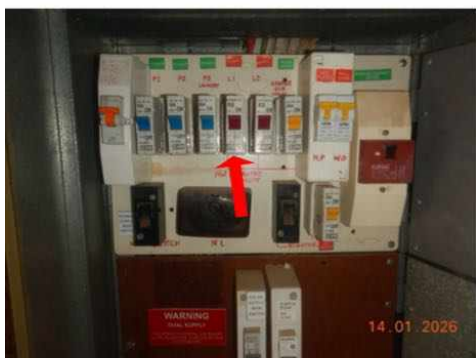
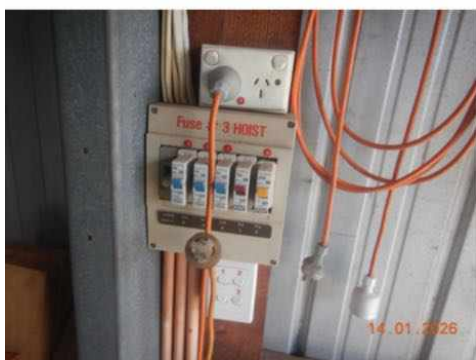
Building:	Main Building
Location:	Electrical Switchboard
Finding:	Electrical switchboard - Old ceramic fuses
Information:	The electrical switchboard while appearing to have adequate safety switches installed has old ceramic fuses in place.

While this on its own on is not considered a defect it is noted for the clients consideration that a switchboard upgrade may be required in the short to mid term to improve the functionality of the electrical system.

Consider switchboard upgrade.

A licensed electrician could be appointed to provide quotation for the works at the client's discretion which may in turn expose other required works to bring the system up to a compliant state.

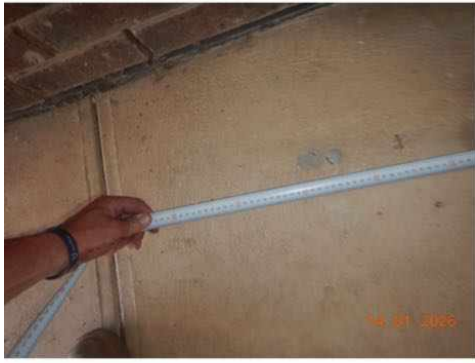
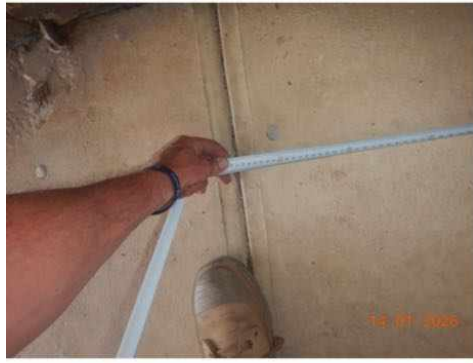
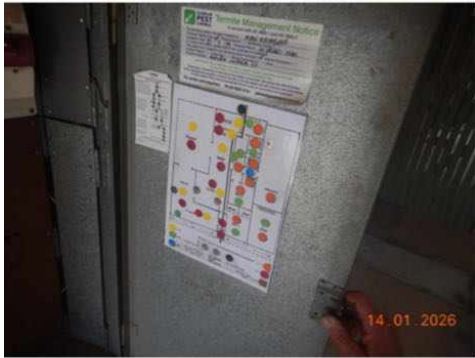
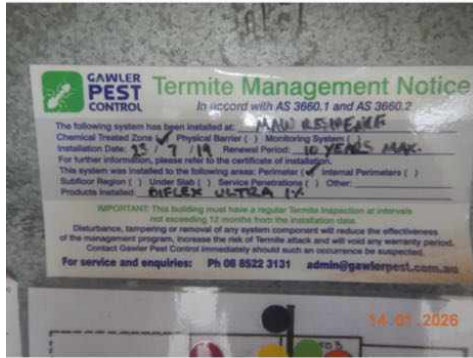
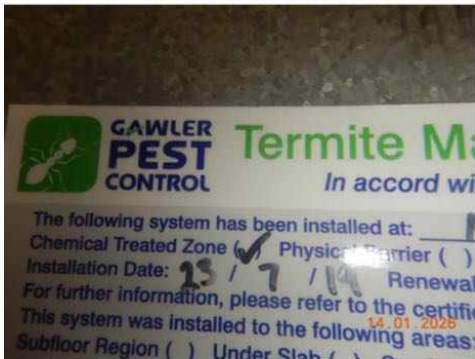
Building:	Main Building
Location:	All External Areas
Finding:	Evidence of a chemical treated zone barrier was identified - drill and inject
Information:	During inspection of the property, it was noted that works to install a chemical treated zone barrier had previously been completed. A chemical treated zone barrier is likely to ensure effective protection against termites.

We strongly recommend annual inspections of the barrier and surrounding areas as there are several factors that can lead to deterioration of the barrier and decrease its effectiveness.

Where a Termite Management System has been identified, the client should identify to the type of barrier, date of installation, warranty conditions and any documentation provided by a builder or past owner. Consult the company who installed the barrier to confirm whether the system is still under warranty.
