# Building and Timber Pest Inspection Report

Inspection Date: Fri, 9 Jan 2026

Property Address: 21 Calida Cres, Hassall Grove NSW 2761, Australia

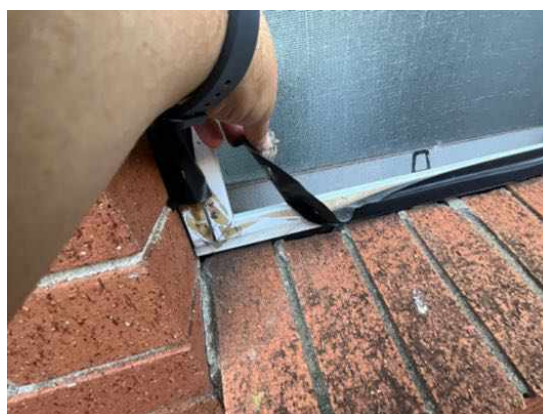
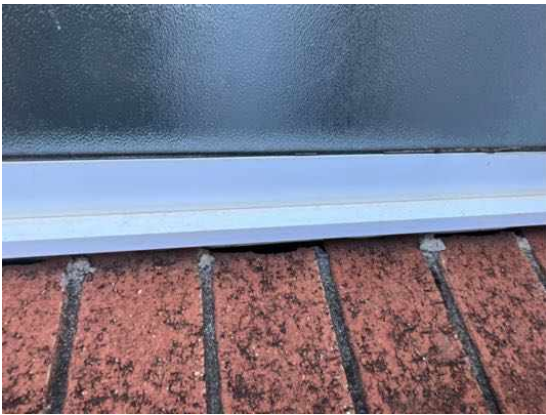
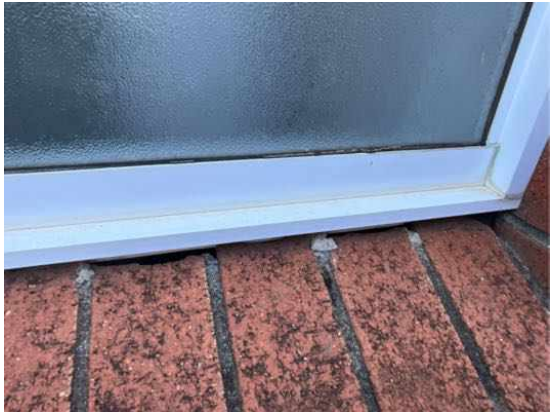
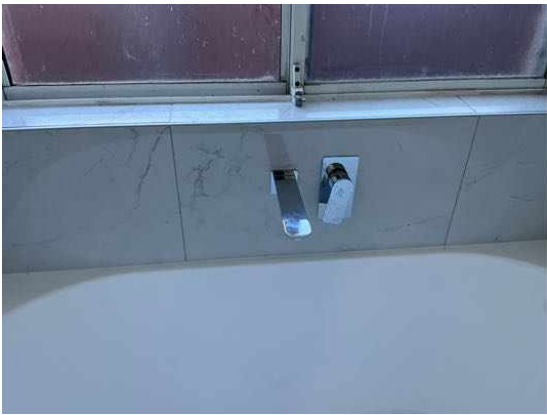
Finding: Window sill gaps are observed  
Information: Gaps are observed between the brick sill and the base of the window frame. Mortar joints are incomplete in multiple areas, and there is no visible weather sealant applied between the window frame and the adjacent bricks.

- Potential for moisture ingress during rainfall events, which may result in internal water damage, mould growth, and deterioration of building materials.
- Gaps may allow pest intrusion and compromise thermal insulation.
- The condition may lead to non-compliance with the National Construction Code (NCC) and relevant Australian Standards (e.g., AS 2047 – Windows and external glazing, and AS 3700 – Masonry structures).

- Repoint all affected mortar joints to close visible gaps.
- Apply a suitable, flexible weatherproof sealant between the brick sill and window frame.
- Inspect and, if necessary, adjust or install flashing to ensure appropriate water diversion and drainage.

Priority: Remediation is recommended to prevent long-term damage, especially before the next major weather event.

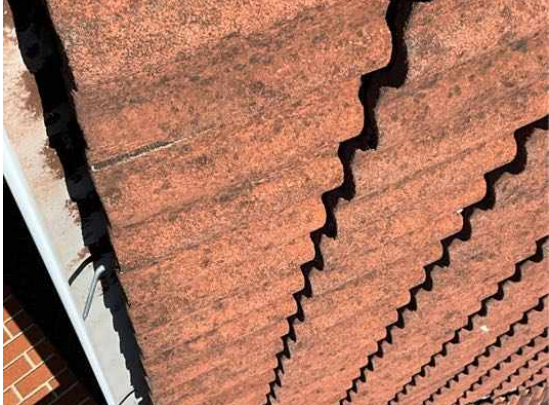
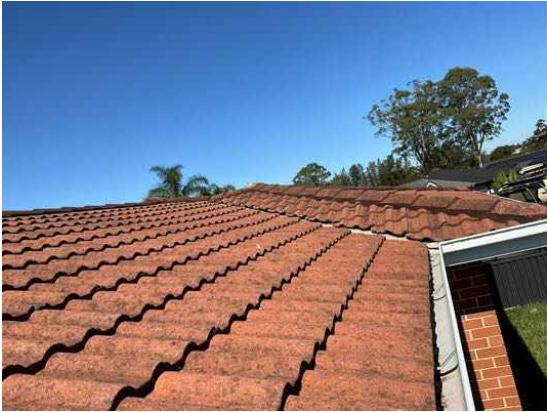
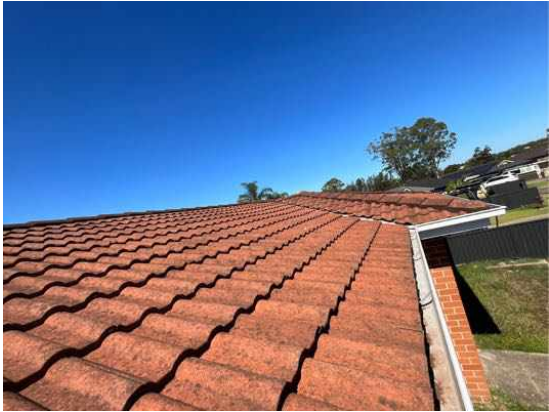
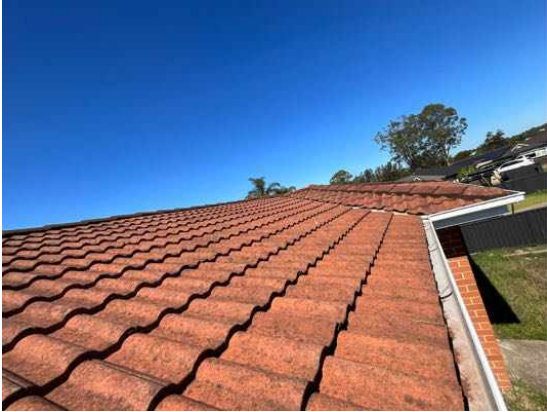
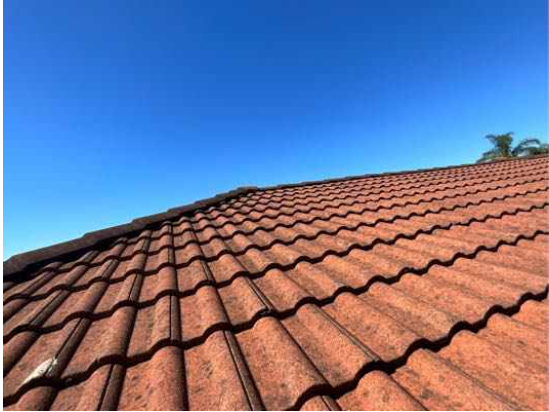
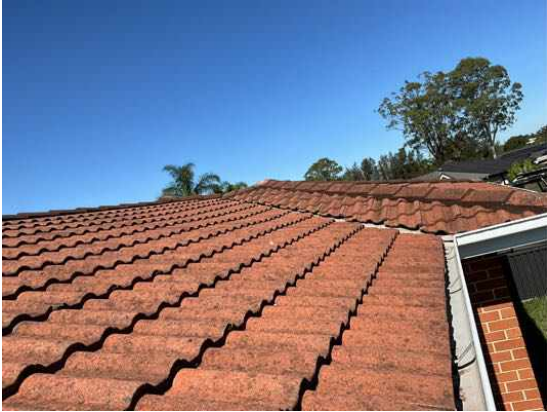
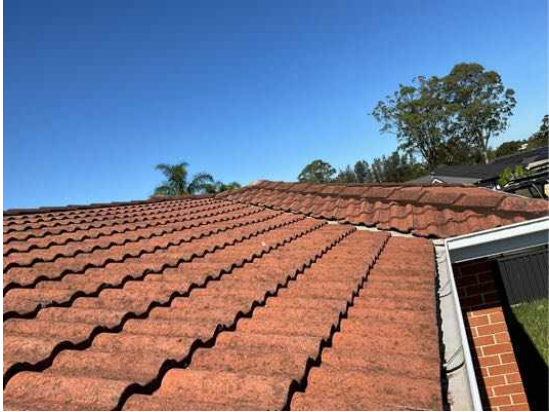
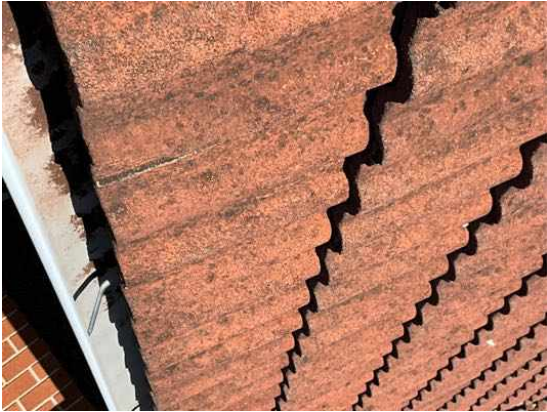
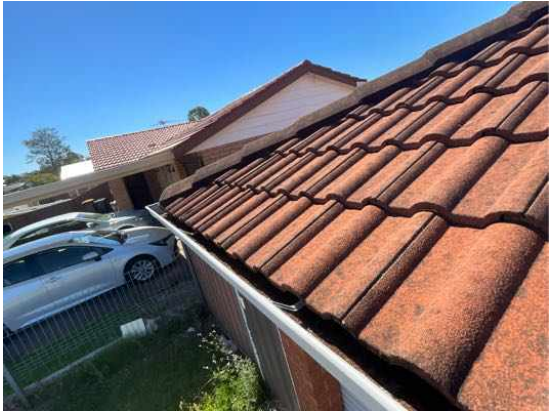
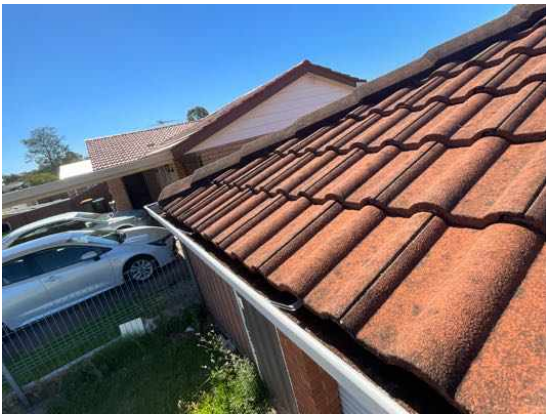
**Finding 3.01**

Information: Inspection of the roof revealed widespread weathering to the tiled roof surface. The tiles show loss of surface finish, colour fading, and age-related deterioration typical of older roof coverings. Although no significant cracking was noted, weathering can lead to increased porosity, reduced water-shedding capability, and a higher risk of future cracking or displacement during adverse weather conditions.

A licensed roofer should be engaged to undertake a closer inspection, carry out routine maintenance, and replace any tiles that may be compromised. Ongoing monitoring is recommended due to the age and condition of the roof covering.

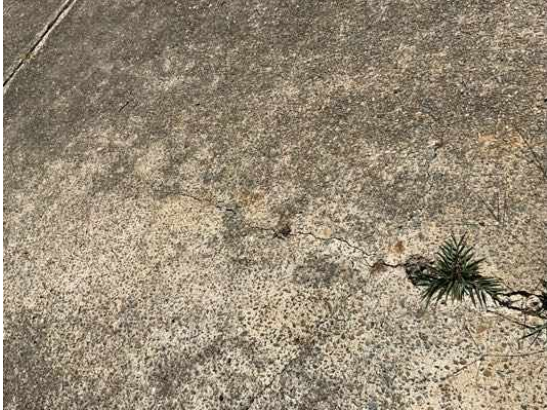
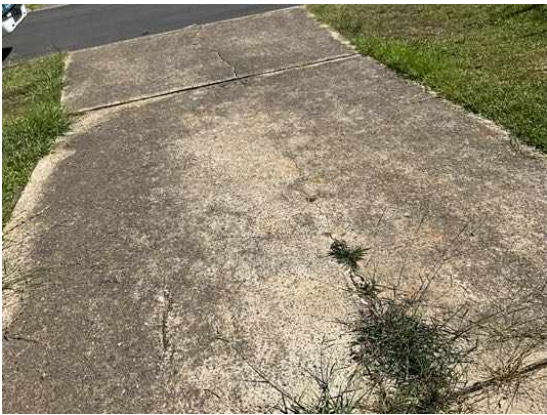
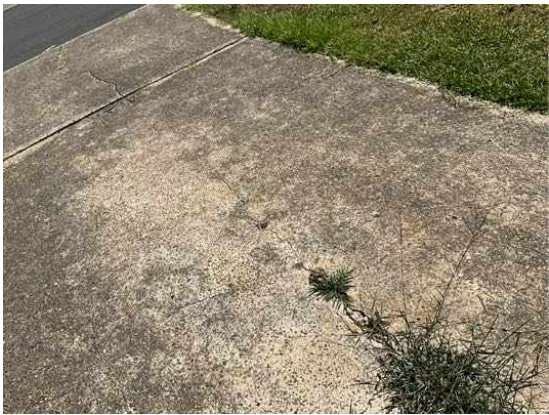
**Finding 3.02**

Building: Main Building  
Location: Driveway  
Finding: Crack in concrete slab - Category 0  
Information: A crack coded as Category 0 was identified in the slab. A Category 0 crack is described as a hairline crack, representing insignificant movement of slab from level.

The approximate width of the crack to be considered Category 0 is 0.3mm, or change in offset of less than 8mm when a 3m straight edge is placed over the defect.

No rectification is required at this time. However, all cracking should be monitored over a 12 month period to identify any further damage in the area.

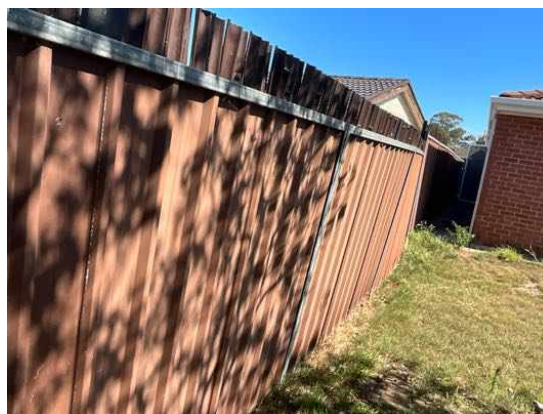
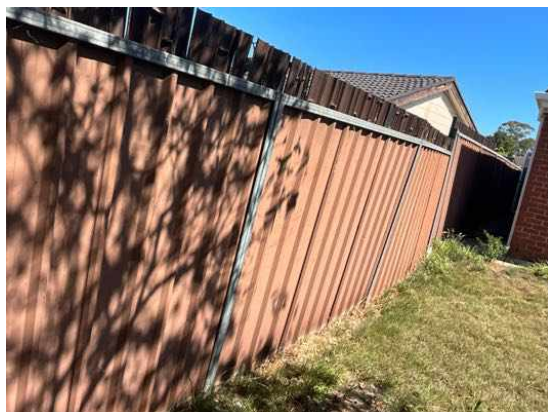
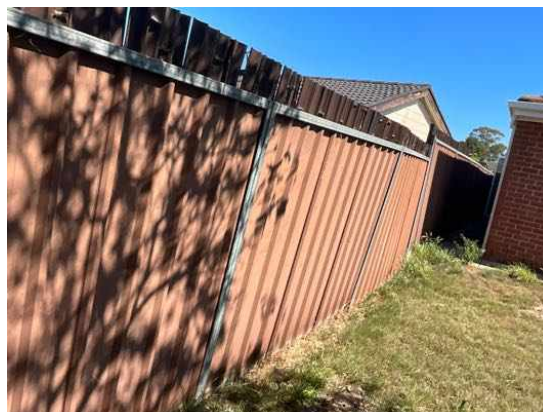
The leaning fence poses a risk of collapse, potential property damage, and a security breach, diminishing its effectiveness as a barrier.

A skilled fencing contractor or handyman is needed to assess and rectify the leaning fence. Timely repair is crucial to restore the fence's stability and prevent further damage or safety hazards.

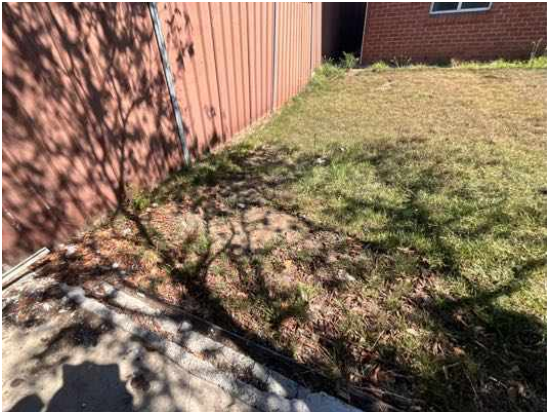
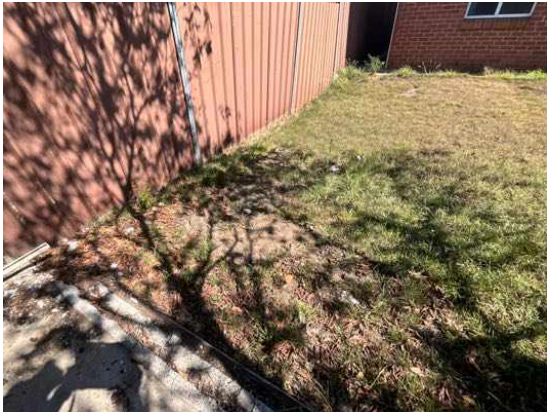
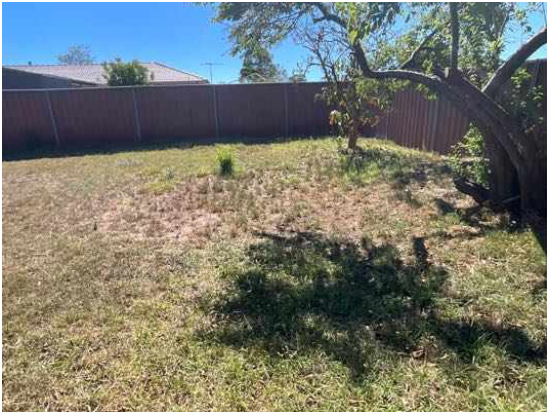
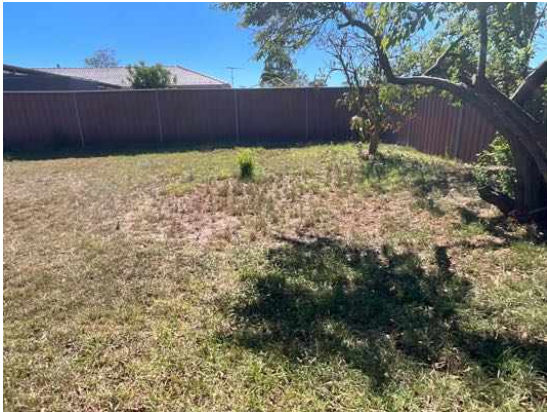
### Finding 3.05

Building:	Main Building
Location:	Yard - Back
Finding:	Water pooling - poor surface drainage
Information:	Surface drainage

Surface water drainage is defective if it is not in accordance with the requirements of the Building Code of Australia.

Such water pooling also increases the risk of termite activity and the development of fungal decay in the area.

Consult a Licensed Plumber regarding the cost of potential site drainage rectification works.

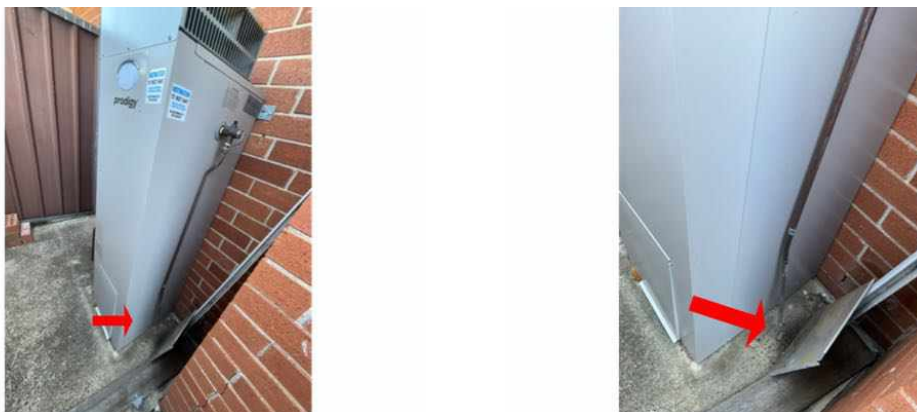
**Finding 3.06**

Building: Main Building  
Location: Exterior walls - right side  
Finding: HWS Overflow - Not Connected  
Information: The Hot Water System (HWS) overflow was found to be disconnected from storm water drainage and is creating excessive moisture in the surrounding area.

These damp conditions can lead to secondary defects such as rot, rust or corrosion of associated building elements, the formation of fungal decay, or even the creation of potential slip hazards. When coupled with poor site drainage, pooling of water may also attract termite activity to this area.

It is highly recommended that a licensed plumber be appointed to connect the HWS overflow in order to prevent such an environment from being created. These minor works should be carried out as soon as possible.

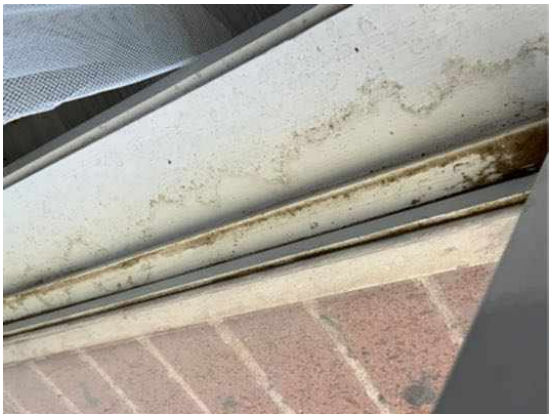
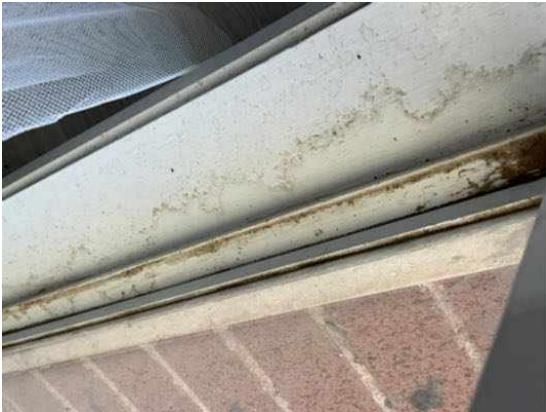
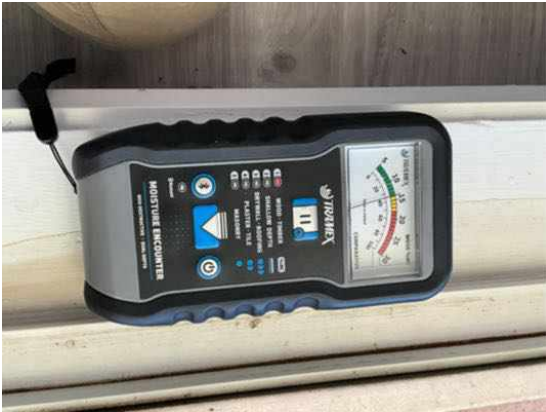
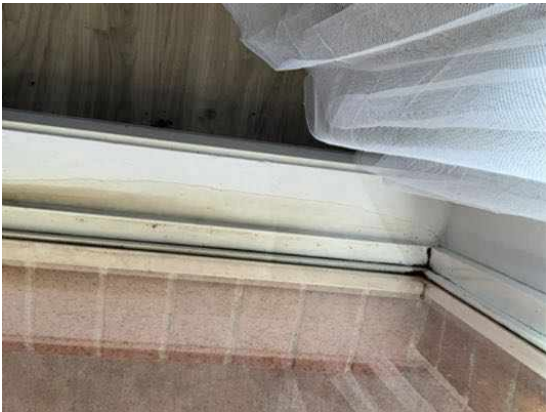
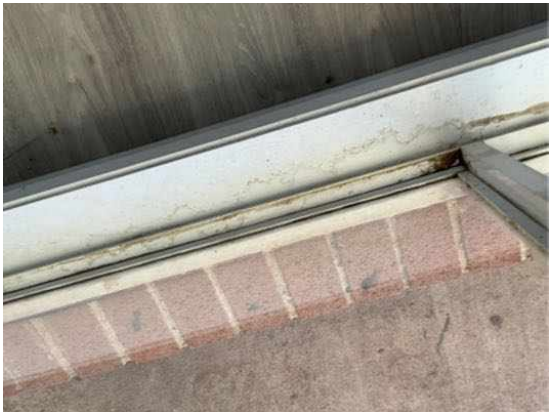
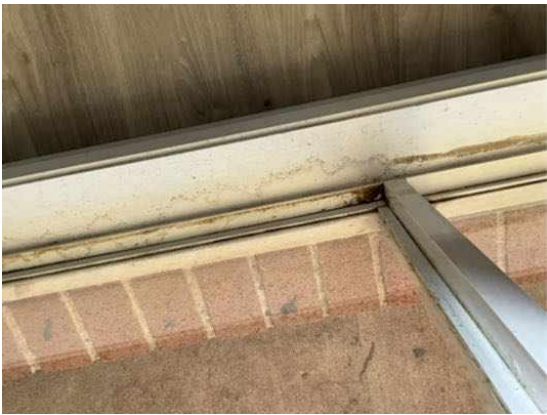
### Finding 3.07

Finding: Water staining

Information: Water staining was evident in this area at the time of inspection. Water staining indicates that surfaces have been exposed to excessive moisture over time. The minerals and other elements in the water lead to staining, which may graduate to corrosion and deterioration if left unmanaged.

While mostly an appearance defect, water staining can be indicative of more serious defects, which may be currently concealed by other building elements.

Where water staining is active, a licensed plumber must be consulted to identify the cause of the staining and to provide advice on any reparation works that may be required. Replacement of any broken or damaged structures is advised.

Conversely, where water staining is old and inactive, affected building materials may be repaired or replaced at client discretion. A qualified carpenter or registered builder may be appointed to perform these works.

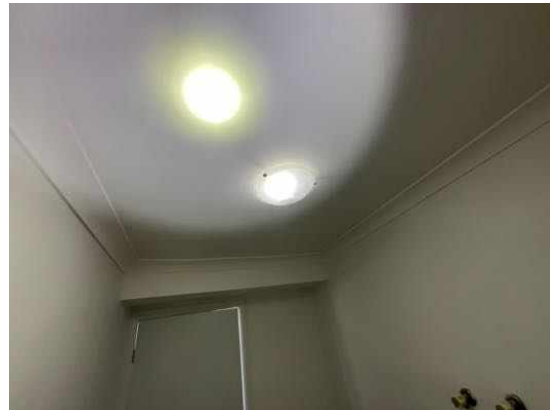
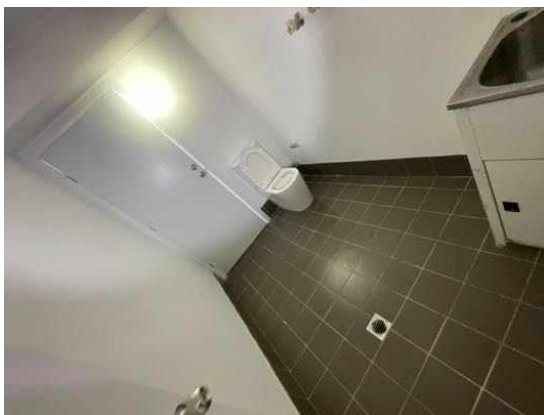
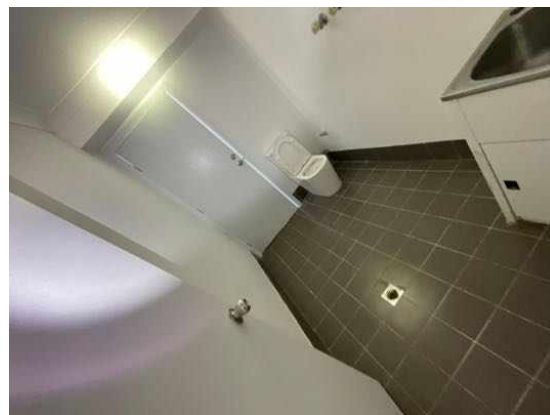
Building:	Main Building
Location:	Laundry / Toilet
Finding:	No exhaust fan in laundry / toilet
Information:	The laundry / toilet lacks an exhaust fan, leading to inadequate ventilation and potential issues with moisture buildup.

1. Mold and mildew growth: Without proper ventilation, moisture accumulates in the bathroom, creating an environment conducive to mold and mildew growth, which can pose health risks and damage surfaces.
2. Odor retention: The absence of an exhaust fan can lead to lingering odors in the bathroom, causing discomfort for occupants and potential embarrassment.
3. Damage to building materials: Excessive moisture can damage paint, wallpaper, and even structural elements like drywall and wood, leading to costly repairs and renovations.

A licensed electrician or general contractor can install an exhaust fan in the bathroom. Additionally, a building inspector or HVAC technician may be consulted to ensure

proper ventilation requirements are met and to recommend the appropriate fan size and placement.

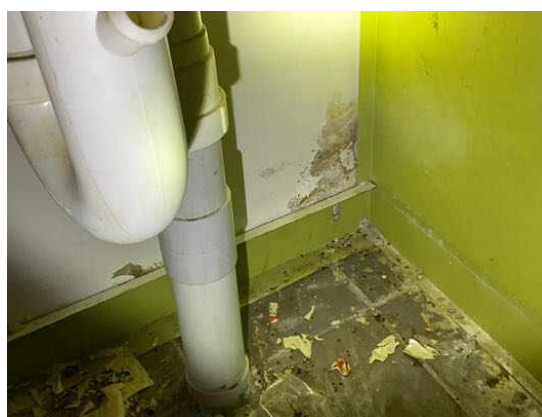
Building:	Main Building
Location:	Laundry / Toilet
Finding:	Water damage / Vanity
Information:	"The vanity in the shower area has sustained water damage, resulting in swelling and discoloration of the wood, as well as potential structural issues. This damage compromises both the aesthetic and functional aspects of the vanity."

1. **Carpenter or Woodworker:** They can assess and repair the damage to the vanity, potentially replacing any irreparable parts.
2. **Plumber:** If the water damage is due to plumbing issues, a plumber can fix leaks and ensure there are no further water-related problems.
3. **General Contractor:** If the damage is extensive and affects the surrounding area, a general contractor can coordinate the repair work, including both the vanity and any related structural or cosmetic repairs.

Make sure to obtain quotes from these professionals to determine the most cost-effective and efficient solution for your specific situation.

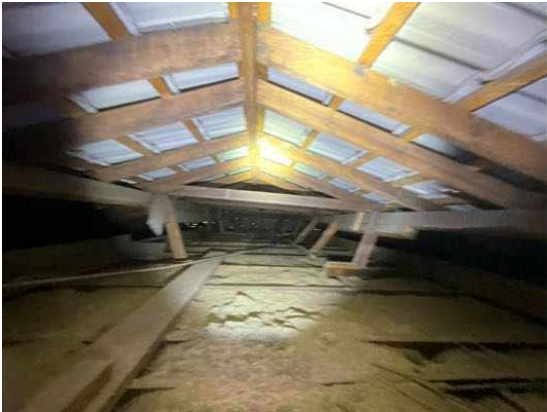
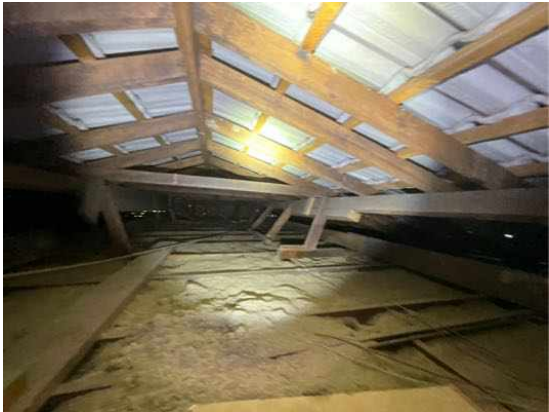
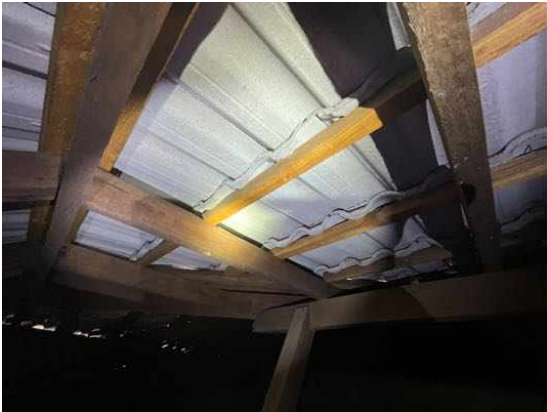
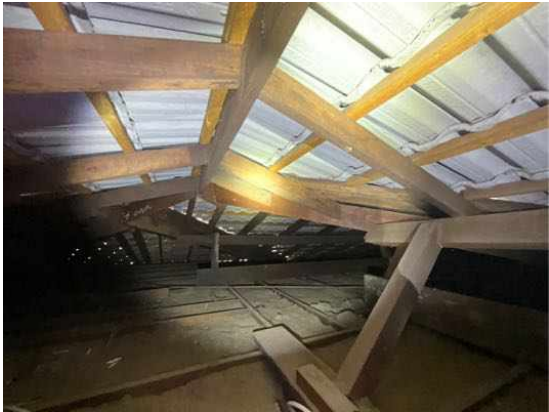
Finding: Sarking - Missing  
Information: Sarking is missing under the roof sheeting. Sarking acts as an insulator that helps with noise reduction and protects against water penetration. Sarking plays a key role in the operation and function of the overall roofing structure and its performance.

Although not a requirement at the time of construction, replacement of any missing building element is advisable (although this can be quite expensive to do after the time of construction). Where sarking is missing, regular inspections of the roof tiles for cracking and potential moisture penetration is required.

Sarking may be retrospectively fitted by a registered builder at the discretion of the client.

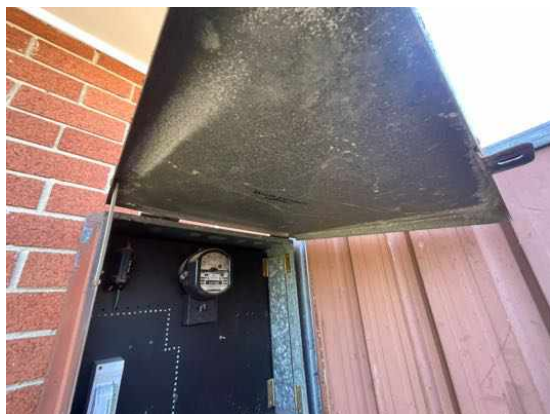
Building: Main Building  
Location: Exterior walls - right side  
Finding: No Evidence of Termite Management System - Durable notice / Legible Sticker  
Information: The application of a pre & post-construction chemical termite barrier is highly recommended for all properties. Such barriers are highly effective in preventing termite attack on any timber building elements throughout the property.

Client must seek further information from the vendor or real estate agent if the conditions of termite management systems were maintained.

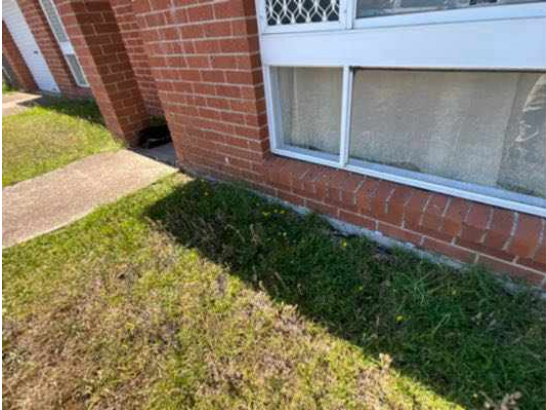
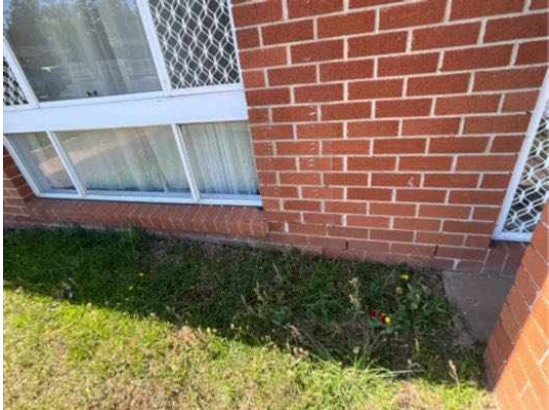
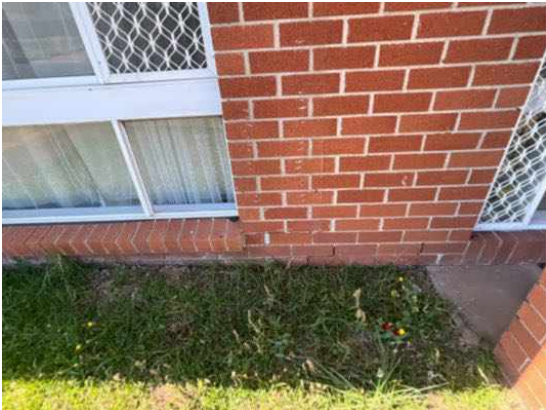
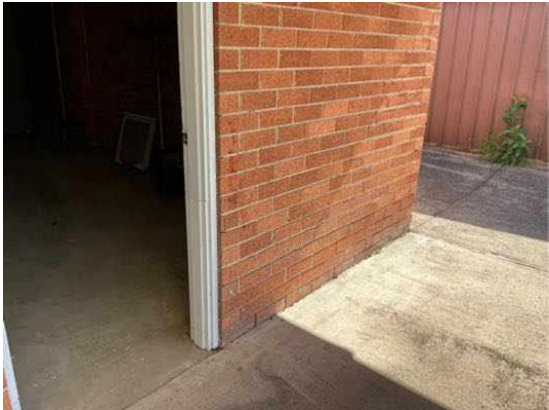
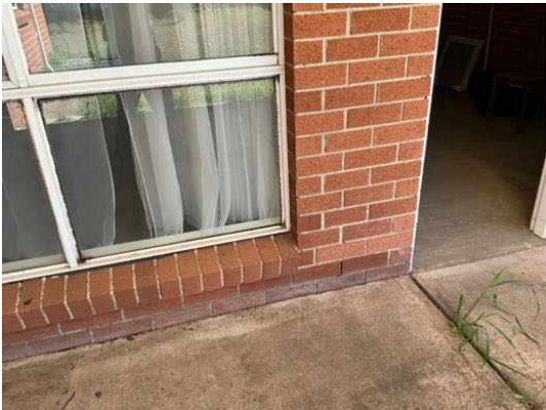
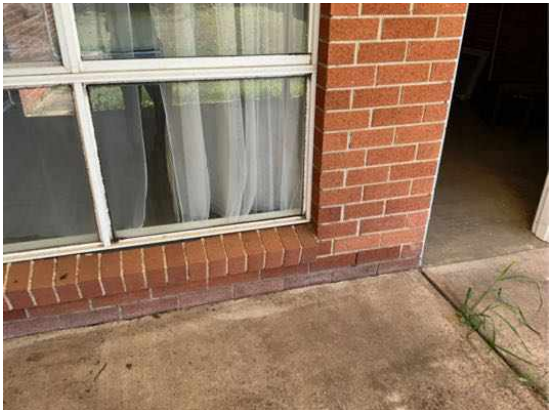
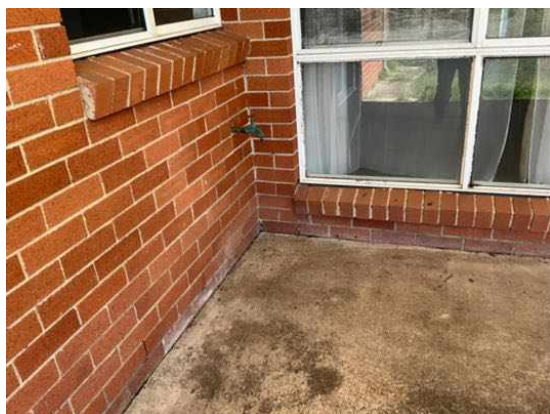
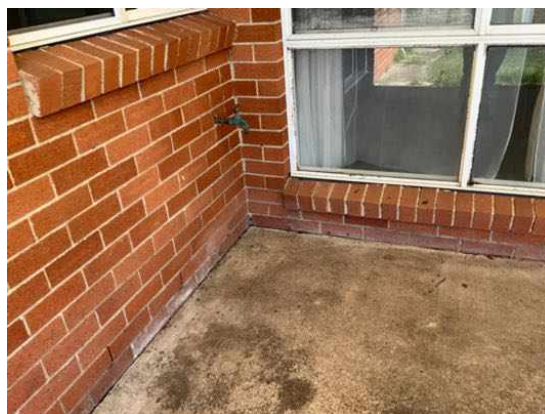
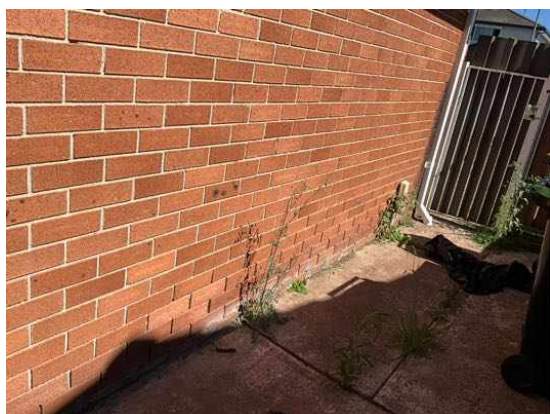
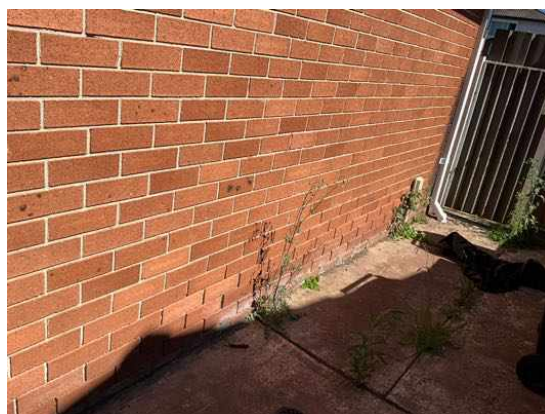
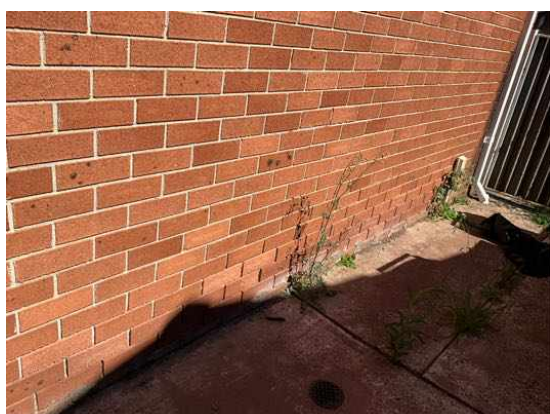
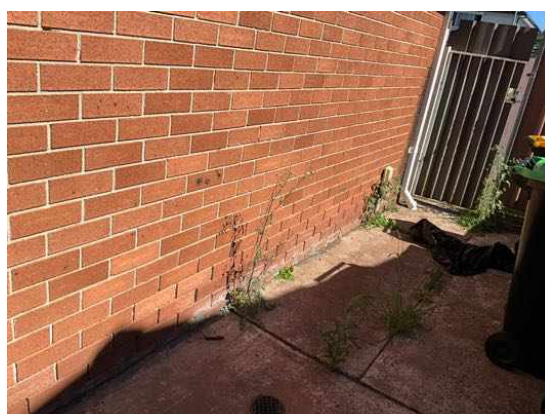
### Finding 6.02

Building:	Main Building
Location:	All Areas
Finding:	Slab Edge - Exposure
Information:	An inspection zone of at least 75mm in relation to the exposed slab edge, between the bottom brick and the perimeter pavement, is required. This inspection zone should be maintained in order to force termites into the open where they can be detected more readily during regular inspections. The slab edge should not be concealed by anything that may prevent inspection of the area, including render, landscaping, soil, turf, paving, concrete cladding or other structures.

If the slab edge is not properly exposed there is a high risk of termite attack. Sometimes, in order to determine the type of slab, a suitably qualified person such as an architect or builder may be required to consult the construction plans.

Where the slab edge cannot be properly inspected, it is highly recommended that termite or timber pest inspections be carried out every 6-12 months to aid protection of the property against infestation.

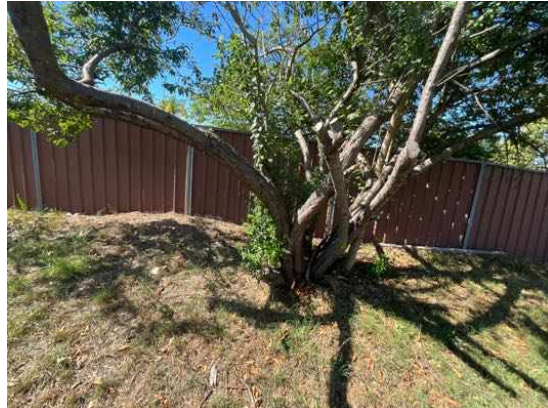
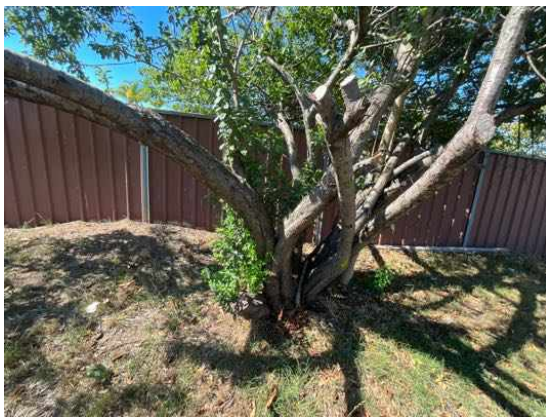
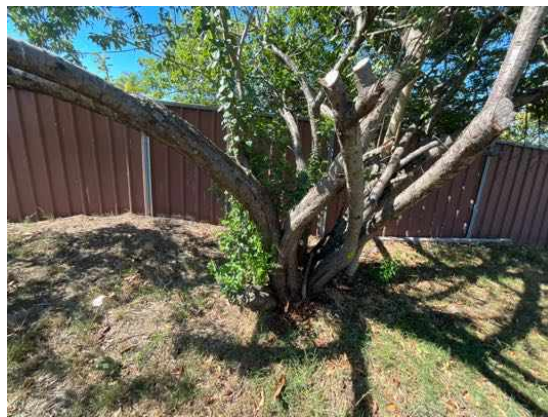
infestation due to its increased vulnerability to termite attacks.

Please contact Licenced pest controller for further advice. Pictures attached for your reference.

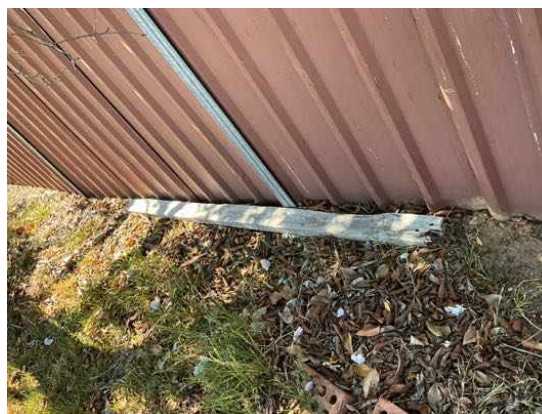
### Finding 6.05

Building:	Main Building
Location:	Yard - Back
Finding:	Timber on ground / conducive conditions to termite damage
Information:	Timber on the ground is indeed conducive to termite damage. Termites are known to thrive in moist environments, and wood in contact with soil or moisture is more susceptible to infestation.

To prevent this, it's important to keep timber elevated and away from direct ground contact. Regular inspections and proper termite control measures are also essential to protect your wooden structures from termite damage.
