## Building Inspection Report

Inspection Date: Tue, 17 Mar 2026

Property Address: 6 Wyperfeld Ave, Taylors Lakes VIC 3038,  
Australia

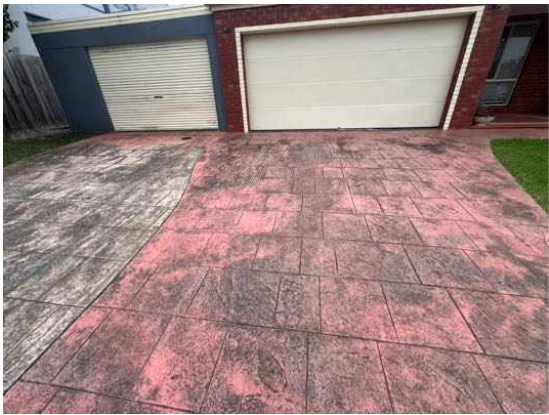
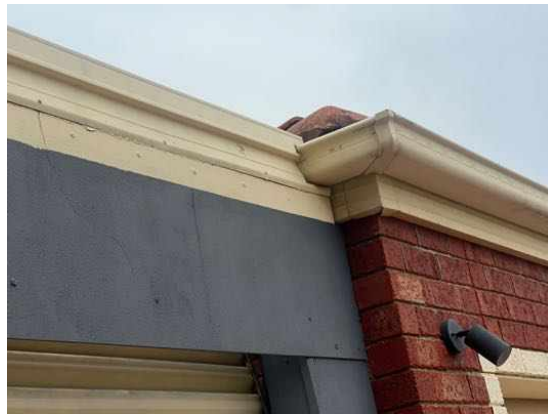
### Defects 3.06

Building:	Main Building
Location:	Front Elevation > Centre Left
Finding:	Unconventional handyman work-poorly constructed fascia to roller door-
Information:	This handyman work appears to have been completed to a substandard level and does not comply with regular building practices. Where handyman work is not completed satisfactorily, accelerated deterioration of the associated building elements is likely to occur and secondary defects to surrounding structures may develop.

It is highly recommended that the substandard work be rectified by professional services. Works to improve this area are likely to increase the safety and the operation of the associated building elements.

The client should exercise care when coming into the immediate vicinity of the substandard works. Rectification works are advised as soon as possible by the appropriate trades.

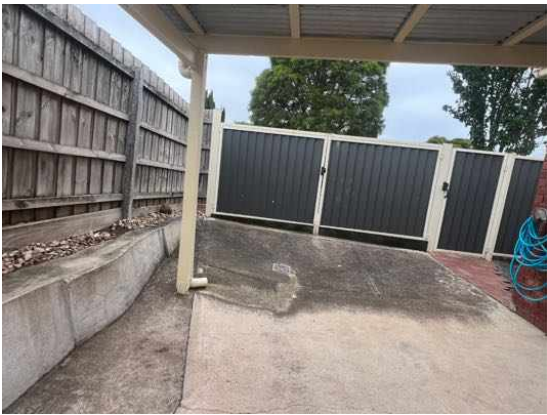
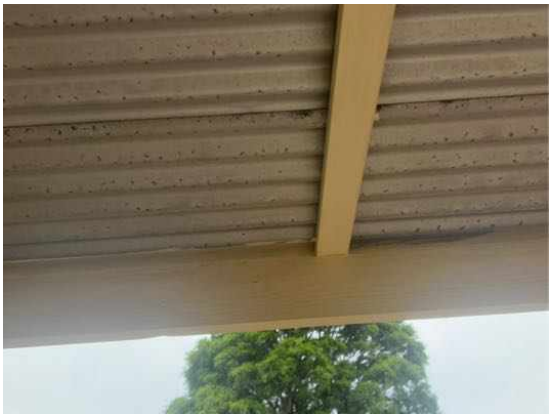
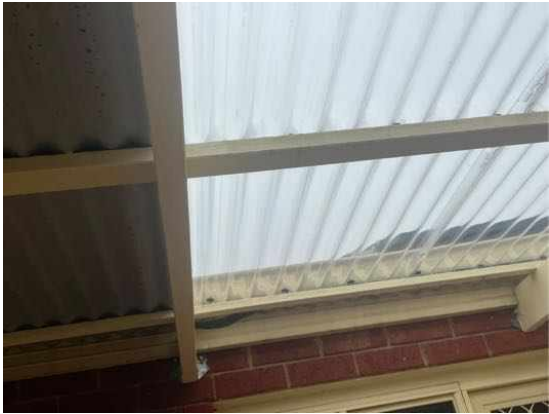
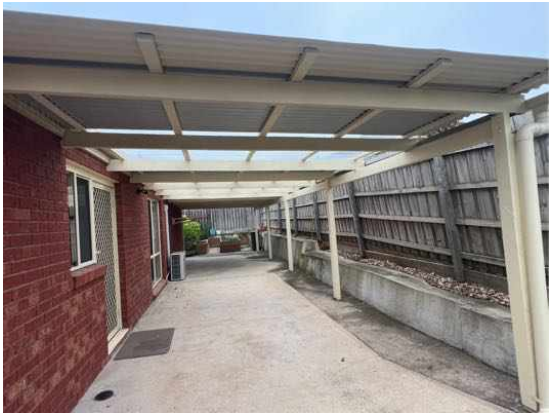
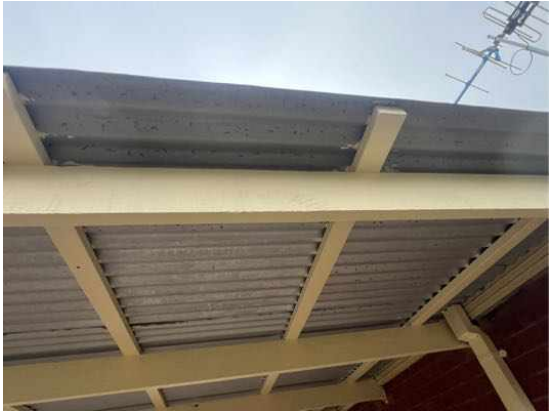
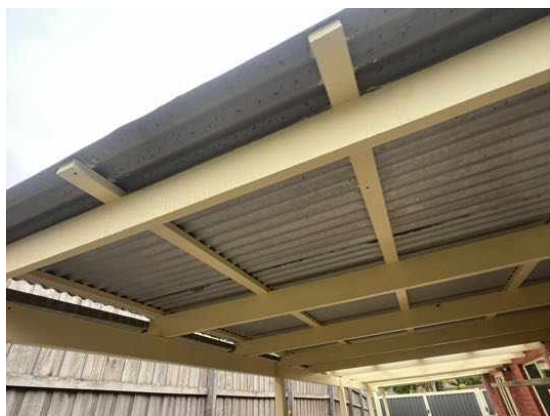
### Defects 3.11

Building:	Main Building
Location:	Pergola > Rear
Finding:	Unconventional handyman work
Information:	This handyman work appears to have been completed to a substandard level and does not comply with regular building practices. Where handyman work is not completed satisfactorily, accelerated deterioration of the associated building elements is likely to occur and secondary defects to surrounding structures may develop.

It is highly recommended that the substandard work be rectified by professional services. Works to improve this area are likely to increase the safety and the operation of the associated building elements.
