# Building and Timber Pest Inspection Report

Inspection Date: Mon, 2 Mar 2026

Property Address: 31 Brendan Ave Farmborough Heights  
NSW 2526, Australia

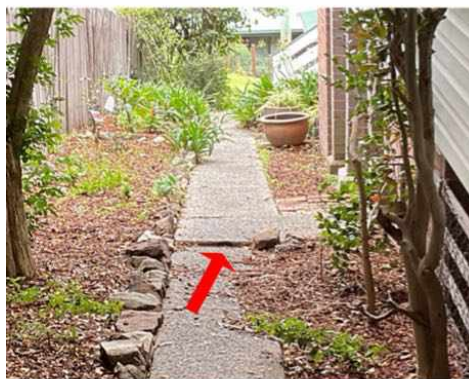
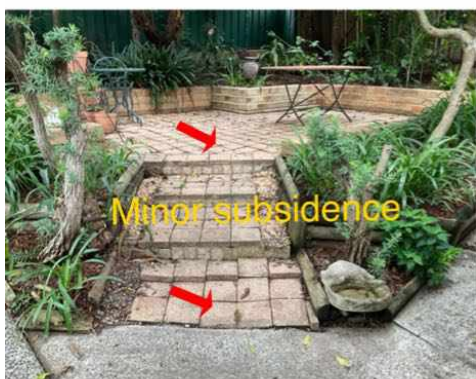
#### Finding 1.01

Building:	Building 1
Location:	Footpaths
Finding:	Trip safety hazards
Information:	A raised section of the left concrete paths, the rear angled path and minor areas of subsidence have created trip hazards. The uneven surface poses a risk to pedestrians, particularly the elderly, children, and individuals with mobility issues. It is recommended to repair these areas by a concreting contractor.

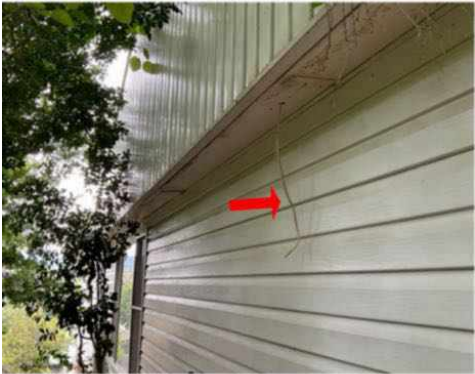
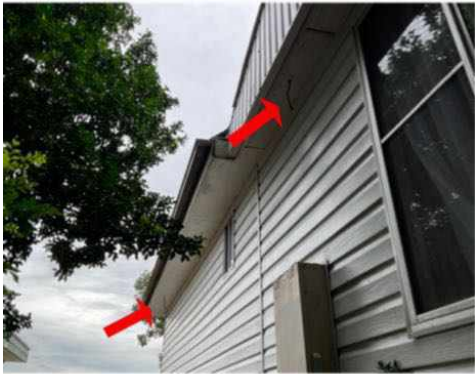
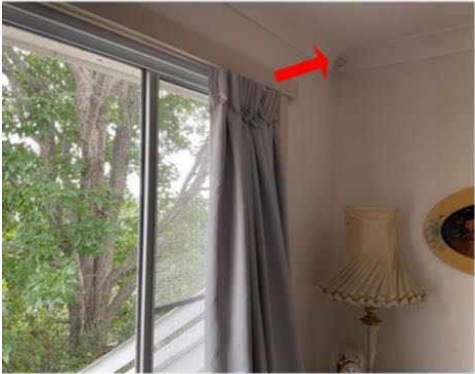
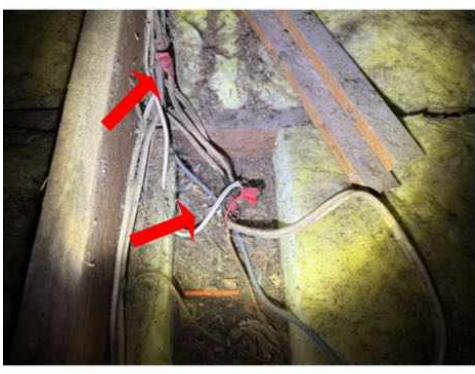
#### Finding 1.02

Building:	Building 1
Location:	Shed, right wall, roof cavity
Finding:	Electrical cables missing a junction box
Information:	Numerous electrical fitting in these areas were found to be missing a junction boxes at the time of inspection.

This missing fittings and loose cables does expose electrical works, and may create a

safety hazard if there is potential contact with persons in the area.

A Licensed electrician should be appointed to rectify these areas immediately.

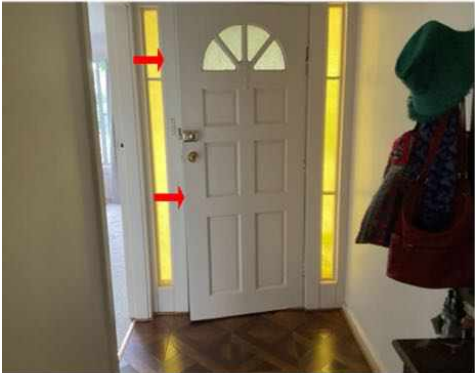
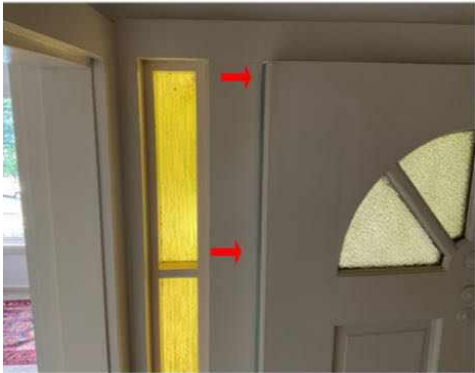
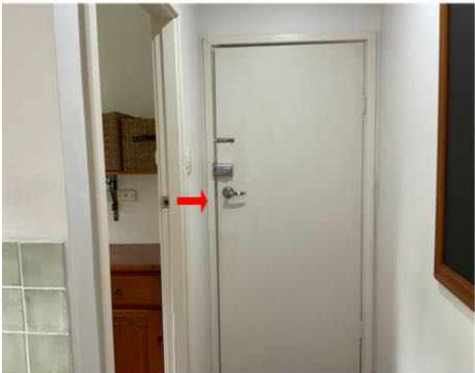
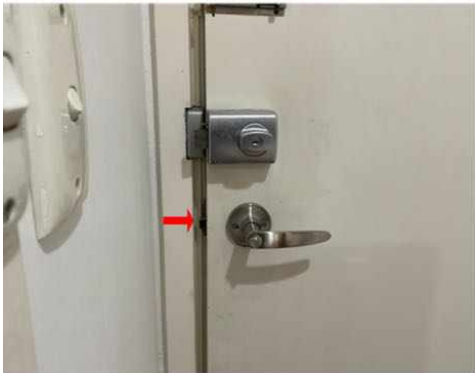
Building:	Building 1
Location:	Entry doors
Finding:	Doors - Binding/jamming
Information:	Binding and/or jamming of these doors is evident during standard operation. This defect inhibits the functionality of the affected doors as well as creating potential for secondary defects to associated building elements, such as damage to the floor covering or the adjoining door jamb. The front door could not be locked with the security latch and was very difficult to close. This front door needs immediate repair.

A door that binds to flooring or to the associated door frame may have several causes, ranging from minor defects, such as poor installation of the door or deteriorated hinges, through to major structural issues, such as damage to subfloor structures.

Where door binding/jamming appears to indicate major structural issues, a registered builder specialising in re-stumping should be appointed to provide an estimate on the cost of rectification.

A qualified carpenter should be appointed immediately to perform minor rectification works at client discretion.

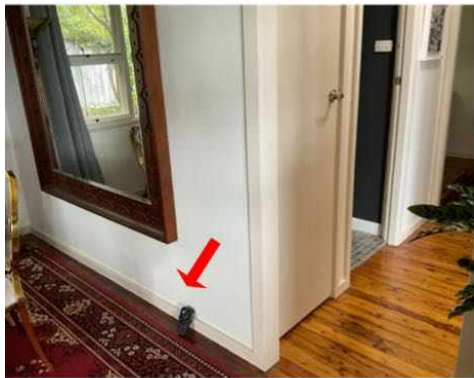
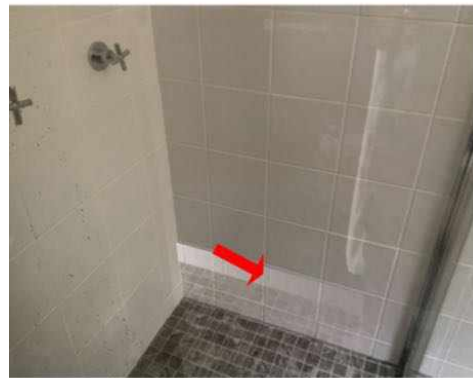
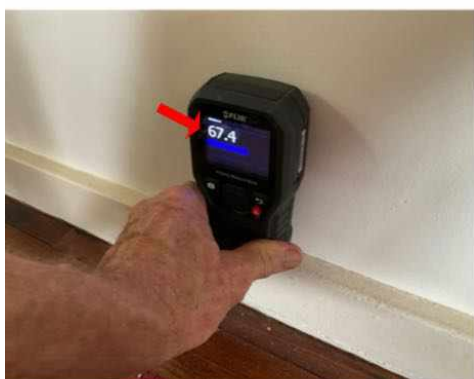
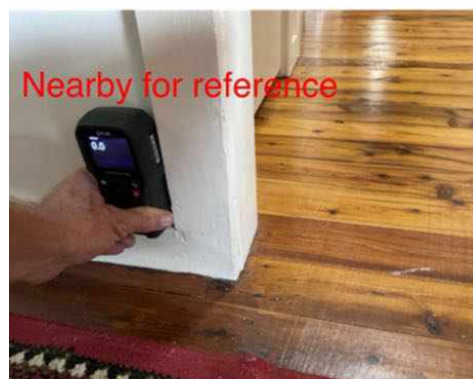
Building:	Building 1
Location:	Bathroom / dining room wall
Finding:	Evidence of excessive moisture in the shower wall
Information:	Excessive moisture was found in the shower/dining room wall after running the shower. A high reading of 67.4 was recorded. Nearby areas were zero for reference.

This moisture can attract termites and produce conditions that promote termite attack, fungal growth and wood decay.

This defect is listed in this report as a minor defect. If it is found by an invasive inspection that this moisture has lead to severe wood rot to the wall framing, then this would then be described as a major defect in this report.

It is highly recommended that all sealant and waterproofing membranes be maintained regularly in order to prevent excessive moisture being present in the internal property.

An invasive inspection is required to determine the reason for the moisture ingress in the wall, then quotes for repairs should be sought.

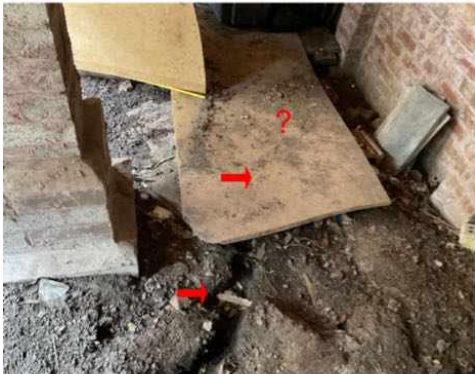
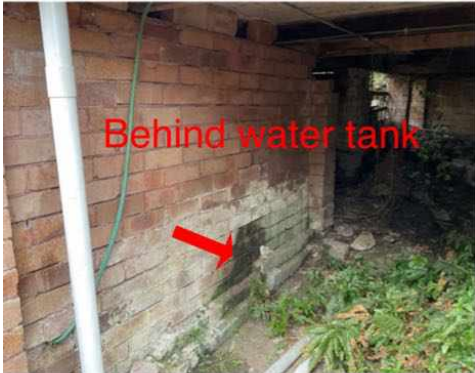
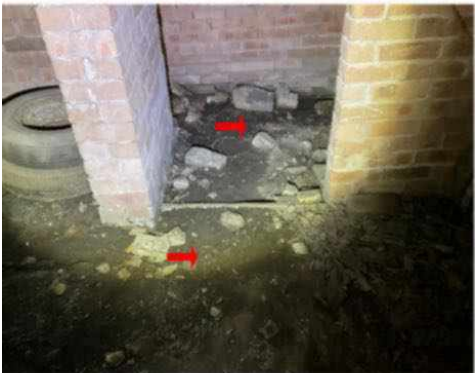
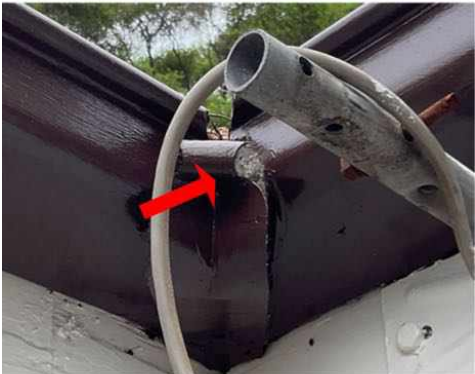
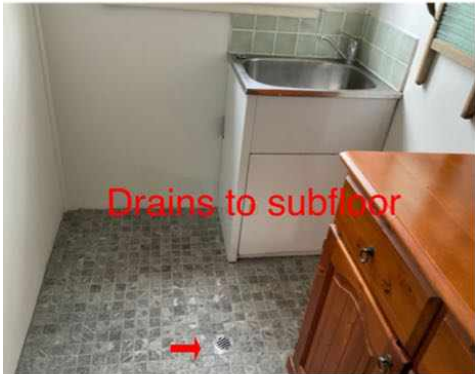
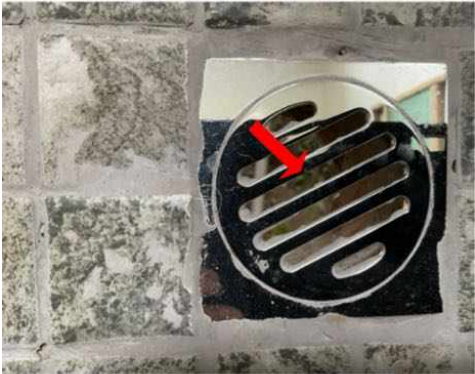
### Finding 3.04

Building:	Building 1
Location:	Subfloor, front gutter, rear wall

Finding: Site drainage - Inadequate  
Information: The site drainage in these areas was found to be inadequate at the time of inspection, creating potential for subsequent water damage to associated building elements.

The front deck gutter is loose. The laundry and bathroom floor wastes empty to the subfloor areas.

It is important that water does not lie against the base of walls; surrounding paths and ground levels should be sloped to drain water away from walls. Downpipes should not discharge stormwater onto lower walls or plinths. Stormwater should be carried away by large, regularly cleaned drains. Ground levels may need to be lowered to expose a buried DPC.

Where site drainage is inadequate, installation of an Agricultural (Aggie) Drain may be required. A qualified plumber should be appointed to further inspect the property and perform any remedial works as necessary. Secondary defects are likely to occur if left unmanaged.

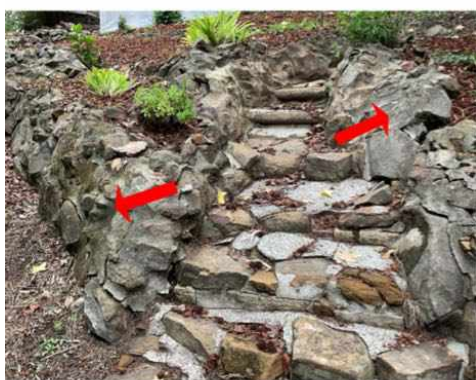
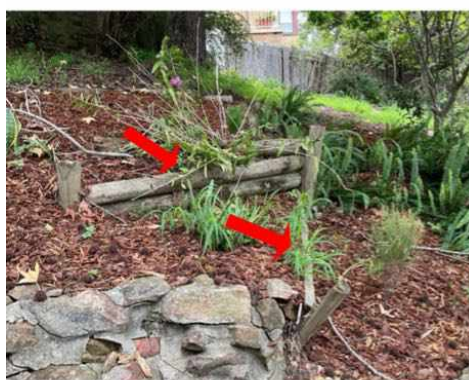
Finding 3.05

Building:	Building 1
Location:	Exterior stonework and pine walks
Finding:	Retaining walls - defective
Information:	Some retaining walls were found to be defective at the time of inspection. Generally, defective retaining walls are caused by poor original design or material use. However, deteriorated retaining walls may also be a result of substandard construction, poor site drainage or unmanaged stormwater flows. The pictured small timber retaining walls are leaning outward and many stone walls have collapsed inward (up the slope).  Due to the small size of these walls, a landscaper or retaining wall installer may be appointed to repair or replace these walls, at the discretion of the client.

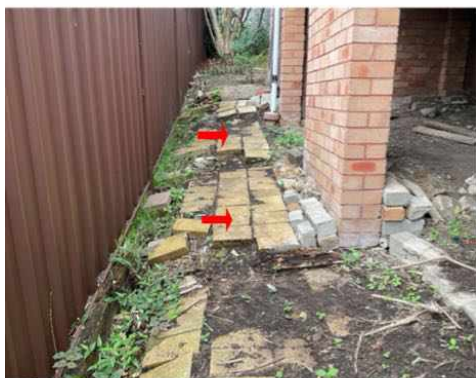
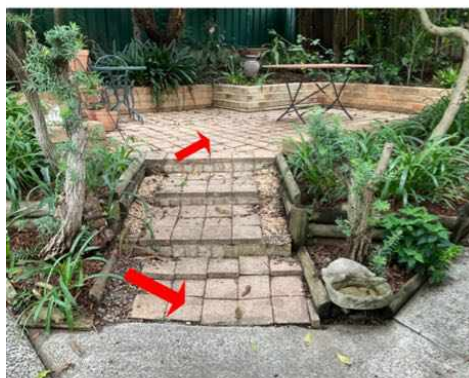
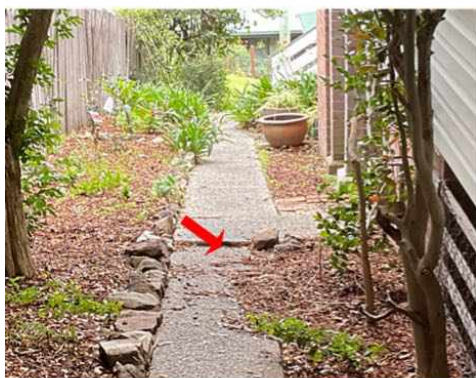
sinking or subsidence. A degree of movement is expected in subfloors over time, especially as environmental conditions change and buildings settle

General subsidence is usually initiated by changes in soil moisture content. The most critical factor is identifying the specific causes, and identifying if this is a recurring or ongoing problem, or one that has been resolved by previous works in the past.

Subsidence can have complex and varying causes, which will influence the required remedial works.

At this point it is recommended to contain storm water flows, ensure pavements flow away from the building to lessen any excessive wetting and drying effects.

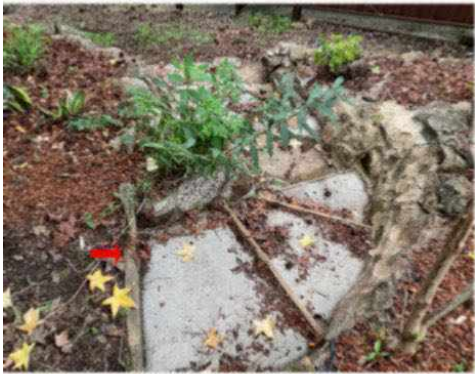
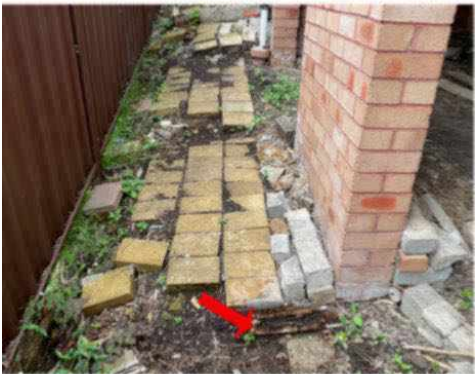
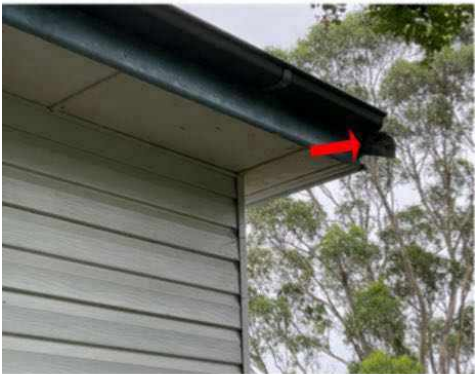
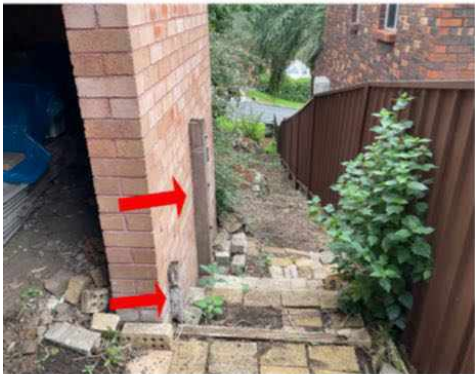
### Finding 3.09

Building:	Building 1
Location:	Pictured areas
Finding:	Wood rot
Information:	The building and fence areas show evidence of wood rot. Wood rot, also known as Fungal Decay, occurs when timbers and other cellulose building materials are exposed to damp conditions on an ongoing basis. This could be the result of exposure to weathering over a prolonged period of time, or the attraction of excessive moisture from other abutting building materials.

Early intervention and regular maintenance, particularly of exterior timbers, will prolong the useful life of these building elements. Prior to any works being performed, the cause of the moisture that has created the visible wood rot should be identified and addressed in a suitable manner. Replacement of affected timbers may then be a necessary step in protecting surrounding building elements from such deterioration.

A qualified carpenter or registered builder may also be required to replace affected building materials.

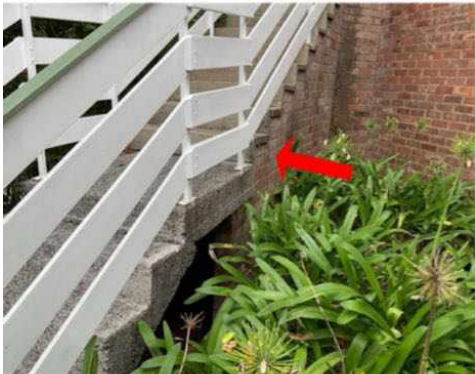
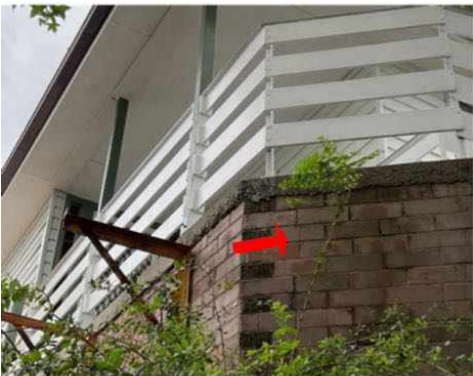
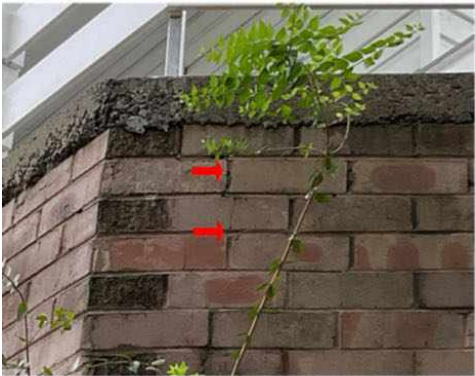
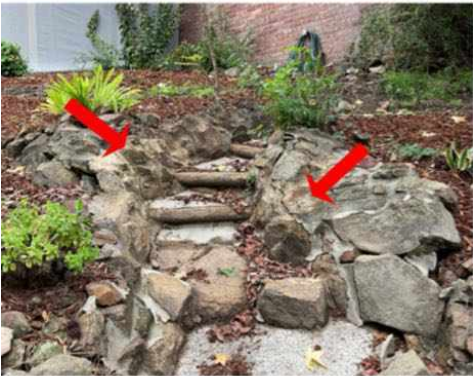
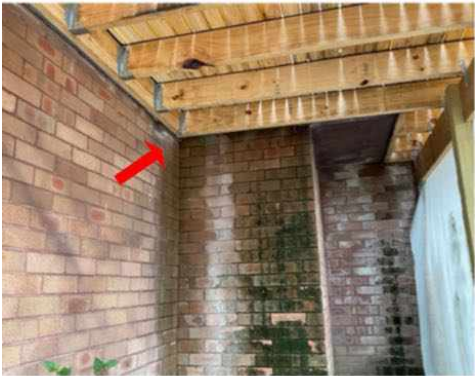
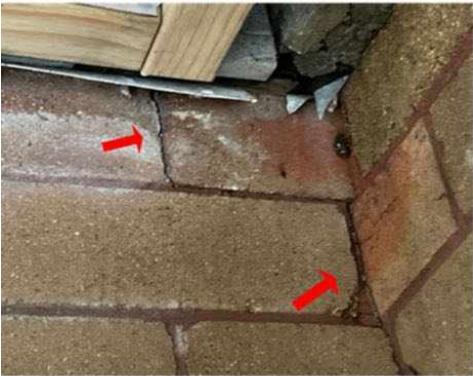
**Finding 3.10**

Building: Building 1  
Location: Exterior stonework  
Finding: Step cracking to brickwork  
Information: Minor step cracking was identified to the brickwork in these areas at the time of inspection. Step cracking, which is similar to other forms of cracking, has a variety of possible causes. However, the most common is the subsidence of adjacent footings.

Step cracking is a relatively common defect, and is most likely to occur adjacent to windows, doors and other openings. Mortar failure in the gaps between affected bricks indicates the stresses and tensions affecting the wall.

Where step cracking is extensive or severe, the client is advised to consult a structural engineer. Minor step cracking can be used as a warning sign to address factors causing stress to the wall, which can include the effect of surrounding trees, water leaks, soil erosion, or even the presence of reactive soils in the surrounding area.

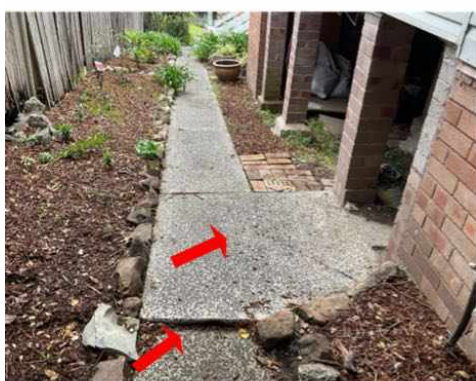
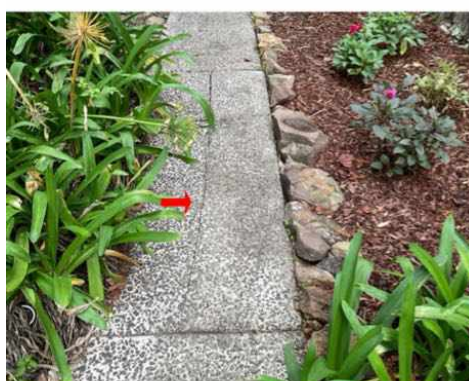
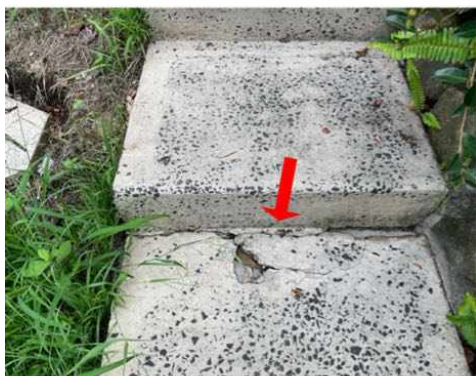
Finding 3.11

Building: Building 1  
 Location: Footpath  
 Finding: Crack in concrete slabs  
 Information: Cracks coded as Category 1 was identified in these pictured slabs. A Category 1 crack is described as a fine but noticeable crack, with the slab at an otherwise reasonable level. To be considered Category 1, the approximate width of the crack is less than 1.0mm, or a less than 10mm change in offset when a 3m straight edge is placed over the defect.

Category 1 cracks should be monitored for a period of 12 months. At the end of the monitoring period, identified cracks that are rated greater than Category 2 are considered defects, and require rectification.

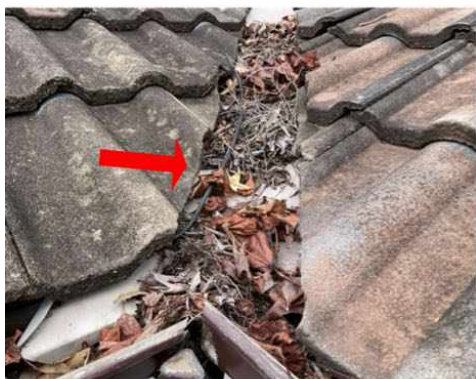
### Finding 3.12

Building: Building 1  
 Location: Roof exterior  
 Finding: Gutters - Full and blocked  
 Information: The guttering on around the roof was found to be blocked at the time of the inspection. Roof plumbing structures, such as guttering and downpipes, should be free of all debris to prevent blockages. Blockages of the guttering and downpipes will lead to pooling and accumulated water overflows, which is likely to subsequently flood eaves and exterior walls.

Blocked gutters are likely to lead to high levels of moisture in the affected areas which can cause rust and decay of the gutters and downpipes and wood rot to adjoining timber areas. Blockages in gutters should therefore be removed immediately to ensure dry conditions are maintained.

It is highly advised that gutters be cleaned by the homeowner or a general handyperson as a matter of urgency.

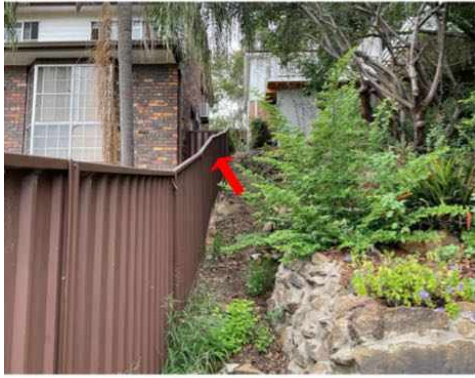
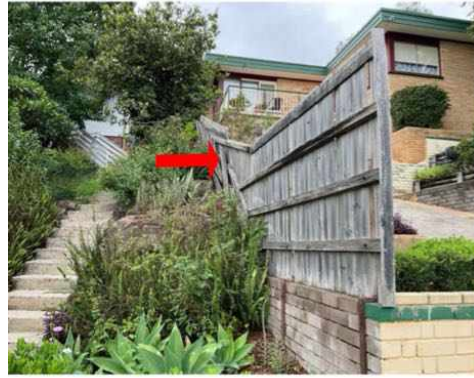
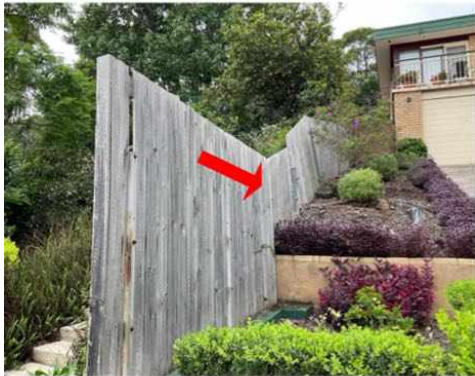
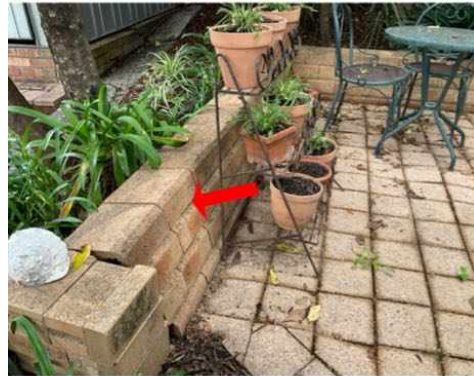
### Finding 3.13

Building:	Building 1
Location:	Pictured fences
Finding:	Fences damaged - leaning
Information:	Evidence of damage to many fences was identified at the time of the inspection. The likely cause of this fence leaning is not enough concrete used in the post footings, wood rot and wood borer damage. If left unmanaged these fences may deteriorate further. It is suggest a fencing contractor be engaged for rectification when convenient.

The cost of repairing fences is often shared between neighbours.

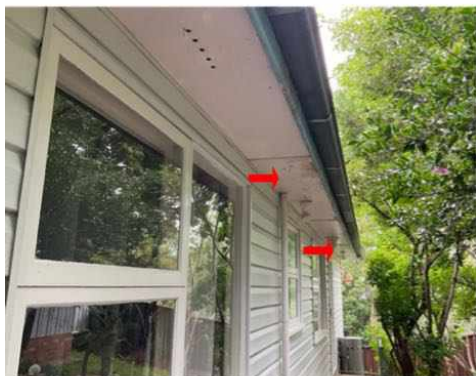
### Finding 3.14

Building:	Building 1
Location:	Eaves
Finding:	External painting deteriorated
Information:	Much of the external paintwork including has been neglected and require attention to repaint.

Whilst incomplete or missing paint finish is generally an appearance defect, it can also lead to the development of secondary building defects over time. Incomplete areas of paint finish expose the area to moisture, potentially accelerating the deterioration of underlying building materials.

Degraded paint finishes should be sanded back, filled, leveled and painted, as applicable. Where inadequate or missing paint protection has led to the deterioration of the associated building element, repair and/or replacement of this building element may be required.

A painting contractor should be appointed as soon as possible to perform necessary works to aid the appearance of the affected area and to ensure the area is protected against further deterioration. Alternatively, the homeowner following manufacturer instructions may perform these works.

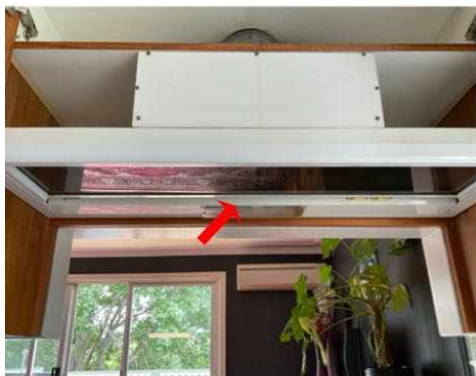
### Finding 3.15

Building:	Building 1
Location:	Kitchen
Finding:	Rangehood not working
Information:	The rangehood fan and light were not working at the time of inspection. This rangehood should also vent to an external area to prevent a build up of grease in the roof void.

Without a functional fan, a build-up of grease and evaporative moisture is likely to accelerate deterioration of the range hood and associated flue. This potential build up may also create a minor fire hazard, particularly if left uncleaned.

A licensed electrician should be appointed to replace the fan on the range hood to restore it to a fully operational state.

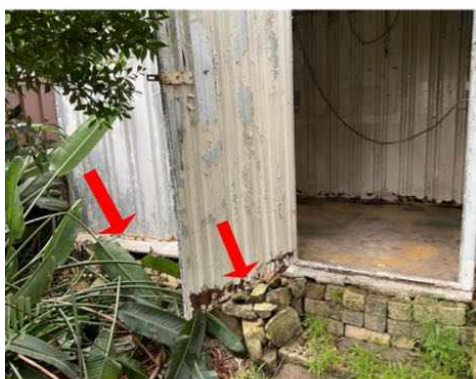
Building:	Building 1
Location:	Sheds
Finding:	Areas rusted or corroded
Information:	Shed areas shows evidence of rusting and corrosion, which is likely to have developed as a result of excessive exposure to moisture and or inadequate coatings.

As surface rust provides no protection to the underlying iron, the deteriorating condition is likely to worsen if not addressed in the short-term future.

Where possible, the use of galvanized (treated) metals or aluminium coated metals aid in rust prevention, as does regular general maintenance. Rust formation can be controlled with coatings, such as paint, that isolate the iron from the environment.

A handy person can replace these sheds if required.

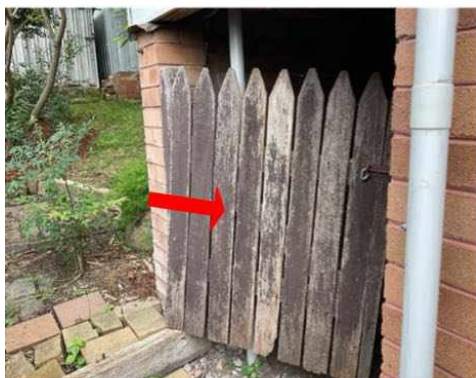
### Finding 3.18

Building:	Building 1
Location:	Pictured areas
Finding:	Building elements damaged
Information:	Evidence of minor missing or damaged areas was identified at the time of the inspection. These include -

1. The rear subfloor door is damaged requiring repair.
2. Some door handles are damaged.

A carpenter would be the trade responsible for rectification of these areas when convenient.

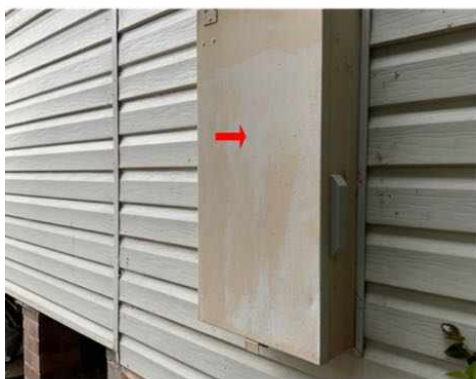
Building:	Building 1
Location:	Meter Box
Finding:	Termite Management System - no evidence of a chemical installation
Information:	The application of a post-construction chemical termite barrier is highly recommended for all properties. Such barriers are highly effective in preventing termite attack on any timber building elements throughout the property.

The client may consider gaining further advice from a pest controller as to the costs and procedures involved with a 'chemical' application. It is recommended that

obtaining such advice be a short-term priority.

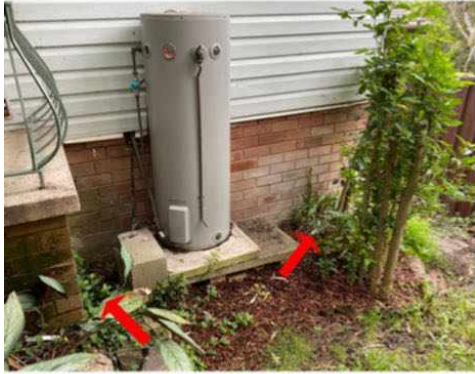
## Finding 6.02

Building:	Building 1
Location:	Many wall areas
Finding:	Bridging - Vegetation, decking, etc
Information:	Where vegetation and decking obstructs inspection of building elements, also known as bridging as it provides a bridging point for the access of termites, full inspection can not be achieved. Consequently moisture or dampness may be present and the areas becomes conducive to termite activity. Plants and decks against or very close to buildings provide cover, shade and can provide an environment that is attractive to termite infestation.

The removal of any such stored building or plant materials that may be conducive to termite activity should be carried out as soon as possible and arrange re inspection to minimize the risk of termite attack.

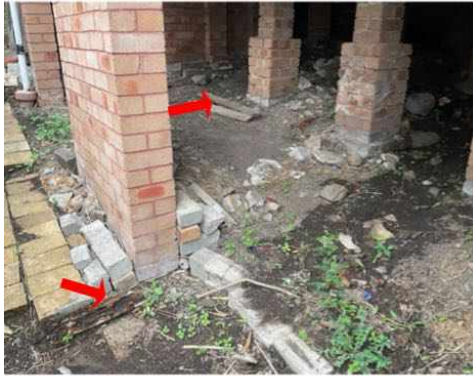
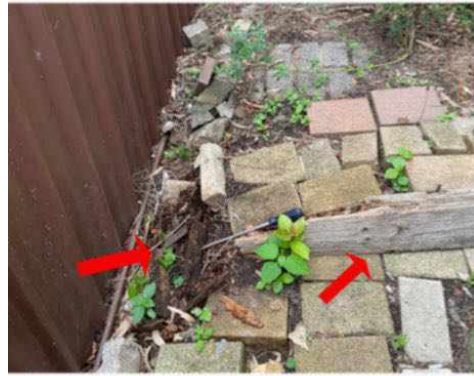
### Finding 6.03

Building:	Building 1
Location:	Yard & subfloor areas
Finding:	Timber in contact with the ground
Information:	Any timbers in direct ground contact provide opportunity for concealed termite entry and are likely to be subject to premature rot and decay as the soil retains moisture or damp conditions against the timbers.

Removal of all waste timber that is in direct contact with ground is highly advised. This timber is promoting mould and wood rot and is very attractive to termites.

Frequent pest inspections are advised to readily identify any termite activity in these areas.

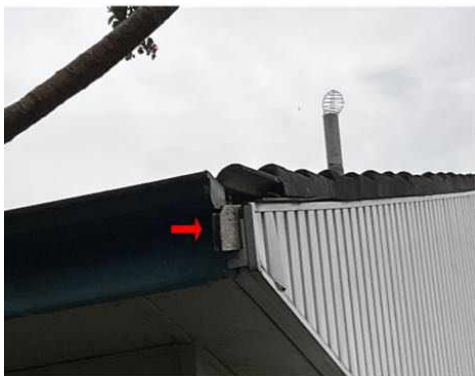
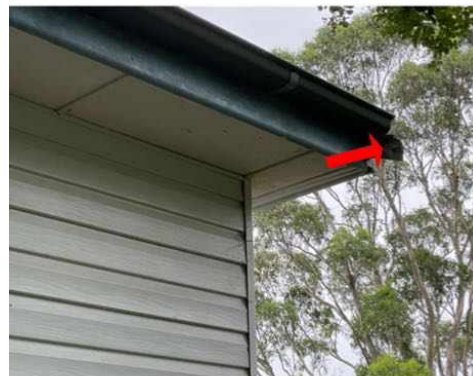
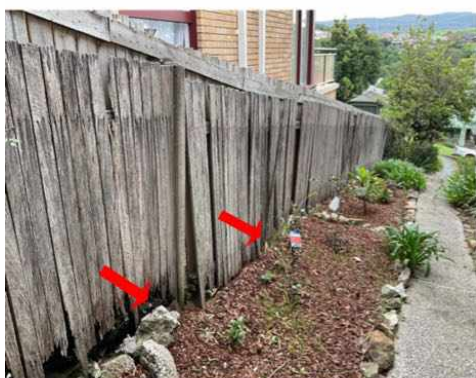
### Finding 7.01

Note - See ALL wood rot photos, all these show fungal decay.

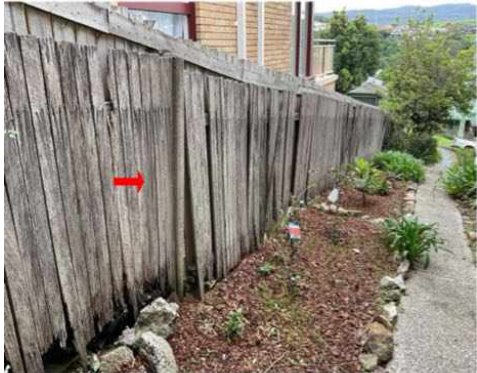
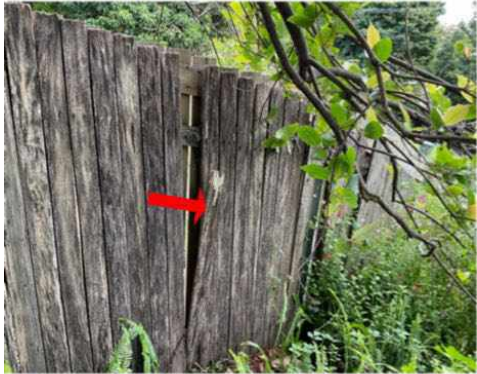
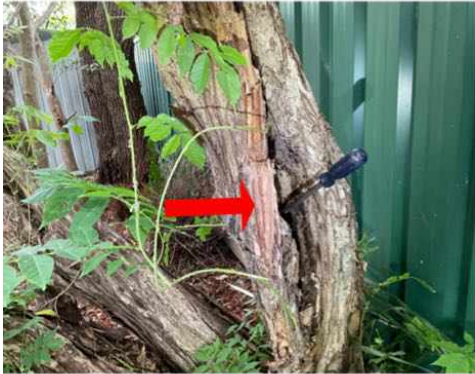
### Finding 8.01

As no live wood borer activity was identified treatment is not required at this time. Replacement of affected timbers may be considered by the client for superficial reasons.

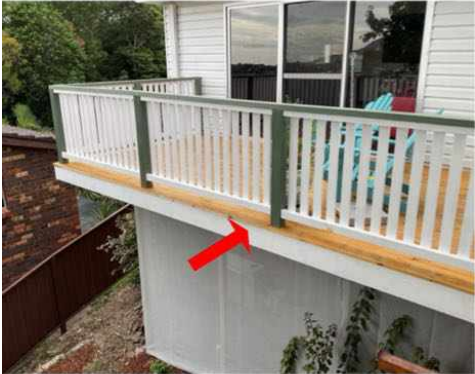
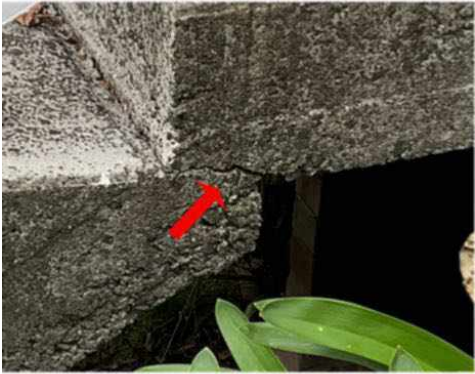
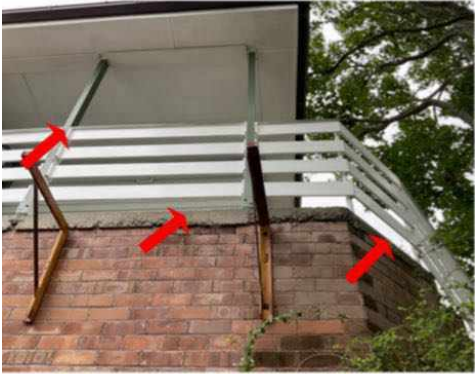
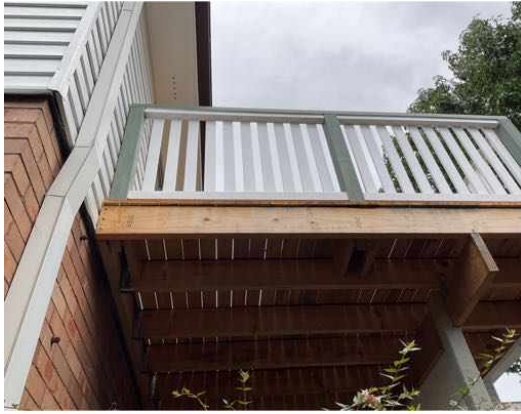
has been made, on any elevated structure, as suitable for any specific number of people or purpose. This can only be done by a qualified engineer. For the purpose of this report, the Structure includes the elevated front decks, handrails and stairs. The visible areas of the front steps show minor step cracking present in the lower steps (pictures 2 & 3).

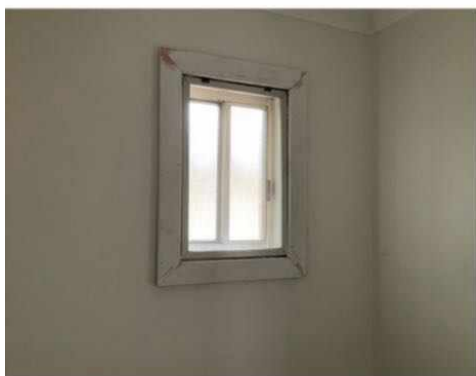
Building: Building 1  
Location: Many areas  
Finding: Repairs evident in many areas  
Information:
