Building and Timber Pest Inspection Report

Inspection Date: Fri, 16 Jan 2026

Property Address: 17 Price St, Bowral NSW 2576, Australia

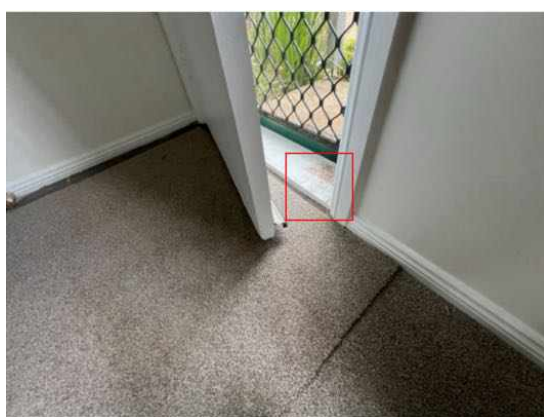
Finding 3.04

Building:	Building 1
Location:	Entry. Laundry
Finding:	Door - Wood rot
Information:	This door shows evidence of wood rot. Wood rot, also known as Fungal Decay, occurs when timbers and other cellulose building materials are exposed to damp conditions on an ongoing basis. This could be the result of exposure to weathering over a prolonged period of time, or the attraction of excessive moisture from other abutting building materials. Contributing factors also include poor air ventilation in the area.

Wood rot is often associated with general damp problems and is evidenced by a 'musty' smell or mould and mildew occurring on surfaces. If left unmanaged, damp conditions can lead to further health problems and the decay of timbers will continue.

Early intervention and regular maintenance, particularly of exterior timbers, will prolong the useful life of these building elements. Prior to any works being performed, the cause of the moisture that has created the visible wood rot should be identified and addressed in a suitable manner. Replacement of affected timbers may then be a necessary step in protecting surrounding building elements from such deterioration.

A qualified plumber may be appointed to assess the cause of excessive moisture and to provide advice on any remedial works as required. A qualified carpenter or registered builder may also be required to replace affected building materials.

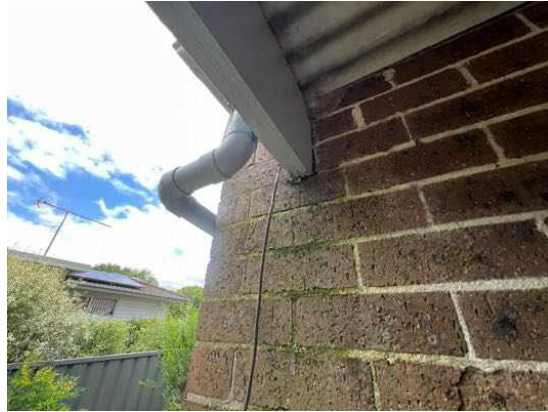
Finding 3.36

Building:	Building 1
Location:	Roof Exterior (carport)
Finding:	Roof plumbing - Flashing inadequate
Information:	Some sections of the roof are missing or have inadequate roof flashings. Flashings are metal and other materials which are applied to seals and intersections between roof coverings and building elements. They are designed to aid in weatherproofing of roof joins.

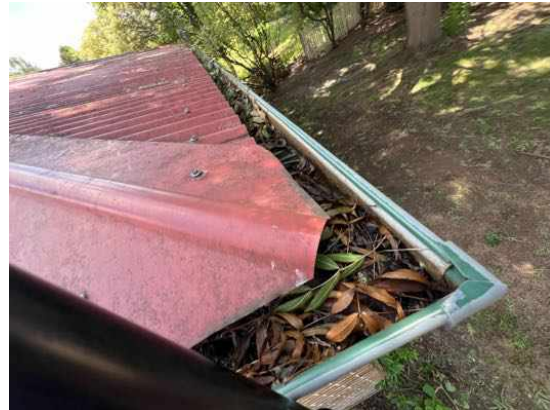
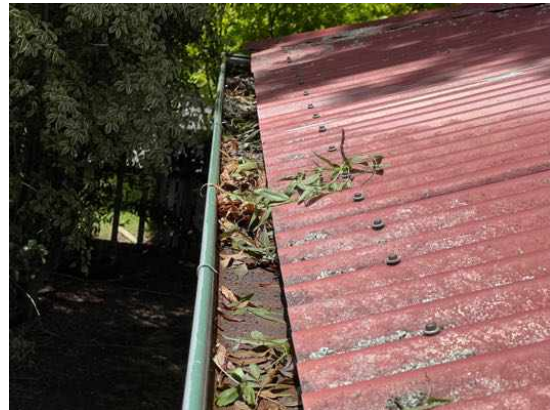
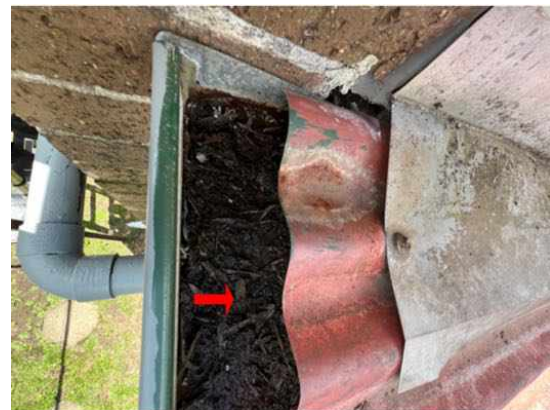
Finding 3.40

Building:	Building 1
Location:	Roof Exterior (porch)
Finding:	Gutters - Water pooling
Information:	Water was found to be pooling in sections of the roof guttering. This is generally a secondary defect caused by blocked or partially blocked gutters. Such blockages and subsequent water pooling are likely to lead to rust and water damage to associated

Any areas of guttering that shows evidence of water pooling should be checked for partial or full blockages and any secondary damage that may have occurred as a result. Depending on the extent of the damage, building elements may require repair and/or replacement to ensure adequate roof drainage and function of exterior plumbing system.

A roofing plumber should be appointed as soon as possible to rectify this issue. It is highly advised that all gutters be maintained on a frequent basis to ensure the condition of roof plumbing.

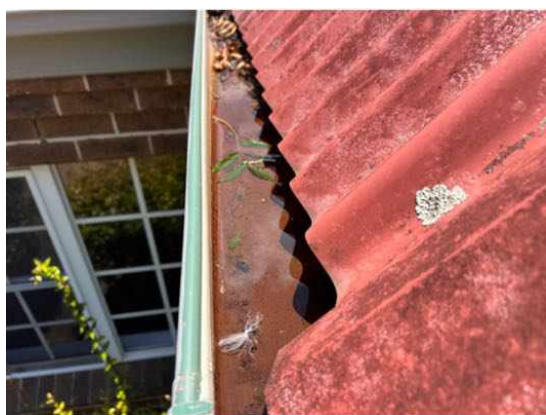
Finding 3.41

Building:	Building 1
Location:	Roof Exterior
Finding:	Roof plumbing - Rusted or corroded
Information:	The roof plumbing has areas of rust and corrosion. It is suspected that this has been caused by blockages, resulting in pooling or standing water, that have prematurely rusted elements of the roof plumbing.

Repair and/or replacement of rusted roof plumbing is highly required in order to reinstate the roof drainage system to a fully operational level. To further maintain these areas, gutters should be cleaned frequently, allowing the avoidance of any partial blockages.

A licensed plumber or specialist roof restoration company should be appointed to undertake these works. It is advised that such works be completed as soon as possible to prevent any further damage and deterioration.

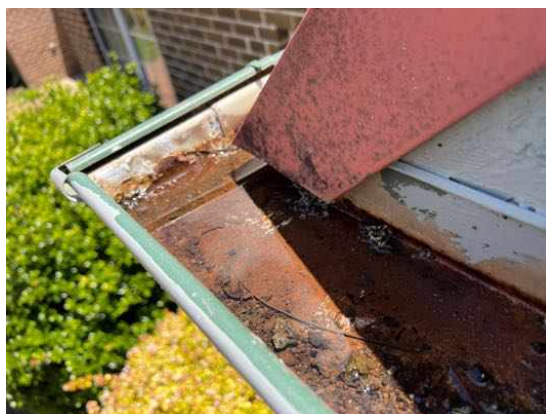
Finding 3.42

Building:	Building 1
Location:	Roof Exterior
Finding:	Roof plumbing - Flashing inadequate
Information:	Some sections of the roof are missing or have inadequate roof flashings. Flashings are metal and other materials which are applied to seals and intersections between roof coverings and building elements. They are designed to aid in weatherproofing of roof joins.

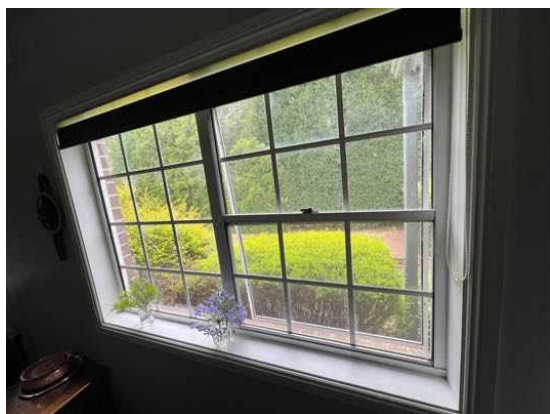
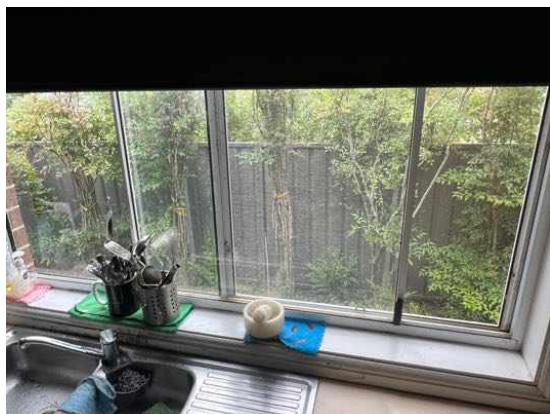
Finding 3.47

Building:	Building 2
Location:	All Internal Areas
Finding:	Painting deteriorated
Information:	The paint work in these areas of the property require attention to prepare and re paint. Whilst incomplete or missing paint finish is generally an appearance defect, it can also lead to the development of secondary building defects over time. Incomplete areas of paint finish exposes the area to moisture, potentially accelerating the deterioration of underlying building materials.

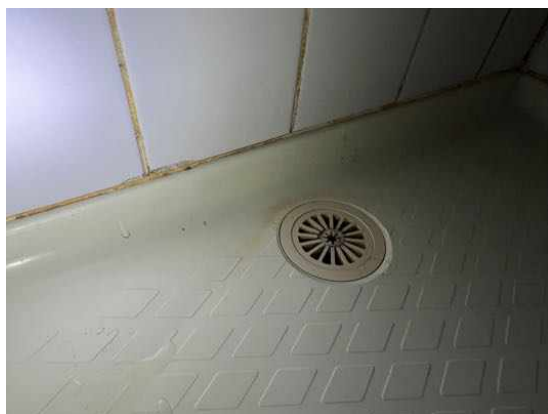
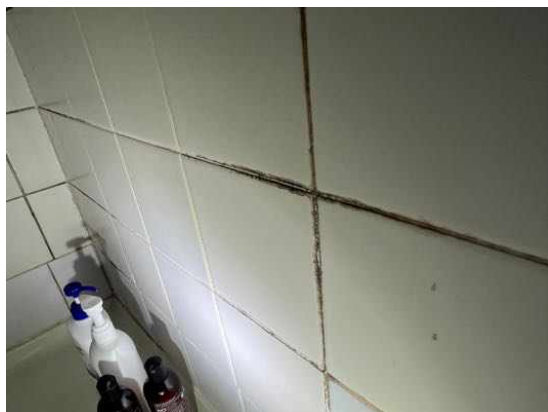
Finding 3.69

Building:	Building 2
Location:	Ensuite, Bathroom
Finding:	Tiles - Cracked or damaged
Information:	Cracking was evident to the tiling in this area at the time of inspection. While the cracking appears to be minor, this area is frequently exposed to water, allowing potential for water penetration into adjoining sections of walls or flooring.

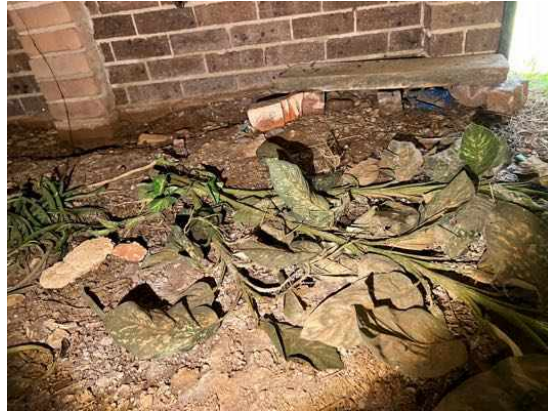
Finding 3.92

Building:	Building 2
Location:	Subfloor
Finding:	Water pooling - against property
Information:	Water appears to be pooling against the house. It is suspected that this is a result of poor site drainage but may also be due to excessive moisture from an unidentified source.

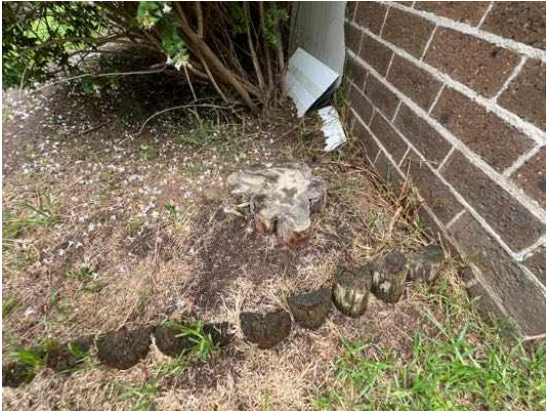
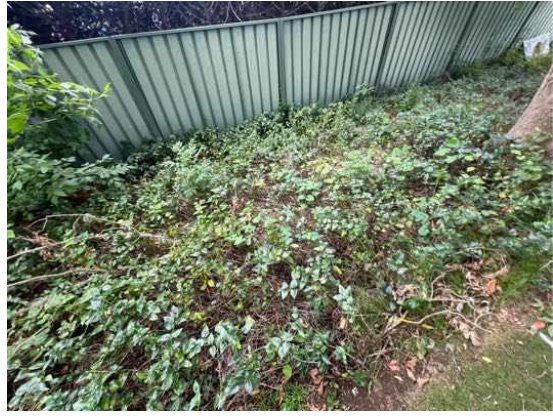
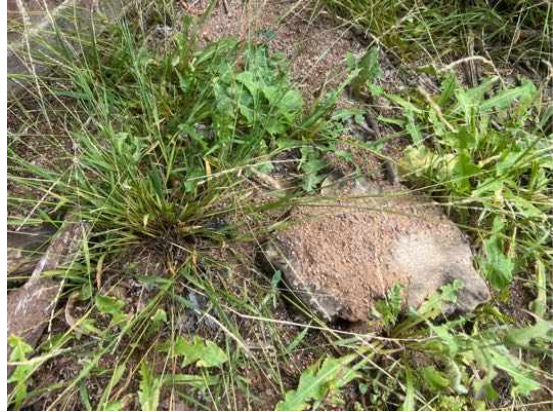
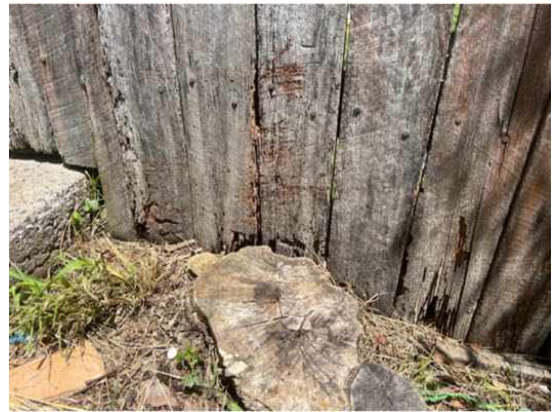
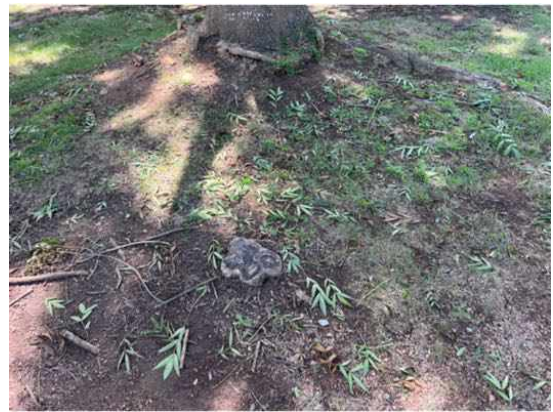
Finding 6.20

Building: Yard
Location: The Site
Finding: Timber Pest Risk – Trees Within 50m of Dwelling
Information: Mature trees were identified within 50 metres of the dwelling. The presence of trees in close proximity to the structure increases the risk of termite activity, as trees provide a natural food source and nesting environment for termites. Tree roots can also contribute to excessive moisture retention in the soil, creating conducive conditions for timber pest activity.

Regular monitoring for signs of termite activity is advised. A licensed pest inspector should be engaged to assess the area and provide further recommendations on risk mitigation and management.
