# Building and Timber Pest Inspection Report

Inspection Date: Fri, 6 Mar 2026

Property Address: 22 Mayfair Dr, West Wodonga VIC 3690,  
Australia

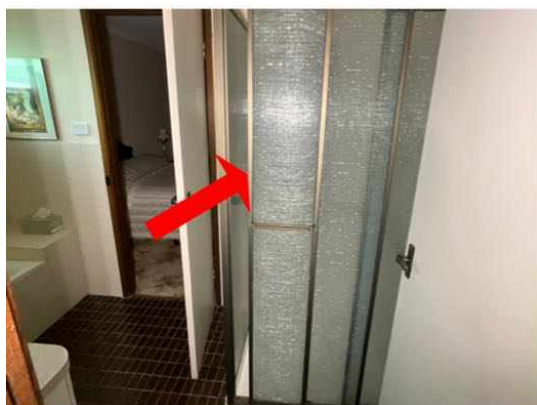
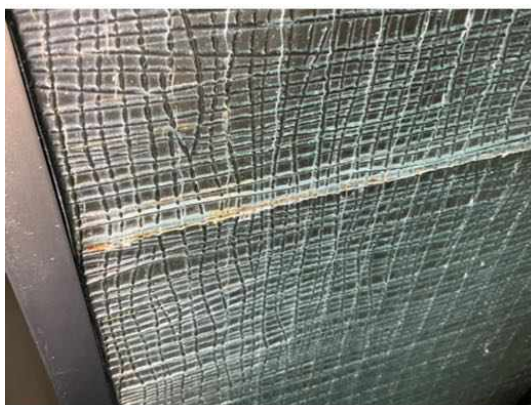
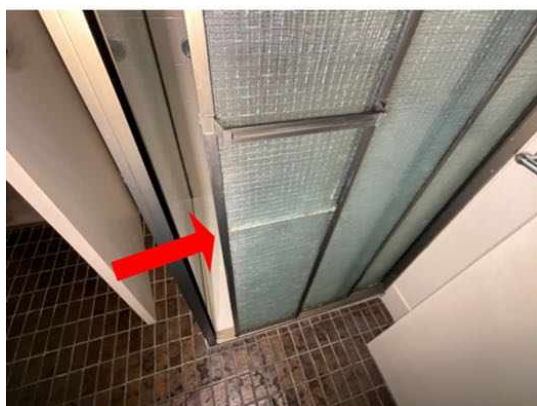
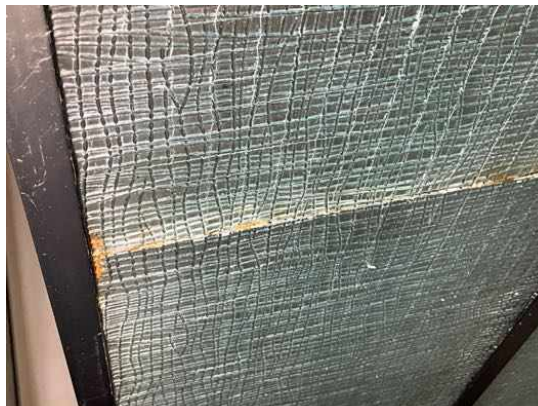
#### Finding 1.01

Building:	Building 1
Location:	Bathroom
Finding:	Shower screen - Cracked
Information:	Cracking was evident to the shower screen at the time of inspection, which is suspected to be due to accidental impact damage.

While the cracking appears to be minor, any further impact may lead to additional cracking and or shattering of the shower screen, creating a potential safety hazard in the area. Further damage would almost certainly necessitate replacement of the entire shower screen.

A safety hazard is noted. The shower screen is cracked. A glazier should be contacted immediately to restore the area and prevent potential injury.

A qualified glazier is required to repair the shower screen as soon as possible. Please be advised that any persons coming into contact with the cracked shower screen should do so with due caution to avoid any personal injury that may ensue.

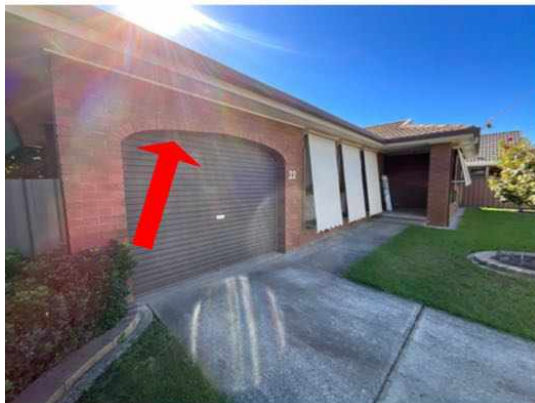
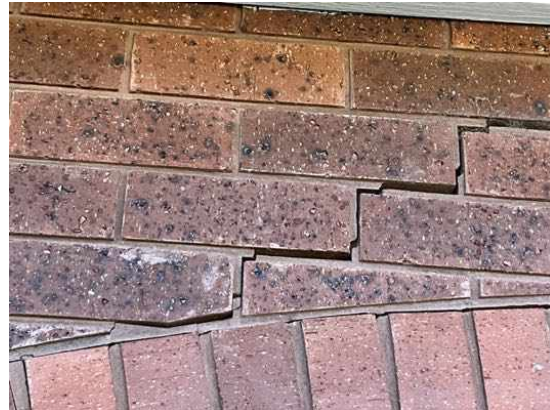
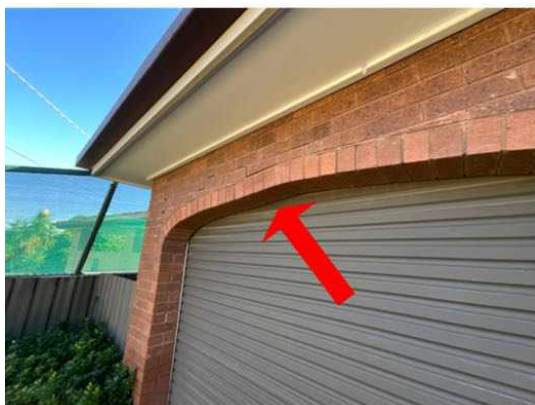
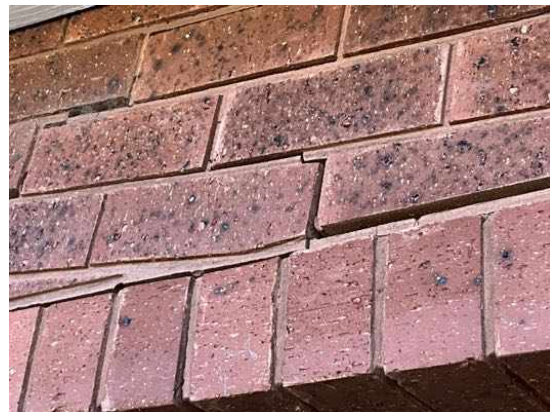
## Finding 2.01

Location: Carport

Finding: Brickwork - Step cracking

Information: Step cracking was identified to the brickwork in this area at the time of inspection. Step cracking, which is similar to other forms of cracking, has a variety of possible causes. However, the most common is the subsidence of adjacent footings.

Step cracking is a relatively common defect, and is most likely to occur adjacent to windows, doors and other openings. Mortar failure in the gaps between affected bricks indicates the stresses and tensions affecting the wall.

The cracking in this area also displays sagging to the arch. Movement is evident when pushed. It is advised that a bricklayer be contacted immediately to restore the area and prevent further deterioration and potential injury.

A major defect is noted. The brickwork above the carport should be repaired by a bricklayer immediately to avoid further deterioration and potential injury.

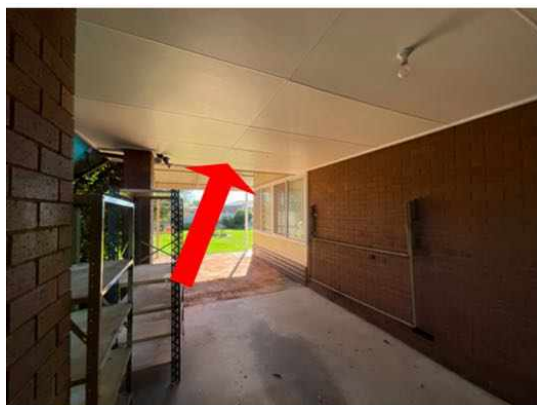
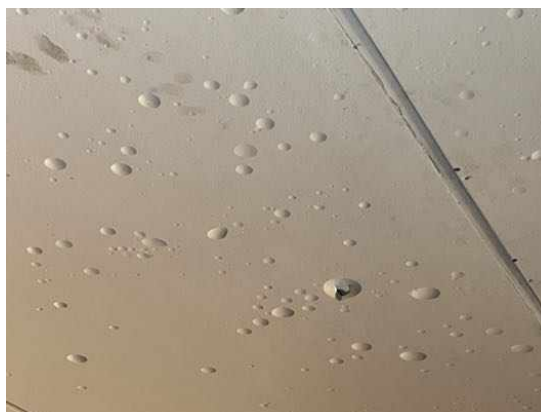
### Finding 3.01

Location: Carport  
 Finding: Painted surface - Bubbling  
 Information: Sections of paint in this area was found to have bubbled and deteriorated. Paint bubbling is generally an indication of excessive moisture in the area, that is currently hidden by the painted surface.

The presence of excessive moisture can have major implications on associated building elements if left unattended. While only seemingly minor at this stage, the damage cannot be determined due to the paint obstructing any further inspection of the damage.

It is highly advised that the affected paint be cleaned to allow a further, more invasive inspection by a licensed plumber. Failure to act on this defect may necessitate major works in the future.

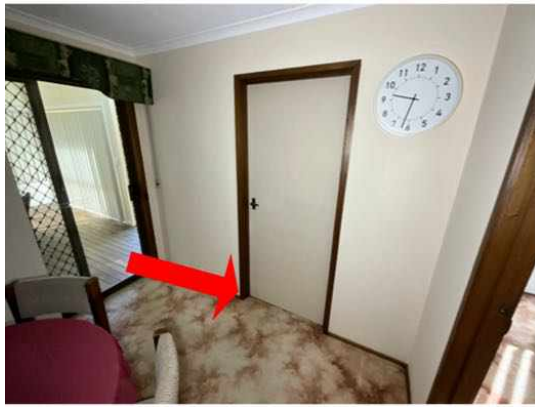
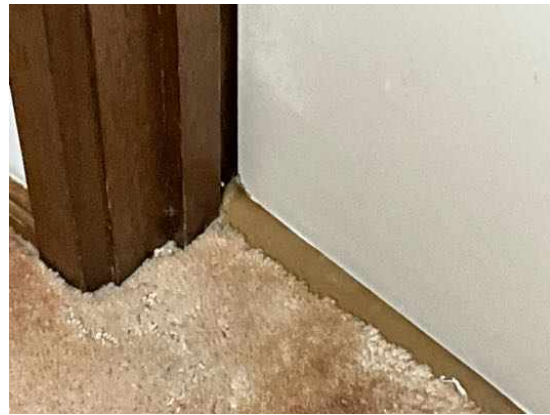
### Finding 3.02

Building: Building 1  
 Location: Laundry  
 Finding: Door- Binding/jamming  
 Information: Binding and/or jamming of this door is evident during standard operation. This defect inhibits the functionality of the affected door as well as creating potential for secondary defects to associated building elements, such as damage to the floor covering.

A door that binds to flooring or to the associated door frame may have several causes, ranging from minor defects, such as poor installation of the door or deteriorated hinges, through to major structural issues, such as damage to subfloor structures.

A qualified carpenter or general handyperson should be appointed to perform minor rectification works at client discretion.

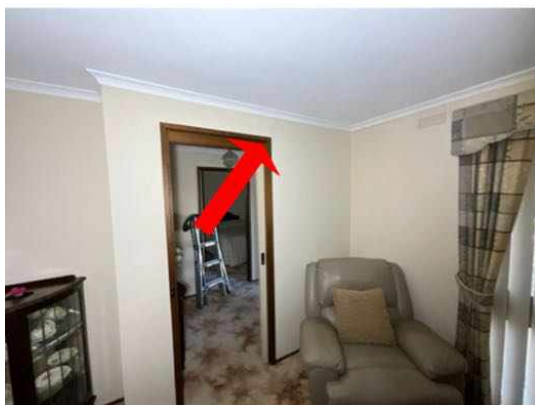
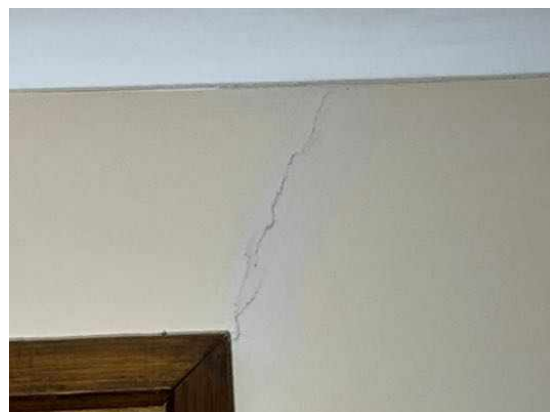
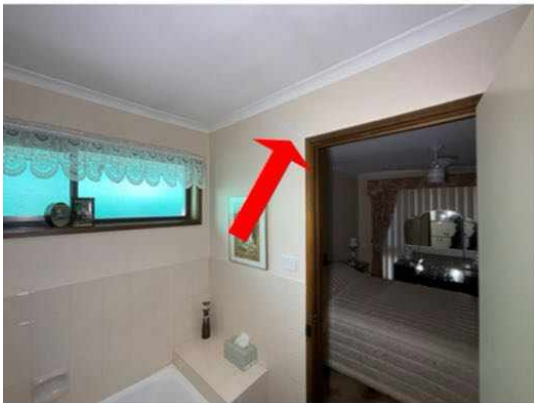
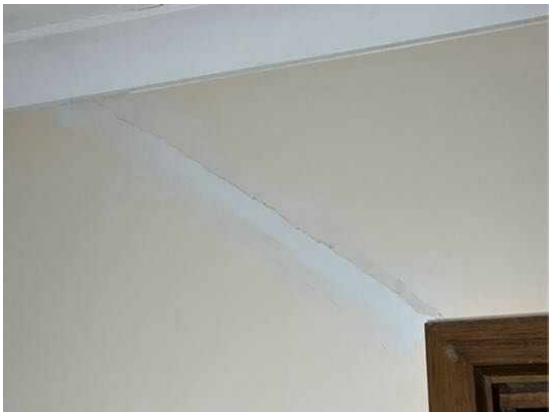
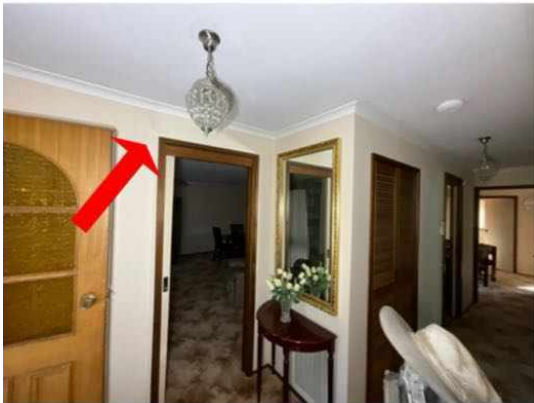
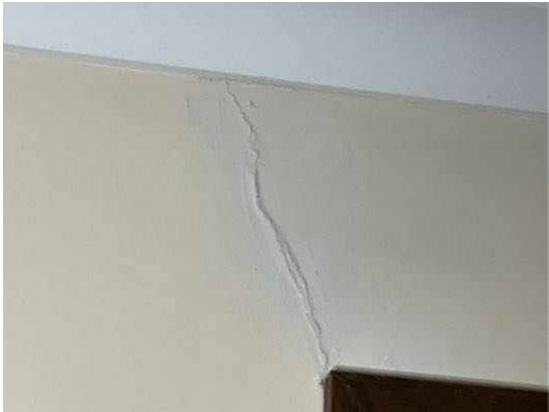
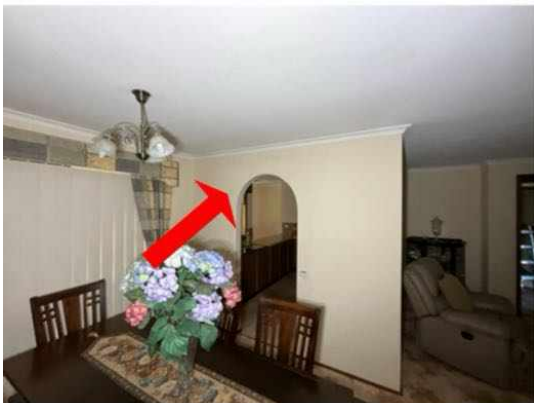
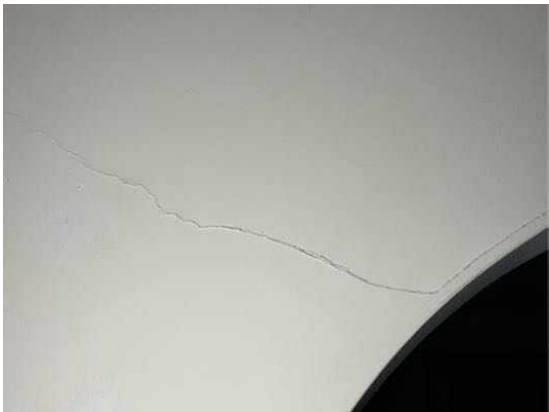
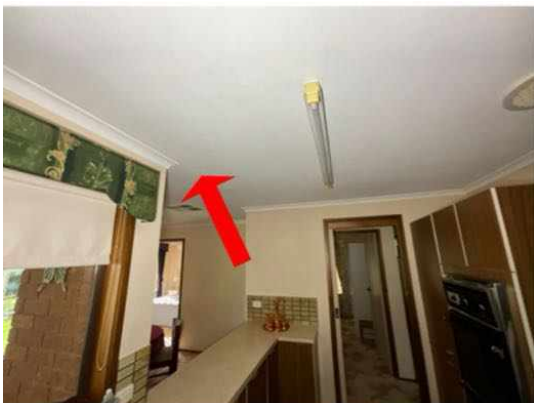
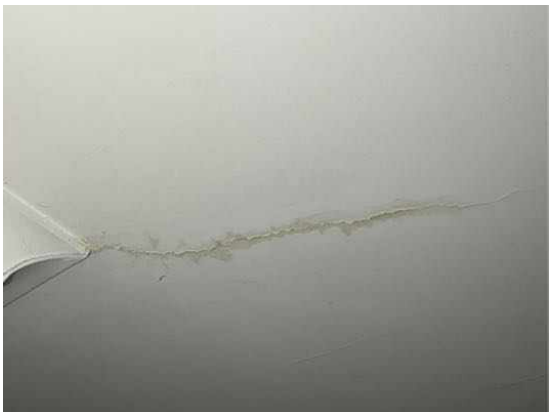
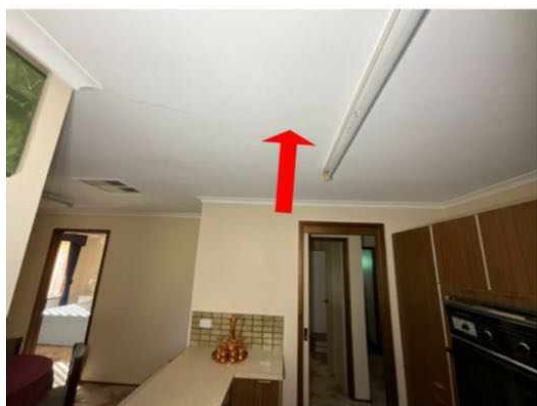
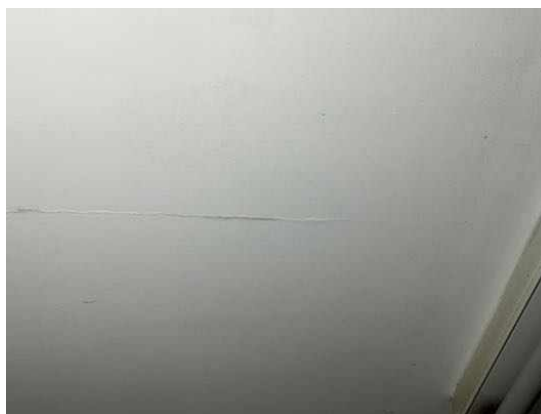
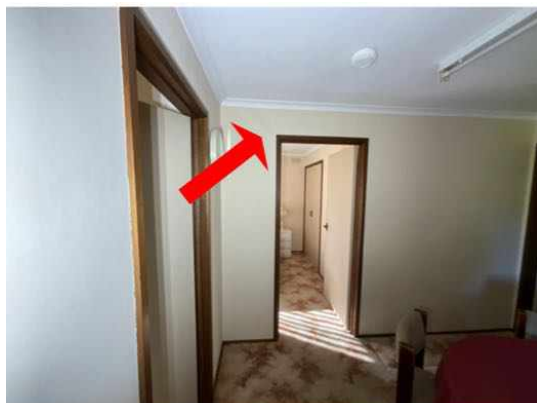
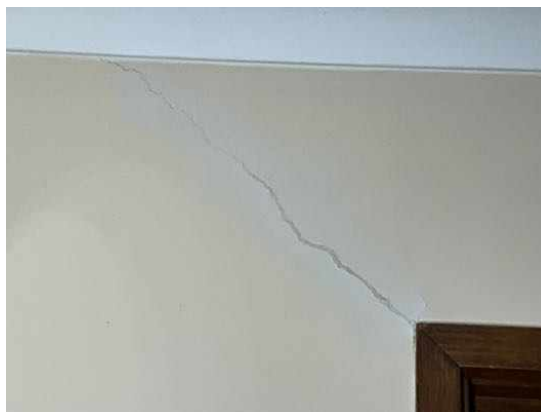
### Finding 3.03

Building:	Building 1
Location:	Living, bathroom, hall, kitchen, dining
Finding:	Cracking - Damage Category 1 - Fine (up to 1mm)
Information:	Although fine cracks are quite noticeable, they are often only considered to be an appearance defect, and usually do not indicate any structural damage. Generally, the cause of a fine crack is indicative of a separation between building materials and finishes (e.g. paint, plaster, etc.) along joins.

Cracking of this nature can generally be repaired with minor sanding, filling and/or repainting. Such works should be performed by a qualified painter or a general handyman.

Monitoring of all cracking should be conducted frequently. Always contact a building inspector should cracks widen, lengthen, or become more numerous.

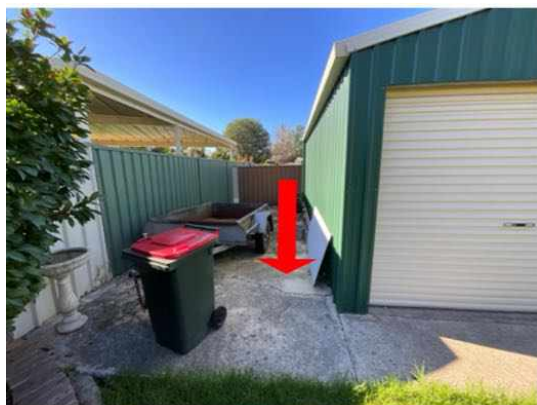
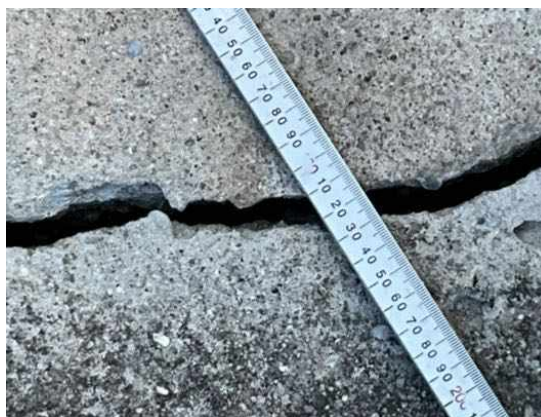
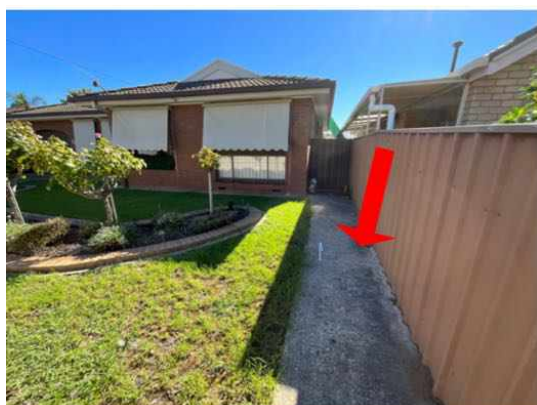
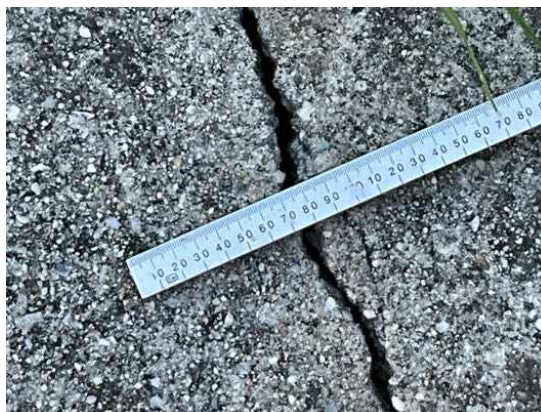
### Finding 3.04

Building:	Building 1
Location:	Yard - Back, front
Finding:	Cracking - External Concrete Paving Damage Category 4 - Gaps in Slab (4mm - 10mm +)
Information:	Gaps in the slab were identified in external concrete paving. Gaps in the slab are significant and are likely to lead to the development of safety hazards and secondary defects if left unmanaged, such as the creation of a trip hazard.

General age and expected deterioration of the paved areas is a common cause of this type of cracking. However, expansion and contraction of the slab may also have occurred due to environmental factors. Such factors include variable moisture and weather conditions, the presence of trees and their roots having a settling or lifting affect on the soil, or the effect of load bearing, e.g. heavy vehicles over a sustained period of time.

Cracking to this degree may also be due to poor original installation of the concrete. Factors such as poor compaction of the sub surface and/or inadequate reinforcing of the slab may create cracking and other secondary defects. Gaps in the concrete paving may also have a more significant structural cause, such as subsidence of soils.

Where gaps in the concrete paving are adjacent to structural elements of the building, the advice of a Structural Engineer is advisable before undertaking repairs. Significant

repair and likely replacement of the concrete paving is probable.

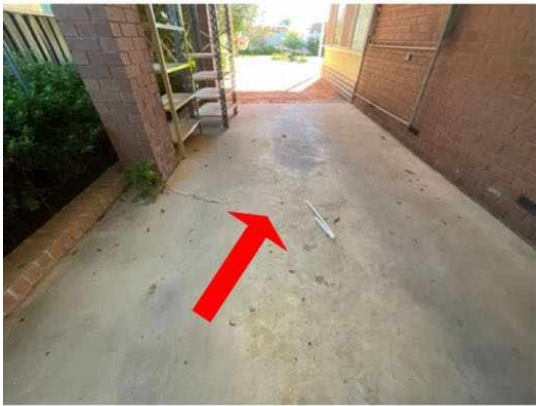
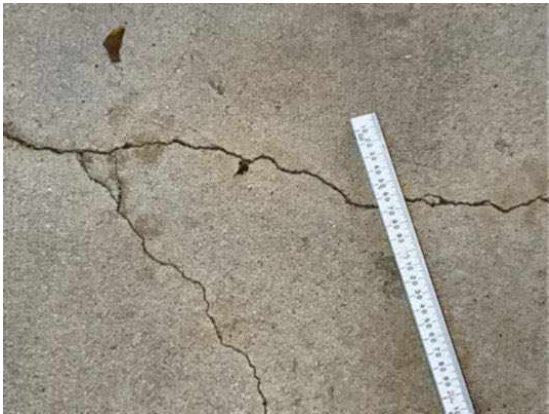
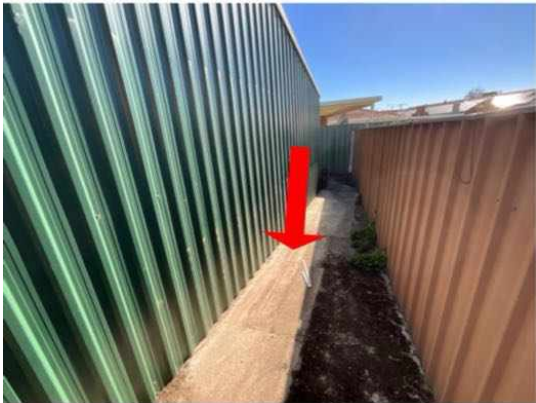
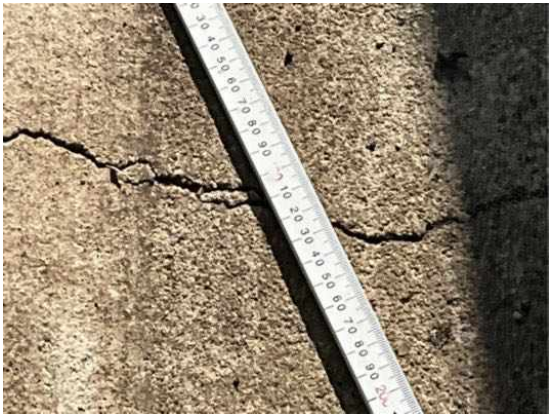
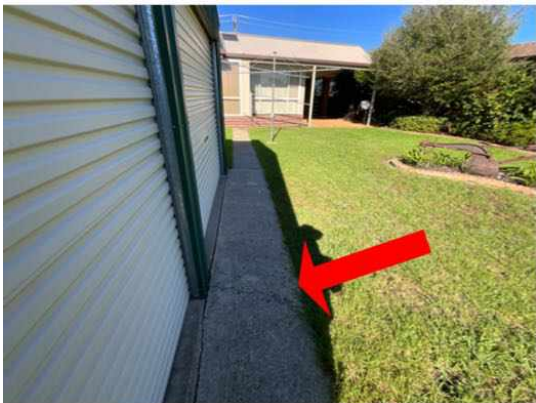
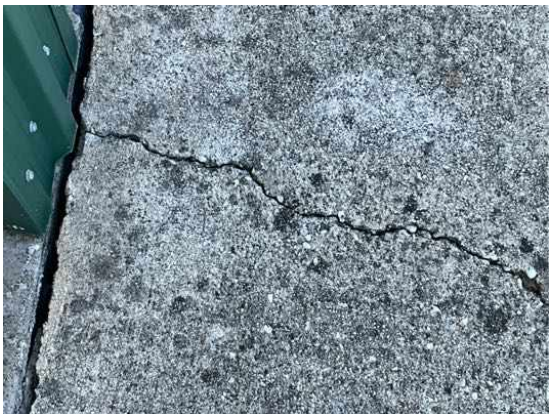
### Finding 3.05

Building:	Building 1
Location:	Carport, yard- back,
Finding:	Cracking - External Concrete Paving Damage Category 1 - Fine (less than 2mm)
Information:	Fine cracks were identified in external concrete paving. Although fine cracks are quite noticeable, they are often only considered to be an appearance defect, and usually do not indicate any structural damage. To be considered a Category 1 or fine crack, the crack is found to be less than 2mm in width.

Generally the cause of a hairline crack in existing concrete paving such as driveways and pathways is indicative of the expansion and contraction of the concrete. Such causes are generally due to environmental factors, such as moisture levels, weather conditions, root systems of nearby trees or the soil types on which they are laid.

Fine cracks may also be due to poor original installation of the concrete. Factors such as poor compaction of the sub surface and/or inadequate reinforcing of the slab may create cracking and other secondary defects.

Monitoring of all cracking should be conducted frequently. Always contact a building inspector should cracks widen, lengthen, or become more numerous.

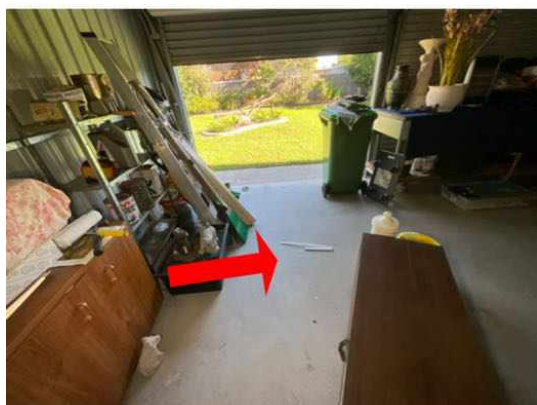
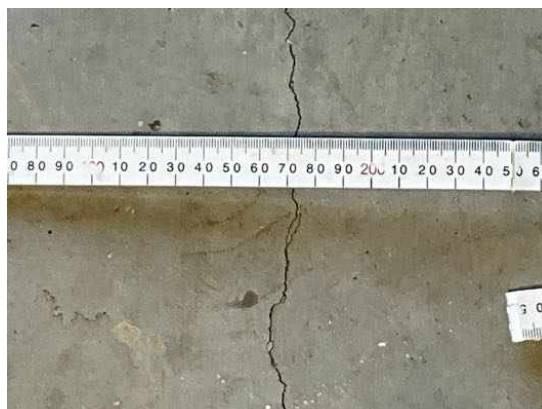
**Finding 3.06**

Building: Building 1  
 Location: Garage  
 Finding: Crack in concrete slab - Category 1  
 Information: A crack coded as Category 1 was identified in the slab. A Category 1 crack is described as a fine but noticeable crack, with the slab at an otherwise reasonable level.

To be considered Category 1, the approximate width of the crack is less than 1.0mm, or a less than 10mm change in offset when a 3m straight edge is placed over the defect.

Category 1 cracks should be monitored for a period of 12 months. At the end of the monitoring period, identified cracks that are rated greater than Category 2 are considered defects, and require rectification.

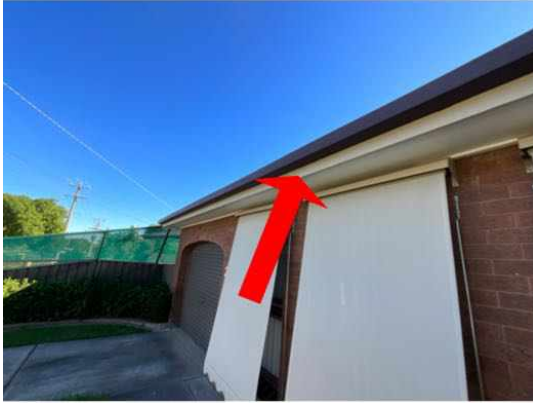
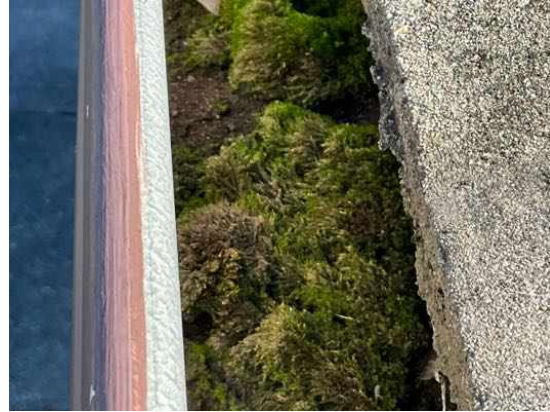
### Finding 6.01

Building: Building 1  
 Location: Eaves  
 Finding: Gutters- Blocked  
 Information: Roof plumbing structures, such as guttering and downpipes, should be free of all debris to prevent blockages. Blockages of the guttering and downpipes will lead to pooling and accumulated water overflows, which is likely to subsequently flood eaves and exterior walls.

Blocked gutters are likely to lead to high levels of moisture in the affected areas. Such moisture will not only cause rust and decay of the associated building materials, but can also provide conditions that are conducive to termite and timber pest activity. Blockages in gutters should therefore be removed immediately to ensure dry conditions are maintained.

Consult a Licensed Plumber for further specific advice on remedial works that may be required. In the interim, it is highly advised that blocked gutters be removed by the homeowner or a general handyperson as a matter of urgency.

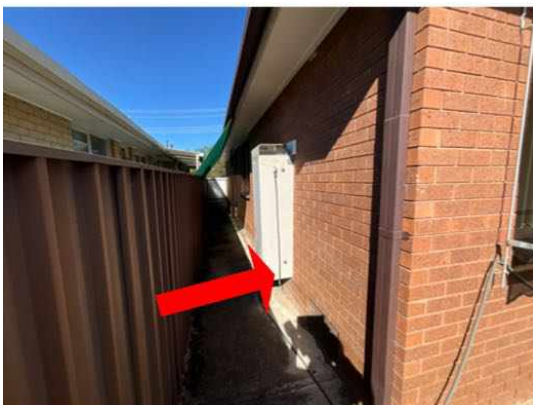
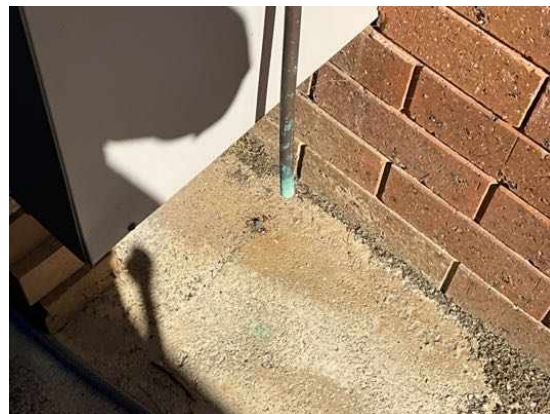
### Finding 6.02

Building:	Building 1
Location:	Yard - Side
Finding:	HWS Overflow - Not Connected
Information:	The Hot Water System (HWS) overflow was found to be disconnected from storm water drainage and is creating excessive moisture in the surrounding area.

These damp conditions can lead to secondary defects such as rot, rust or corrosion of associated building elements, the formation of fungal decay, or even the creation of potential slip hazards. When coupled with poor site drainage, pooling of water may also attract termite activity to this area.

It is highly recommended that a licensed plumber be appointed to connect the HWS overflow in order to prevent such an environment from being created. These minor works should be carried out as soon as possible.

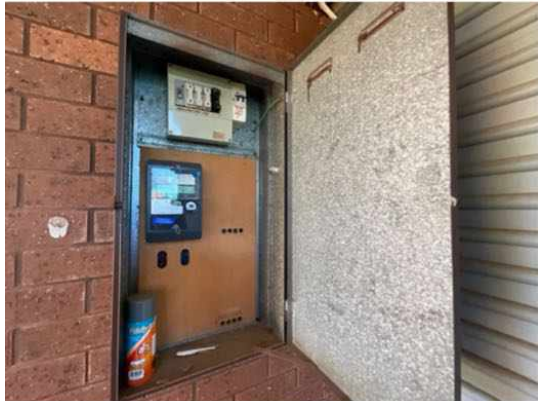
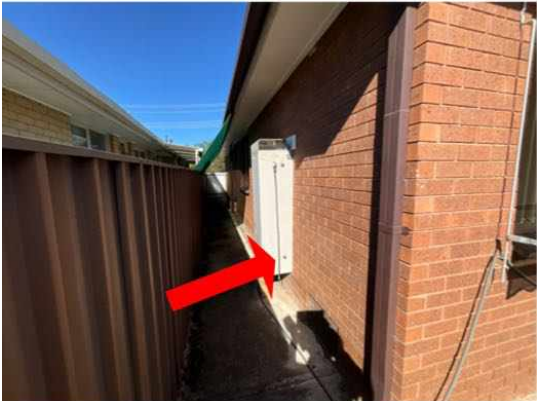
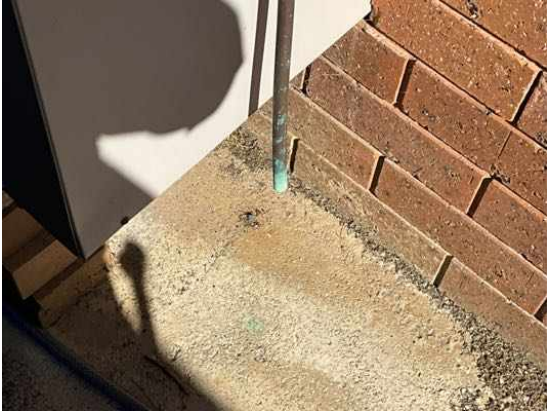
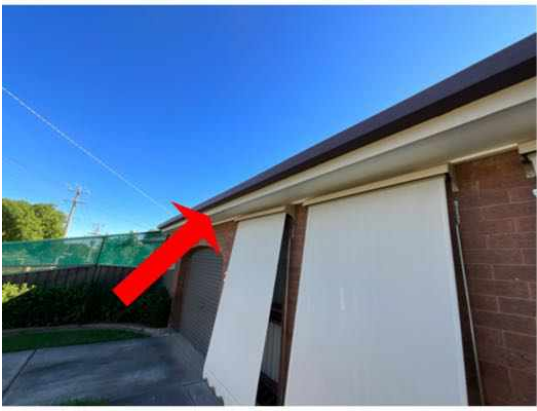
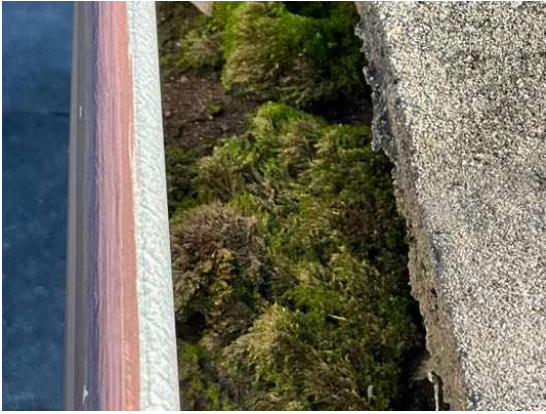
### Finding 6.03

Building:	Building 1
Location:	All External Areas
Finding:	Termite Management System - no evidence of a chemical installation

The application of a post-construction chemical termite barrier is highly recommended for all properties, particularly if live termite activity has been found on the site previously. Such barriers are highly effective in preventing termite attack on any timber building elements throughout the property.

A durable notice should be placed in the switchboard unit to indicate current termite barriers. At the time of inspection, it appeared as though no termite management system has been installed, with no evidence to suggest preventative works taking place.

The client may consider gaining further advice from a pest controller as to the costs and procedures involved with this application. It is recommended that obtaining such advice be a short-term priority.

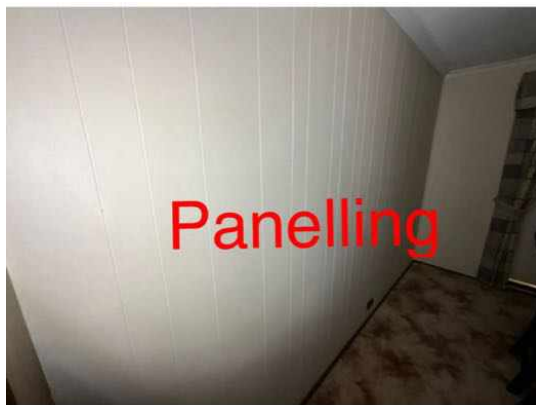
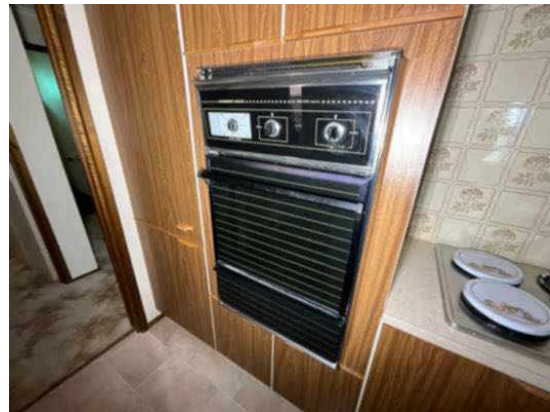
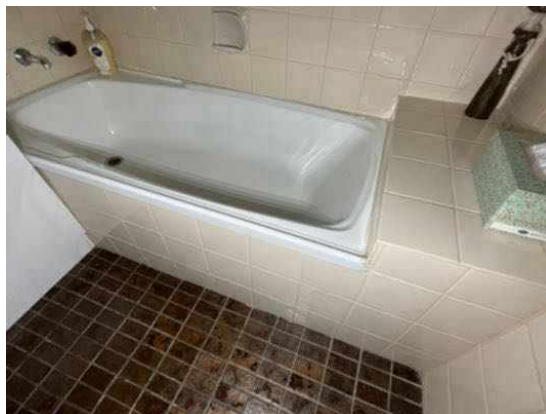
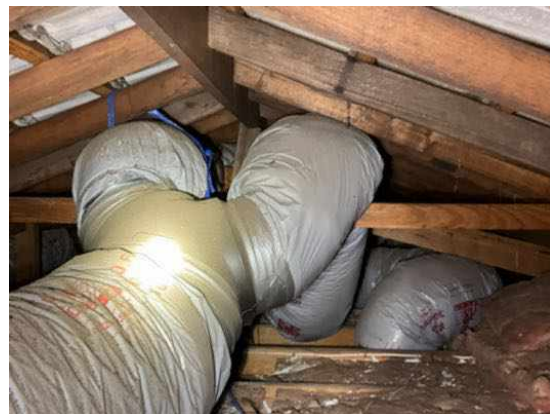
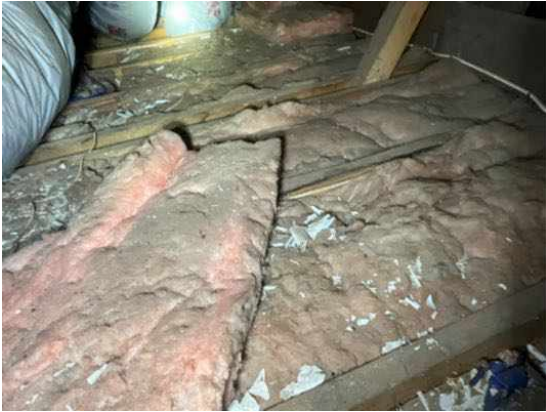
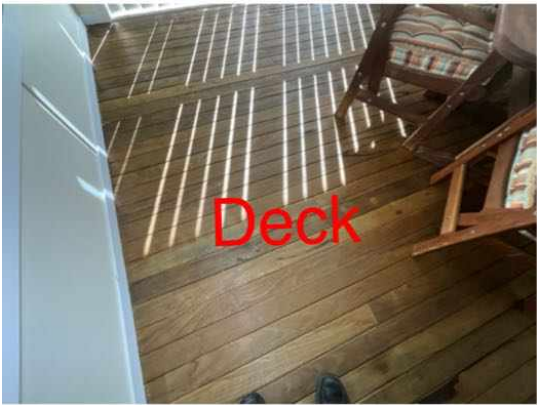
#### Noted Item

Building: Building 1  
Location: All Areas  
Finding: Additional Photos - Obstructions and Limitations  
Information: These photographs are an indication of the obstructions and limitations which impeded full inspection of the property at the time of inspection. These obstructions can hide an array of defects and should be removed to allow full inspection to be carried out. A re-inspection is recommended once the areas are made accessible.
