Building and Timber Pest Inspection Report

Inspection Date: Tue, 17 Mar 2026

Property Address: 38 Westminster Dr, Castle Hill NSW 2154,
Australia

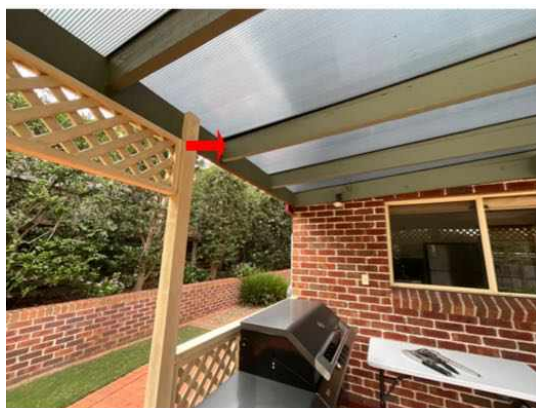
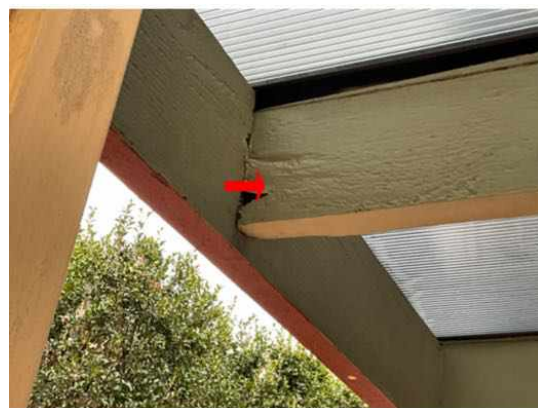
Finding: Wood decay / Rot

Information: This building element shows evidence of severe wood rot. Wood rot, also known as Fungal Decay, occurs when timbers and other cellulose building materials are exposed to damp conditions on an ongoing basis. This could be the result of exposure to weathering over a prolonged period of time.

If left unmanaged, damp conditions can lead to further health problems and the decay of timbers will continue.

Severe timber rot was identified to the alfresco timber structures. Immediate replacement must be carried out by a licensed carpenter to ensure further deterioration is stopped and hence prevented from collapse.

Early intervention and regular maintenance, particularly of exterior timbers, will prolong the useful life of these building elements. Prior to any works being performed, the cause of the moisture that has created the visible wood rot should be identified and addressed in a suitable manner. A licensed roof plumber should be appointed for this work. Replacement of affected timbers by a licensed carpenter is then a necessary step in protecting surrounding building elements from such deterioration.

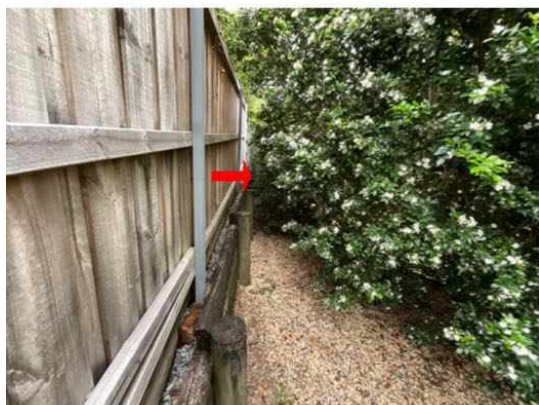
Building:	Main Building
Location:	Retaining Walls
Finding:	Timber retaining wall — Defective
Information:	The retaining wall in this area was found to be defective at the time of inspection. Generally, defective retaining walls are caused by poor original design or material use. However, deteriorated retaining walls may also be a result of substandard construction, poor site drainage or unmanaged stormwater flows.

Where retaining walls further rot and decay, an environment is created that is conducive to termite and pest infestation.

The structural engineer may draft a scope of works for a licensed trade to carry out

rectifications.

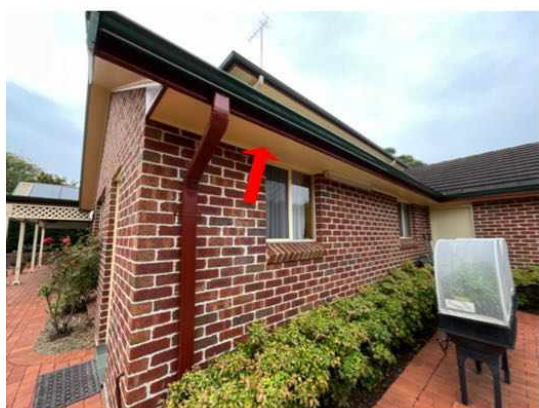
Finding 3.02

Building:	Main Building
Location:	Rear right corner
Finding:	Painted surface — Bubbling
Information:	Sections of paint in this area was found to have bubbled and deteriorated. Paint bubbling is generally an indication of excessive moisture in the area, that is currently hidden by the painted surface.

The presence of excessive moisture can have major implications on associated building elements if left unattended. While only seemingly minor at this stage, the damage cannot be determined due to the paint obstructing any further inspection of the damage.

A possible cause could be overflow of stormwater from the gutters due to gutters being blocked. It is highly advised that the affected paint be cleaned to allow a further, more invasive inspection by a licensed roof plumber. Failure to act on this defect may necessitate major works in the future.

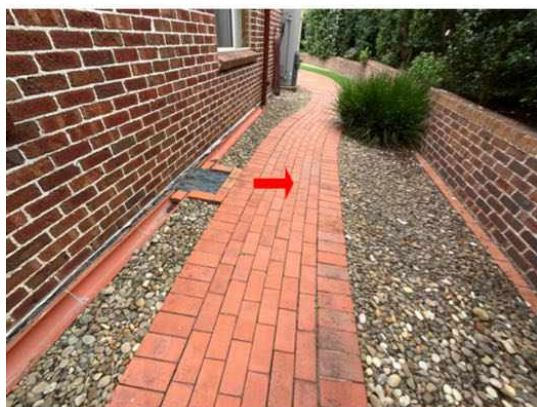
Finding 3.03

Building: Main Building
 Location: Multiple areas
 Finding: Paving — Uneven
 Information:

Sections of the external paved area are uneven, which may develop into a trip hazard. It appears as though the area has been subject to rough installation, or that paving sections have lifted due to movements in the foundation.

Left unmanaged, the May develop into a safety hazard due to trip and fall.

Re-paving of the area is required to remedy this situation. Further consultation with a specialist concreter is advised.

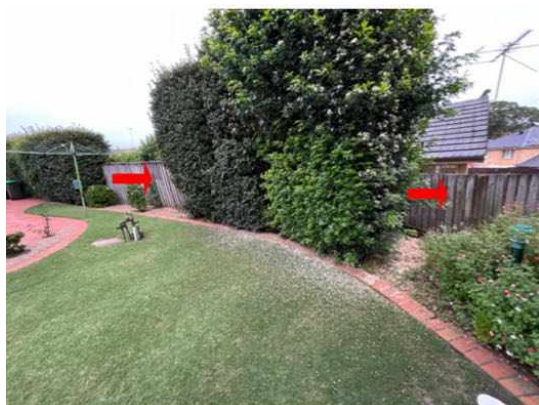
Finding 3.04

Building: Main Building
 Location: Fencing
 Finding: Fencing - Deteriorated
 Information:

It was noted at the time of inspection that sections of the fencing in this area has deteriorated. Typically fencing deteriorates due to age and or wear, rot and or rust which is generally expected for a structure of this age, due to prolonged exposure to weather conditions. Sometimes inadequate installation or maintenance can be to blame.

If left unattended, it is likely that further damage will occur. It is suspected that repair of several elements of the fencing may be required however replacement may be a consideration of the client also.

A licensed fencing contractor should be appointed to provide further advice and perform rectification works as necessary.

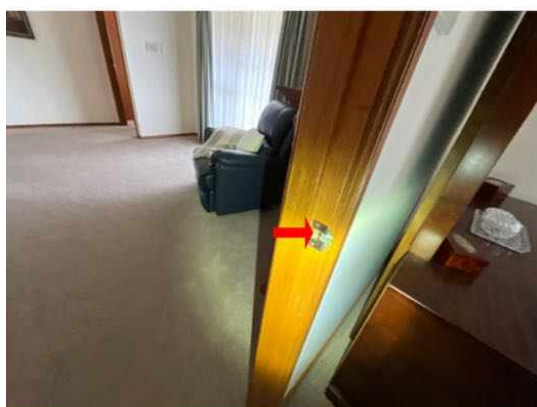
Binding and/or jamming of this door is evident during standard operation. This defect inhibits the functionality of the affected door as well as creating potential for secondary defects to associated building elements, such as damage to the floor covering or adjacent frame.

A door that binds to flooring or to the associated door frame may have several causes, ranging from minor defects, such as poor installation of the door or deteriorated hinges.

This is a common defect and is expected in a property of this age, whether being due to substandard installation or general deterioration of the door hardware.

Readjustment of the striker plate is recommended at client discretion. Works such as these can be completed by a general handyman or qualified carpenter.

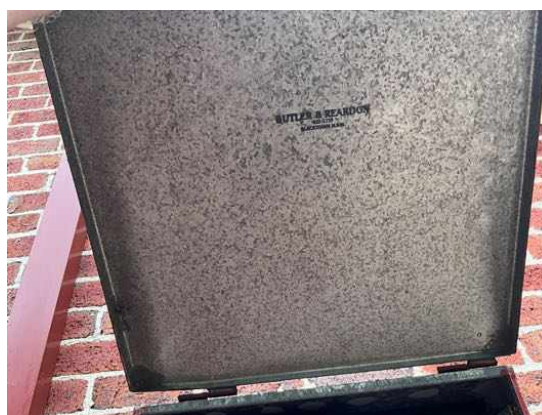
Building:	Main Building
Location:	Meterbox
Finding:	Termite Management System - no evidence of installation
Information:	The application of a post-construction chemical termite barrier is highly recommended for all properties, particularly if live termite activity has been found on the site previously. Such barriers are highly effective in preventing termite attack on any timber building elements throughout the property.

A durable notice should be placed in the switchboard unit to indicate current termite barriers. At the time of inspection, it appeared as though no termite management system has been installed, with no evidence to suggest preventative works taking place.

The client may consider gaining further advice from a pest controller as to the costs and procedures involved with this application. It is recommended that obtaining such advice be a short-term priority.

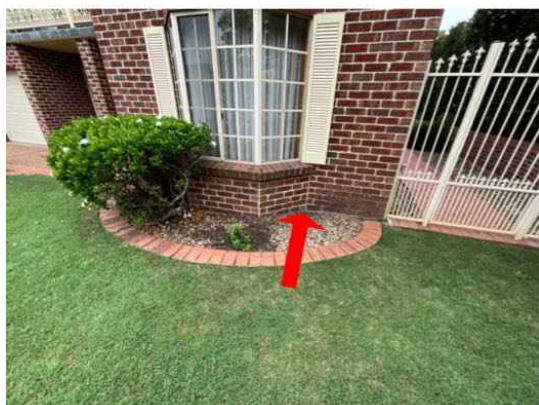
Finding 6.02

Not able to comment. A very high proportion of termite attacks are over the edge of both Infill and other concrete slabs types. Covering the edge of a concrete slab makes concealed termite entry easy. Infill slab type construction has an even higher risk of concealed termite ingress as the slab edge is concealed due to the construction design and cannot be exposed. The type of slab may only be determined by assessment of the construction plans by a qualified person e.g. Builder, Architect. Construction Plans may be obtainable by your local Council or Builder. Termite activity and or damage may be present in concealed timbers of the building. We strongly recommend frequent regular inspections in accordance with AS 3660.2. Where the

slab edge is not fully exposed or the slab is an infill slab or the slab type cannot be determined then we strongly recommend inspections every 3 to 6 months in accordance with AS 3660.2 or AS 4349.3.

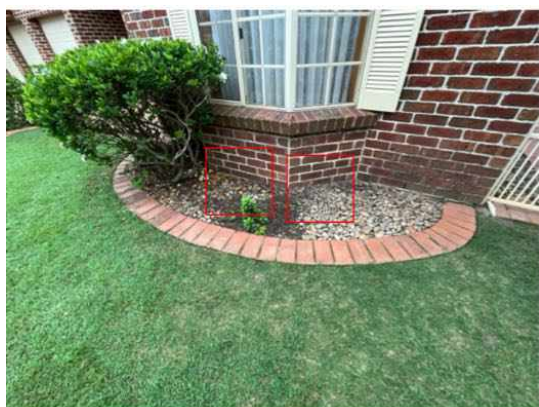
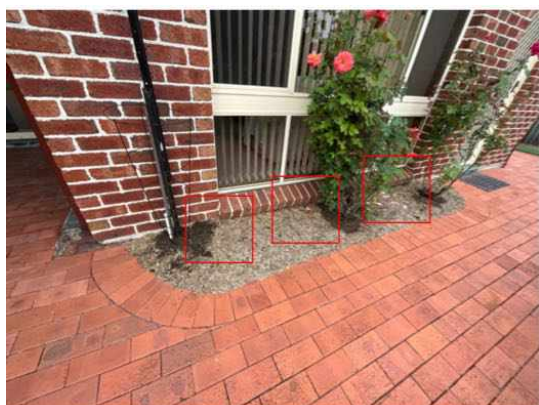
Damp proof course (DPC) is a barrier of impervious material built into a wall or pier to prevent moisture from moving to any part of the building. Where external ground levels are built up over this barrier ingress is provided for moisture from the exterior grounds into the base brickwork or other building material and allowed to rise.

Such conditions attract termites into these damp areas which is likely to lead to infestation if left untreated.

While retrospective fitting of DPC is considered to be impractical works are required in order to prevent the extraction of moisture from the external environment into exterior brickwork or wall materials. Landscaping or re-paving of external grounds may be

considered by the client. Regular annual inspections are strongly advised.

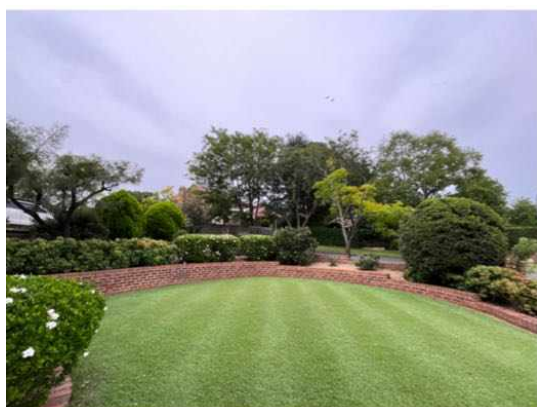
Finding 6.07

Building:	Main Building
Location:	
Finding:	Surrounding bushland - Conductive
Information:	Home and or building is situated in a high risk area for termite activity, due to close proximity to surrounding bushland.

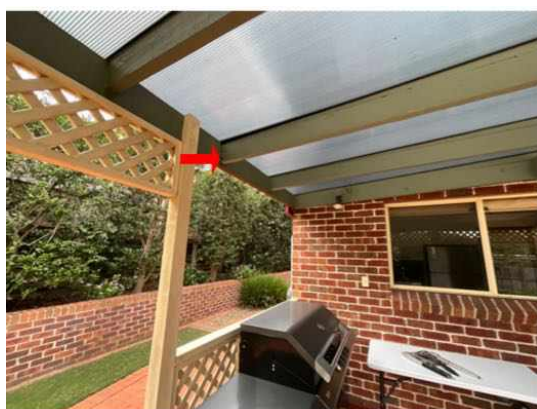
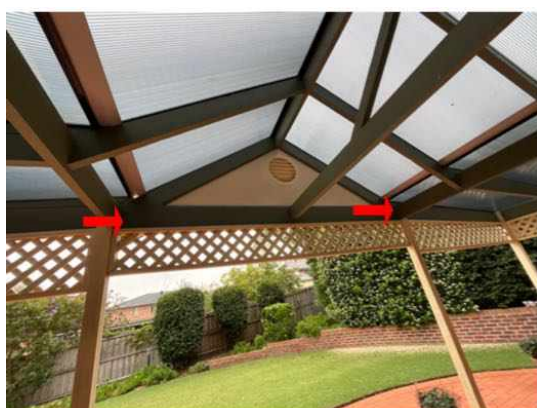
Building:	Main Building
Location:	Fascias
Finding:	Wood rot/decay
Information:	This building element shows evidence of severe wood rot. Wood rot, also known as Fungal Decay, occurs when timbers and other cellulose building materials are exposed to damp conditions on an ongoing basis. This could be the result of exposure to weathering over a prolonged period of time.

If left unmanaged, damp conditions can lead to further health problems and the decay of timbers will continue.

Early intervention and regular maintenance, particularly of exterior timbers, will prolong the useful life of these building elements. Prior to any works being performed, the cause of the moisture that has created the visible wood rot should be identified and addressed in a suitable manner. A licensed roof plumber should be appointed for this work. Replacement of affected timbers by a licensed carpenter is then a necessary step in protecting surrounding building elements from such deterioration.
