# Building and Timber Pest Inspection Report

Inspection Date: Wed, 18 Feb 2026

Property Address: 42 Hail St, Austral NSW 2179, Australia

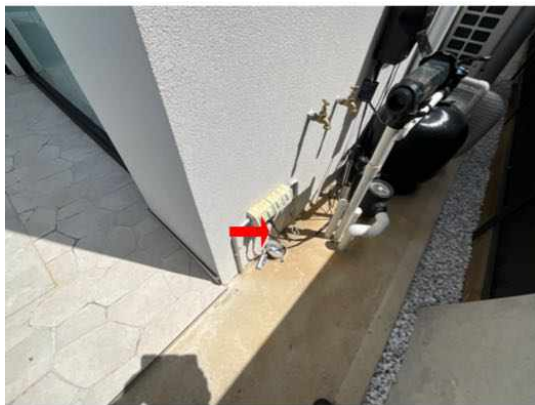
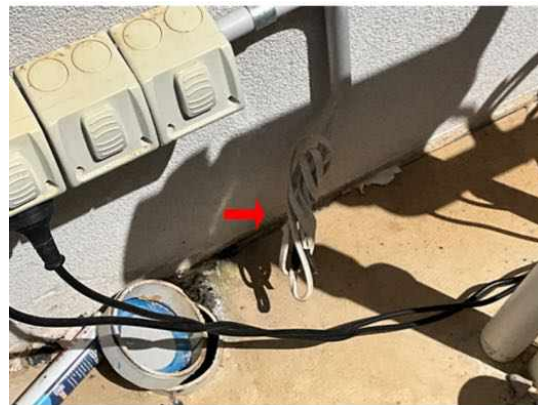
#### Finding 1.01

Building:	Main Building
Location:	Pool pump
Finding:	Electrical wiring - Exposed/Messy
Information:	Instances of exposed wiring, messy wiring, not in junction boxes or unprotected with electrical tape was identified in this area at the time of inspection.

We highly recommend that a licensed electrician be engaged to check this area and make safe all exposed wiring before any further inspections or works are carried out.

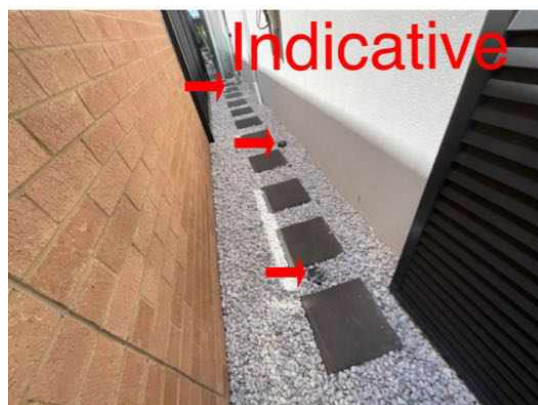
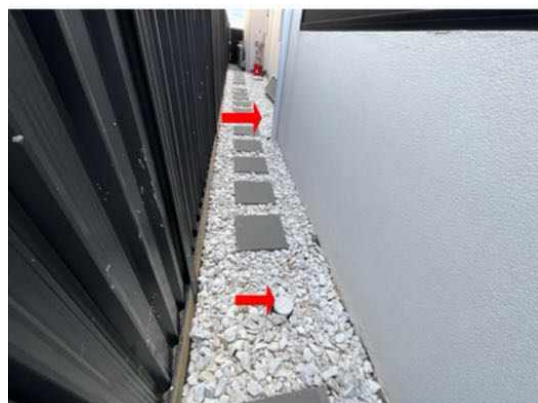
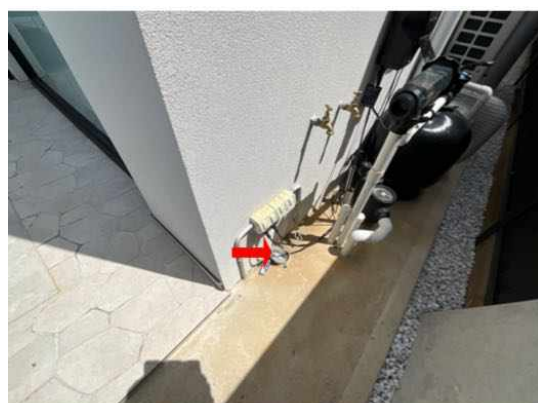
Building:	Main Building
Location:	Yard
Finding:	Site drainage— Inadequate
Information:	The site drainage in this area was found to be inadequate at the time of inspection, which is indicative of incomplete landscaping, creating potential for subsequent water damage to associated building elements. This is additionally conducive to termite activity.

ground levels should be sloped to drain water away from walls. Downpipes should not discharge stormwater onto lower walls or plinths. Stormwater should be carried away by large, regularly cleaned drains. Ground levels may need to be lowered to expose a buried DPC.

Where site drainage is inadequate, installation of an Agricultural (Aggie) Drain may be required. A landscaper should be appointed for this work. Water damage and secondary defects are likely to occur if left unmanaged.

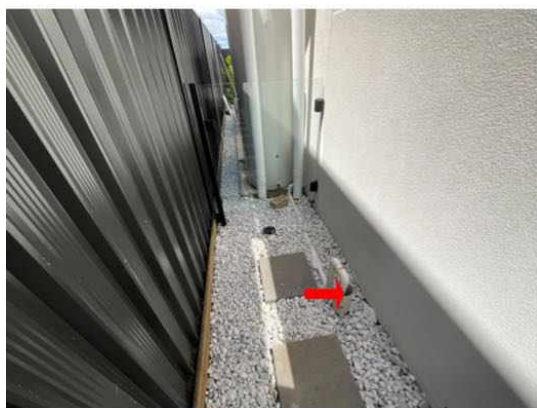
### Finding 3.02

Location: Yard - RHS  
 Finding: Plumbing - Point of connection non-compliant  
 Information: At the time of inspection it was noted that connections between above ground pipe work and below ground sewer/storm water systems were incomplete.

Additionally, where sewer pipes are concerned, gases can escape from unsealed connections which can pose a serious health risk.

Engagement of a certified plumber is strongly recommended to ensure all connection points are sealed in accordance with the plumbing construction guidelines.

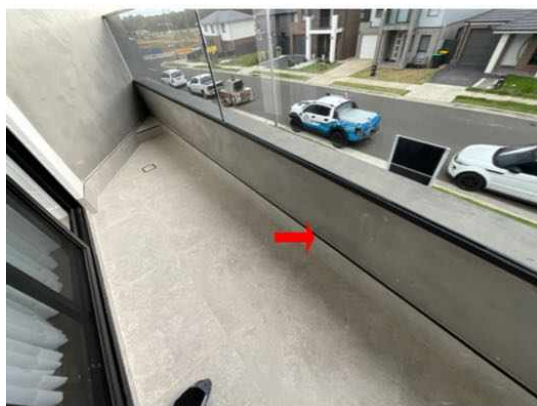
### Finding 3.03

Building: Main Building  
 Location: Balcony  
 Finding: Balcony — Missing overflow  
 Information: NCC Volume Two (Housing Provisions), Part 10.6 and Part 10.7, and

Major works must be expected.

The client is highly advised to seek further advice from a licensed plumber.

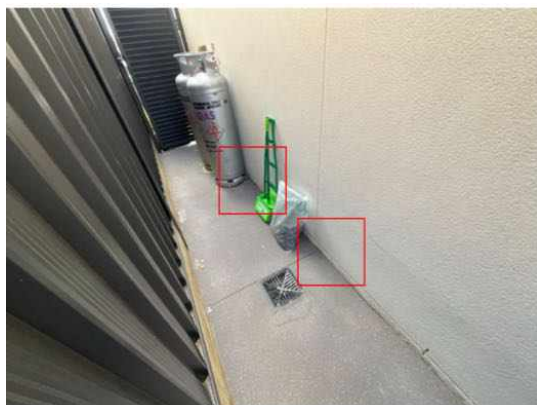
### Finding 3.04

Building:	Main Building
Location:	Multiple areas
Finding:	Weepholes — inadequate
Information:	The weepholes to areas of the property are missing or inadequate.

Weepholes should be provided wherever it is necessary to drain moisture from or through masonry construction. Where flashings are incorporated in the masonry, weepholes shall be provided in the masonry course immediately above the flashing, at centres not exceeding 1200mm. The entire perimeter needs to be checked and repaired to comply with AS 3700-2011 Section 4.2.7.

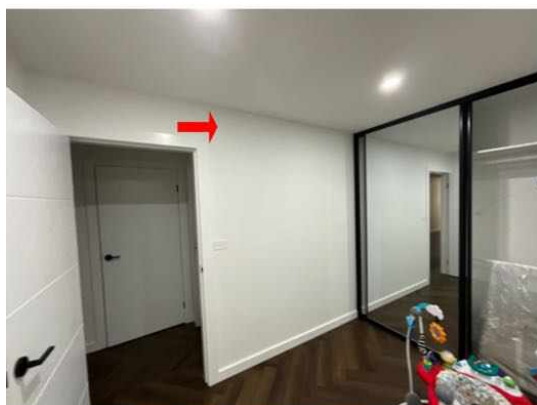
### Finding 3.05

Building:	Main Building
Location:	Bedroom 3
Finding:	Cracking - Damage Category 1 - Fine (up to 1mm)
Information:	Although fine cracks are quite noticeable, they are often only considered to be an appearance defect, and usually do not indicate any structural damage. Generally, the cause of a fine crack is indicative of a separation between building materials and finishes (e.g. paint, plaster, etc.) along joins.

Cracking of this nature can generally be repaired with minor sanding, filling and/or repainting. Such works should be performed by a qualified painter or a general handyman.

Monitoring of all cracking should be conducted frequently. Always contact a building inspector should cracks widen, lengthen, or become more numerous.

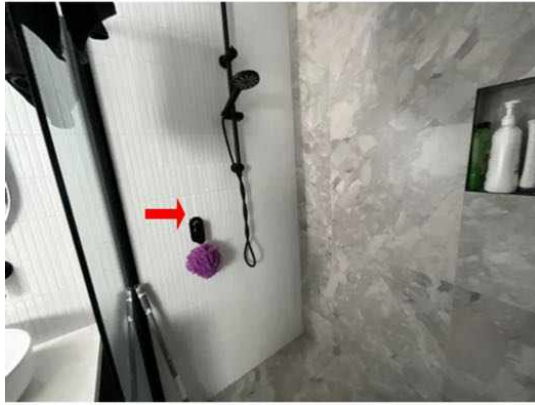
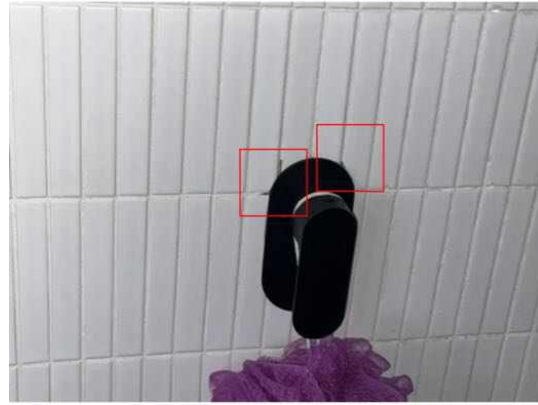
### Finding 3.06

Building: Main Building  
 Location: Bedroom - Master  
 Finding: Sealant and grouting - Missing or damaged  
 Information:

It was noted on inspection that sealant or grout is degraded to this area.

Different materials and floor areas move at different rates, generally causing cracking to grout or sealant at this point. A flexible sealant is required to allow for expected expansion and contraction, while keeping the joint water tight and protective of all associated building materials.

Flexible and mould resistant materials should be applied to affected areas to prevent any subsequent water damage that is likely to occur. Regular maintenance and replacement of damage or missing or damaged sealant and grout is highly recommended to the wet areas, as this is a regular wear and tear defect. Sealant and grouting in areas that come into regular contact with water should be maintained for the long term care of your property.

A sealant specialist should be appointed to complete these works as soon as possible.

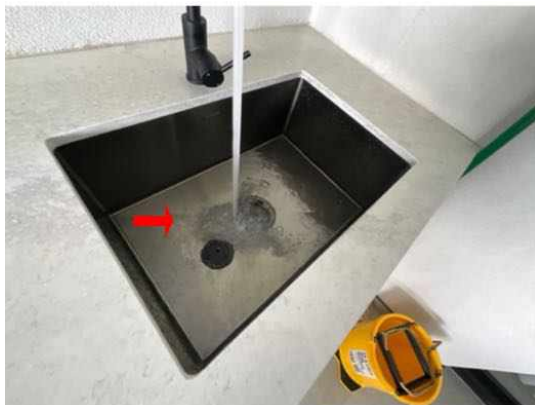
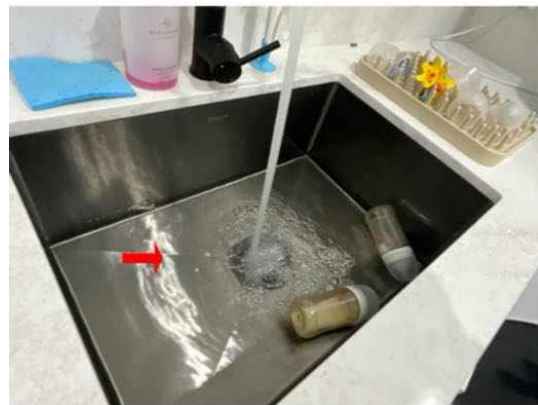
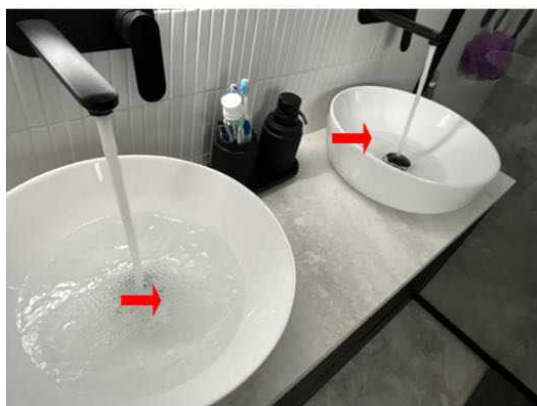
### Finding 3.07

Building: Main Building  
 Location: Multiple areas  
 Finding: Sink/basin - slow draining  
 Information:

The sink/basin drain appeared to be partially blocked at the time of inspection. Blockages here are usually caused by hair and other debris. If left unmanaged, a lack of general maintenance may lead to the development of more significant defects, such as water damage to surrounding building materials.

A licensed plumber should be appointed to remove the blockage at the client discretion.

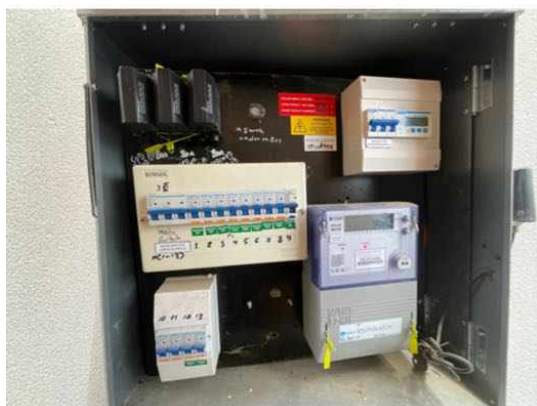
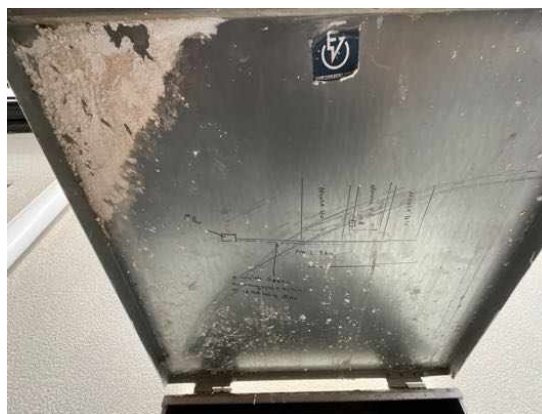
Building:	Main Building
Location:	Meterbox
Finding:	Termite Management System - no evidence of installation
Information:	The application of a post-construction chemical termite barrier is highly recommended for all properties, particularly if live termite activity has been found on the site previously. Such barriers are highly effective in preventing termite attack on any timber building elements throughout the property.

A durable notice should be placed in the switchboard unit to indicate current termite barriers. At the time of inspection, it appeared as though no termite management system has been installed, with no evidence to suggest preventative works taking place.

The client may consider gaining further advice from a pest controller as to the costs and procedures involved with this application. It is recommended that obtaining such advice be a short-term priority.

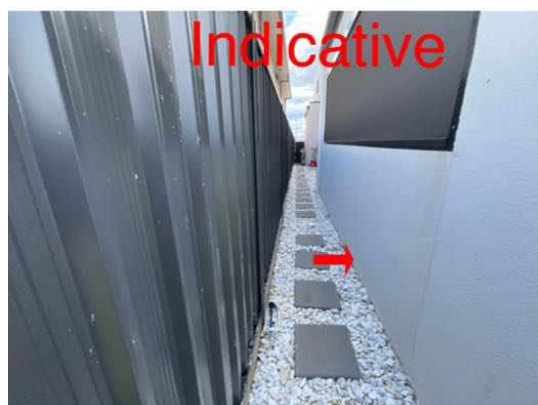
## Finding 6.02

Information: Slab Edge Exposure: Where external concrete slab edges are not exposed there is a high risk of concealed termite entry. In some buildings built since July 1995 the edge of the slab forms part of the termite shield system. In these buildings an inspection zone of at least 75mm should be maintained to permit detection of termite entry. The concrete edge should not be concealed by render, tiles, cladding, flashings, adjoining structures, paving, soil, turf or landscaping etc. Where this is the case you should arrange to have the slab edge exposed for inspection. Concealed termite entry may already be taking place but could not be detected at the time of the inspection. This may have resulted in concealed timber damage. Does the slab edge inspection zone fully comply?

Not able to comment. A very high proportion of termite attacks are over the edge of both Infill and other concrete slabs types. Covering the edge of a concrete slab makes concealed termite entry easy. Infill slab type construction has an even higher risk of concealed termite ingress as the slab edge is concealed due to the construction design and cannot be exposed. The type of slab may only be determined by assessment of the construction plans by a qualified person e.g. Builder, Architect. Construction Plans may be obtainable by your local Council or Builder. Termite activity and or damage may be present in concealed timbers of the building. We strongly recommend frequent regular inspections in accordance with AS 3660.2. Where the slab edge is not fully exposed or the slab is an infill slab or the slab type cannot be determined then we strongly recommend inspections every 3 to 6 months in accordance with AS 3660.2 or AS 4349.3.

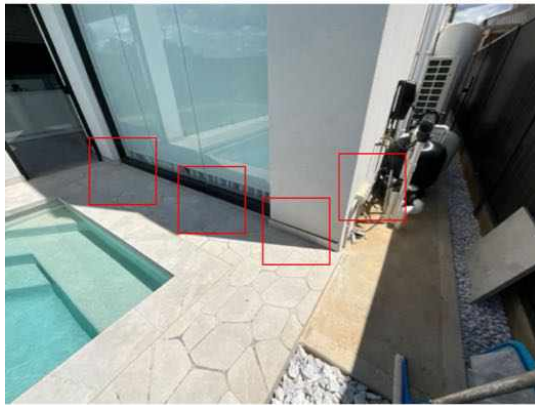
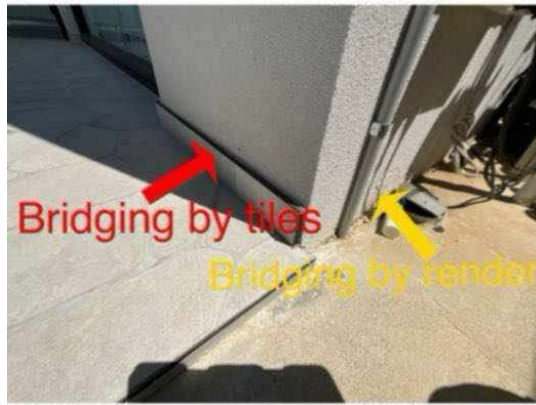
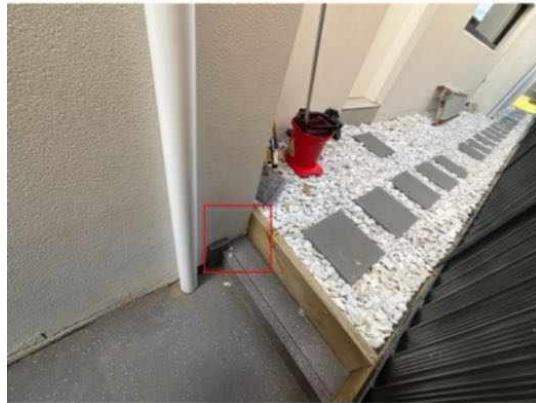
Damp proof course (DPC) is a barrier of impervious material built into a wall or pier to prevent moisture from moving to any part of the building. Where external ground levels are built up over this barrier ingress is provided for moisture from the exterior grounds into the base brickwork or other building material and allowed to rise.

Such conditions attract termites into these damp areas which is likely to lead to infestation if left untreated.

While retrospective fitting of DPC is considered to be impractical works are required in order to prevent the extraction of moisture from the external environment into exterior brickwork or wall materials. Landscaping or re-paving of external grounds may be considered by the client. Regular annual inspections are strongly advised.

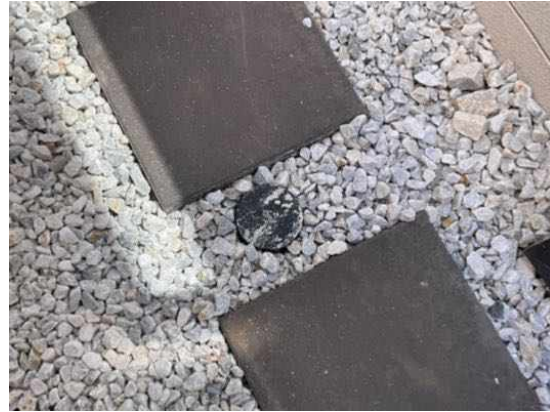
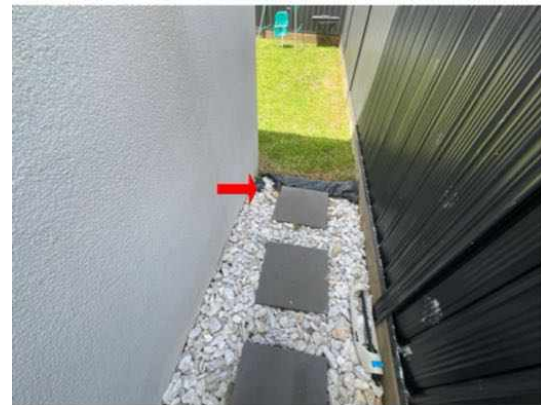
### Finding 6.05

Finding: Site drainage— Inadequate

Information: The site drainage in this area was found to be inadequate at the time of inspection, which is indicative of incomplete landscaping, creating potential for subsequent water damage to associated building elements. This is additionally conducive to termite activity.

by large, regularly cleaned drains. Ground levels may need to be lowered to expose a buried DPC.

Where site drainage is inadequate, installation of an Agricultural (Aggie) Drain may be required. A landscaper should be appointed for this work. Water damage and secondary defects are likely to occur if left unmanaged.

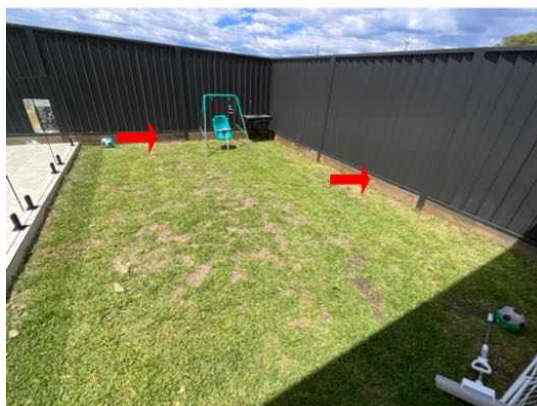
### Finding 6.06

Building:	Main Building
Location:	Fencing & Landscaping
Finding:	Building materials in direct ground contact - conducive to termites

Information: Where timber elements are in direct contact with the ground and consequently moisture or dampness they become conducive to termite activity. Whether timber is used as a building element part of a fencing structure or stored as an unused item they can provide an environment that is attractive to termite infestation.

When met with excessive moisture timber begins to decay and develop wood rot. Any timbers that are in direct contact with external grounds especially if left untreated or non-durable also provide ingress for subterranean termites into that particular element.

The removal of any such materials that may be conducive to termite activity should be removed as soon as possible to minimise the risk of termite attack.

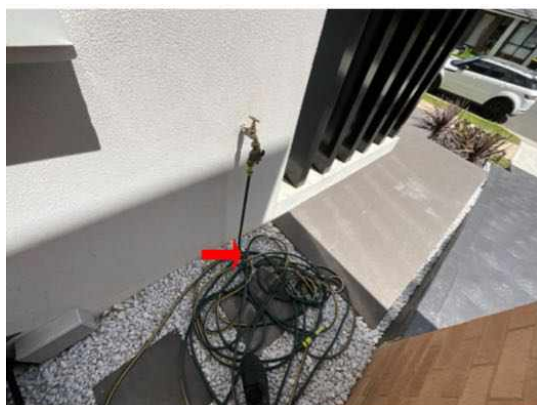
### Finding 6.07

Building: Main Building  
 Location: External tap  
 Finding: Tap - No drain  
 Information: The external tap in this area was noted to have no drain at the time of inspection.

This keeps the surrounding surfaces damp while using the tap, which becomes conducive to termite activity.

A licensed plumber must be appointed to ensure an appropriate drain is installed.
