Building and Timber Pest Inspection Report

Inspection Date: Tue, 13 Jan 2026

Property Address: 15 Gilbert St, Tumbarumba NSW 2653,
Australia

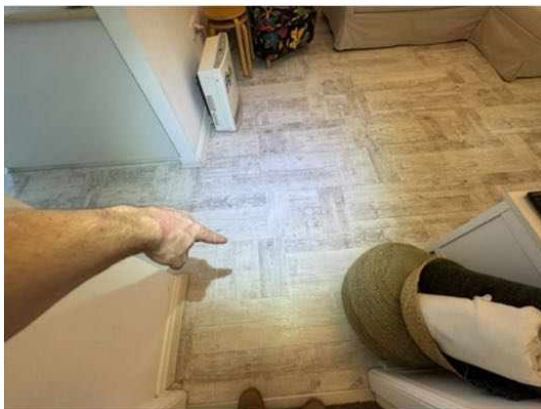
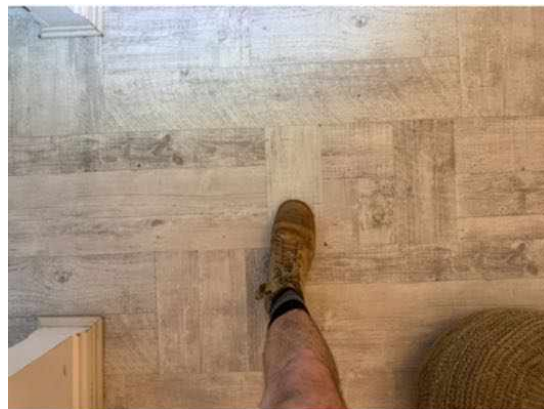
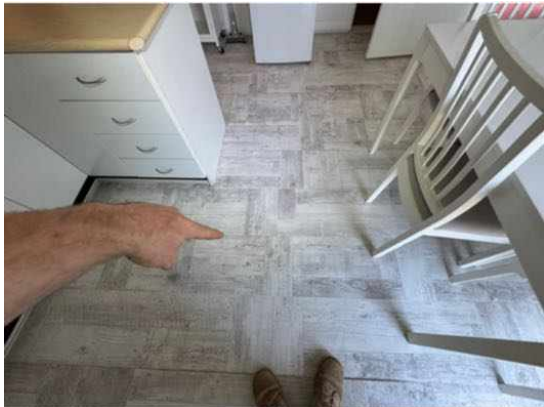
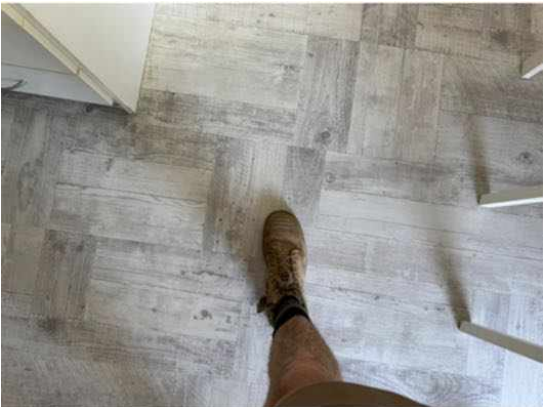
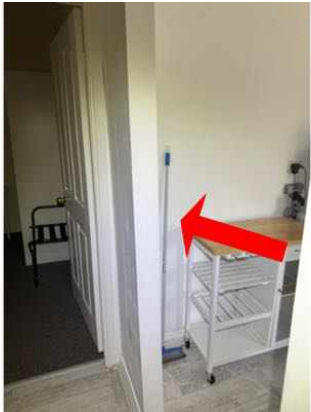
Finding 3.01

Building: Main Building
Location: All Areas, Lounge Room Wall
Finding: Flooring & Lounge Room Wall - Uneven / Leaning
Information: Some areas, of the flooring throughout the building appear to be uneven & springy. A further inspection of the subfloor is recommended to identify the cause of this defect. It appears the lounge room wall was leaning and appears to have moved.

The client should monitor the flooring and lounge room wall to identify any further movement. Where flooring remains relatively unchanged for an extended period of time, it is likely that this defect has been caused by expected movement of the foundations of the property. However, where further movement and unevenness occurs, a structural engineer should be engaged promptly for further evaluation.

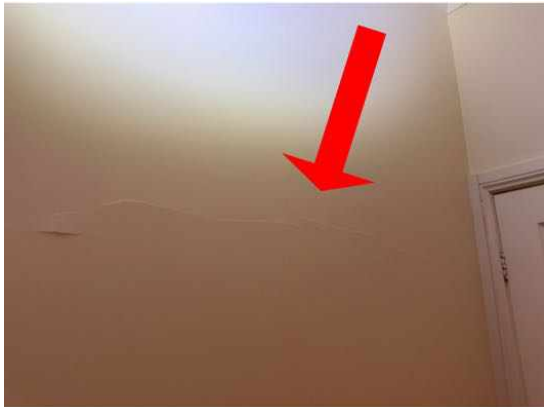
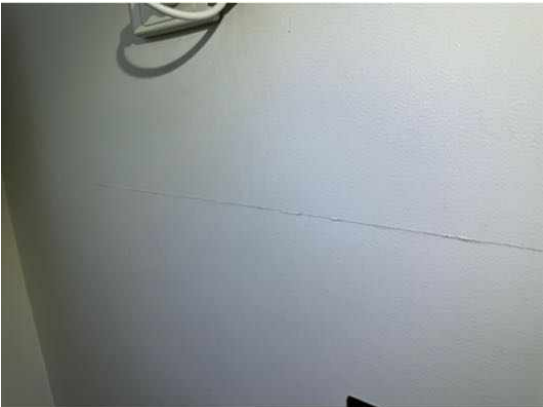
Finding 3.02

Building: Main Building
Location: All Internal Areas
Finding: Plaster - Cracking
Information: There appears to be cracking in some areas throughout the building. The client should monitor these areas. Should cracking widen, lengthen, or become more numerous, the client should consult with a structural engineer promptly, to provide further advice.

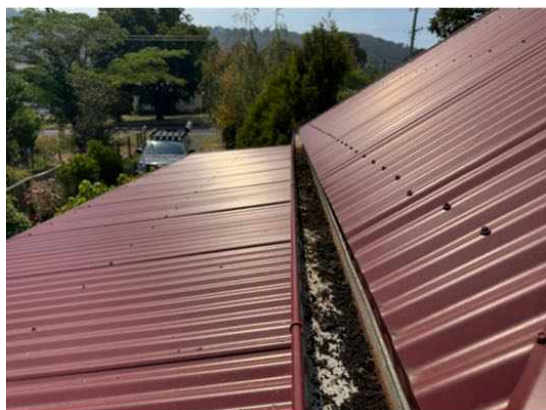
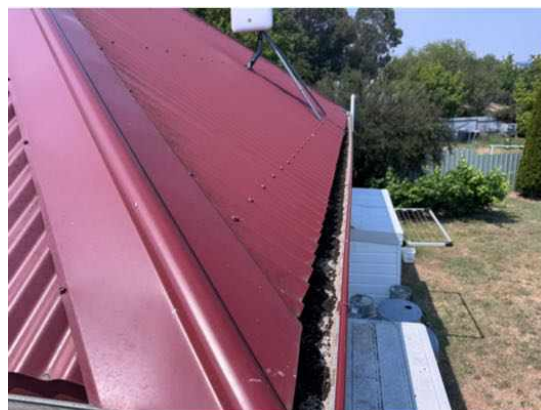
Finding 3.03

Location: Gutters
 Finding: Debris in Gutters
 Information: Debris is present in some areas of the guttering. Accumulation of debris can lead to blockages & water overflows, if neglected.

Recommend engaging a general handyman to remove all debris from the gutters to prevent overflows.

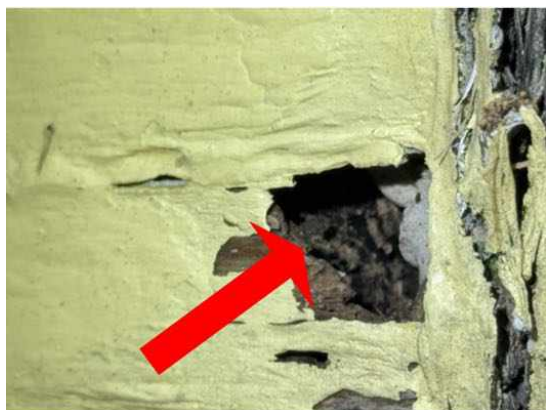
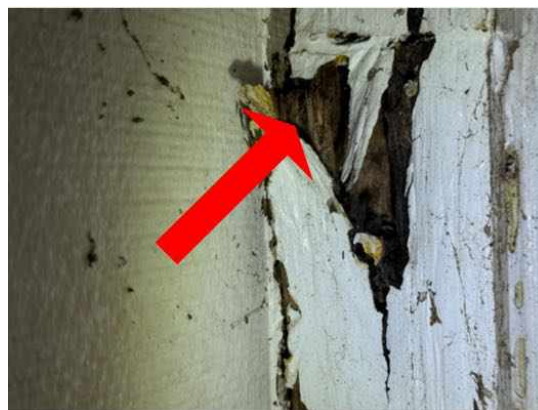
Finding 5.01

Building: Main Building
 Location: Patio Framing, Weatherboards
 Finding: Evidence of termite workings & damage
 Information: It appears termite damage & workings were identified at, but not limited to, areas of the patio framing, and weatherboards. A more invasive inspection is recommended, to confirm and identify the extent of the damage, and ensure the damage is inactive.

The client should engage a licensed pest controller promptly, to provide further advice regarding installation of a termite treatment.

6 monthly ongoing termite inspections, conducted by a qualified termite inspector, are also recommended

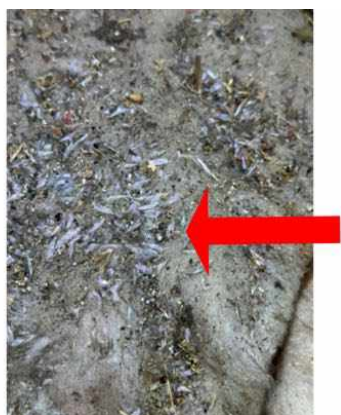
Finding 5.02

Building:	Main Building
Location:	Roof Void
Finding:	Suspected Termite Alate Wings Identified
Information:	It appears discarded termite alate (reproductive) wings were present at, but not limited to, areas of the roof void, indicating a previous or nearby termite swarm event. This may suggest the presence of an active or recent termite colony within or close to the building, warranting a further, more invasive inspection.

A licensed pest management professional should be engaged promptly to undertake a more invasive inspection, implement a termite treatment and provide further advice.

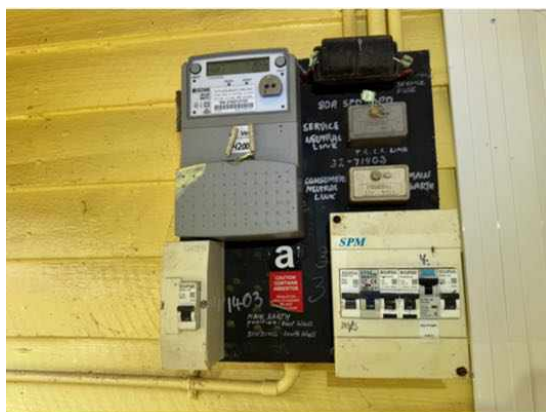
Finding 6.01

Building:	Main Building
Location:	Switchboard
Finding:	Termite Management System - no evidence of a chemical installation
Information:	The application of a termite barrier is strongly recommended, as it appears no termite management system has been installed, with no evidence or durable notice to

suggest works taking place. Generally, a durable notice is placed in the meter box to indicate current termite barriers.

Such barriers are highly effective in preventing termite attack on the building and therefore should be installed.

Recommend seeking further advice from a licensed pest controller.

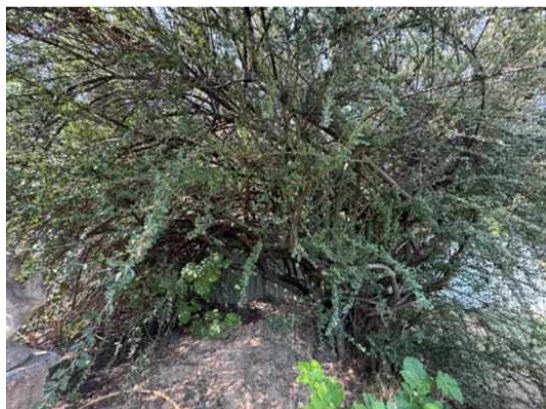
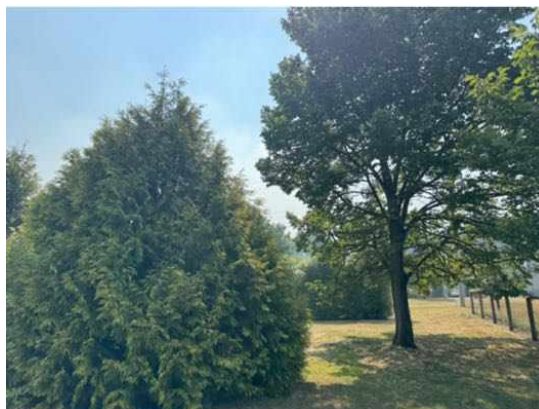
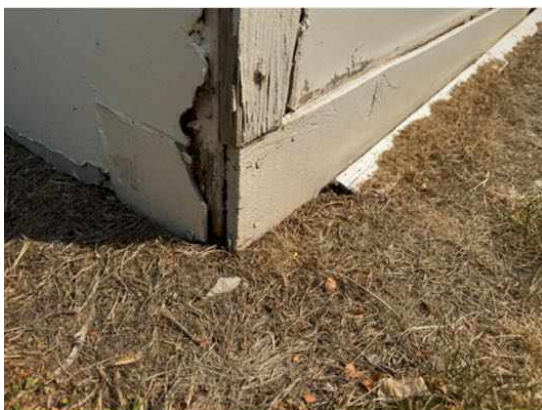
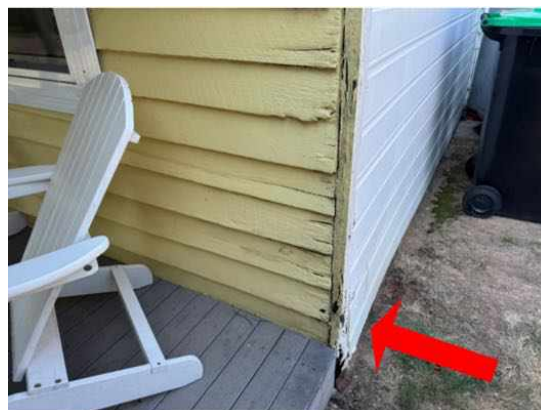
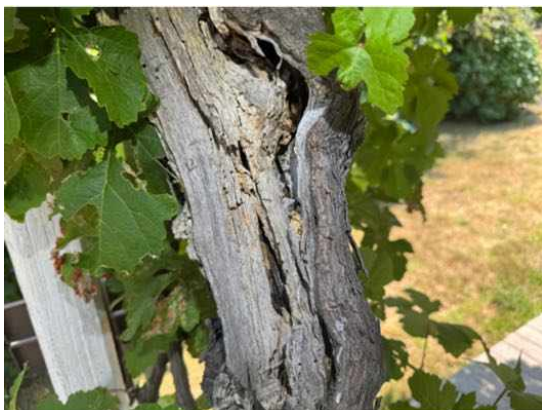
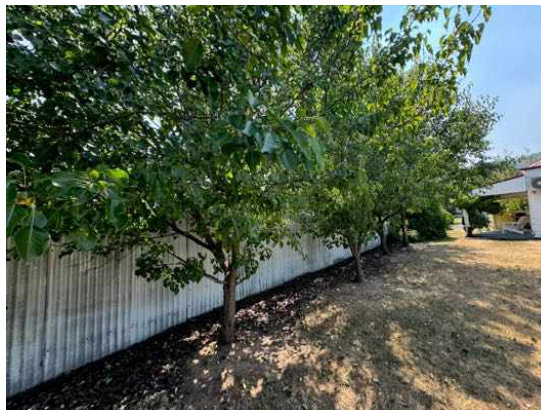
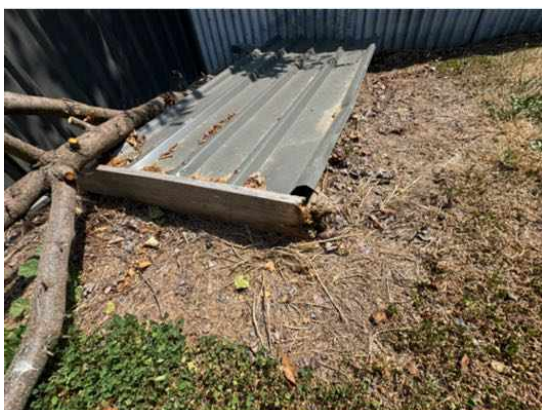
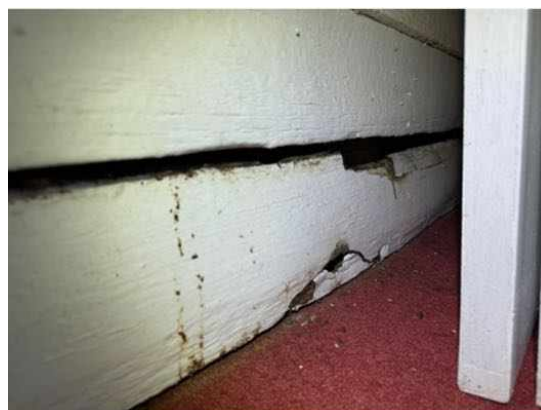
Finding 6.02

Building:	Main Building
Location:	All External Areas
Finding:	Timber in direct ground contact & trees - conducive to termites
Information:	Where timber materials are in direct contact with the ground and consequently moisture, they become conducive to termite activity. The landscaping timbers, weatherboards, decking, posts and trees surrounding the building create an environment conducive to termite infestation.

Where feasible, any timbers in direct contact with the ground should be removed and any trees in close proximity to the building should be removed or test drilled (inspected) at least annually to reduce the risk of termite infestation & detect any early signs of termite activity.

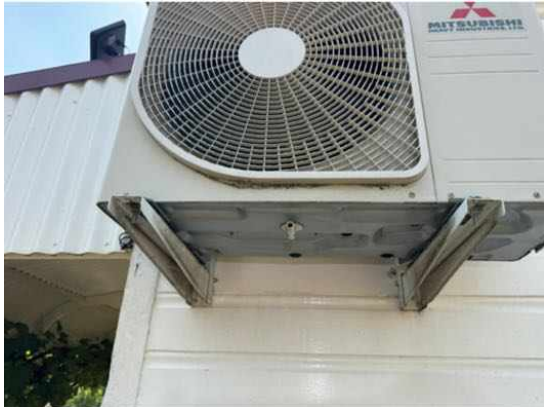
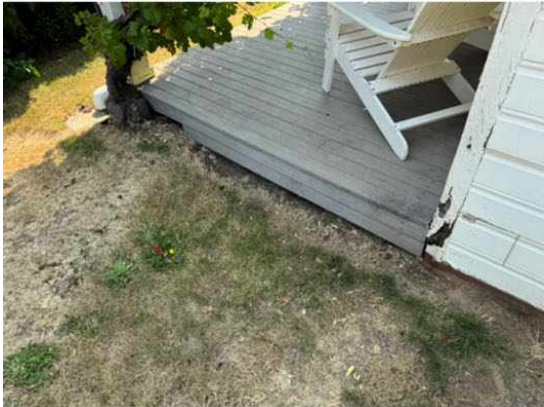
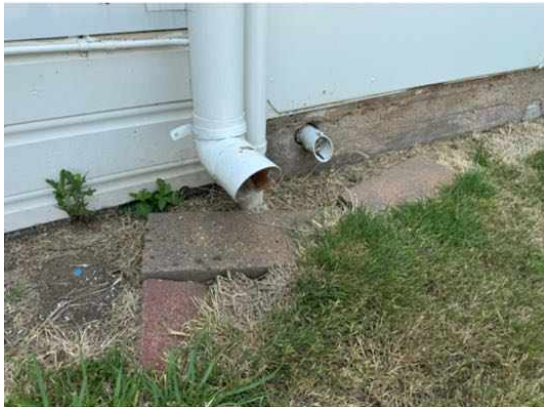
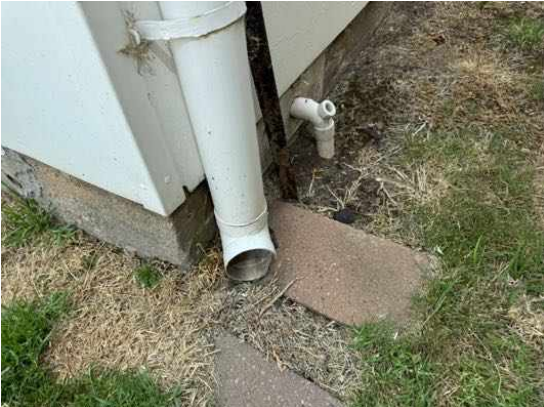
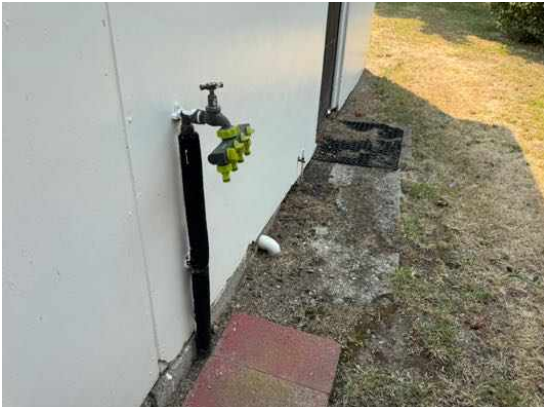
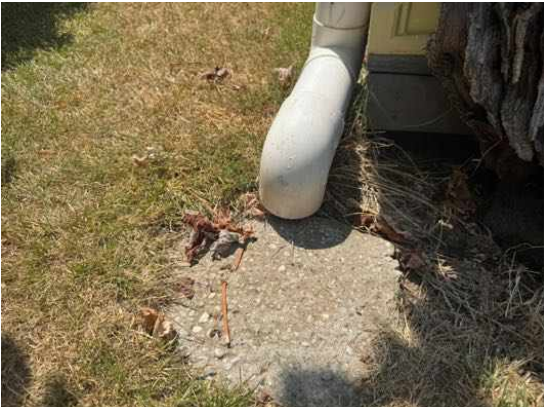
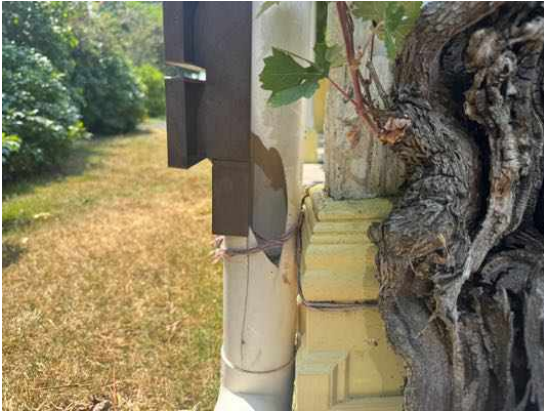
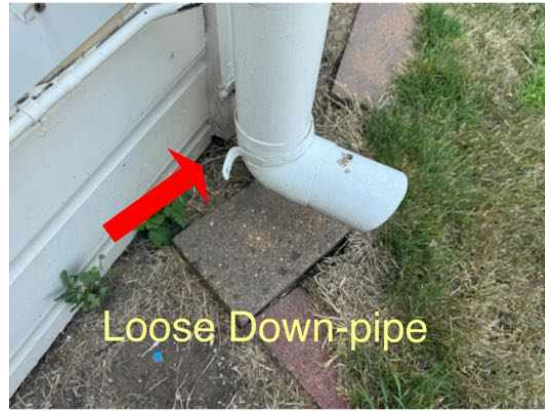
Finding 6.03

Building:	Main Building
Location:	All external areas
Finding:	Potential Water pooling - against property
Information:	It appears that there are potential areas around the perimeter of the property that could be susceptible to water pooling. Several downpipes were also found to be disconnected and broken.

Where there is insufficient drainage of taps, air-cons, HWS's, & down-pipes, and garden beds against the house are present, water pooling is likely to occur, and can create areas conducive to timber pests and potential damage to the subfloor structure overtime, if neglected.

Recommend consulting with a licensed plumber in the short term to further assess and provide remedial works.

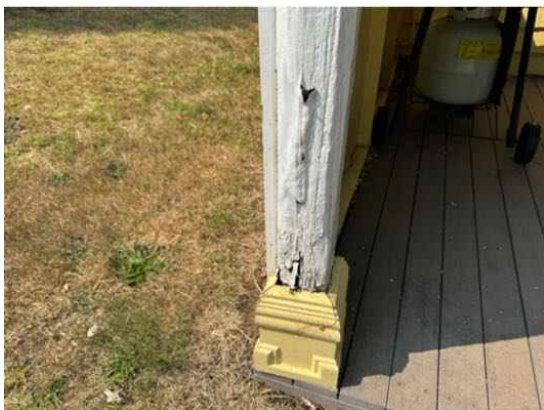
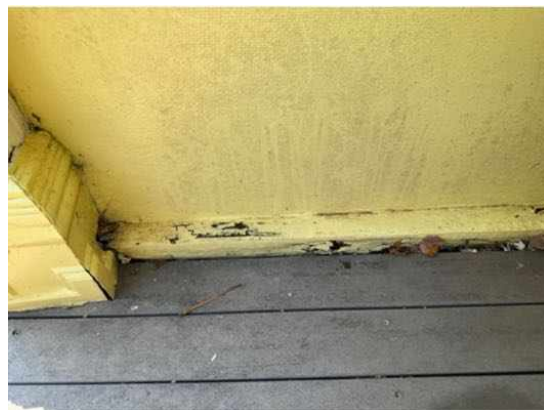
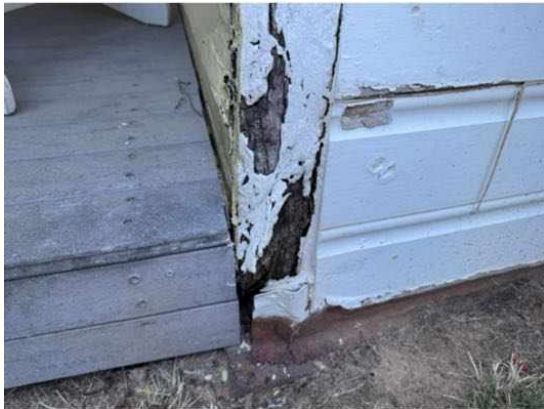
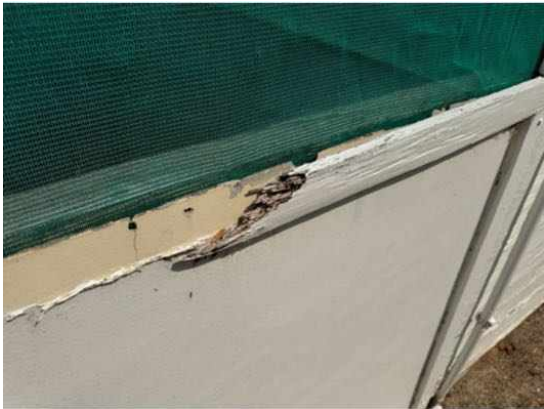
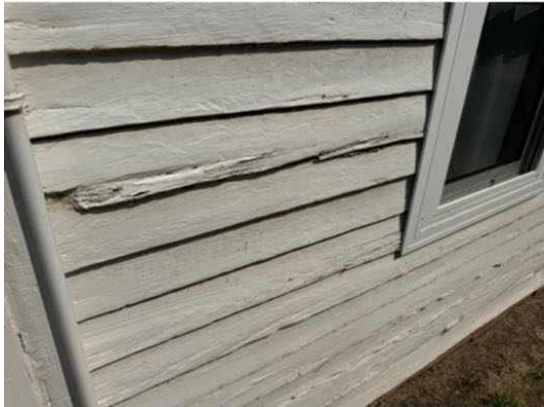
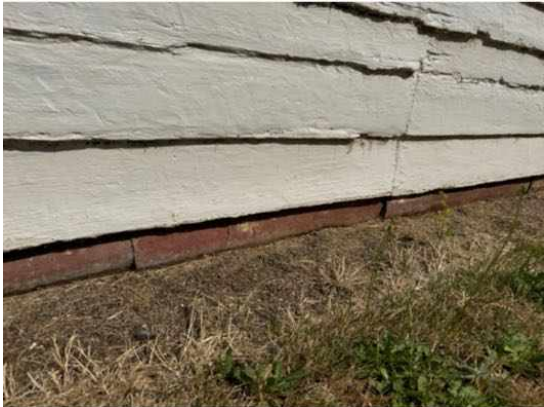
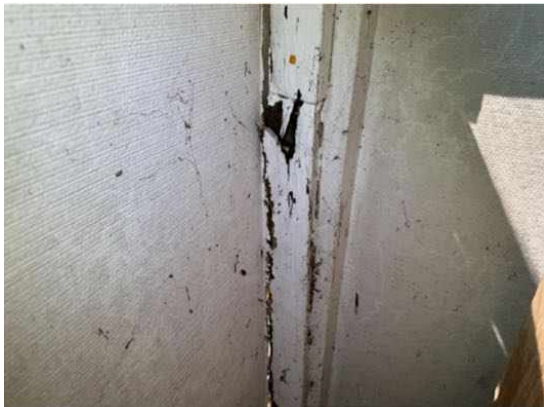
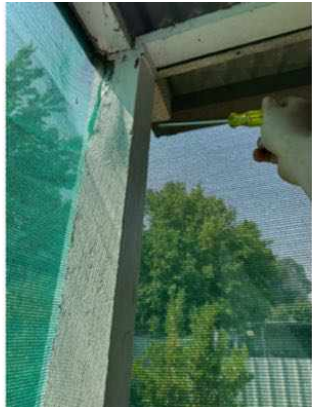
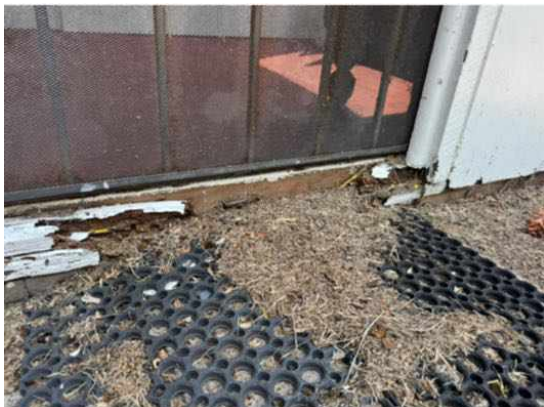
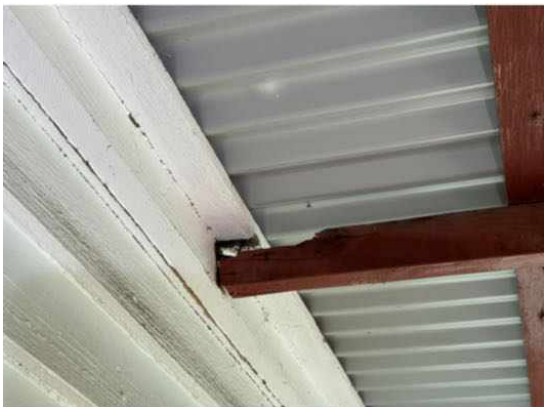
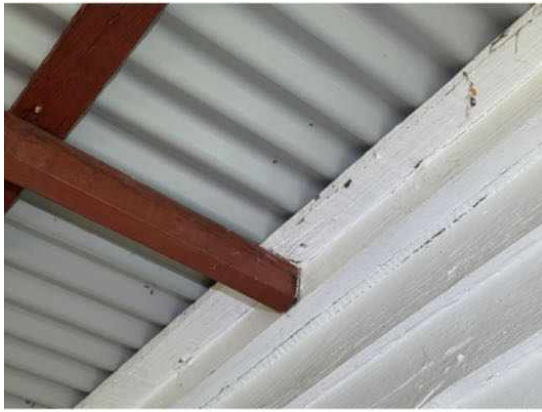
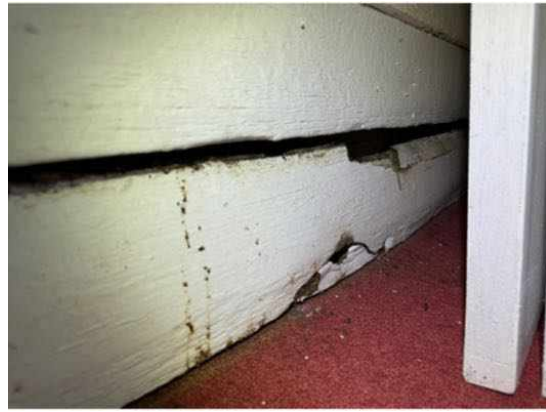
Finding 7.01

Building:	Main Building
Location:	Verandah Posts, Patio Framing, Weatherboards
Finding:	Fungal decay & weathering
Information:	Areas of fungal decay (wood rot) & weathering were identified to several areas at, but not limited to weatherboards, patio and verandah framing, posts and other external timbers.

For areas where structural timbers are affected by wood rot (verandah posts & patio framing) a registered builder should be engaged promptly to replace affected materials where necessary. For areas where fungal decay is superficial, the client can engage a licensed carpenter at their discretion to replace affected materials.

For areas of general weathering, it is advised the client engage a licensed painter to apply protective sealant or coating to areas of weathered external timbers.

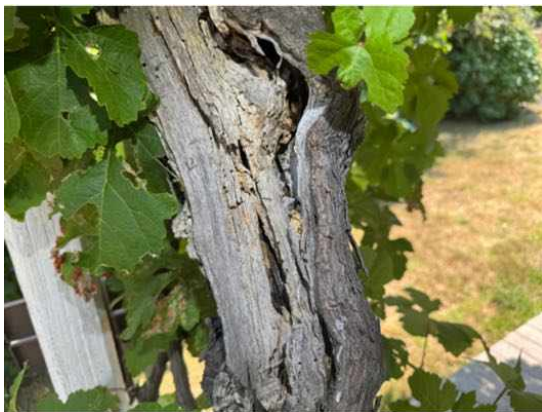
Finding 8.01

Building: Main Building
Location: Tree
Finding: Evidence of wood borer damage identified (powder-post)
Information: Evidence of previous Lyctus Borer (powder-post beetle) damage was identified at but not limited to the front verandah tree, and some weatherboards.

As no live wood borer activity was identified treatment is not required.

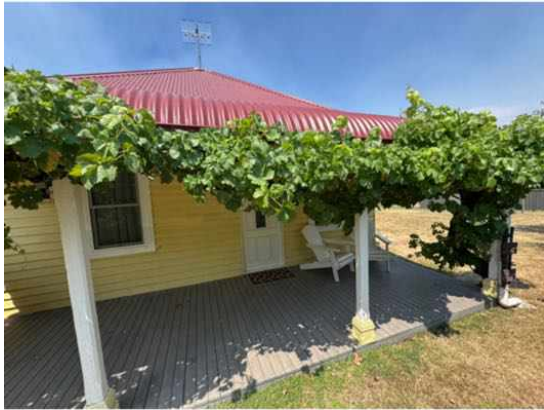
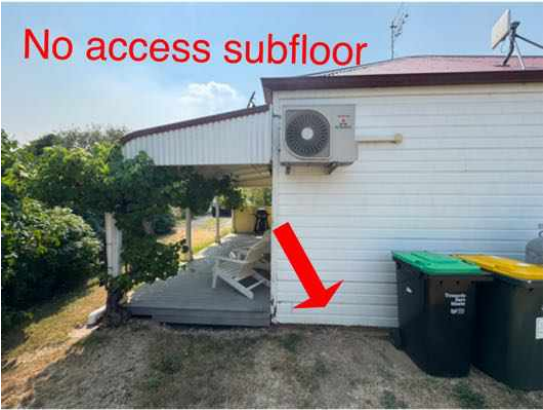
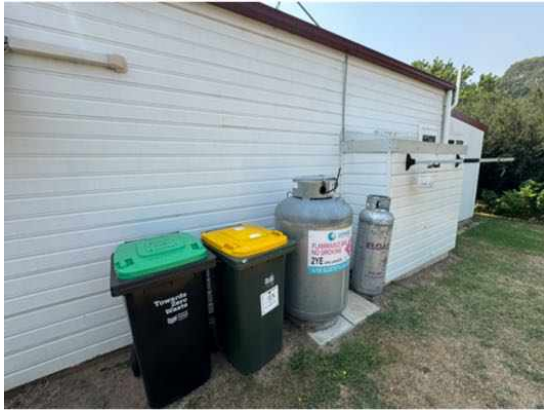
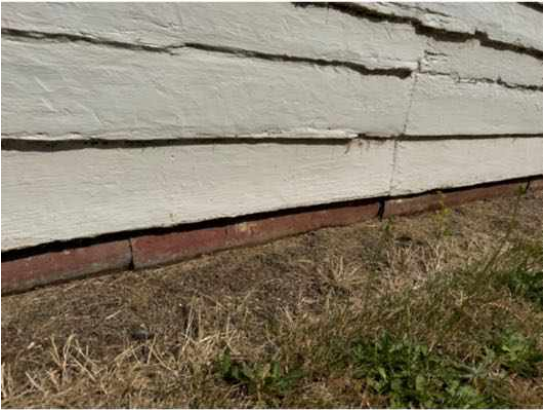
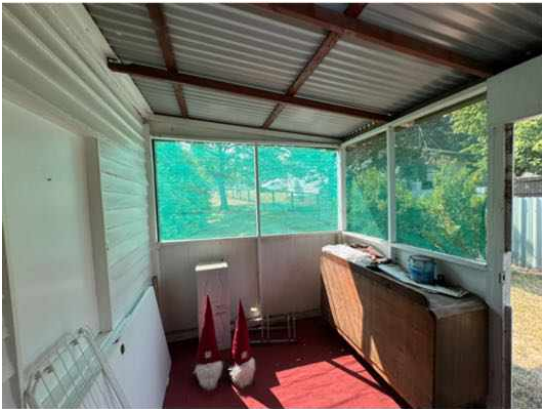
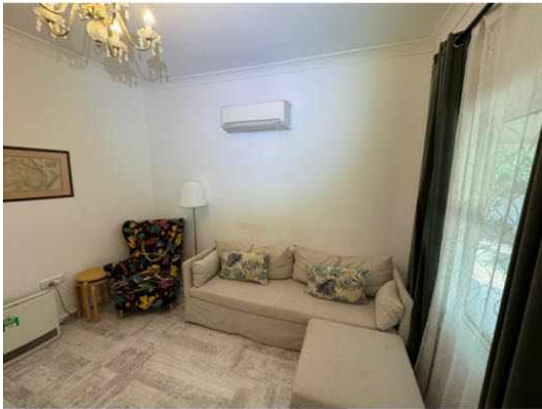
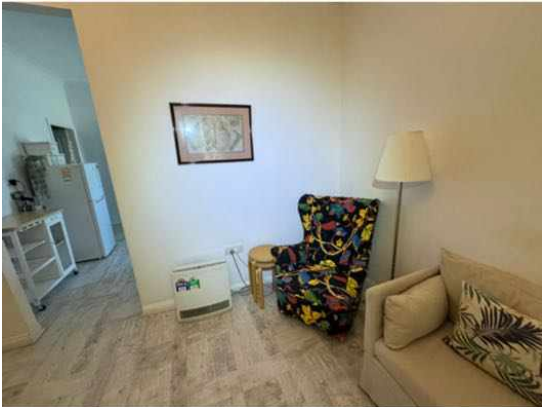
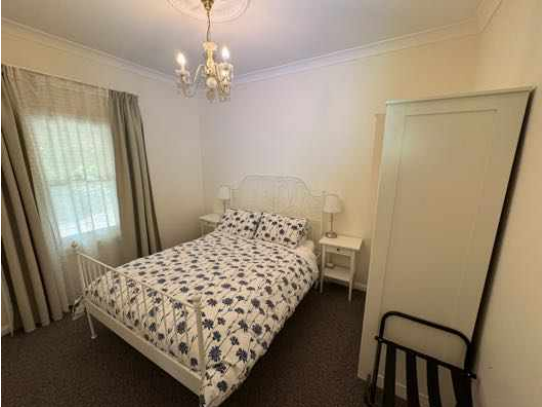
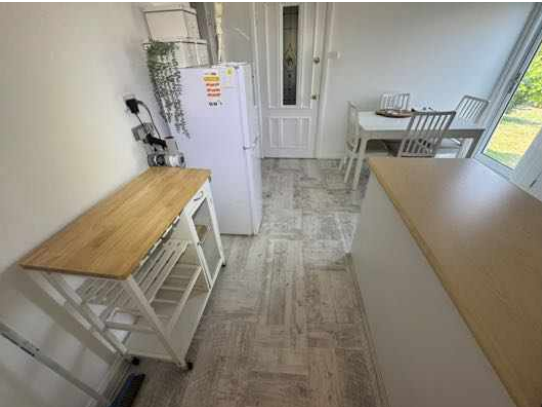
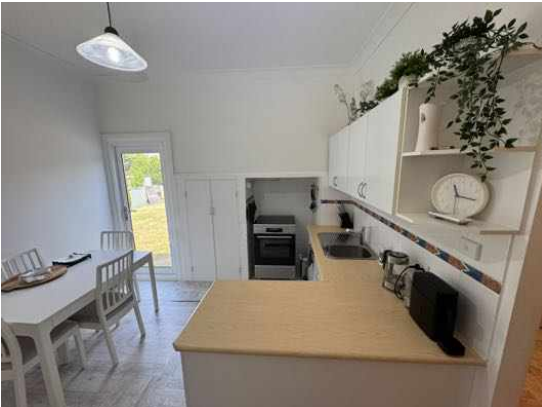
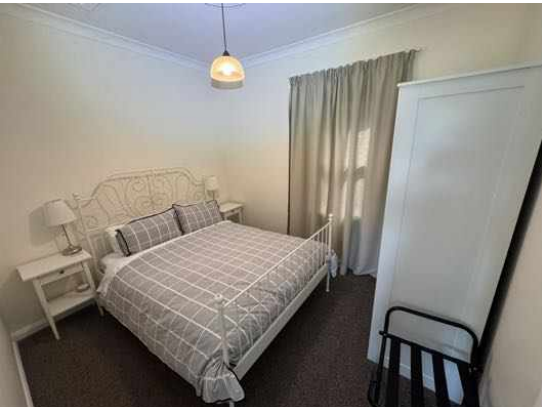
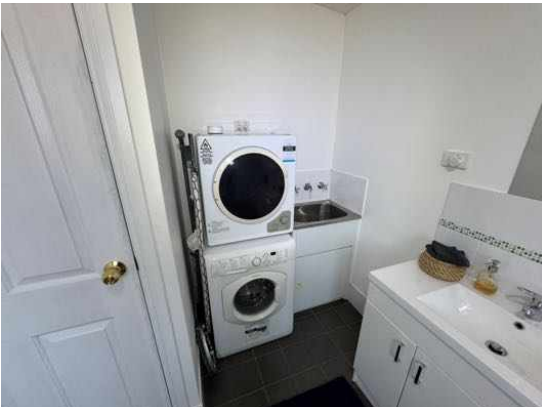
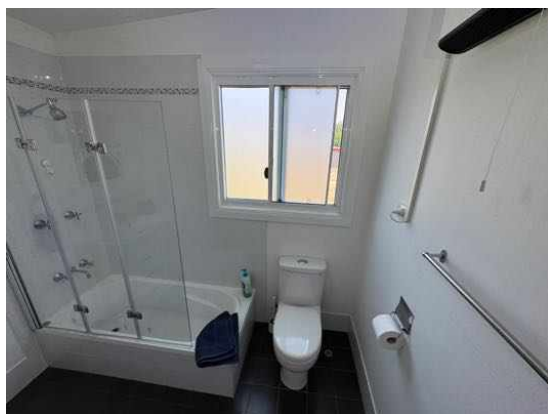
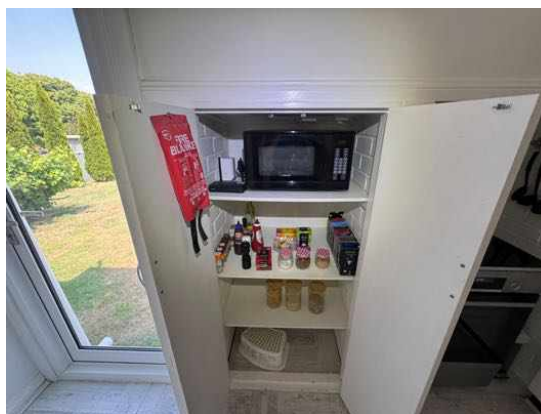
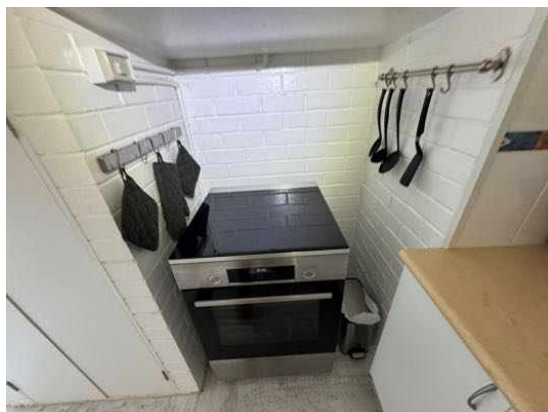
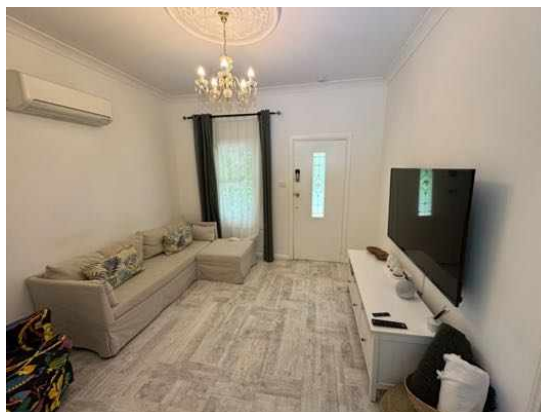
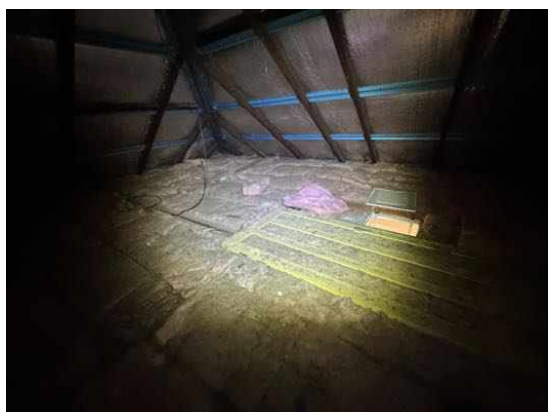
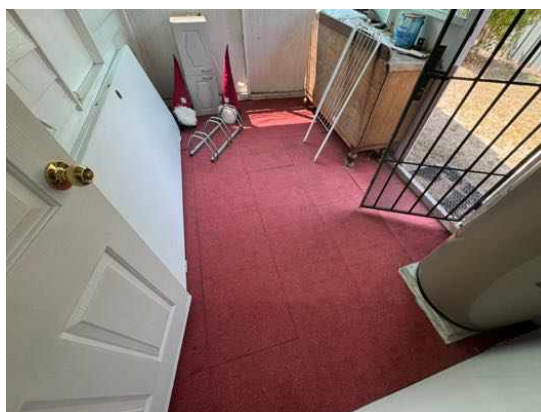
Building: Main Building
Location: All Areas
Finding: Additional Photos - Obstructions and Limitations
Information: These photographs are an indication of the obstructions and limitations which impeded full inspection of the property at the time of inspection. These obstructions can hide an array of defects and should be removed to allow full inspection to be carried out. A re-inspection is recommended once the areas are made accessible.

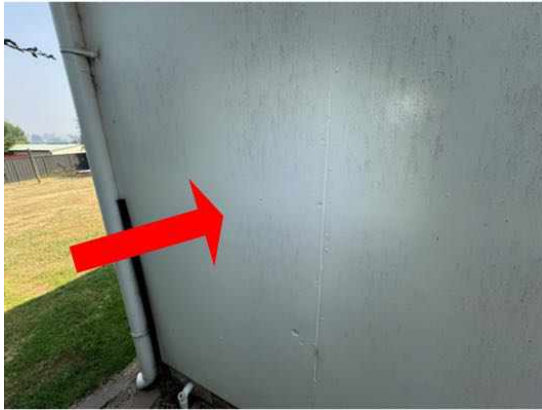
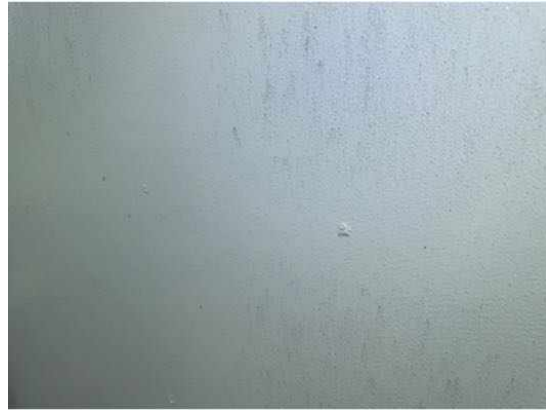
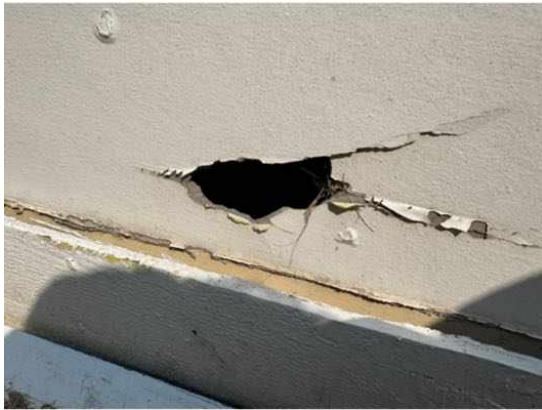
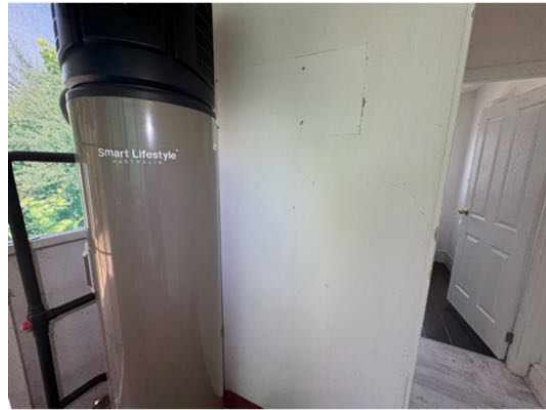
Building: Main Building
 Location: Claddings, Wall Linings
 Finding: Asbestos - Suspected ACM Identified on Site
 Information: This suspected defect is highlighted as a caution only as reporting on asbestos is outside the scope of this report. It is suspected that there is ACM (Asbestos containing material) present at, but not limited to the external cladding sheets, and some wall linings. Damage was identified to an external cladding sheet.

It is advised that the client consider a separate Asbestos Inspection and Condition Audit, which can include the taking of samples for definitive confirmation of the presence of Asbestos, carried out by a licensed Asbestos Inspector.

In the interim, the client is advised to act with caution & avoid areas of damage/deterioration due to the suspected presence of Asbestos.

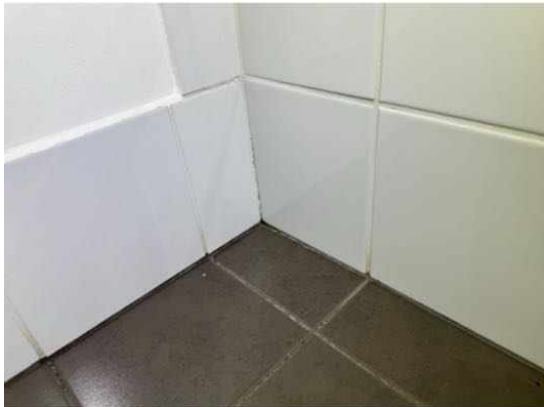
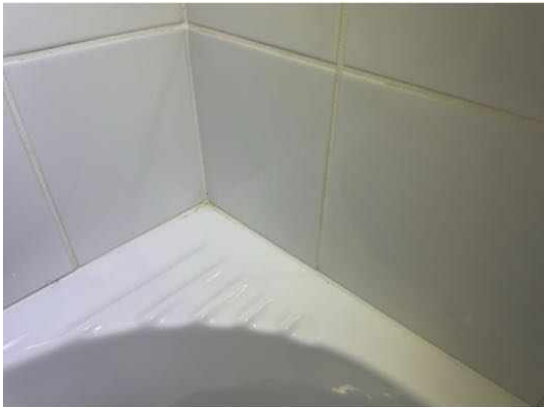
Building:	Main Building
Location:	Tiled Areas
Finding:	Sealant and grouting - Monitor & General Maintenance
Information:	It appears that the sealant and grouting in the tiled areas are slightly weathered, a common defect in houses of a similar age.

It is noted for the clients information that sealant and grouting in areas that come into regular contact with water should be maintained.

Should the sealant deteriorate further, a tiling contractor should be engaged to provide maintenance works where necessary to ensure all wet areas are sufficiently sealed.
